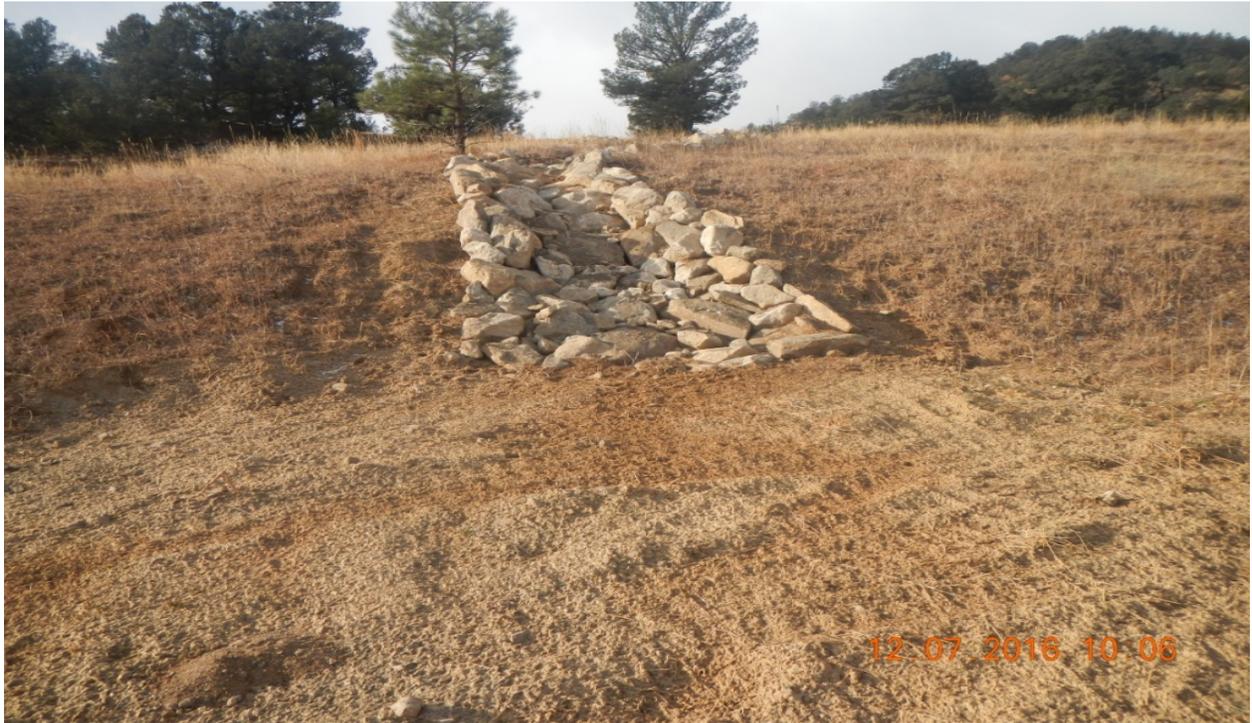
photo 1: Rock rip/rap has been added to area near the access road.

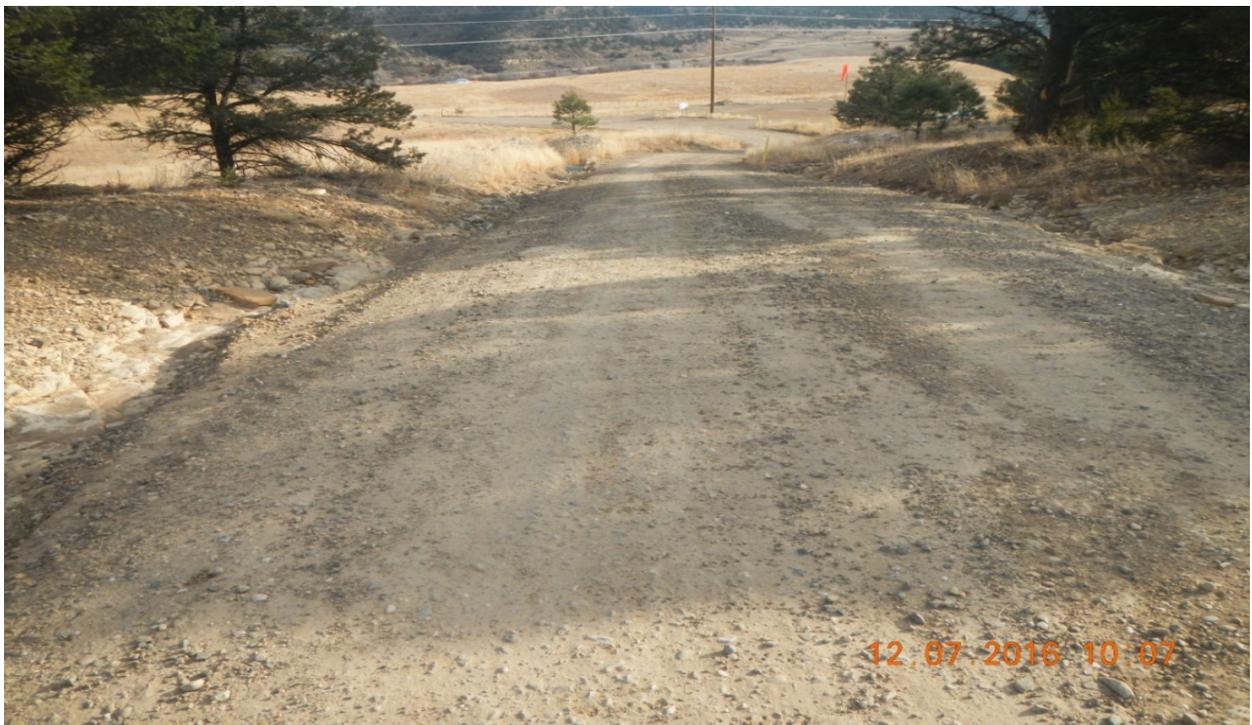
photo 2: Facing back to the northeast along the main road. Gravel has been applied to this area of the road.

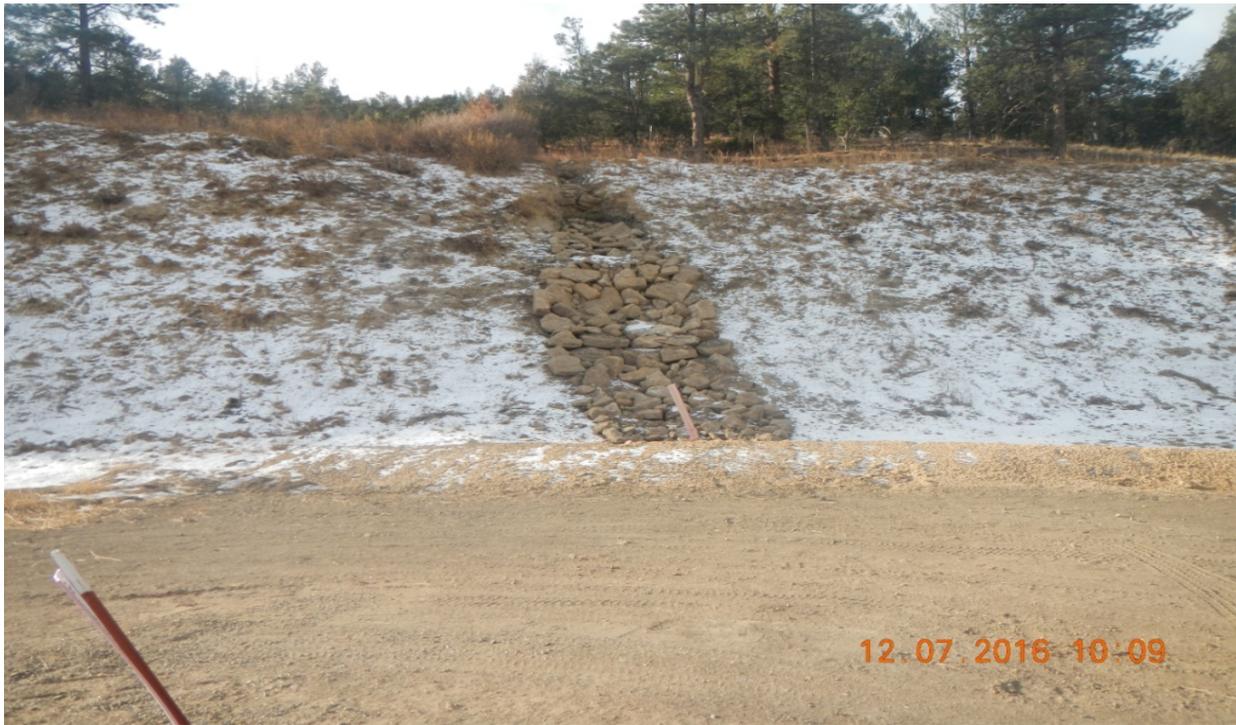
photo 3: Facing toward the southwest side of the location.

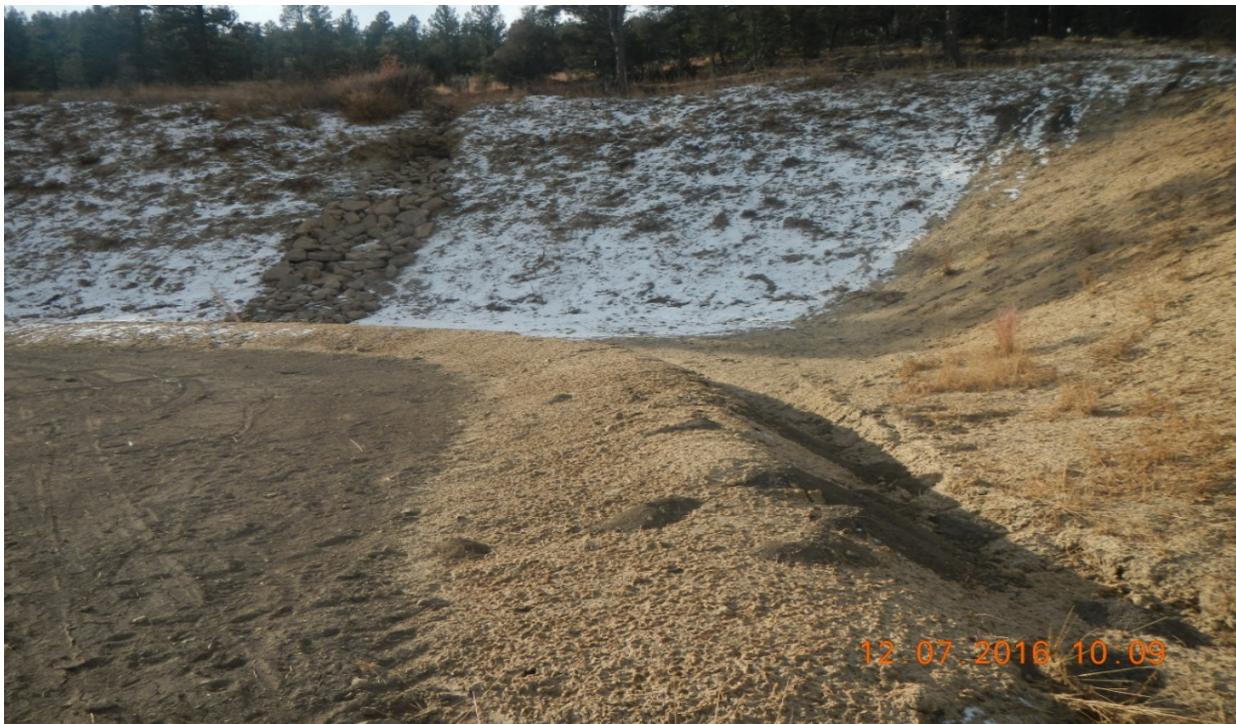
photo 4: Facing toward the southwest side of the location.
