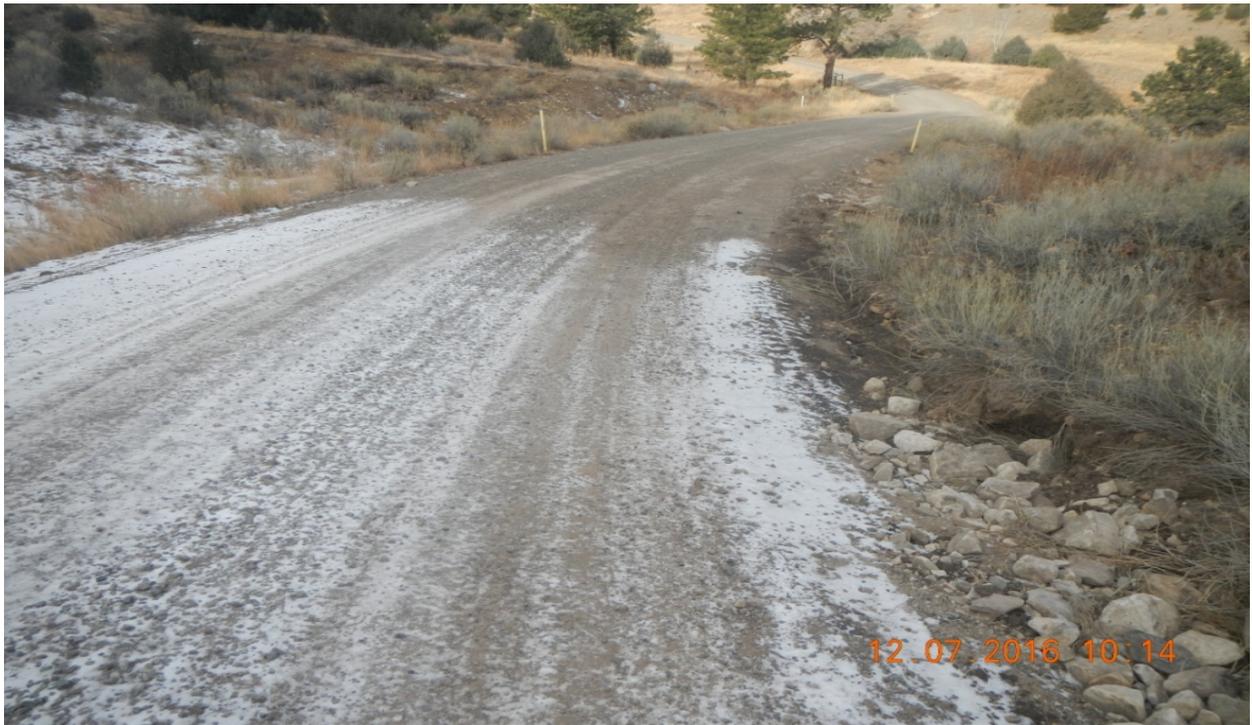
**photo 1:** Facing west along the main access road.

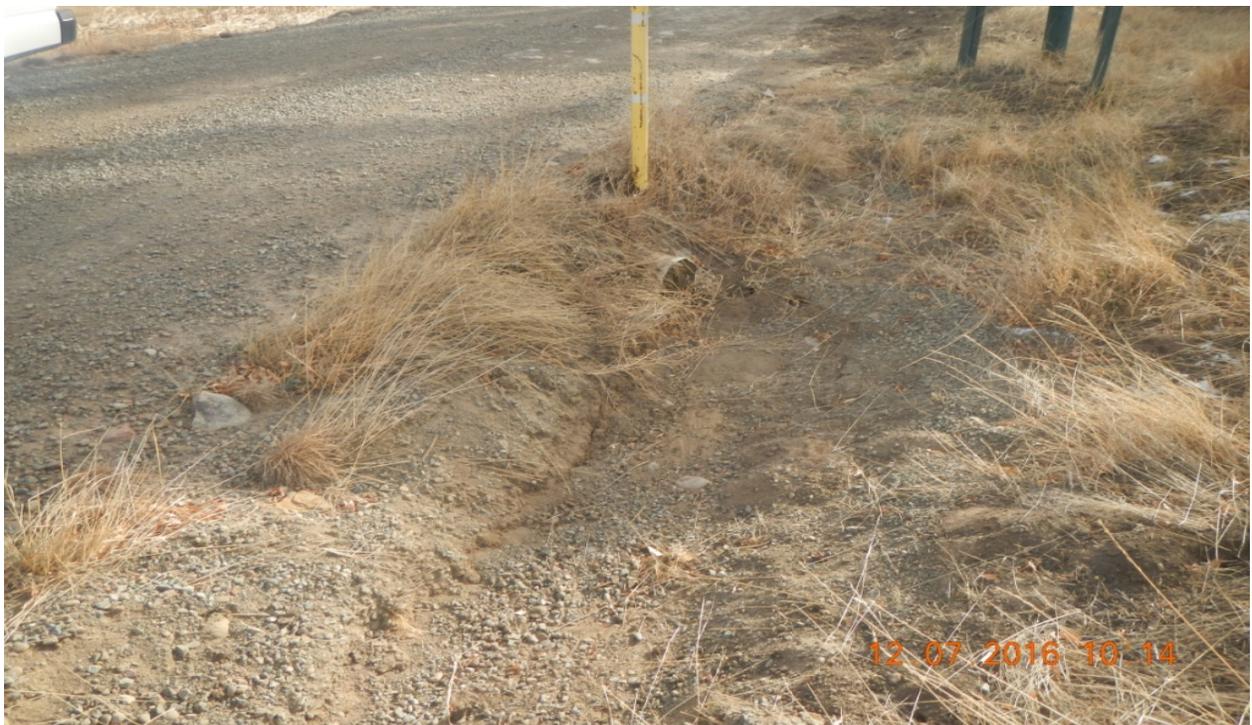
**photo 2:** The culvert along the access road is maintained.

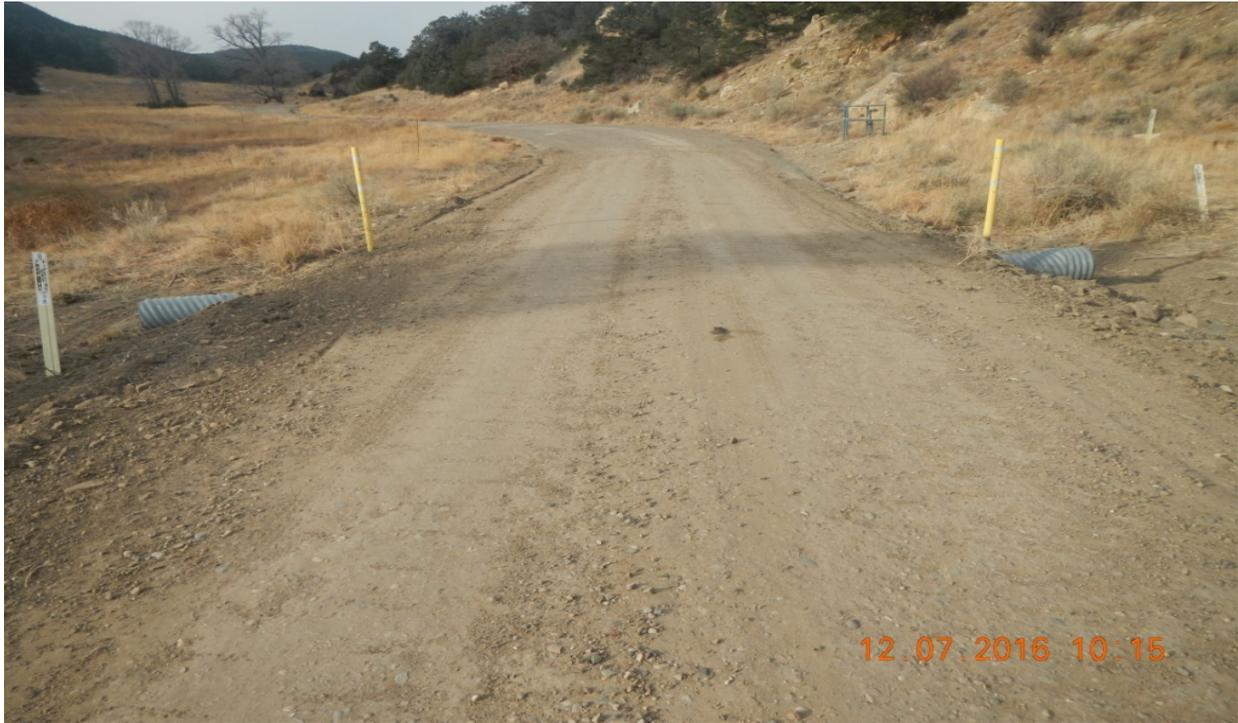
**photo 3:** Facing southwest along the main access road. Gravel was applied and the culvert is maintained.

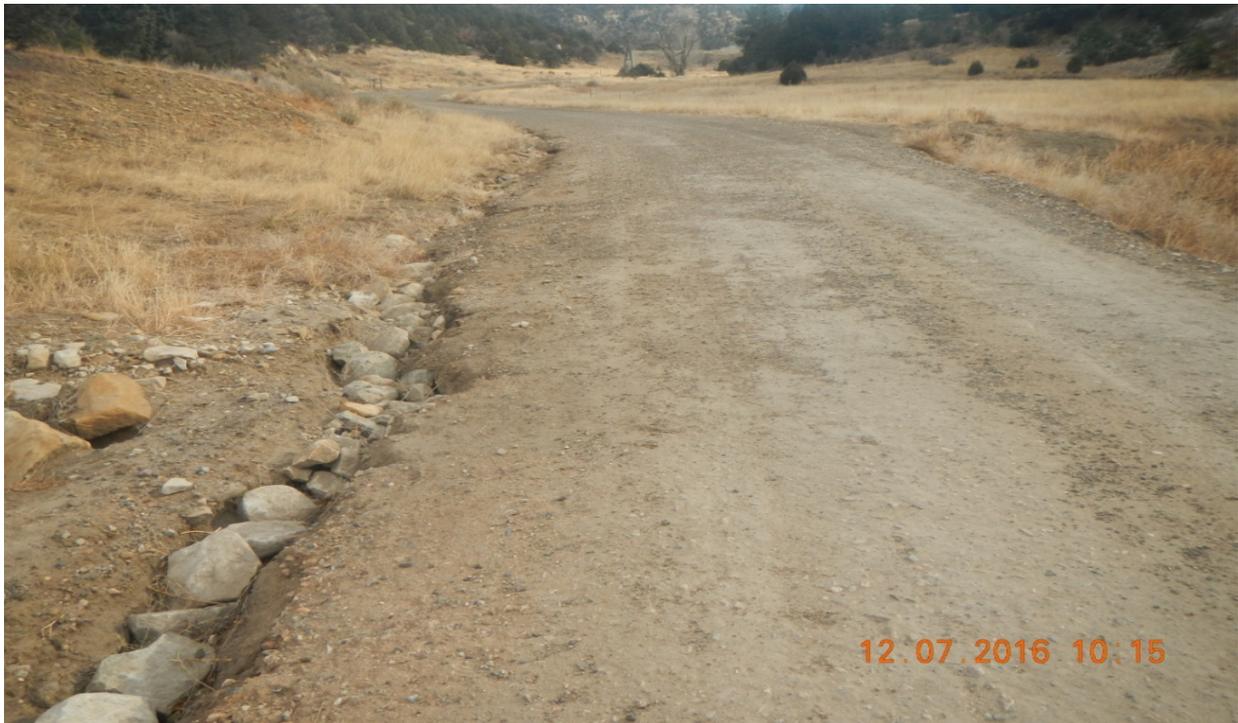
**photo 4:** Facing back to the northeast along the road. Erosion along the side of the road was repaired.

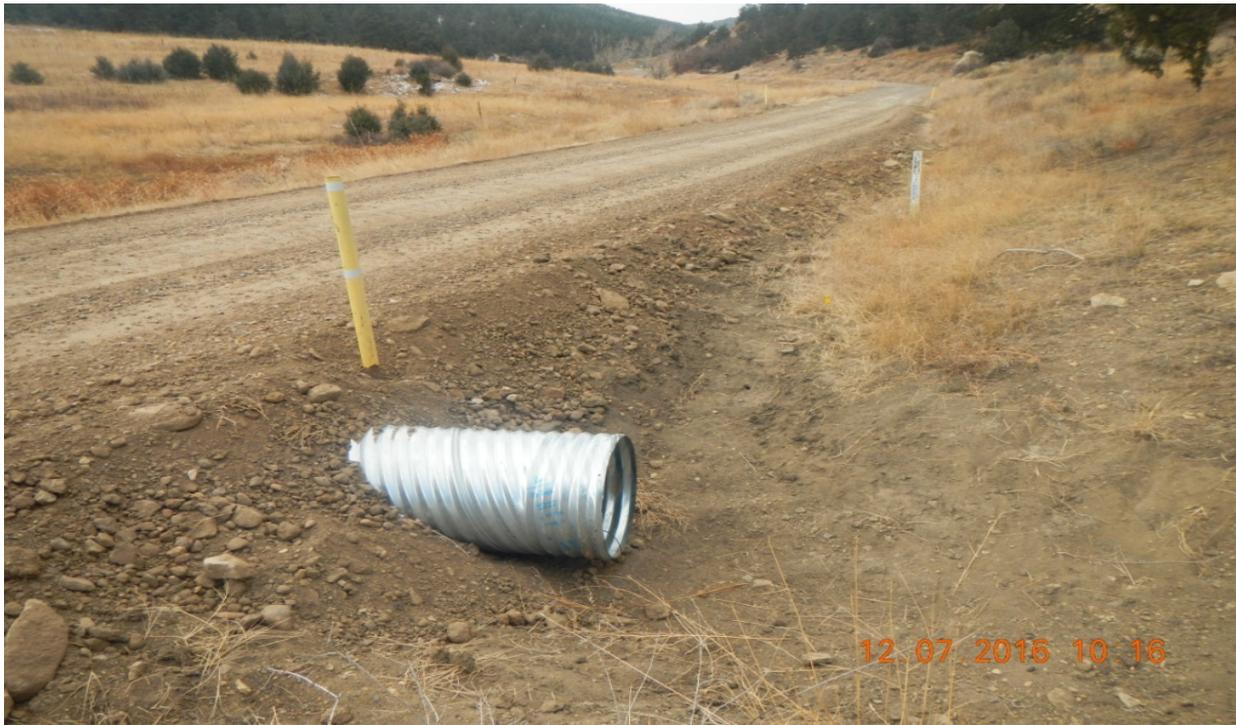
**photo 5:** A new culvert was installed along the road.

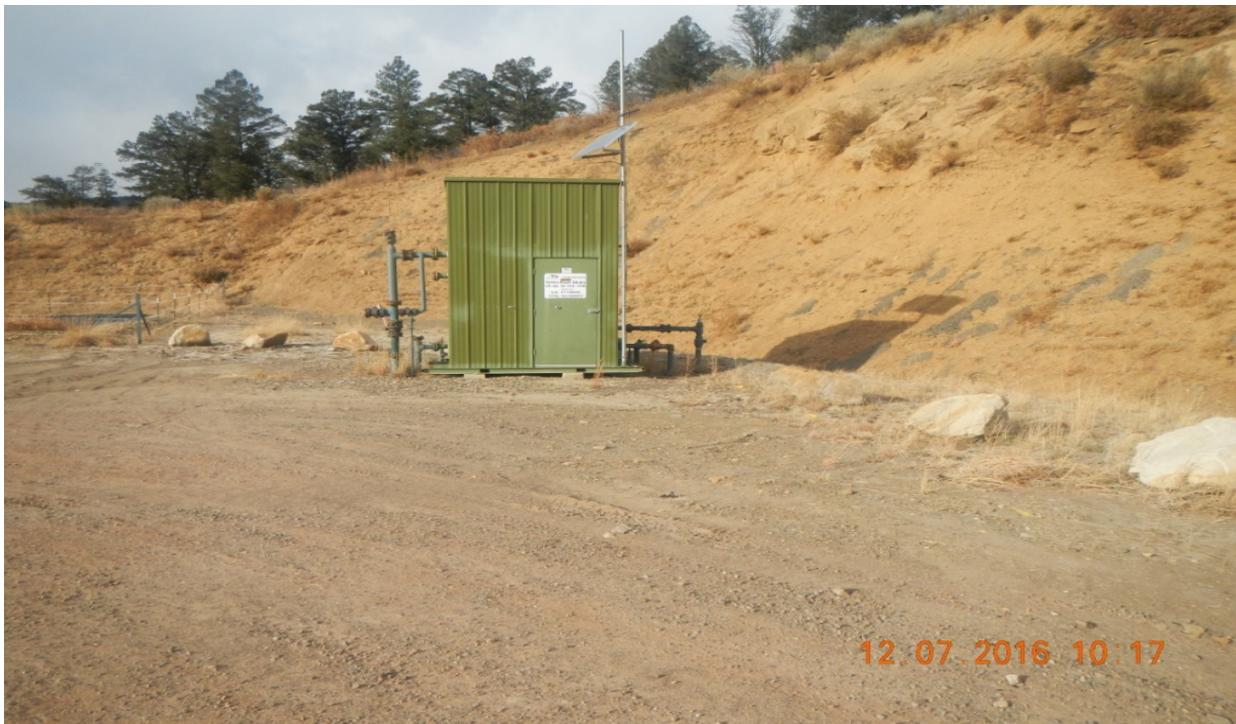
**photo 6:** Facing southwest toward the location. The cut slope has been seeded and hydromulched.
