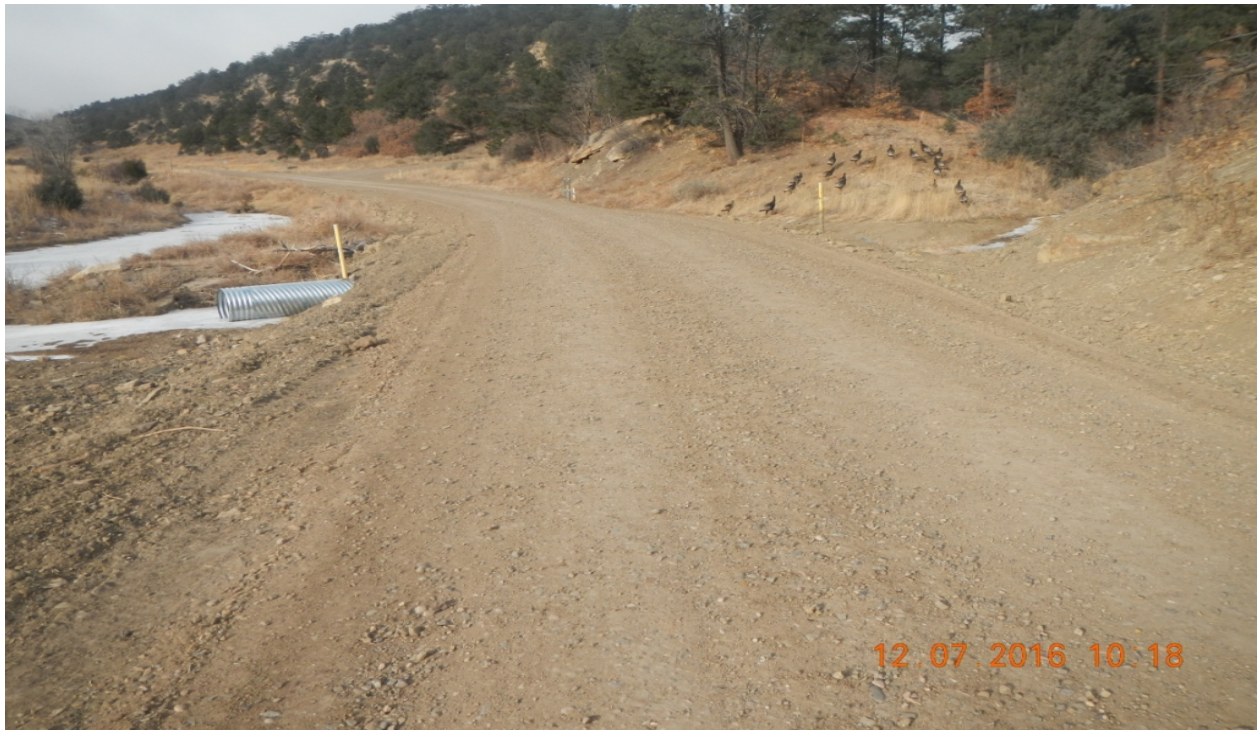
photo 1: Facing west along the main access road. A new culvert has been installed along the road and gravel has been applied.

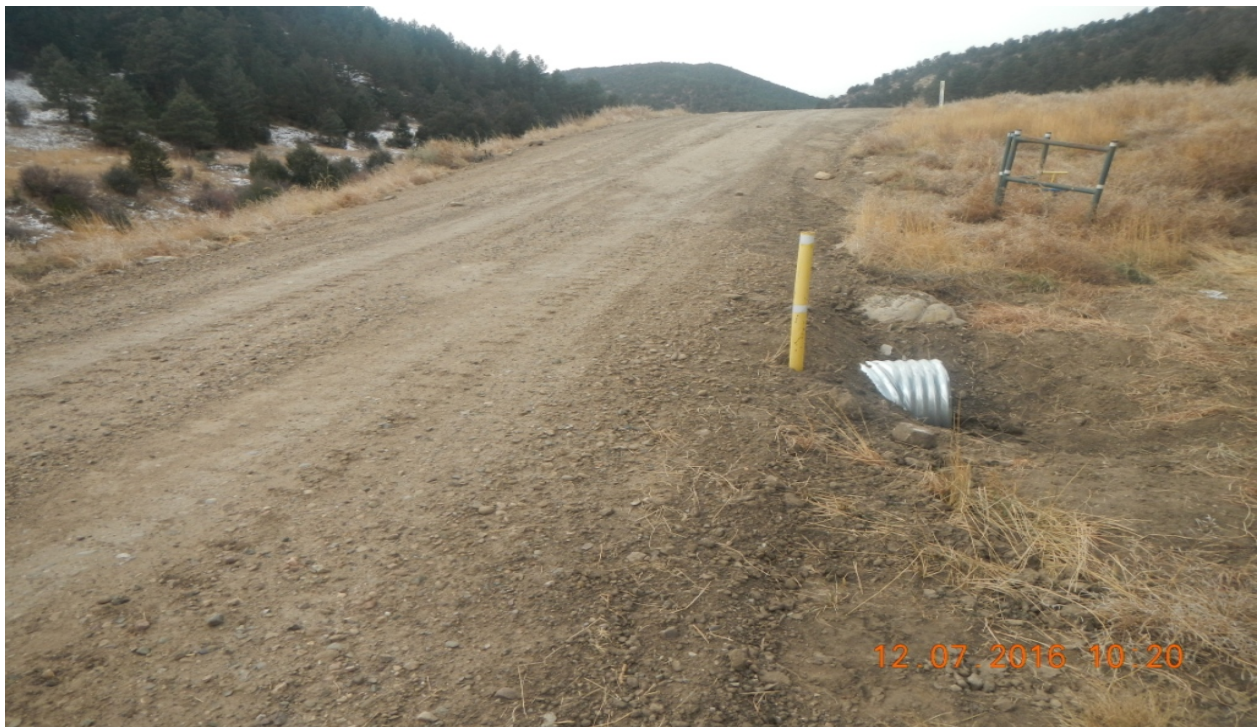
photo 2: Facing west along the main access road. A new culvert has been installed along the road and gravel has been applied.

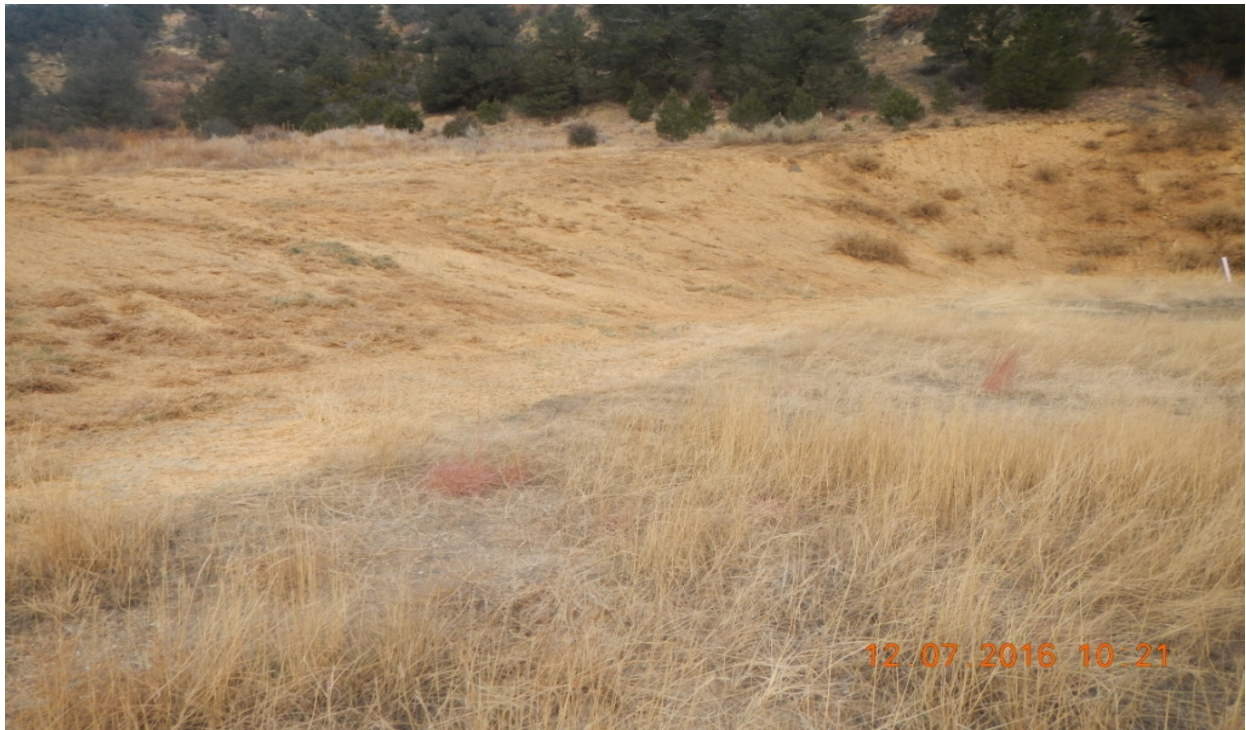
photo 3: Facing toward the northwest cut slope which was seeded and hydro-mulched.
