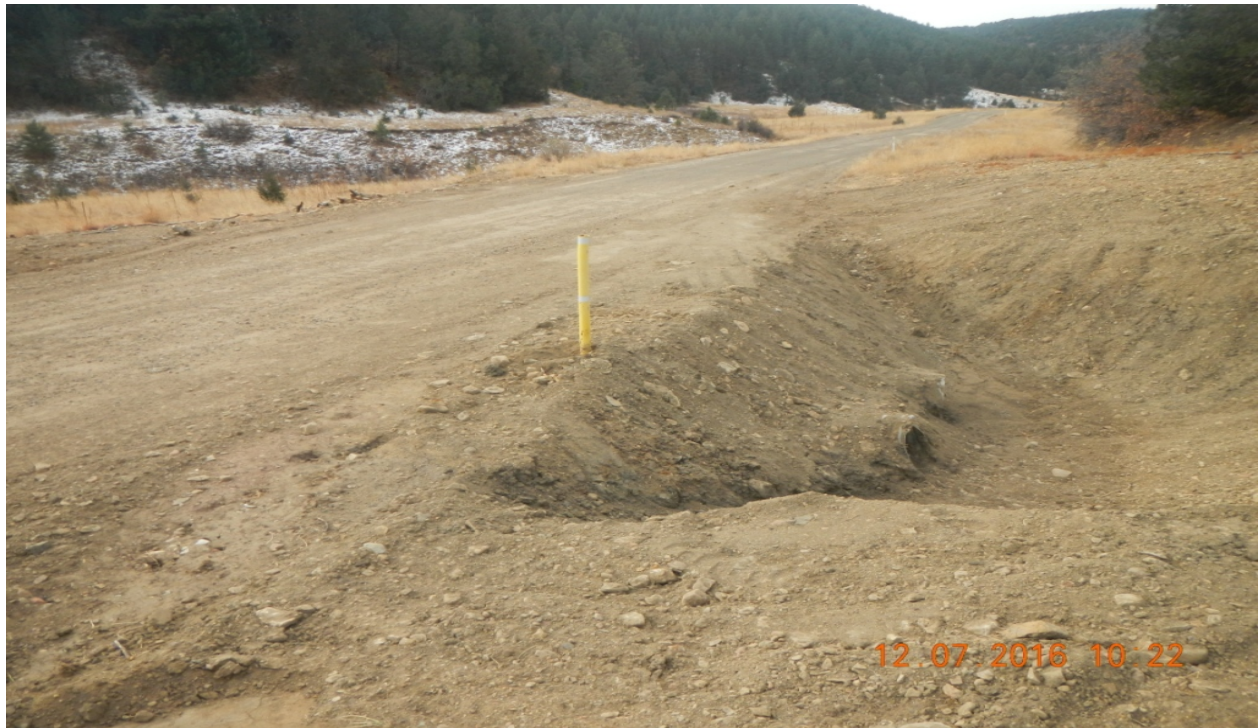
**photo 1:** Facing west along the main access road. The culverts are maintained.

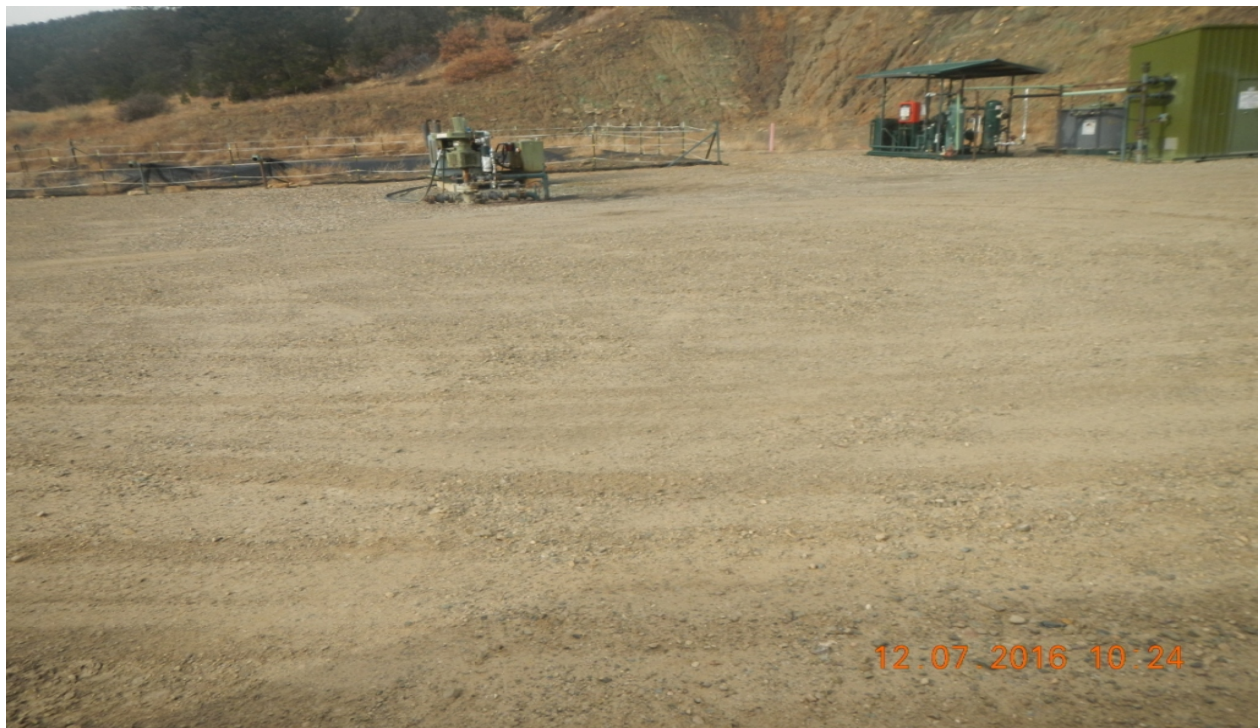
**photo 2:** Facing west toward the location.
