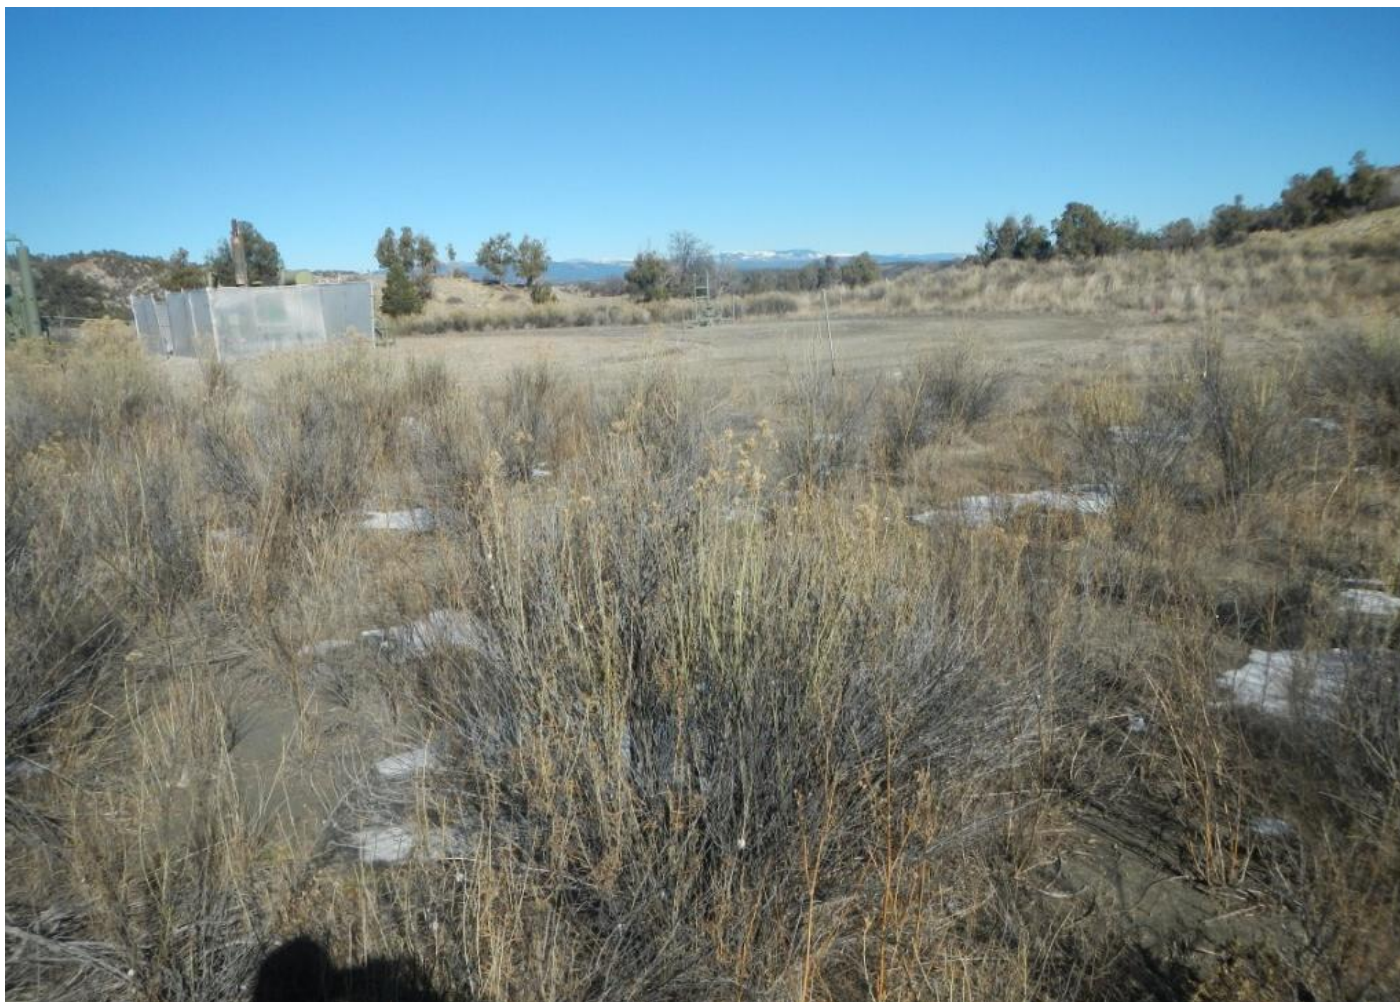
Photo 1. View of the project area from the southwestern corner facing center.

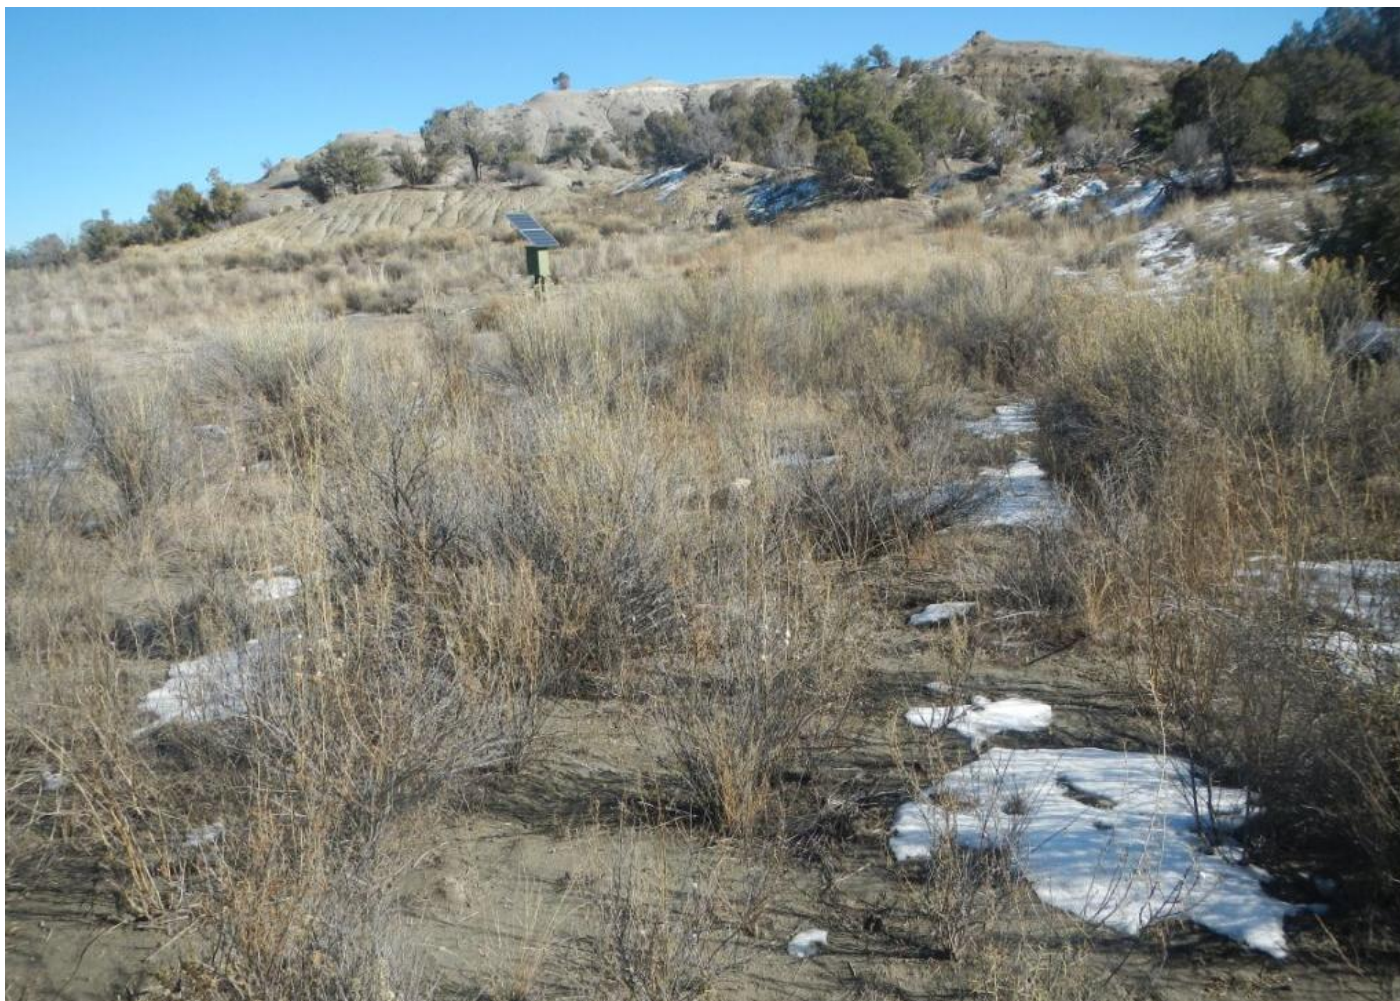
Photo 2. View of the southern portion of the project area from the southwestern corner facing eastward. Interim reclamation areas are revegetating with desirable species such as rubber rabbitbrush (*Chrysothamnus nauseosus*), Indian ricegrass (*Achnatherum hymenoides*), and dropseed (*Sporobolus* sp.).

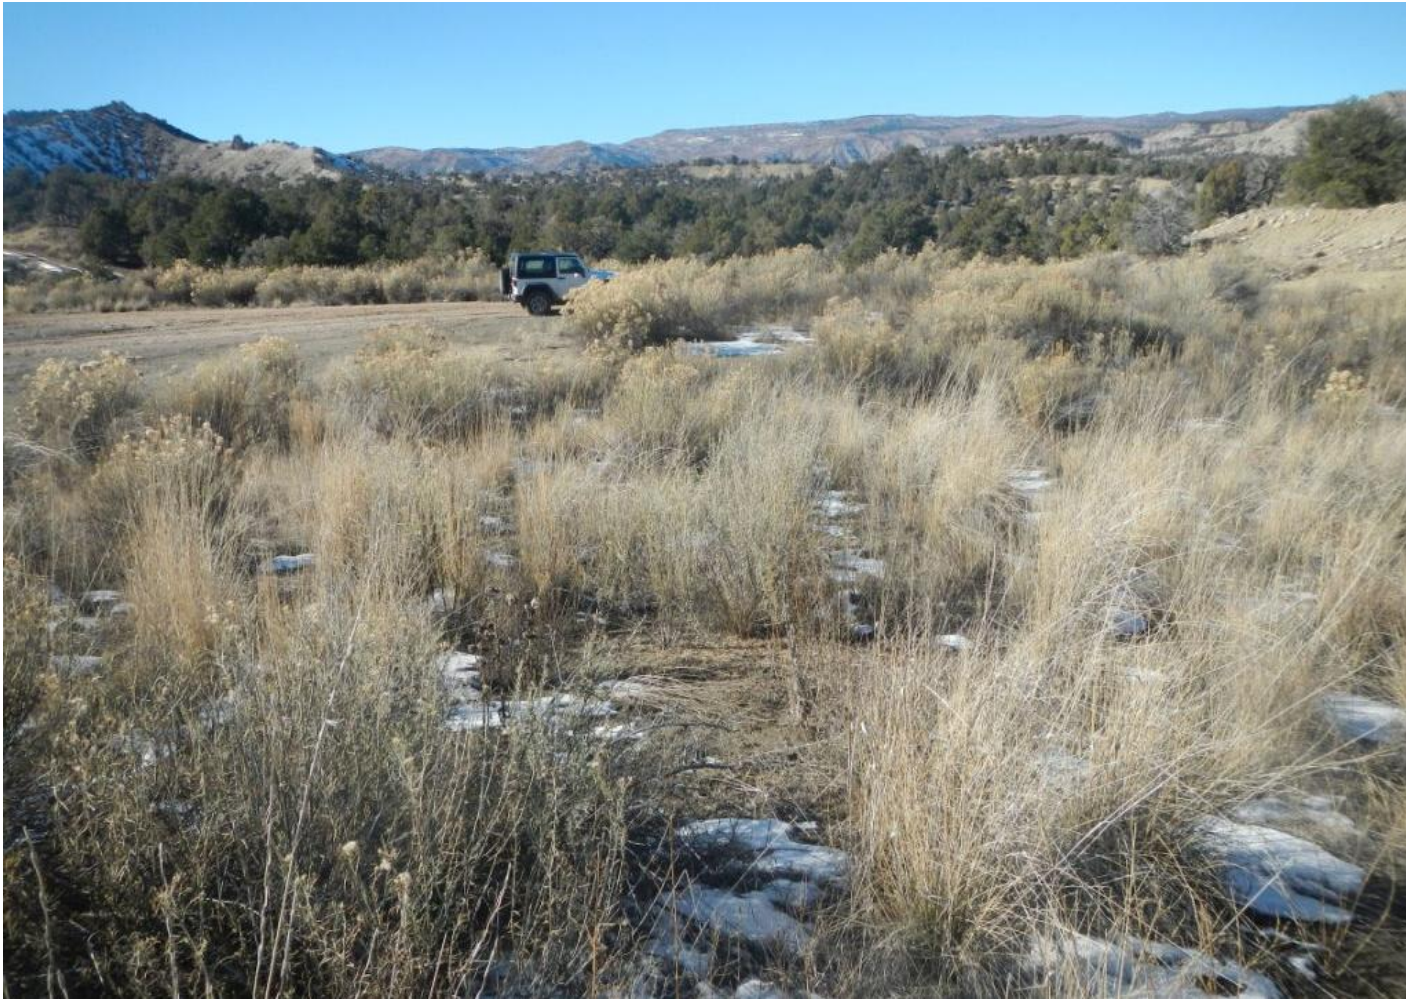
Photo 3. View of the northern portion of the project area from the northeastern corner facing westward.

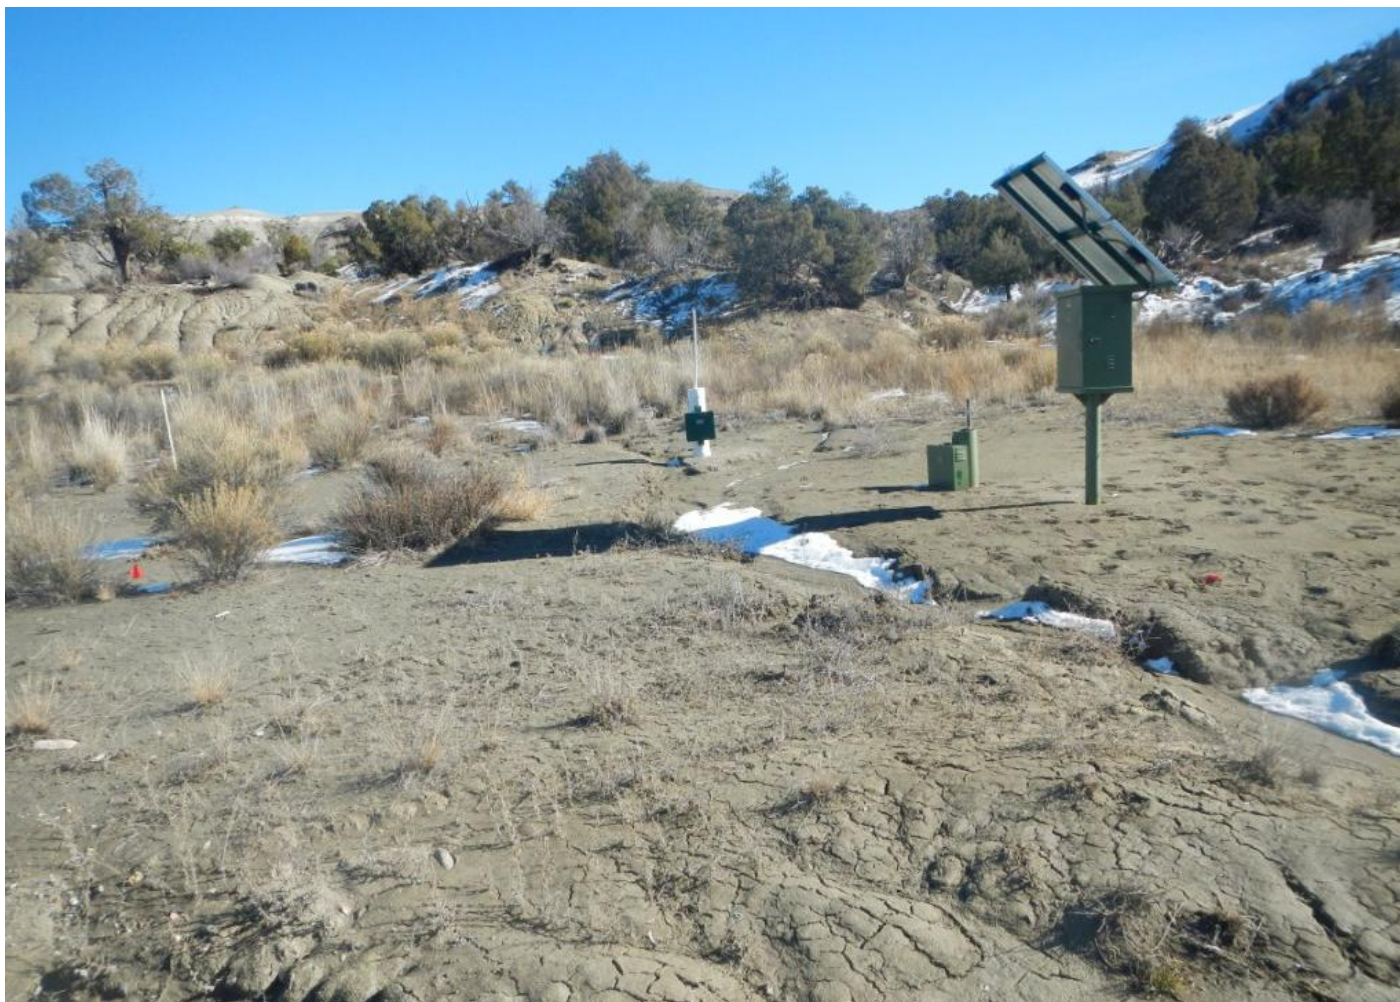
Photo 4. View of erosional channels in the southeastern portion of the project area that needs stabilization, facing upstream.

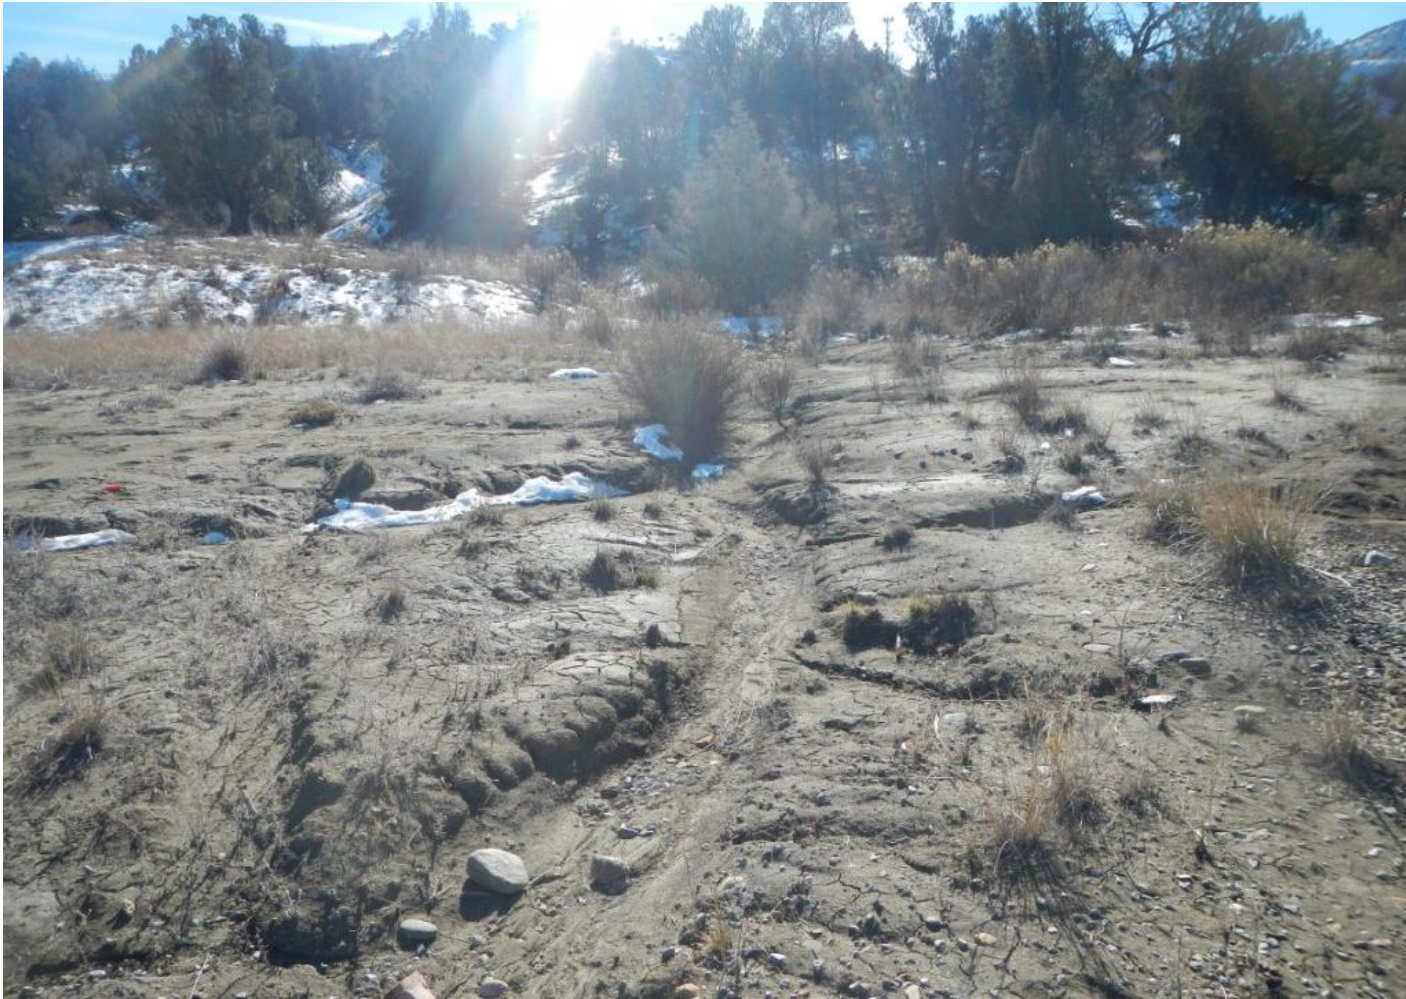
Photo 5. View of erosional channels in the southeastern portion of the project area that needs stabilization, facing downstream.

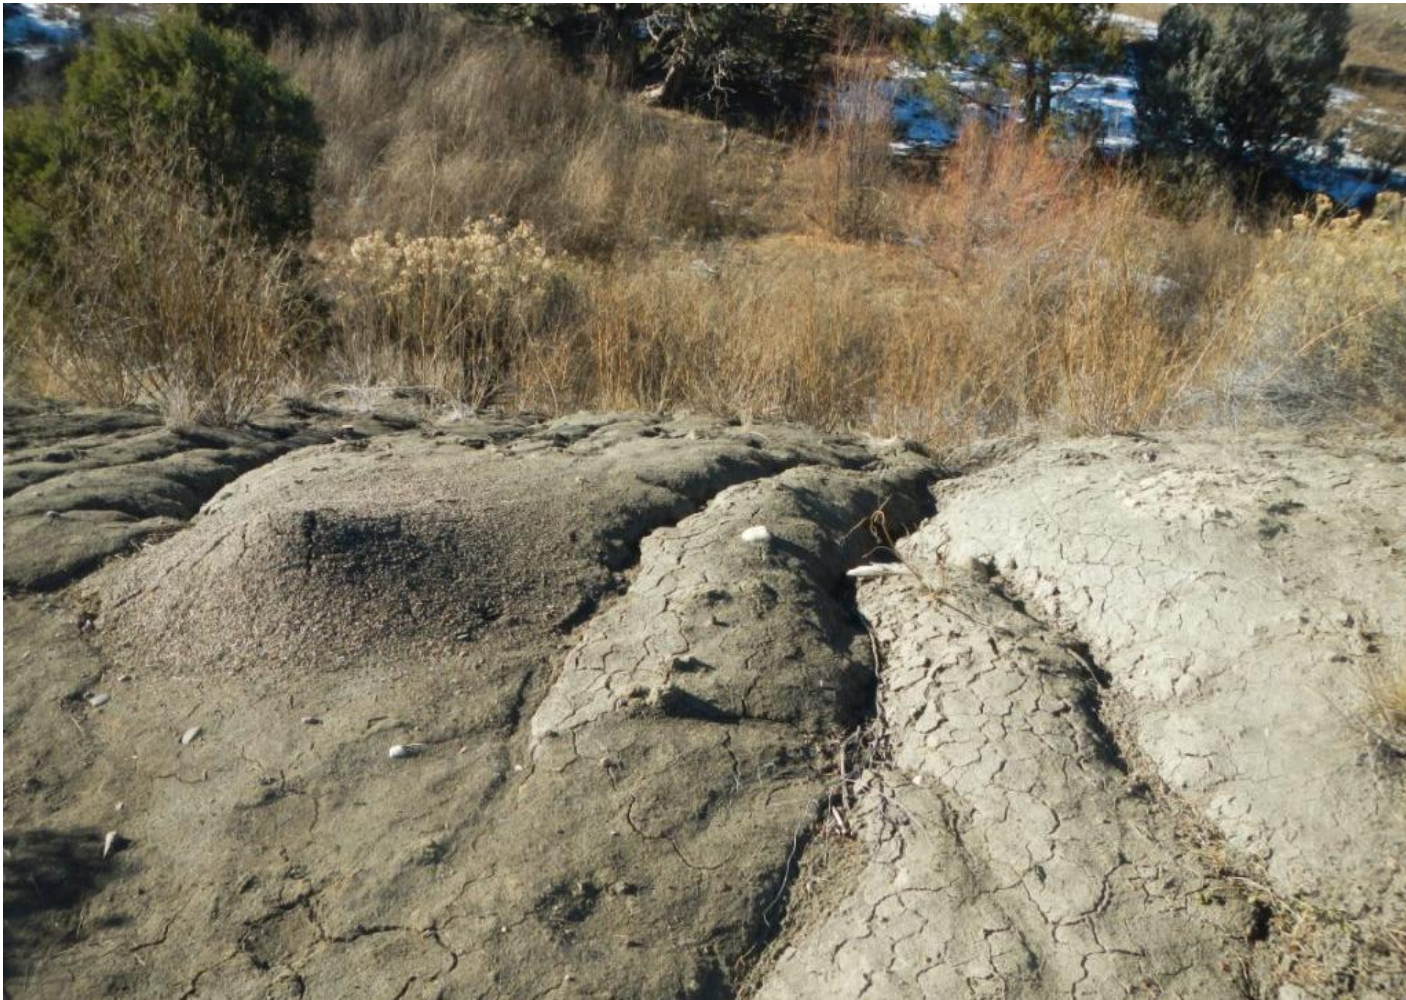
Photo 6. View of rilling that is occurring in the eastern fill slope. Additional reinforcement is needed to reduce the energy of surface flows from the well pad.

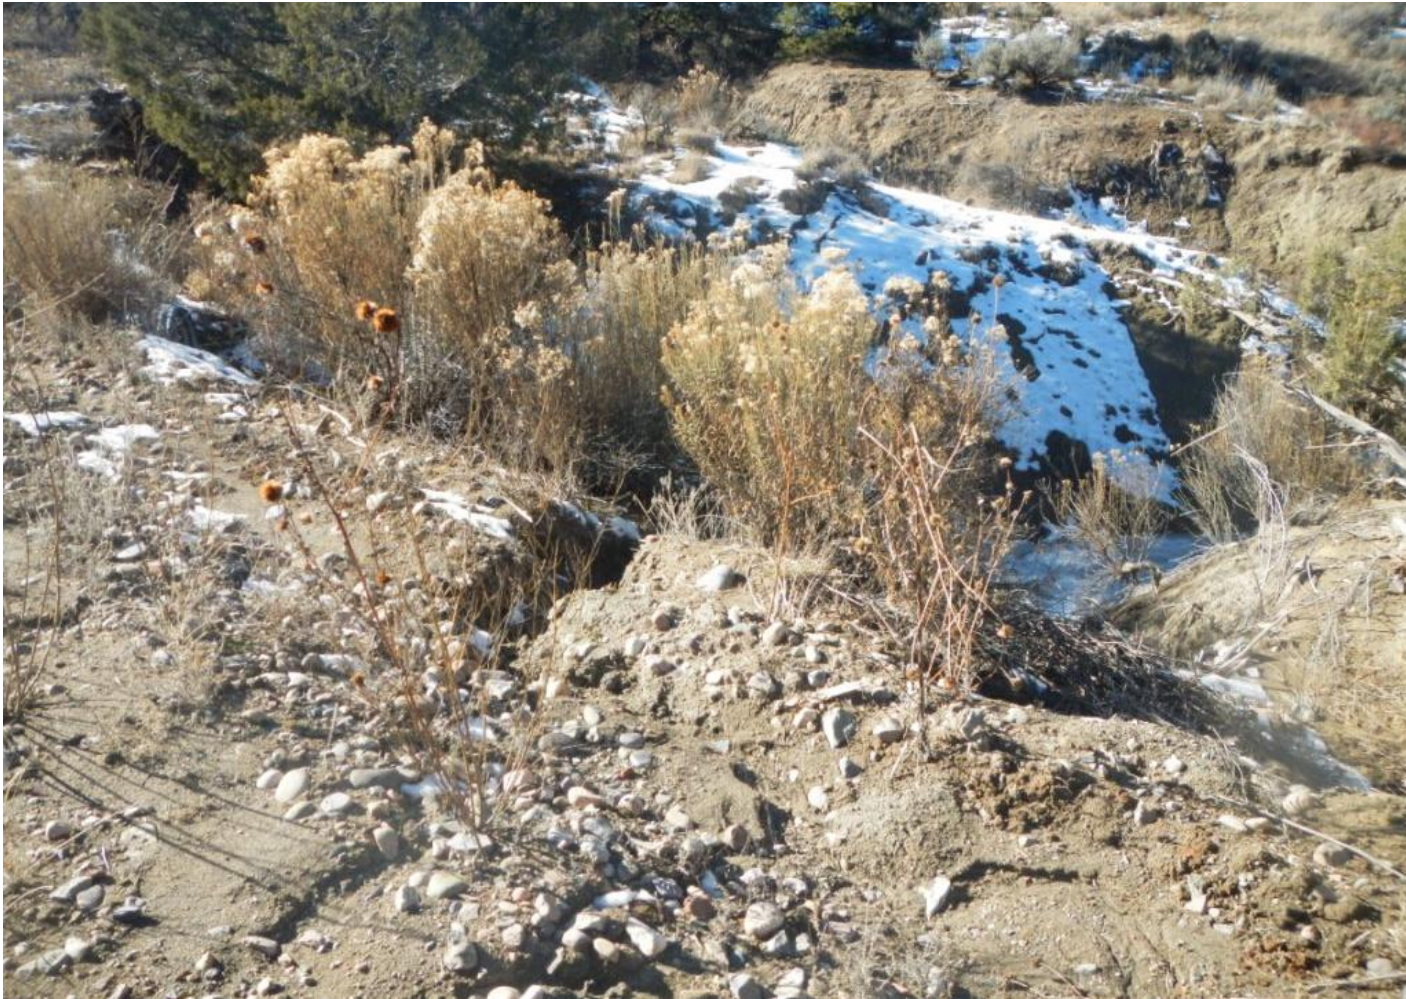
Photo 7. View of area along access road that is eroding and needs stabilization. This is where the access crosses over a drainage approximately 210 feet before the well pad entrance.

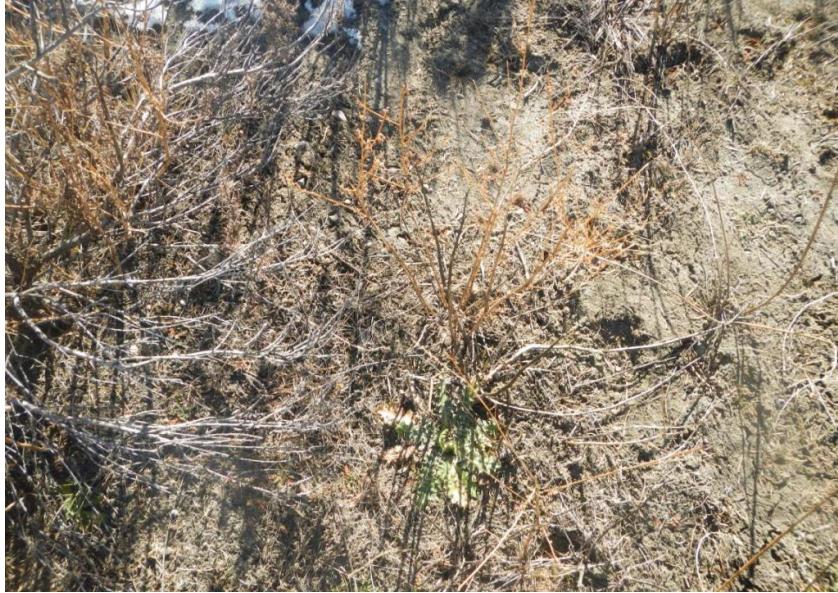
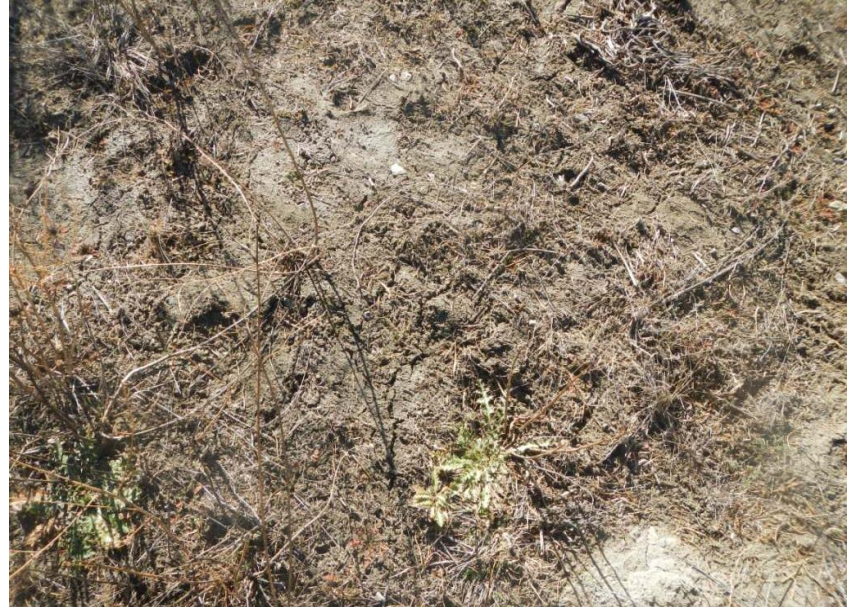
Photo 7. View of musk thistles (*Carduus nutans*) growing within the western portion of the interim reclamation area.
