# Final Reclamation & Stormwater Inspection

12/13/2016

Operator: Petro-Canada #72085

Location ID: 311664

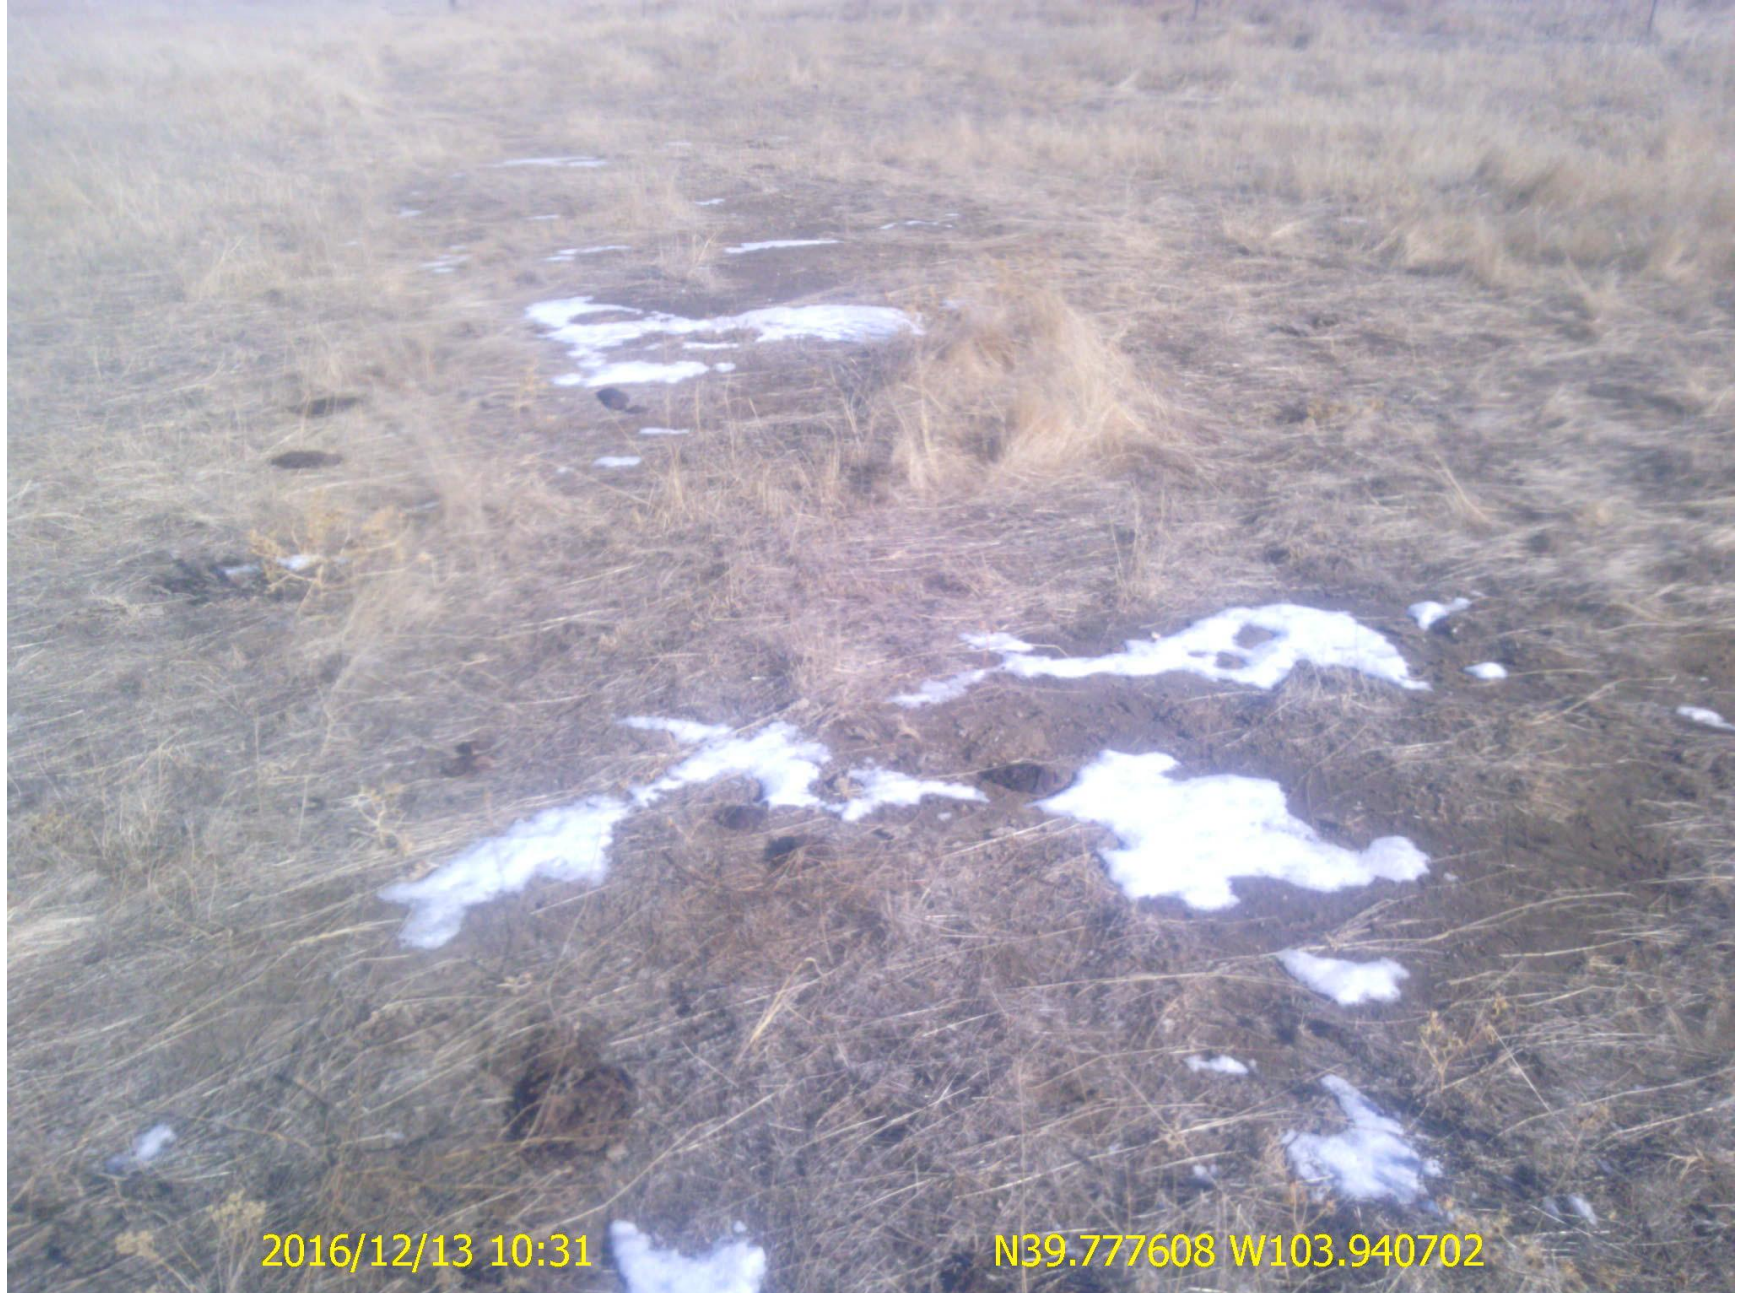
**Figure 2:** Photo taken west (down slope) of the fenced remediation area, facing east. Photo shows large unvegetated areas . Refer to photos from inspection Doc. # 682500938 for additional details.

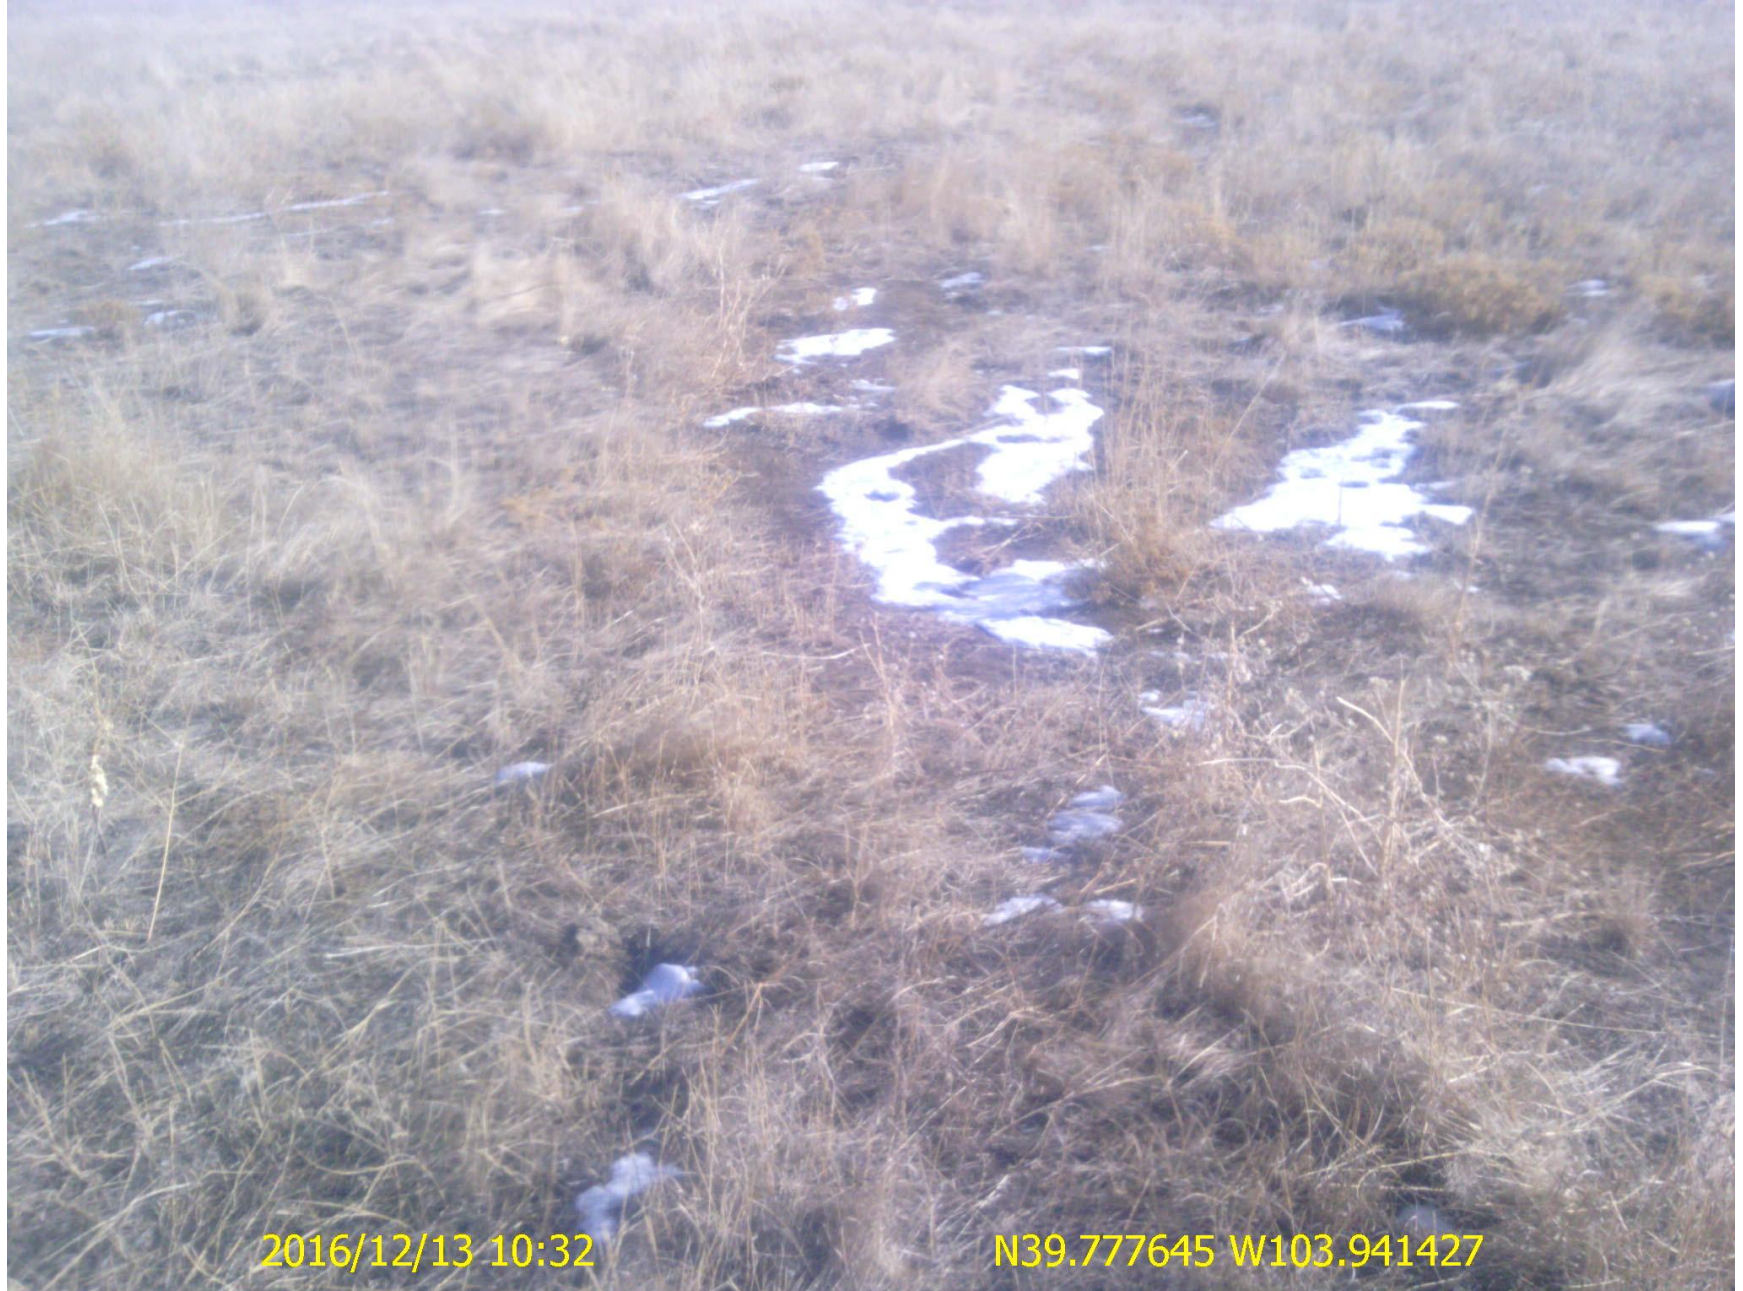
**Figure 3:** : Photo taken west (down slope) of the fenced remediation area, facing east. Photo shows large unvegetated areas . Refer to photos from inspection Doc. # 682500938 for additional details.

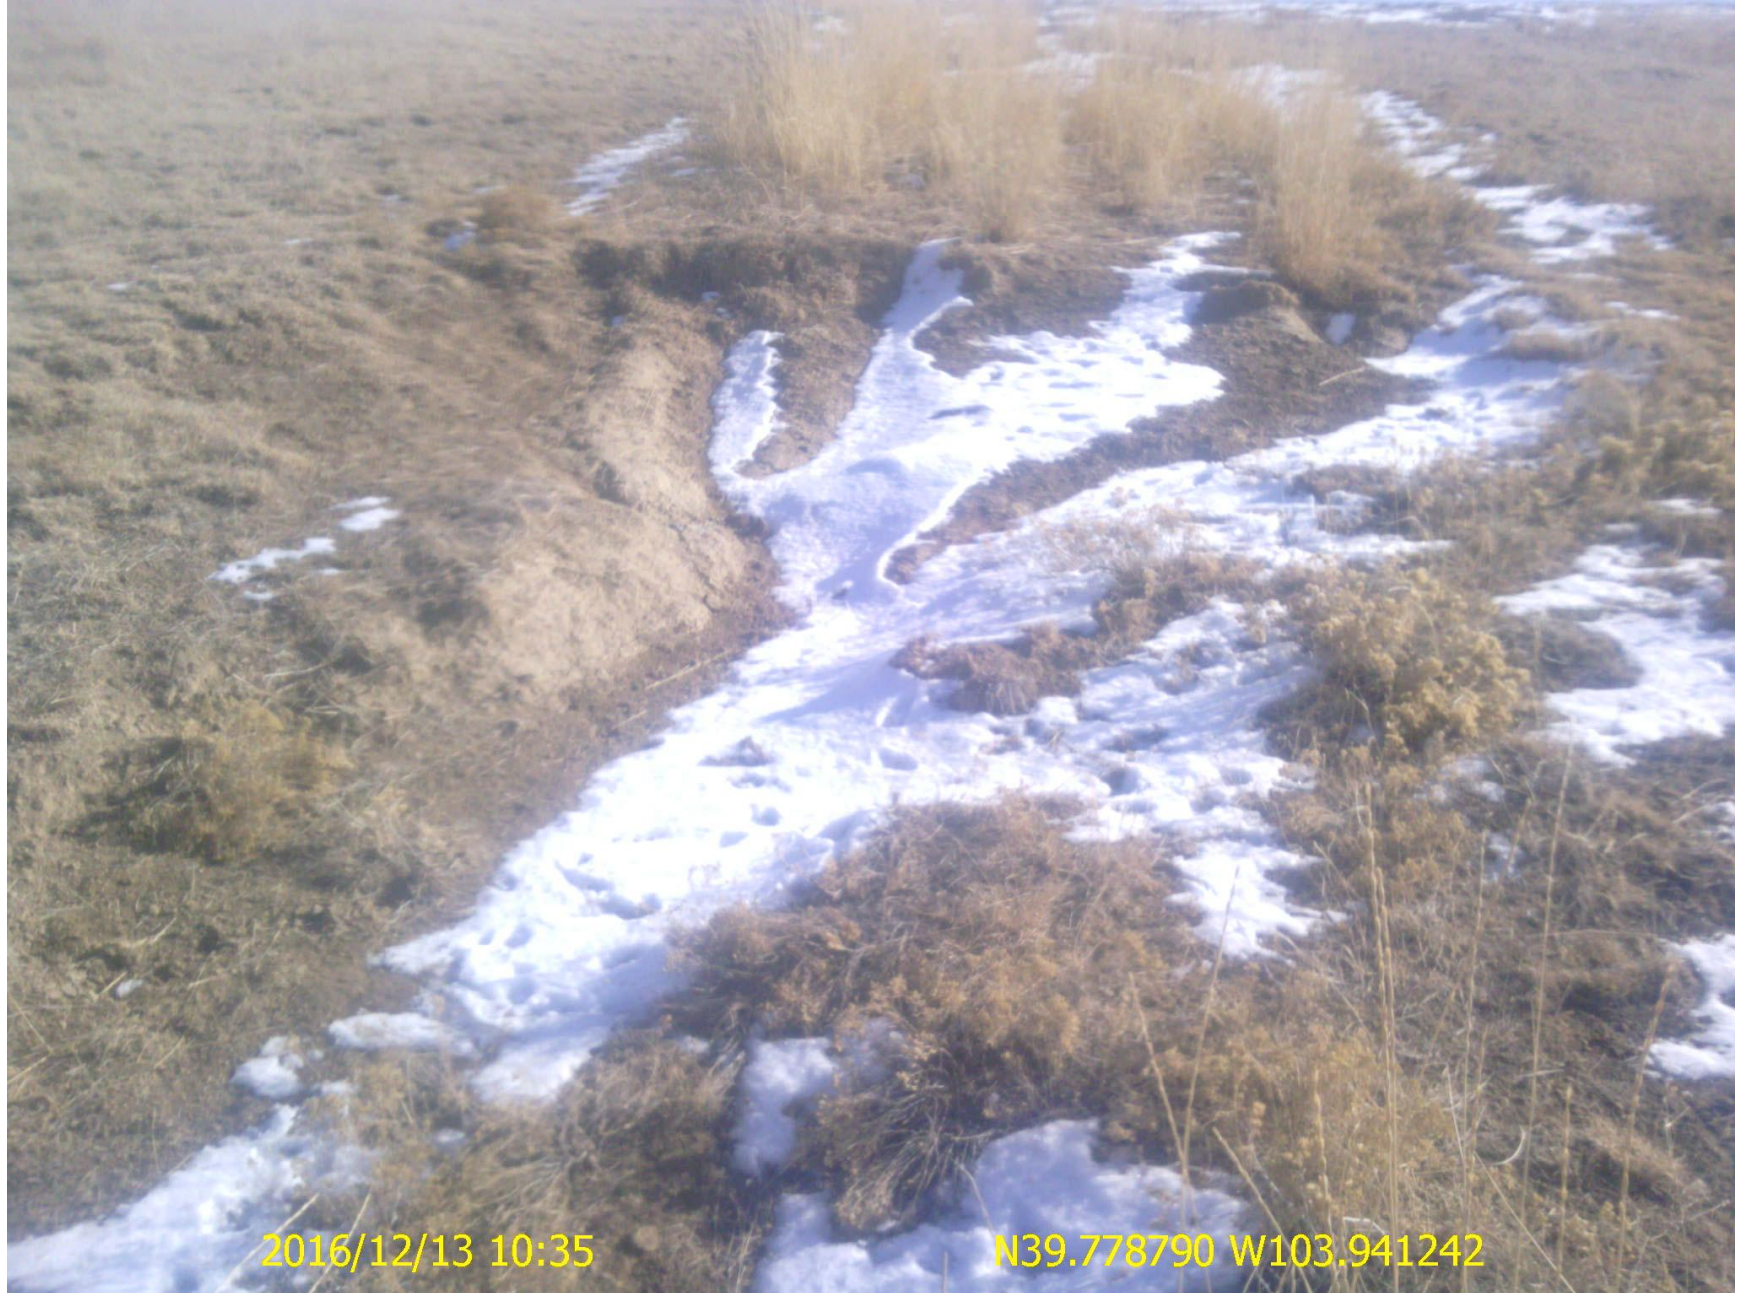
**Figure 4:** Photo taken from the northern disturbance area, facing east towards the access road. Photo shows erosion has not been stabilized. Refer to photos from inspection Doc. # 682500938 for additional details.

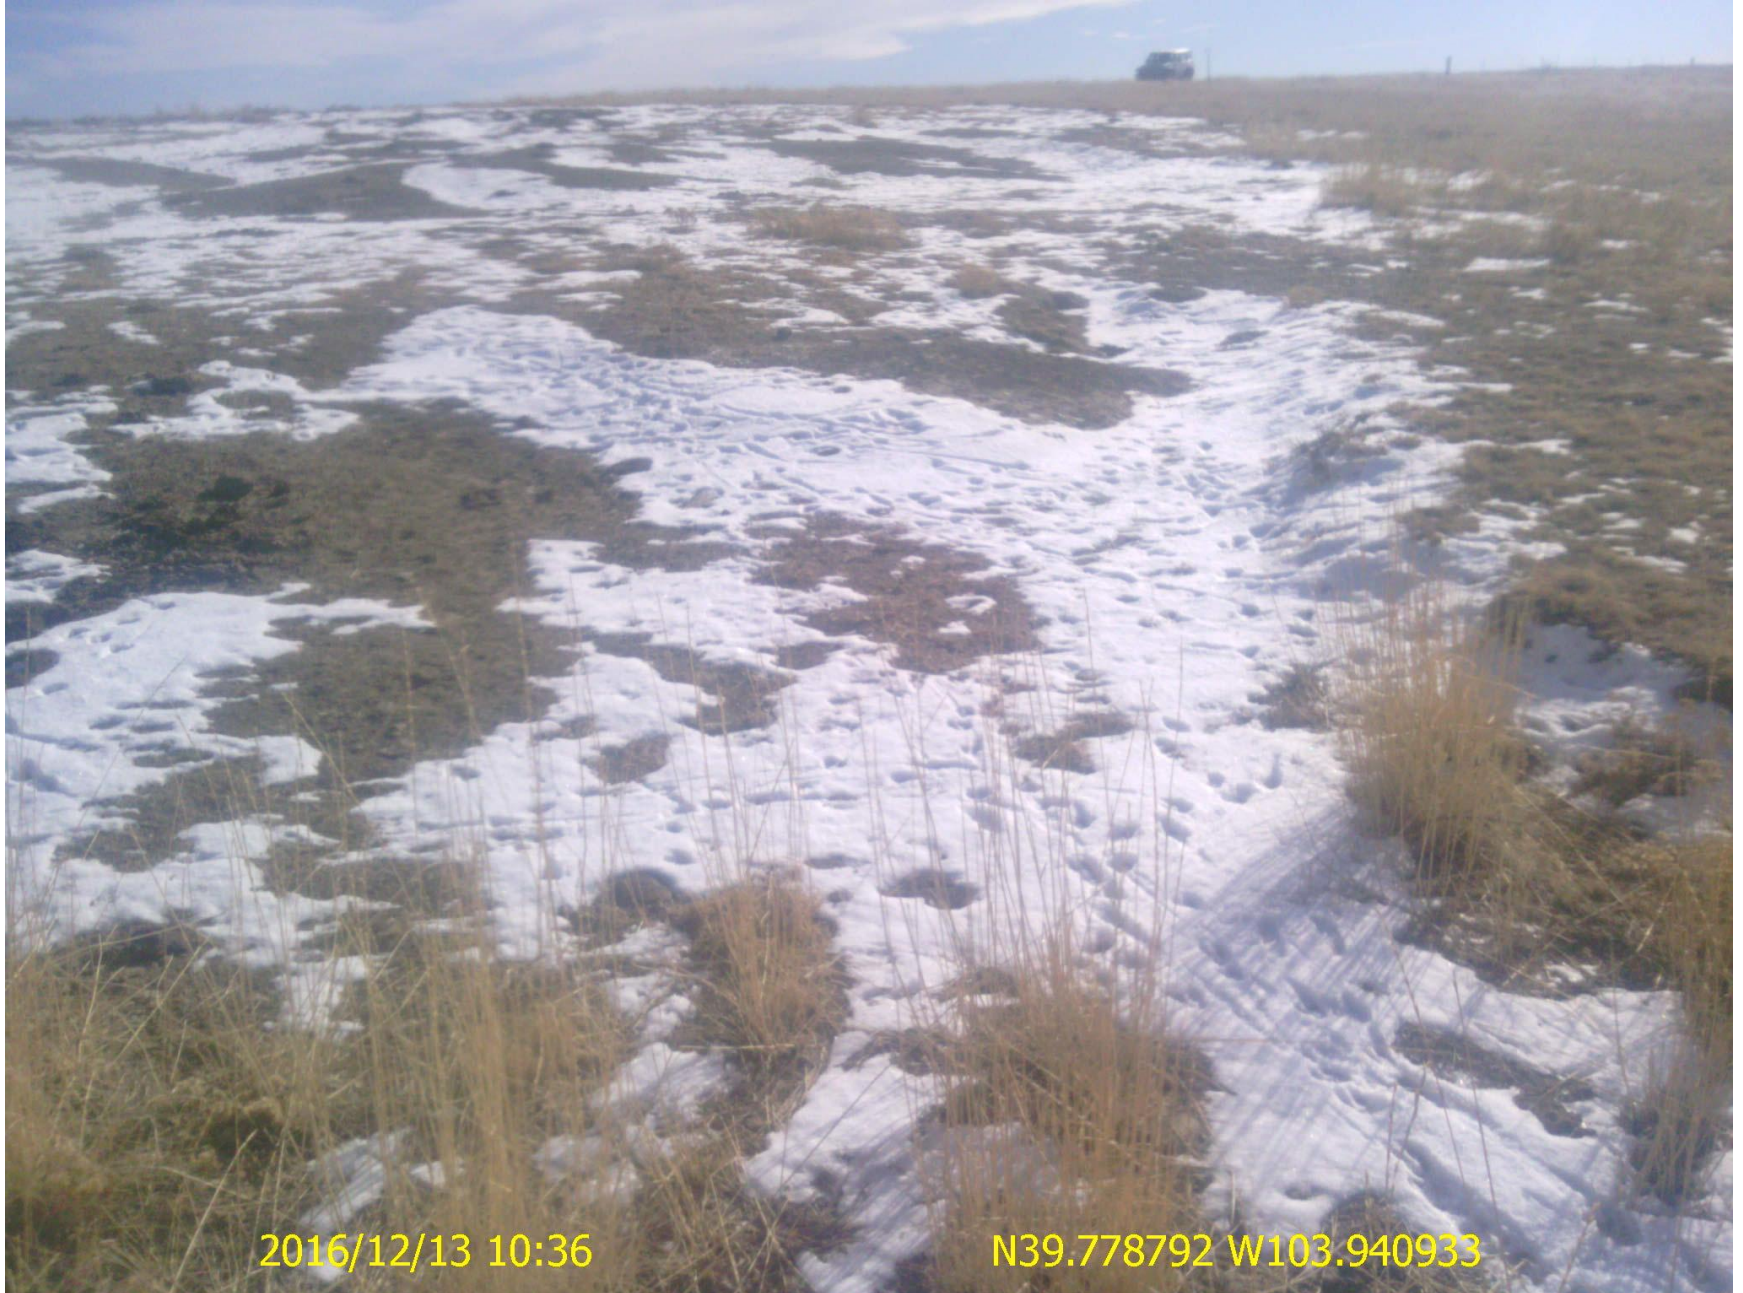
**Figure 5:** Photo taken from the northern disturbance area, facing east towards the access road. Photo shows erosion has not been stabilized or reclaimed. Refer to photos from inspection Doc. # 682500938 for additional details.

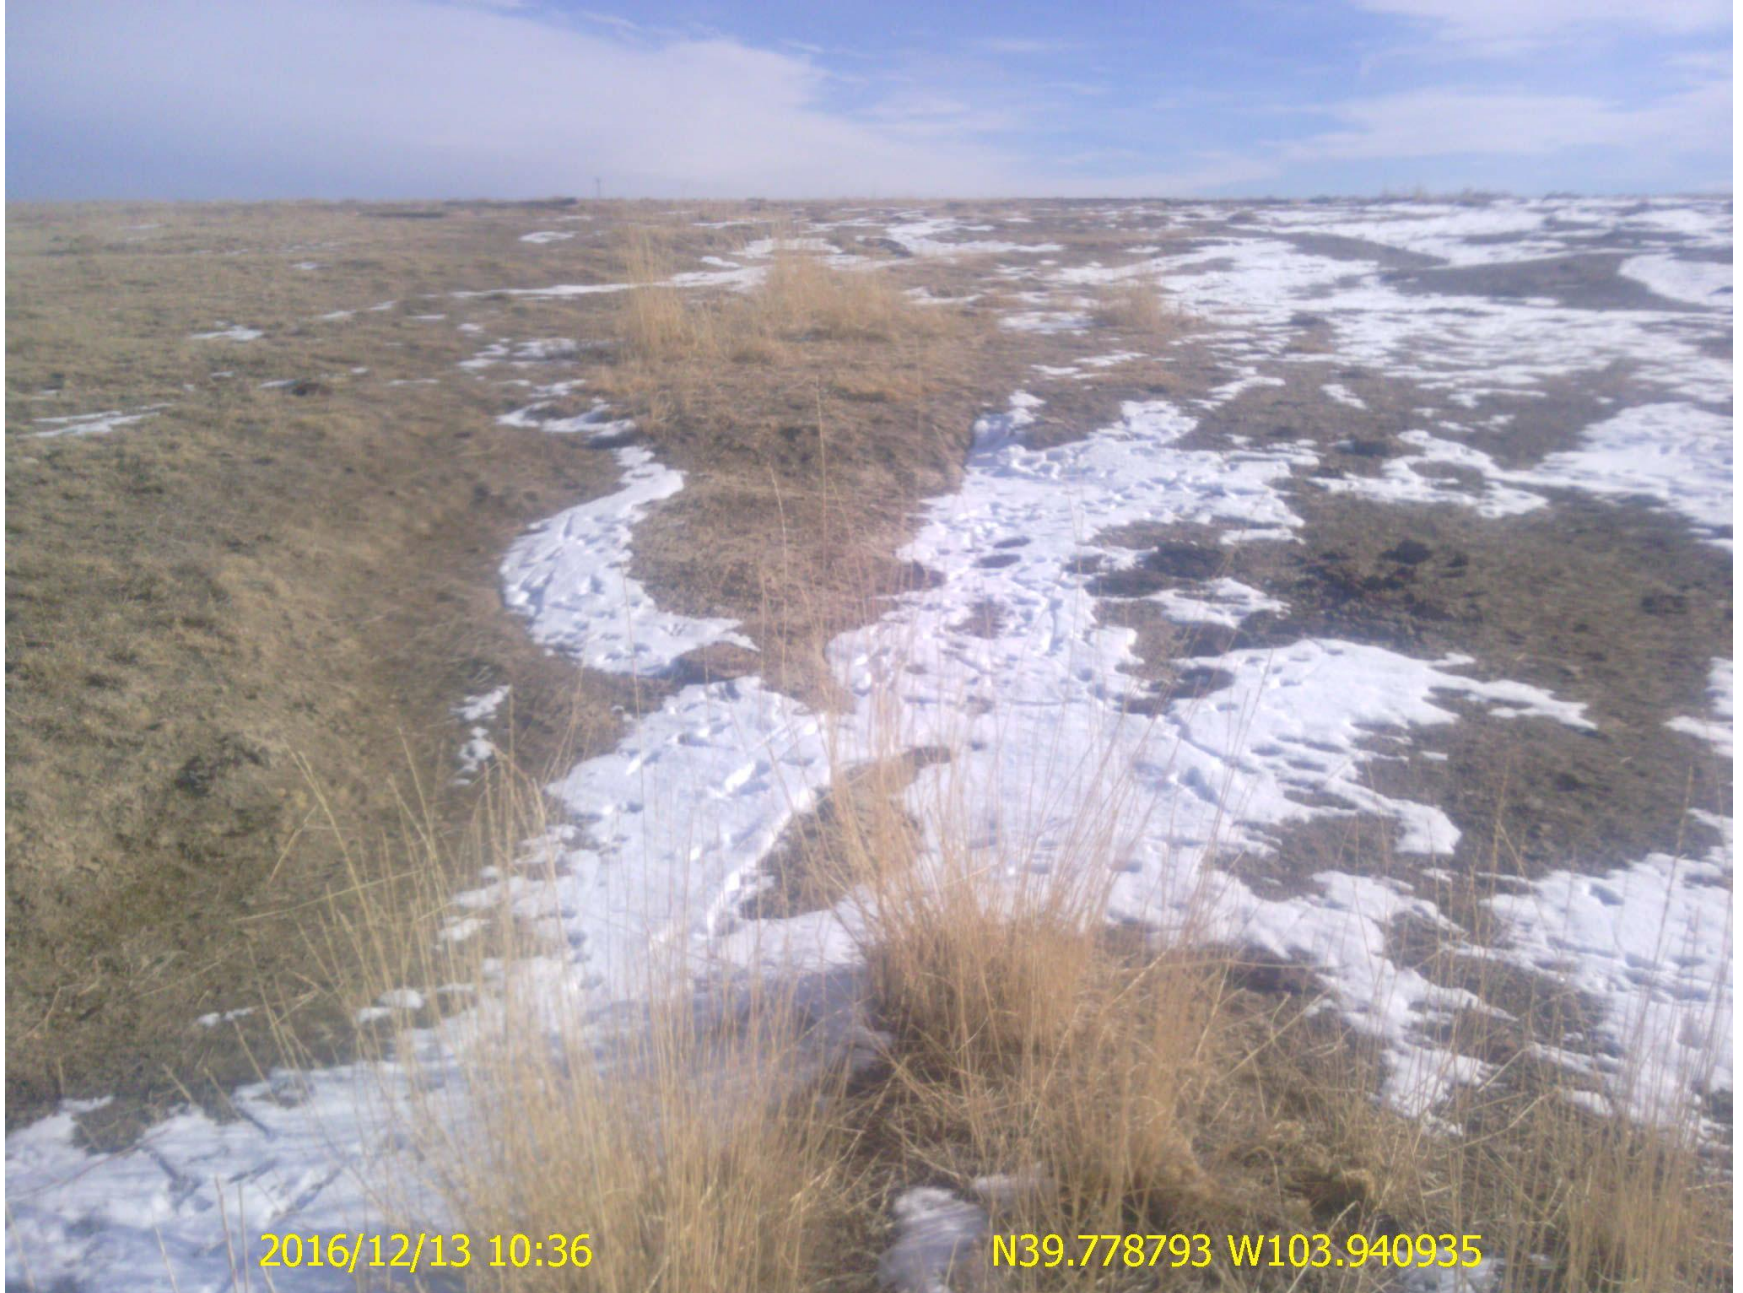
**Figure 6:** Photo taken from the northern disturbance area, facing east towards the access road. Photo shows erosion has not been stabilized or reclaimed. Refer to photos from inspection Doc. # 682500938 for additional details.

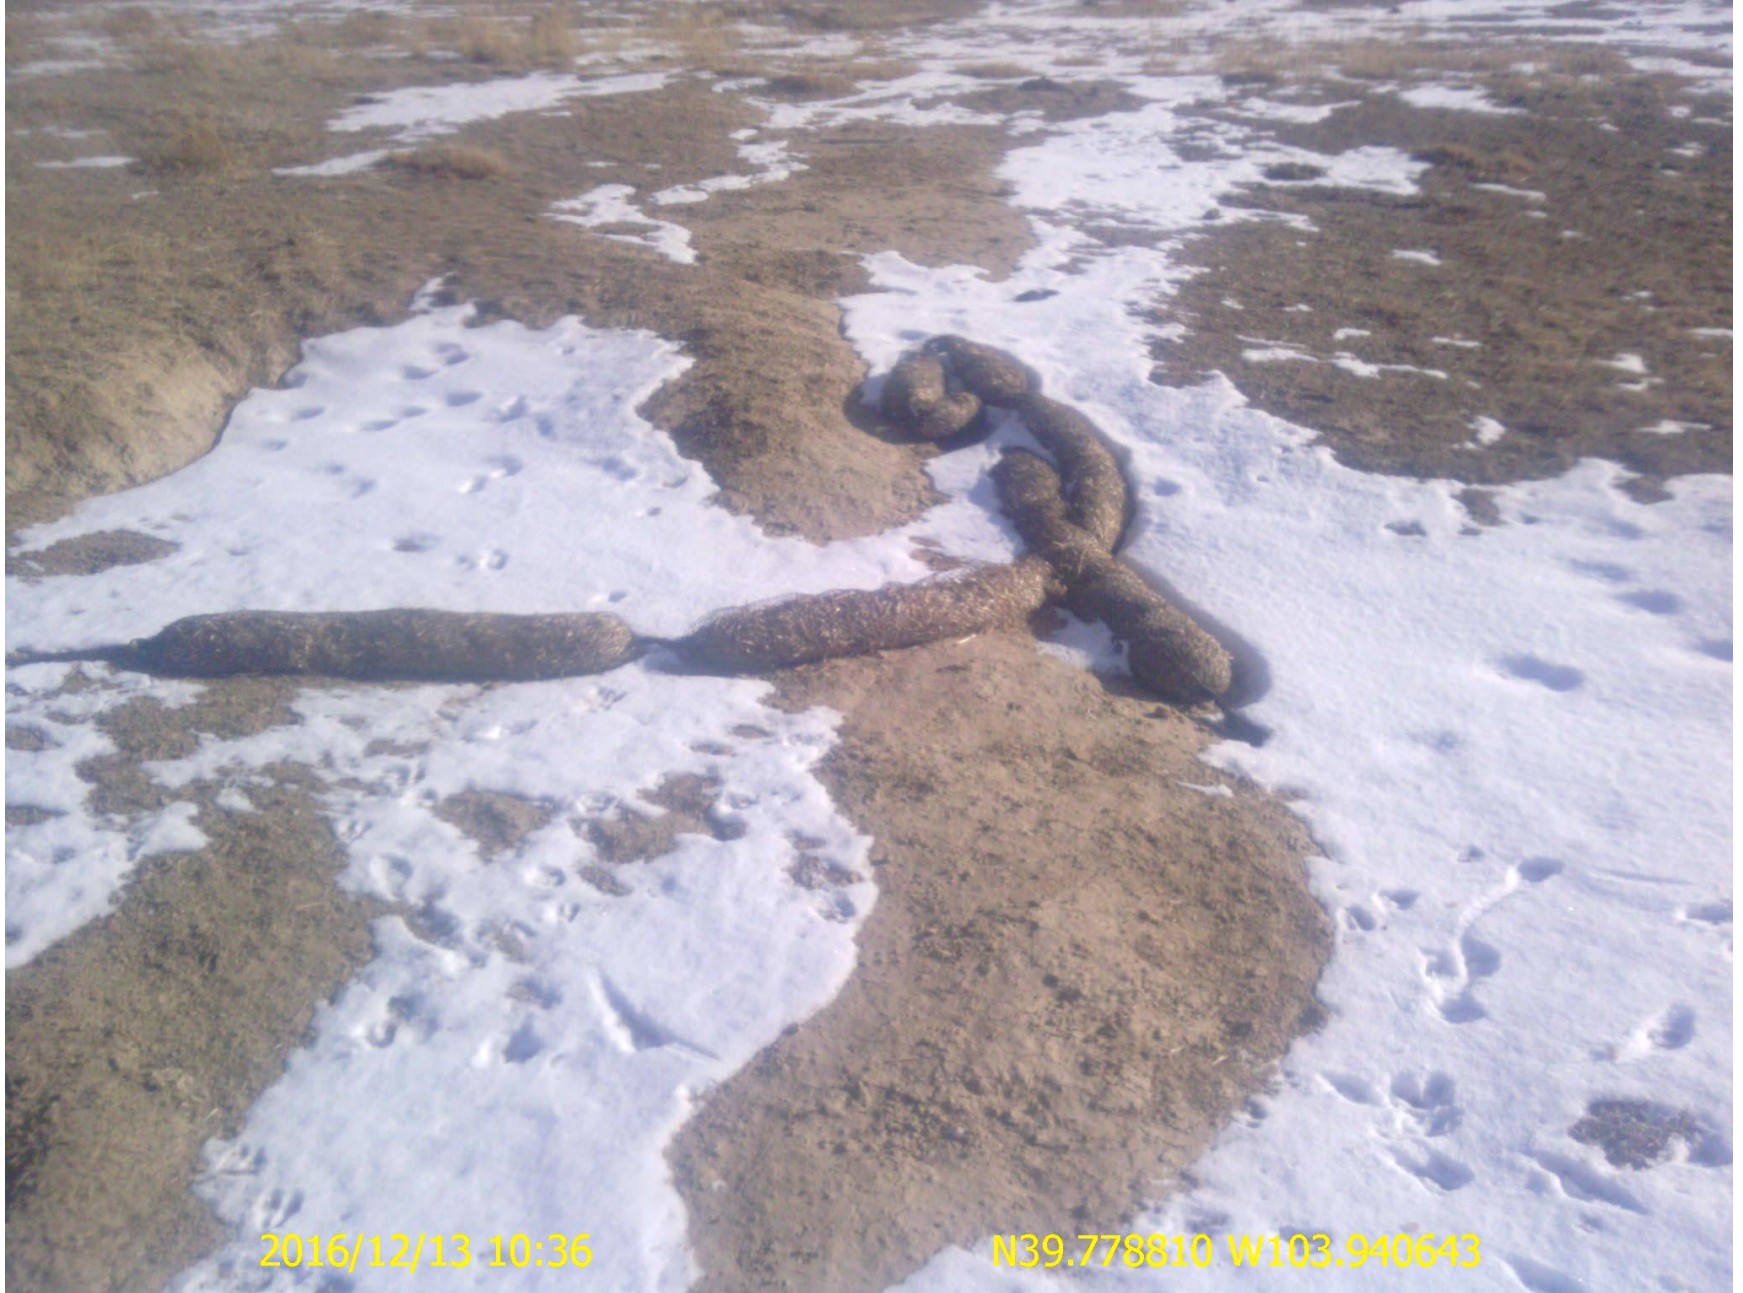
**Figure 7:** Photo taken from the northern disturbance area, facing east towards the access road. Photo shows erosion has not been stabilized or reclaimed. Refer to photos from inspection Doc. # 682500938 for additional details.

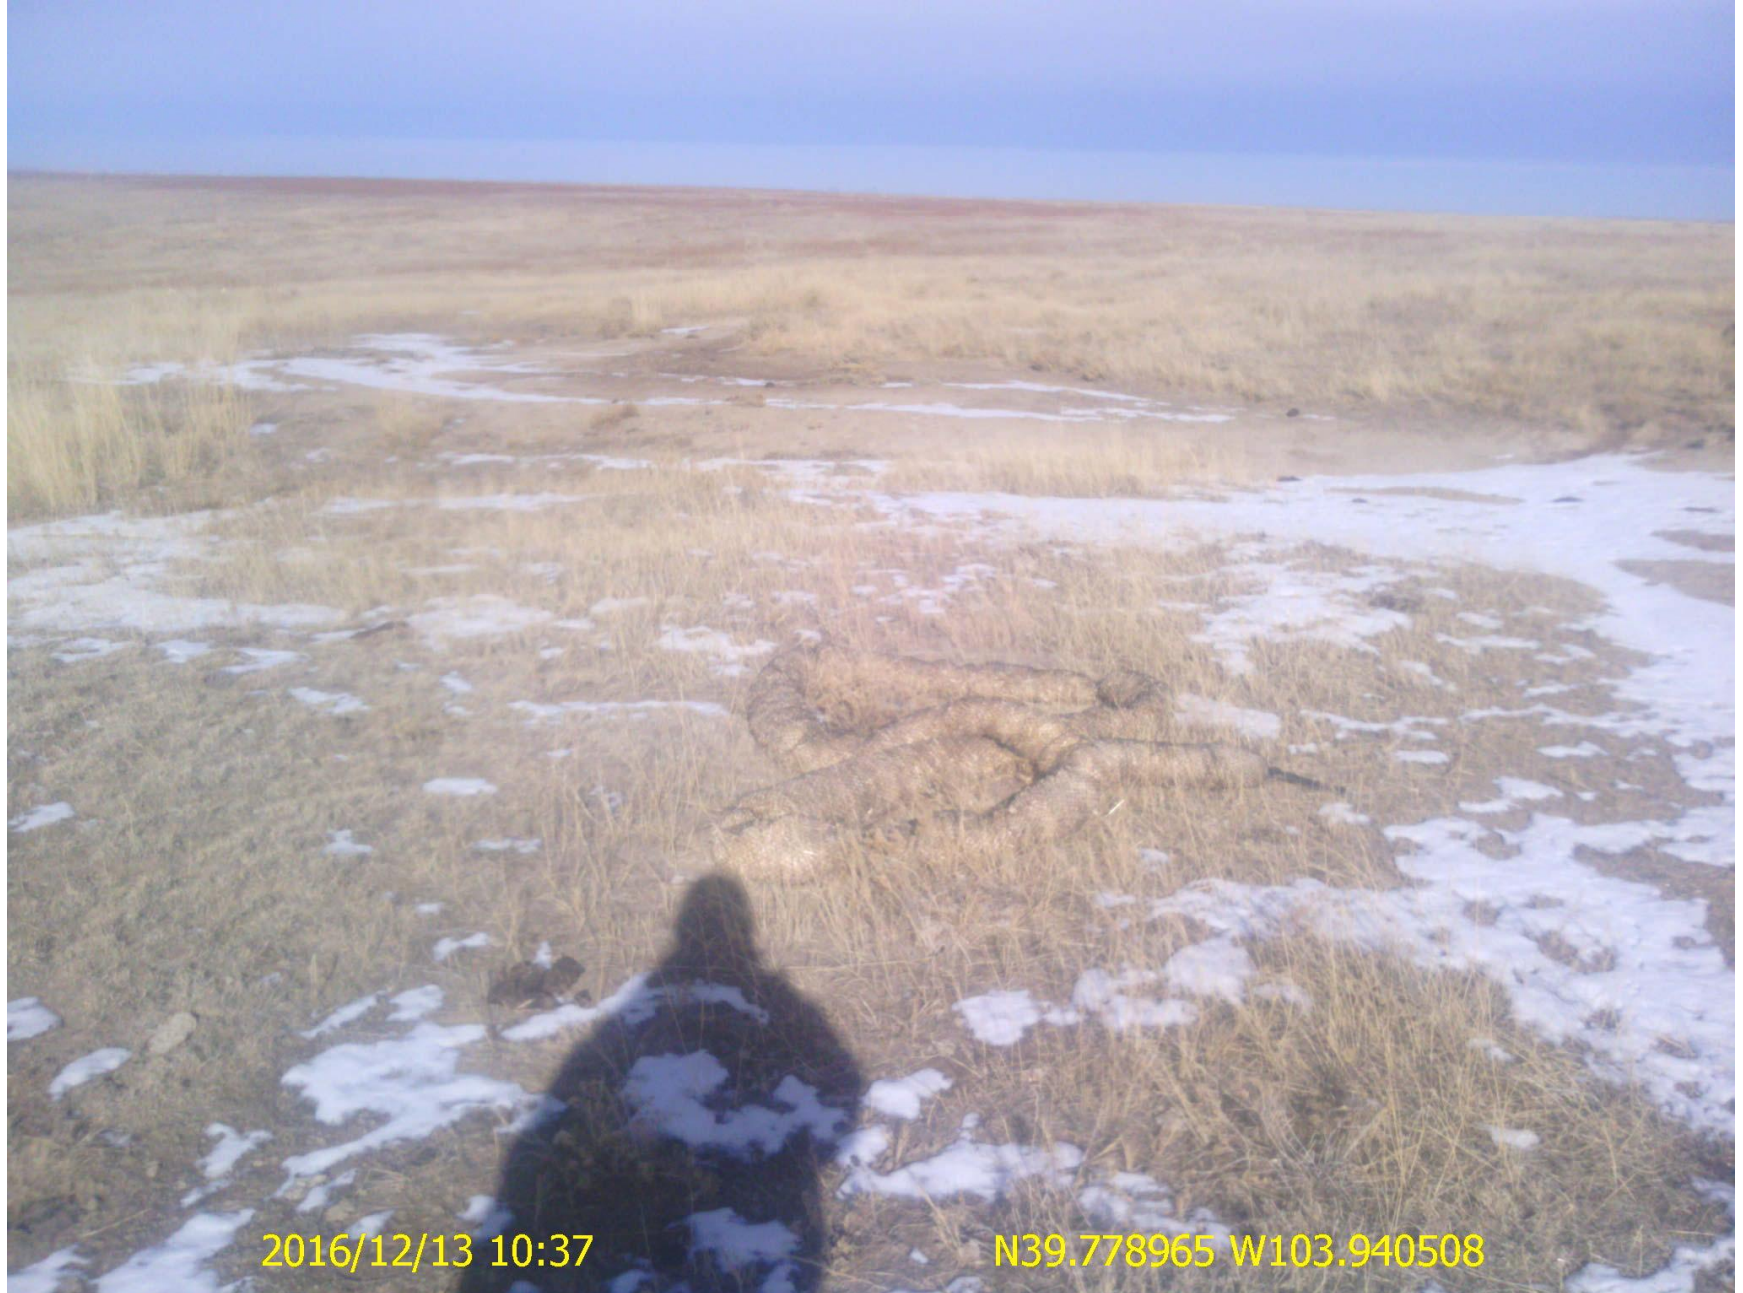
**Figure 8:** Photo taken from the northern disturbance area, facing east towards the access road. Photo shows erosion has not been stabilized or reclaimed. Refer to photos from inspection Doc. # 682500938 for additional details.
