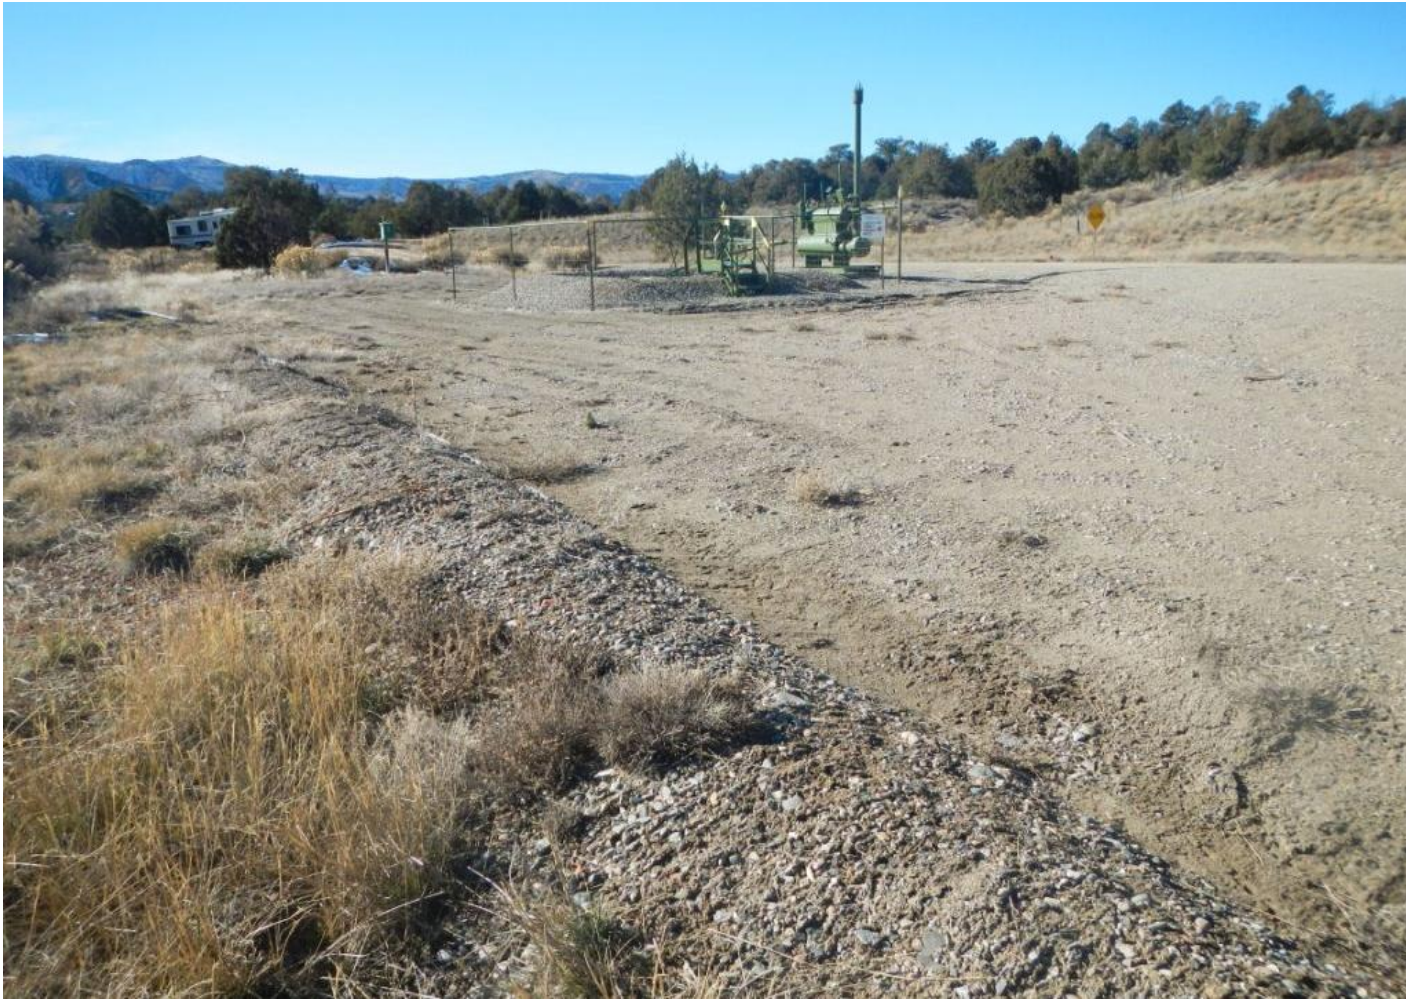
Photo 1. View of the project area from the southeastern corner facing center.

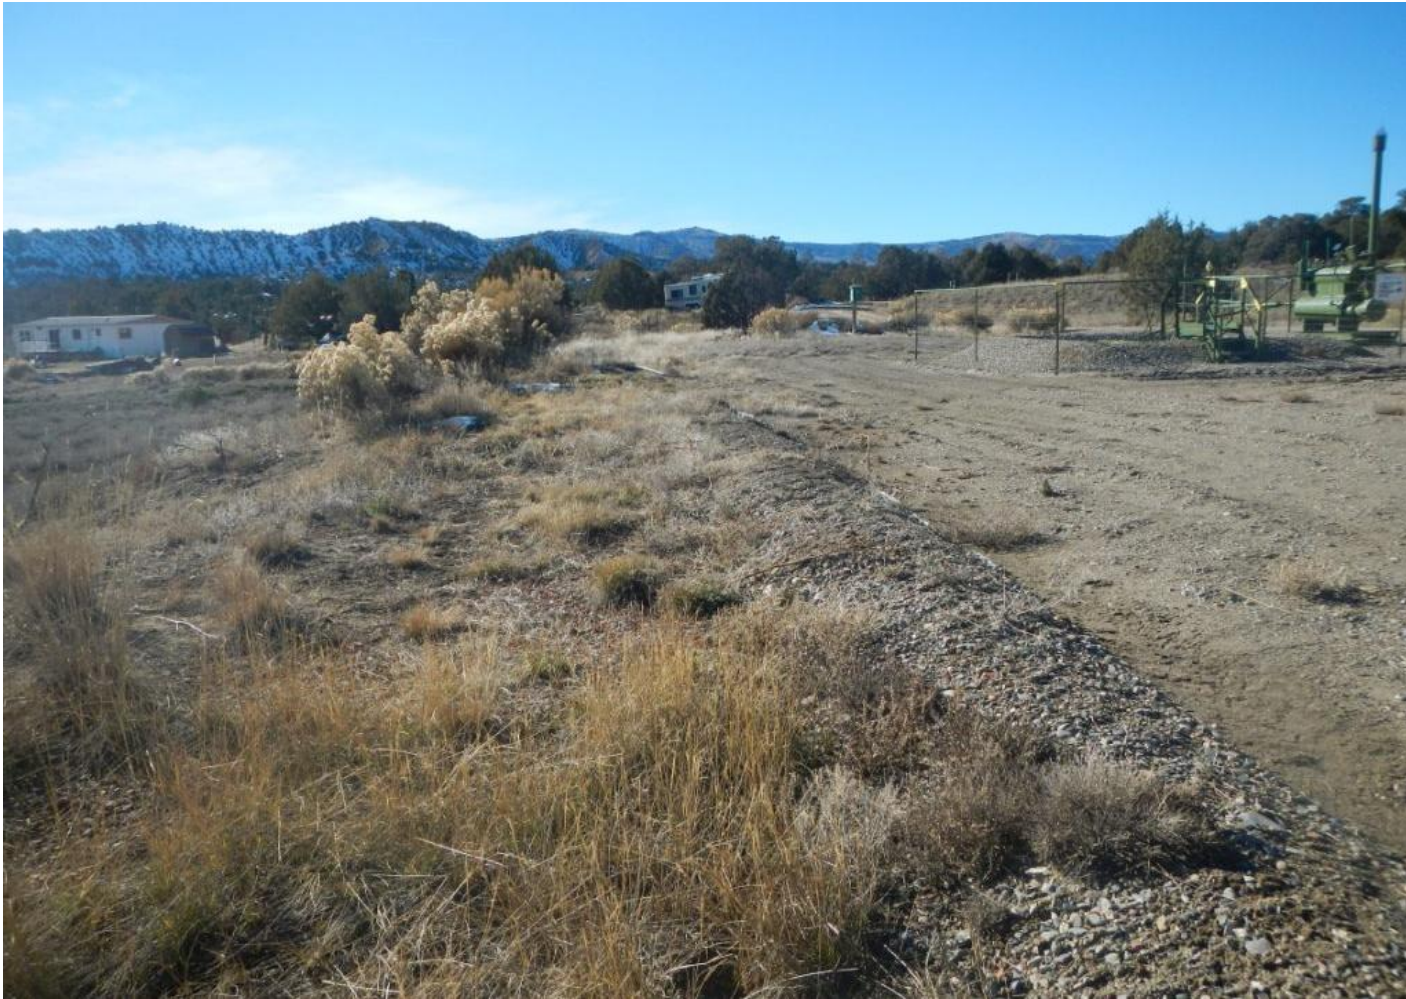
Photo 2. View of the southern portion of the project area from the southwestern corner facing westward.

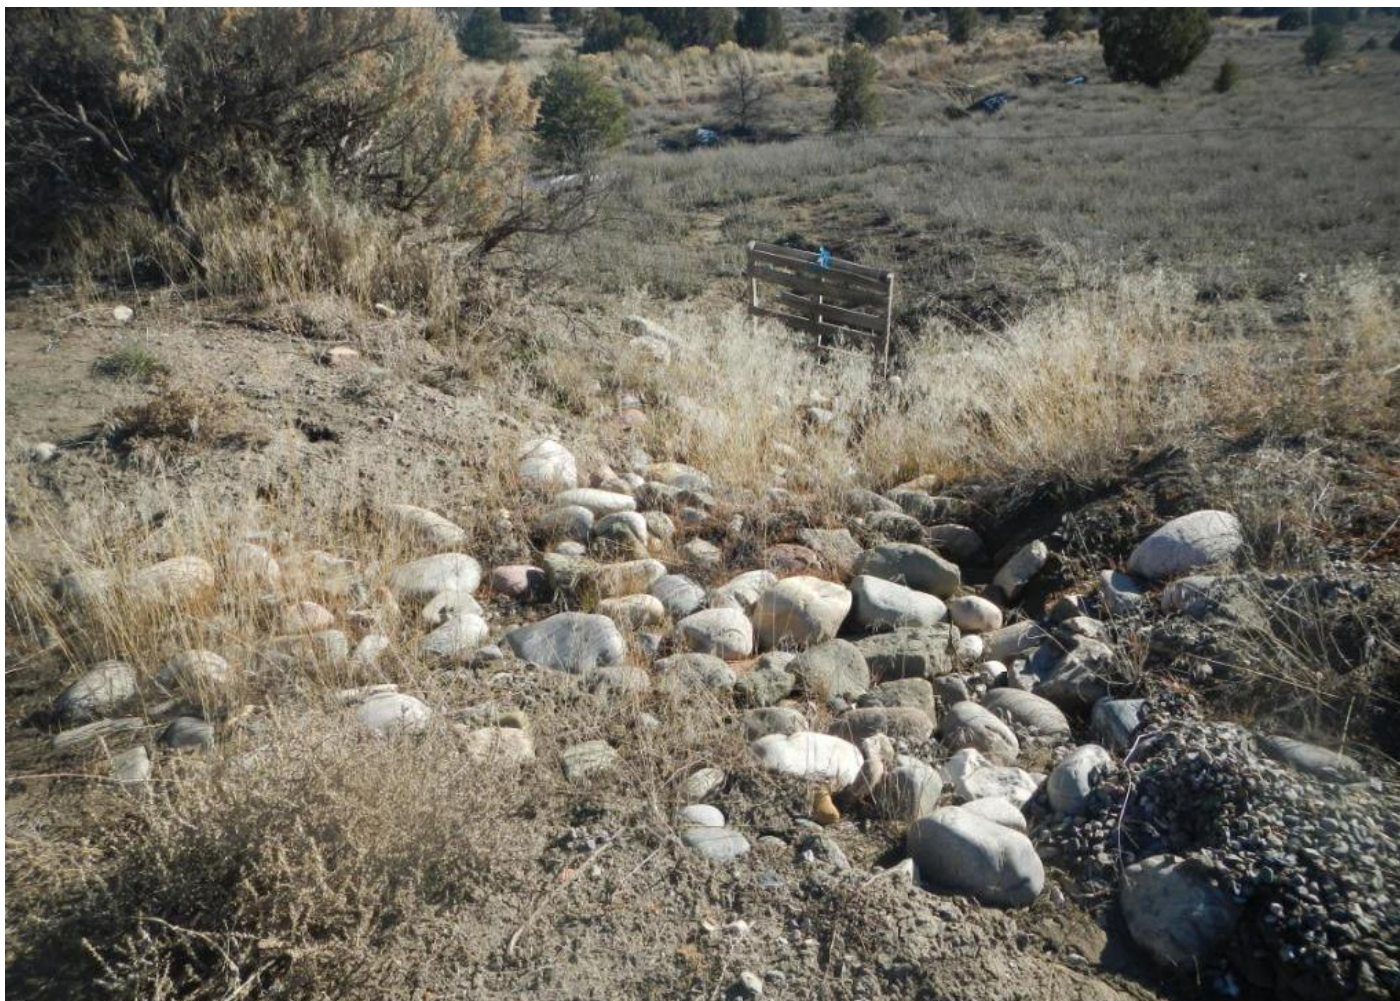
Photo 3. View of stormwater controls in the southern portion of the project area. Appear to be functioning at this time but will soon need maintenance.

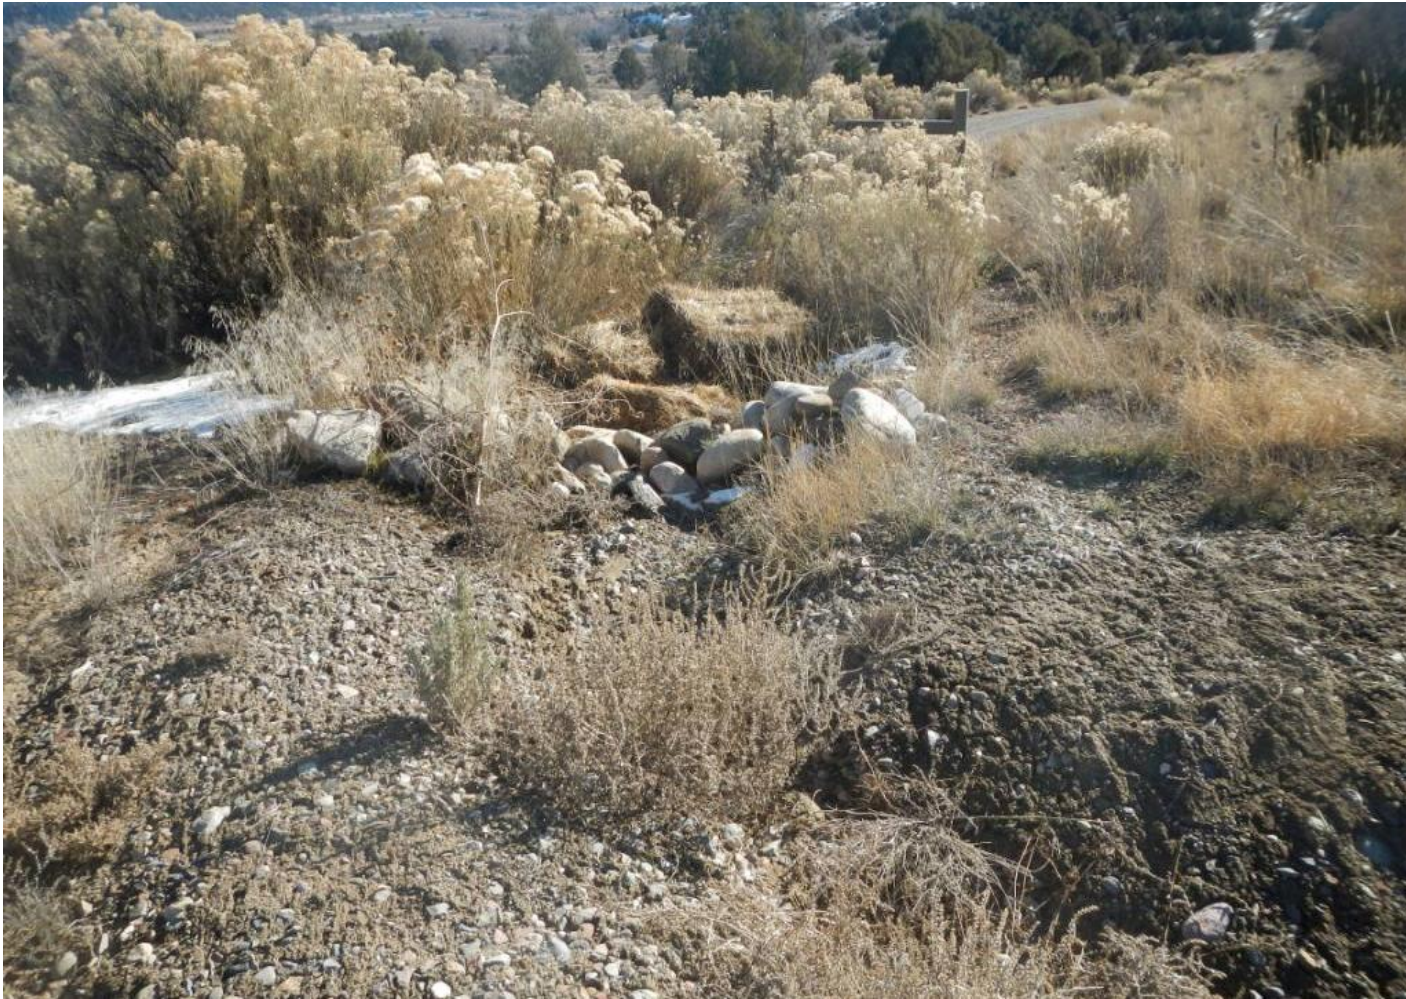
Photo 4. View of more stormwater controls in the southern portion of the project area. Appear to be functioning at this time but will soon need maintenance.
