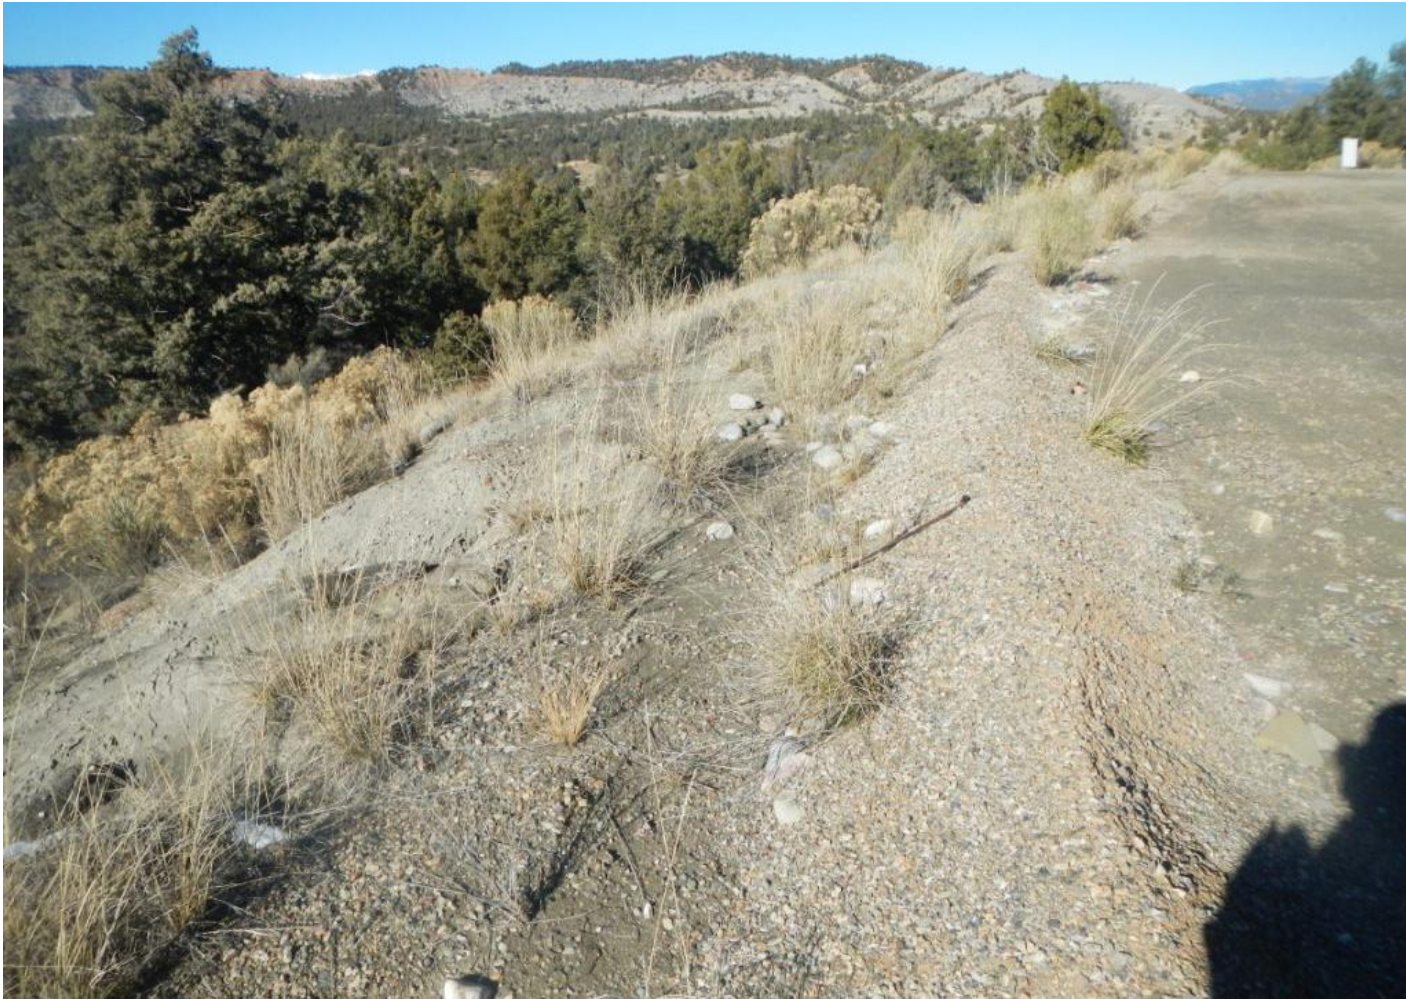
Photo 2. View of the western portion of the project area from the southwestern corner facing northward. Interim reclamation areas are revegetating with desirable species such as western wheatgrass (*Pascopyrum smithii*) and rubber rabbitbrush (*Chrysothamnus nauseosus*).

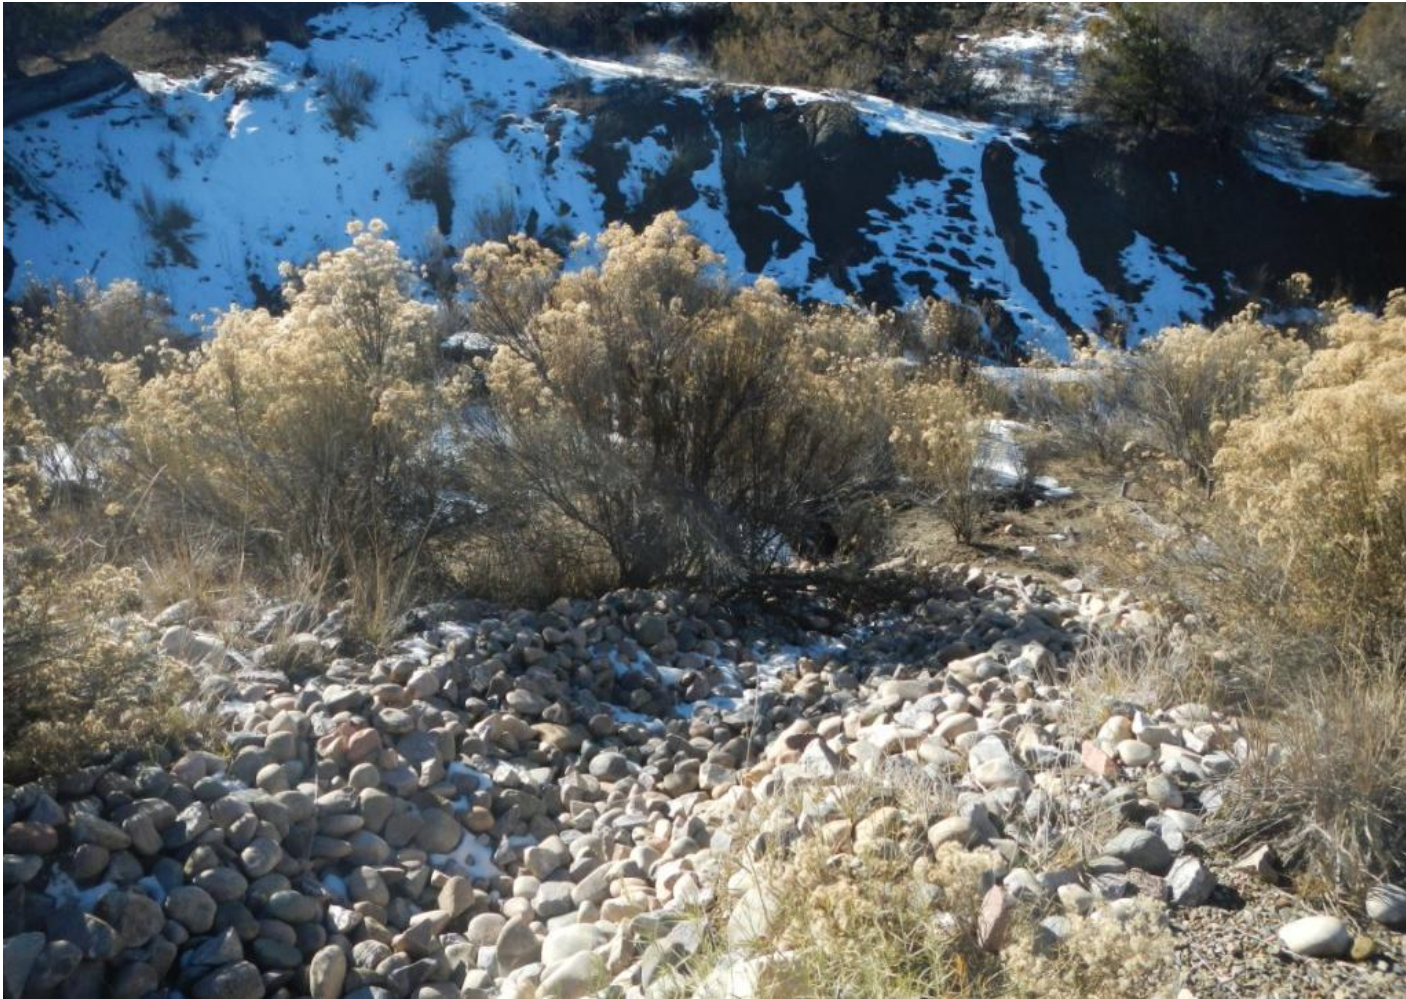
Photo 5. View of cobble run-down in the southwestern corner of the project area appears to be functioning at this time.

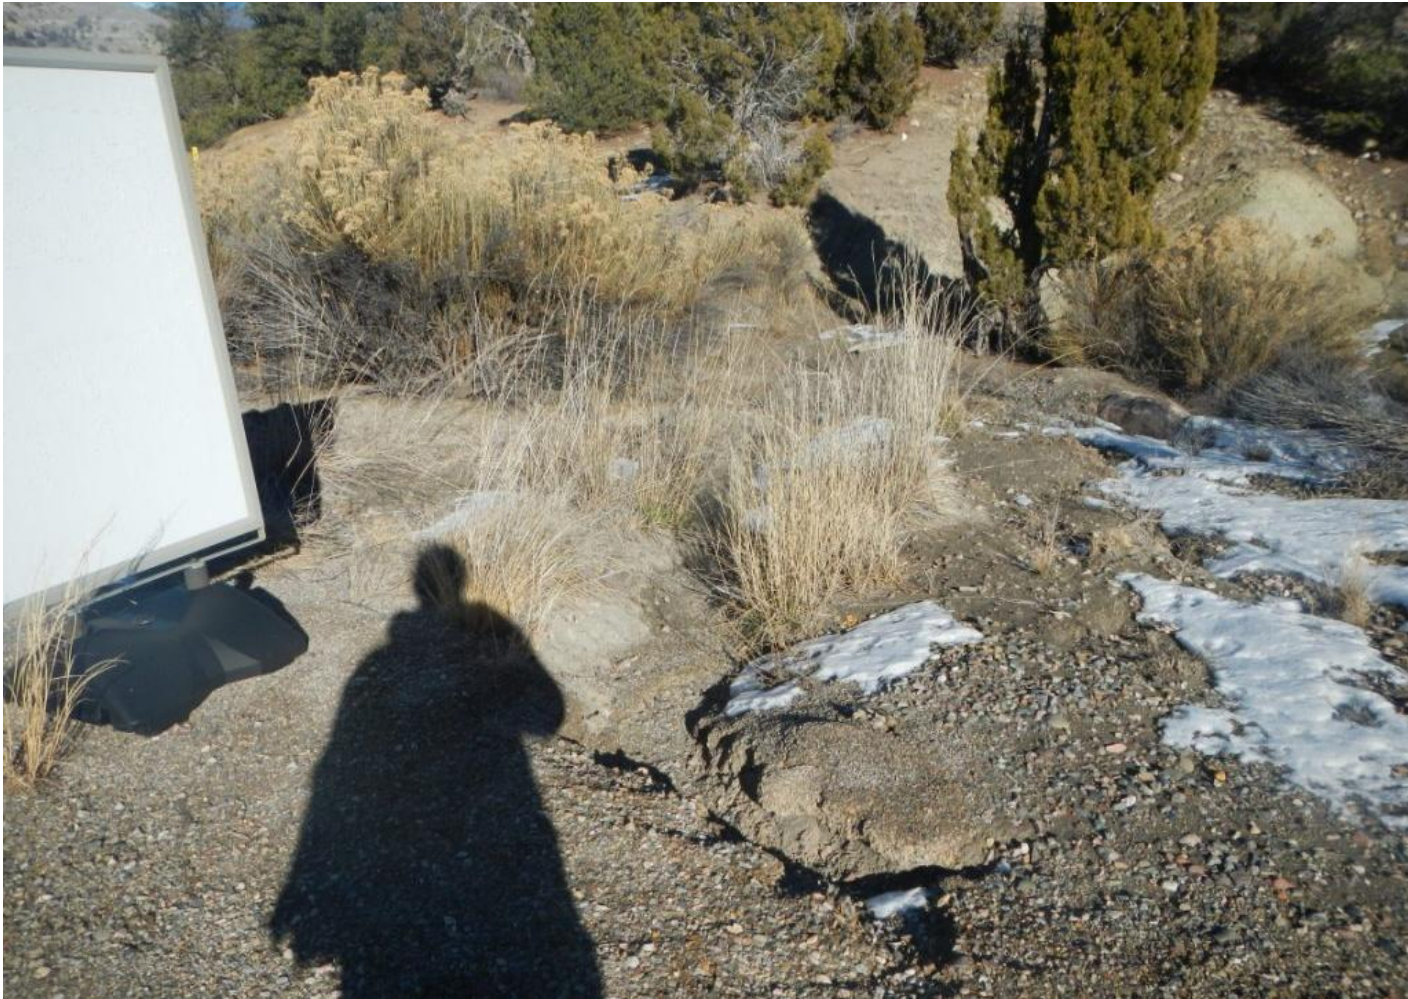
Photo 6. View of erosional channel near the entrance to the well pad.
