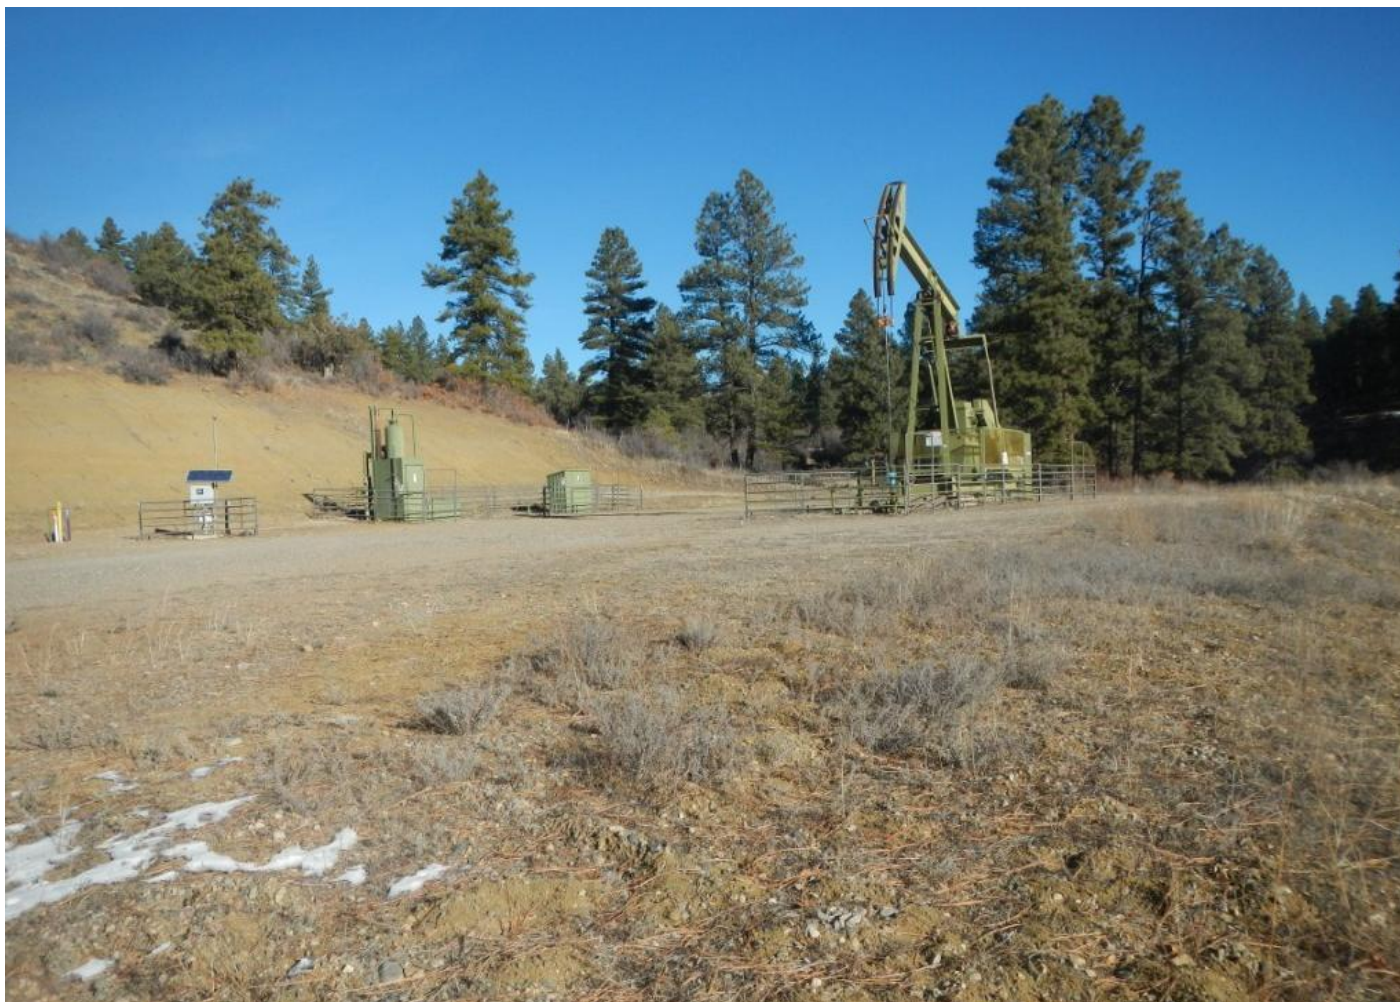
Photo 1. View of the project area from the southwestern corner facing center.

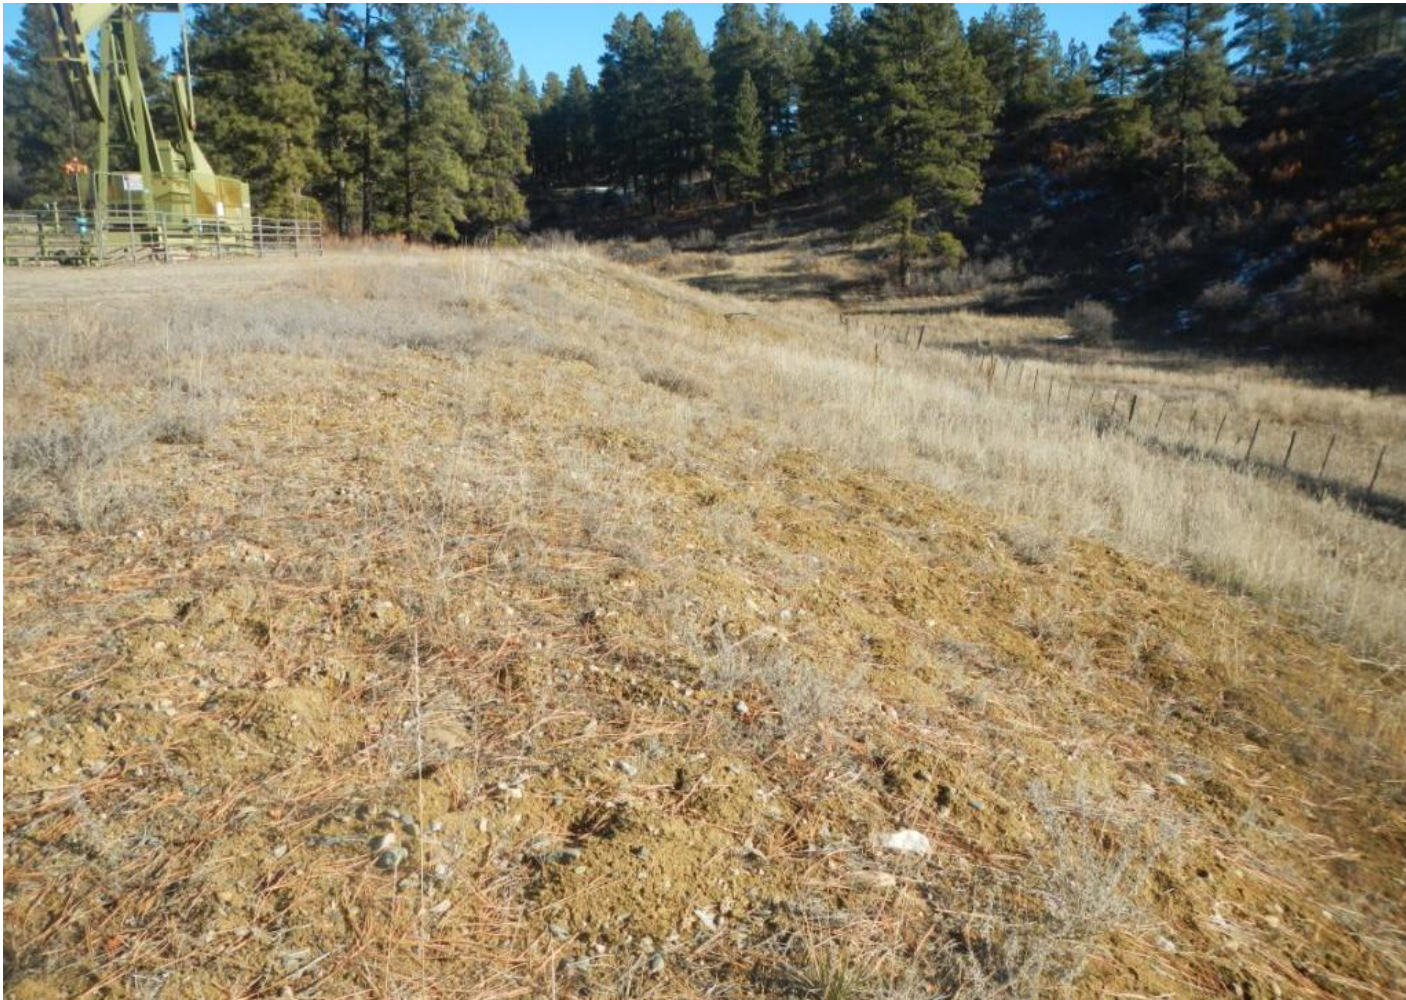
Photo 2. View of the southern portion of the project area from the southwestern corner facing eastward. Interim reclamation areas are revegetating with desirable species such as smooth brome (*Bromus inermis*), false goldenaster (*Heterotheca villosa*), and dropseed (*Sporobolus* sp.).

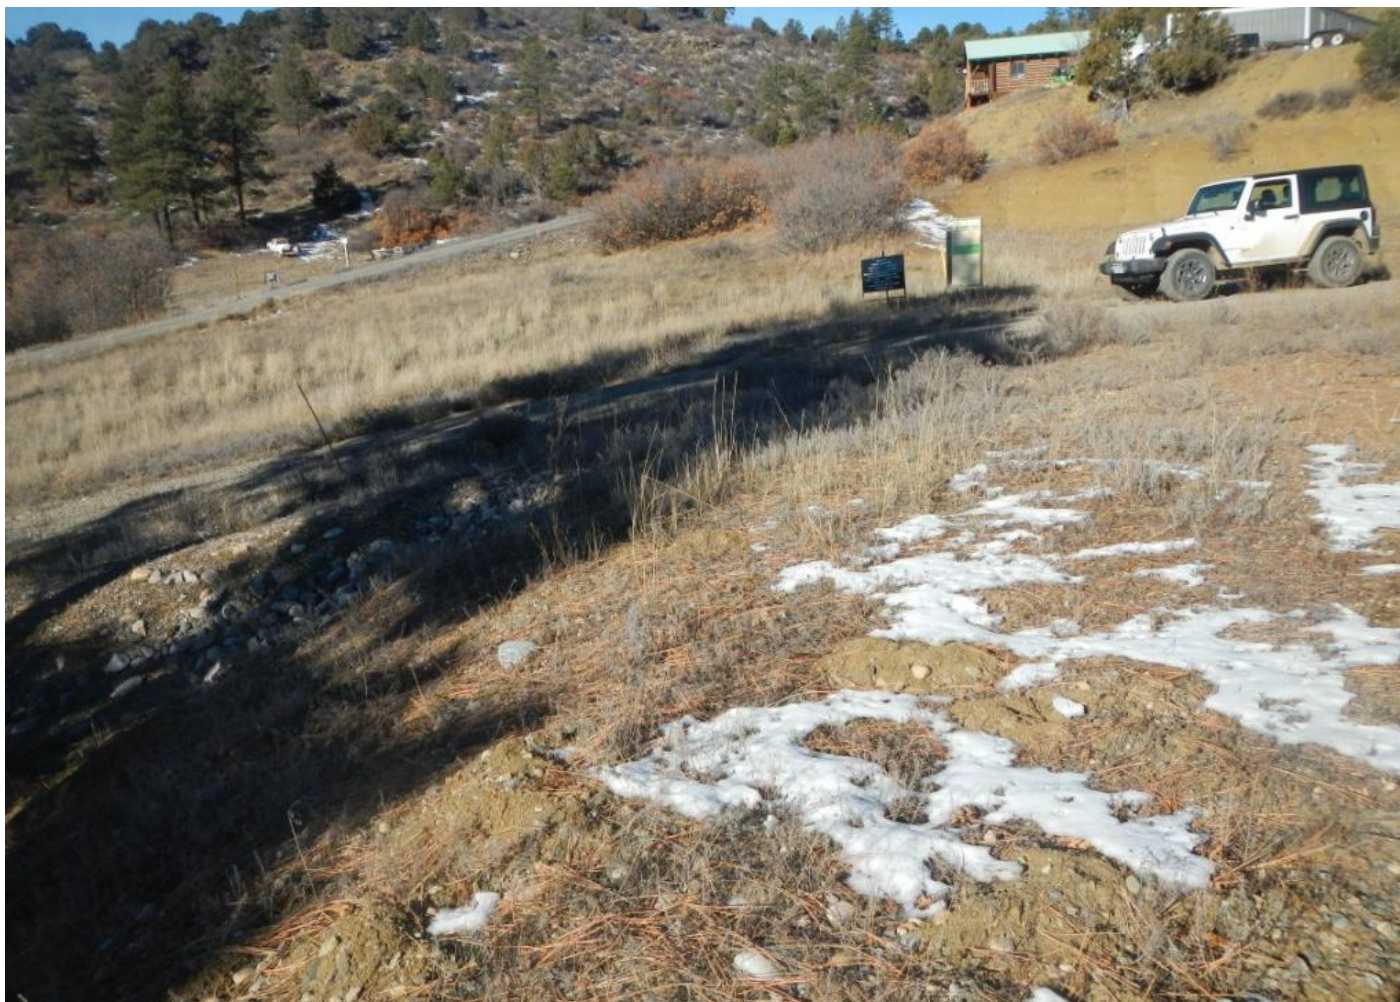
Photo 3. View of the western portion of the project area from the southwestern corner facing northward.

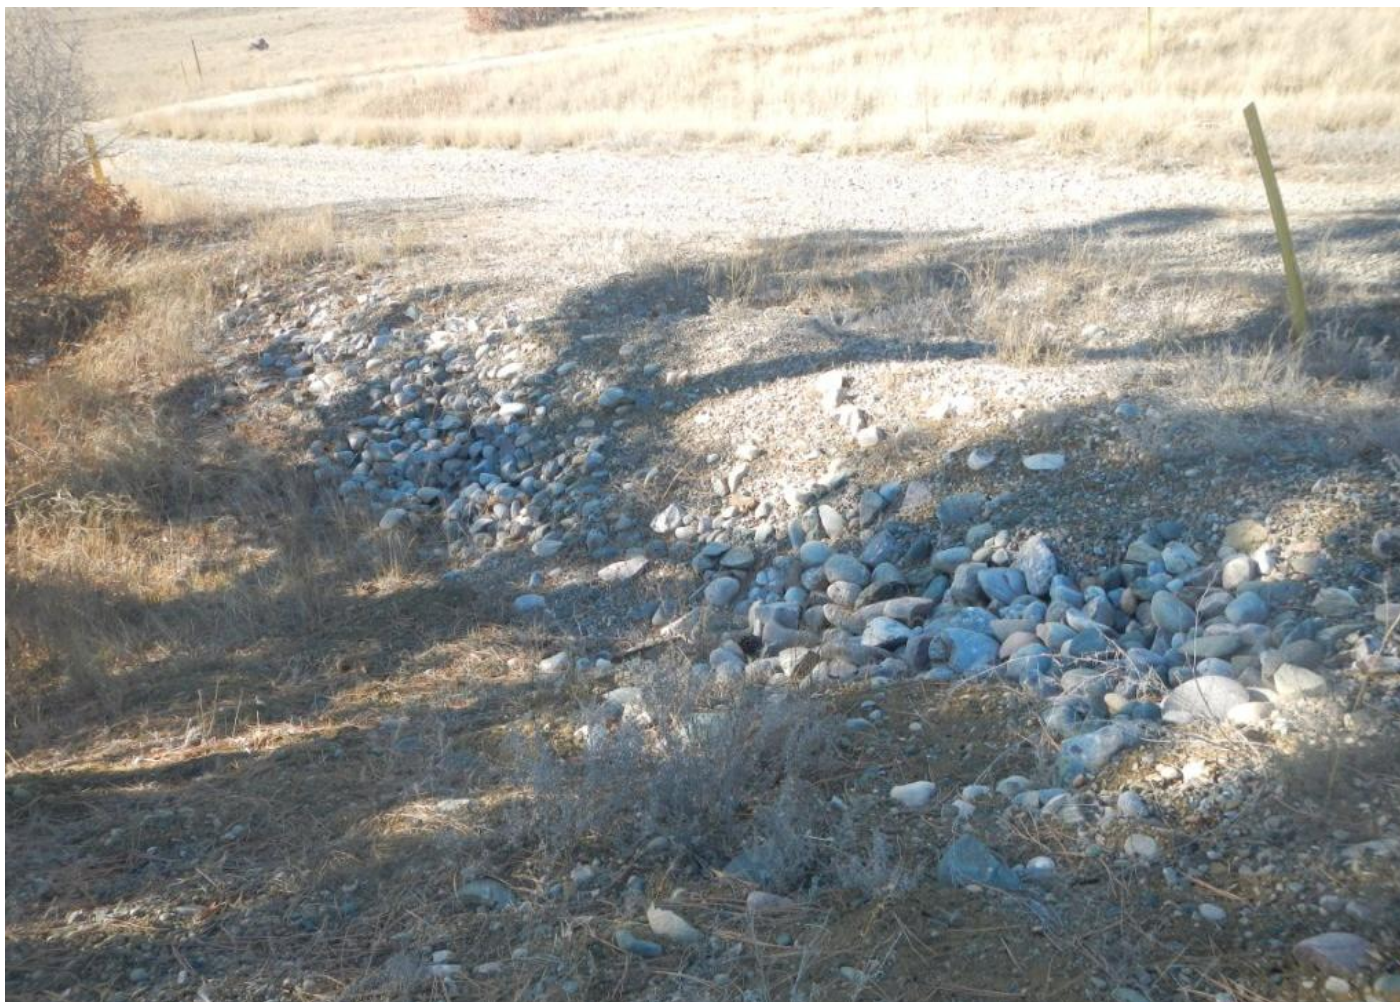
Photo 4. View of cobble armouring along well pad entrance and access ramp appears to be functioning.

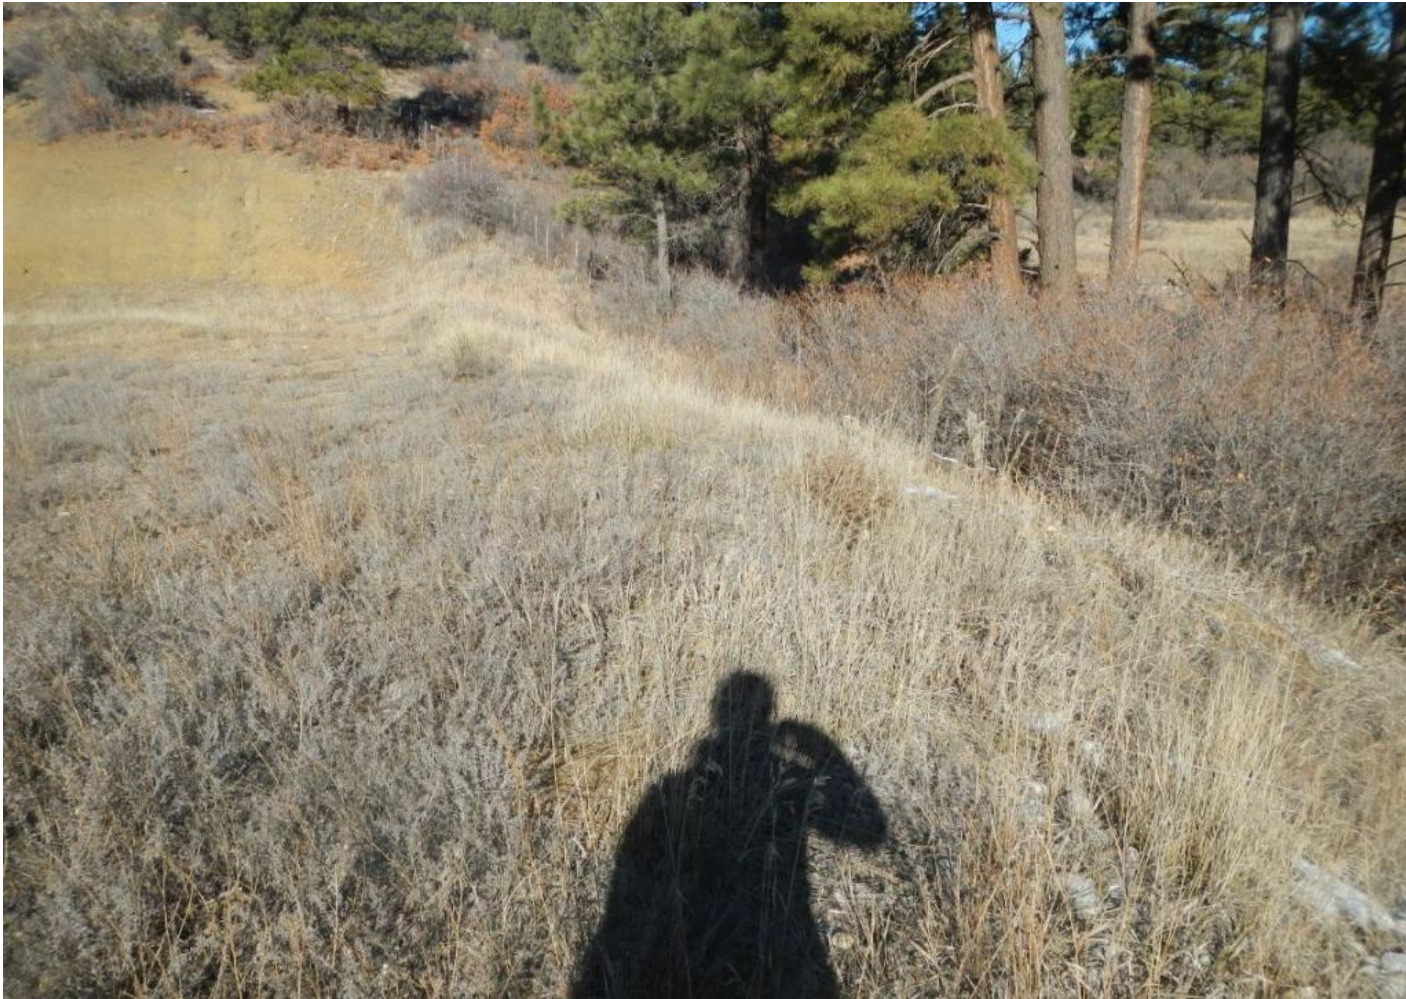
Photo 5. View of the eastern portion of the project area from the southeastern corner facing northward.

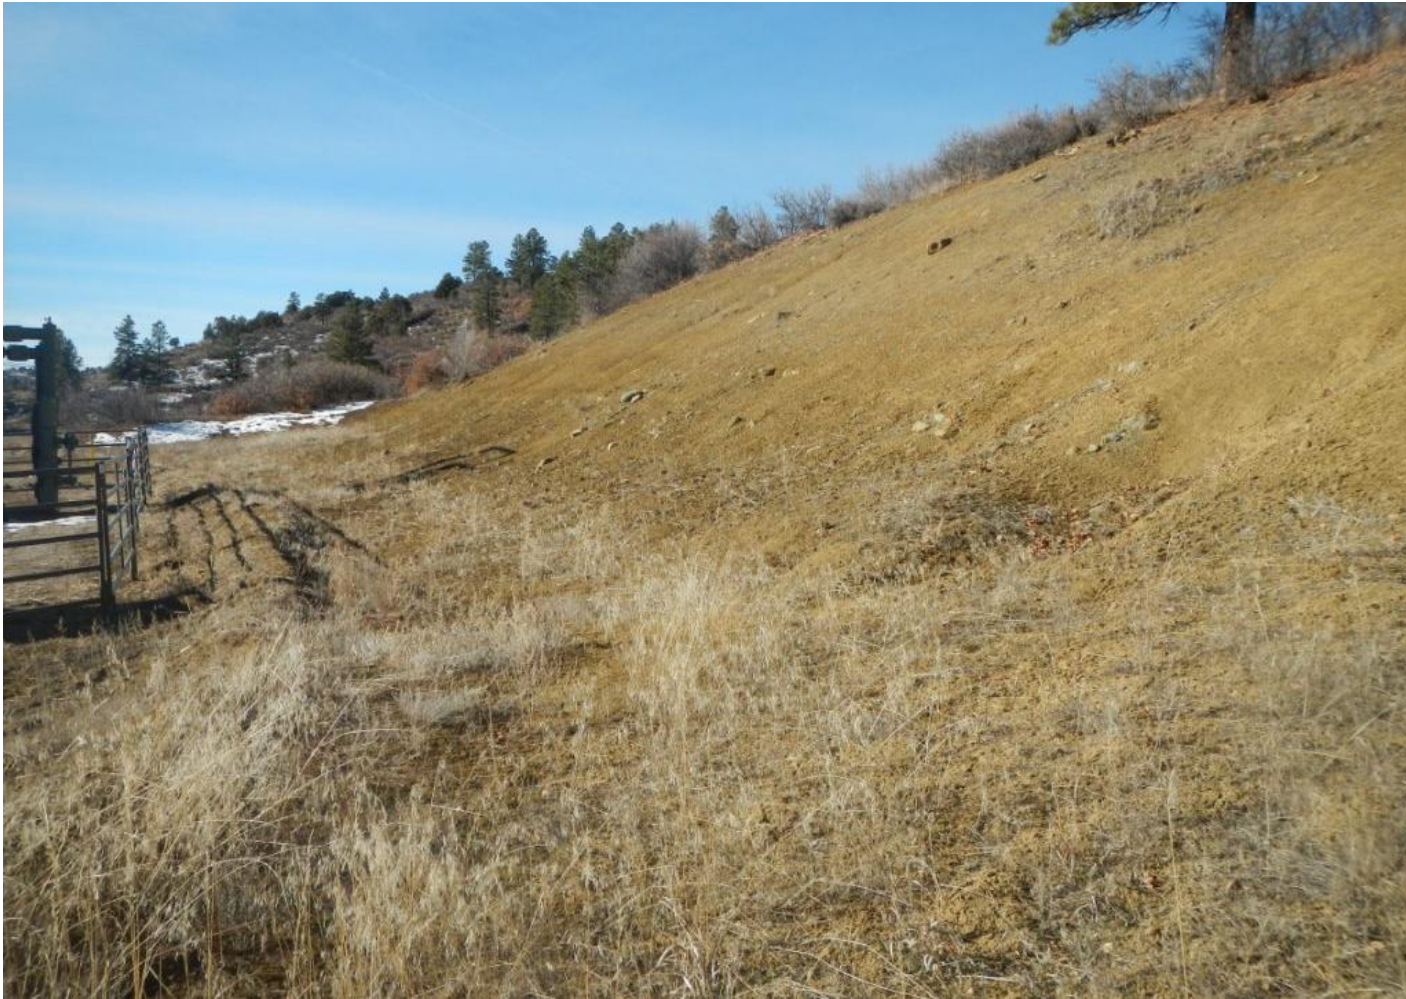
Photo 6. View of northern portion of the project area from the northeastern edge facing westward.
