Inspection Photos: Laramie Energy Cascade Creek Loc#423240

November 14, 2016

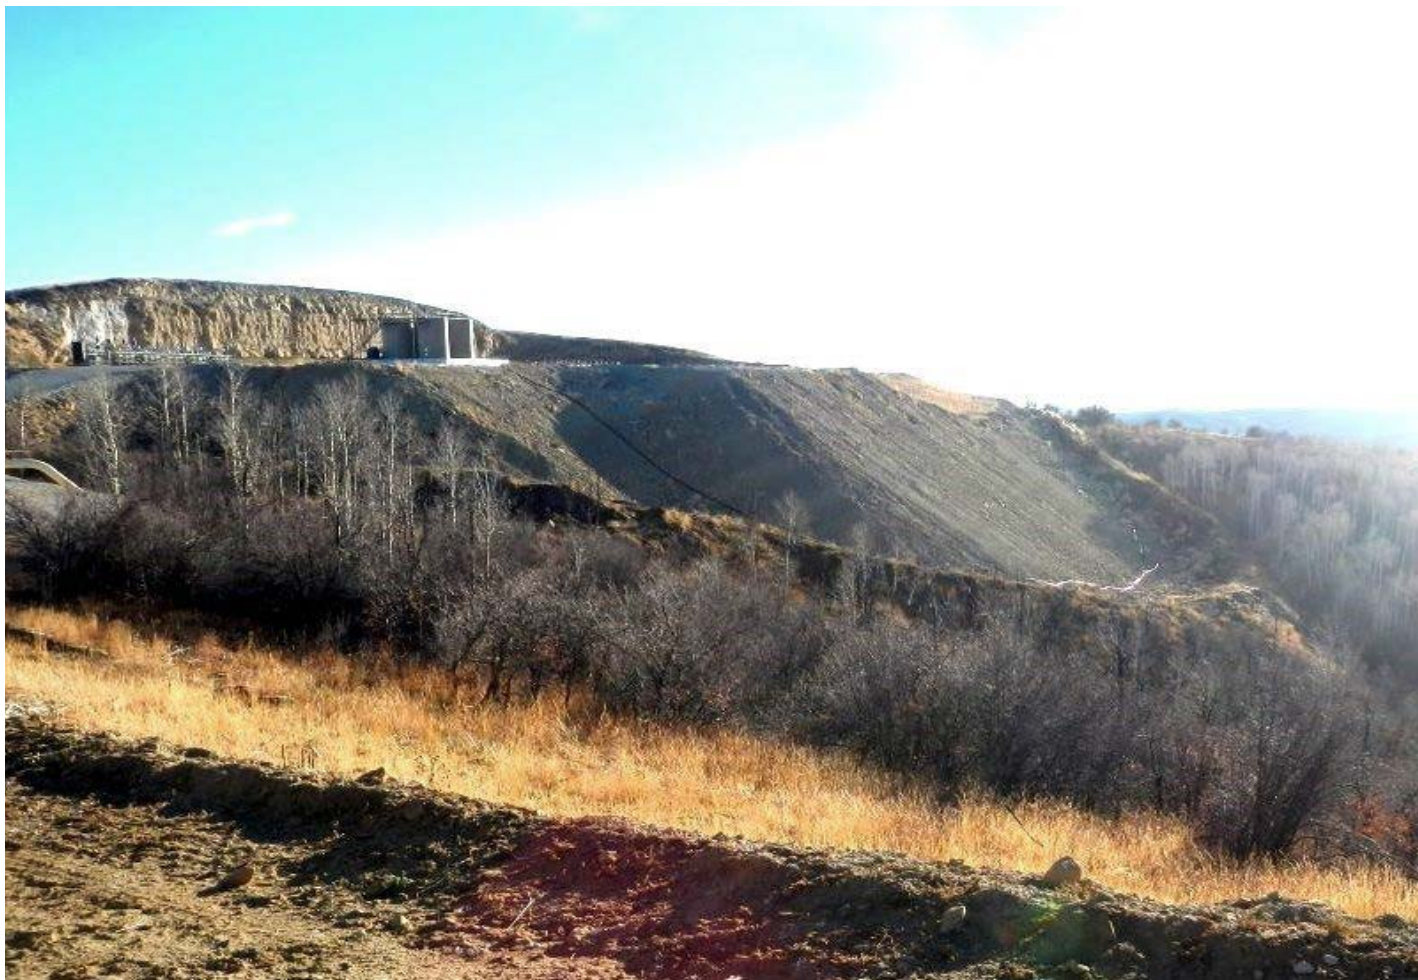
Photo#1: View of Location from Road opposite to SE.

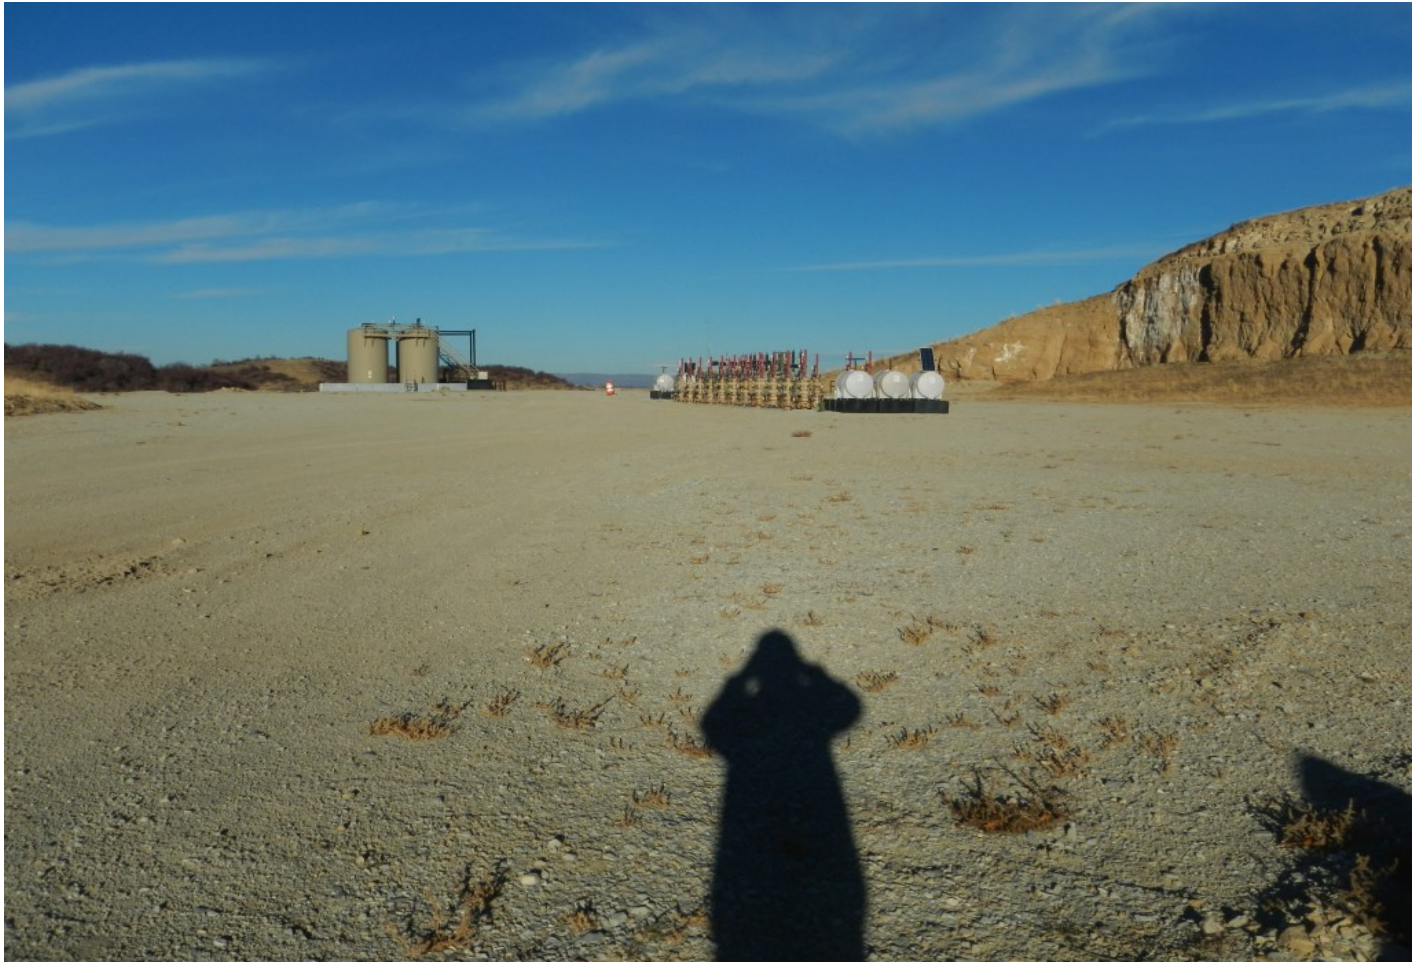
Photo#2: Overview of Location to North.

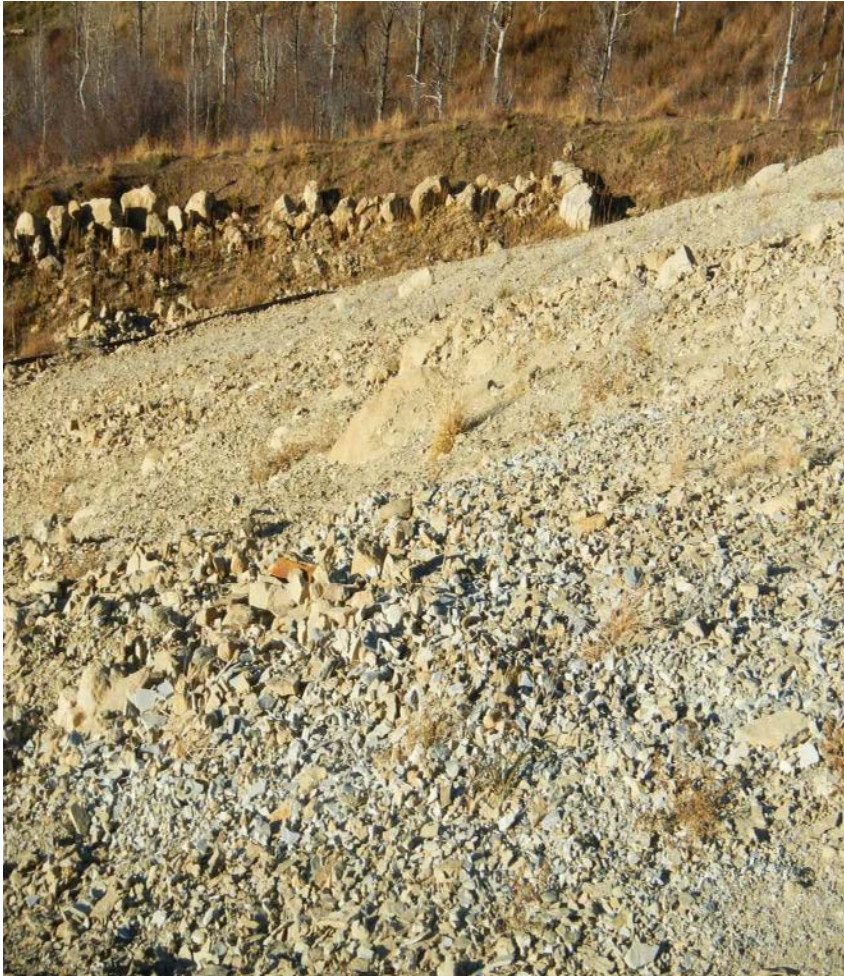
Photo#3:

## Revegetation of Fill Slopes is Unsuccessful

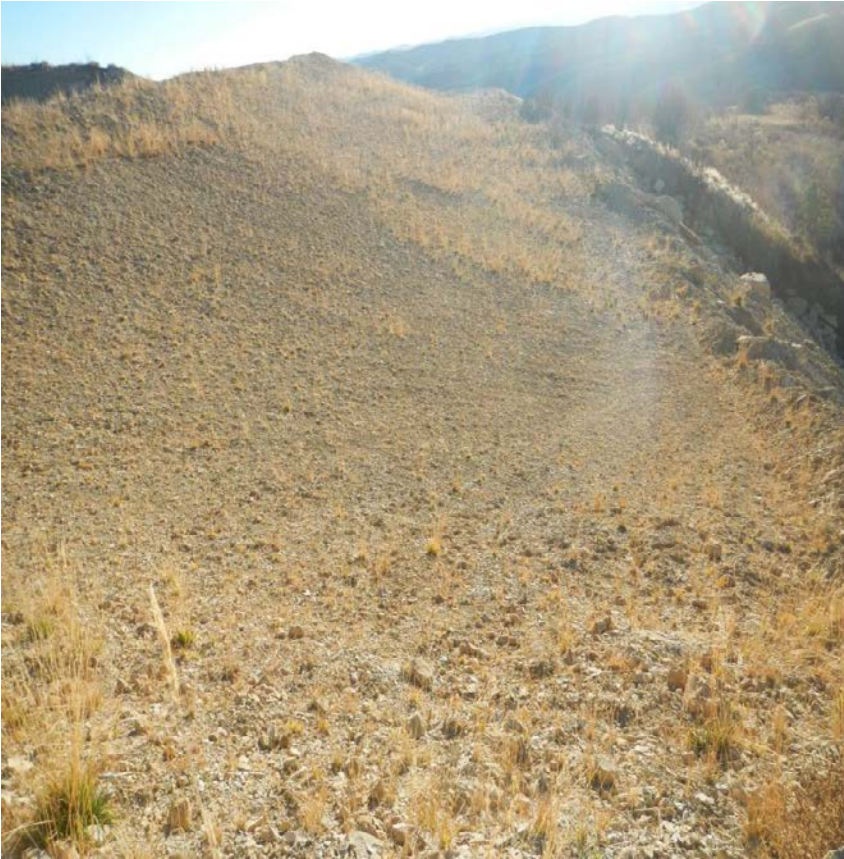
Vegetation is establishing in a few areas  
Photo#5:

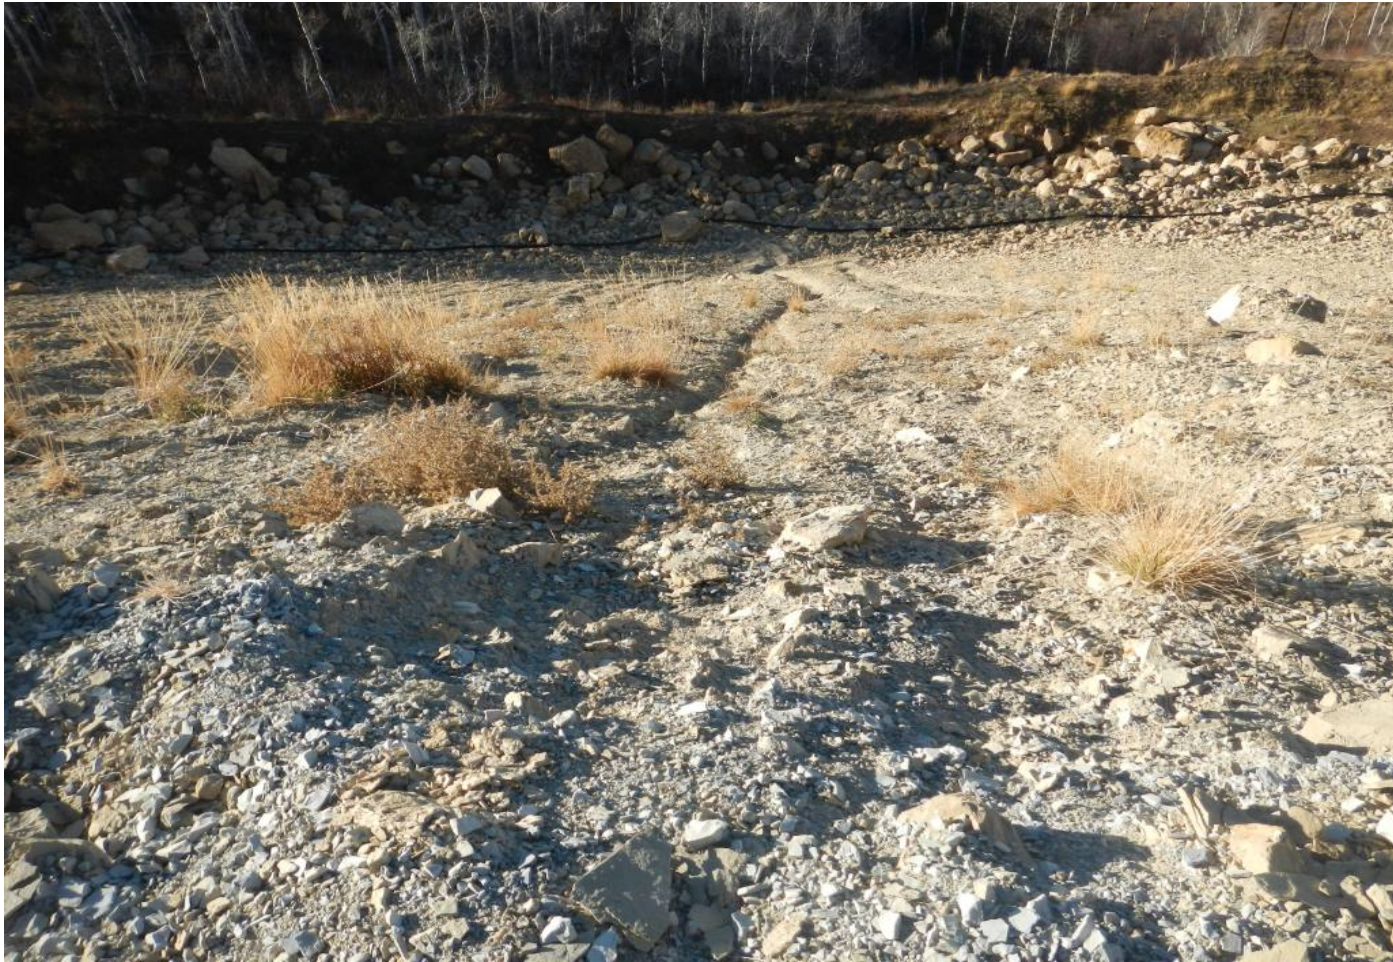
Photo#7: Erosion occurring on Fill Slope.
