**Reference Area Photographs**  
**Inspections Conducted on**  
**October 5,6,and 11 , 2016**

**Hunter Ridge Energy Services #10442**  
**A27 CDP (Centralized Distribution Point )**  
**6" Transfer Line**  
**Spill/Release Point ID #446199**

## Hunter Ridge A27 CDP Pipeline Spill

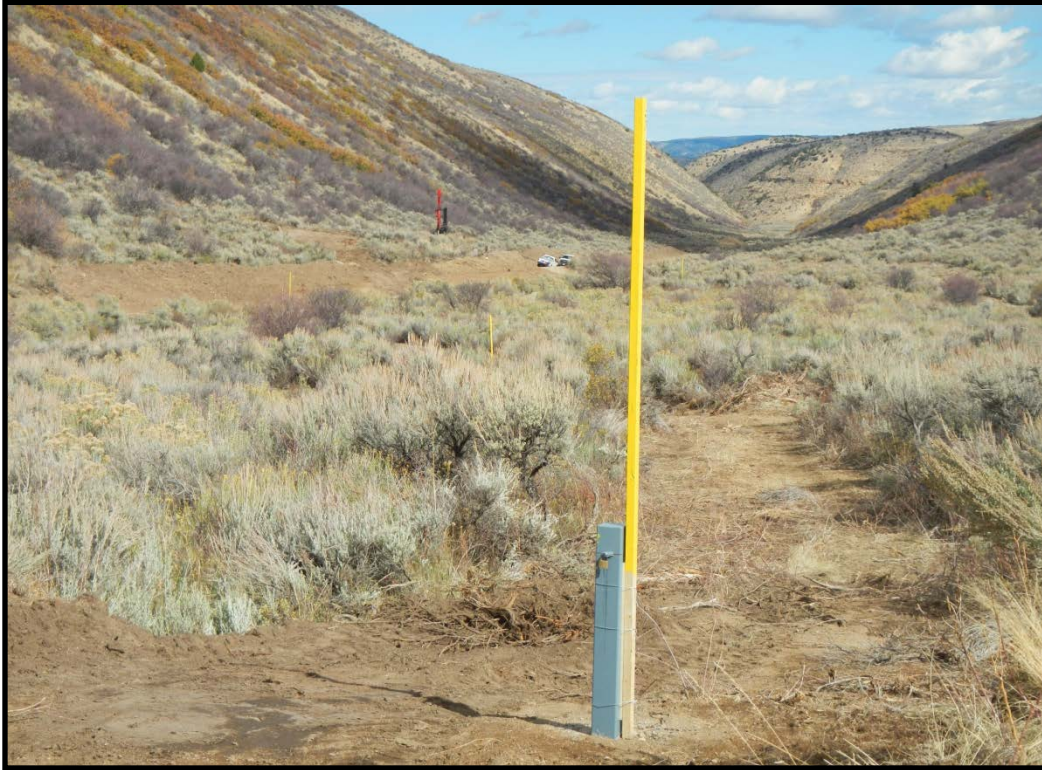
Looking North (downgradient). Yellow marker identifies monitoring well locations. At the distance, drilling new set of MWs (approximately 20) to complete Site Assessment.

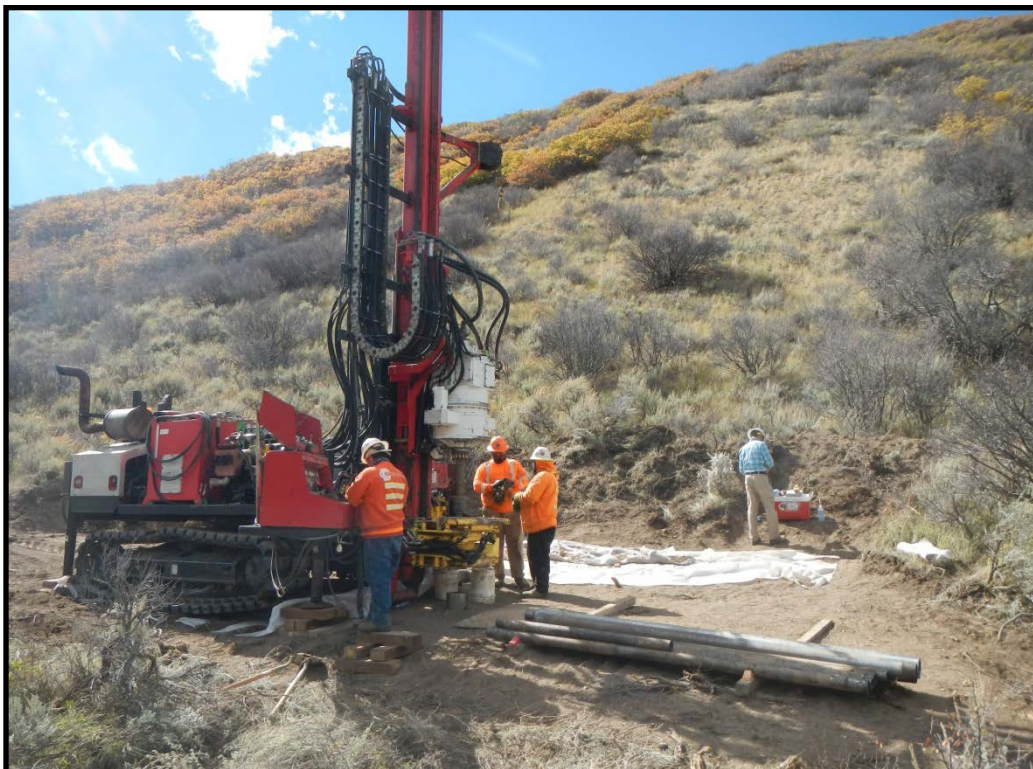
Rotosonic drilling rig . Most monitoring wells completed with 4" PVC pipes to be used for monitoring and remediation purpose.

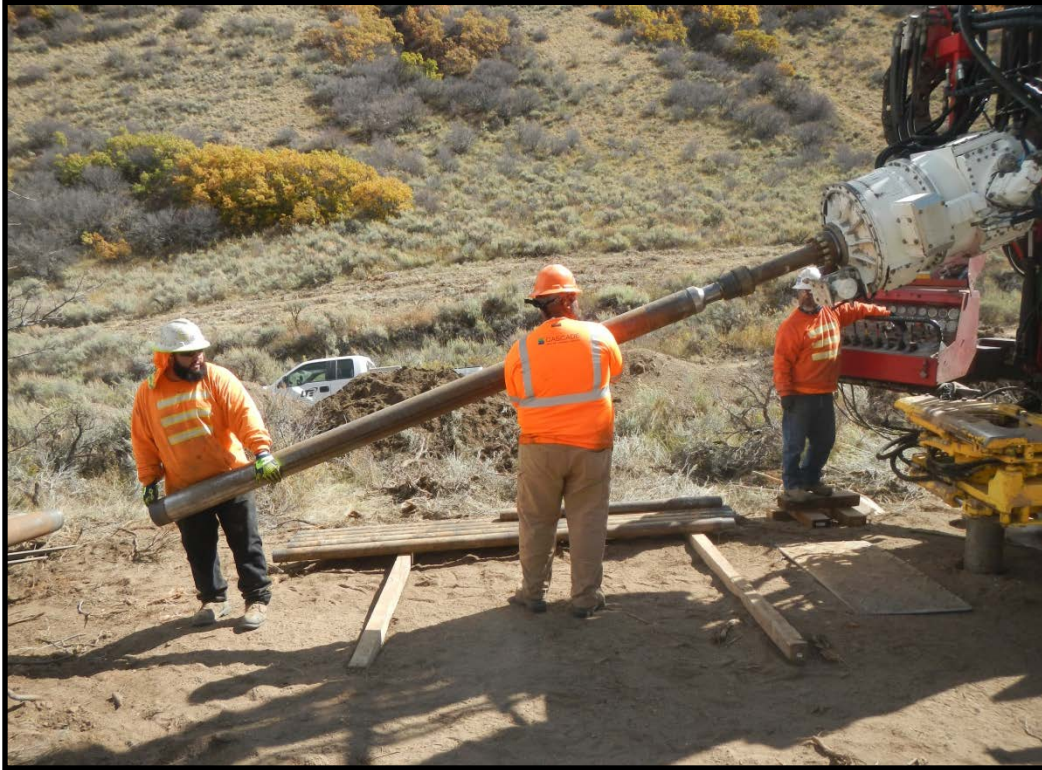
Drilling activities

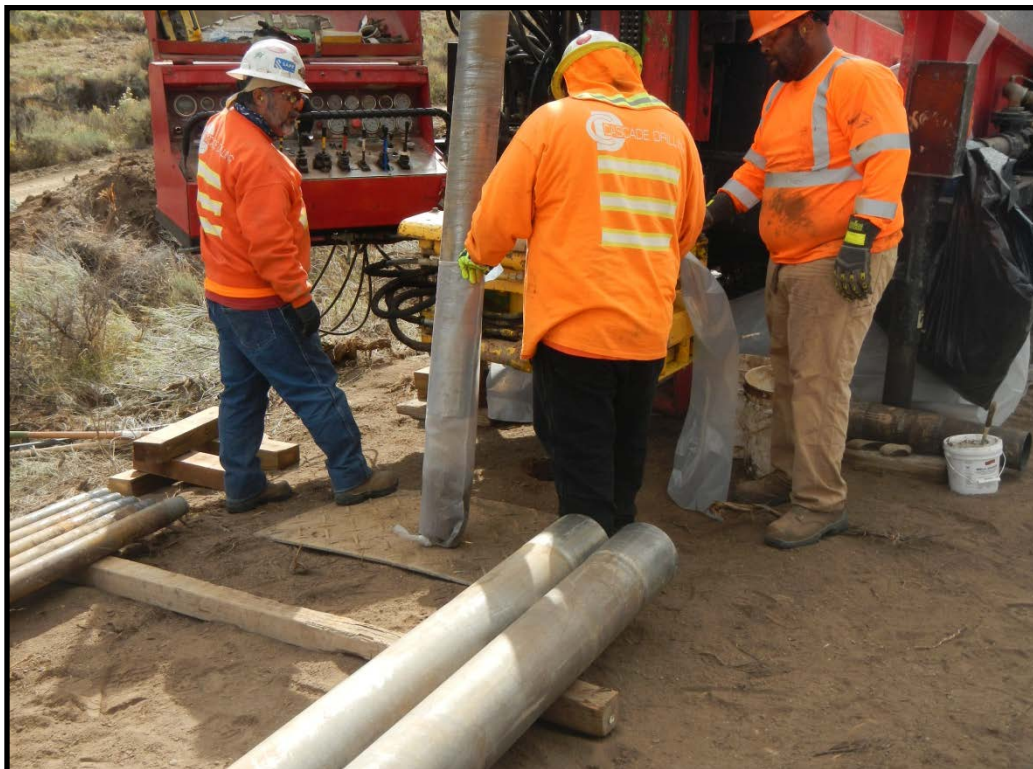
Recovering core samples

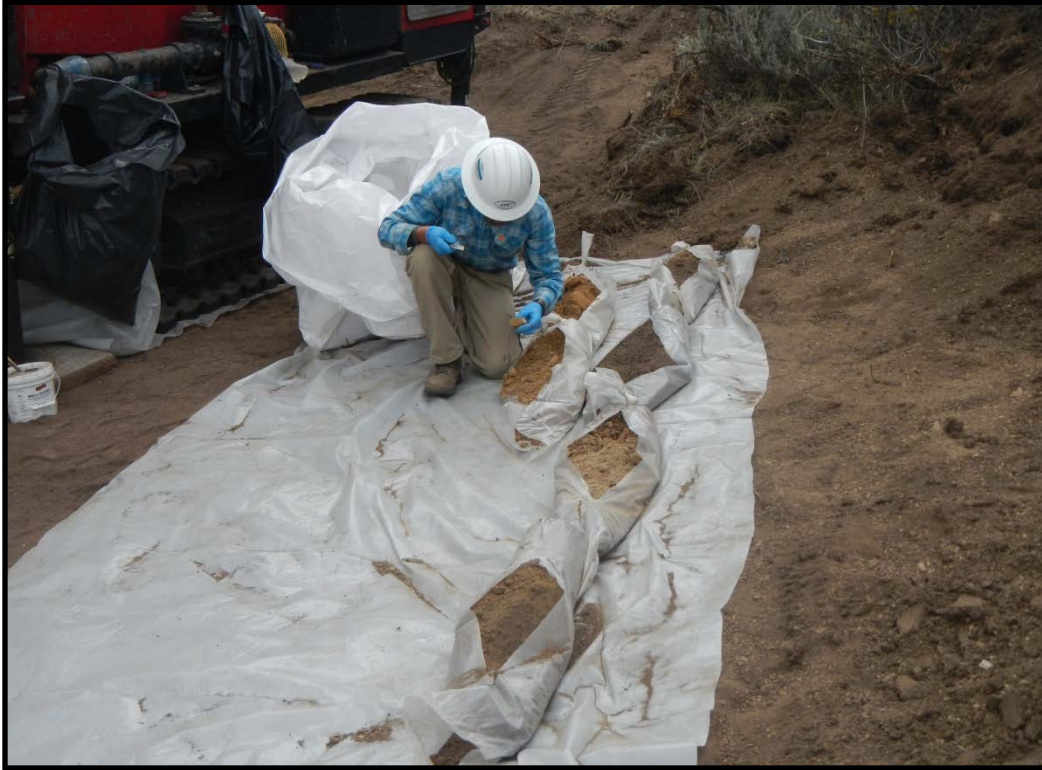
Geologist analyzing core samples. Mostly fine poorly cemented sandstone observed on MWs drilled on the west and east flanks of the valley. Rotasonic vibration pulverizes poorly cemented sandstone. Looks like sand...

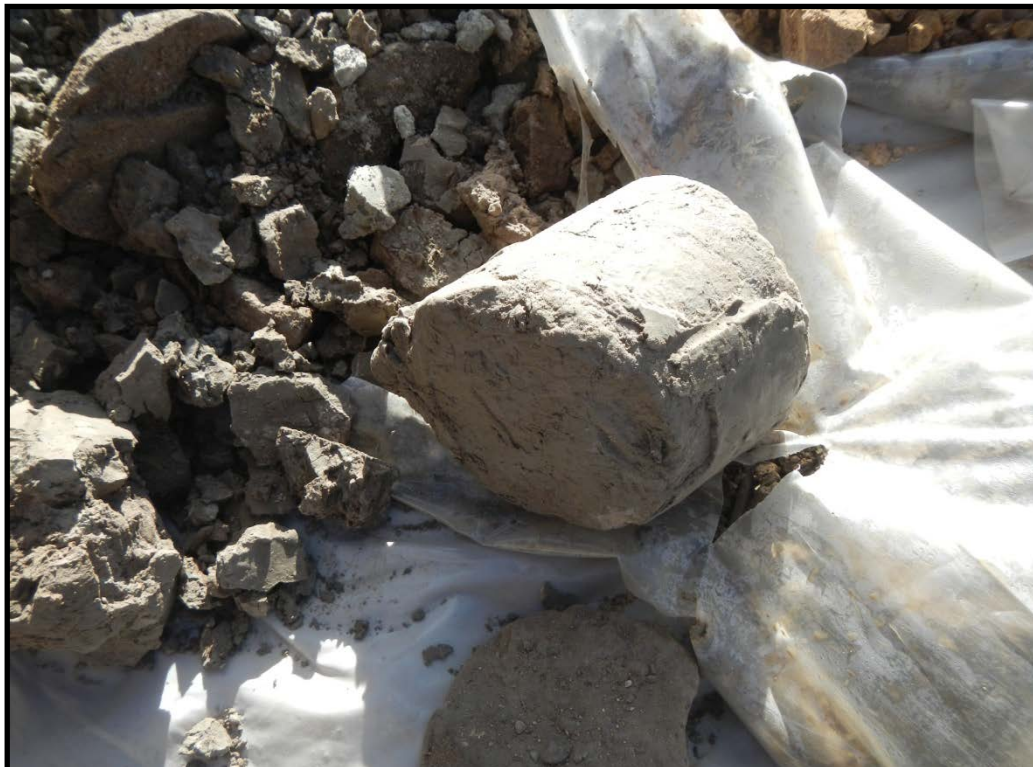
Bedrock of hard sandstone on MW-19 (west side of the gulch). Depending on location and elevation, well depth between 50 and 70 feet, typically about 10 to 20 feet of water in well.

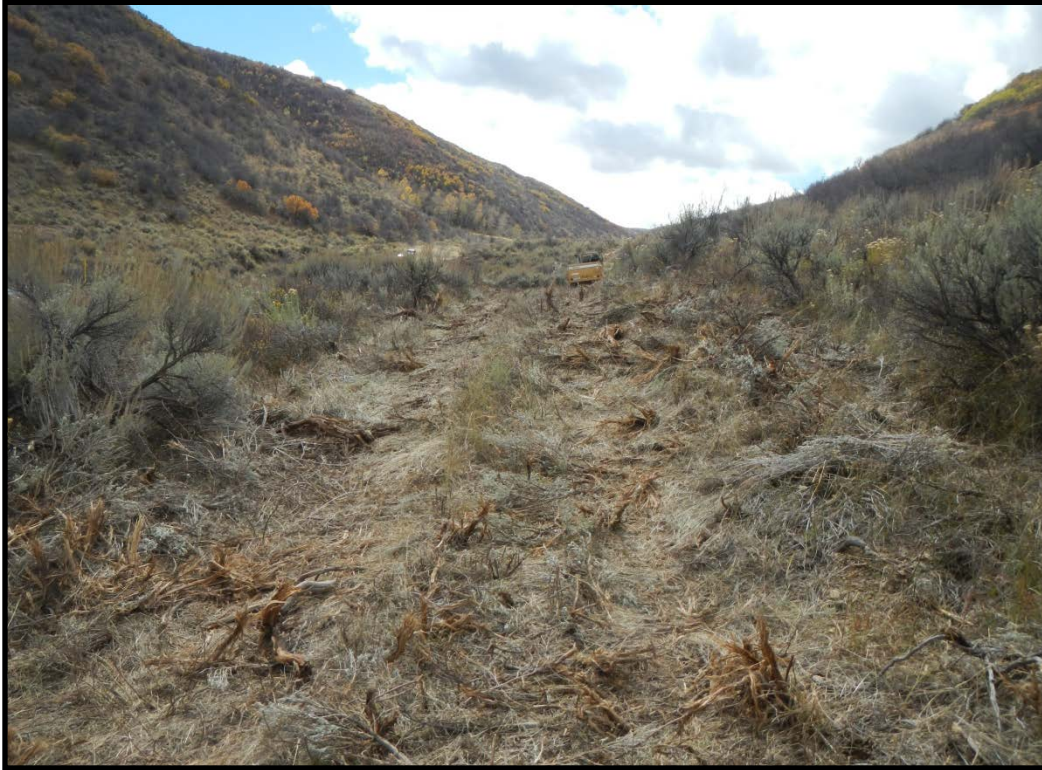
Moving south on west side of gulch to next MW location, closer to A27 pipeline spill location.

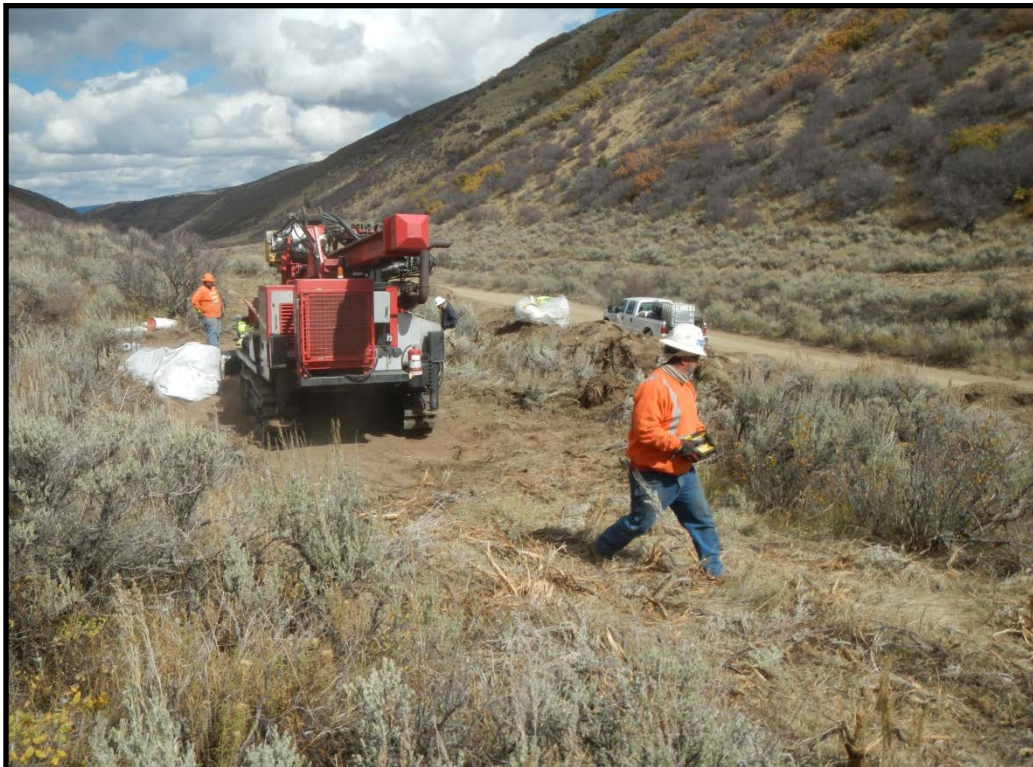
Driving the rig by remote control to next drilling location

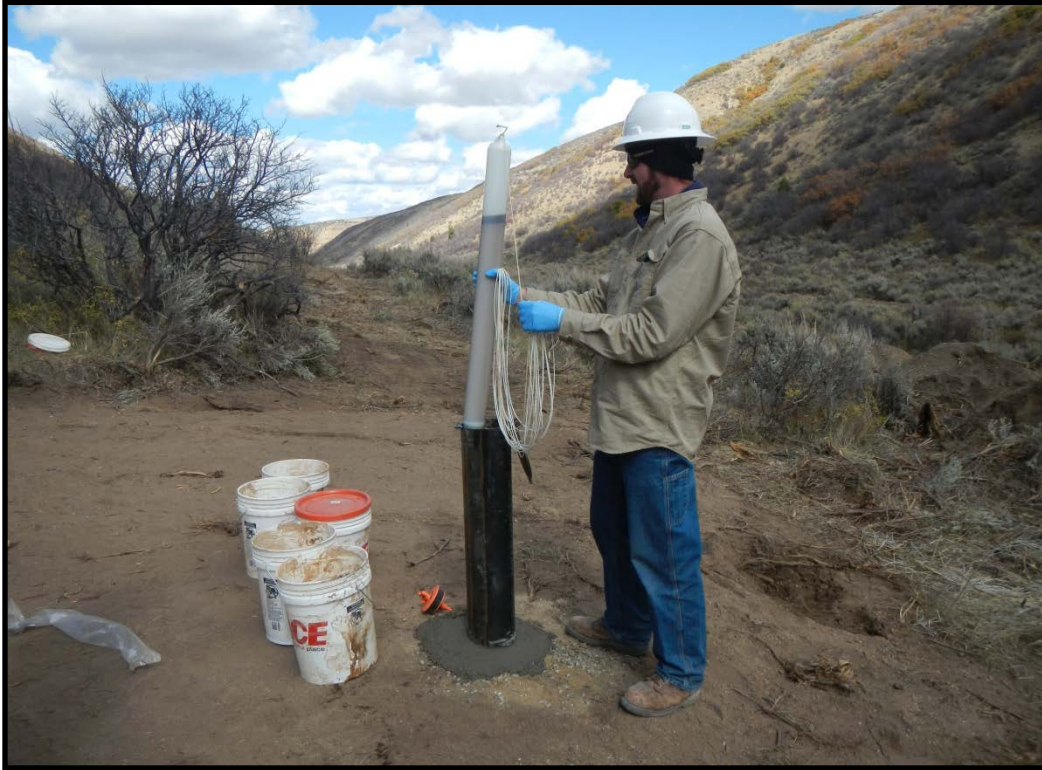
Developing (first installed) MW20, first of this round of approximately 20.  
See free product recovered during bailing.

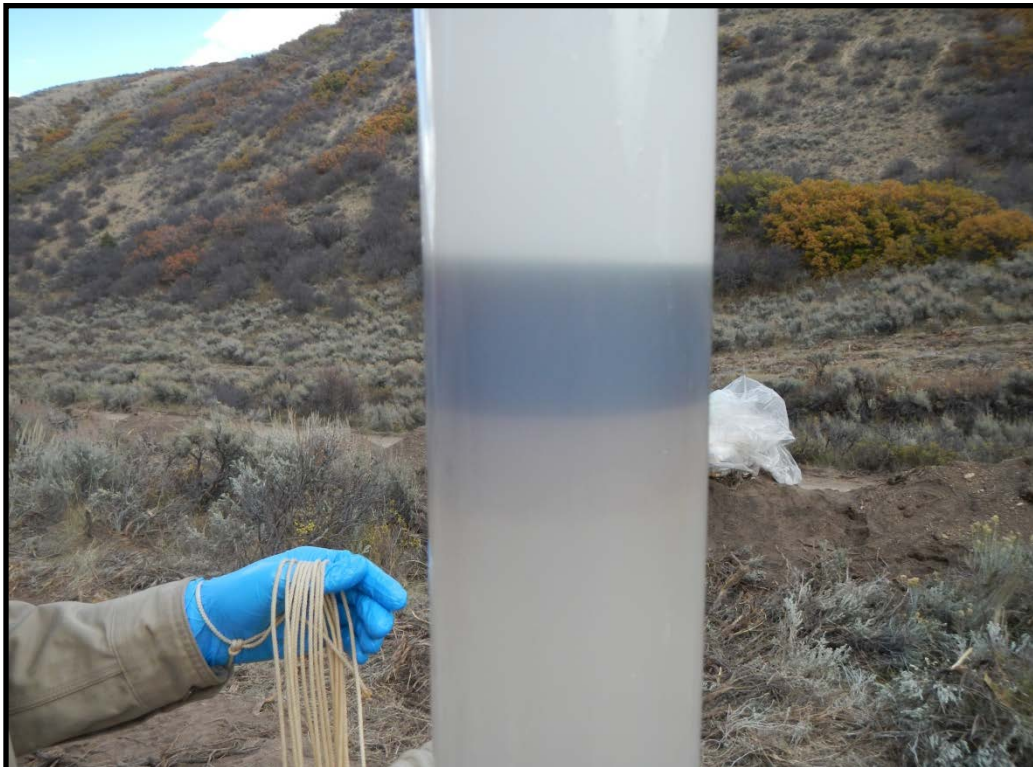
Dark free product on top and a distinguishable (about 2 inches) lighter layer of fluid floating on top of water

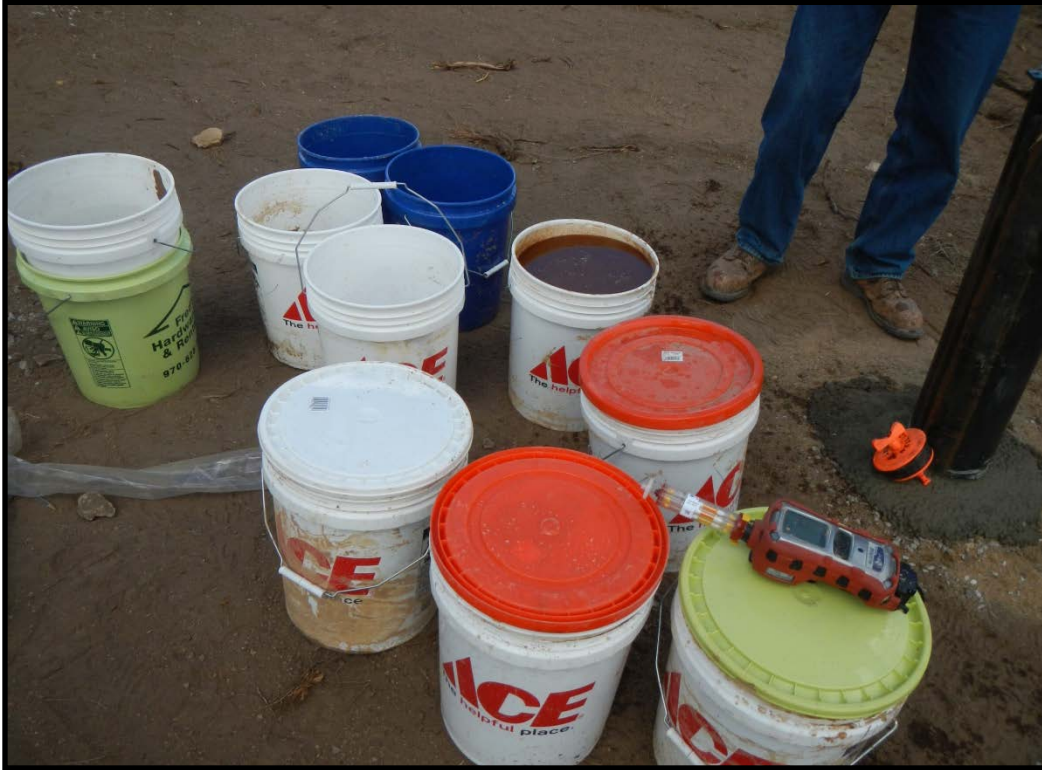
Buckets filled with water during well development.

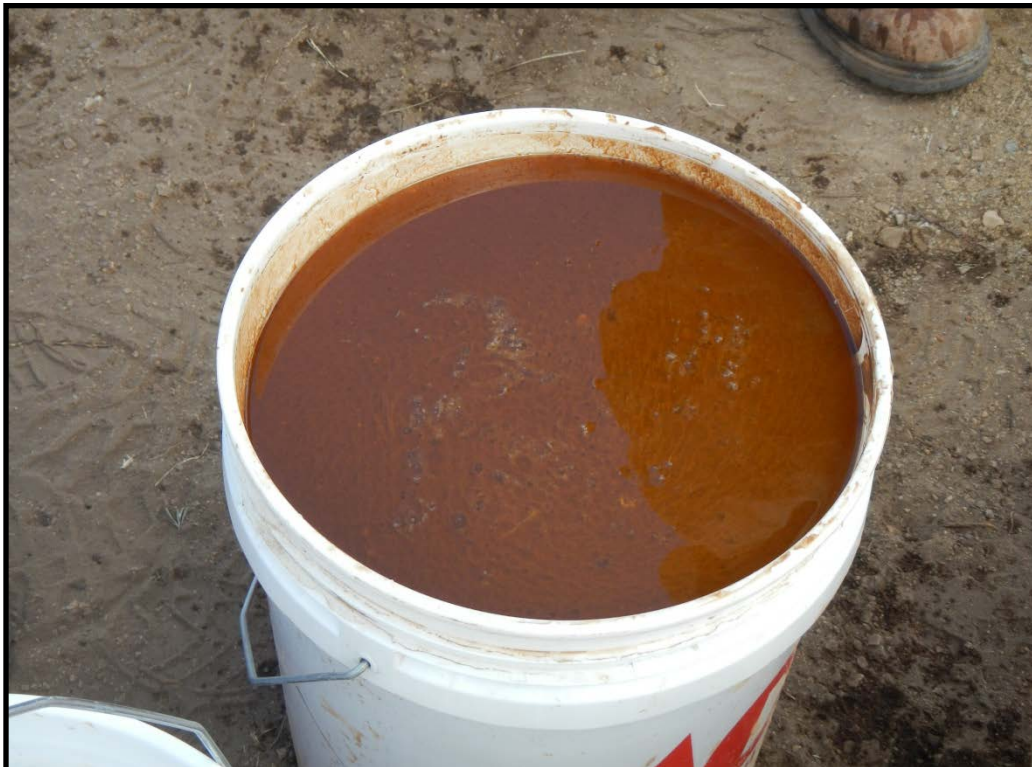
Free product has an orange color. Compare color with clay on last slide of this presentation.

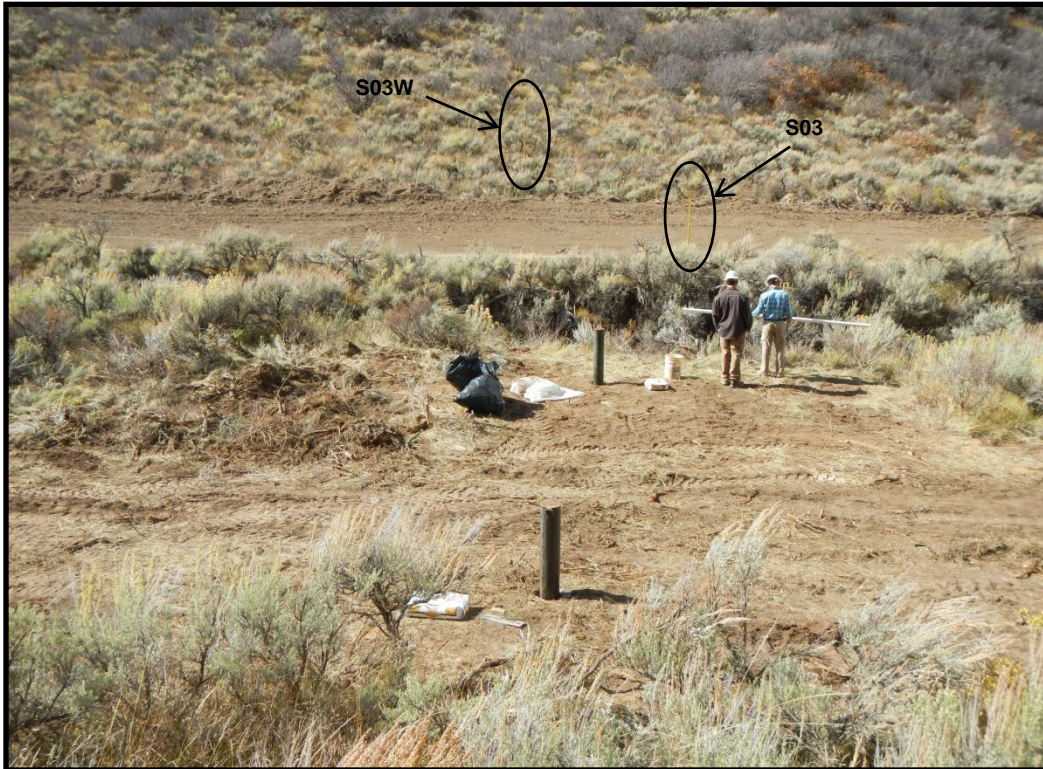
Looking west: From east to west, MW 12, MW11, S03, and S03W. According to Encana records, MW12 has no product; MW11, S03, and S03W do have free product.

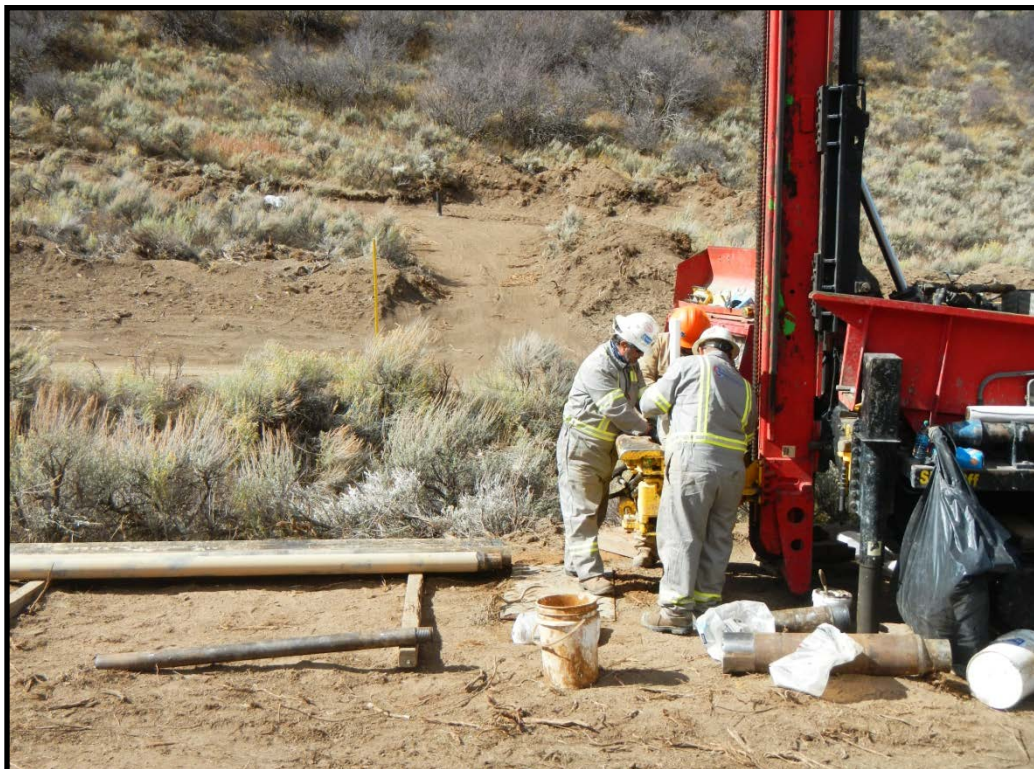
Looking west. Drilling MW13 on east side of creek. Yellow marker on MW-S03A (immediately west of creek). MW20 at the distance on west side of the gulch.

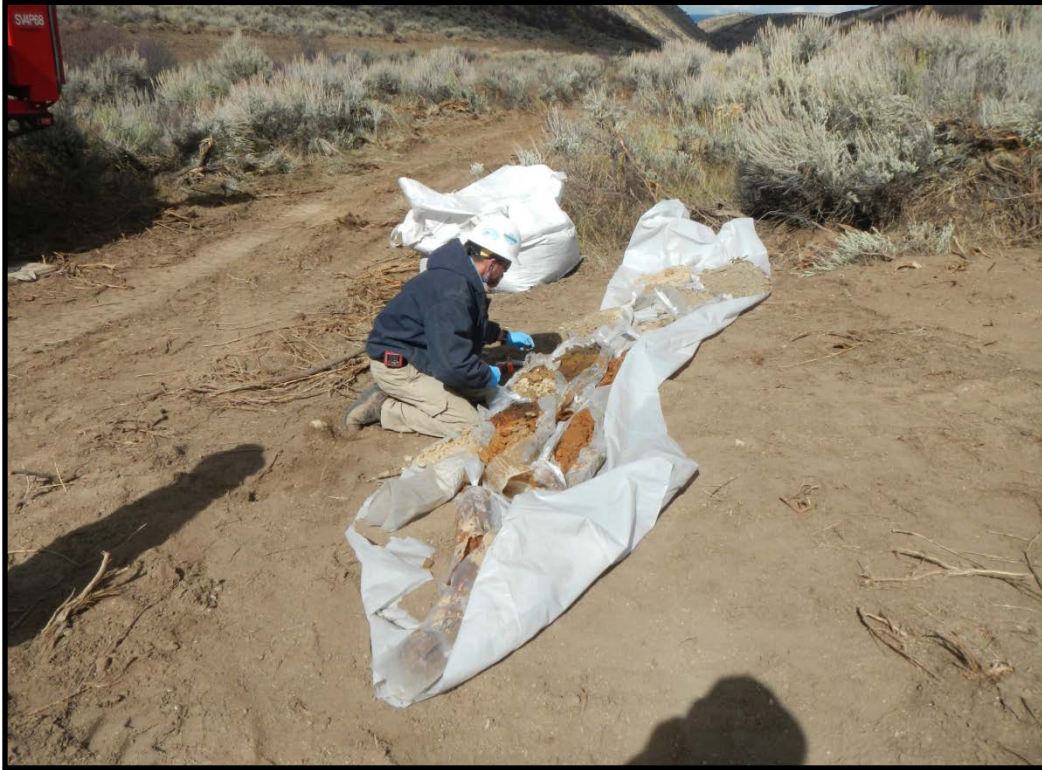
A tick layer of clayey soil (orange) was observed at approximately 30 to 40 feet.

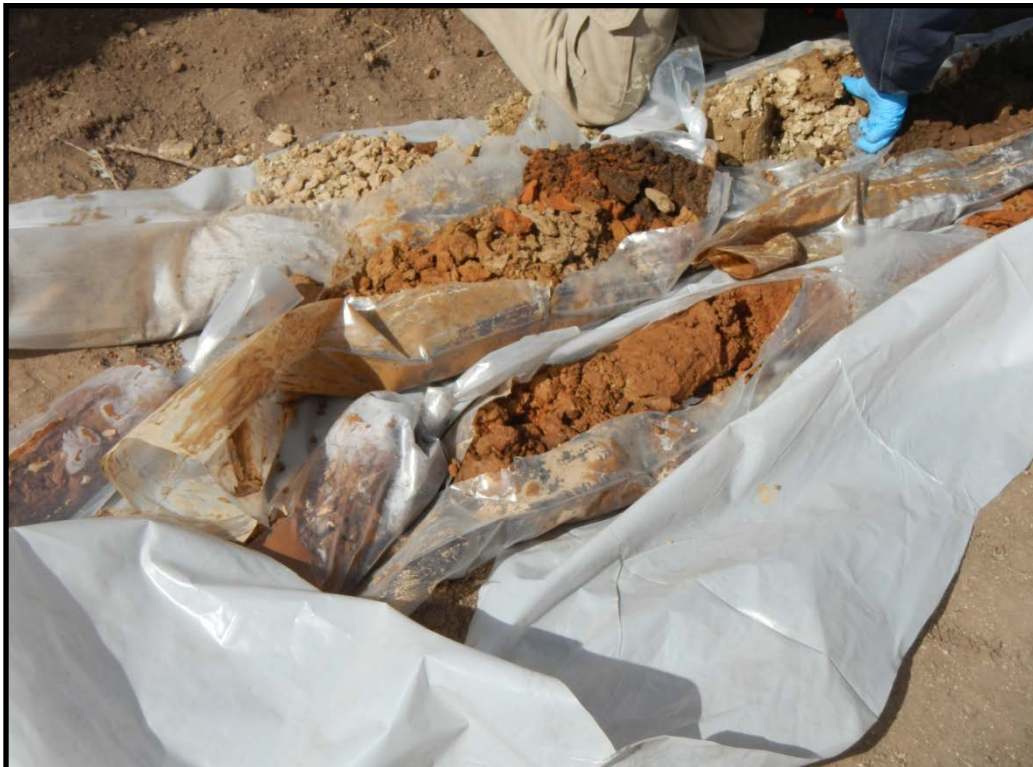
Color of wet clay is similar to free product from previous slide. Also similar to the color observed lately on the streambed, immediately downstream of the impacted springs.
