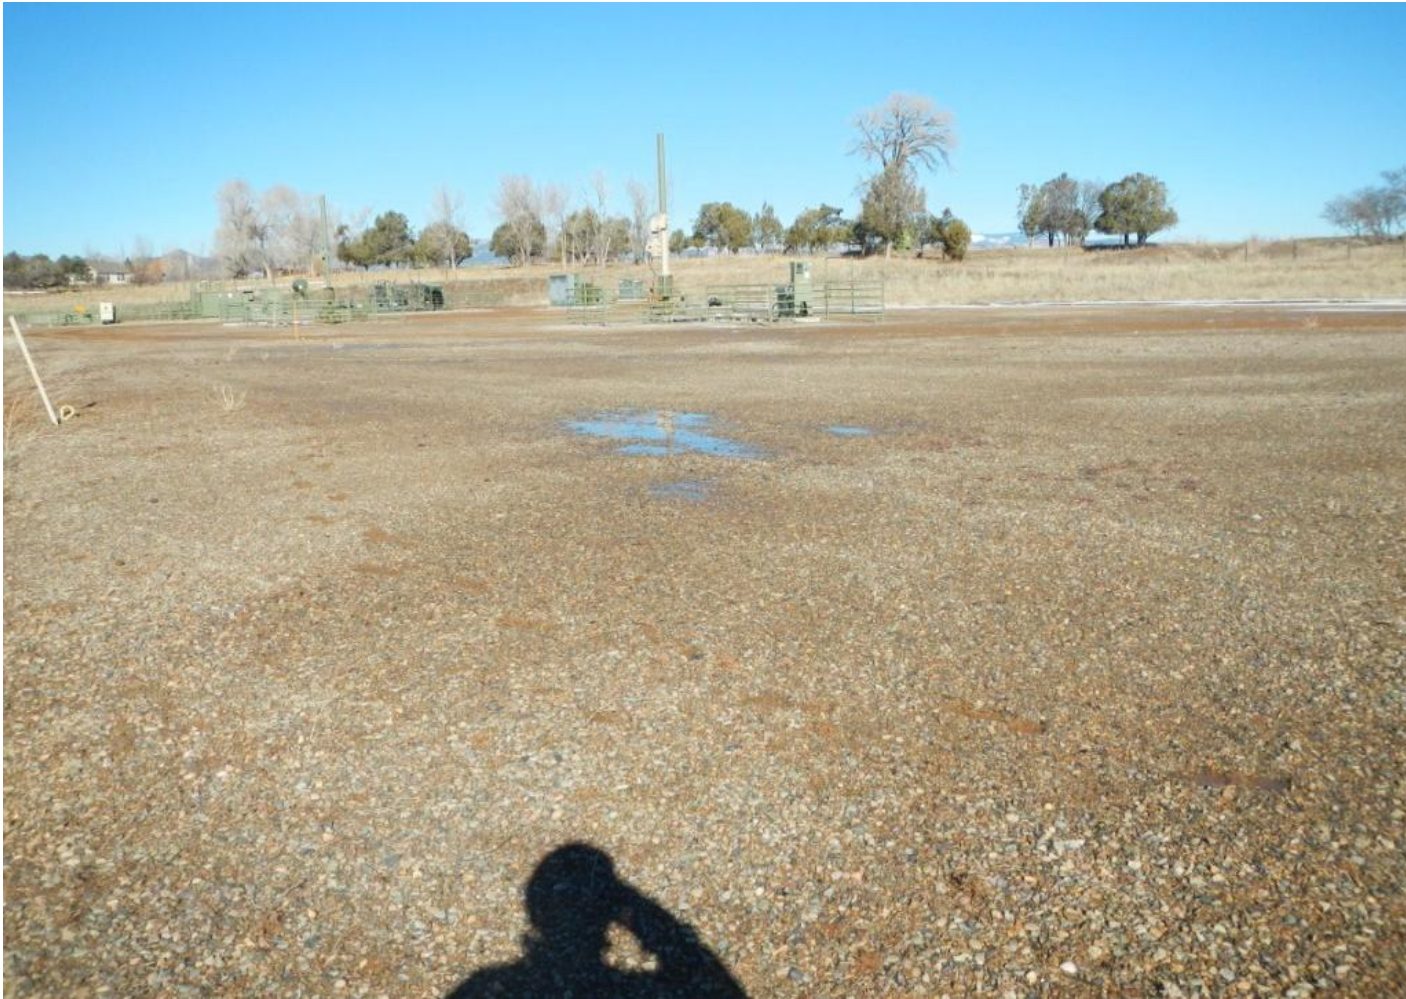
Photo 1. View of the project area from the southwestern corner facing center.

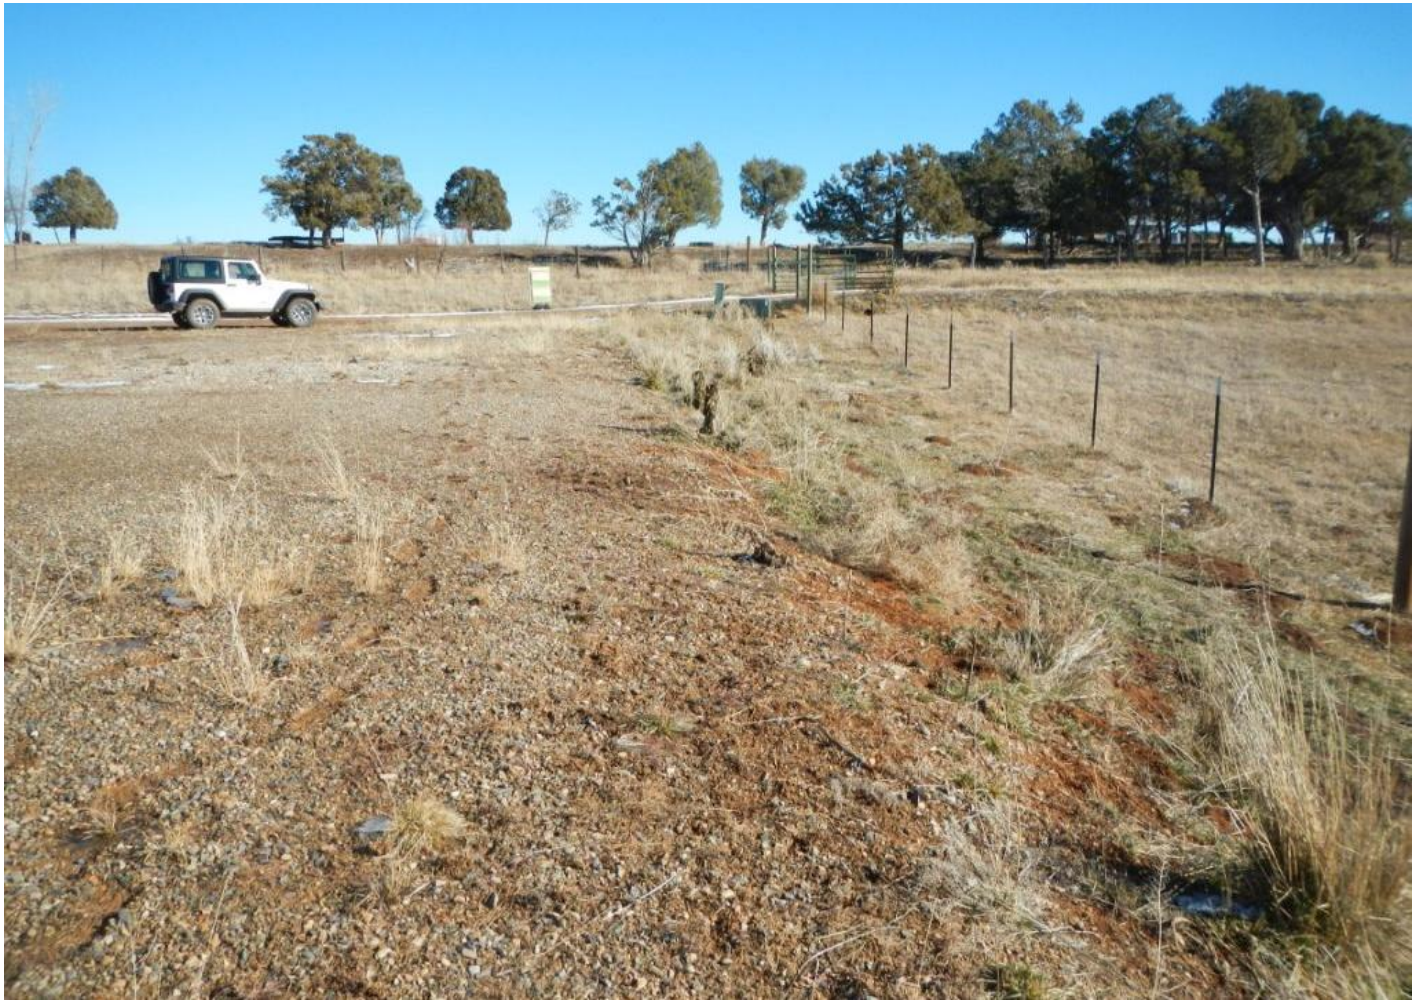
Photo 2. View of the southern portion of the project area from the southwestern corner facing eastward. Interim reclamation areas are revegetating with desirable species such as smooth brome (*Bromus inermis*), intermediate wheatgrass (*Thinopyron intermedium*), and dropseed (*Sporobolus* sp.).

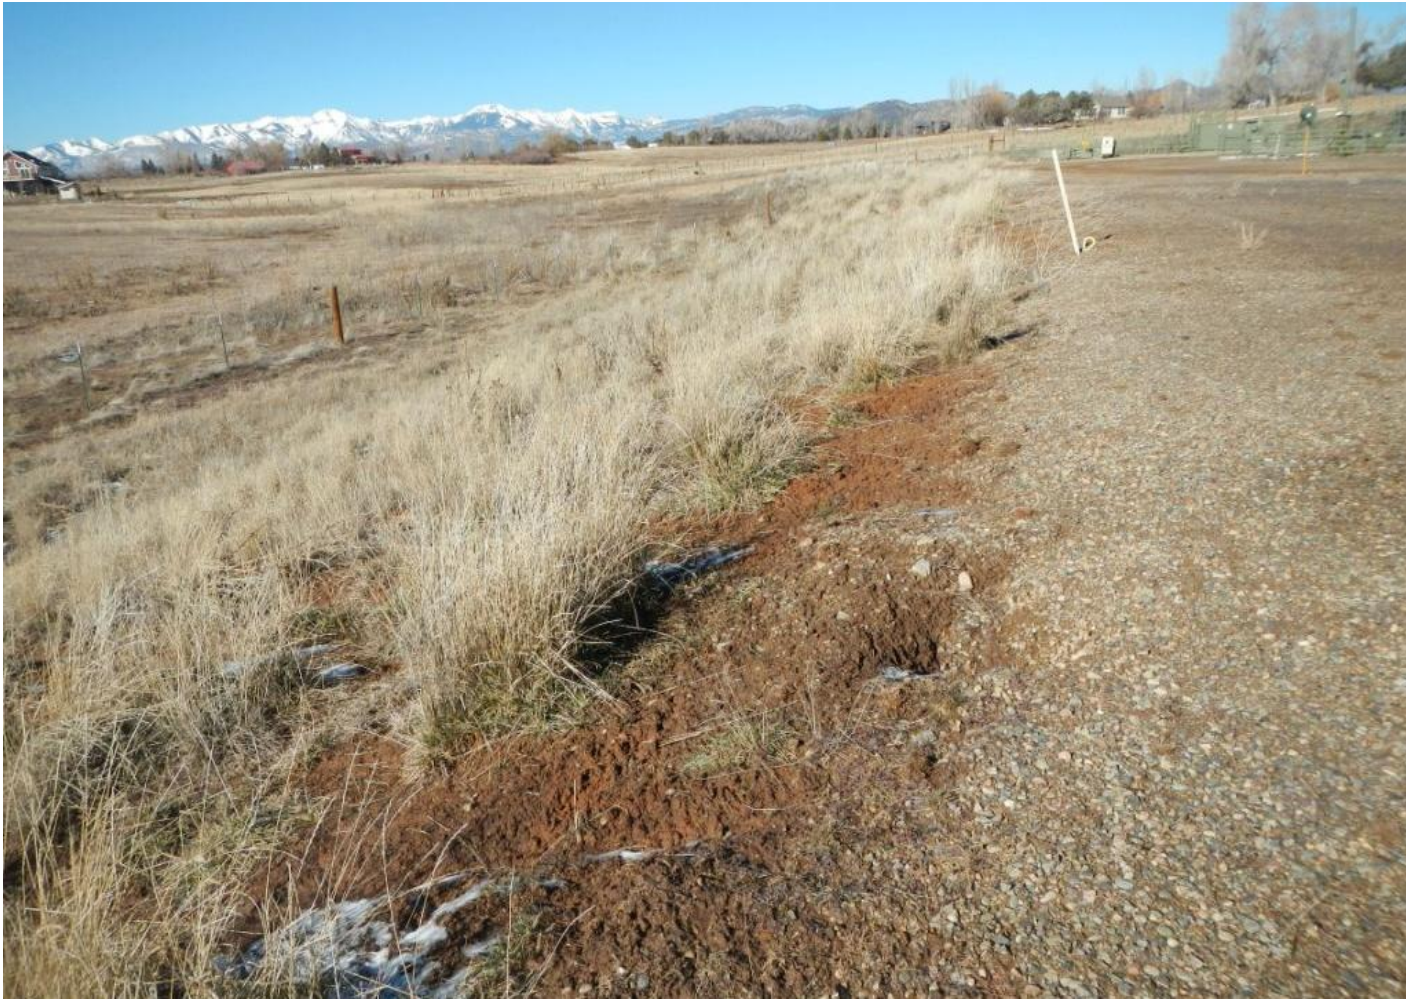
Photo 3. View of the western portion of the project area from the southwestern corner facing northward.

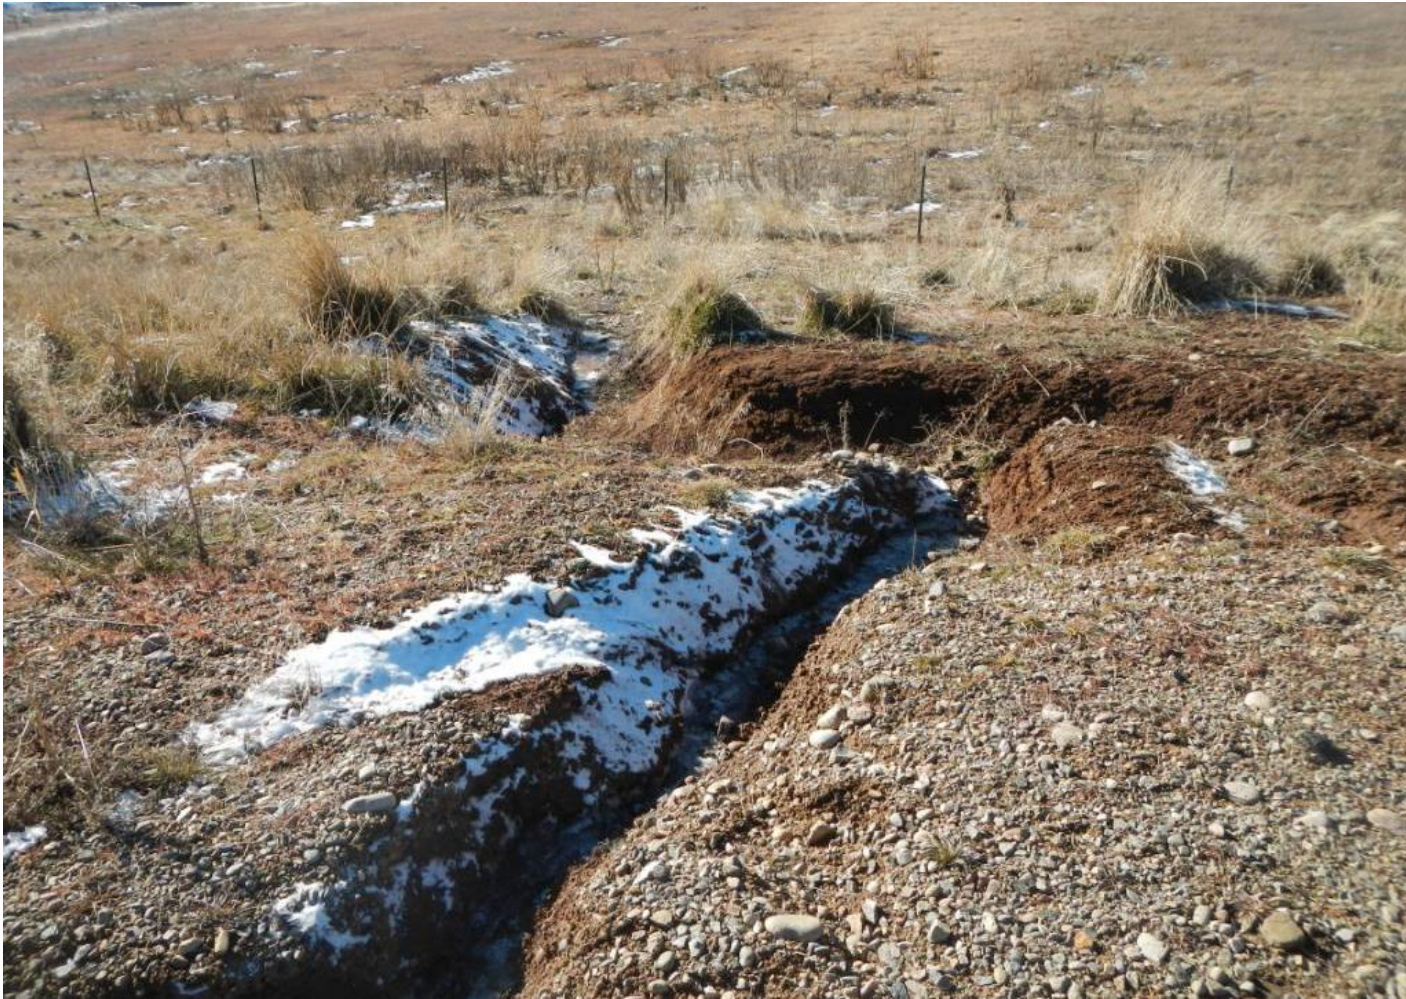
Photo 4. View stormwater erosion in the western portion of the project area that needs to be repaired.

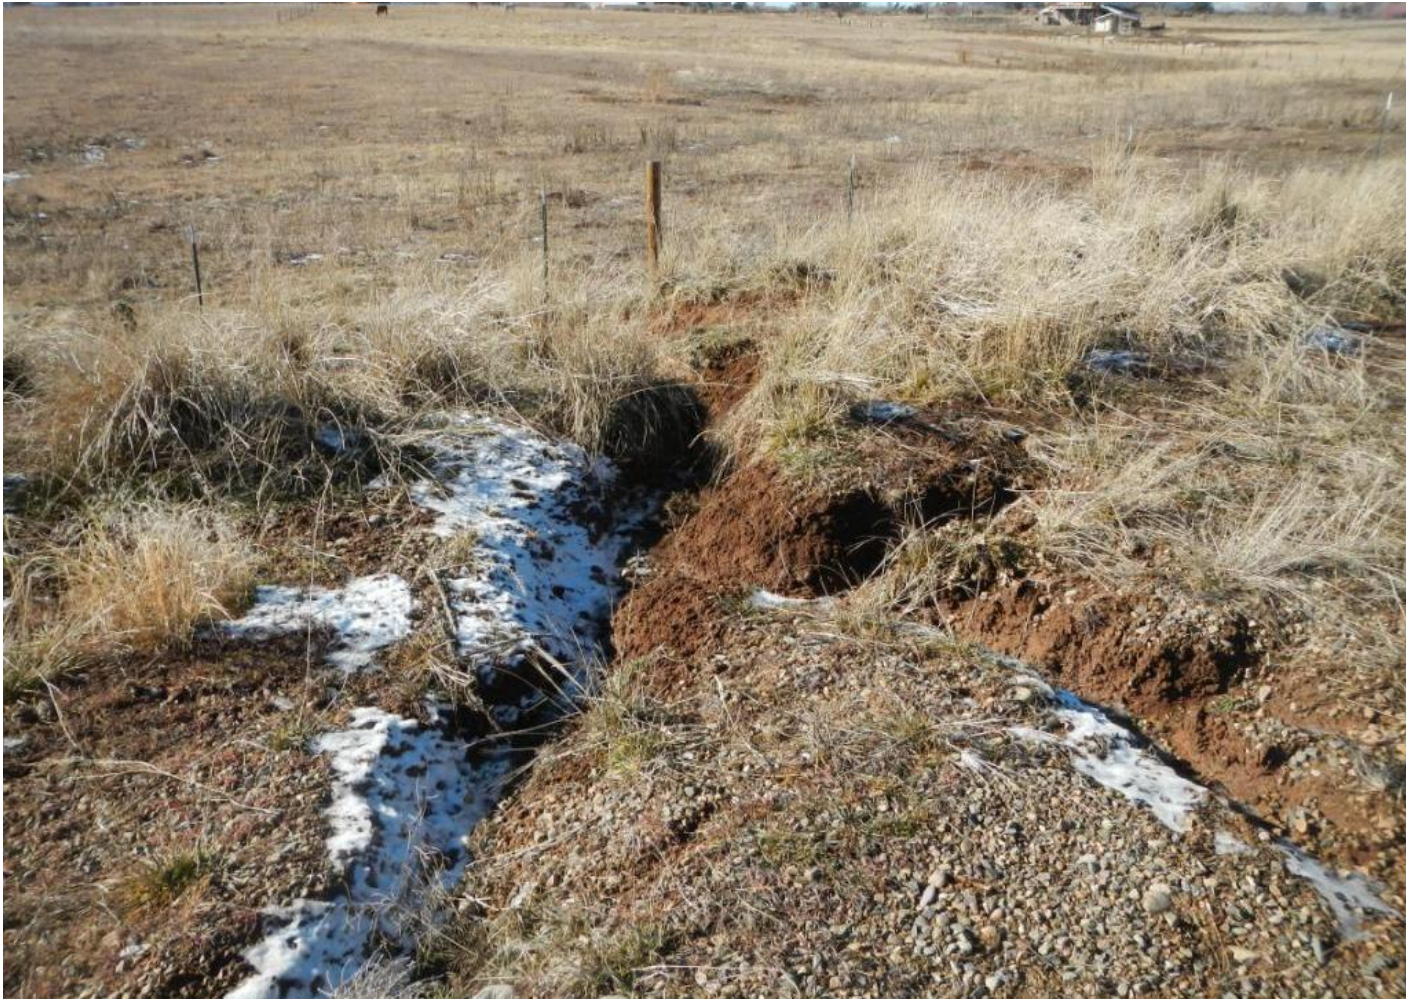
Photo 5. Another view of stormwater erosion in the western portion of the project area that needs to be repaired.

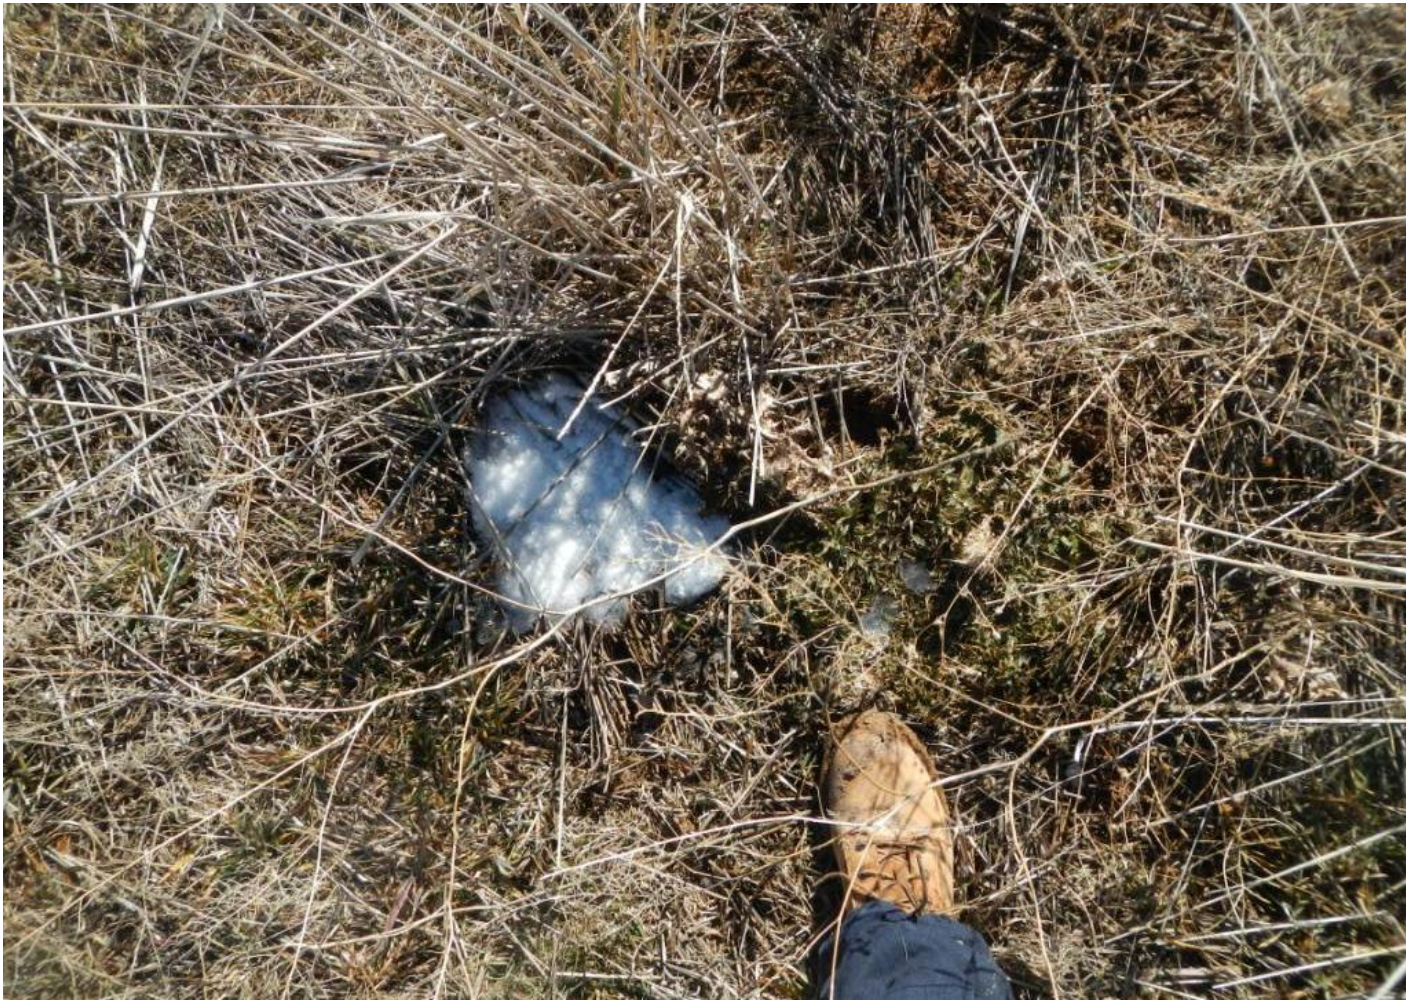
Photo 6. View of musk thistles (*Carduus nutans*) in the southern portion of the project area.

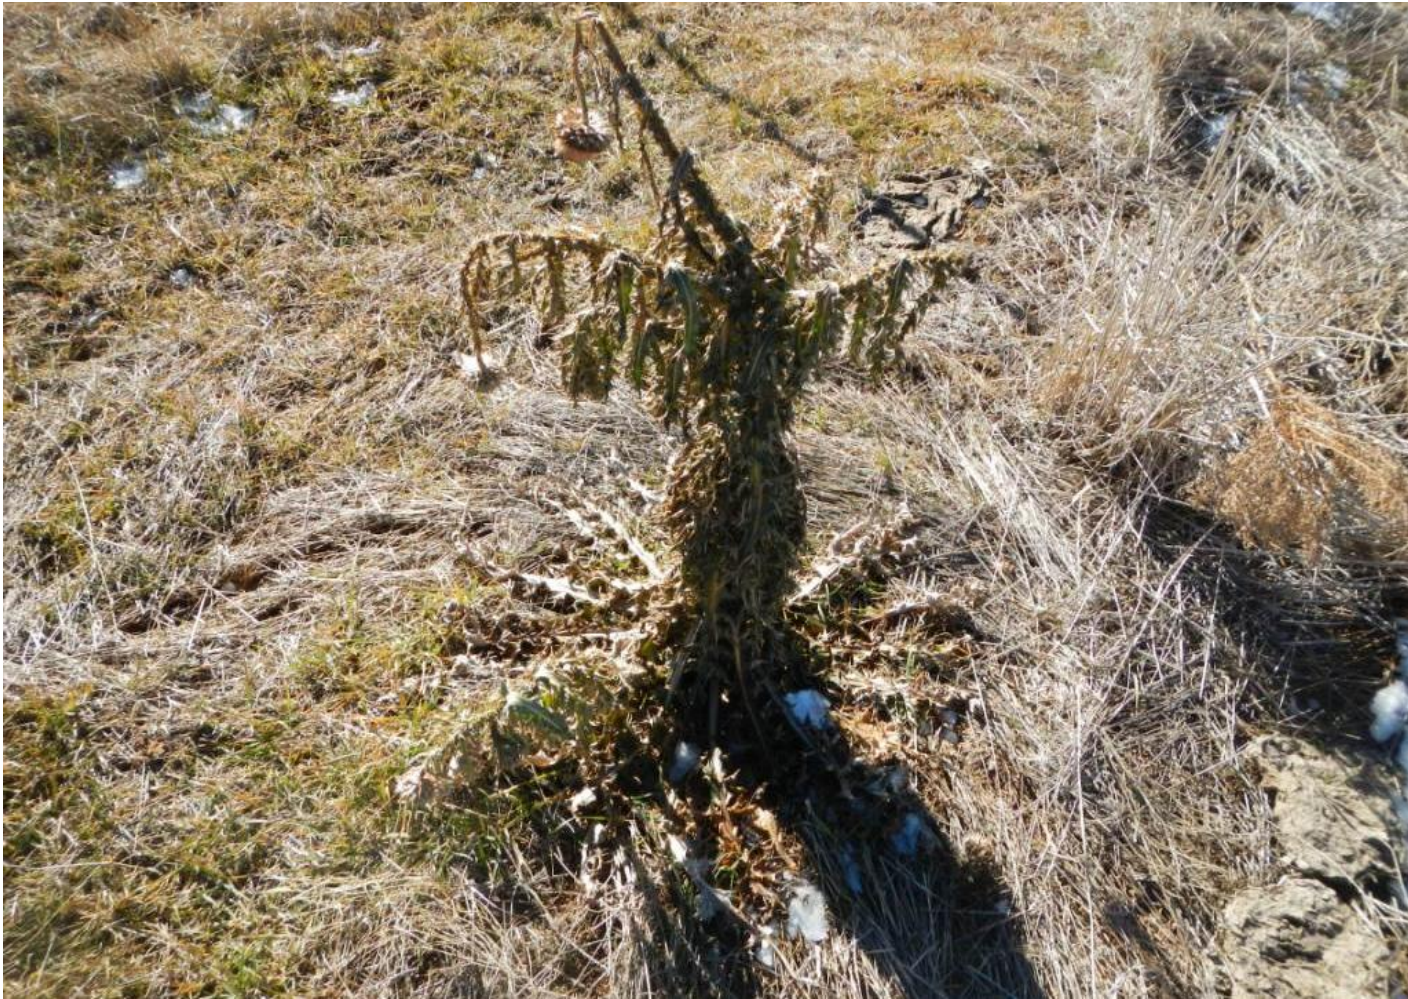
Photo 7. Another view of musk thistles within the project area.
