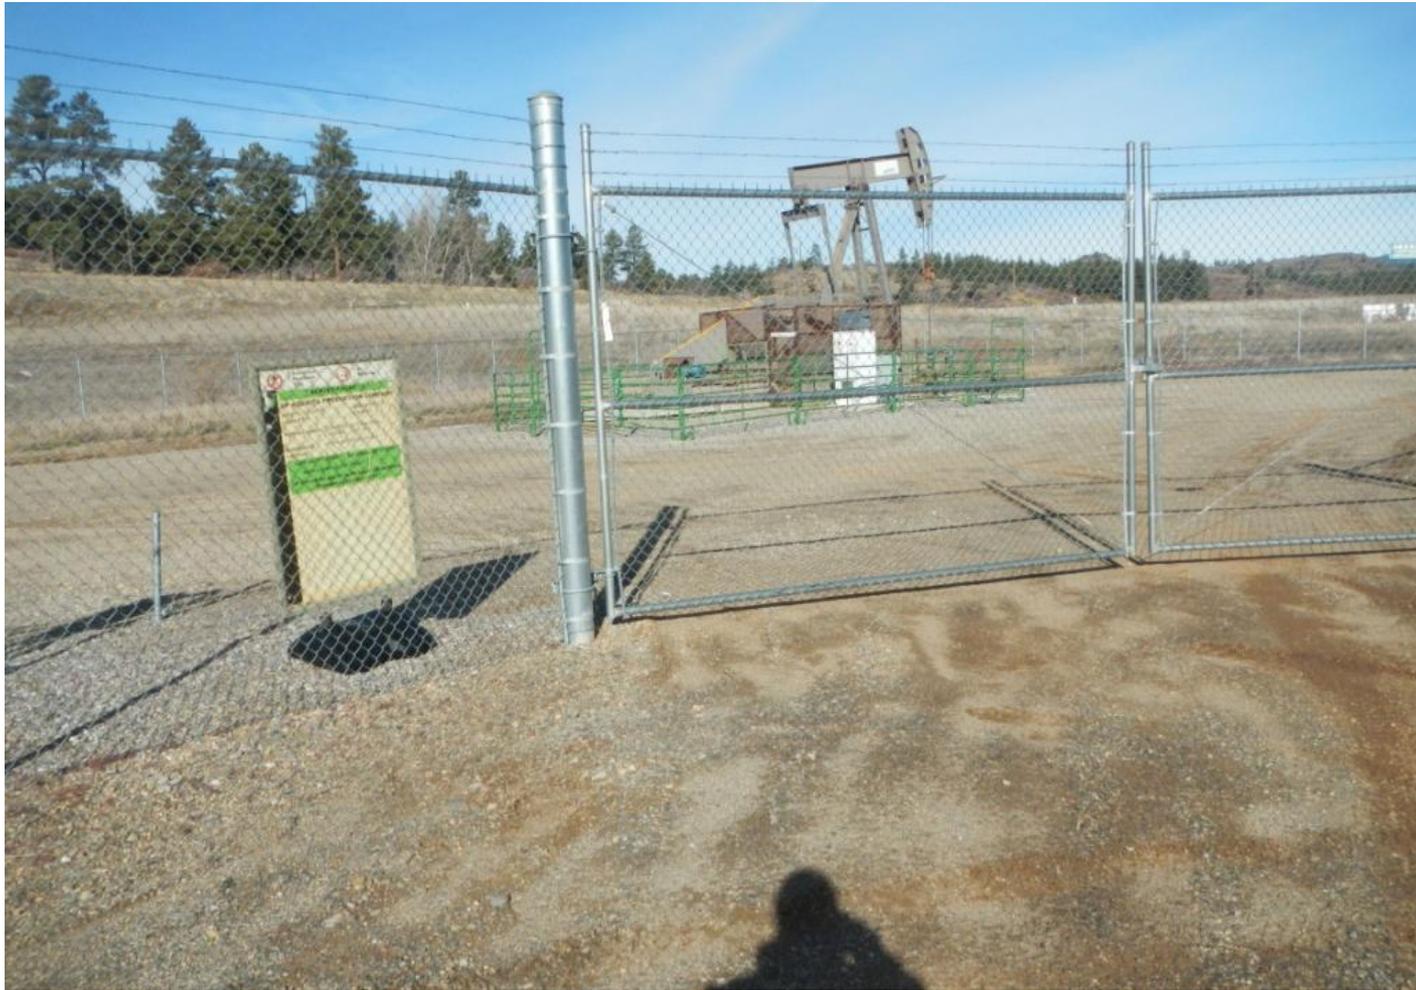
Photo 1. View of the project area from the southeastern corner facing center.

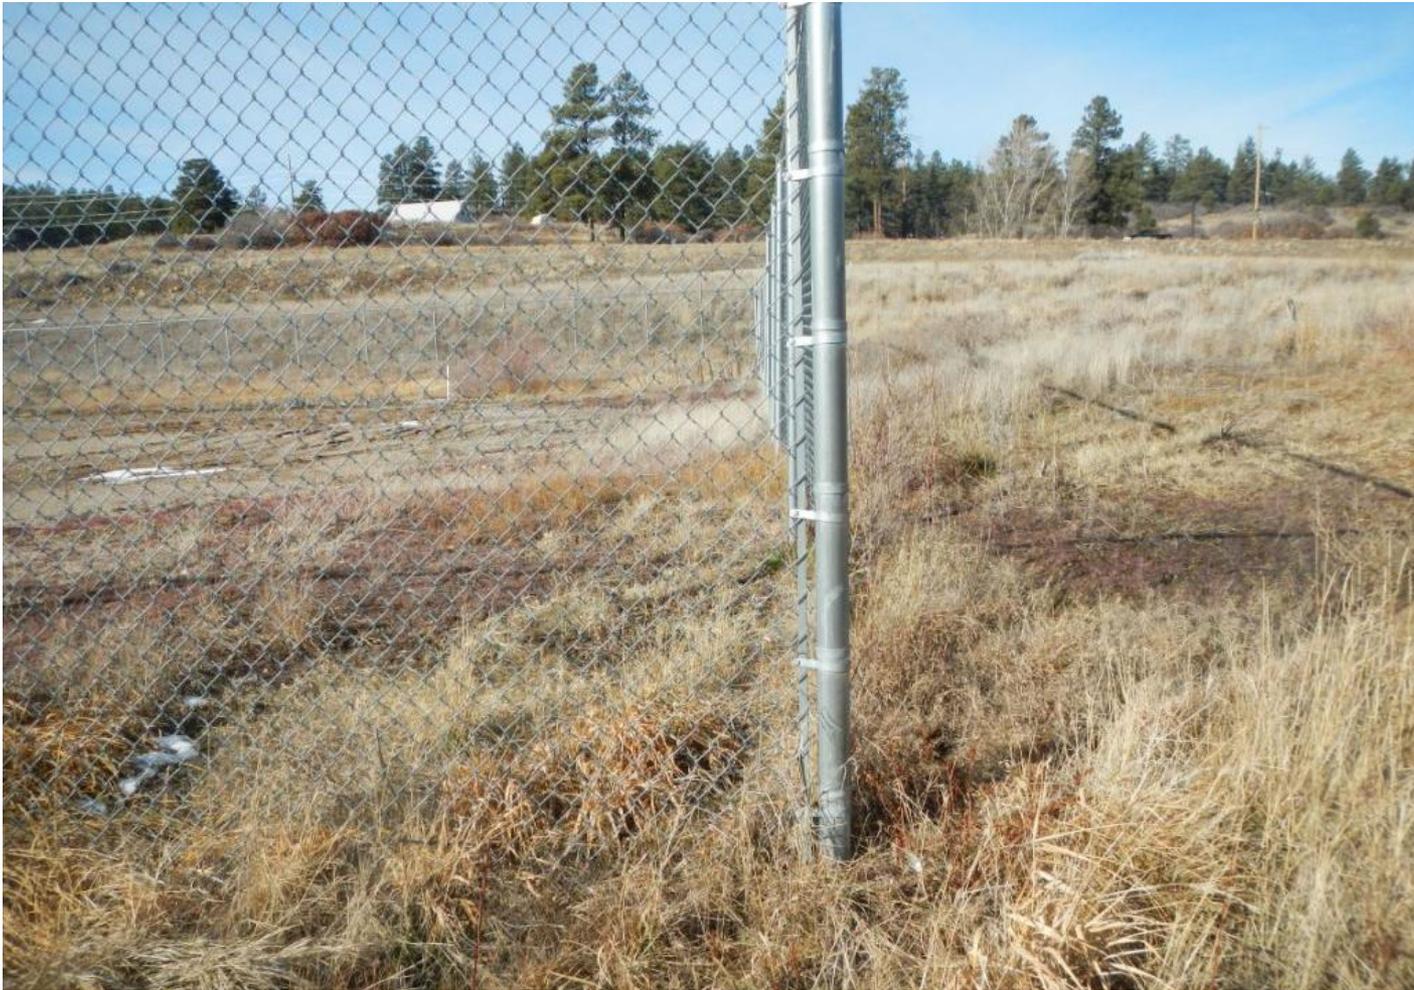
Photo 2. View of the northern portion of the project area from the northeastern corner facing westward.

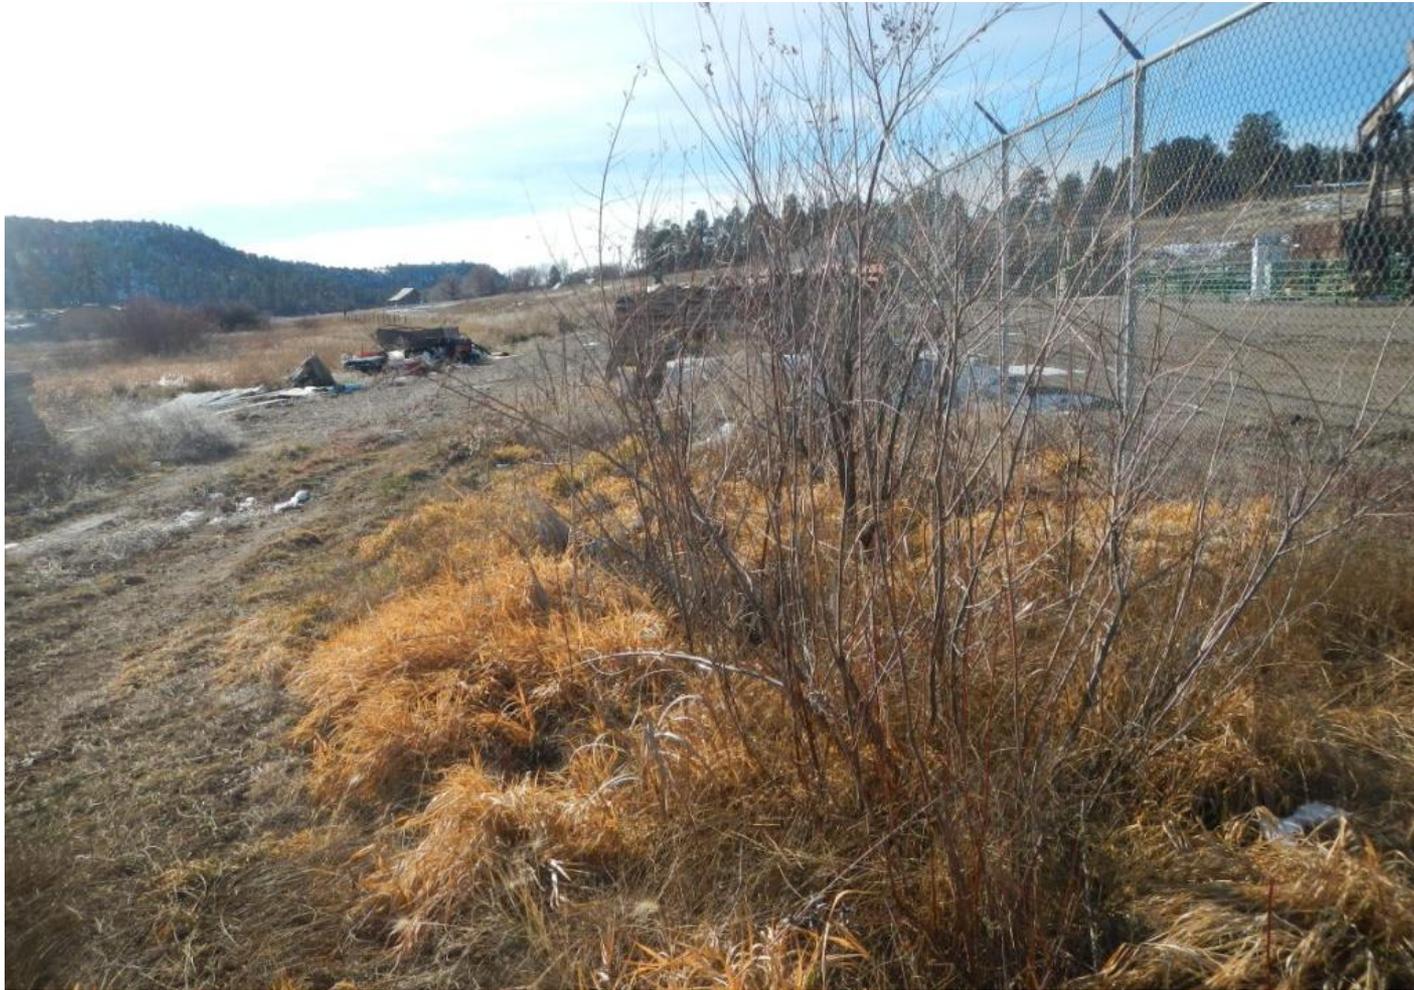
Photo 3. View of the eastern portion of the project area from the northeastern corner facing southward. It appears surface owner is storing materials along the outer edges of the project area.

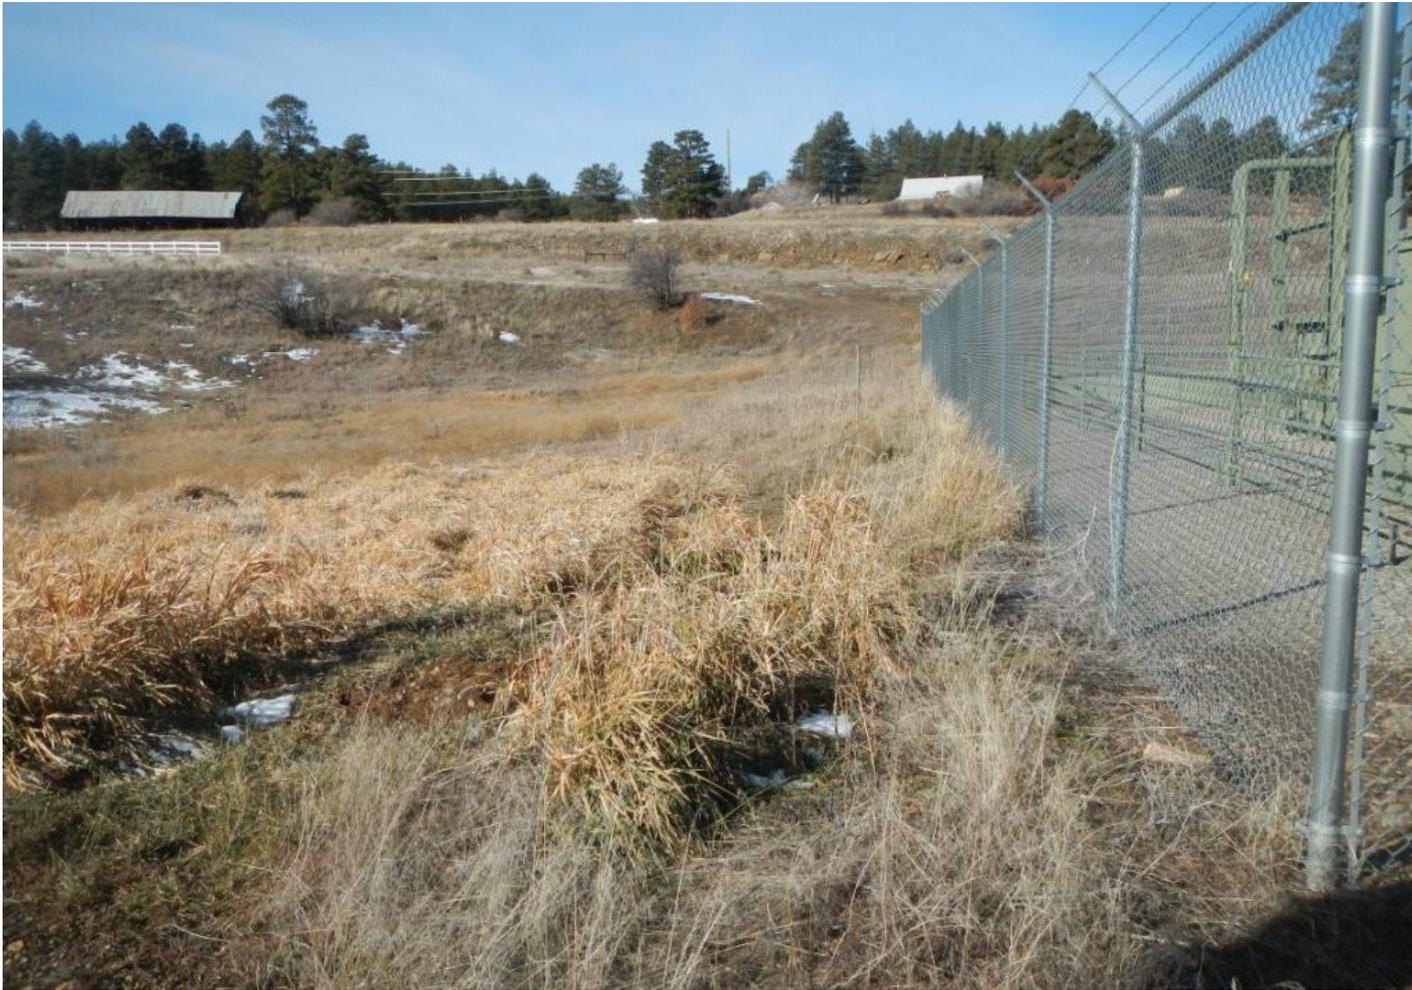
Photo 4. View of the southern portion of the project area facing westward. Wetland vegetation is growing around the perimeter of the project area.
