Location Overview

Stormwater Inspection

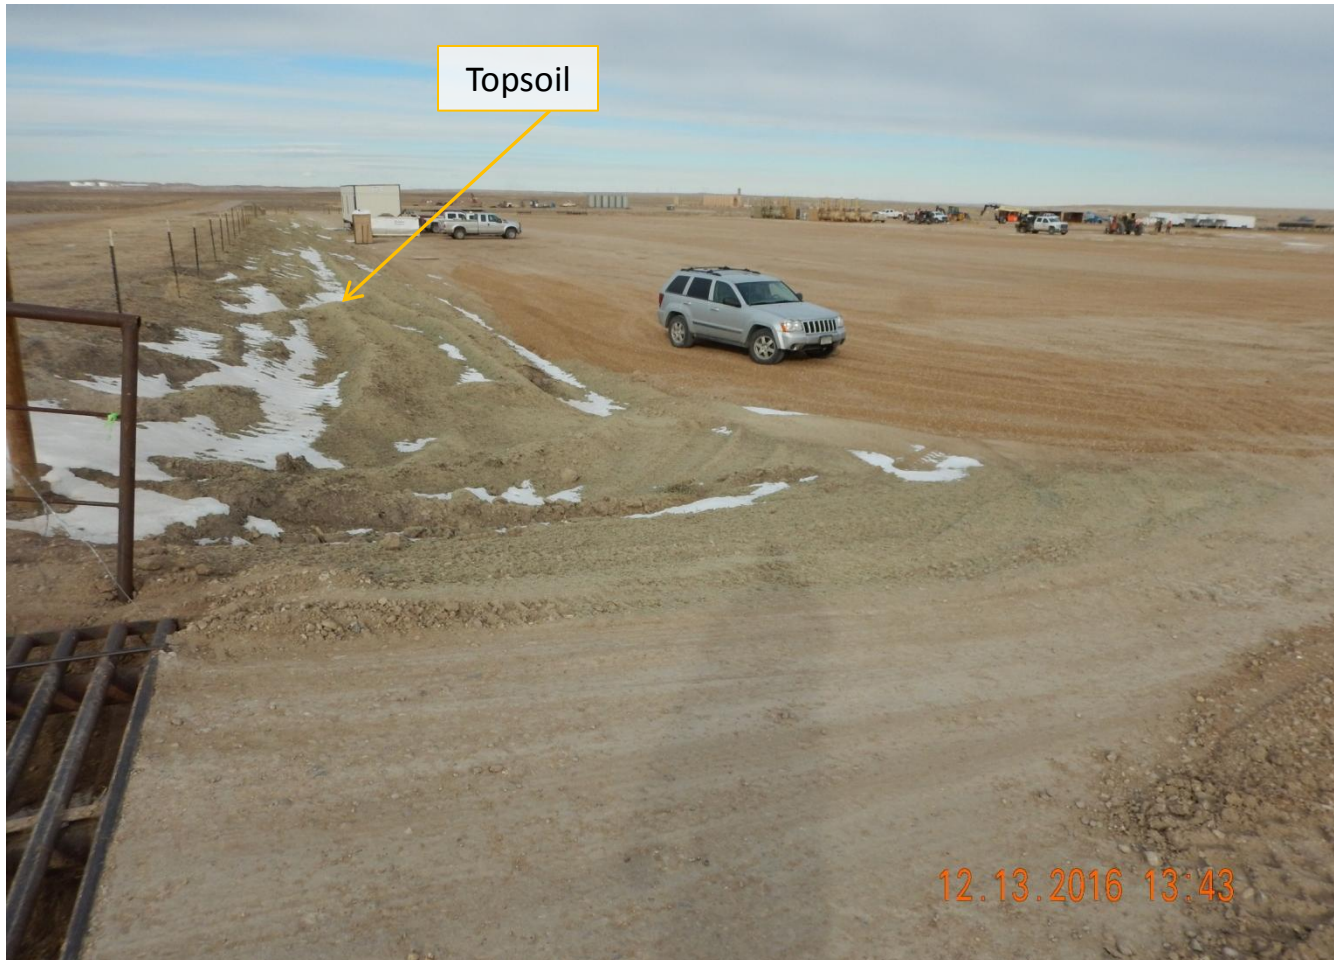
Photo 1. Photo taken from the southwest corner of location, facing North. Based on documentation, topsoil has been stored along the entire perimeter of the location. Tackifier has been applied to the topsoil but areas need additional tackifier because the application rate was too low- see Photos 3 & 4. Also, need to install sufficient stormwater BMPs for the location.

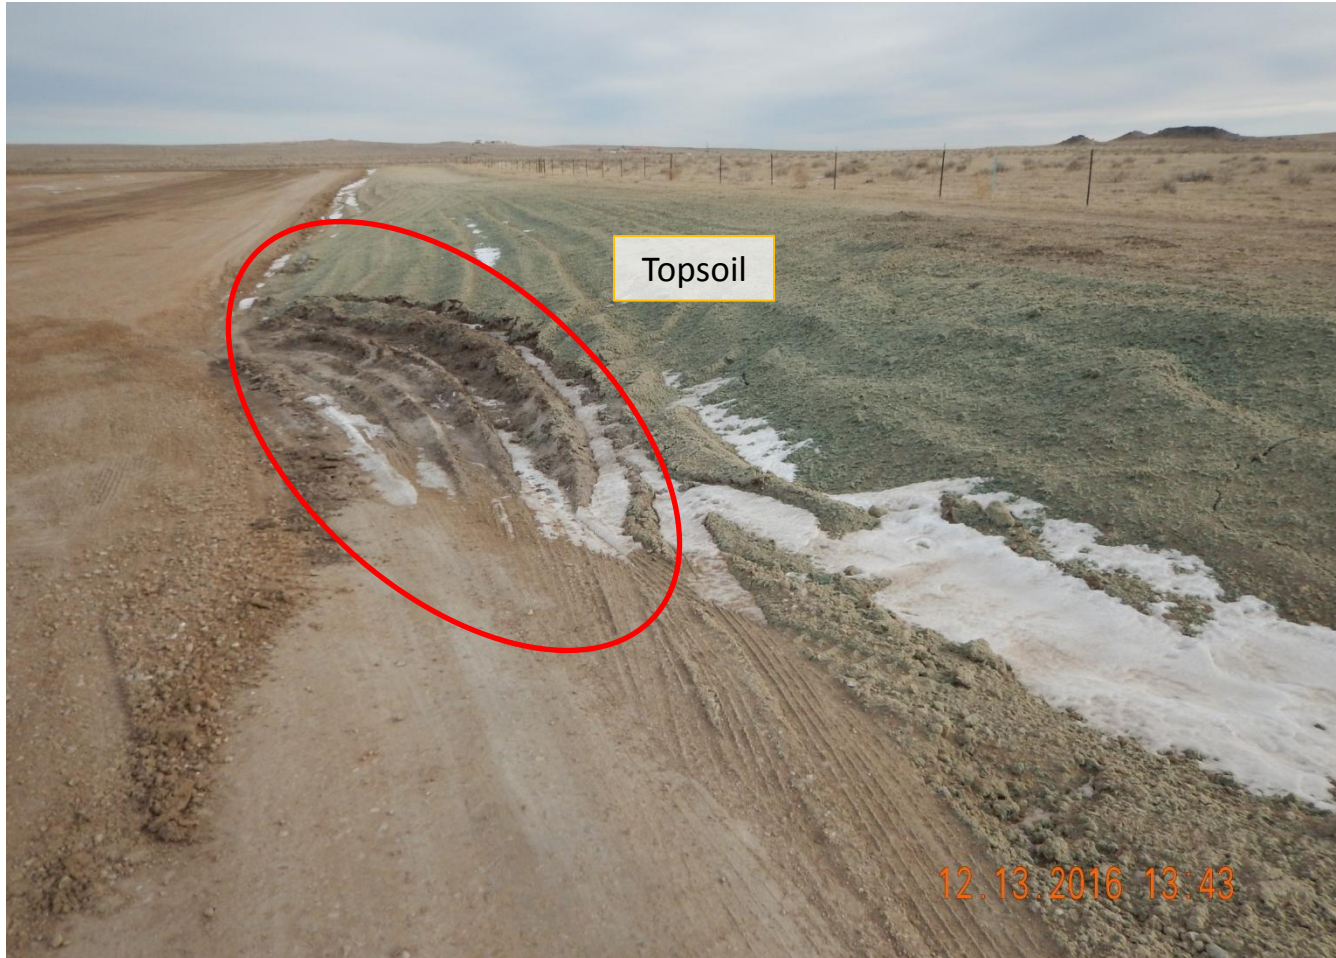
Photo 2. Photo taken from the southwest corner of location, facing East. Based on documentation, topsoil has been stored along the entire perimeter of the location. Tackifier has been applied to the topsoil but areas need additional tackifier because the application rate was too low- see Photos 3 & 4. Need to protect topsoil as it appears vehicle traffic is damaging the highlighted area. Also, need to install sufficient stormwater BMPs for the location.

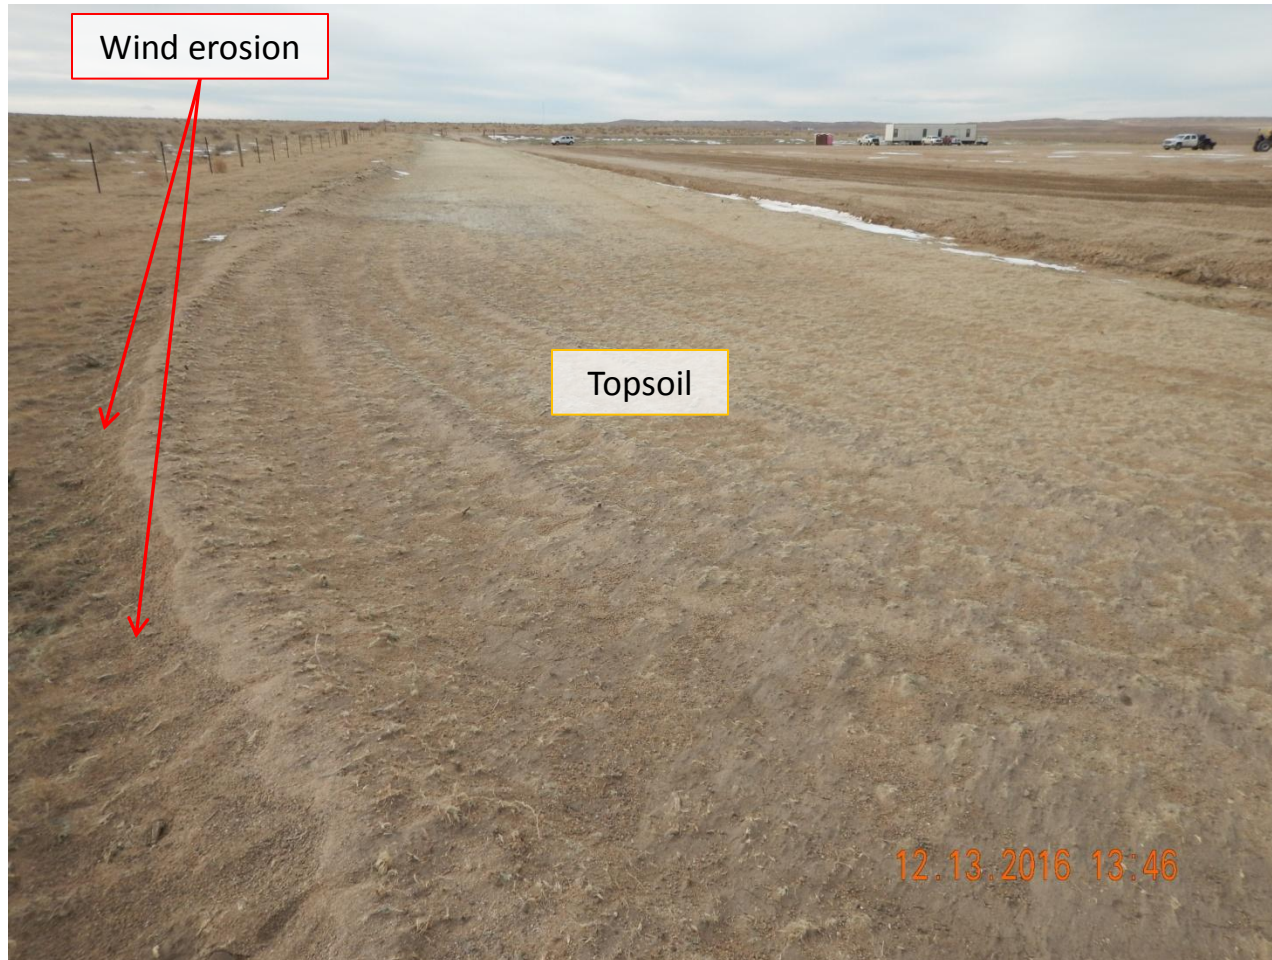
Photo 3. Photo taken from the southeast corner of location, facing West. Based on documentation, topsoil has been stored along the entire perimeter of the location. Tackifier has started to lose its stabilization capability. Need additional tackifier along this area. Also, need to install sufficient stormwater BMPs for the location.

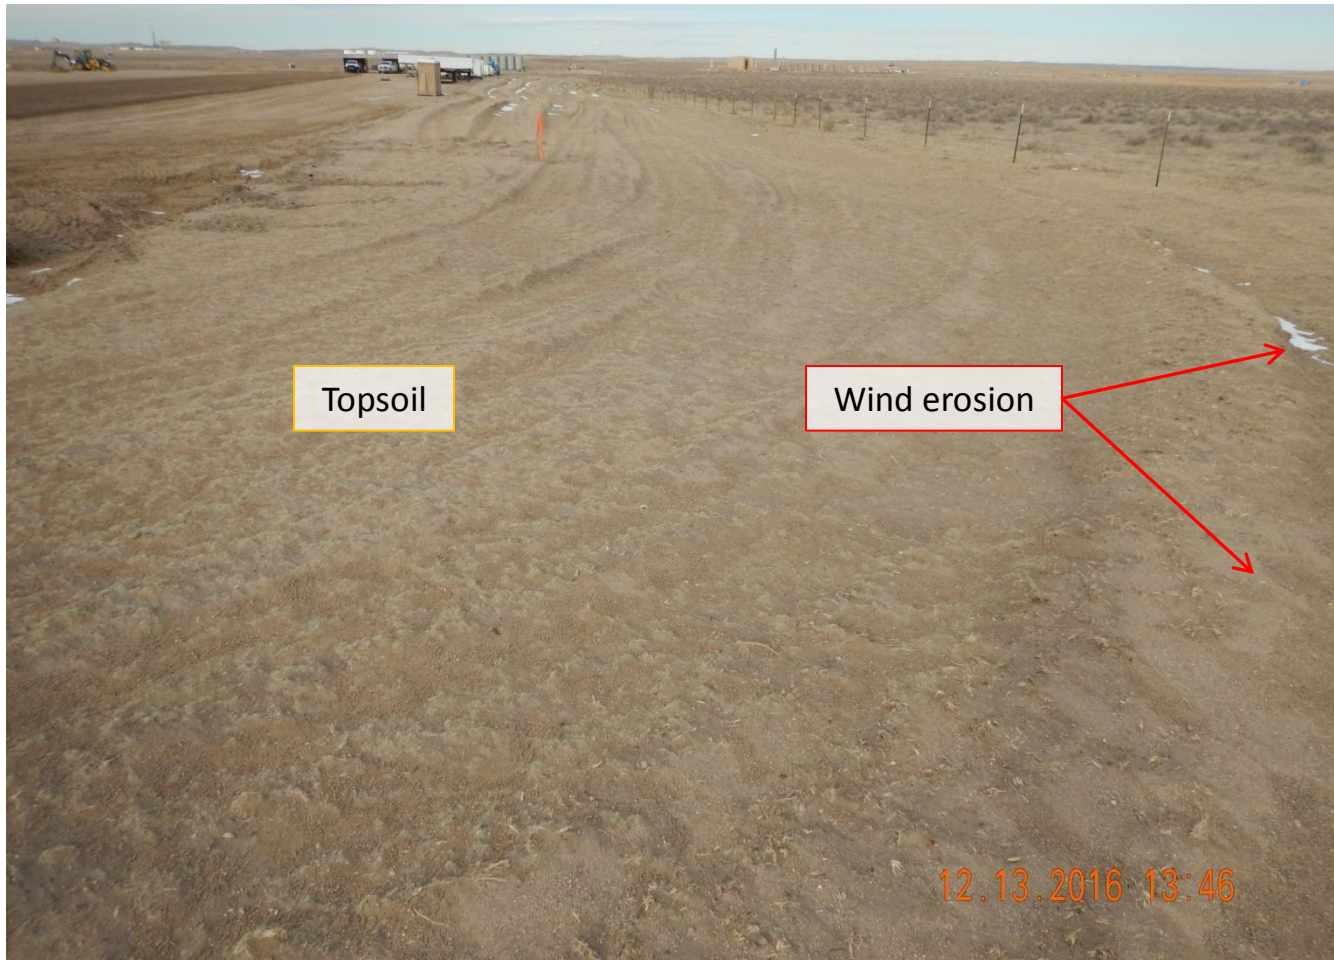
Photo 4. Photo taken from the southeast corner of location, facing North. Based on documentation, topsoil has been stored along the entire perimeter of the location. Tackifier has started to lose its stabilization capability. Need additional tackifier along this area. Also, need to install sufficient stormwater BMPs for the location.

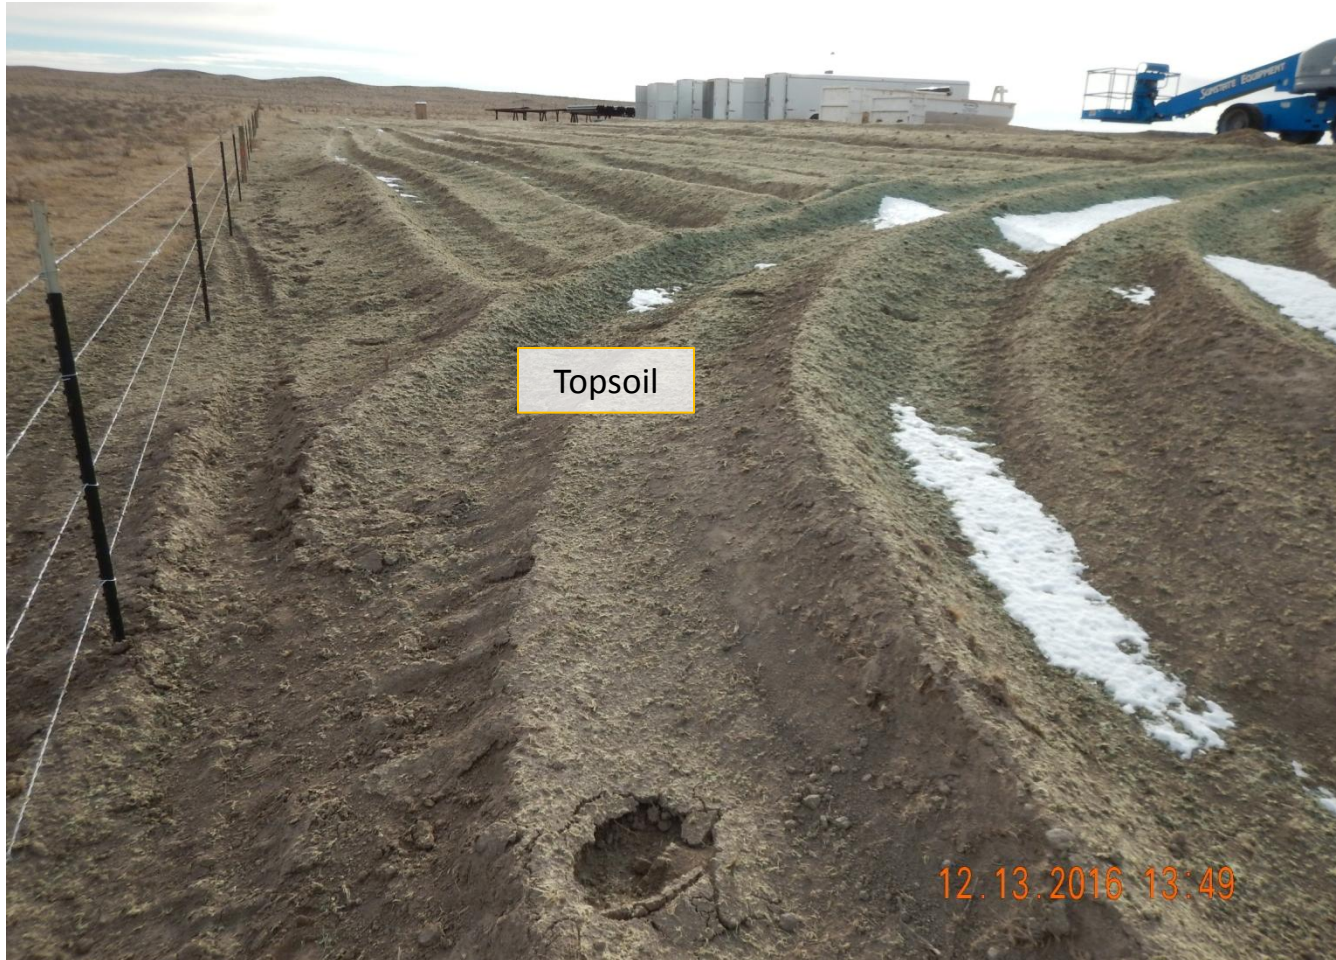
Photo 5. Photo taken from the northeast corner of location, facing South. Based on documentation, topsoil has been stored along the entire perimeter of the location. Tackifier has been applied to the topsoil but areas need additional tackifier because the application rate was too low- see Photos 3 & 4. Also, need to install sufficient stormwater BMPs for the location.

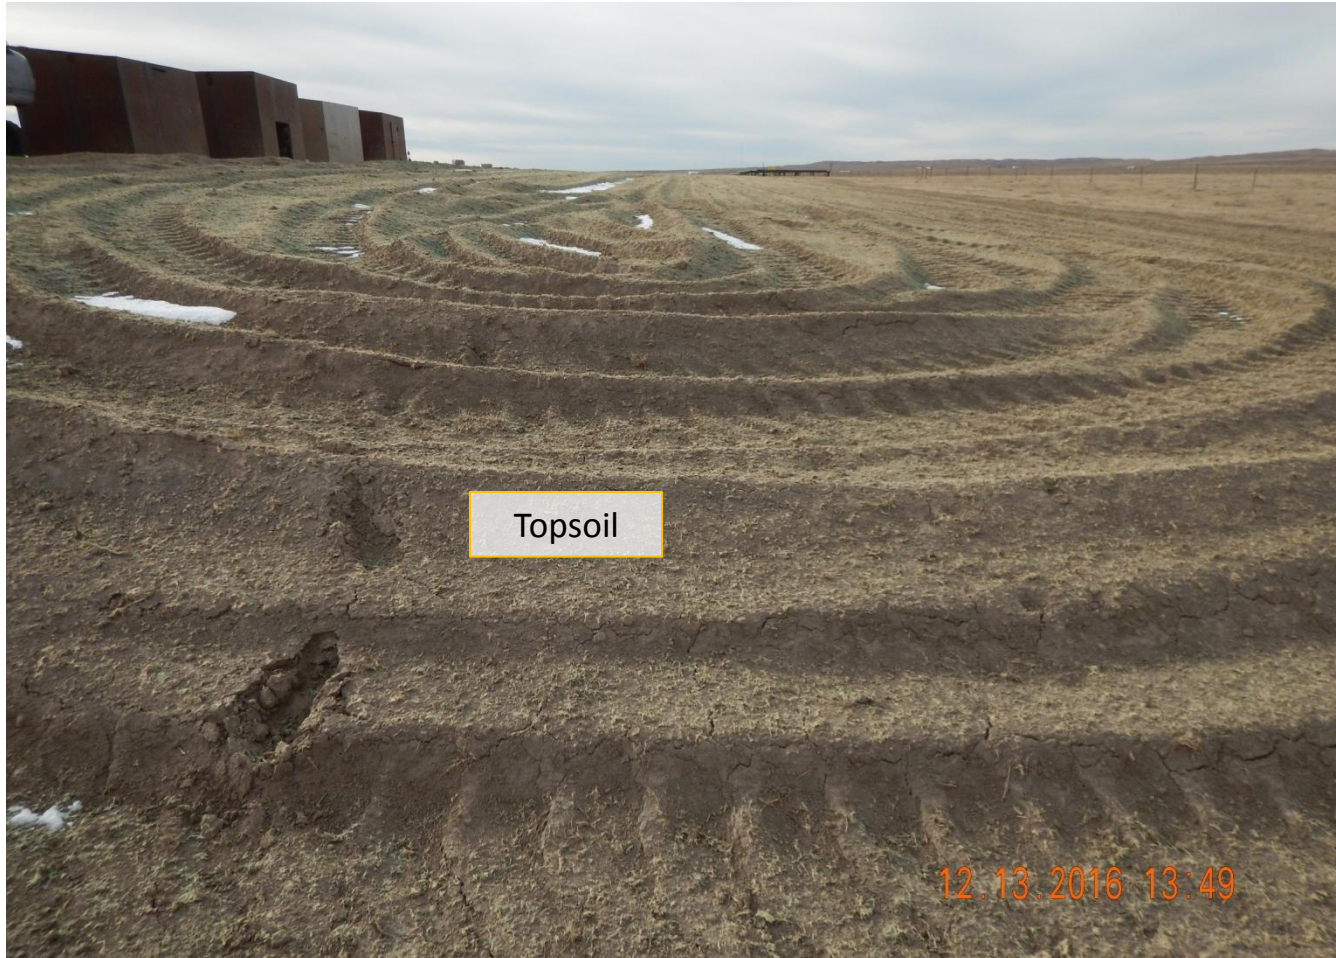
Photo 6. Photo taken from the northeast corner of location, facing West. Based on documentation, topsoil has been stored along the entire perimeter of the location. Tackifier has been applied to the topsoil but areas need additional tackifier because the application rate was too low- see Photos 3 & 4. Also, need to install sufficient stormwater BMPs for the location.

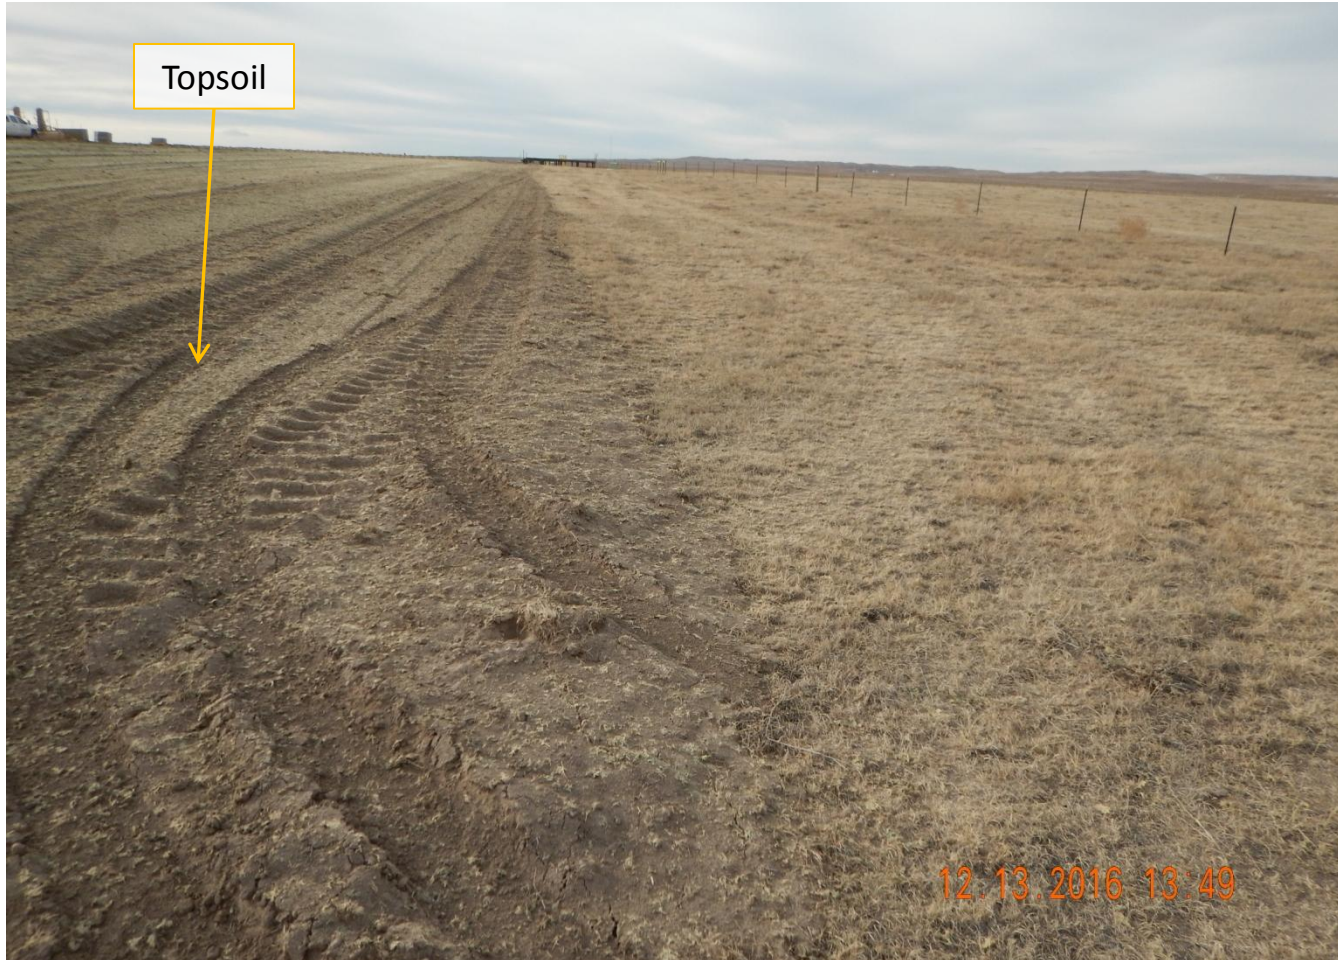
Photo 7. Photo taken from the northern corner of location, facing West. Based on documentation, topsoil has been stored along the entire perimeter of the location. Tackifier has been applied to the topsoil but areas need additional tackifier because the application rate was too low- see Photos 3 & 4. Also, need to install sufficient stormwater BMPs for the location.

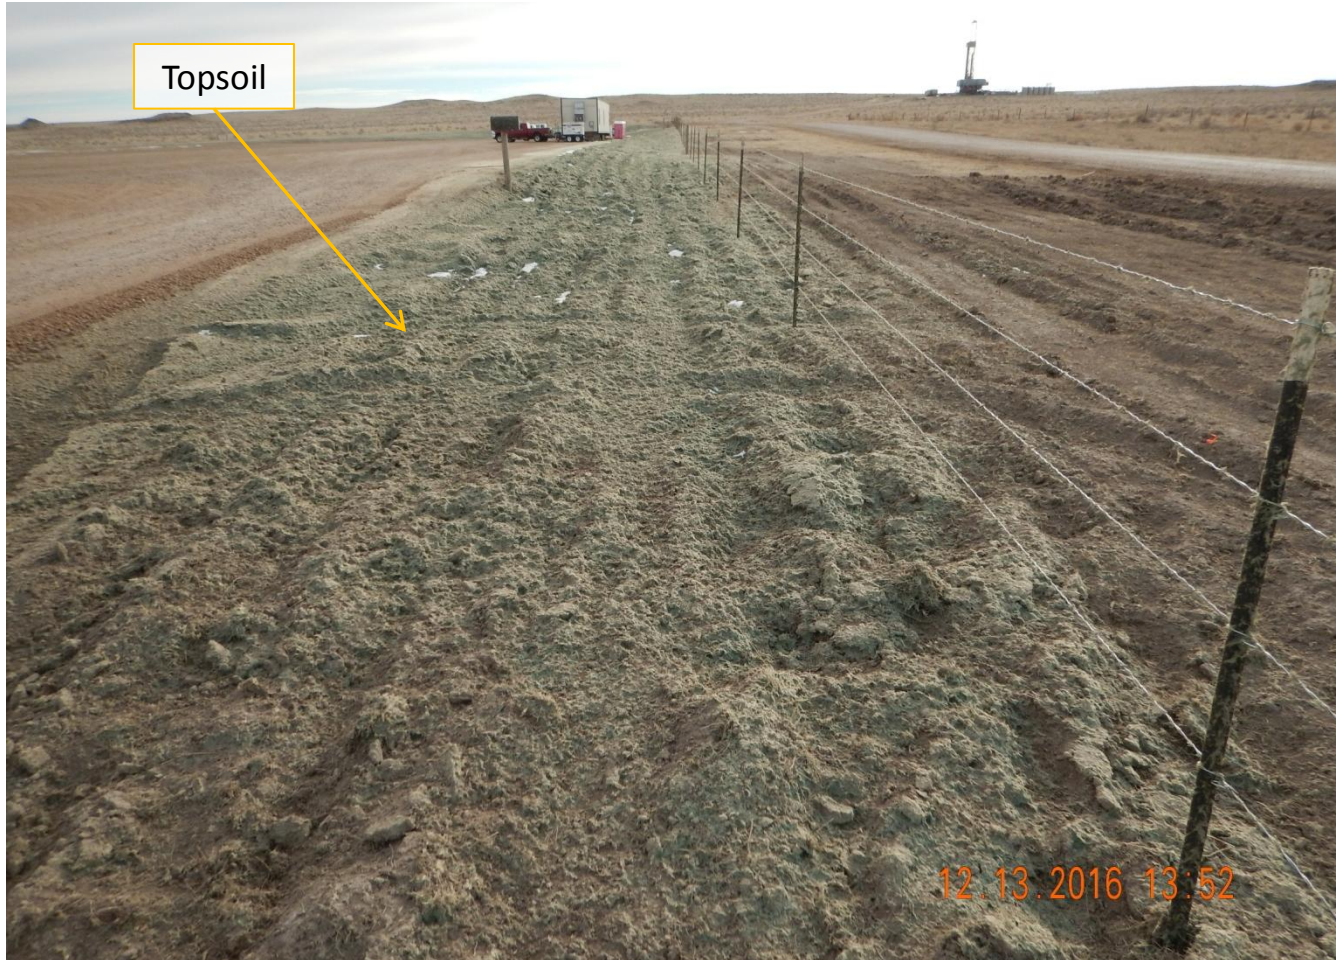
Photo 8. Photo taken from the northwest corner of location, facing South. Based on documentation, topsoil has been stored along the entire perimeter of the location. Tackifier has been applied to the topsoil but areas need additional tackifier because the application rate was too low- see Photos 3 & 4. Also, need to install sufficient stormwater BMPs for the location.
