Construction and Stormwater Inspection

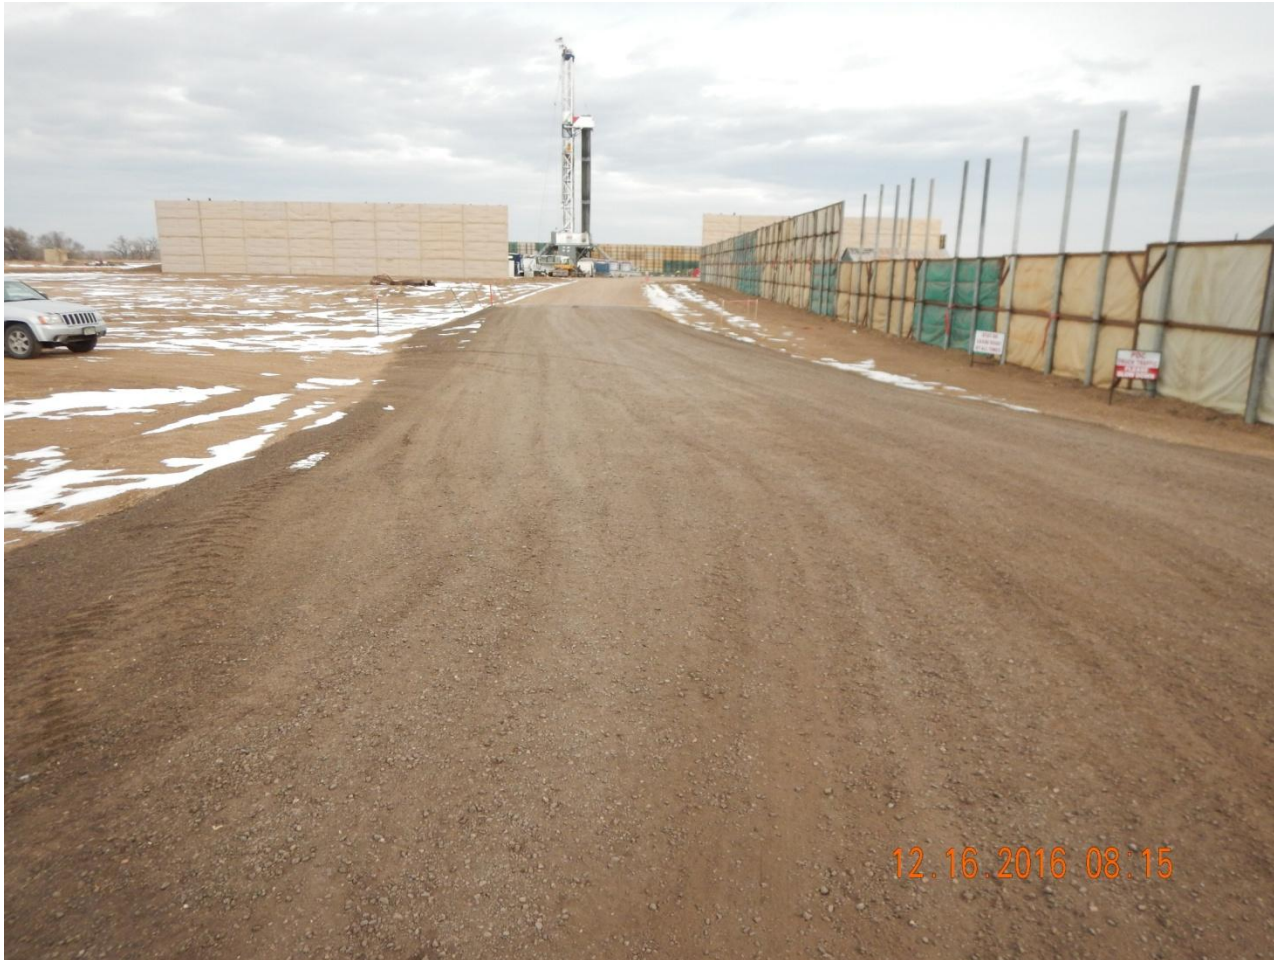
Photo 1. Photo taken from the entrance of location, facing South. Vehicle tracking pad installed at entrance to mitigate sediment discharge offsite.

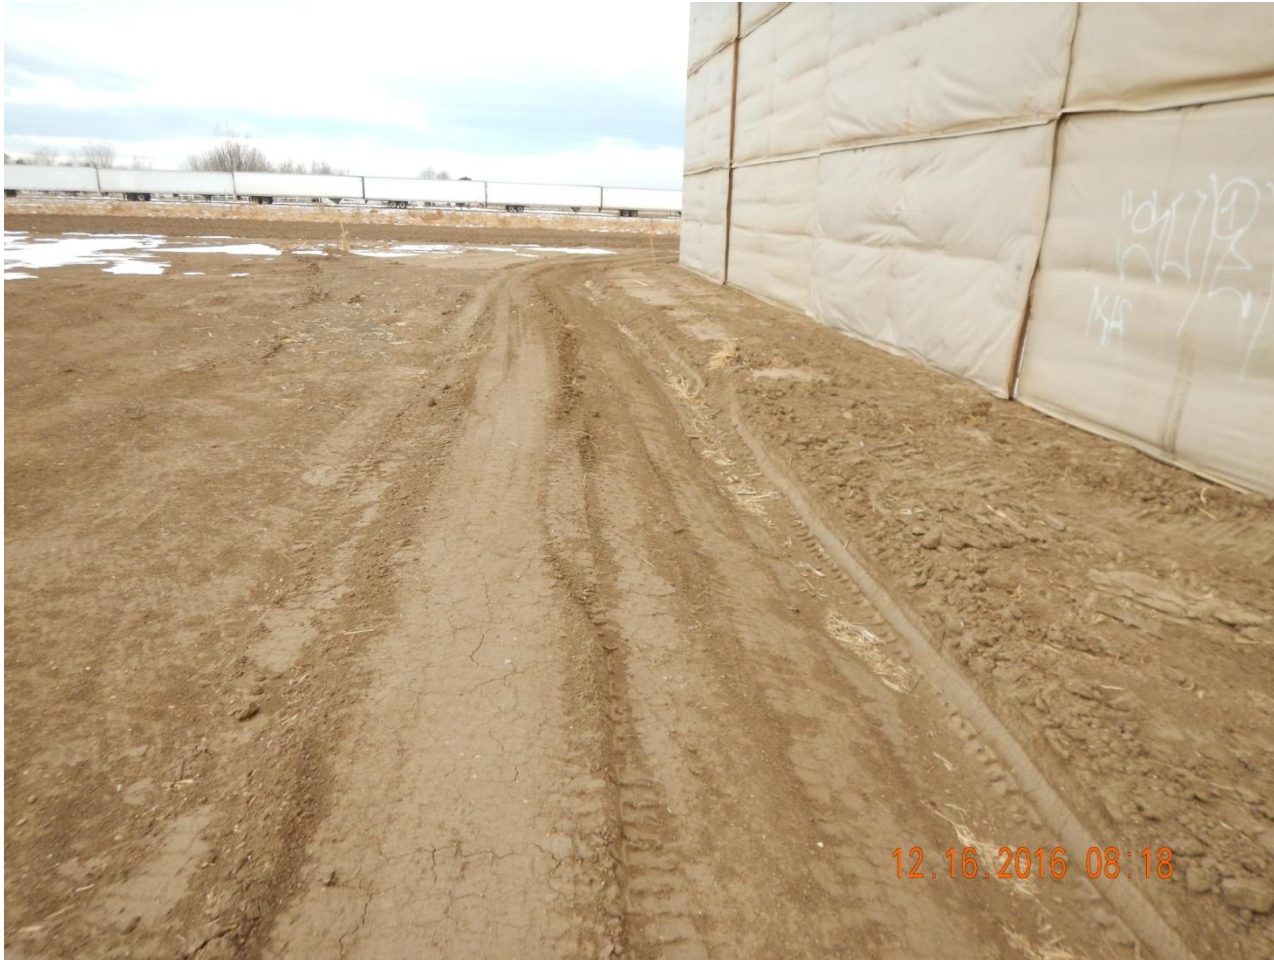
Photo 2. Photo taken from the southern location, facing West. Ditch and berm BMP installed around the perimeter of the location.

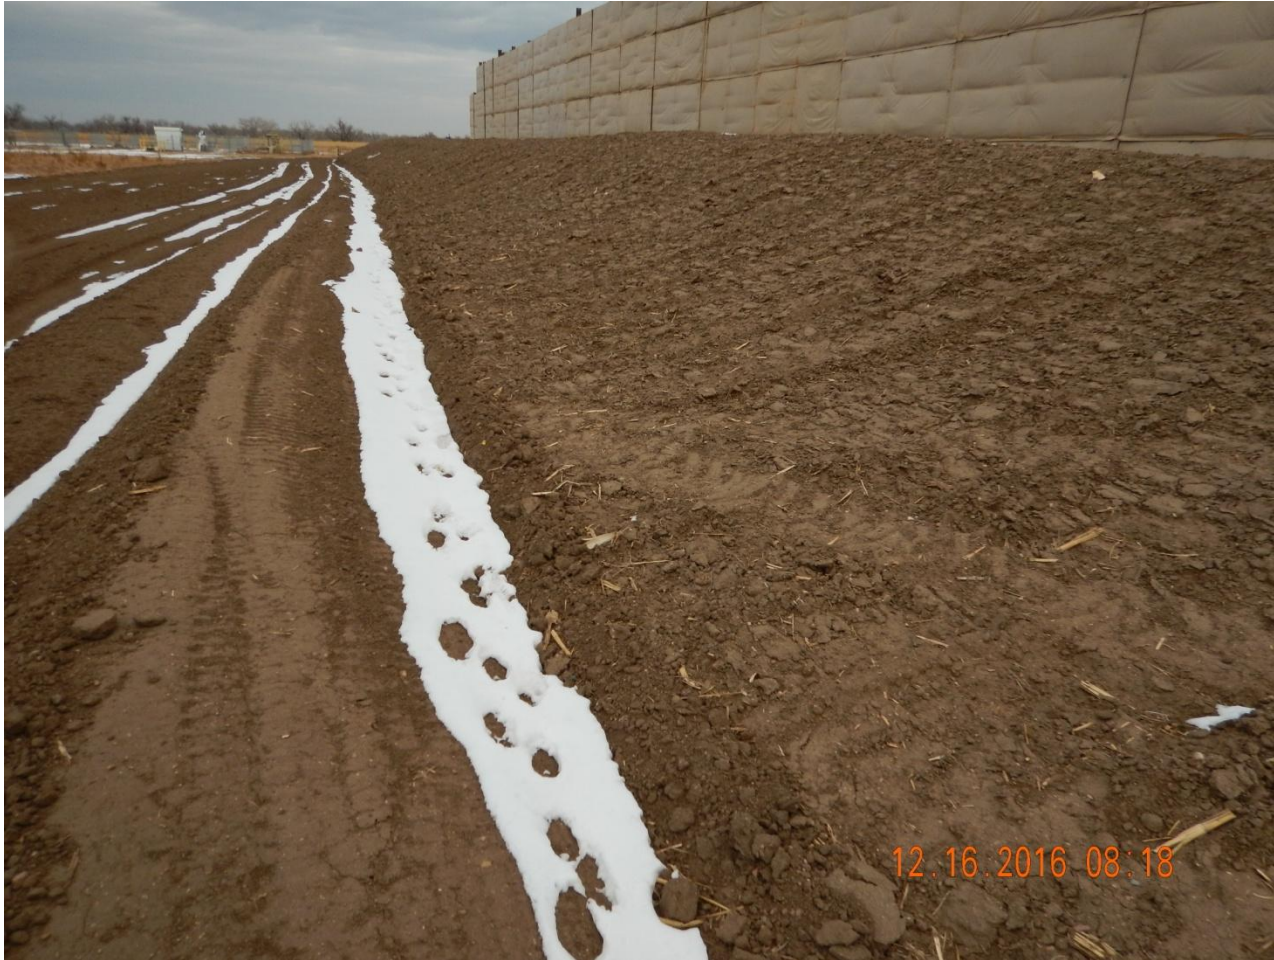
Photo 3. Photo taken from the western location, facing North, along the topsoil stockpile. Ditch and berm BMP installed around the perimeter of the location.

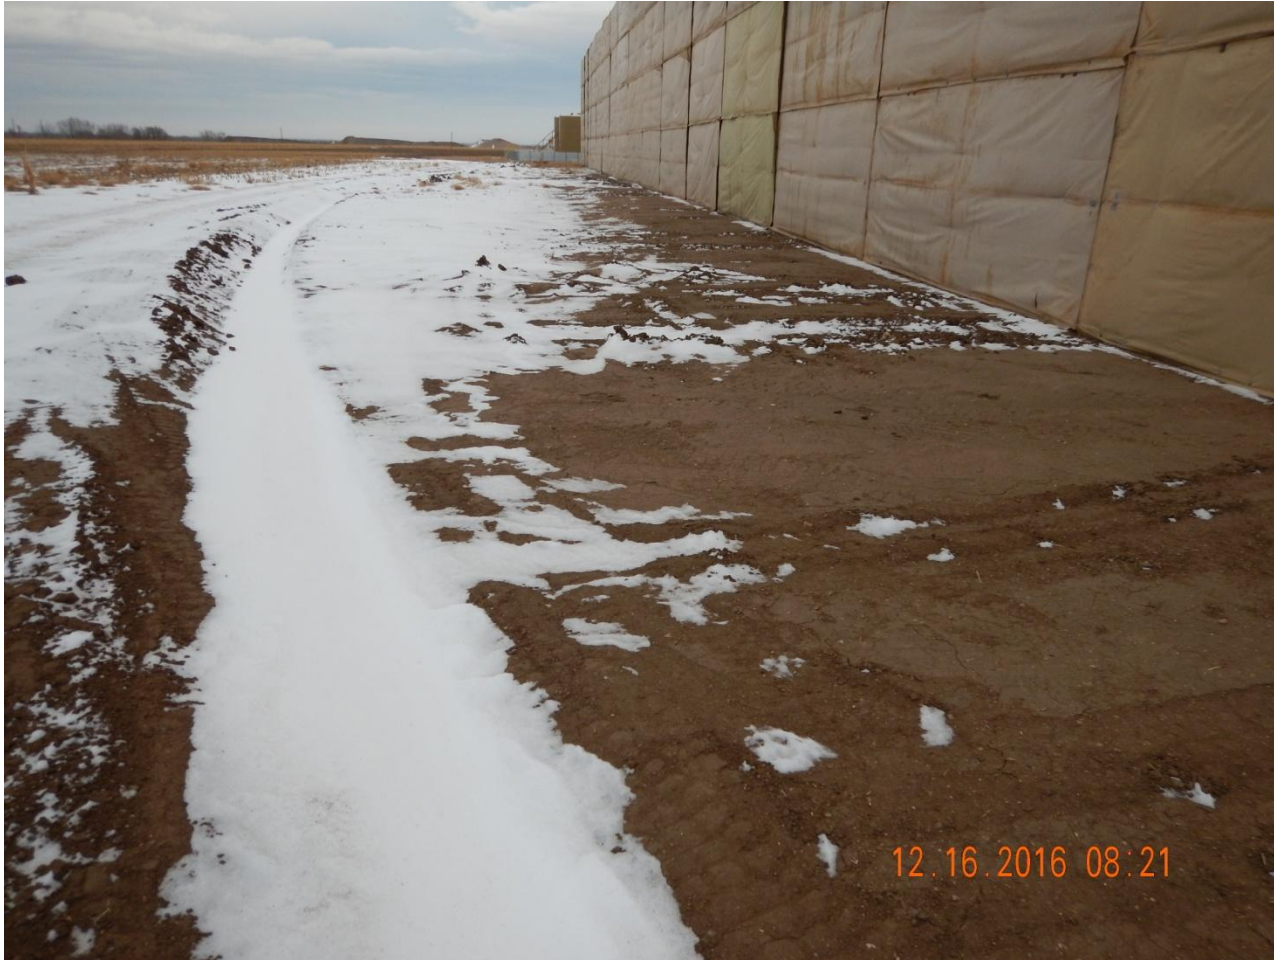
Photo 4. Photo taken from the northern location, facing East. Ditch and berm BMP installed around the perimeter of the location.

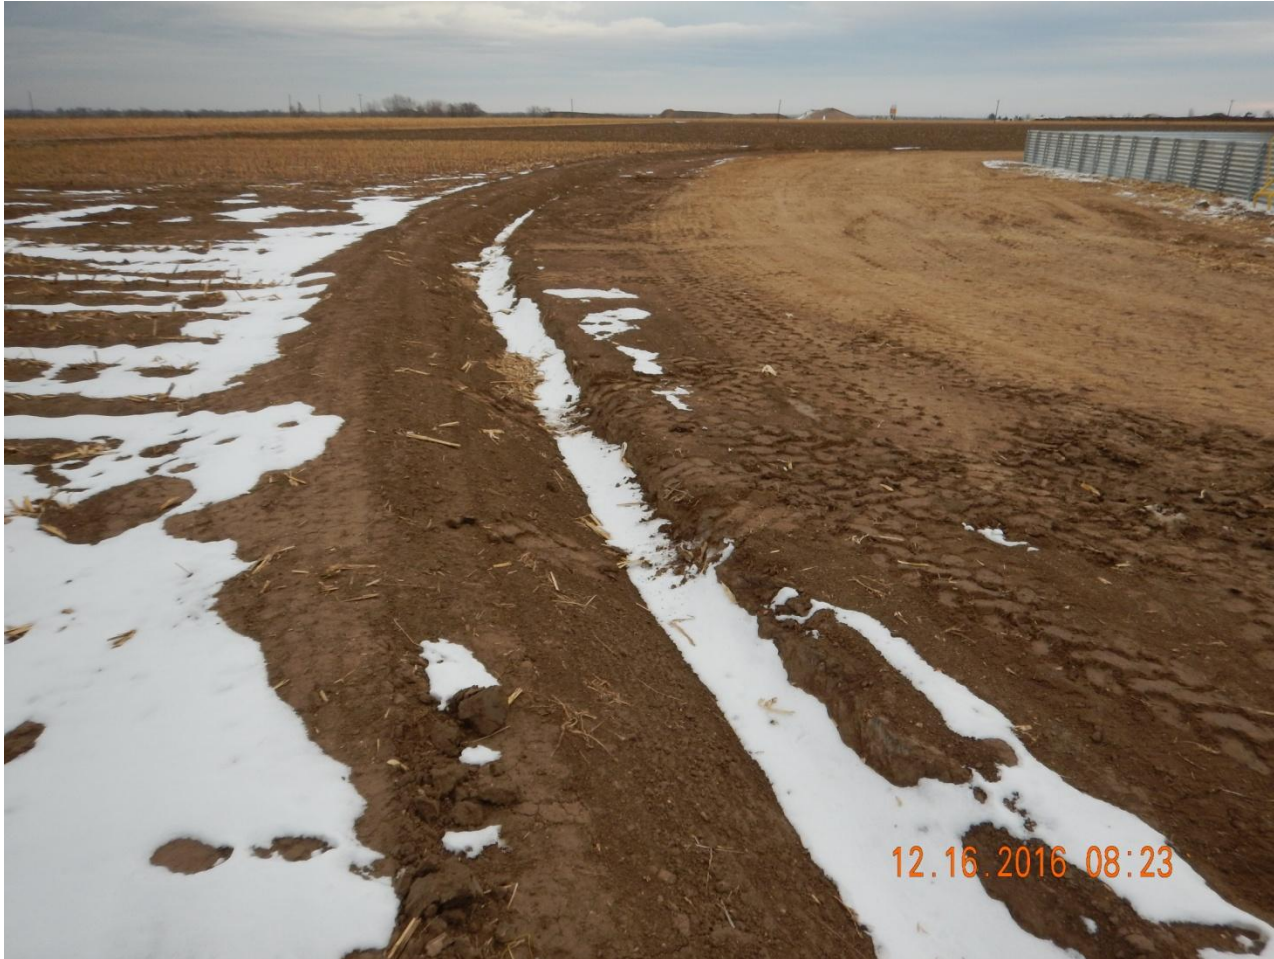
Photo 5. Photo taken from the northeastern location, facing East. Ditch and berm BMP installed around the perimeter of the location.

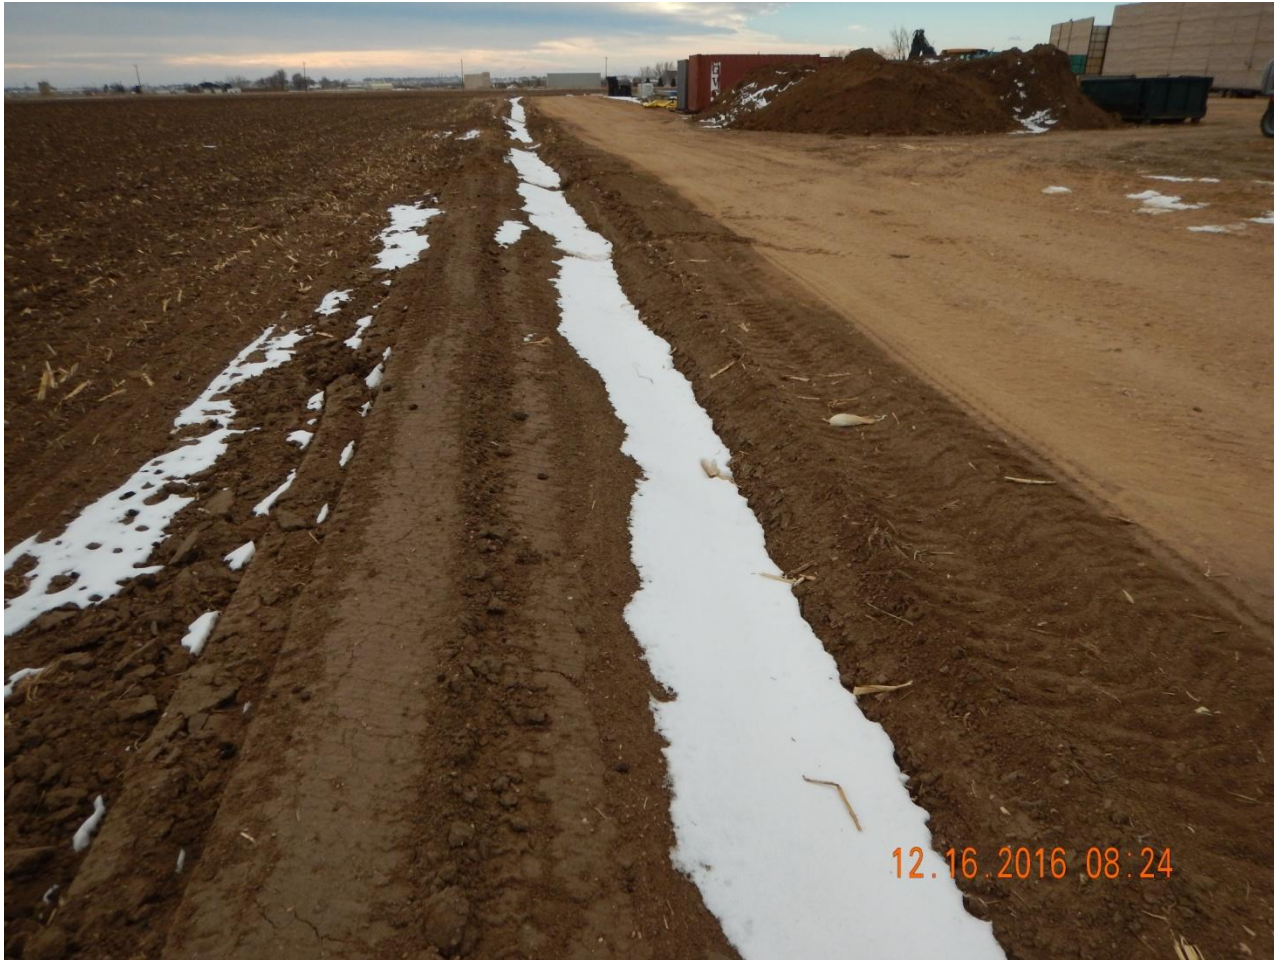
Photo 6. Photo taken from the eastern location, facing South. Ditch and berm BMP installed around the perimeter of the location.
