This is a follow up stormwater inspection for the east well pad.

Stormwater Inspection- East Well Pad

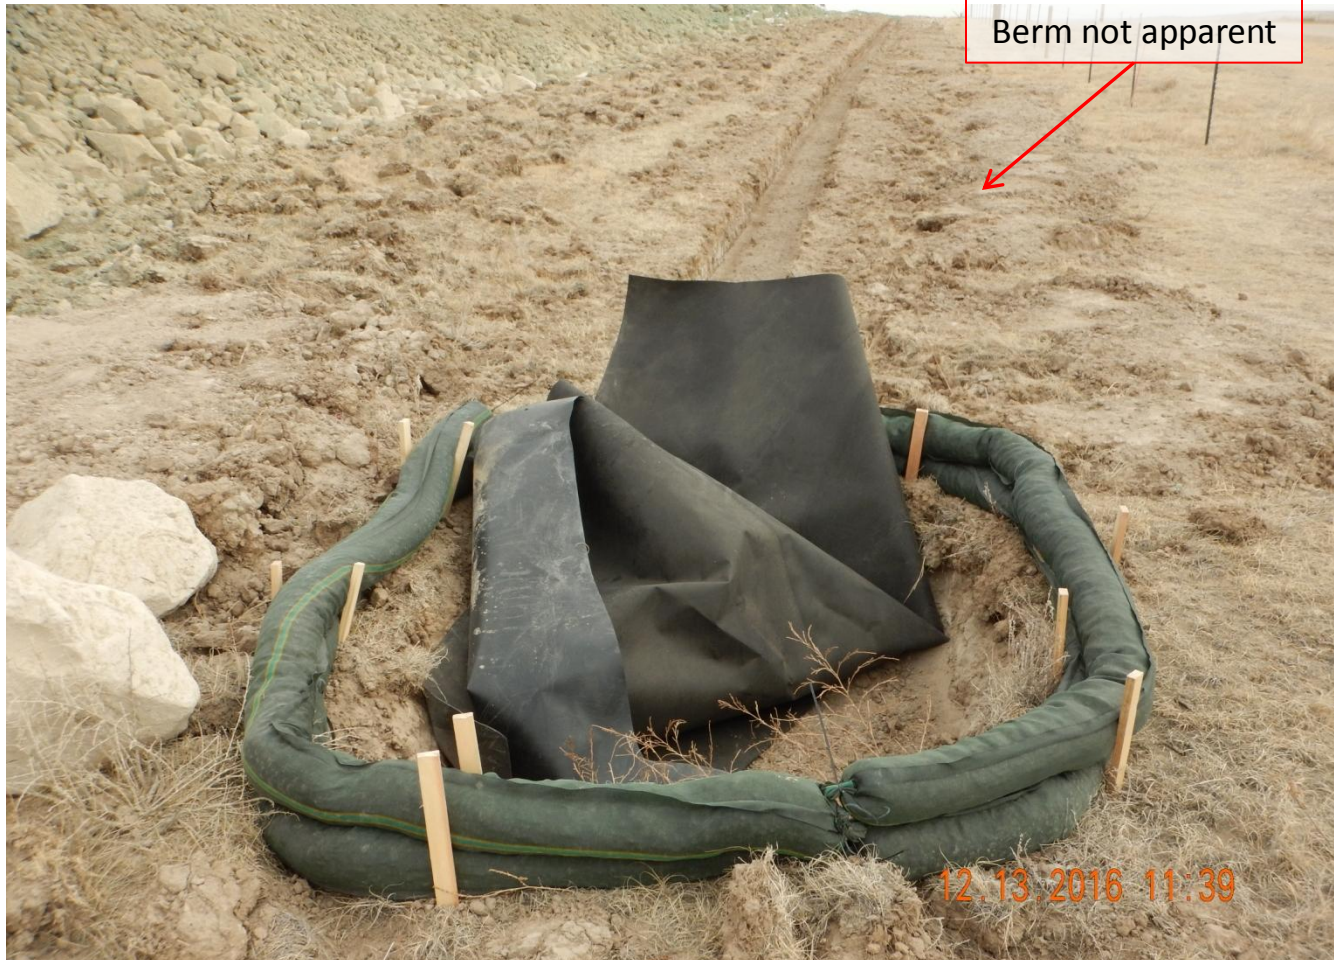
Photo 1. Photo taken from southwestern location, facing East. Sediment trap approximately 4'x4'x2' with the outer perimeter lined with rock socks. Trench approximately 18"x 12" (width x depth). Remove waste material from sediment trap per Rule 603.f.

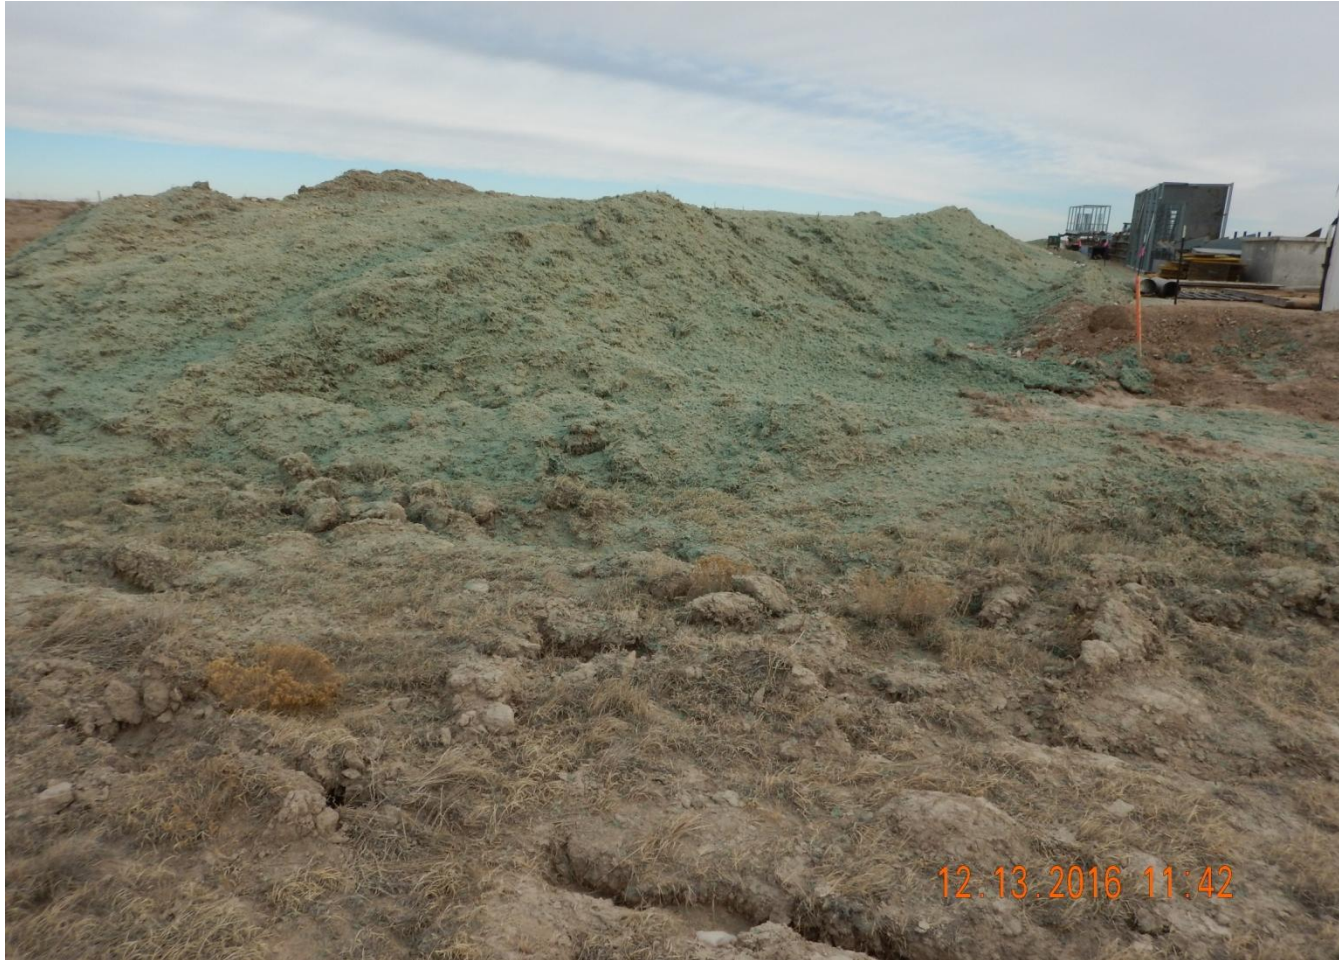
Photo 2. Photo taken from the northwest location, facing East, towards the topsoil stockpile. Tackifier applied to the topsoil stockpile. Not certain whether topsoil was seeded in addition to applying tackifier, but tackifier alone is not a long-term stabilization BMP to protect topsoil from erosion and weed establishment.

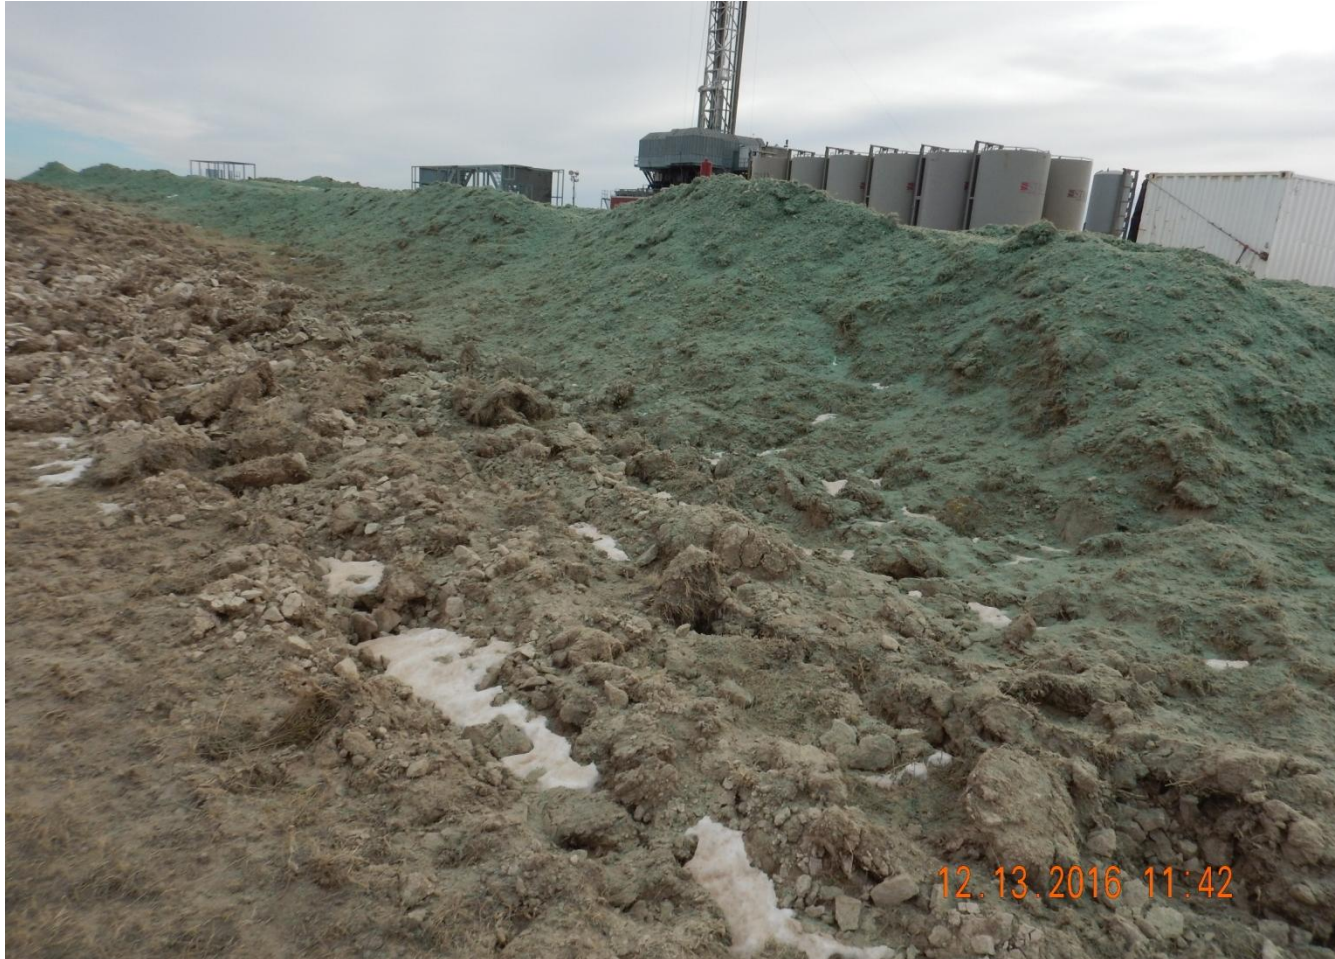
Photo 3. Photo taken from the northern location, facing Southeast, towards the topsoil stockpile. Tackifier applied to the topsoil stockpile with surface roughening on the leading edge. Not certain whether topsoil was seeded in addition to applying tackifier, but tackifier alone is not a long-term stabilization BMP to protect topsoil from erosion and weed establishment.

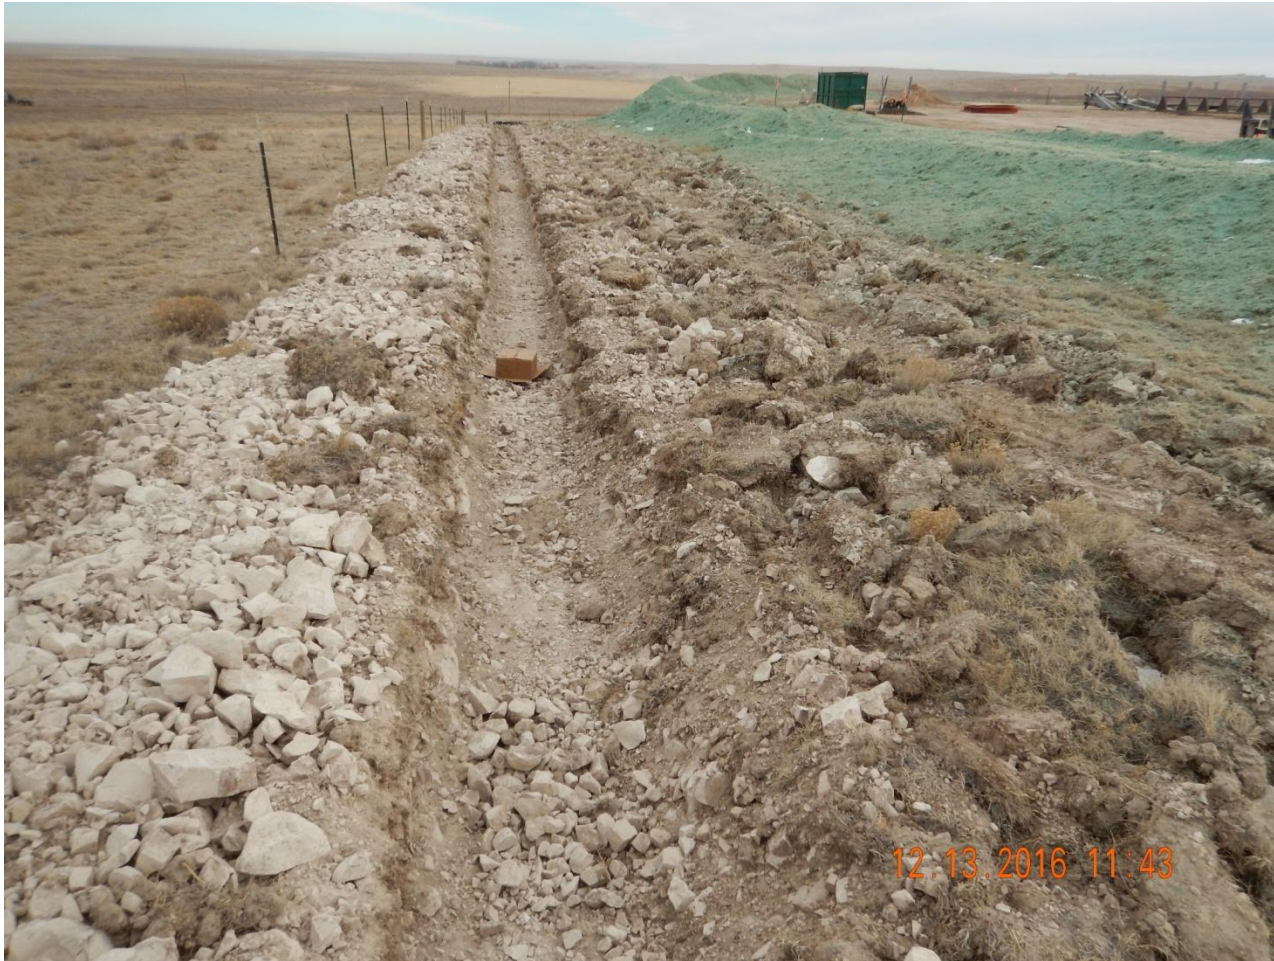
Photo 4. Photo taken from the northern location, facing East. Trench approximately 18"x12" (width x depth) with surface roughening between trench and topsoil stockpile. Remove waste material from trench per Rule 603.f.

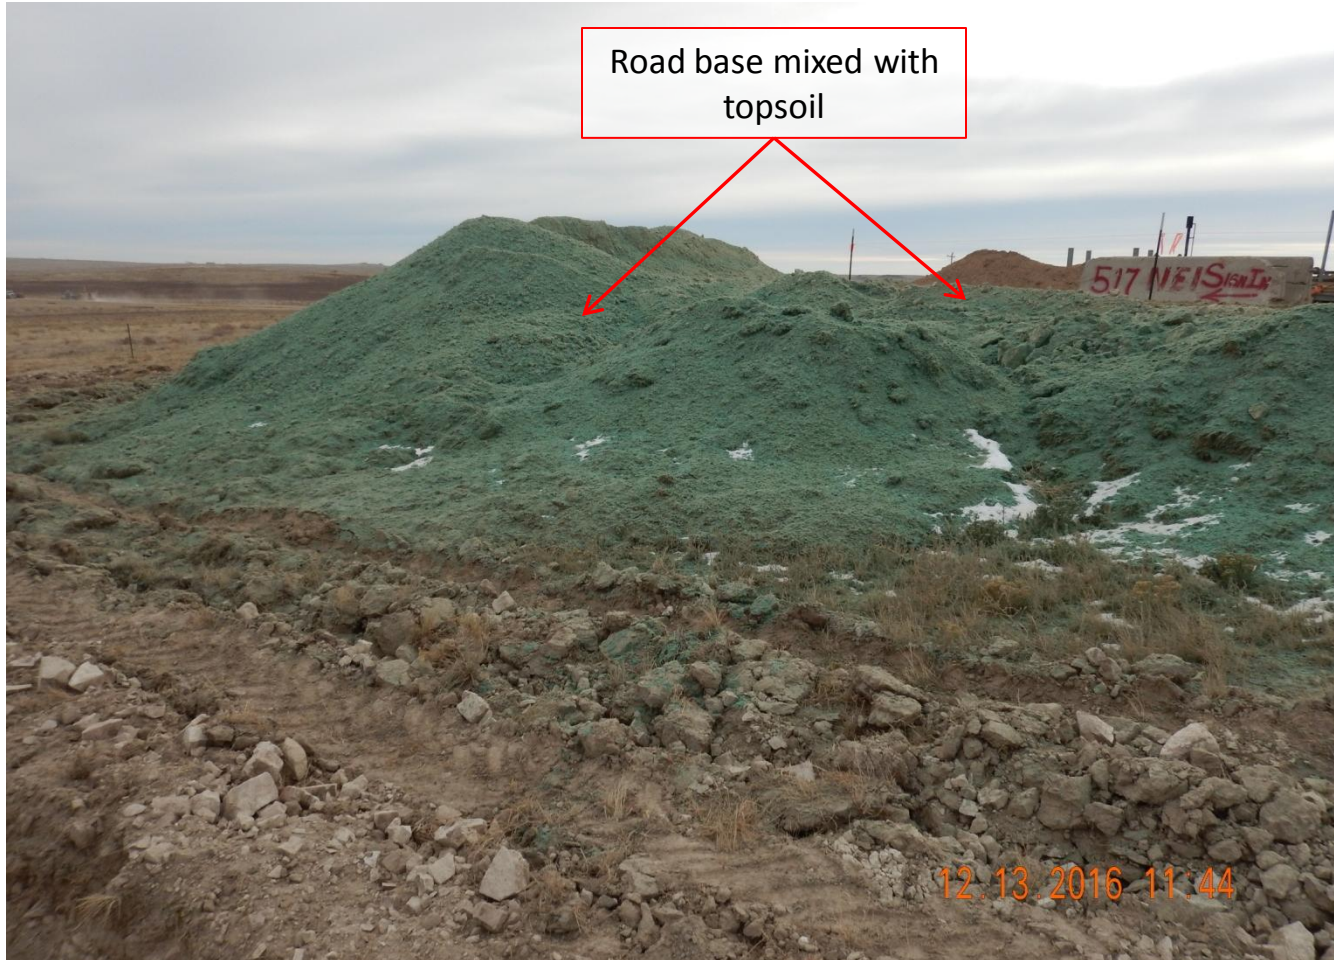
Photo 5. Photo taken from northeast location, facing East. Road base has been mixed with the topsoil. Need to separate and store topsoil per Rule 1002.b. Not certain whether topsoil was seeded in addition to applying tackifier, but tackifier alone is not a long-term stabilization BMP to protect topsoil from erosion and weed establishment.

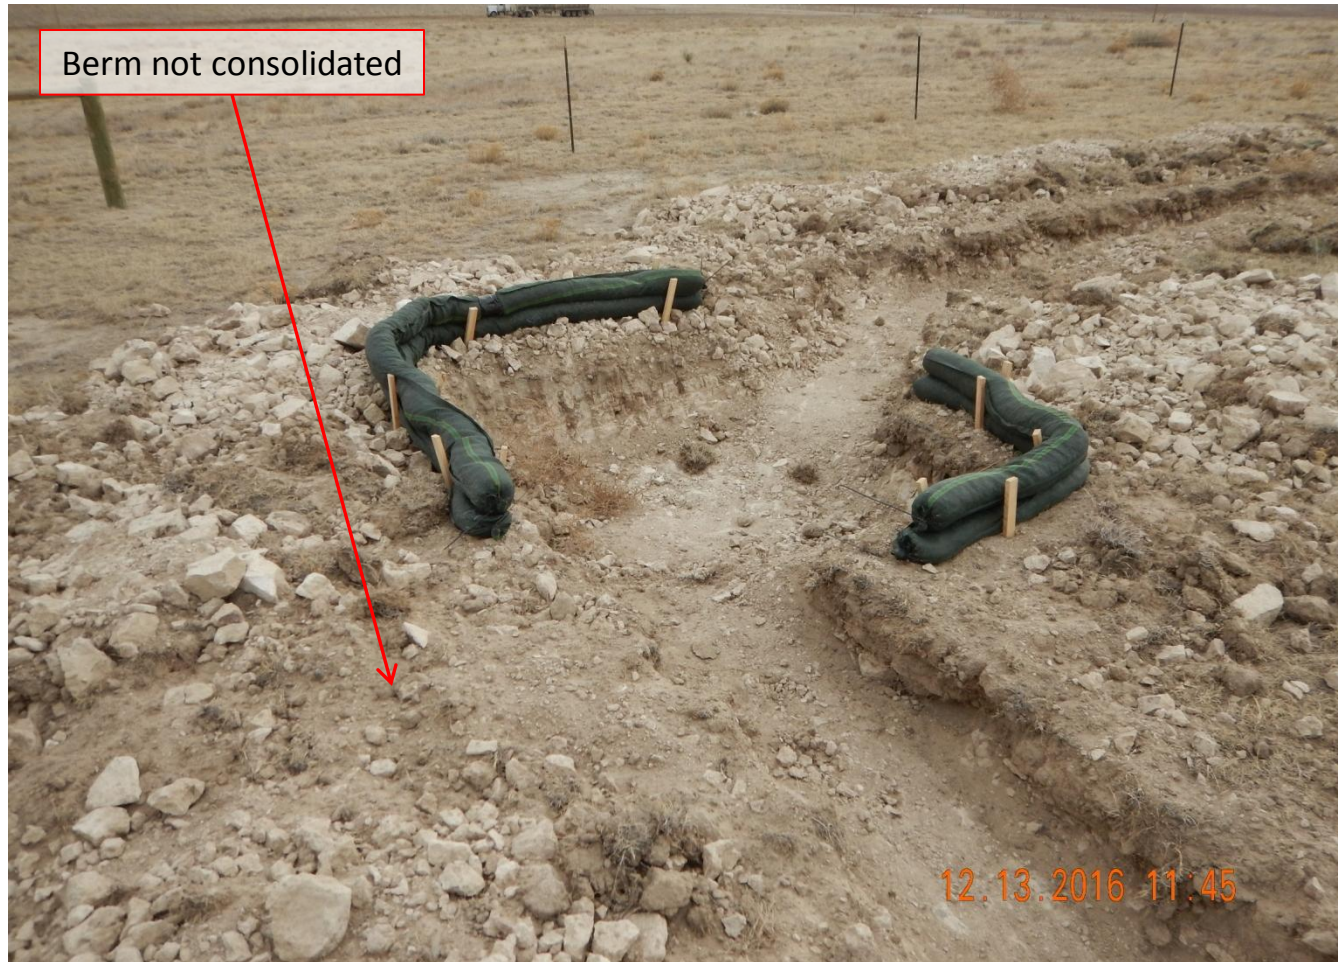
Photo 6. Photo taken from northeast location, facing East. Sediment trap approximately 4'x4'x2.5' with rock socks. Constructed berms have not been consolidated.

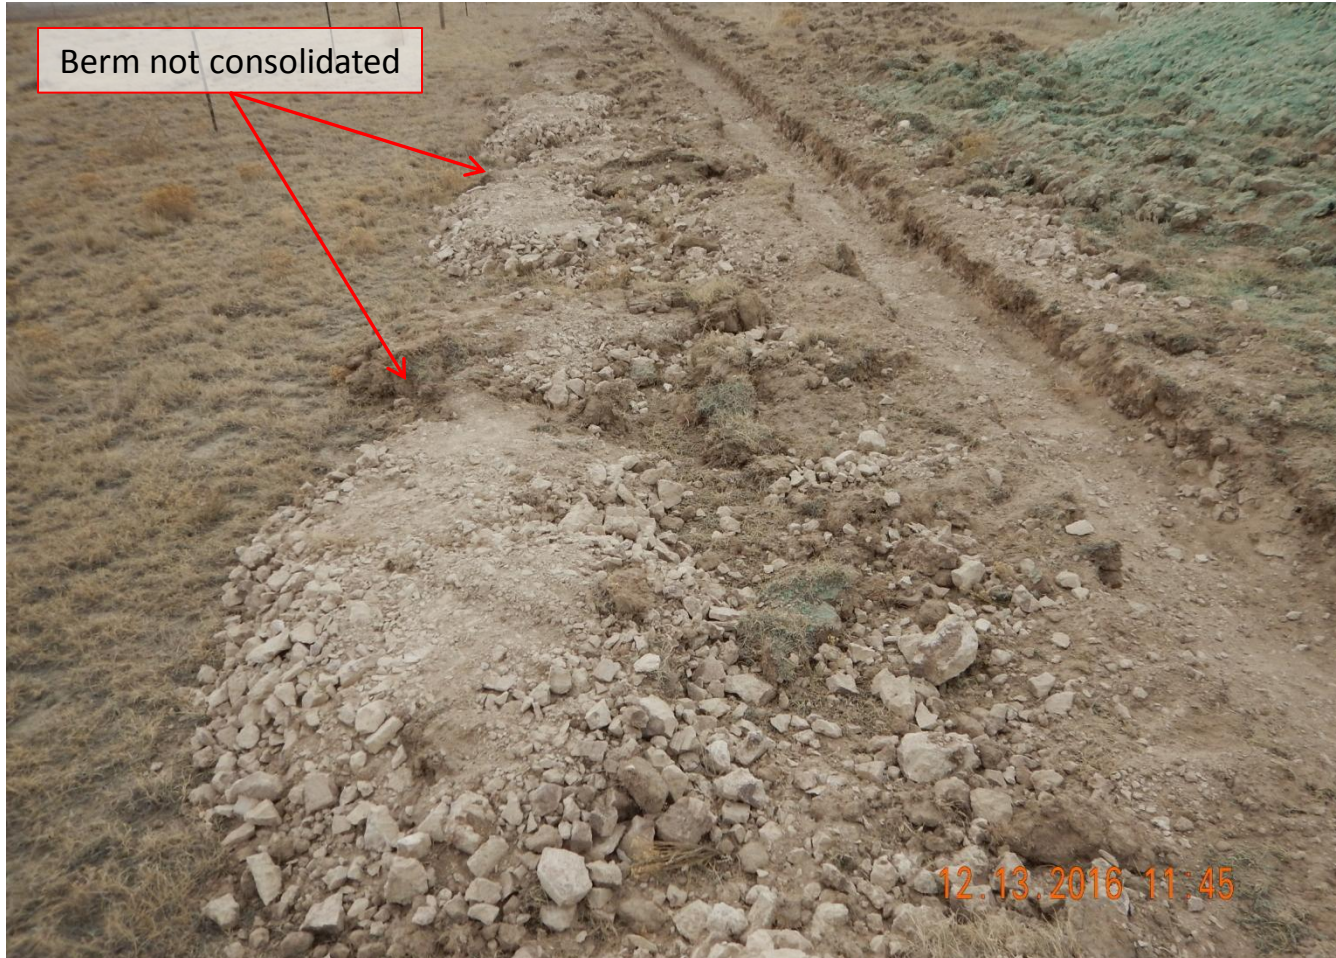
Photo 7. Photo taken from east location, facing South. Trench approximately 18"x12" (width x depth). Constructed berms have not been consolidated throughout the entire length.

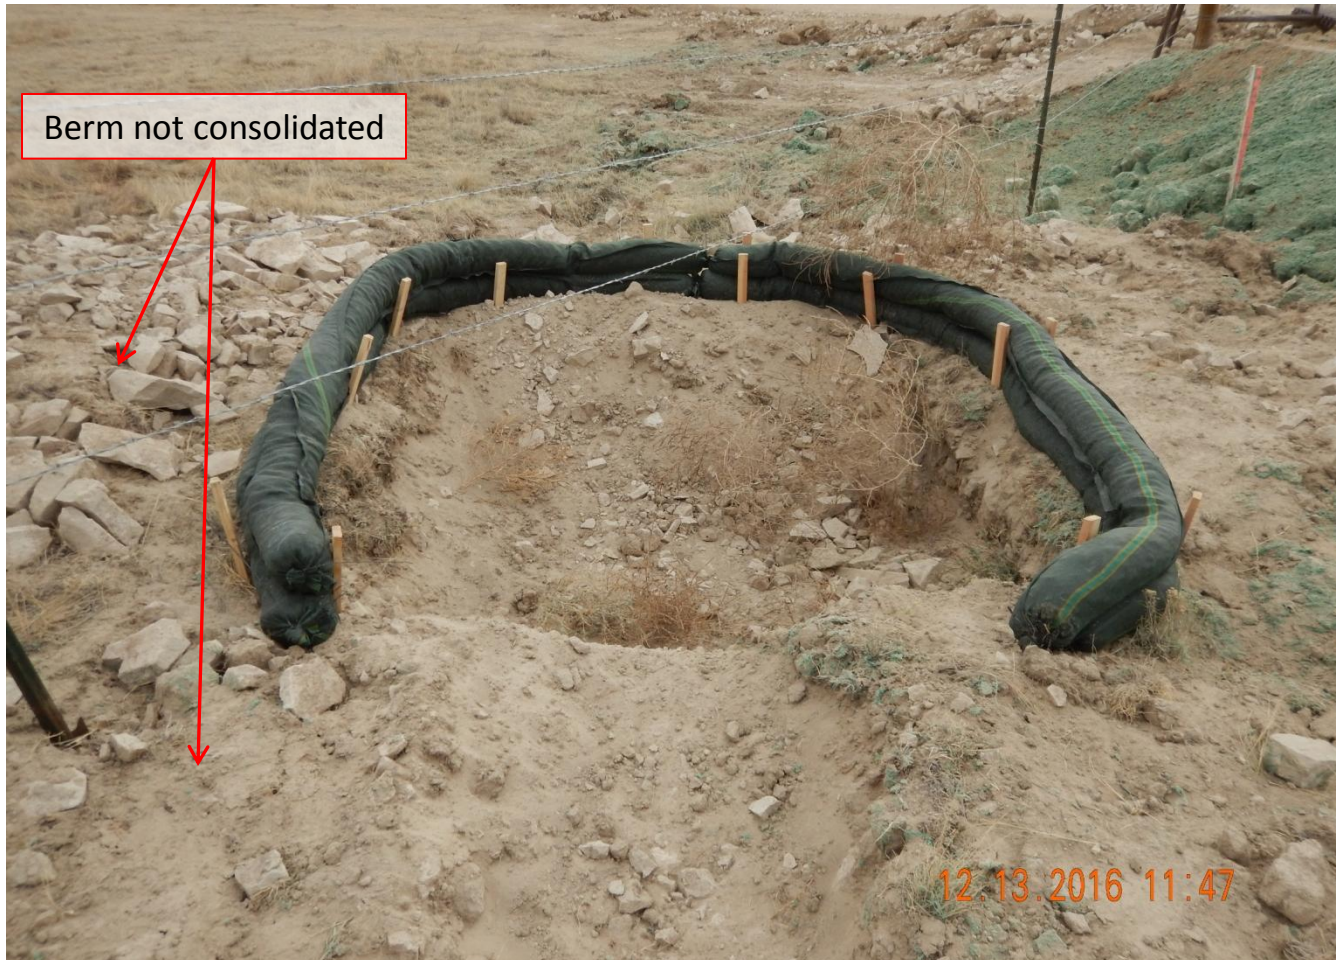
Photo 8. Photo taken from southeast location on the east side of the access road. Sediment trap approximately 4'x4'x2' with the outer perimeter lined with rock socks.

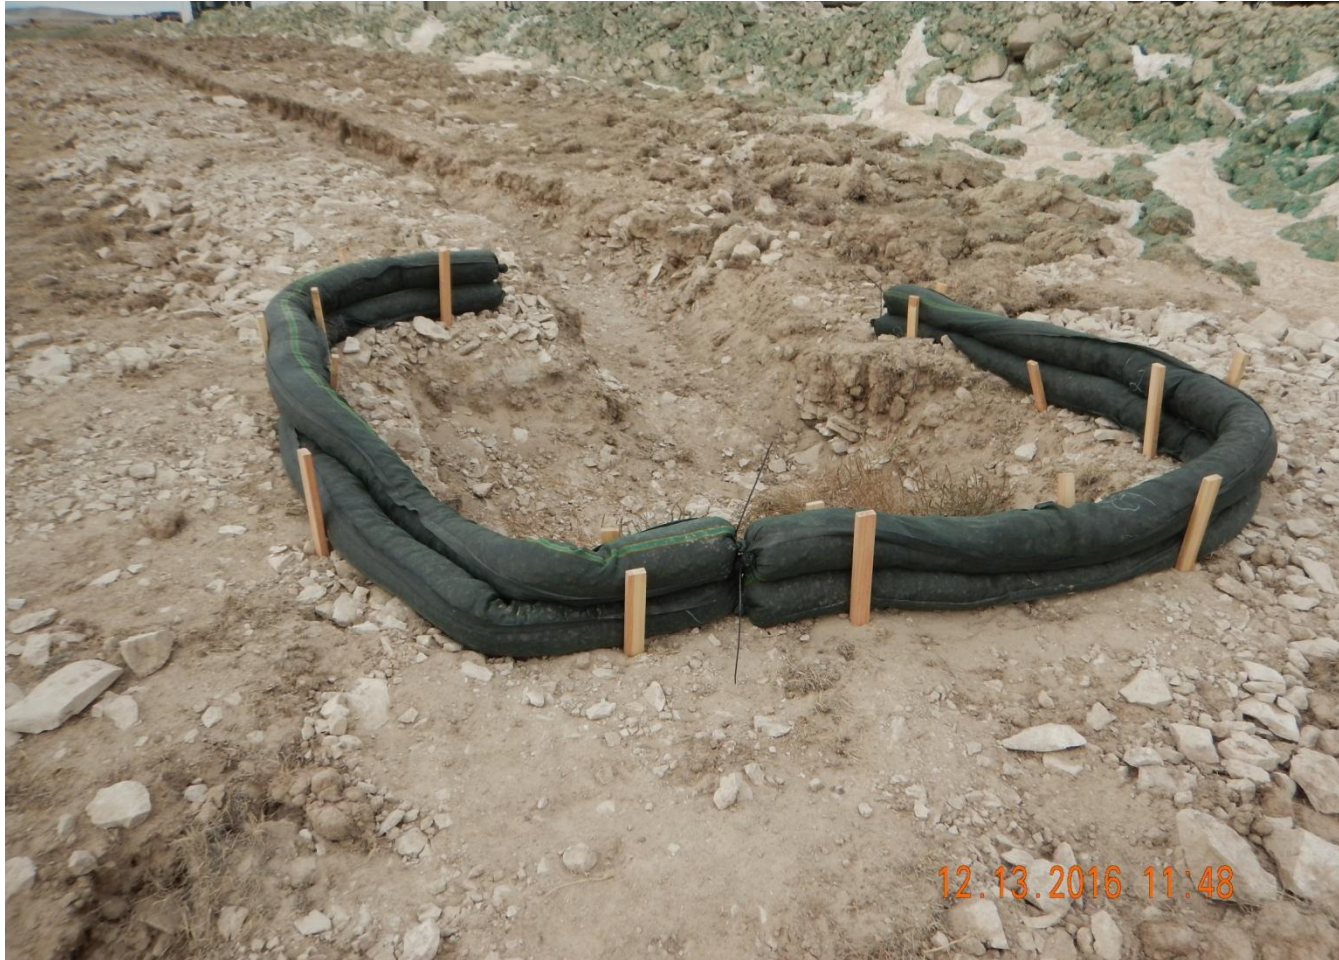
Photo 9. Photo taken from southeast location on the west side of the access road, facing West. Sediment trap approximately 4'x4'x2' with the outer perimeter lined with rock socks. Trench approximately 18"x12" (width x depth) with surface roughening between trench and fill slope.
