## Location Overview

# Stormwater Inspection

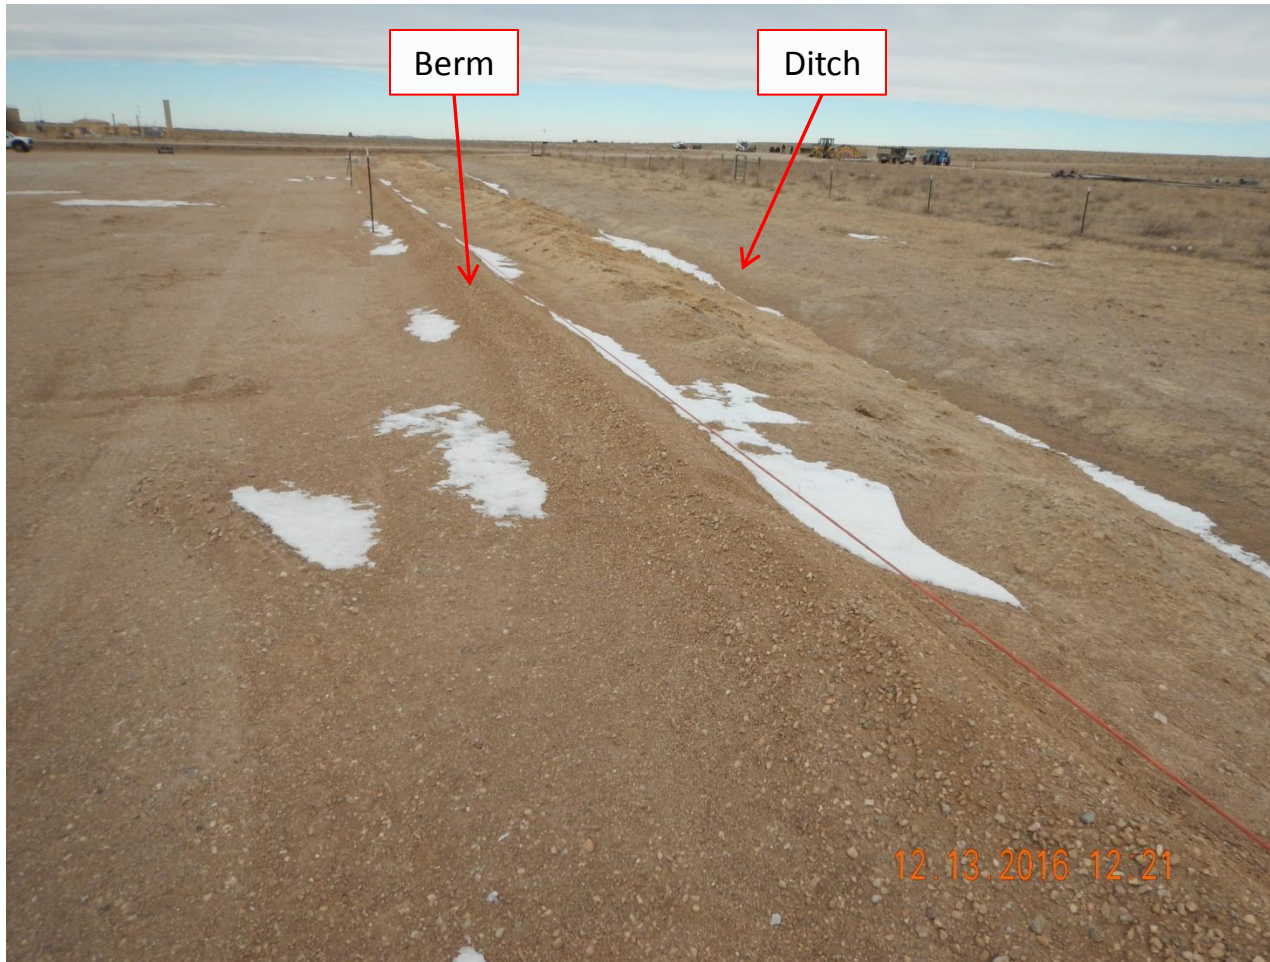
**Photo 1.** Photo taken from eastern location, facing North. A berm approximately 10"-12" constructed of road base installed along the east, south, and west pad perimeter. An outer perimeter ditch installed along the east, south and west pad perimeter.

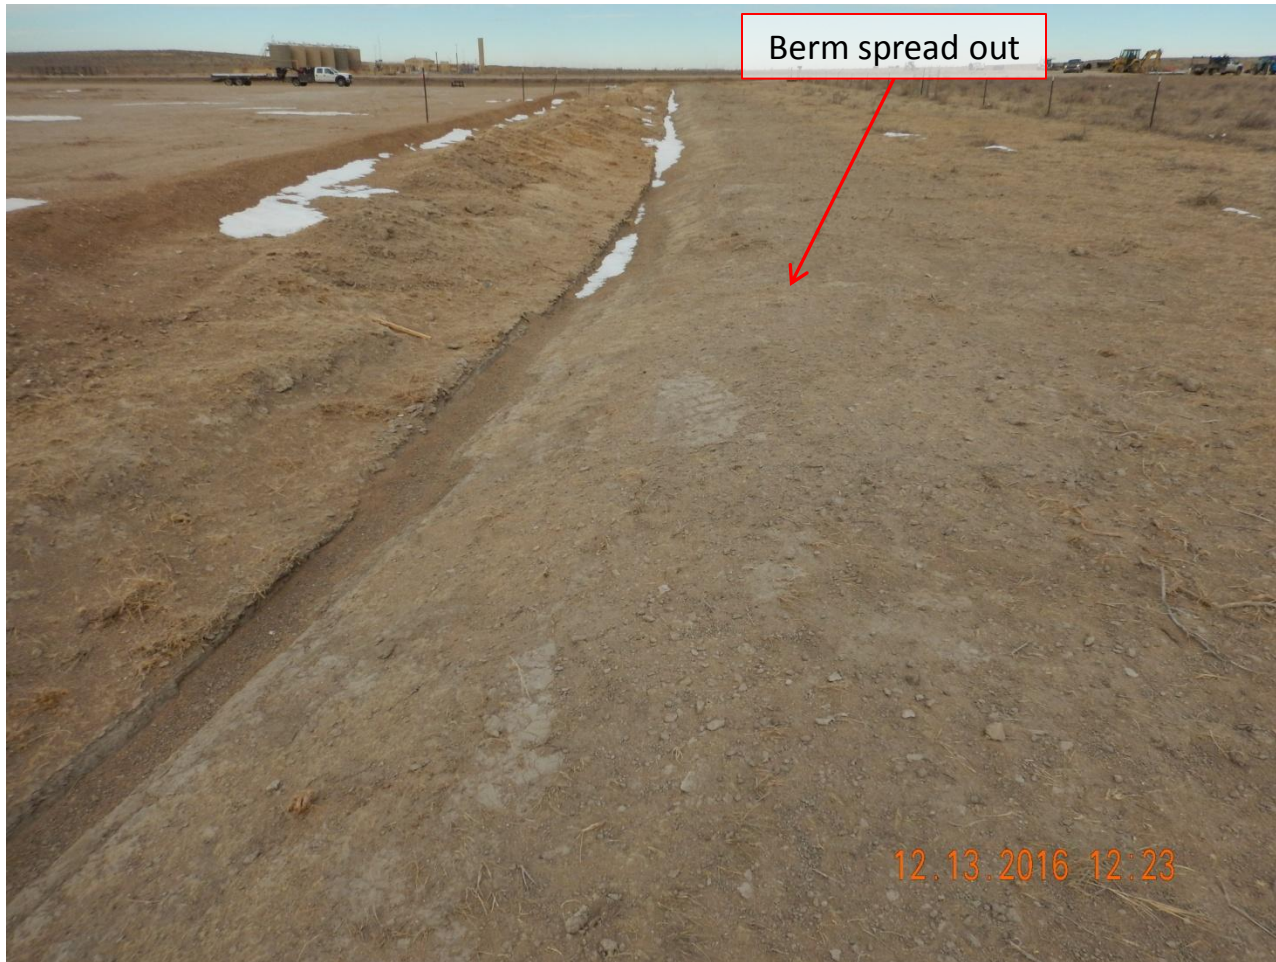
**Photo 2.** Photo taken from eastern location, facing North. Ditch approximately 8-12" in depth installed along the eastern perimeter is filling in with sediment. Berm appears to be spread out and not apparent along the western perimeter.

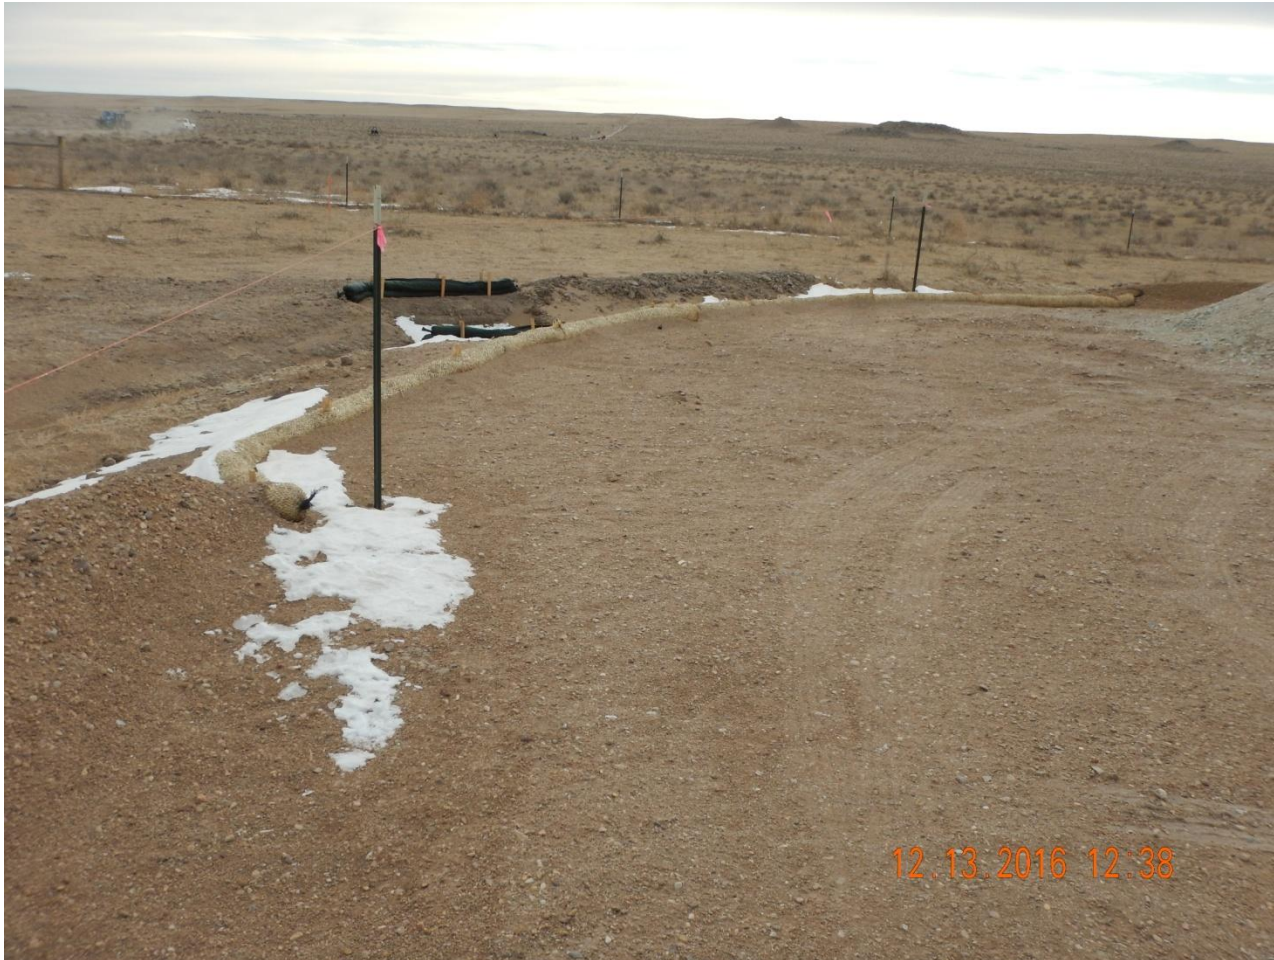
**Photo 3.** Photo taken from the southeast location, facing South. Wattles have been installed along the southeast pad corner with a sediment trap to the outer perimeter. Appears wattles may be used to filter storm runoff before entering the sediment trap which is not the proper use. See inspection for more details.

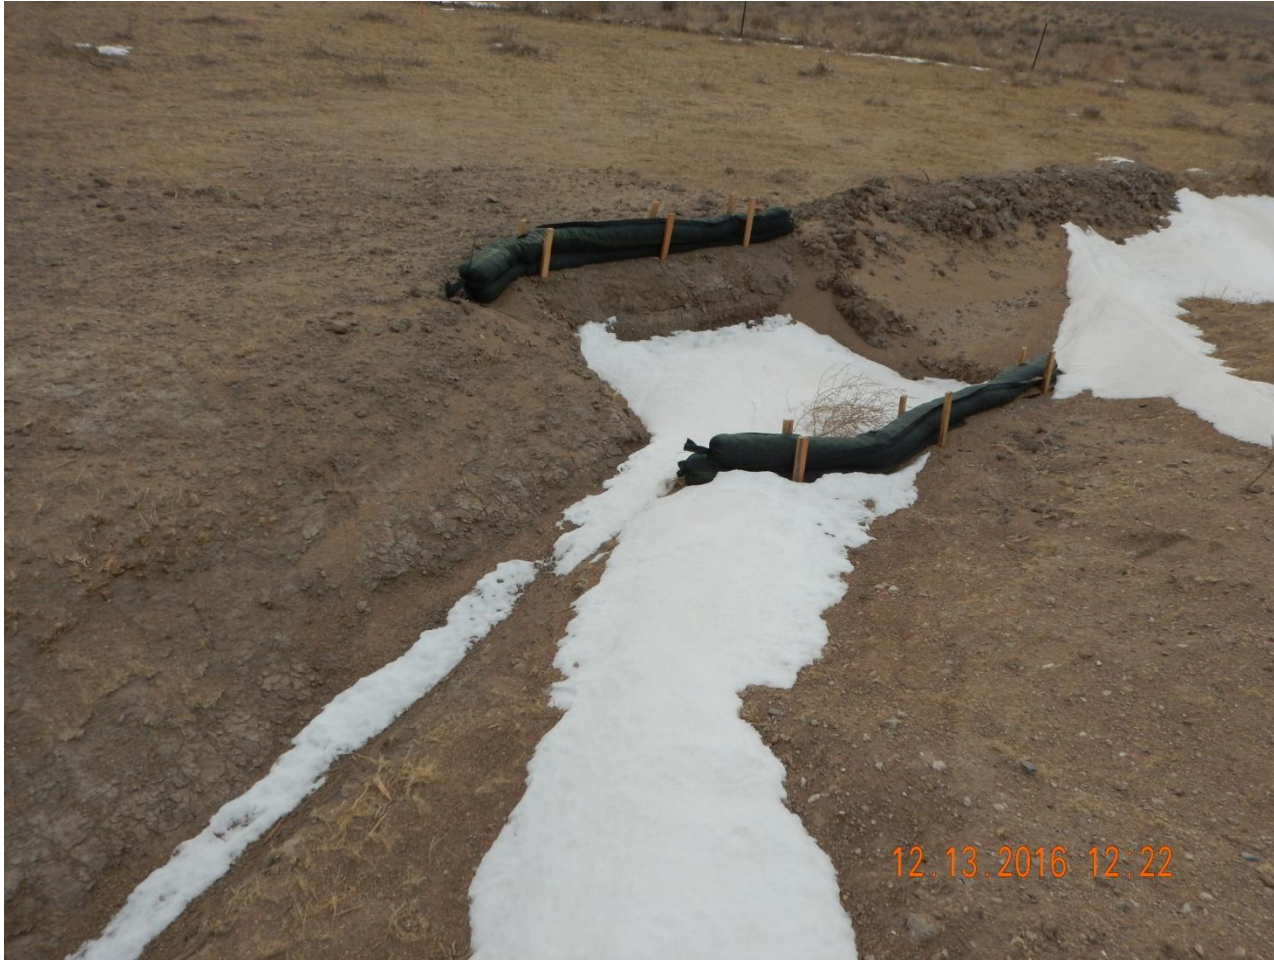
**Photo 4.** Photo taken from the southeast sediment trap. Sediment trap approximately 4'x4'x2.5' with filter socks. Sediment trap is about 1/3 filled in with sediment.

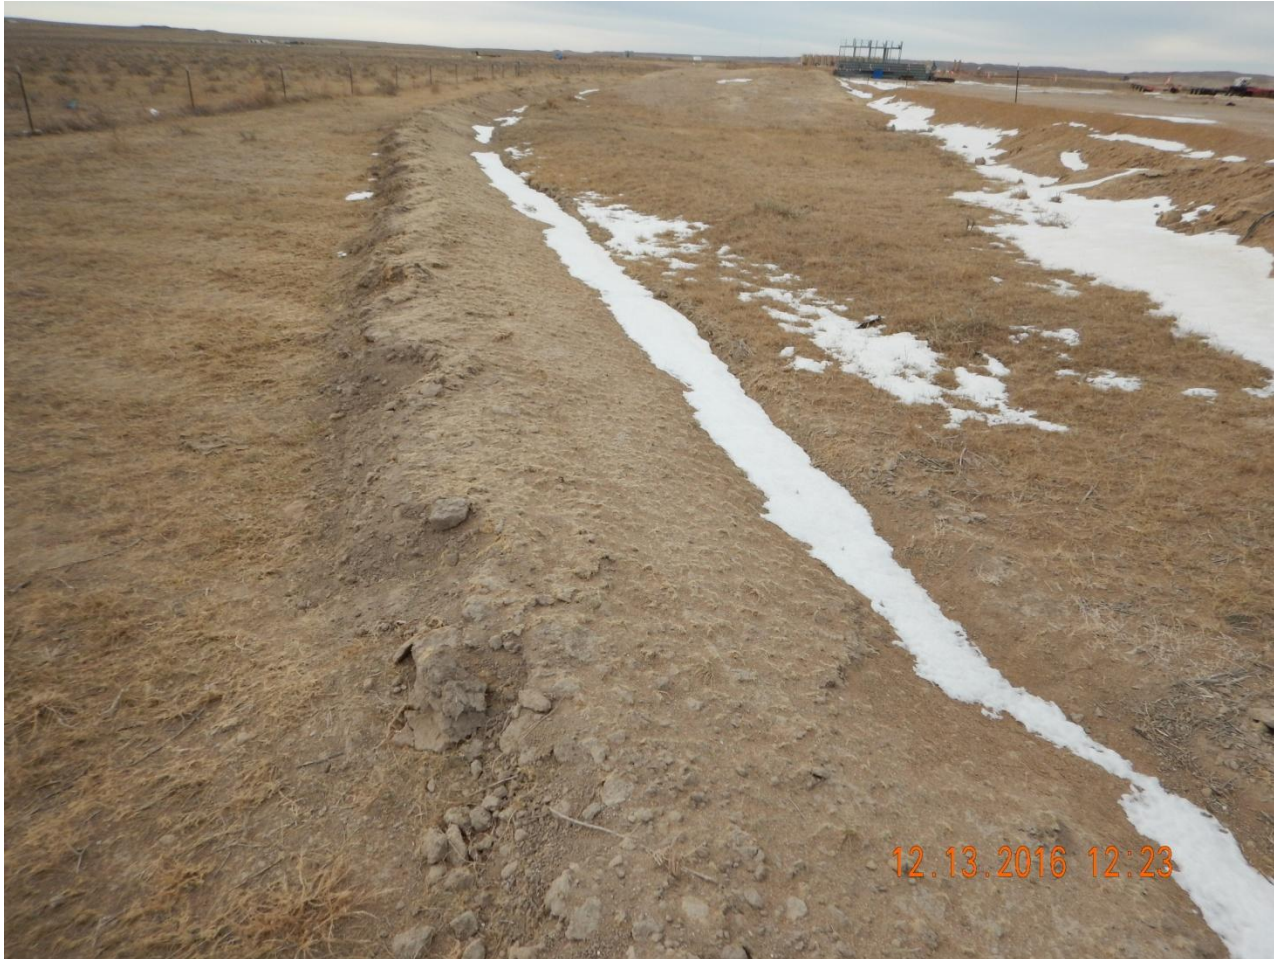
**Photo 5.** Photo taken from the southeast location, facing West. Ditch and berm installed along the southern location. Unconsolidated berm has been sprayed with a tackifier. May need additional stabilization along portions of the berm.

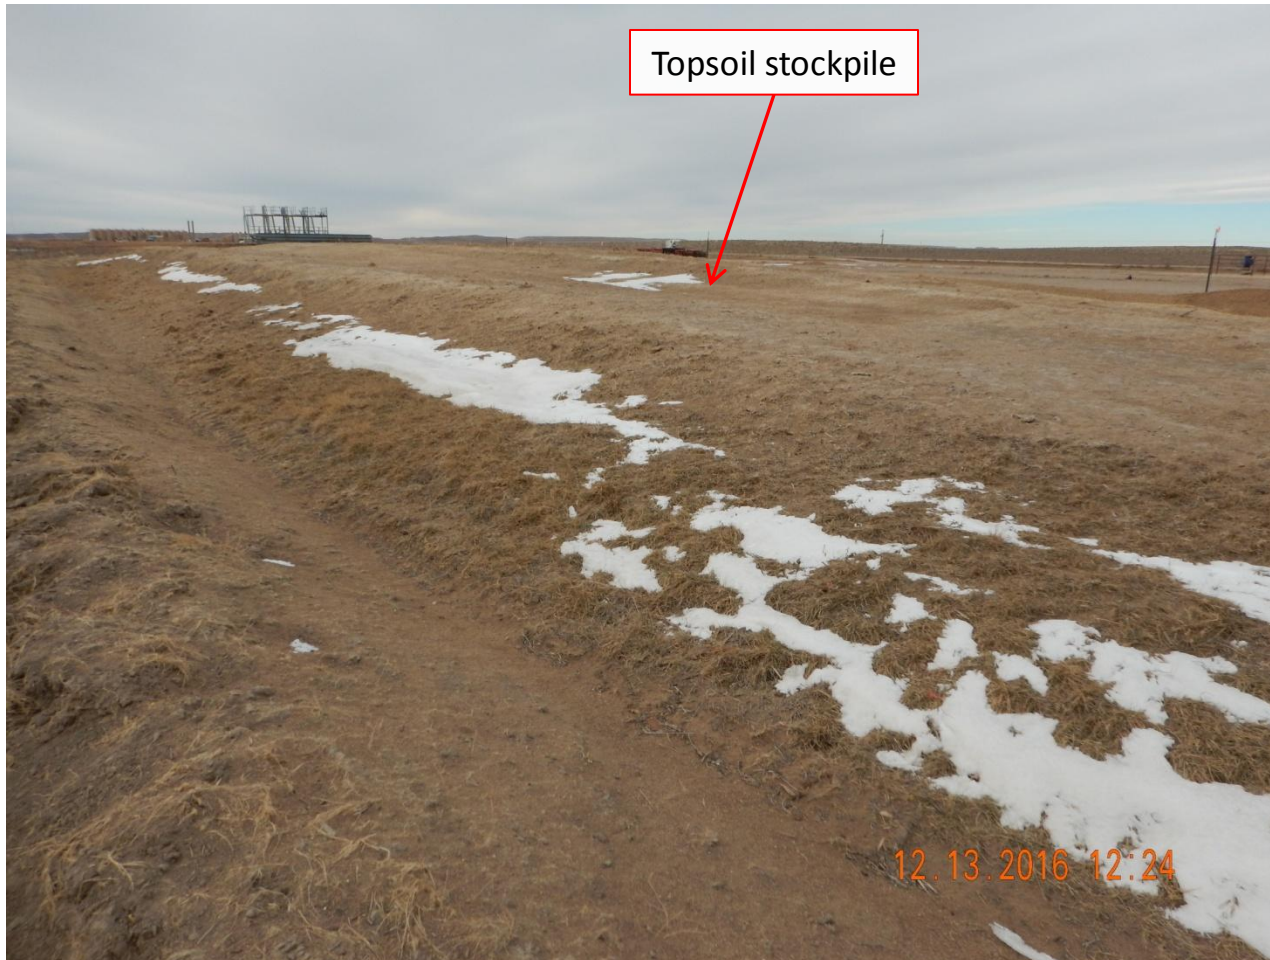
**Photo 6.** Photo taken from the southern location, facing North, towards the topsoil stockpile. Tackifier applied to the topsoil stockpile. May need additional stabilization on the top of the stockpile where it is susceptible to wind erosion.

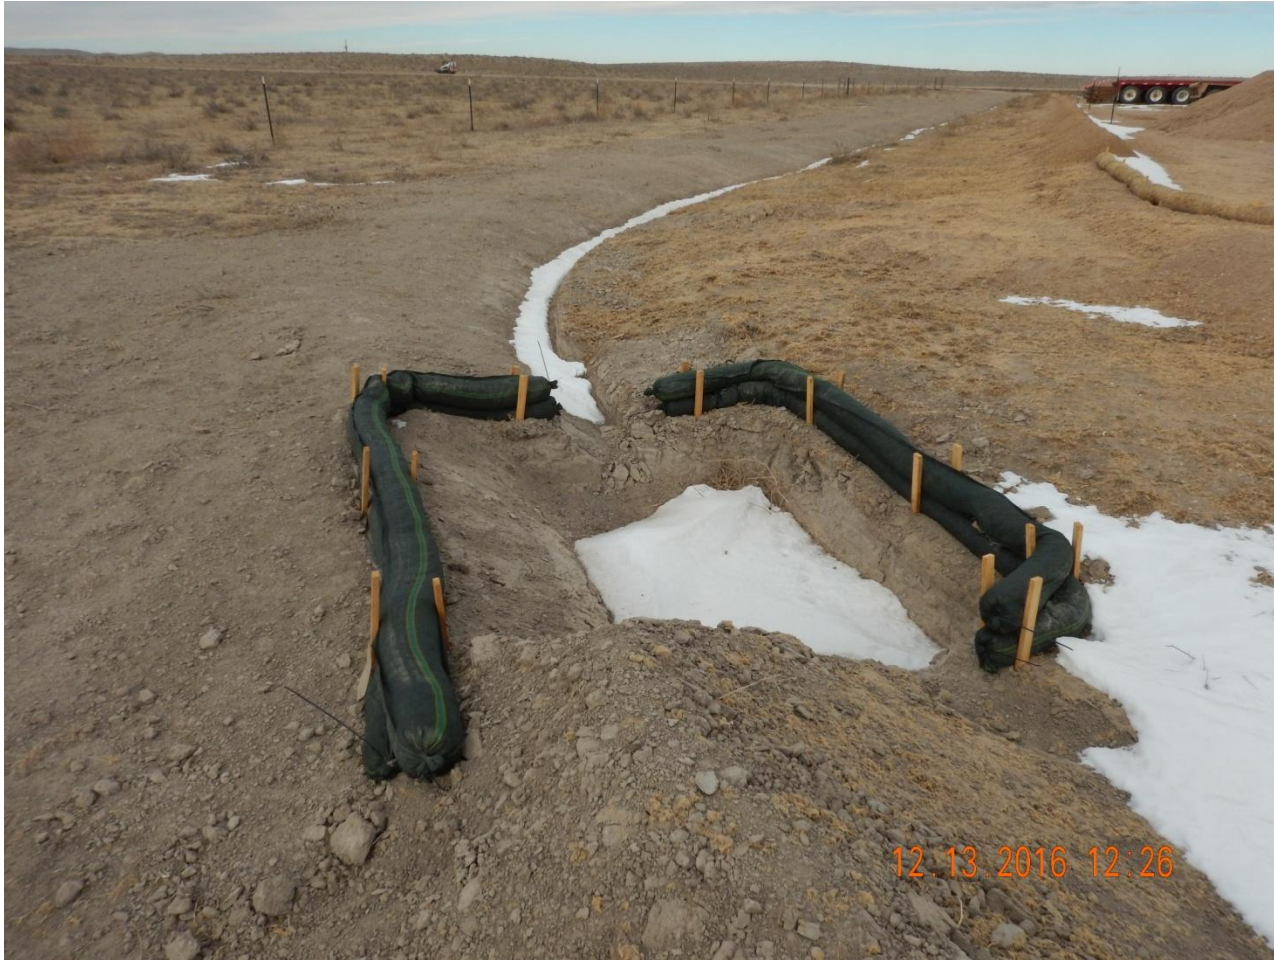
**Photo 7.** Photo taken from southwest location, facing North. Sediment trap approximately 3'x3'x2' with rock socks.

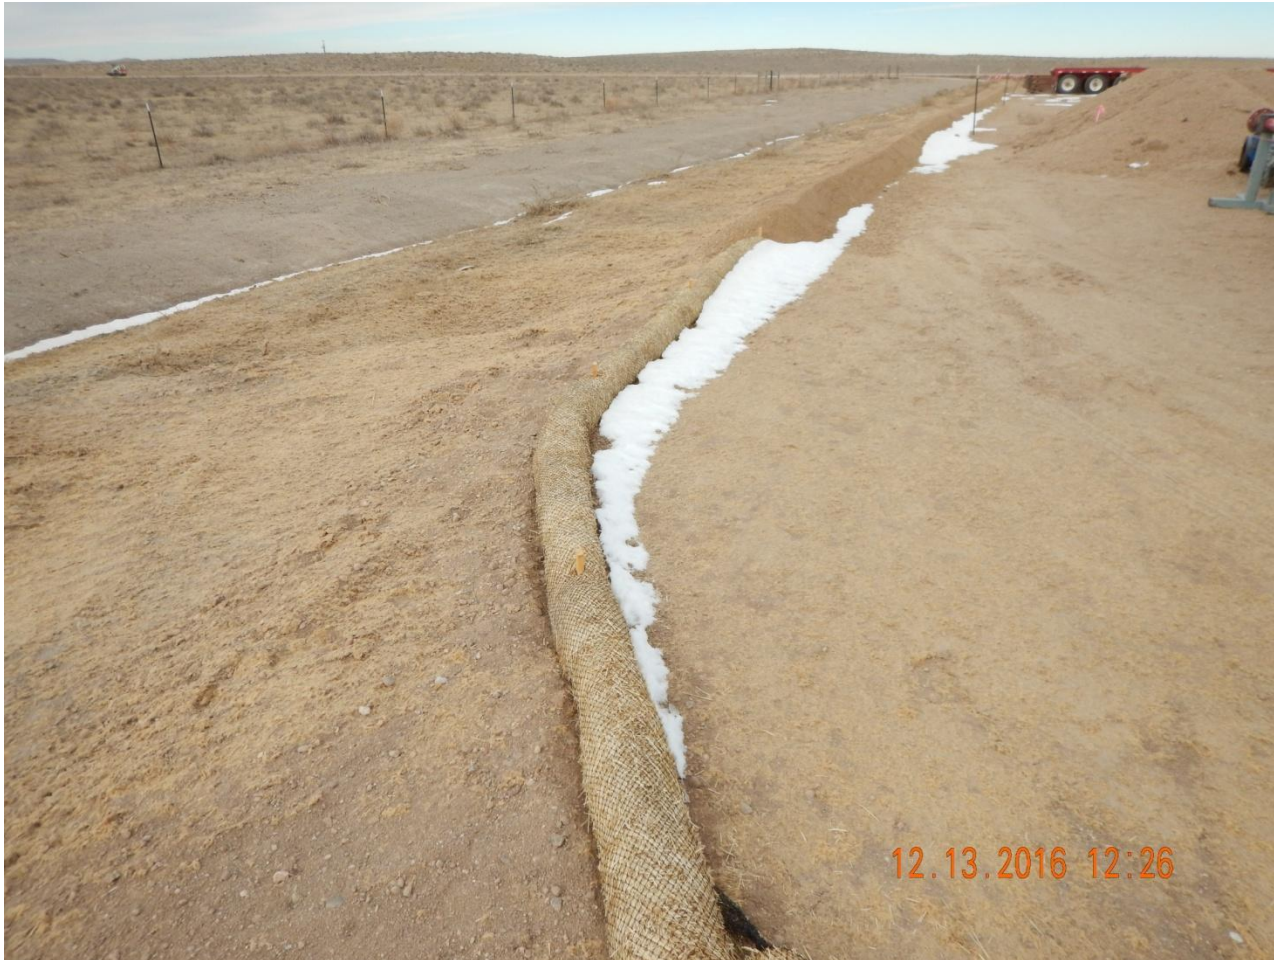
**Photo 8.** Photo taken from the southwest location, facing North. Wattles have been installed along the southwest pad corner in conjunction with a 12" berm along the pad perimeter. Appears wattles may be used to filter storm runoff before entering the sediment trap which is not the proper use. See inspection for more details.

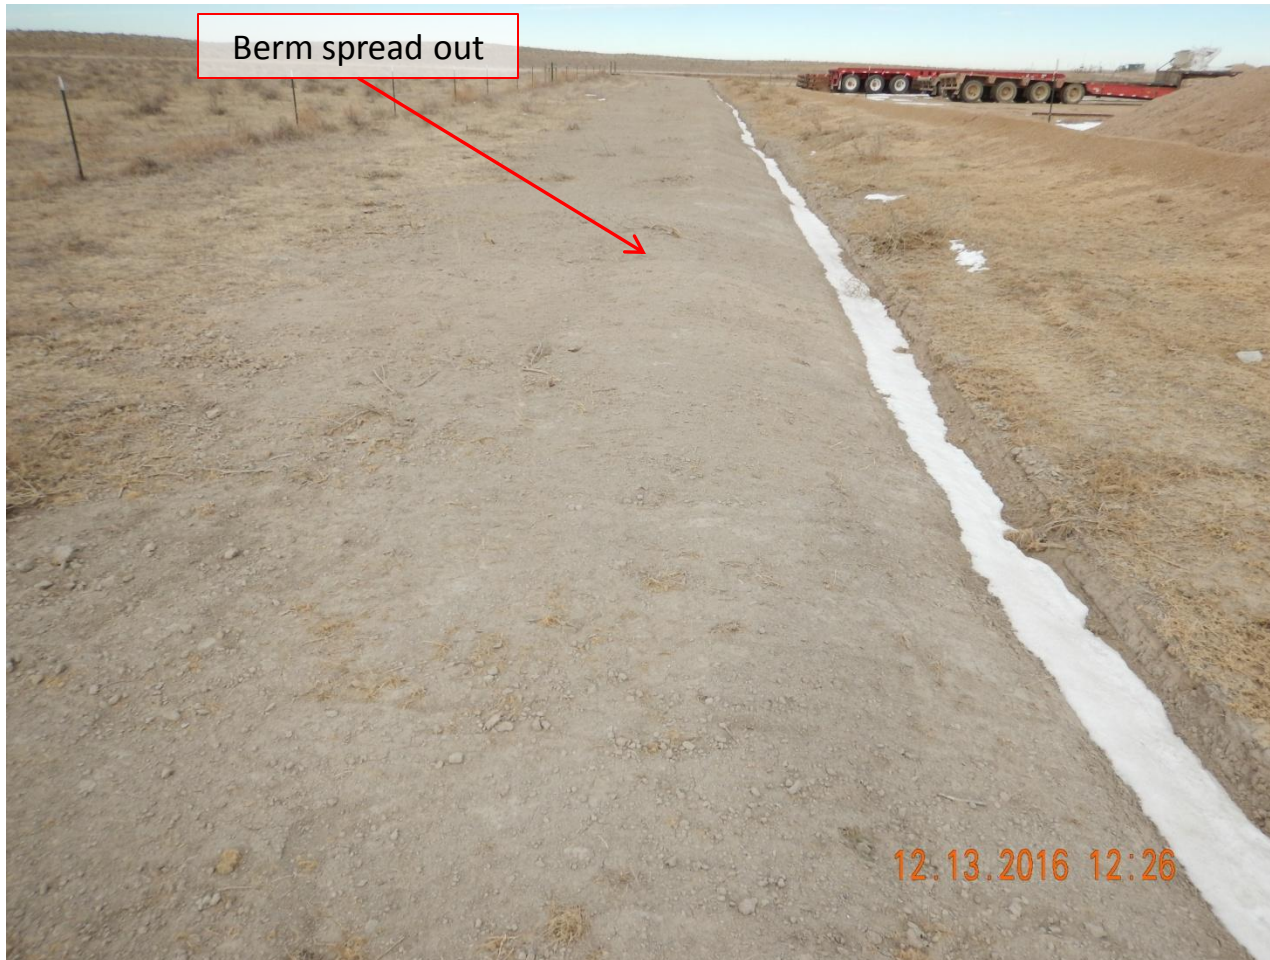
**Photo 9.** Photo taken from western location, facing North. Ditch approximately 8-12" in depth installed along the western perimeter. Berm appears to be spread out and not apparent along the western perimeter.

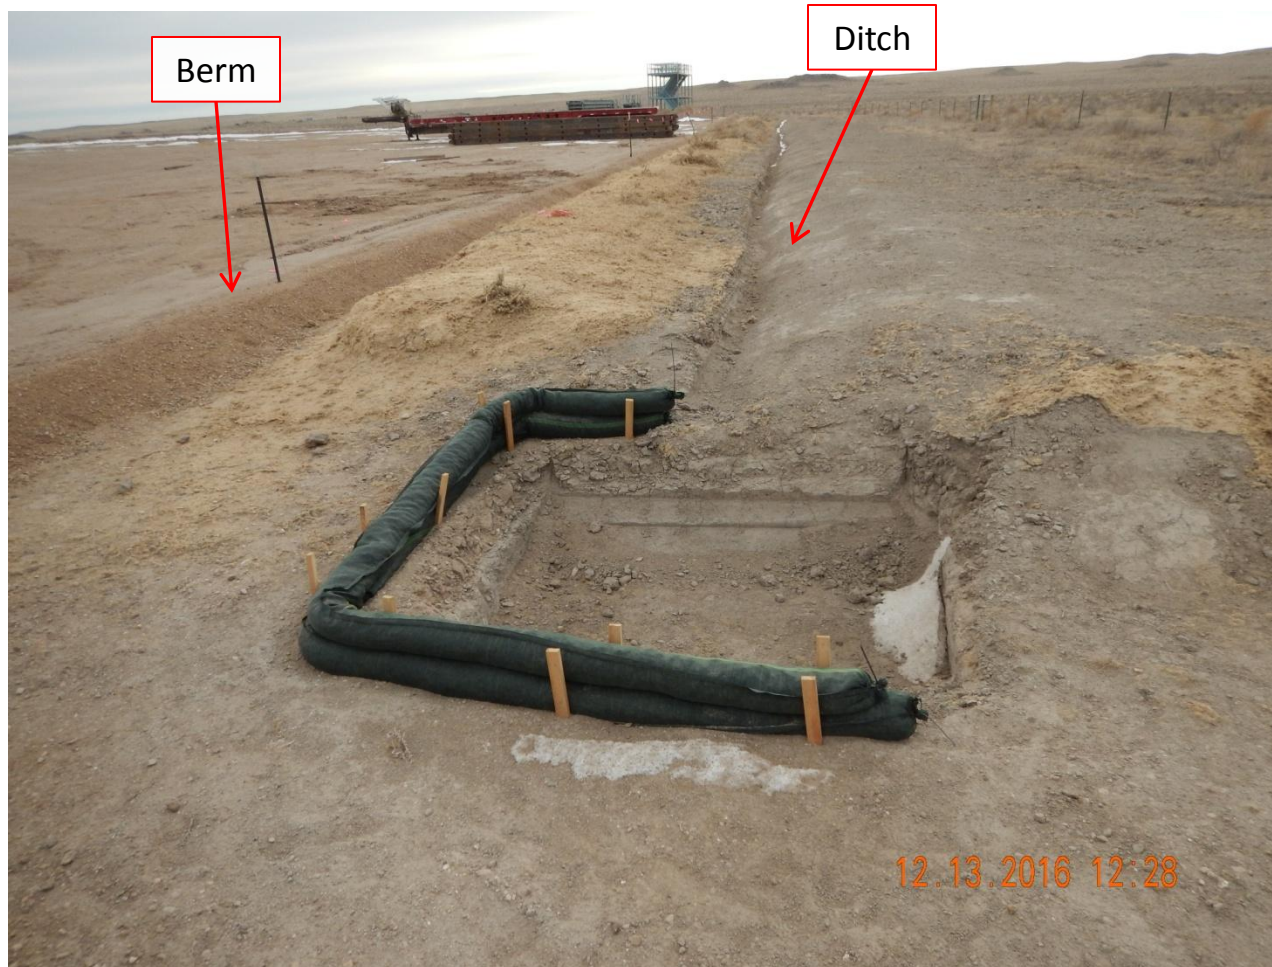
**Photo 10.** Photo taken from northwest location, facing South. Sediment trap approximately 4'x4'x2' with filter socks. A berm approximately 10"-12" constructed of road base installed along the west pad perimeter.
