## Location Overview

# Stormwater Inspection

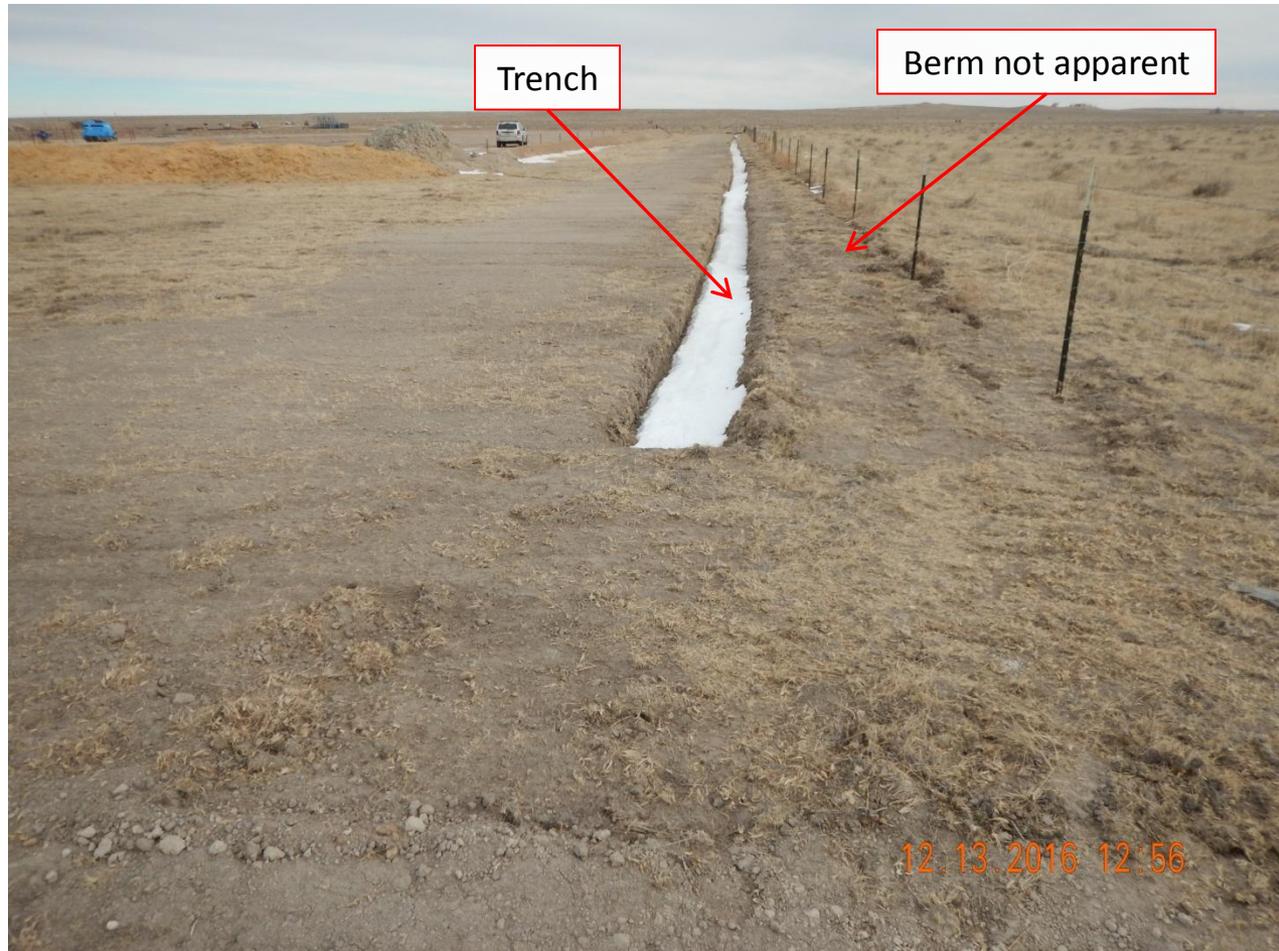
**Photo 1.** Photo taken from southwest location, facing East. Trench approximately 18"x12" (width x depth) installed along the southern perimeter of location. No apparent berm associated with trench.

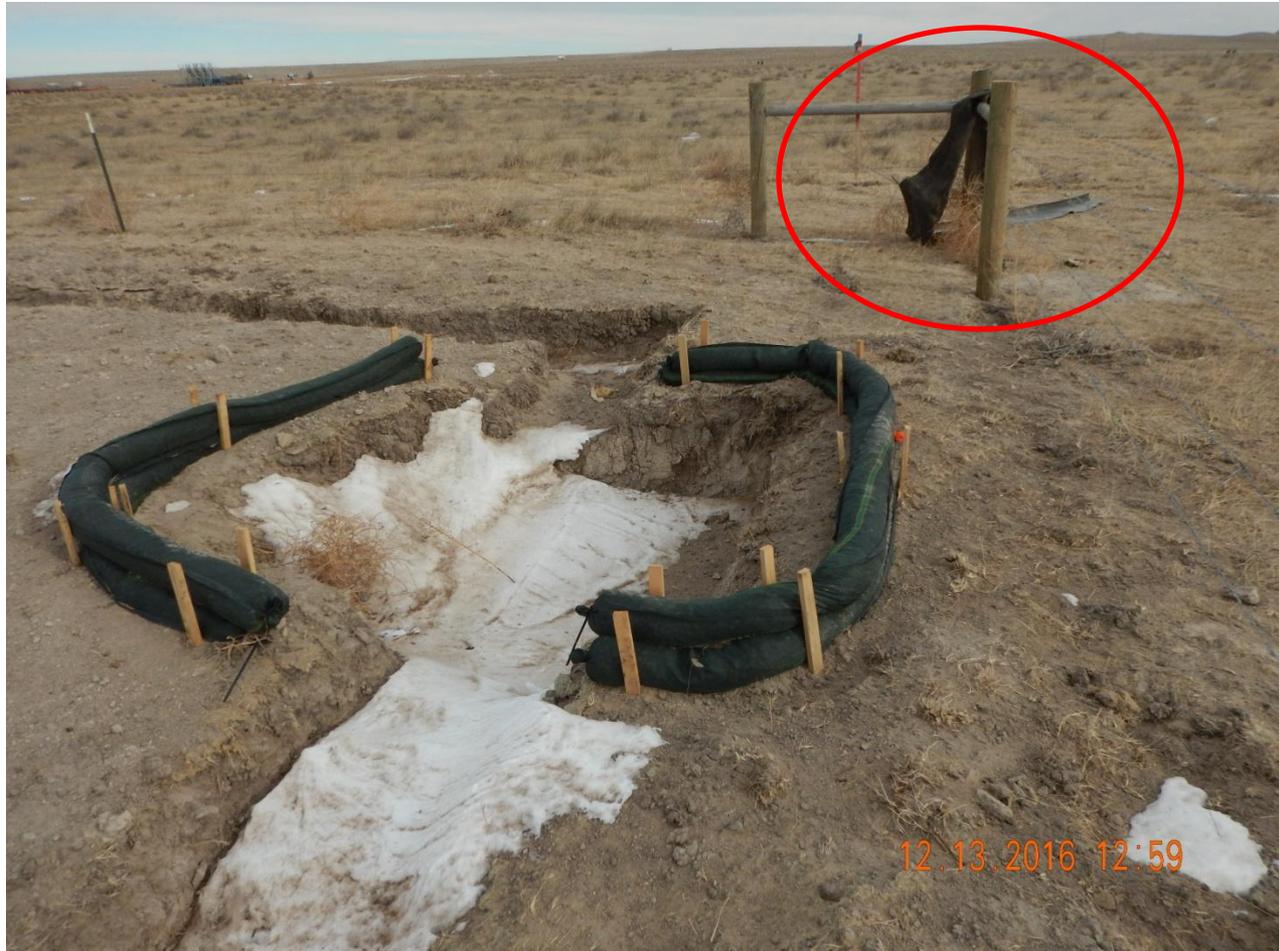
**Photo 2.** Photo taken from the southeast sediment trap, facing East. Sediment trap approximately 4'x4'x2.5' with rock socks. Need to remove waste material from fence per Rule 603.f.

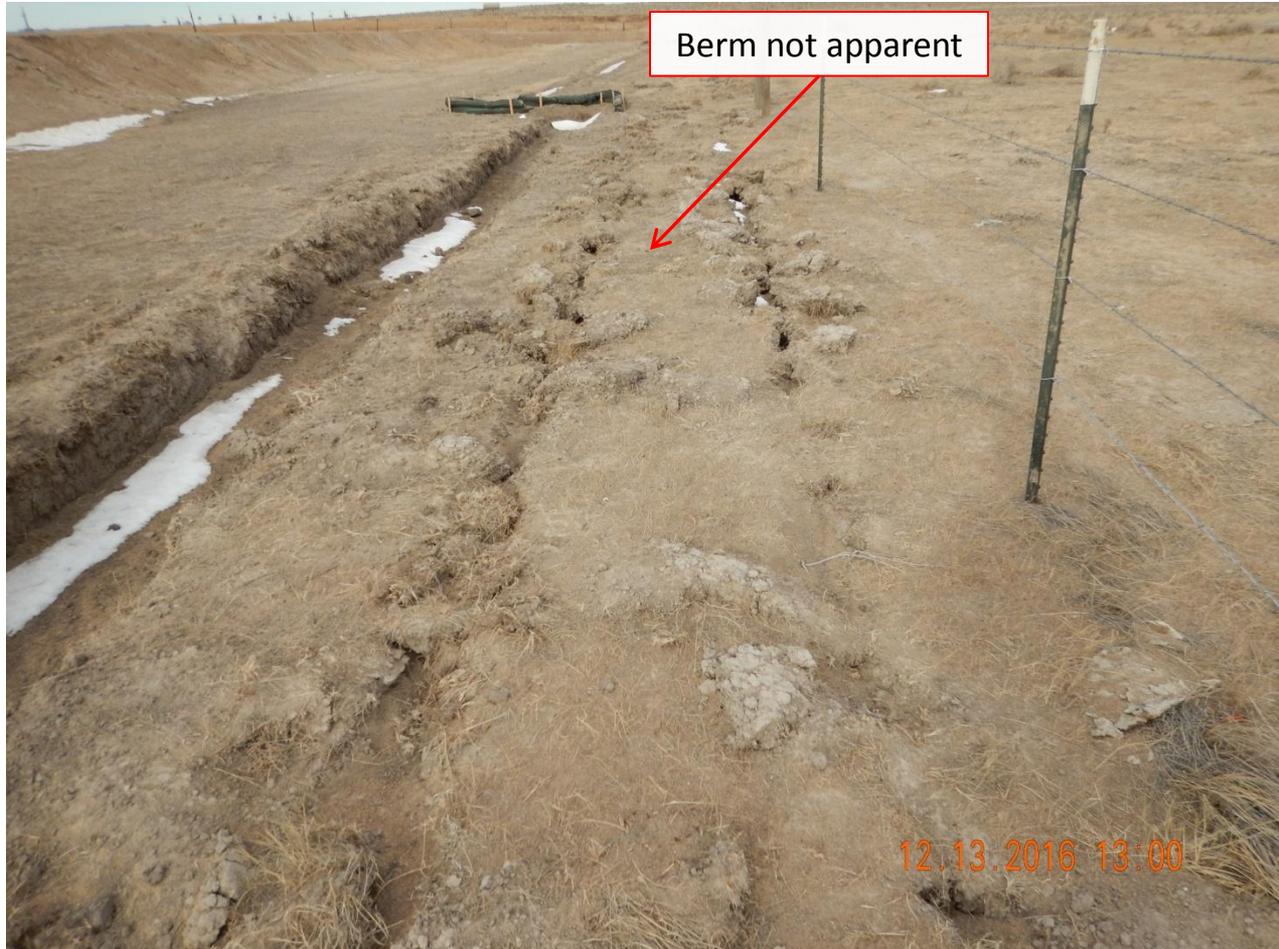
**Photo 4.** Photo taken from southeast location, facing North. Trench approximately 18"x12" (width x depth) installed along the eastern perimeter of location. No apparent berm associated with trench.

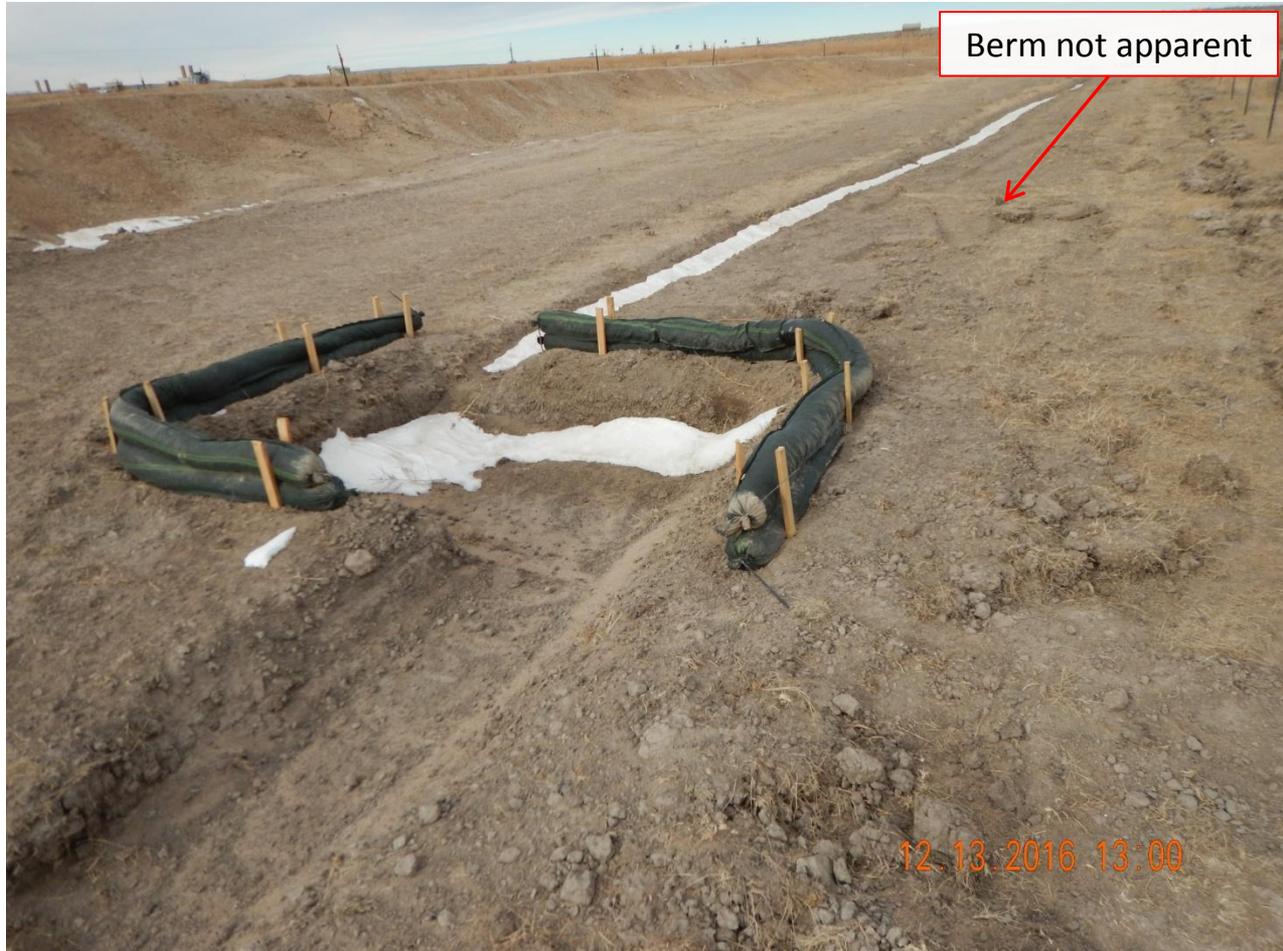
**Photo 4.** Photo taken from the east central sediment trap, facing North. Sediment trap approximately 4'x4'x2' with rock socks.

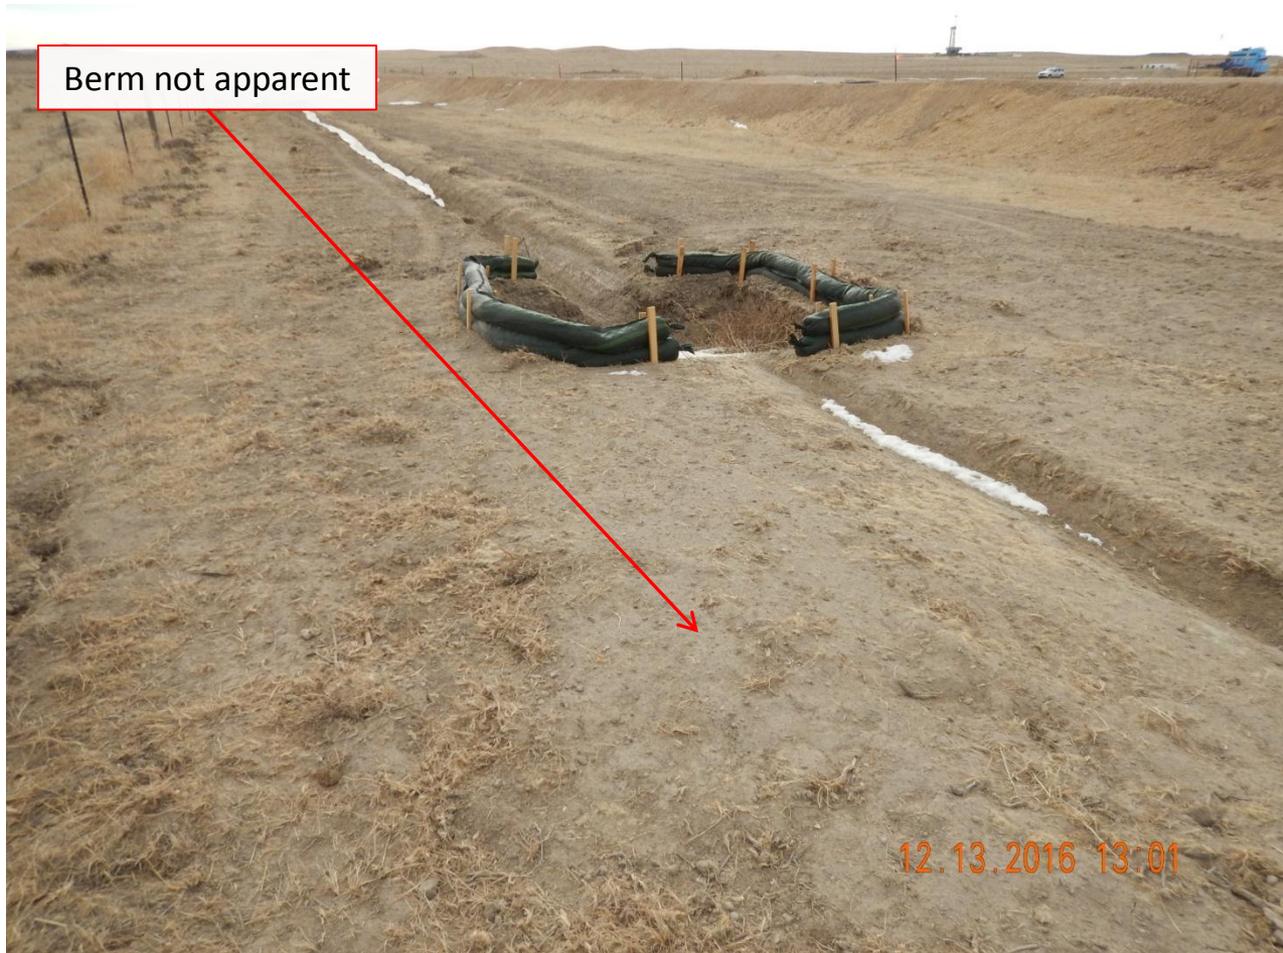
**Photo 5.** Photo taken from the northeast location, facing South. Sediment trap approximately 4'x4'x2.5' with filter socks.

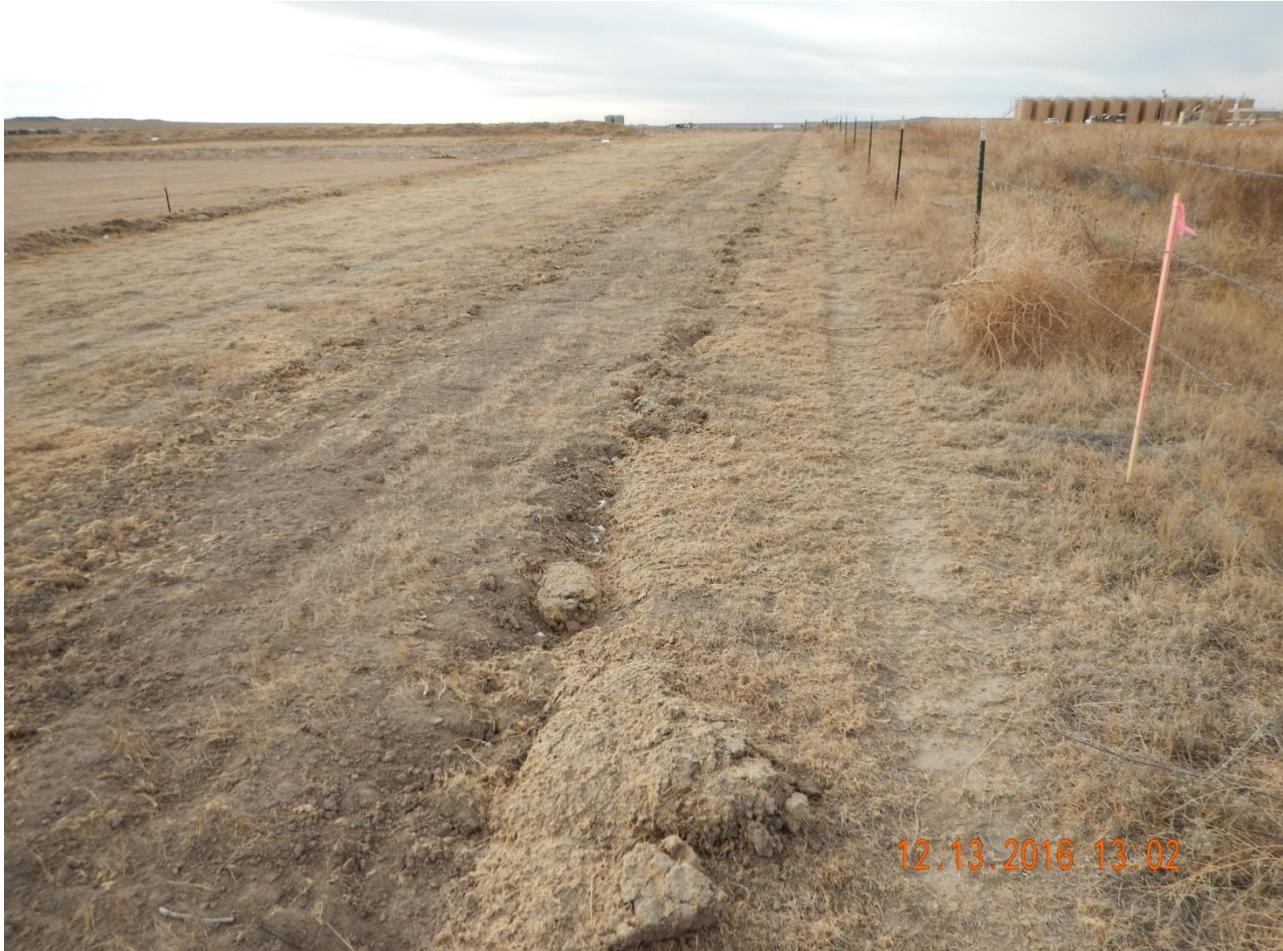
**Photo 6.** Photo taken from the northern location, facing West. Vegetated area between disturbance area and perimeter of location.

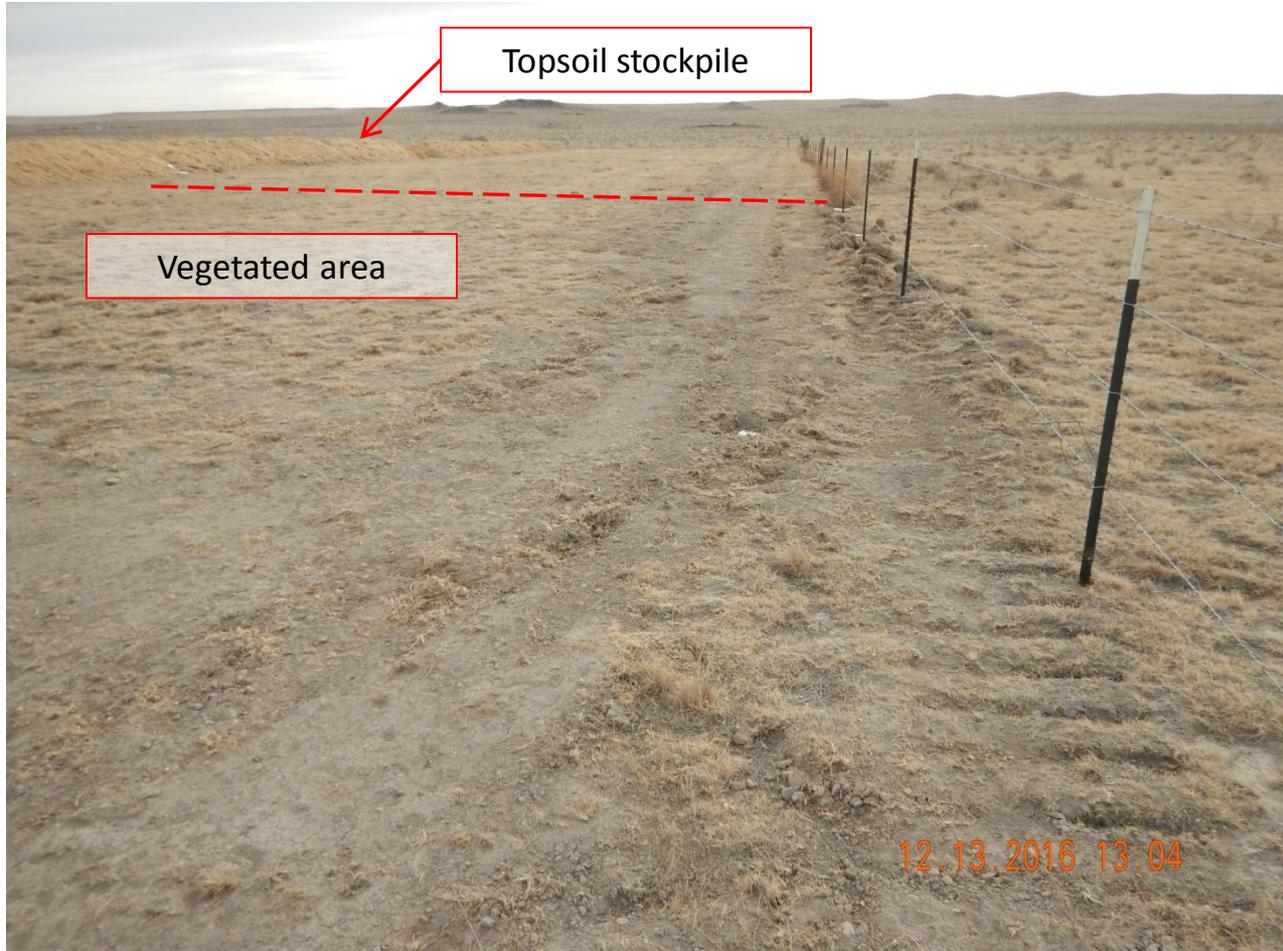
**Photo 7.** Photo taken from northwest location, facing South. Vegetated area between topsoil stockpile and perimeter of location.

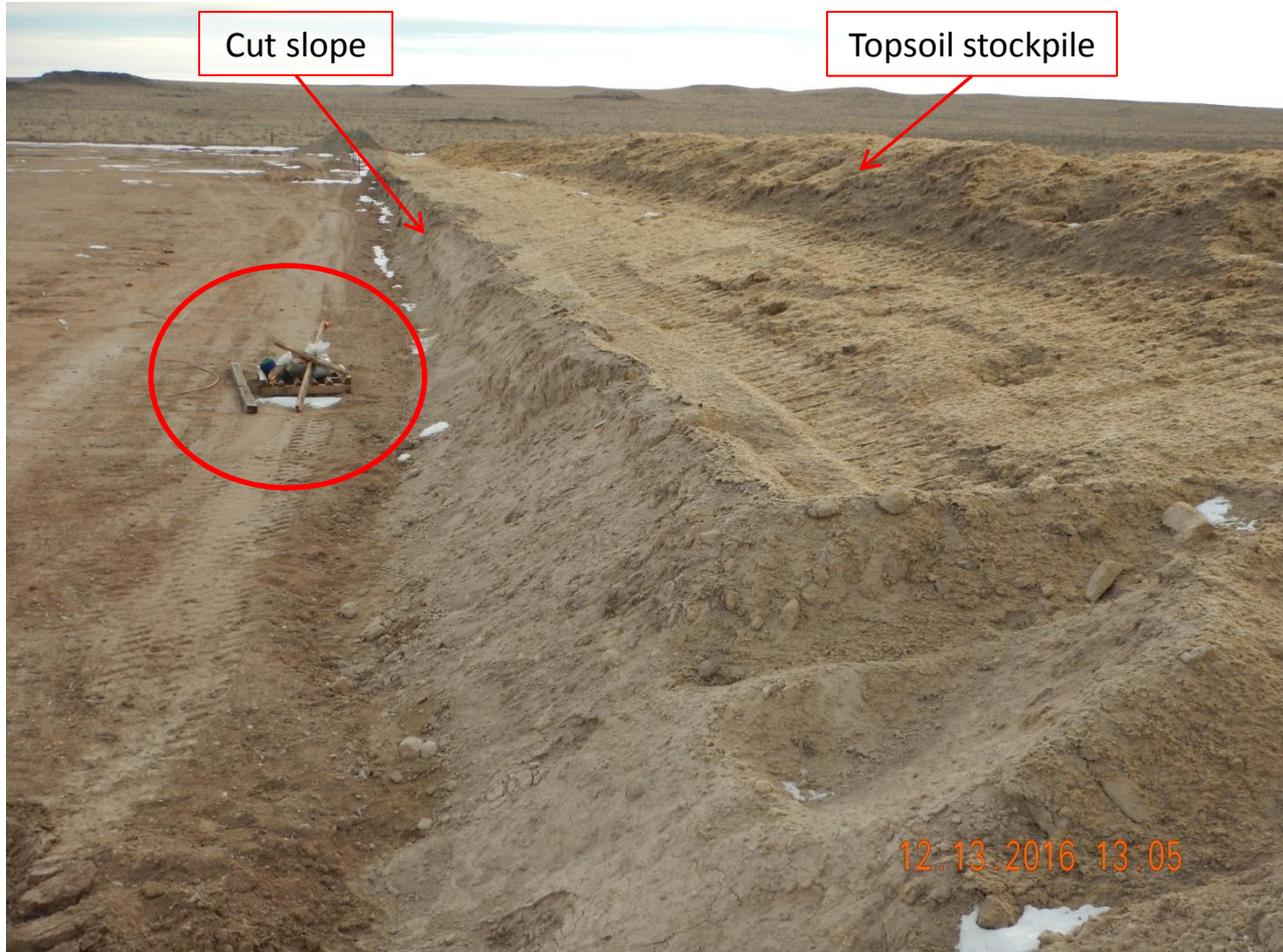
**Photo 8.** Photo taken from western pad cut slope, facing South. Cut slope does not appear to be stabilized (1:1 slope) and a 2:1 slope would be appropriate with additional stabilization measures. Remove waste material per Rule 603.f.

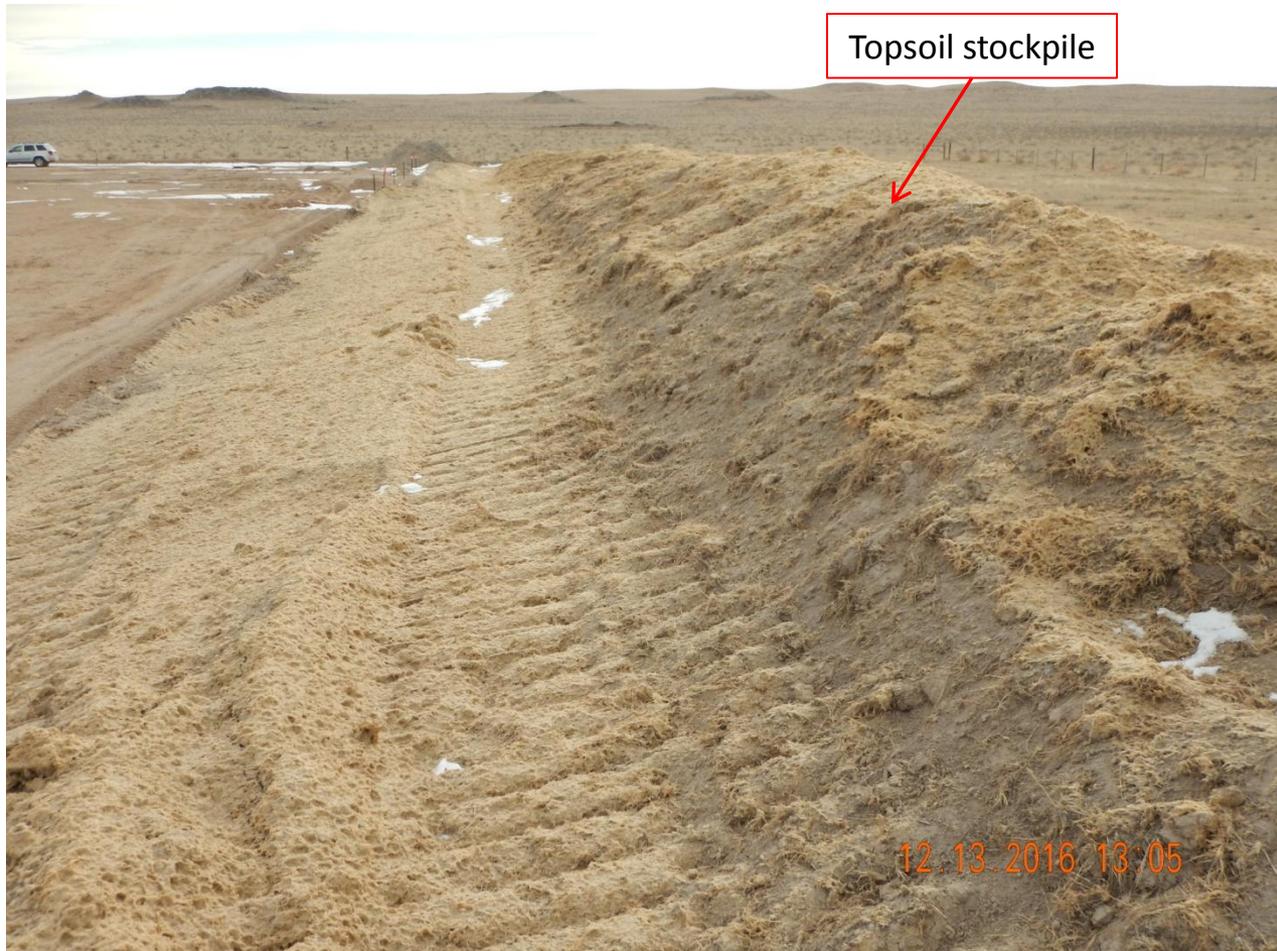
**Photo 9.** Photo taken from the western location, facing South, along the topsoil stockpile. Tackifier applied to the topsoil stockpile and the east-facing edge. Not certain whether topsoil was seeded in addition to applying tackifier, but tackifier alone is not a long-term stabilization BMP to protect topsoil from erosion and weed establishment.

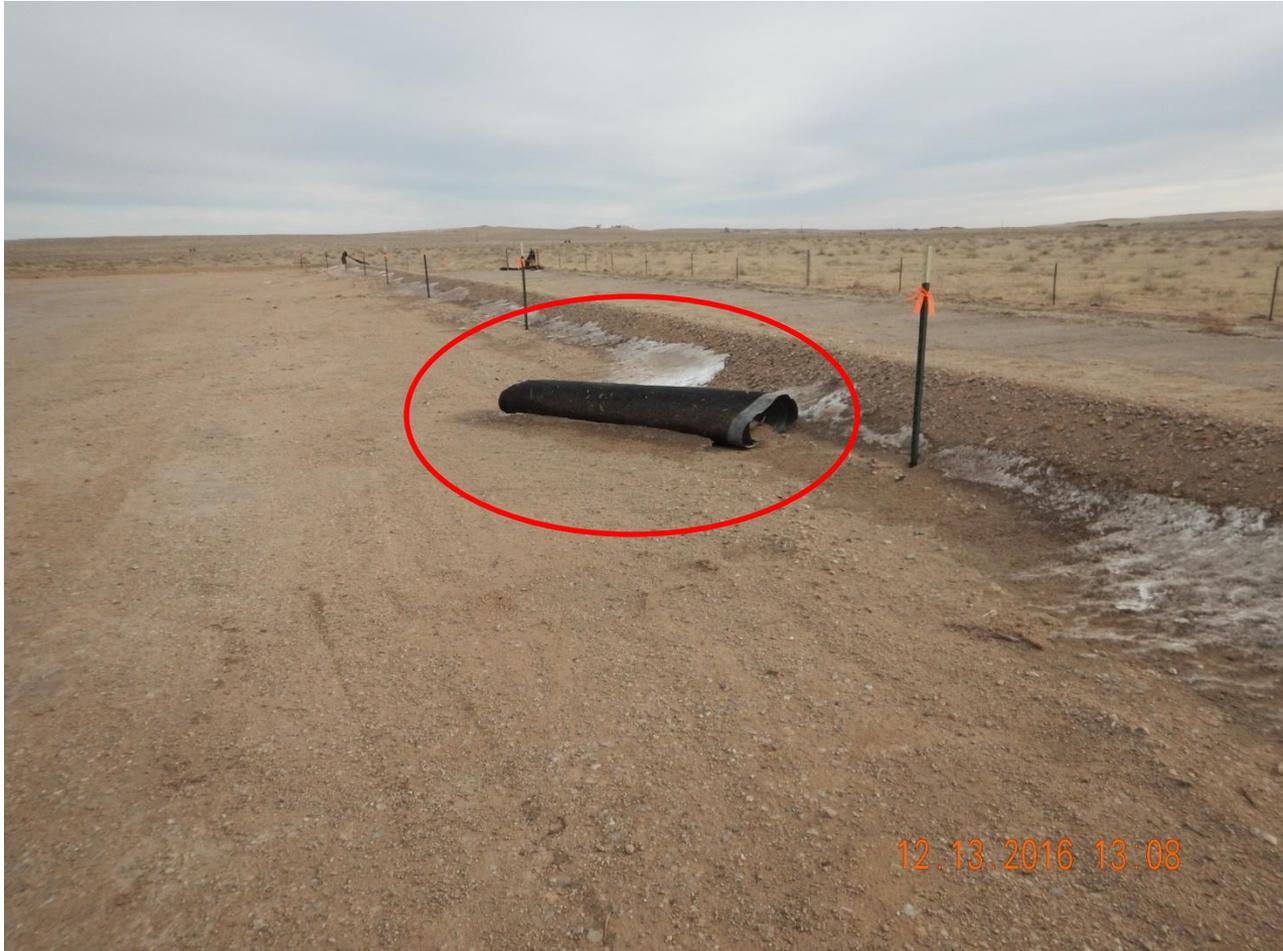
**Photo 10.** Photo taken from the southern location, facing East. Remove waste material per Rule 603.f.

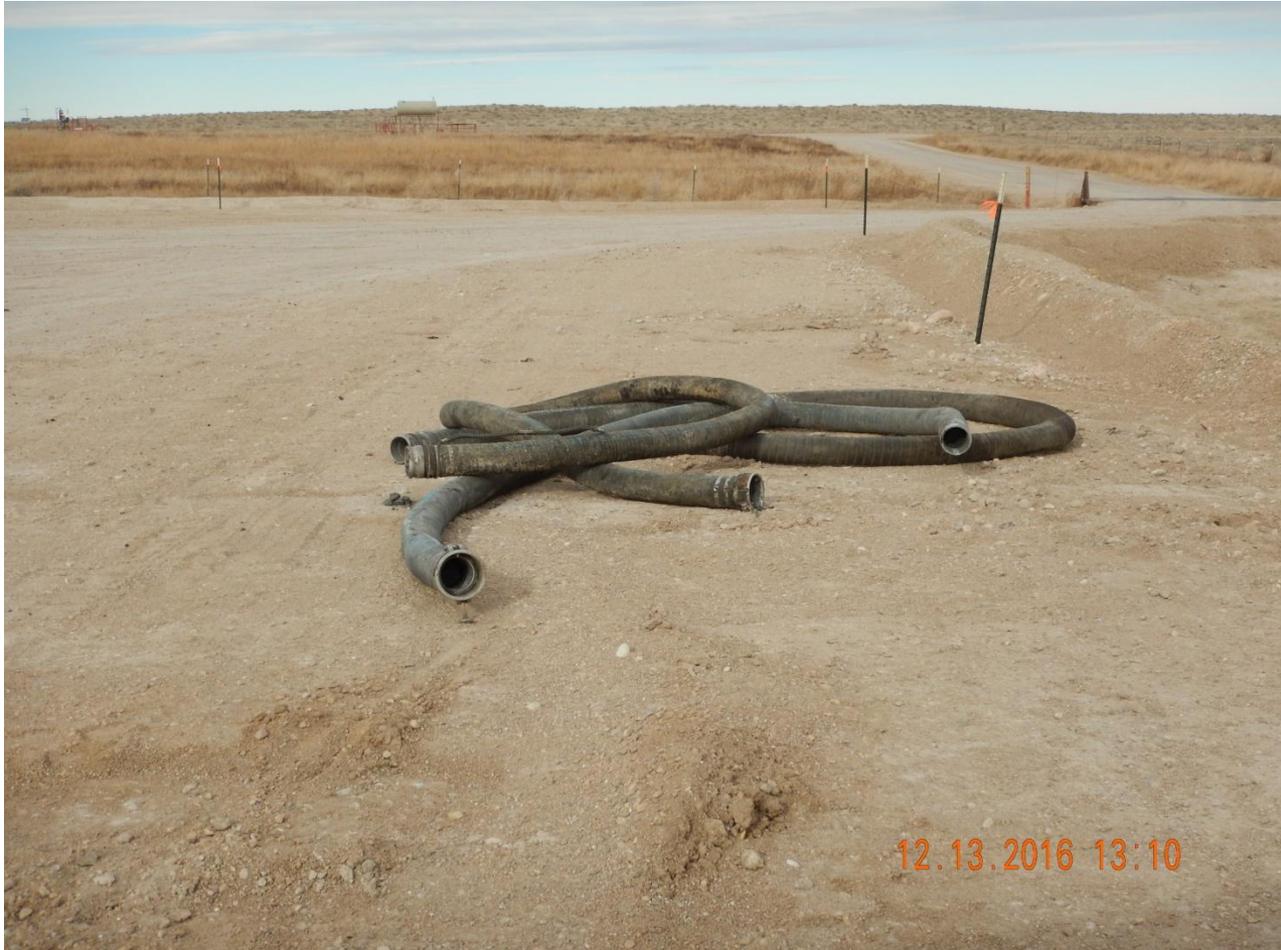
**Photo 11.** Photo taken from the northeast location, facing North. Remove waste material per Rule 603.f.
