Location Overview

Google Earth aerial photo taken 9/7/2013 of the LC24-03 location highlighted in green. Total area of 7.2 acres was mapped using a Trimble Juno 3B handheld device. Tank battery servicing the well location highlighted in red.

Stormwater Inspection

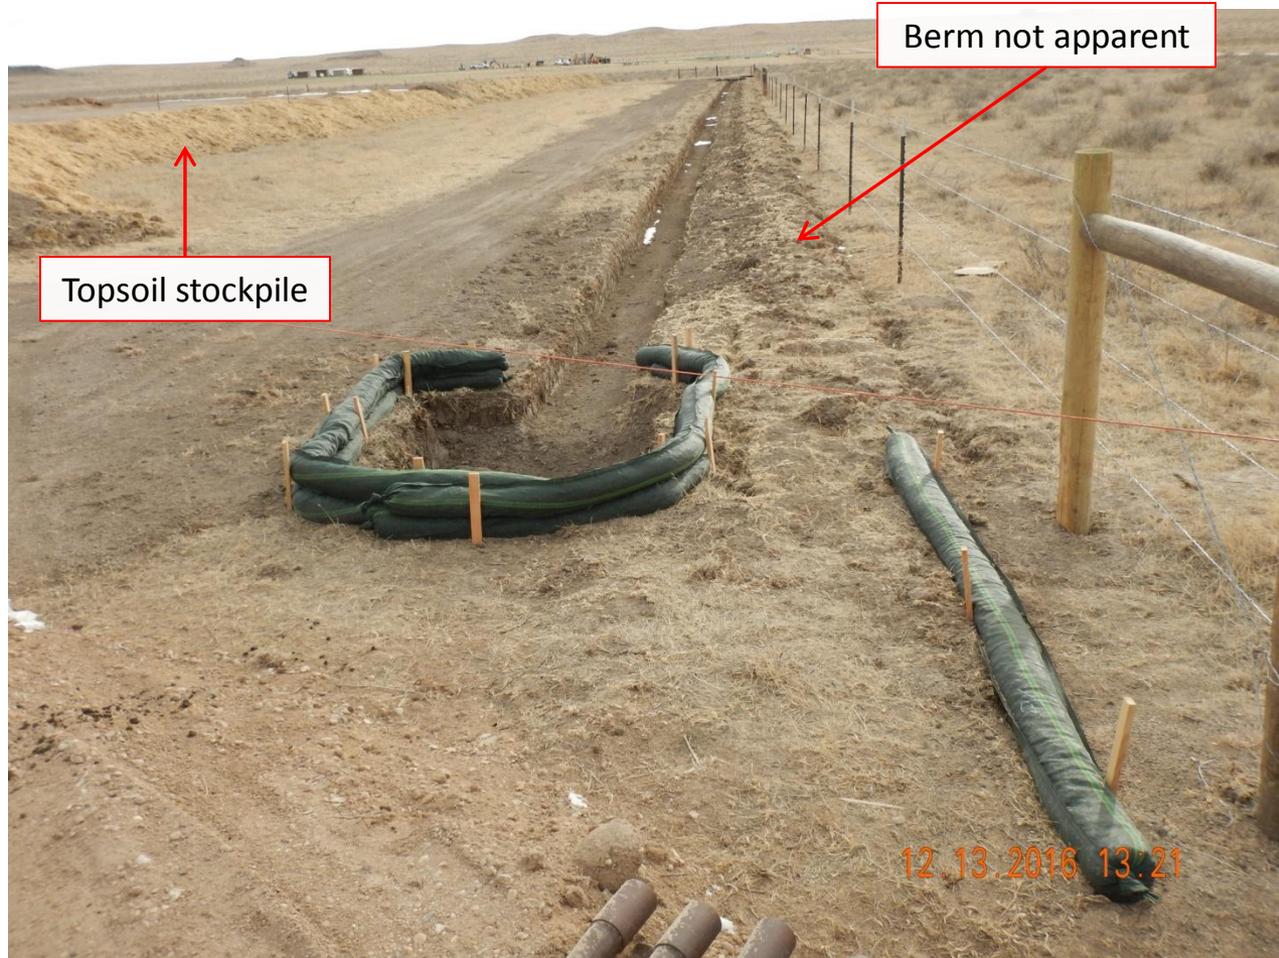
Photo 1. Photo taken from northwest location, facing South. Sediment trap approximately 4'x4'x2.5' with rock socks. Trench approximately 18"x12" (width x depth) installed along the western perimeter of location. No apparent berm associated with trench.

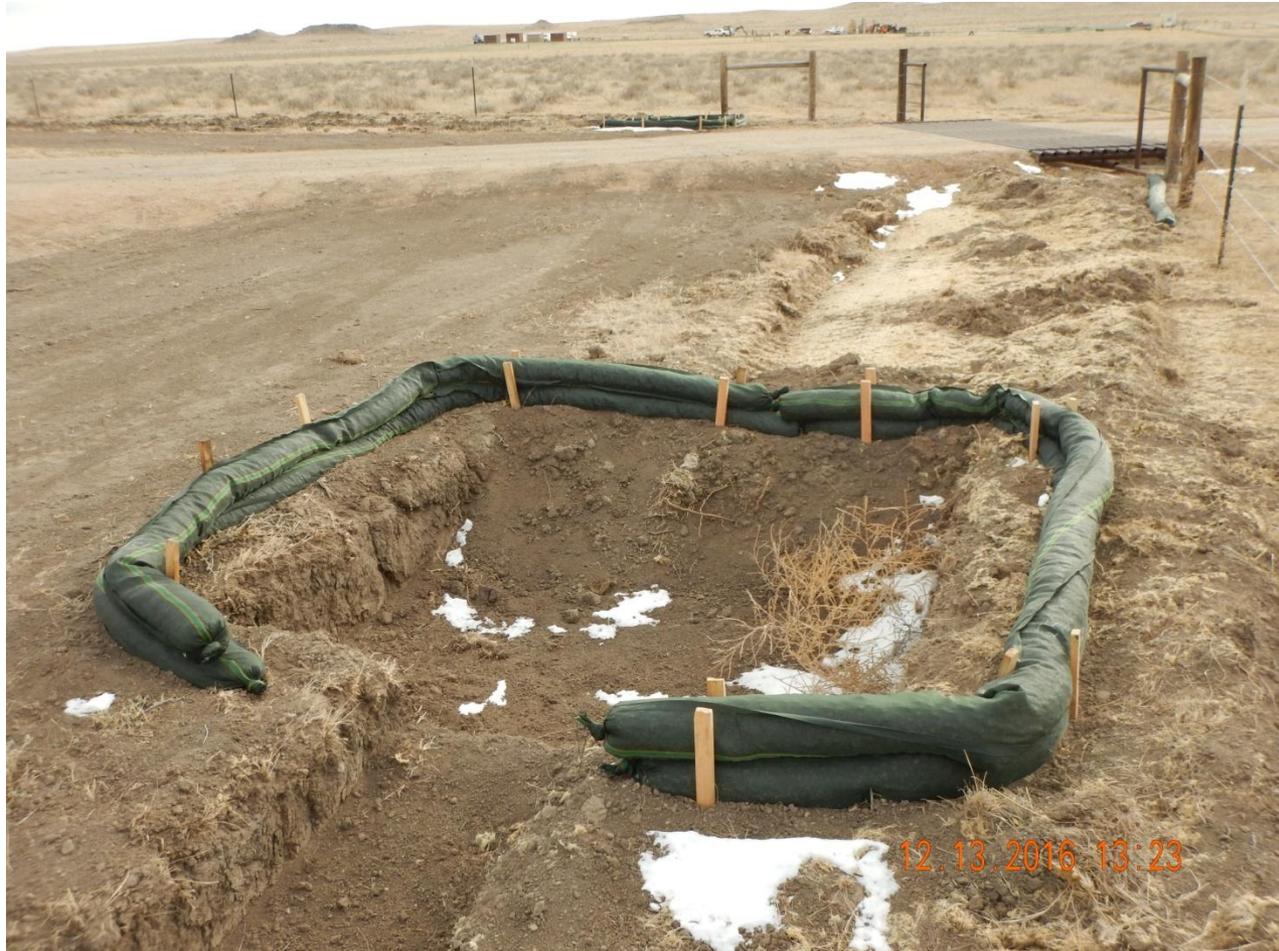
Photo 2. Photo taken from the southwest sediment trap north of the access road, facing South. Sediment trap approximately 4'x4'x2.5' with rock socks.

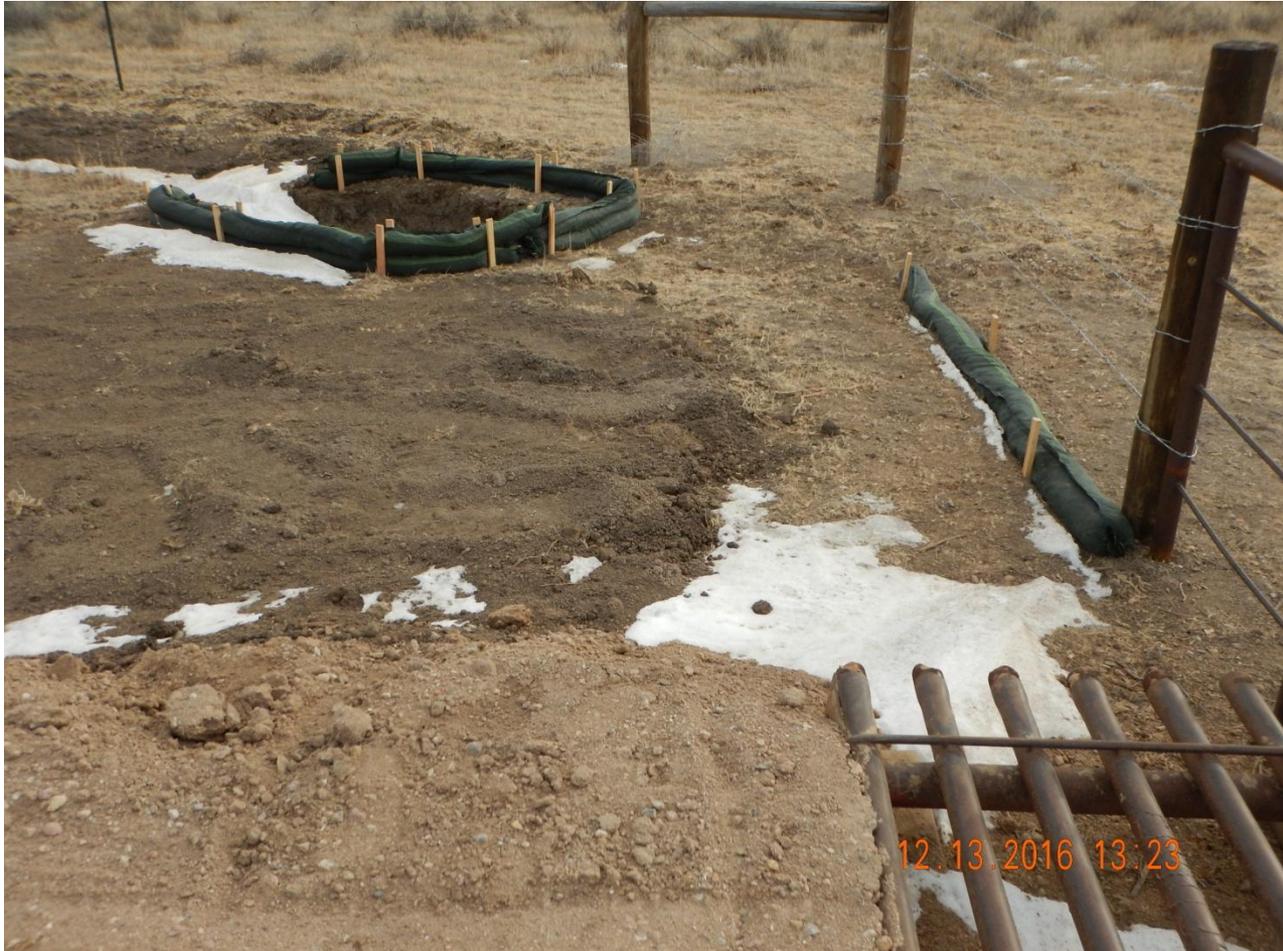
Photo 3. Photo taken from the southwest sediment trap south of the access road, facing South. Sediment trap approximately 4'x4'x2.5' with rock socks.

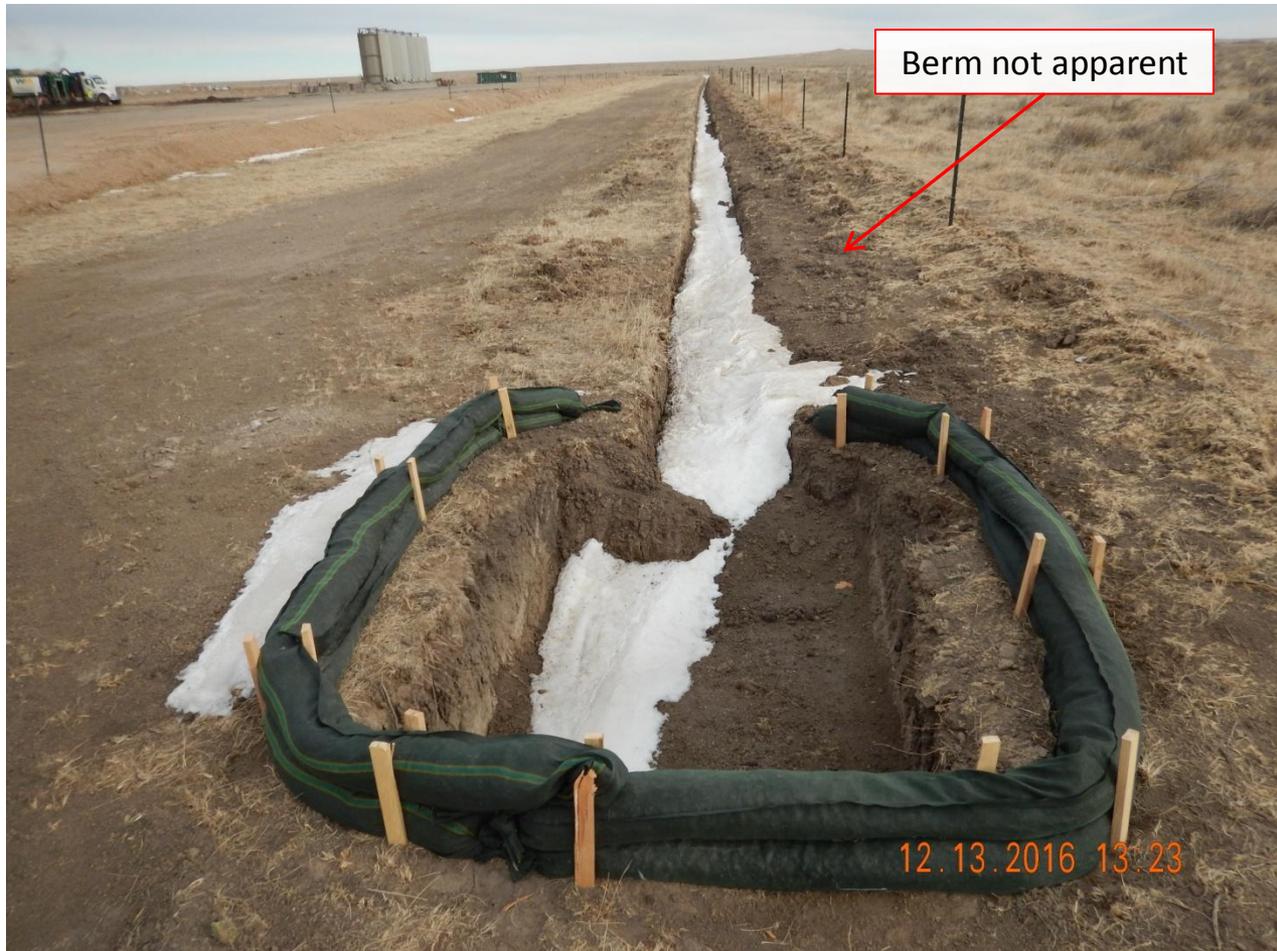
Photo 4. Photo taken from the previous sediment trap, facing East. Trench approximately 18"x12" (width x depth) installed along the southern perimeter of location. No apparent berm associated with trench.

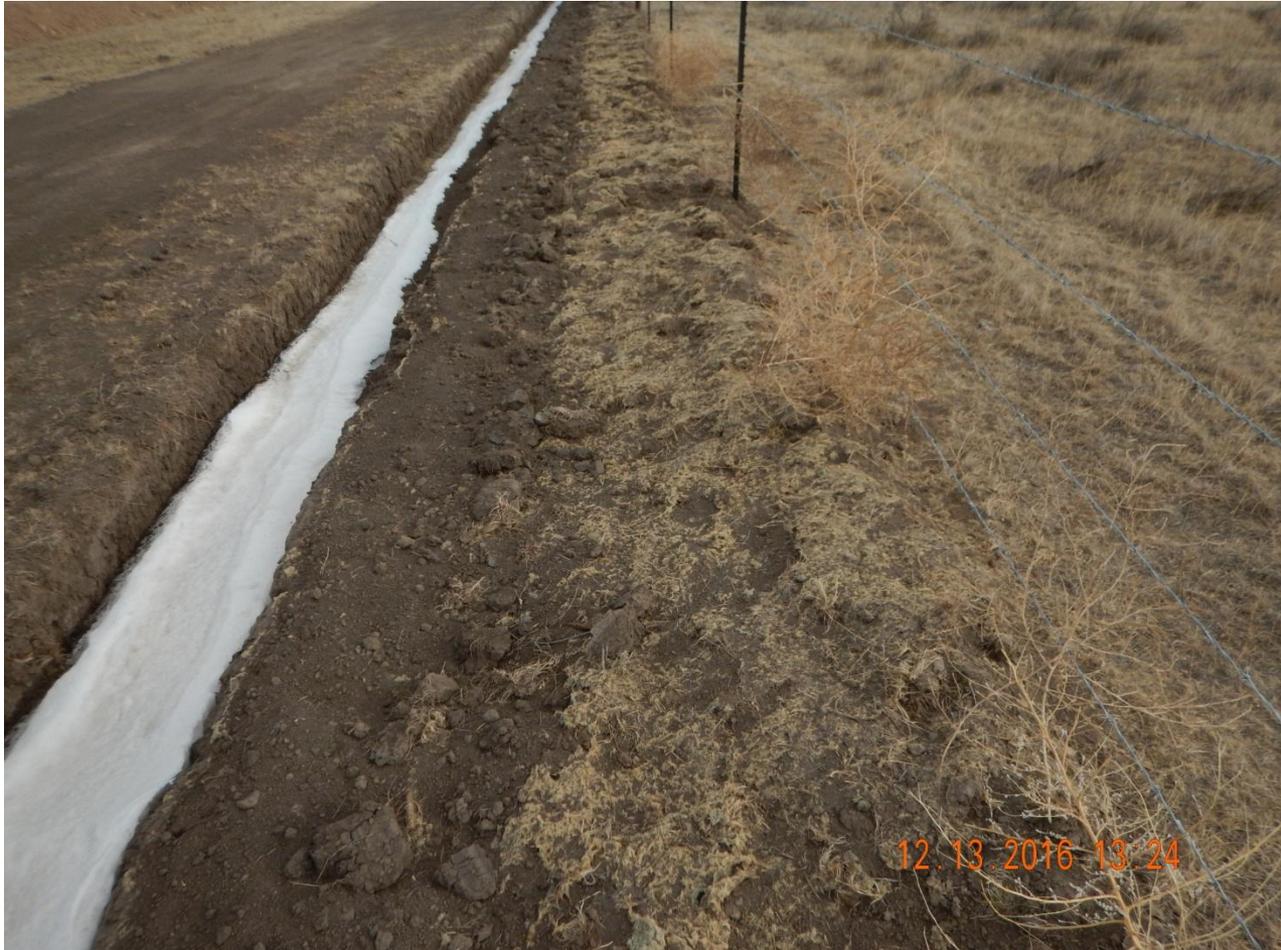
Photo 5. Photo taken from the southern location, facing East. Unconsolidated soil dug out from the trench sprayed with tackifier but may need additional tackifier because the application rate appears too low.

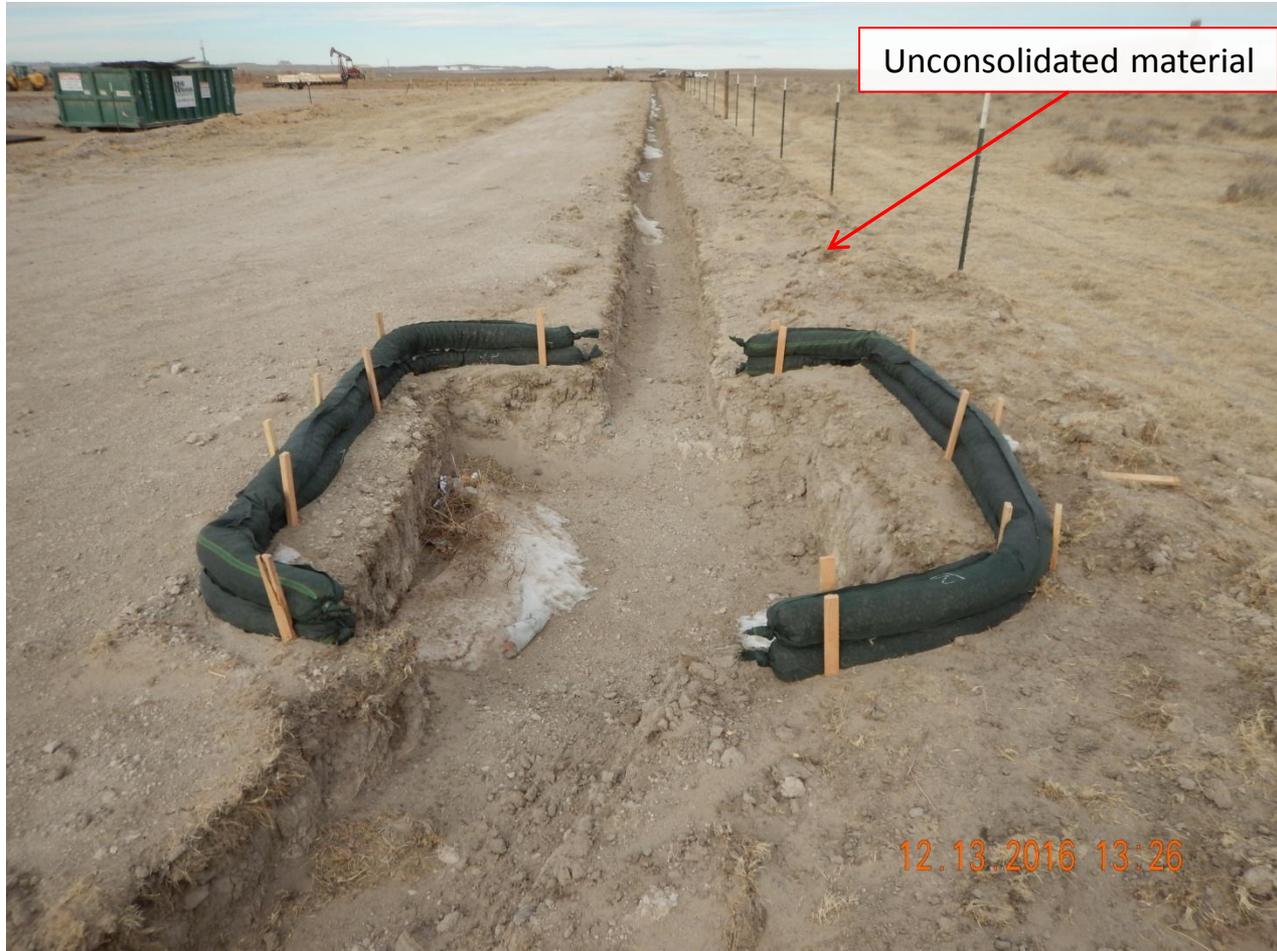
Photo 6. Photo taken from the southeast sediment trap, facing North. Sediment trap approximately 4'x4'x2.5' with filter socks. Trench approximately 18"x12" (width x depth) installed along the eastern perimeter of location. Unconsolidated soil dug out from the trench has not been stabilized.

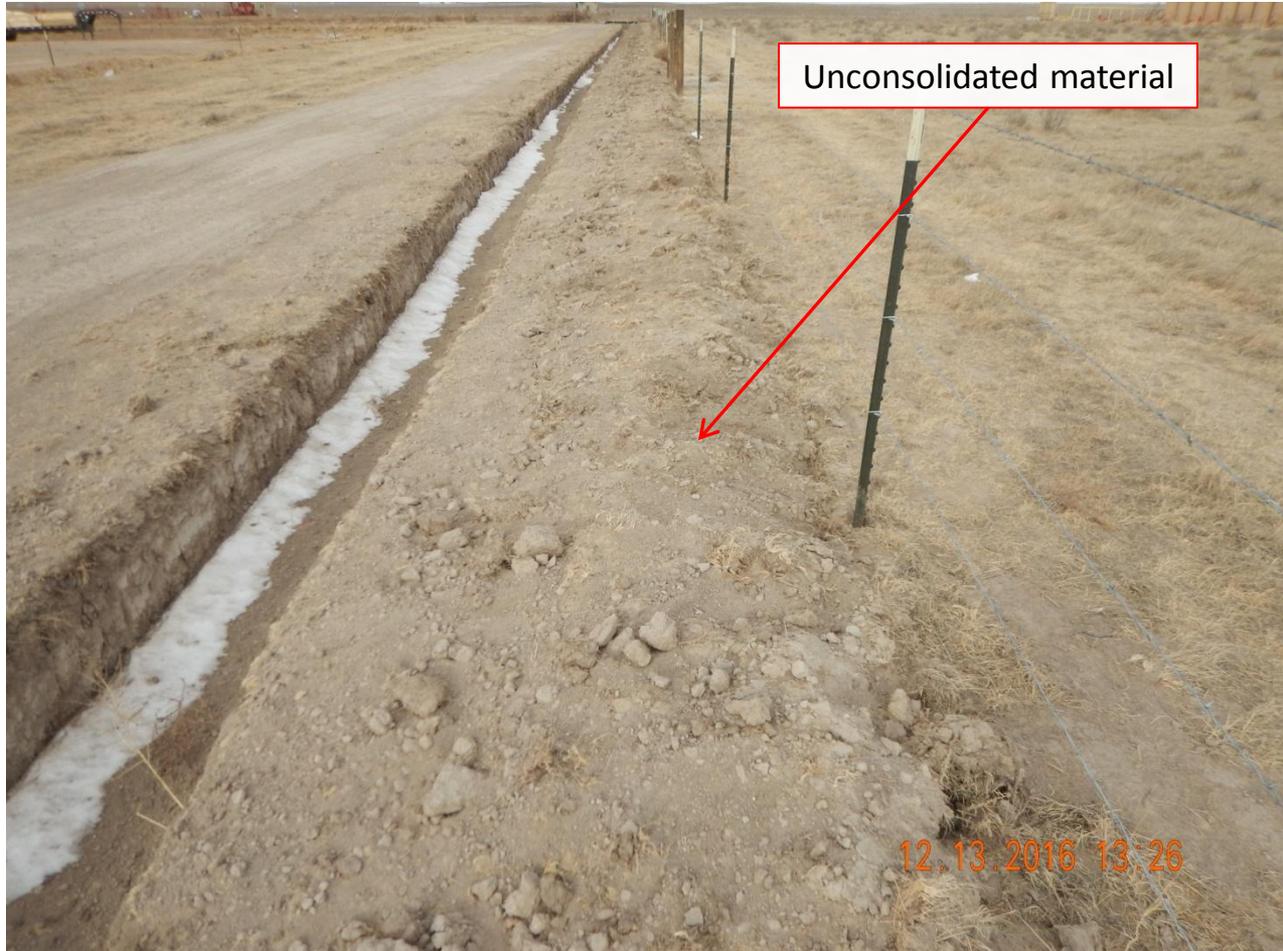
Photo 7. Photo taken from eastern location, facing North. Unconsolidated soil dug out from the trench has not been stabilized.

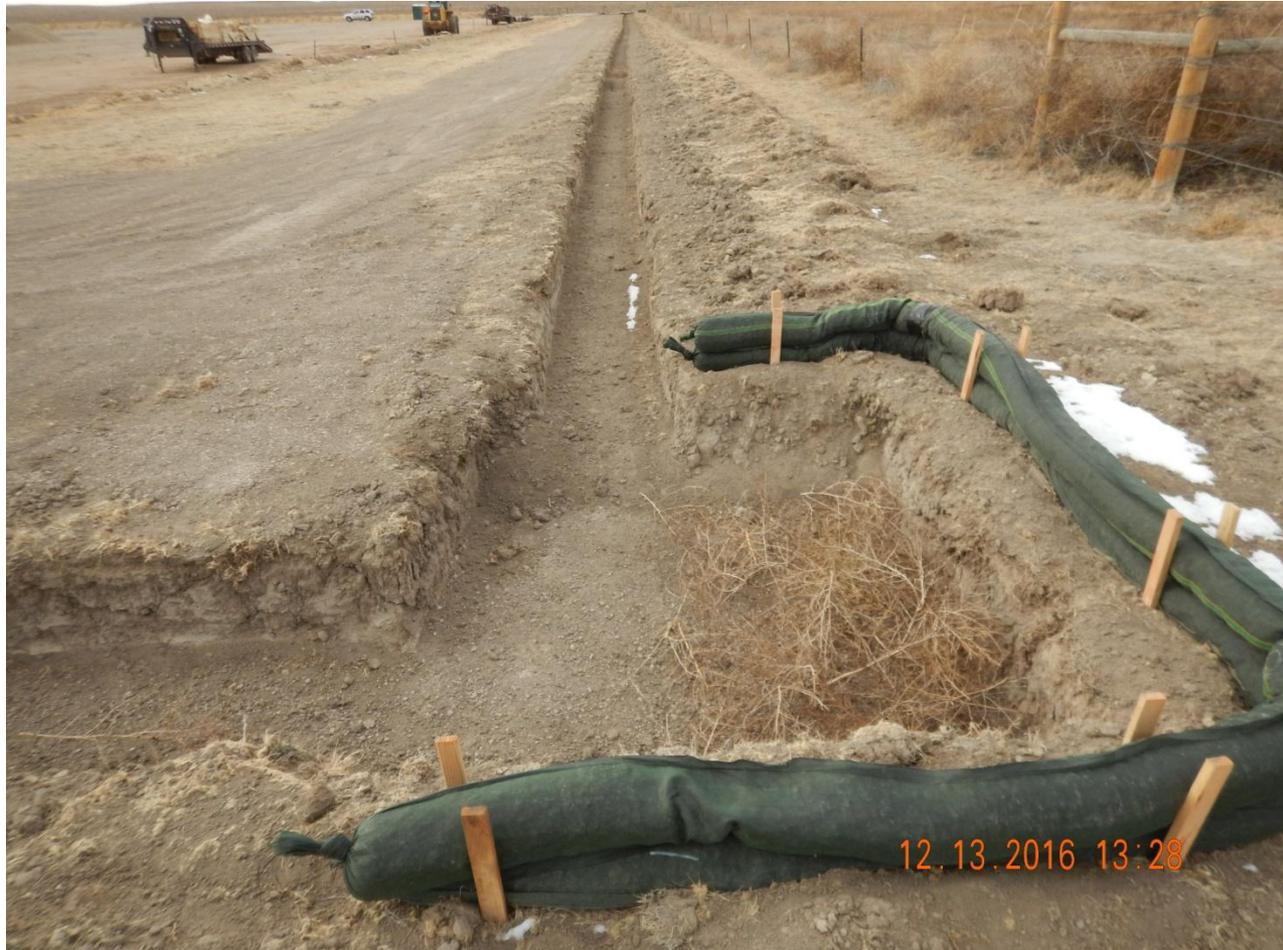
Photo 8. Photo taken from the northeast sediment trap, facing West. Sediment trap approximately 4'x3'x2' with rock socks. Trench approximately 18"x12" (width x depth) installed along the northern perimeter of location. A light application of tackifier has been applied to soil dug out from the trench. May need additional tackifier to stabilize soil.

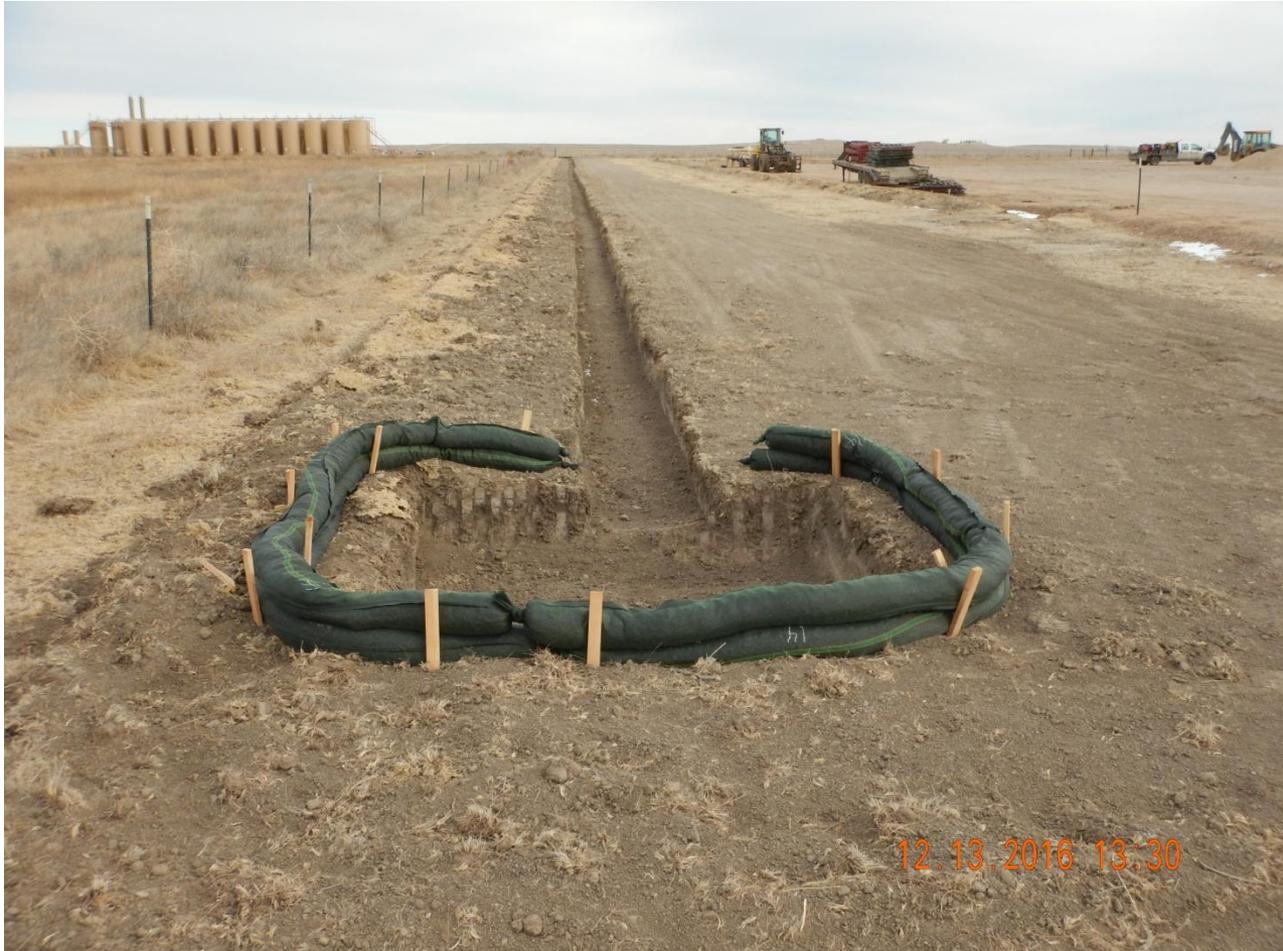
Photo 9. Photo taken from the northwest sediment trap, facing East. Sediment trap approximately 4'x3'x2' with rock socks.

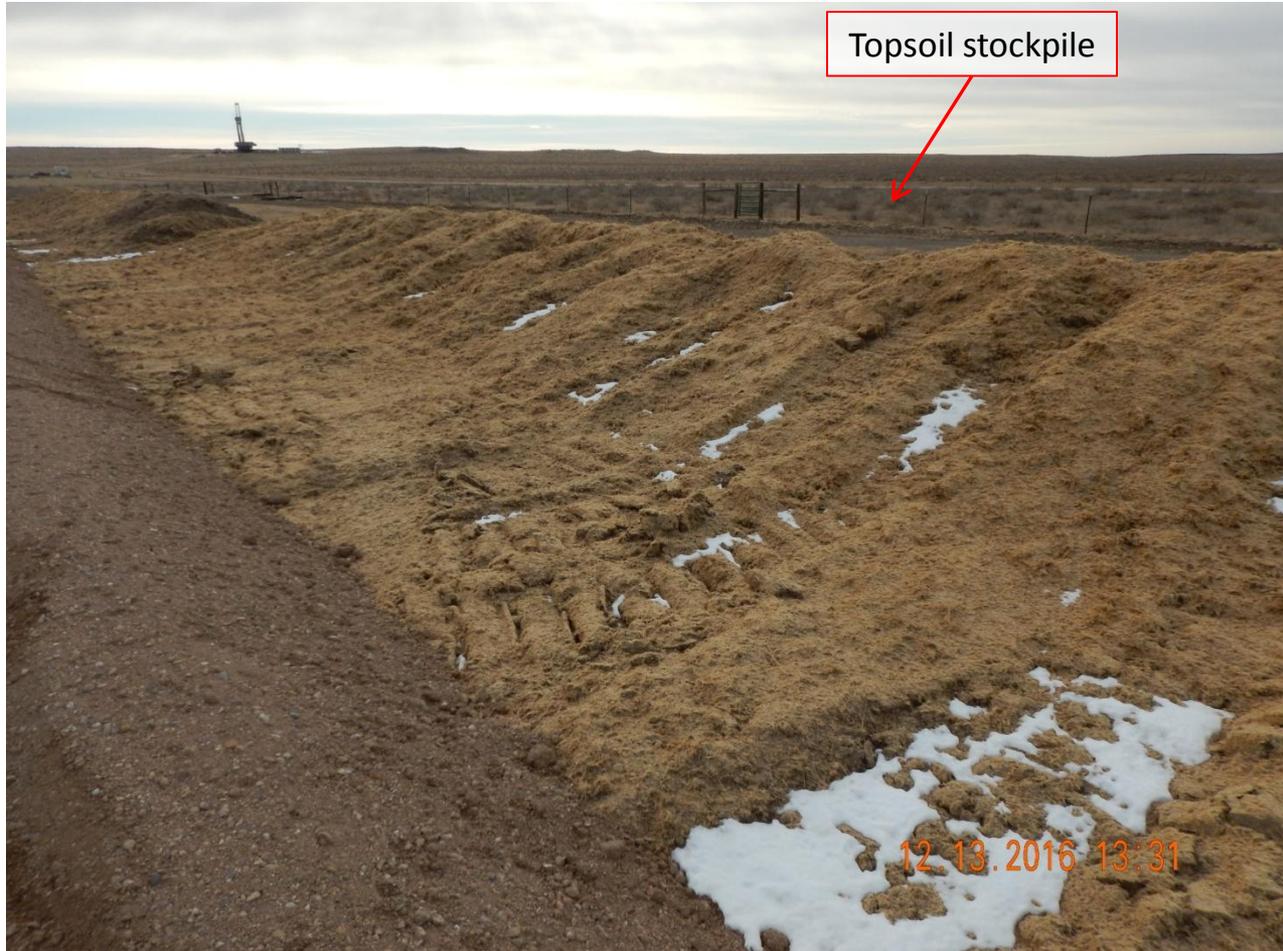
Photo 10. Photo taken from the western location, facing Southwest, along the topsoil stockpile. Tackifier applied to the topsoil stockpile. Not certain whether topsoil was seeded in addition to applying tackifier, but tackifier alone is not a long-term stabilization BMP to protect topsoil from erosion and weed establishment.

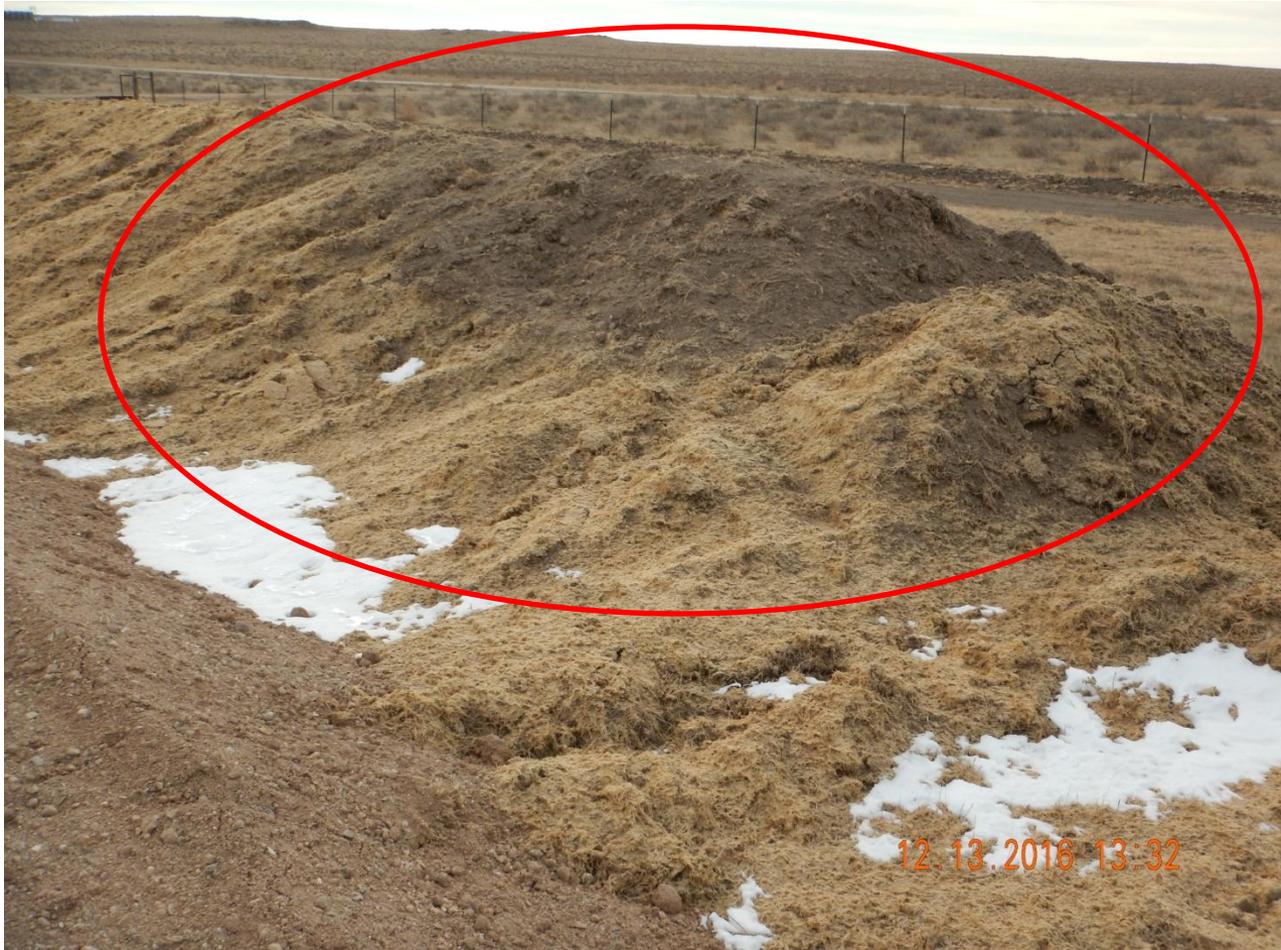
Photo 11. Photo taken from the western location, facing West, along the topsoil stockpile. May need to stabilize topsoil stockpile with additional tackifier in areas.
