Google Earth aerial photo taken 9/7/2013 of the LC24-13 location highlighted in green. Total area of 7.2 acres was mapped using a Trimble Juno 3B handheld device. Tank battery servicing the well location highlighted in red.

Stormwater Inspection

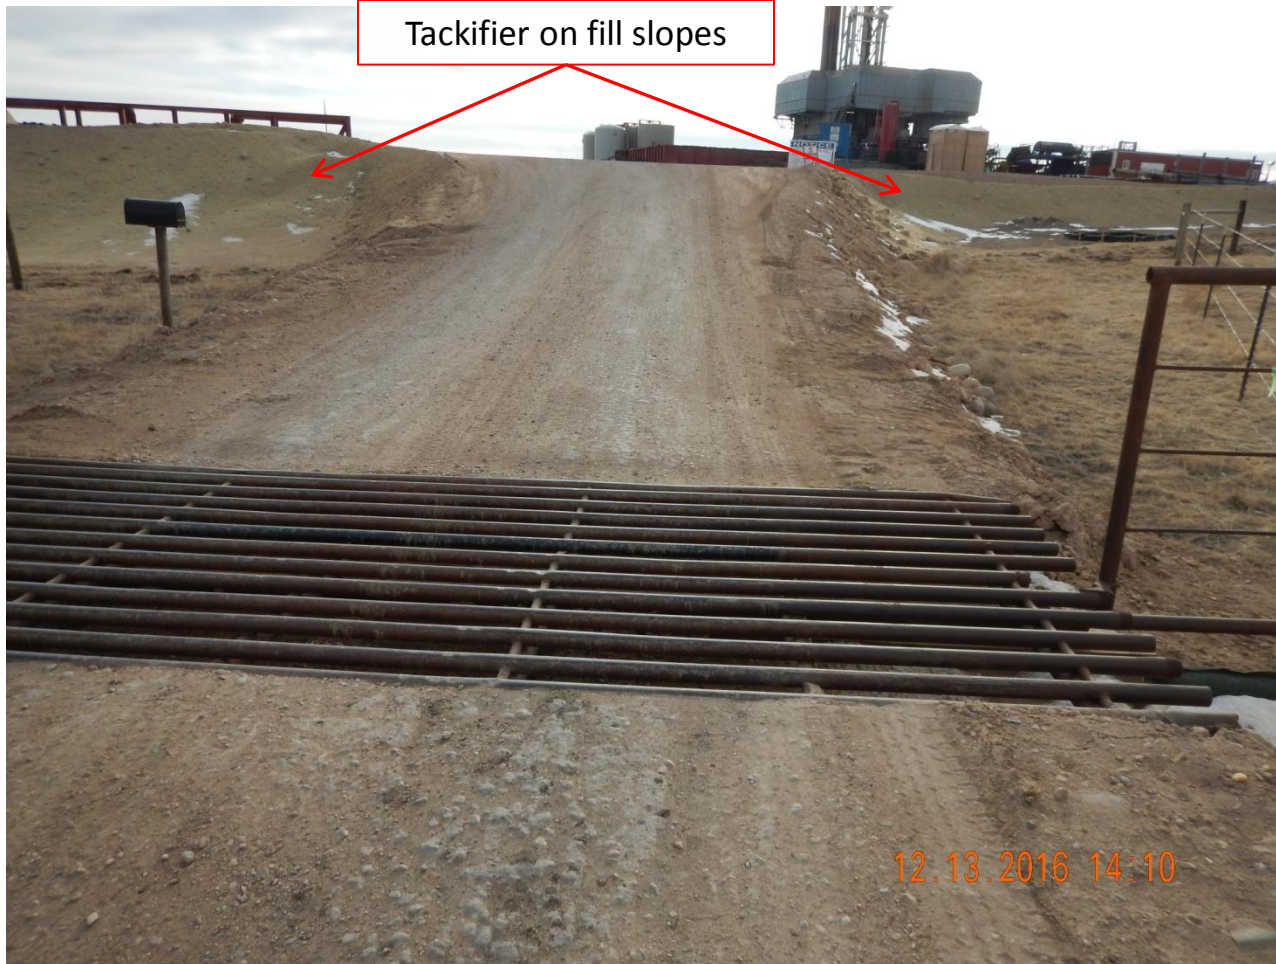
Photo 1. Photo taken from the entrance of the location, facing South. Tackifier has been applied to all fill and cut slopes on location.

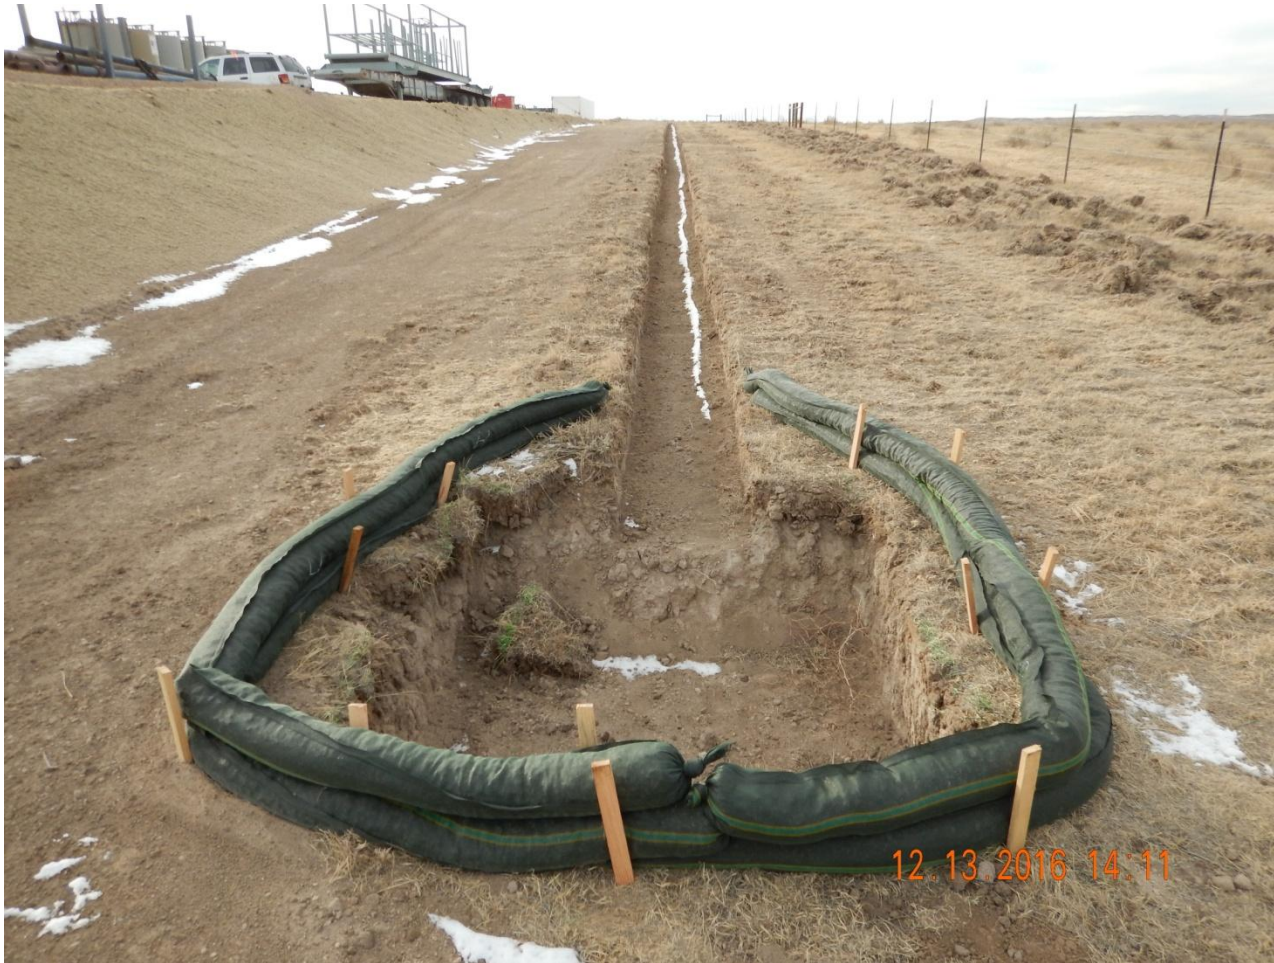
Photo 2. Photo taken from the northeast sediment trap, facing West. Sediment trap approximately 4'x4'x3' with rock socks. Trench approximately 18"x12" (width xdepth) installed along the northern perimeter of location.

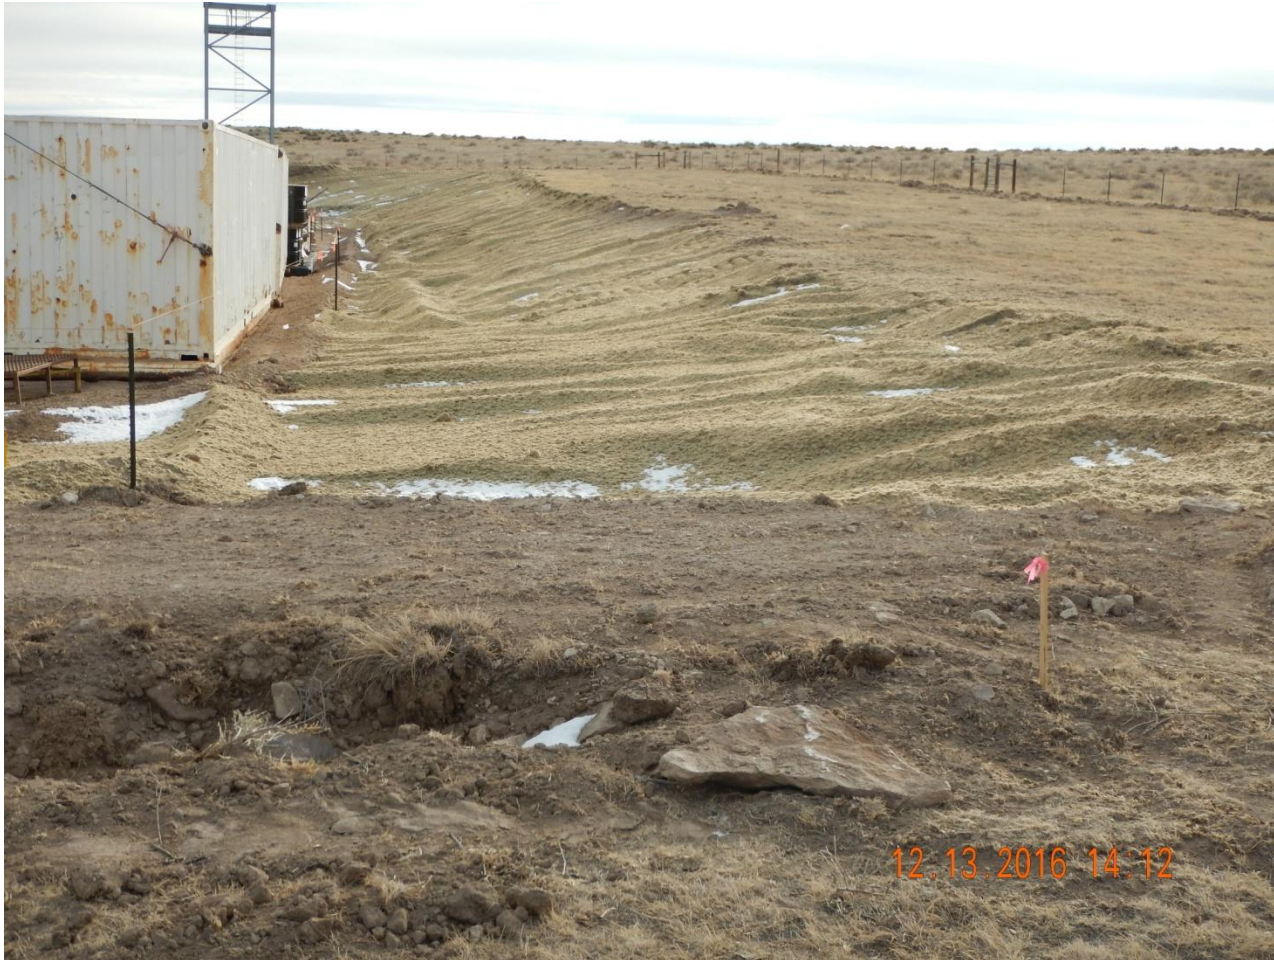
Photo 3. Photo taken from the northwest location, facing South. Cut slope has been stabilized with a tackifier.

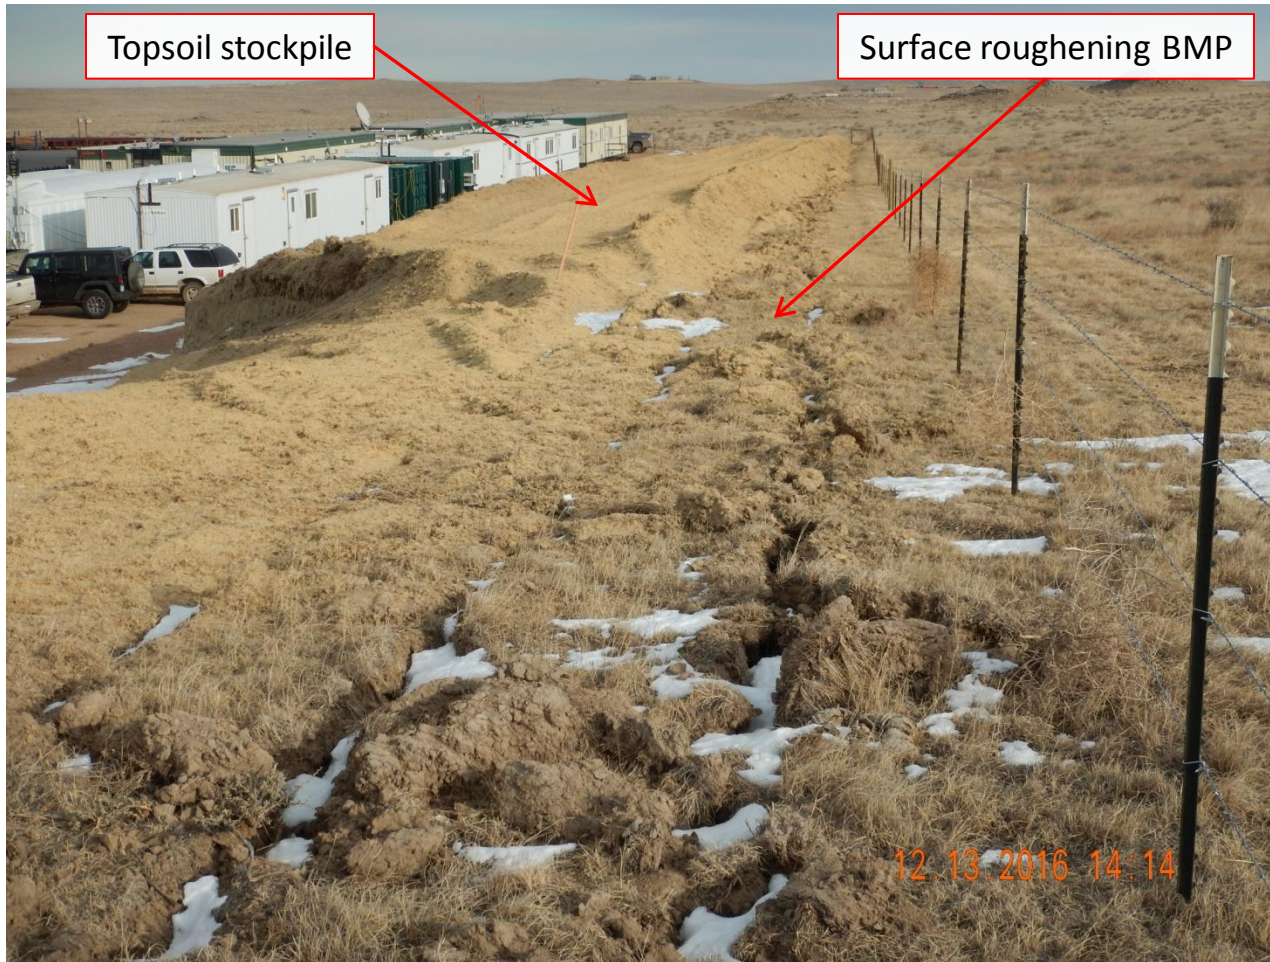
Photo 4. Photo taken from the southwest location, facing East. Surface roughening BMP installed along southern location with 3'-4' vegetated area between perimeter boundary.

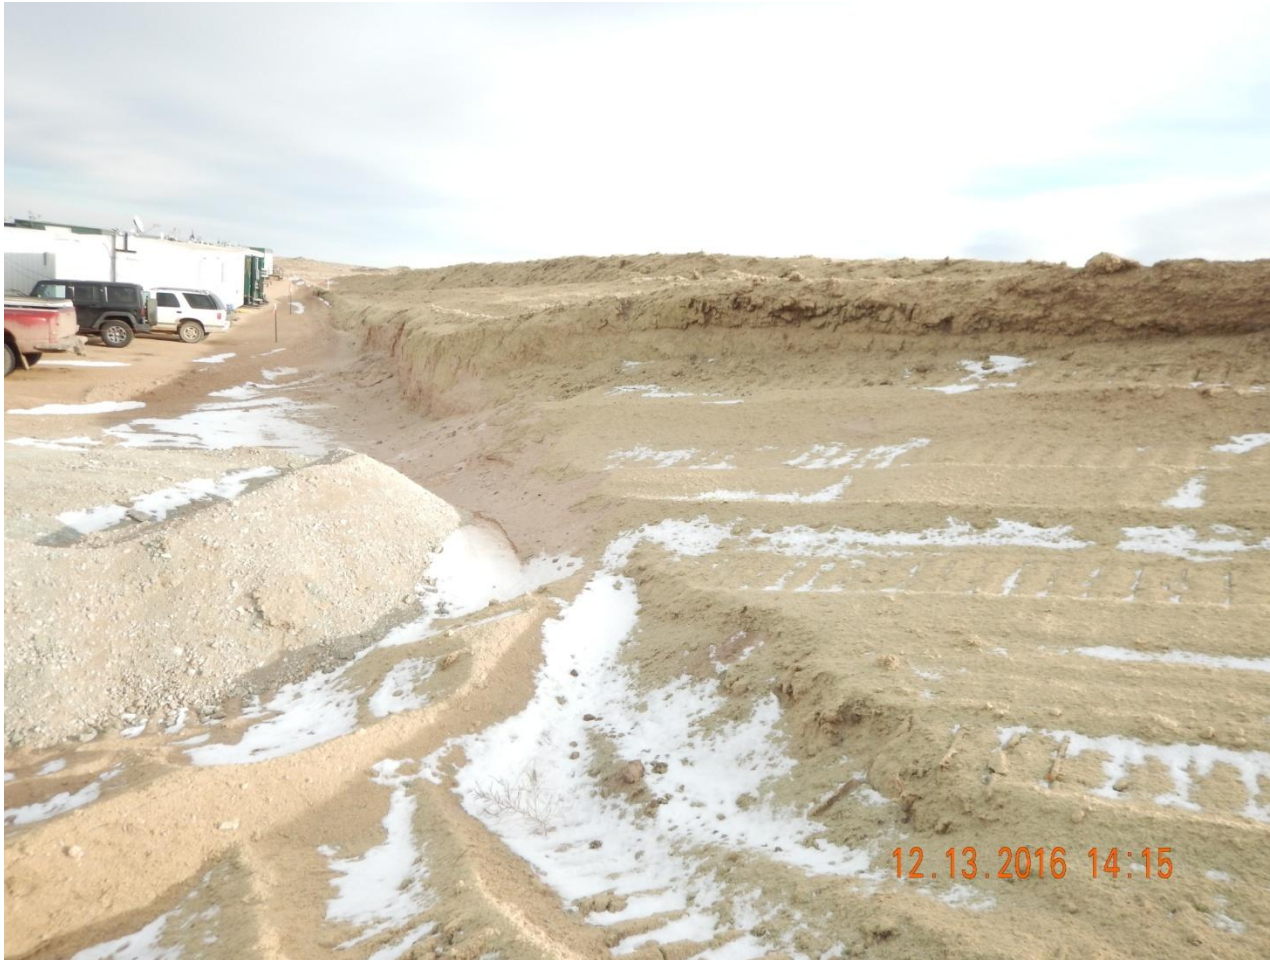
Photo 5. Photo taken from the southwest pad location, facing East. Tackifier has been applied to cut slope but may need additional stabilization with a 1:1 slope.

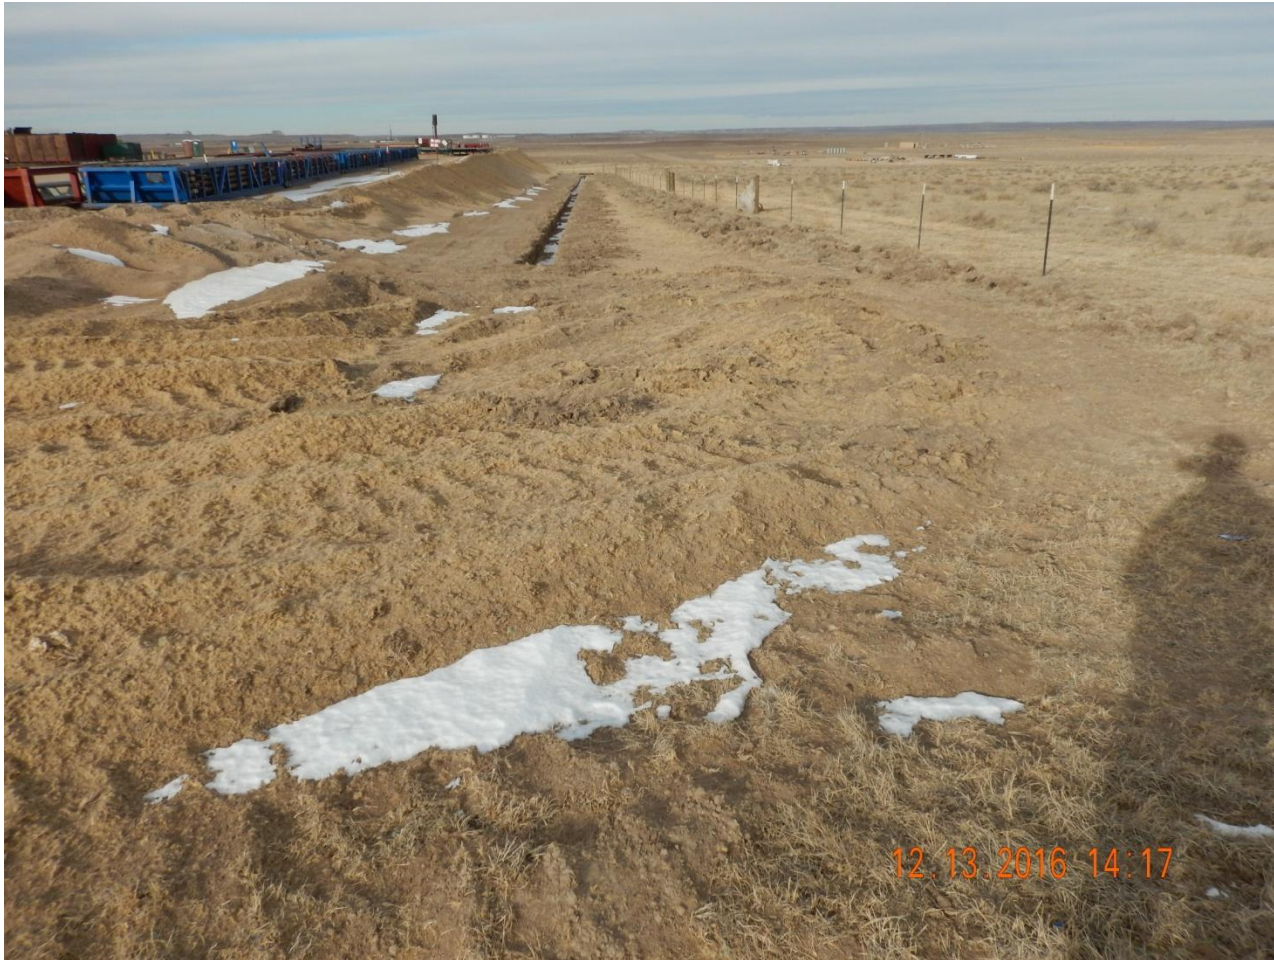
Photo 6. Photo taken from the southeast location, facing North. Surface roughening BMP installed along eastern location with 5'-6' vegetated area between trench and BMP. A sediment trap approximately 4'x4'x3' with filter socks is installed at the northeast corner of location.

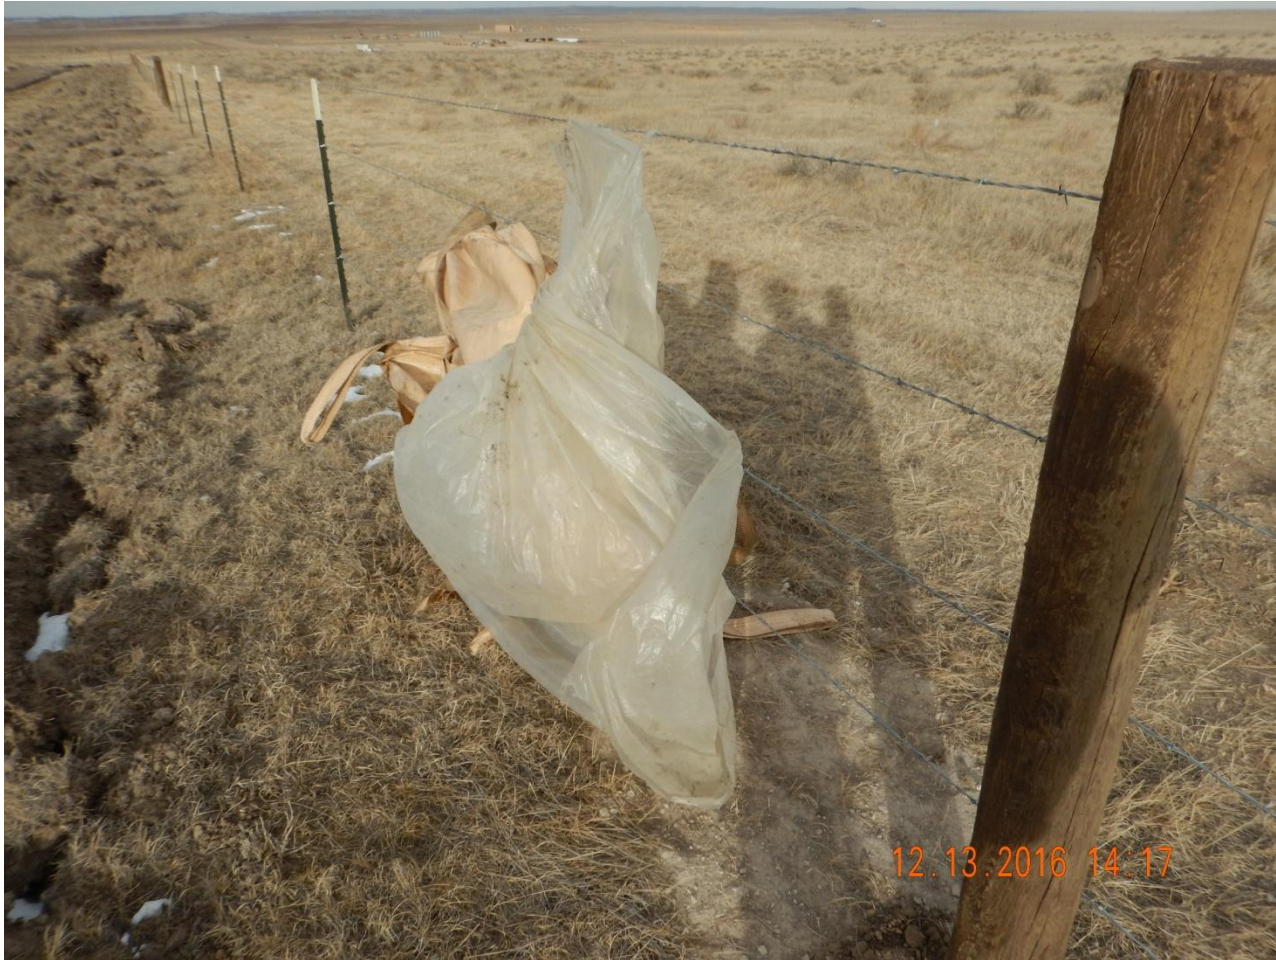
Photo 7. Photo taken from eastern location. Remove waste material from fence line per Rule 603.f.

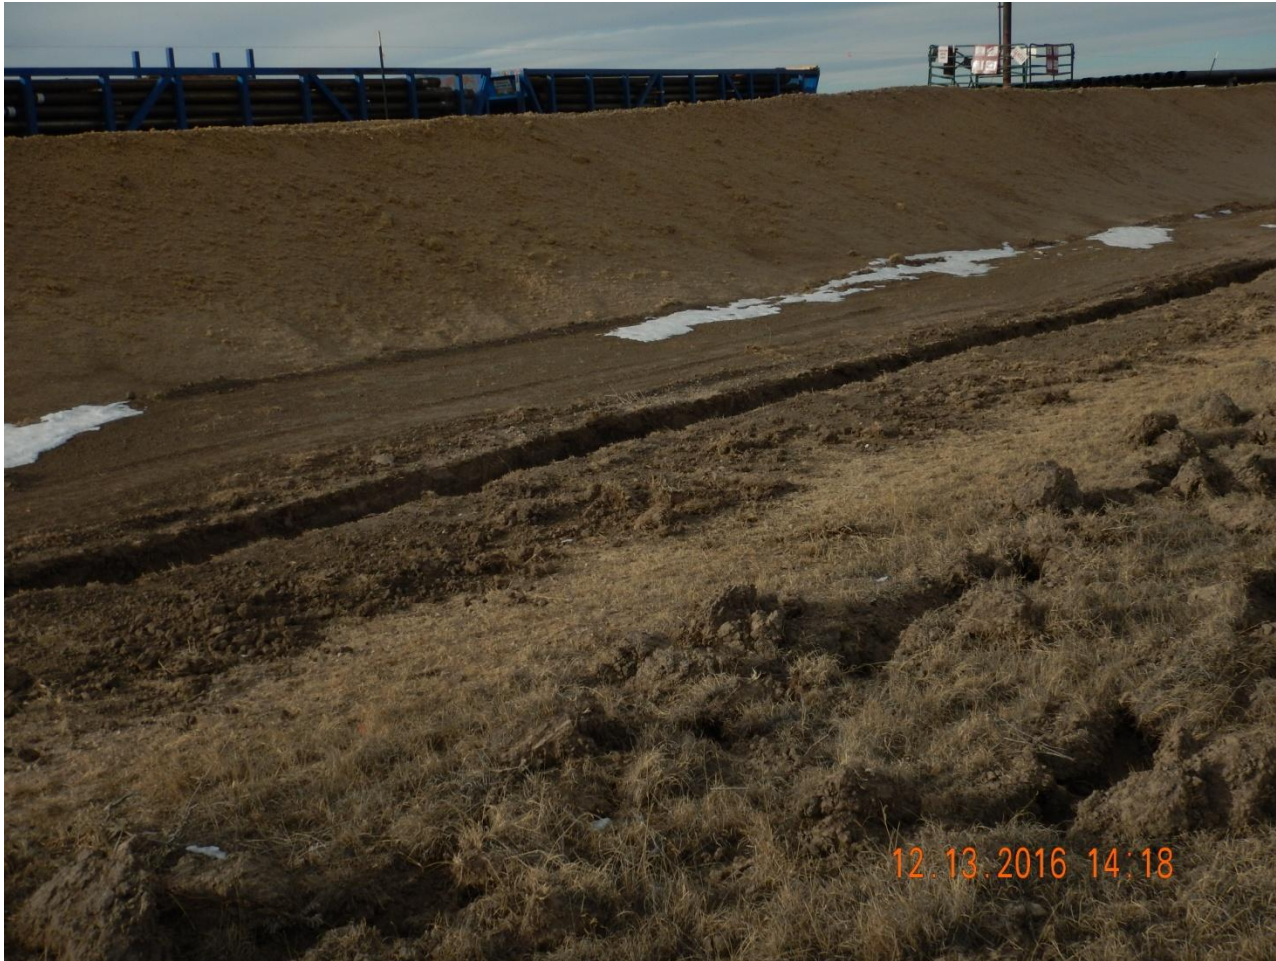
Photo 8. Photo taken from eastern location, facing West. Tackifier applied to fill slope.
