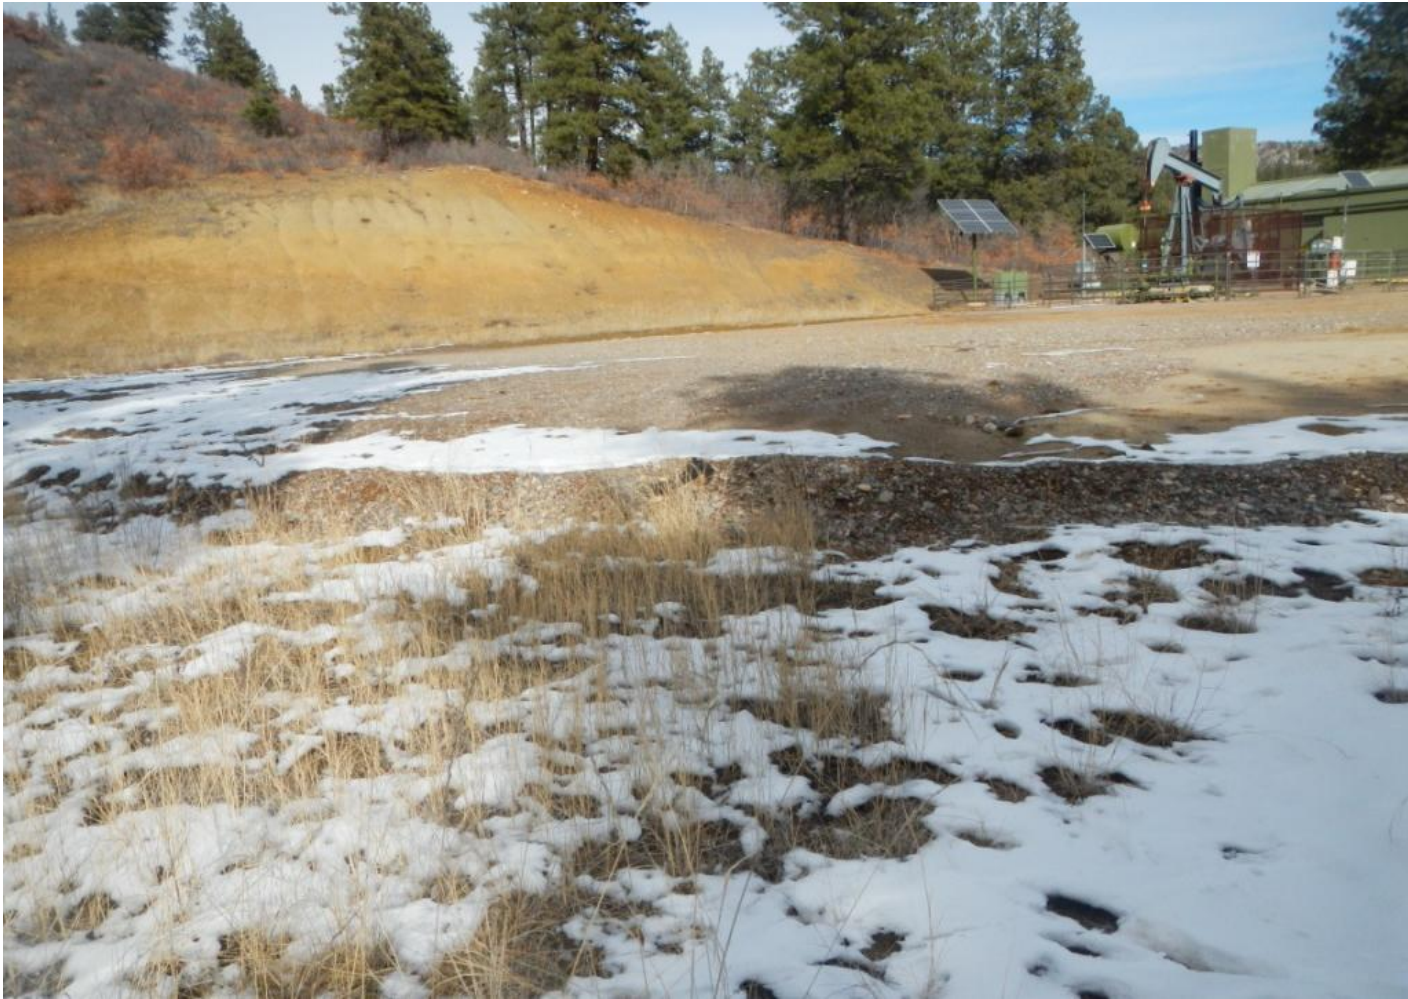
Photo 1. View of the project area from the southwestern corner facing center.

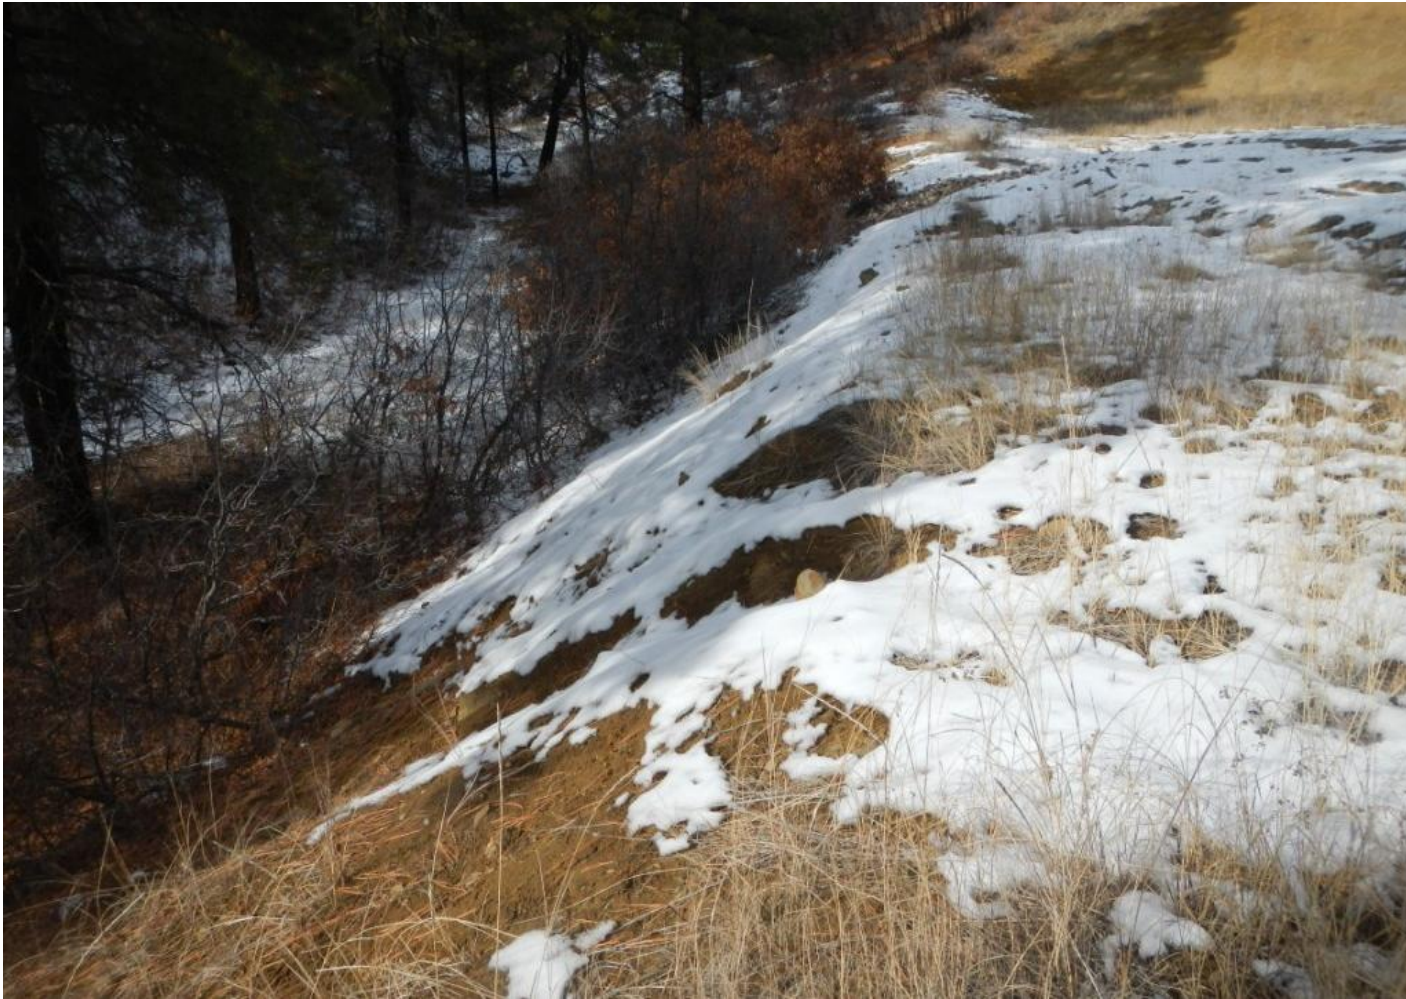
Photo 2. View of the western portion of the project area from the southwestern corner facing northward. Interim reclamation areas are revegetating with desirable species such as smooth brome (*Bromus inermis*), western wheatgrass (*Pascopyrum smithii*), and dropseed (*Sporobolus* sp.).

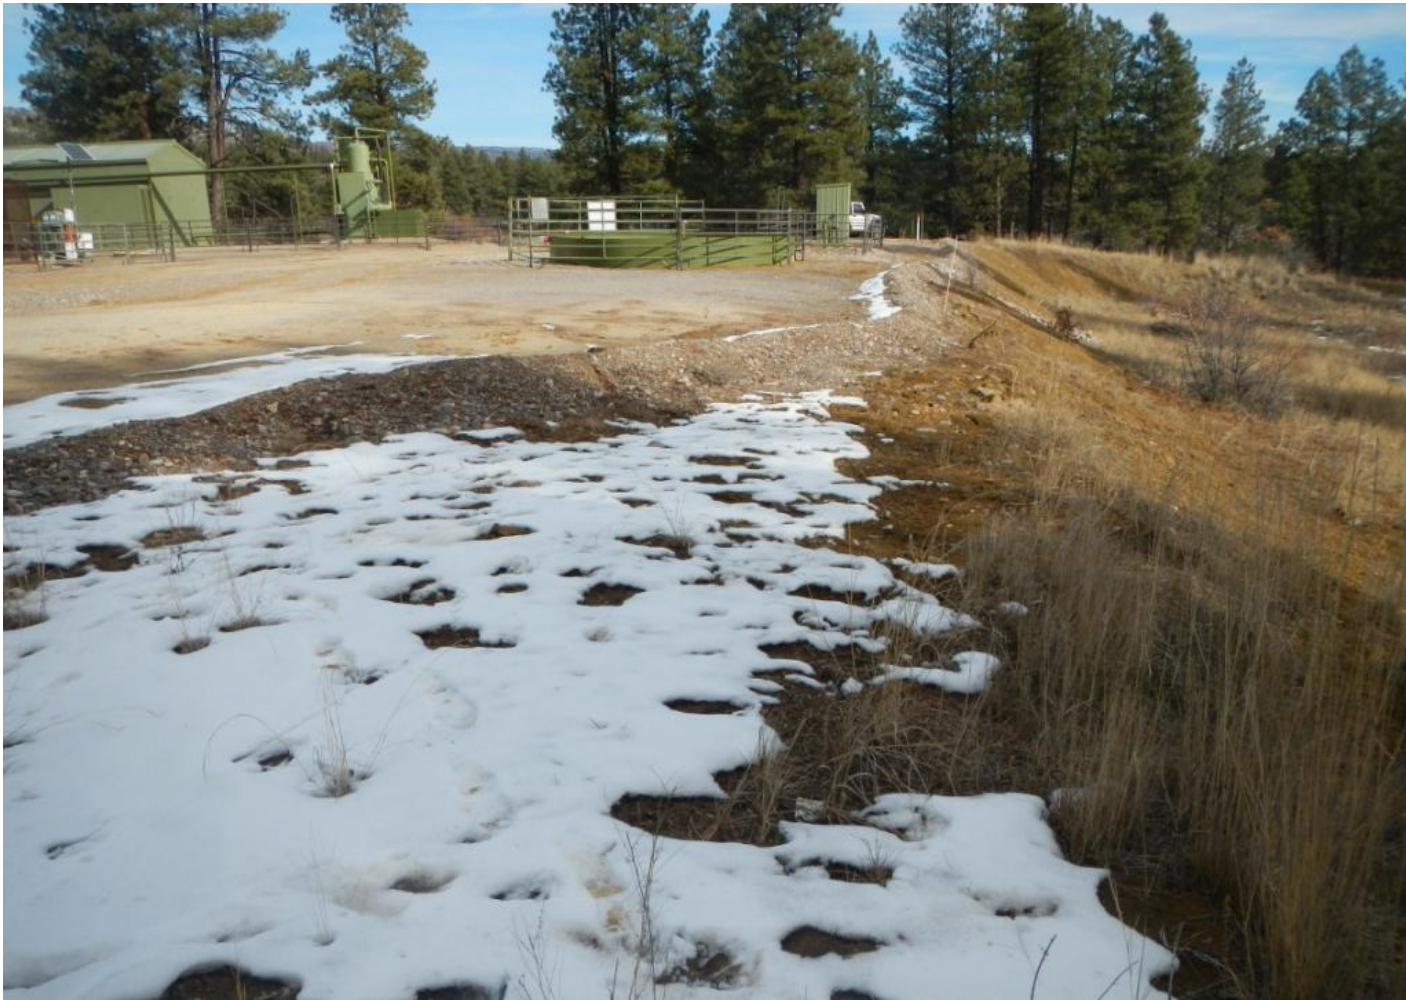
Photo 3. View of the southern portion of the project area from the southwestern corner facing eastward.

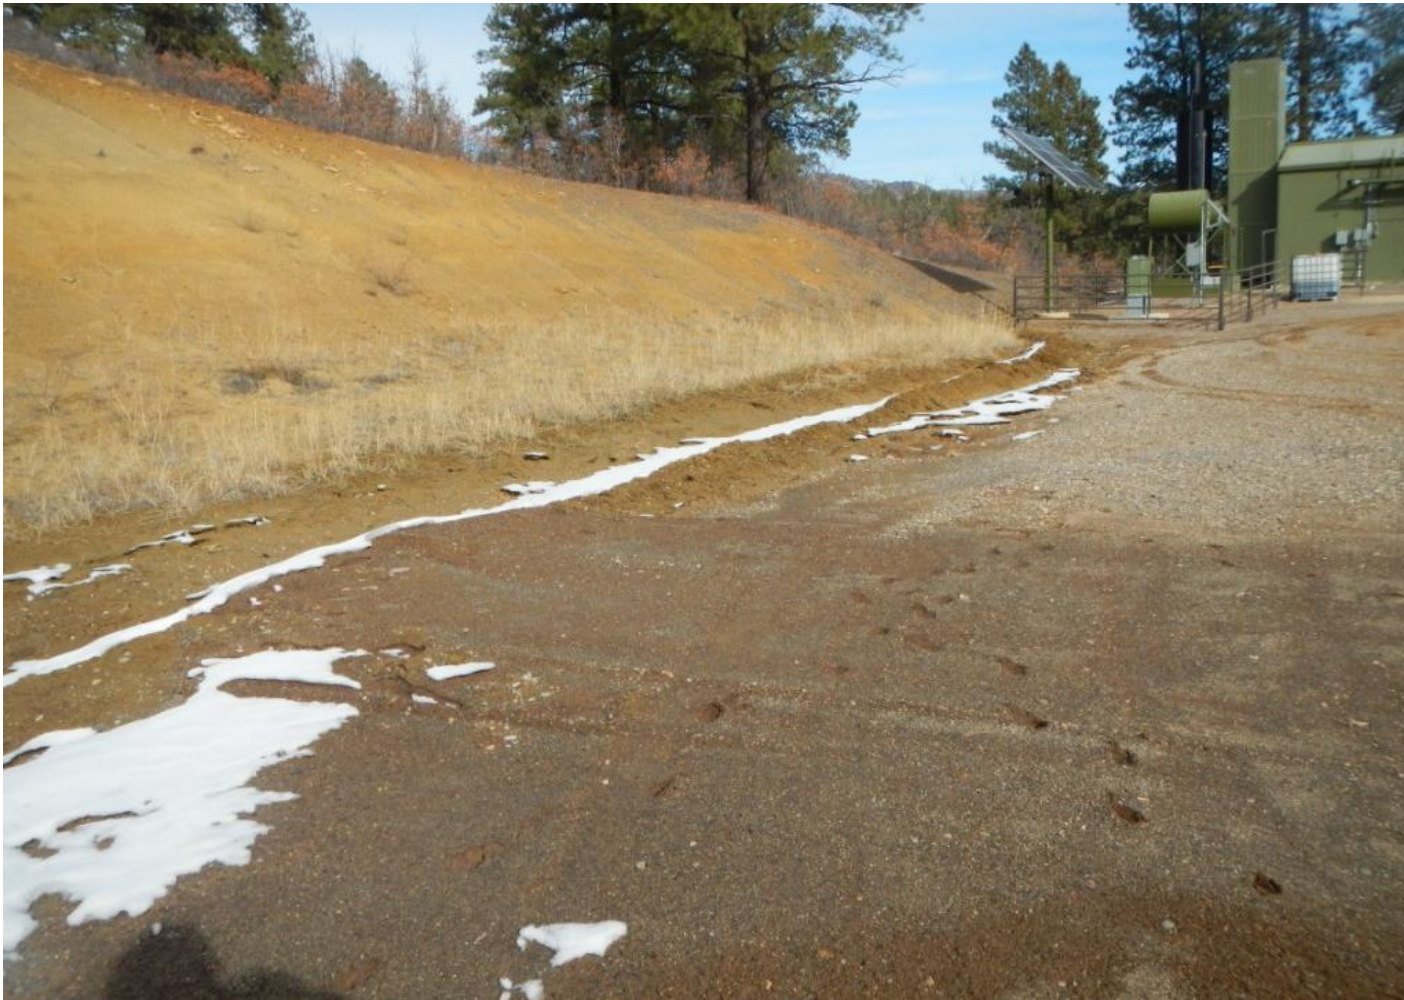
Photo 4. View of the northern portion of the project area from the northwestern edge facing eastward. Vegetation on northern cut-slope is sparse and may need to be revegetated if it is not increasing.

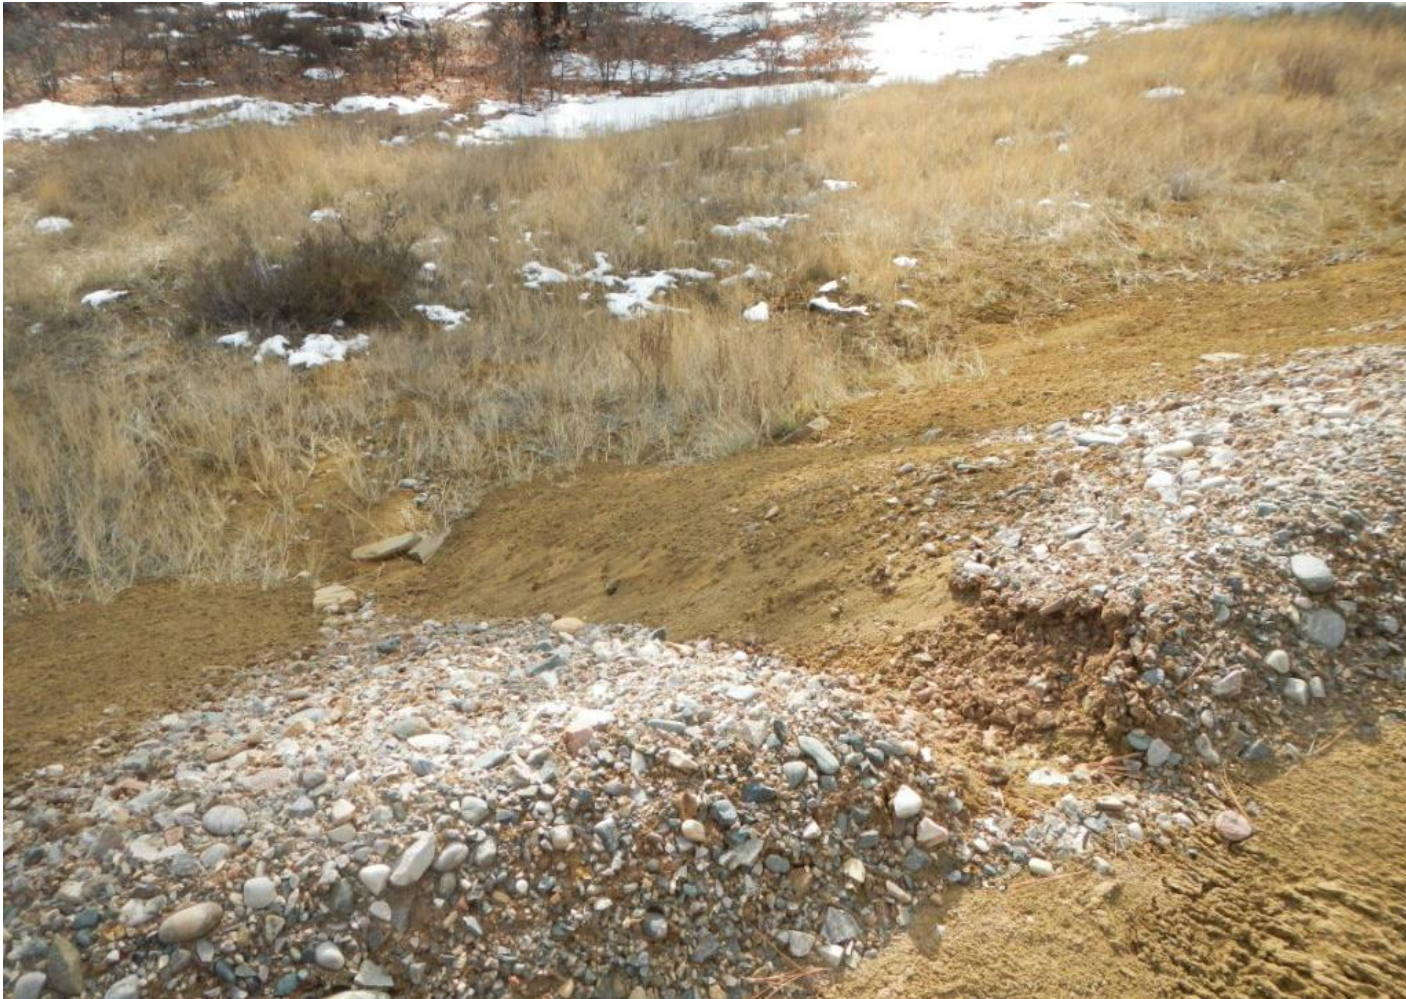
Photo 5. View of area in the southern portion of the project area where it appears stormwater has breached the stormwater berm. This area needs to be stabilized.

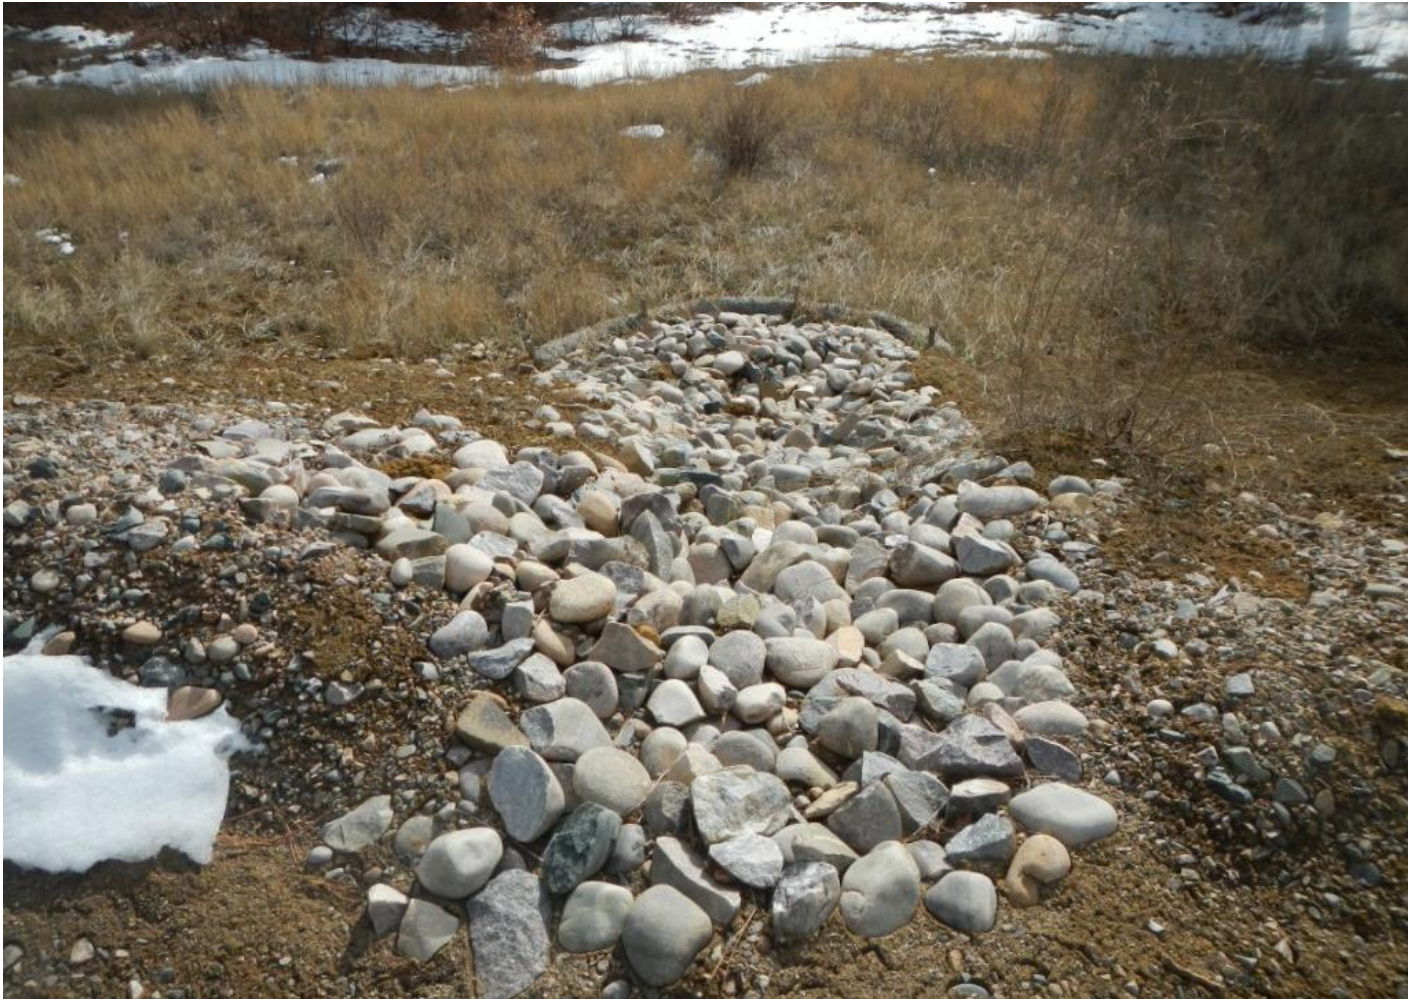
Photo 6. View of cobble run-down in the southwestern portion of the project area.
