Construction and Stormwater Inspection

COLORADO
Oil & Gas Conservation
Commission
Department of Natural Resources

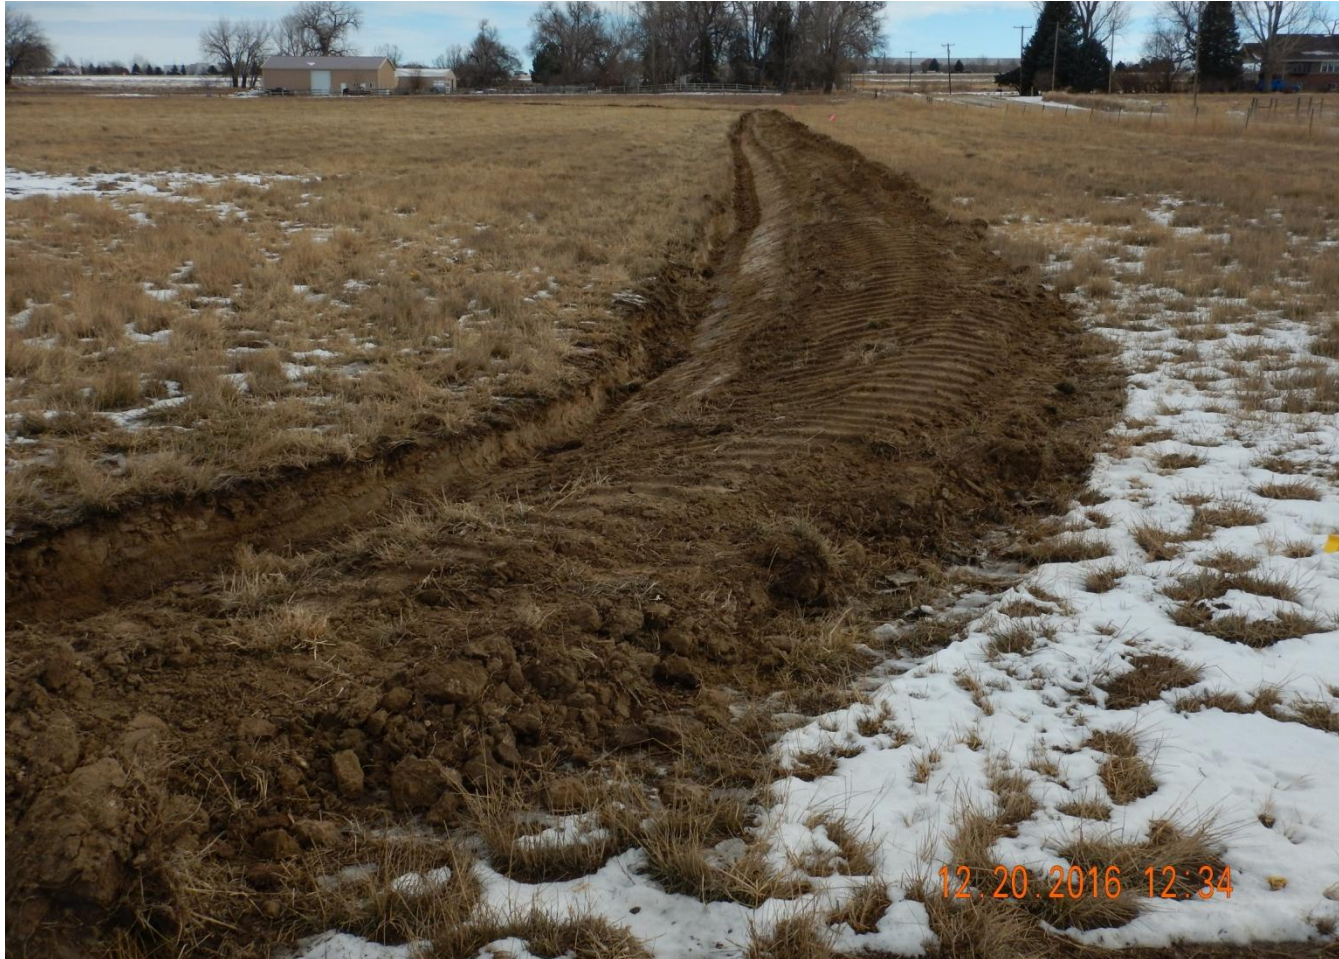
Photo 1. Photo taken from the southwest location, facing East. Ditch and berm installed around the entire perimeter of the location. Operator said berms will be further compacted.

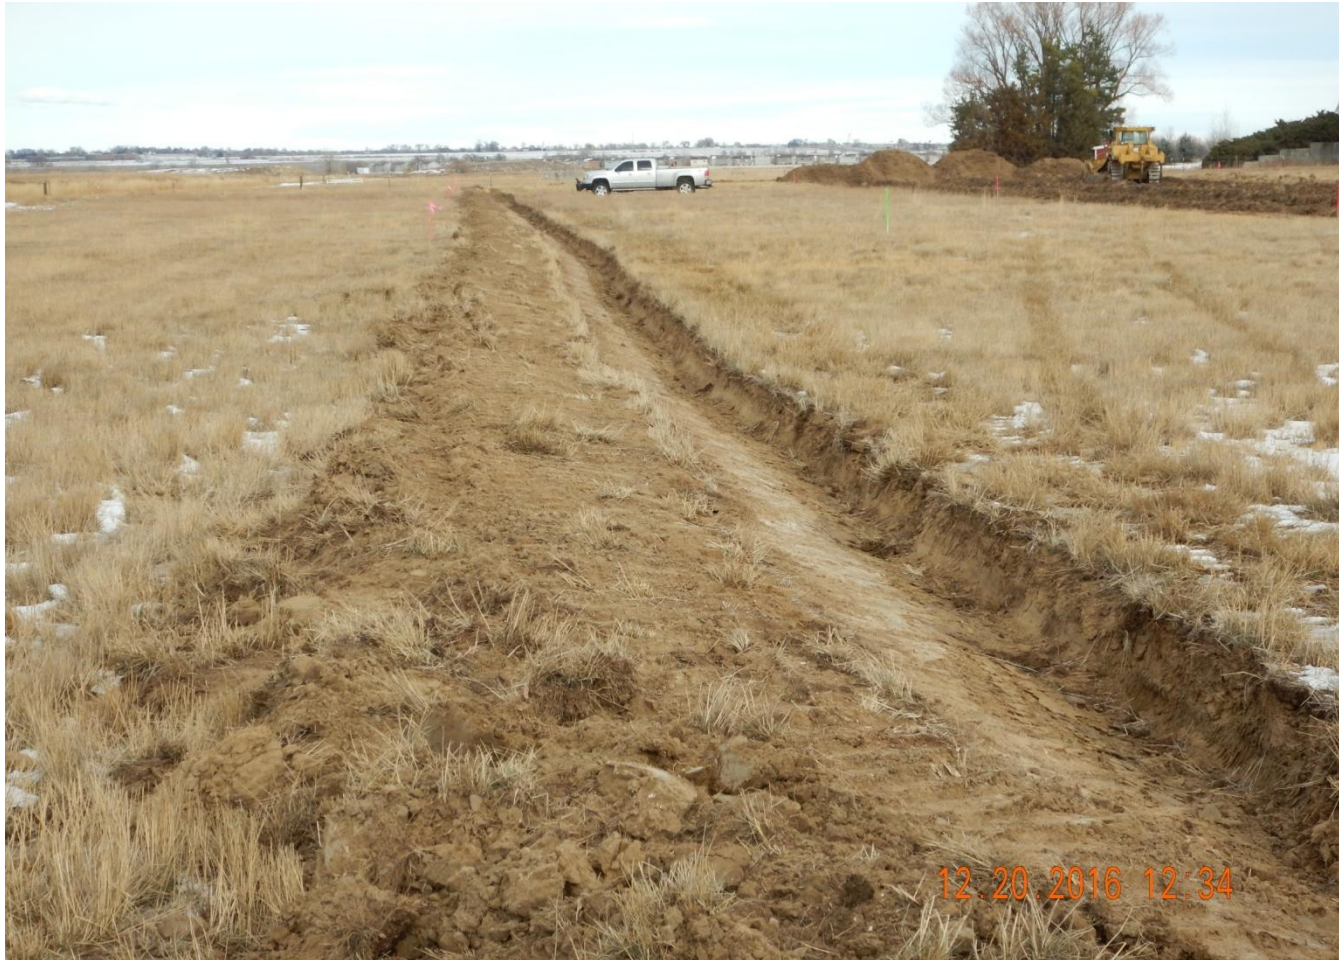
Photo 2. Photo taken from the southwest location, facing North. Ditch and berm installed around the entire perimeter of the location. Operator said berms will be further compacted.

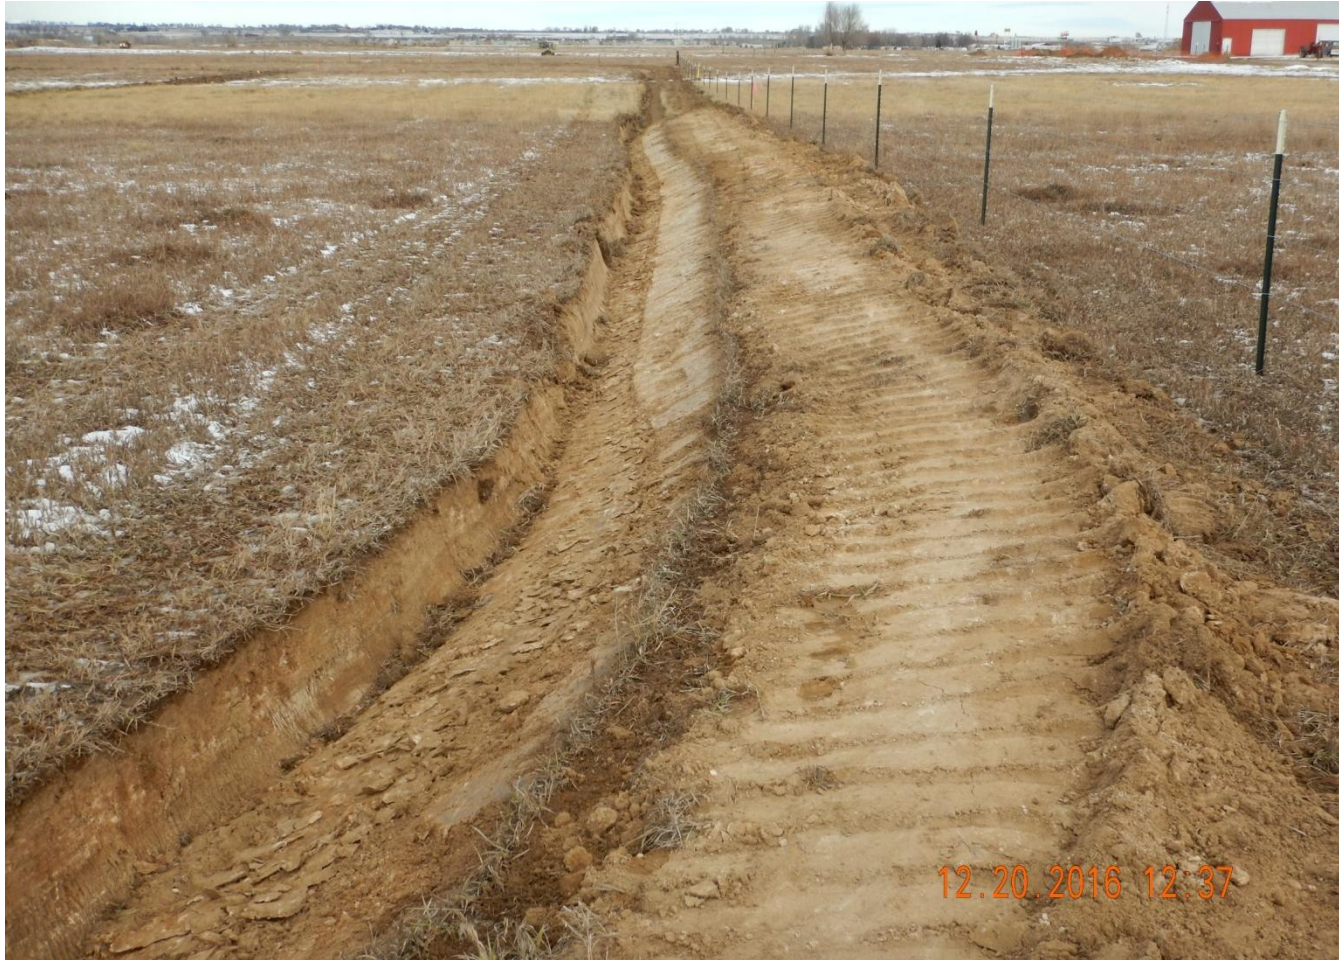
Photo 3. Photo taken from the southeast location, facing North. Ditch and berm installed around the entire perimeter of the location. Operator said berms will be further compacted.

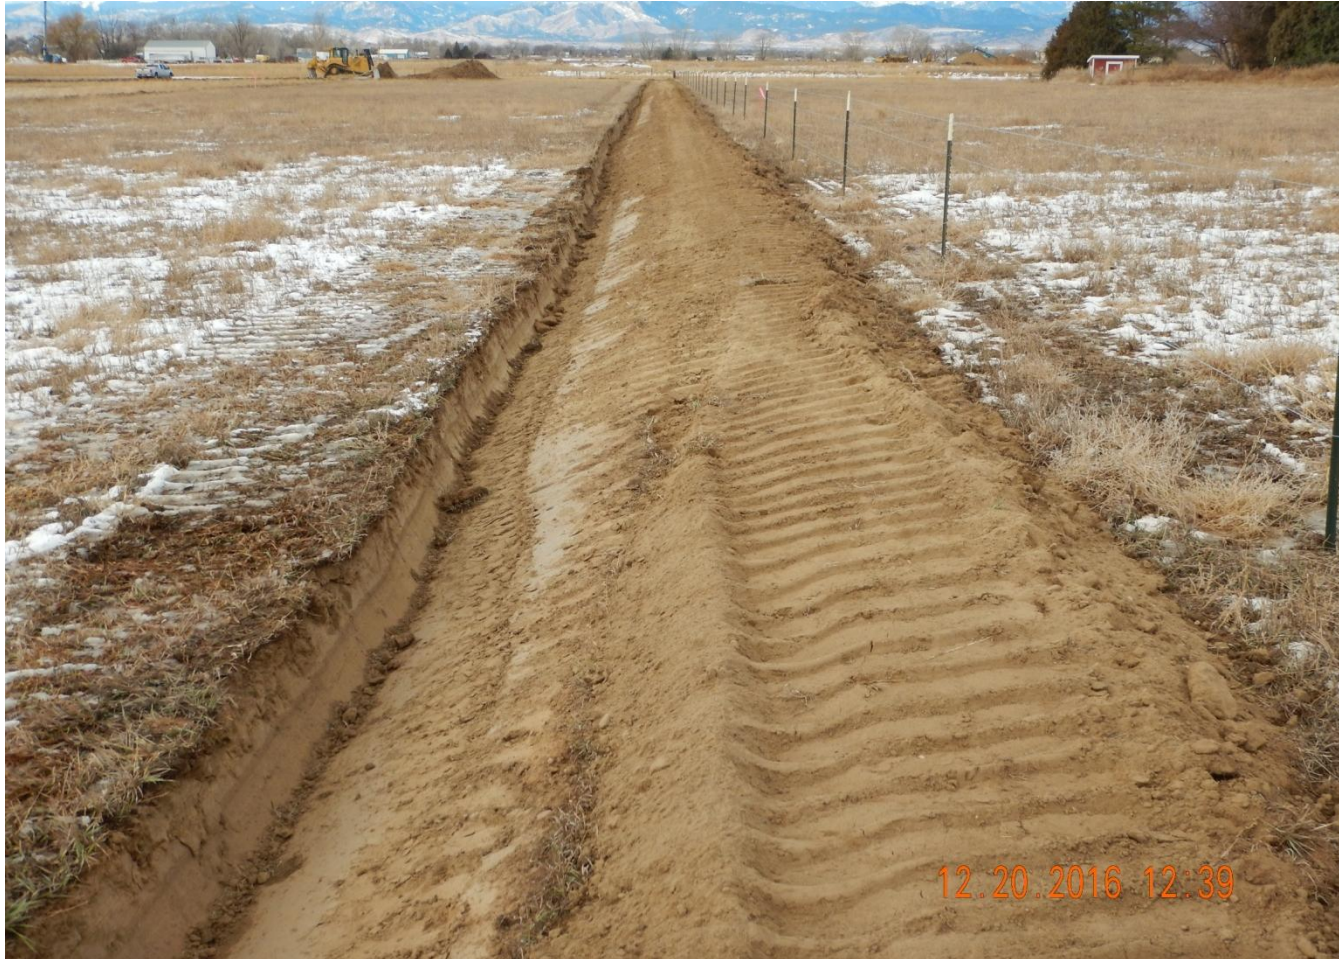
Photo 4. Photo taken from the northeast location, facing West. Ditch and berm installed around the entire perimeter of the location. Operator said berms will be further compacted.

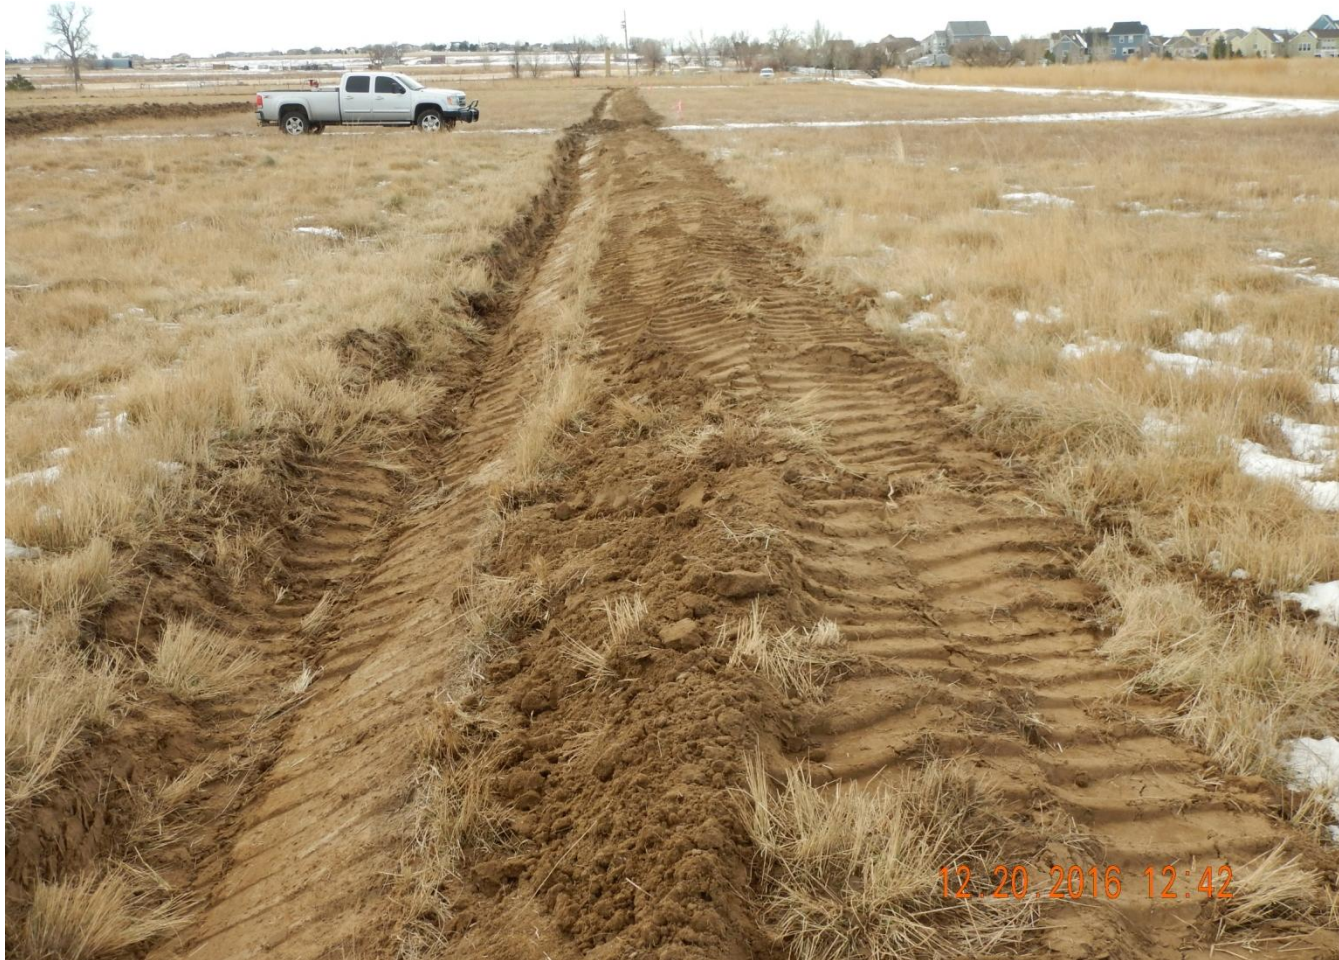
Photo 5. Photo taken from the northwest location, facing South. Ditch and berm installed around the entire perimeter of the location. Operator said berms will be further compacted.

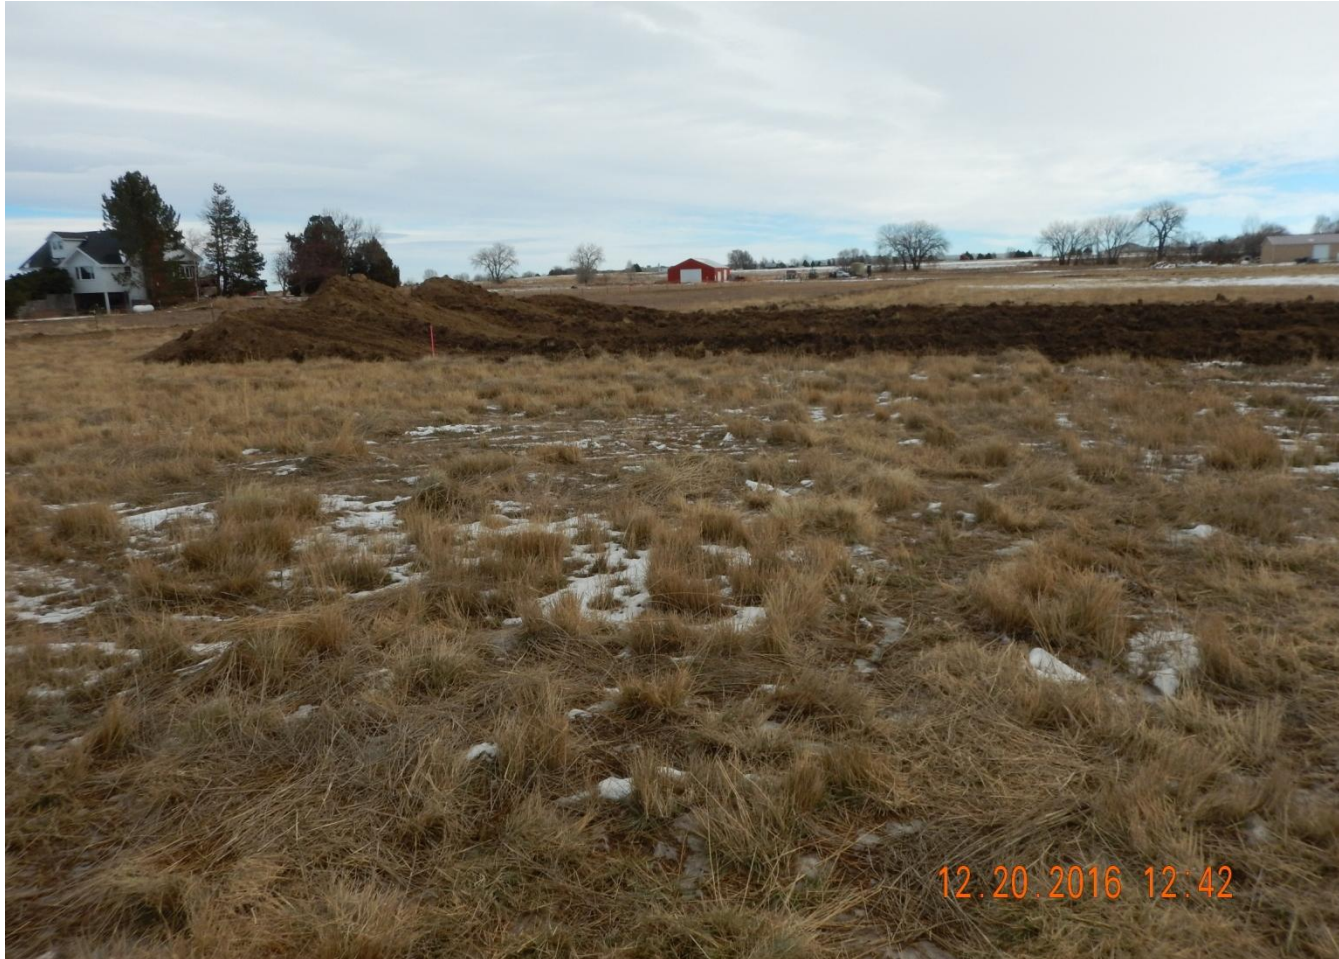
Photo 6. Photo taken from the western location, facing East towards the topsoil stockpile. Topsoil salvage IN-PROCESS.
