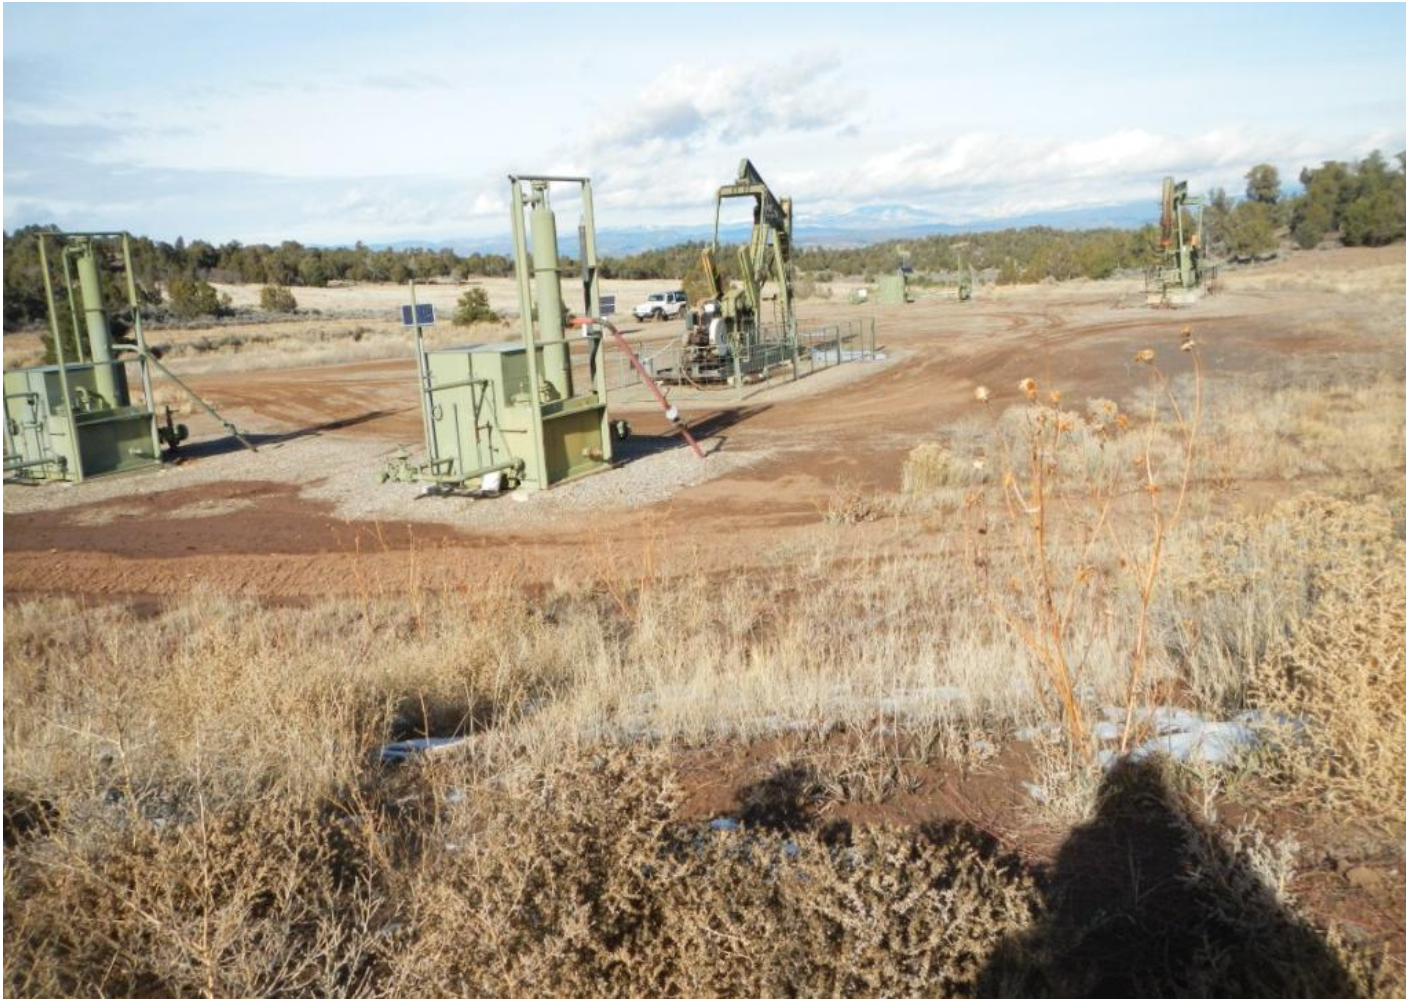
Photo 1. View of the project area from the southern corner facing center.

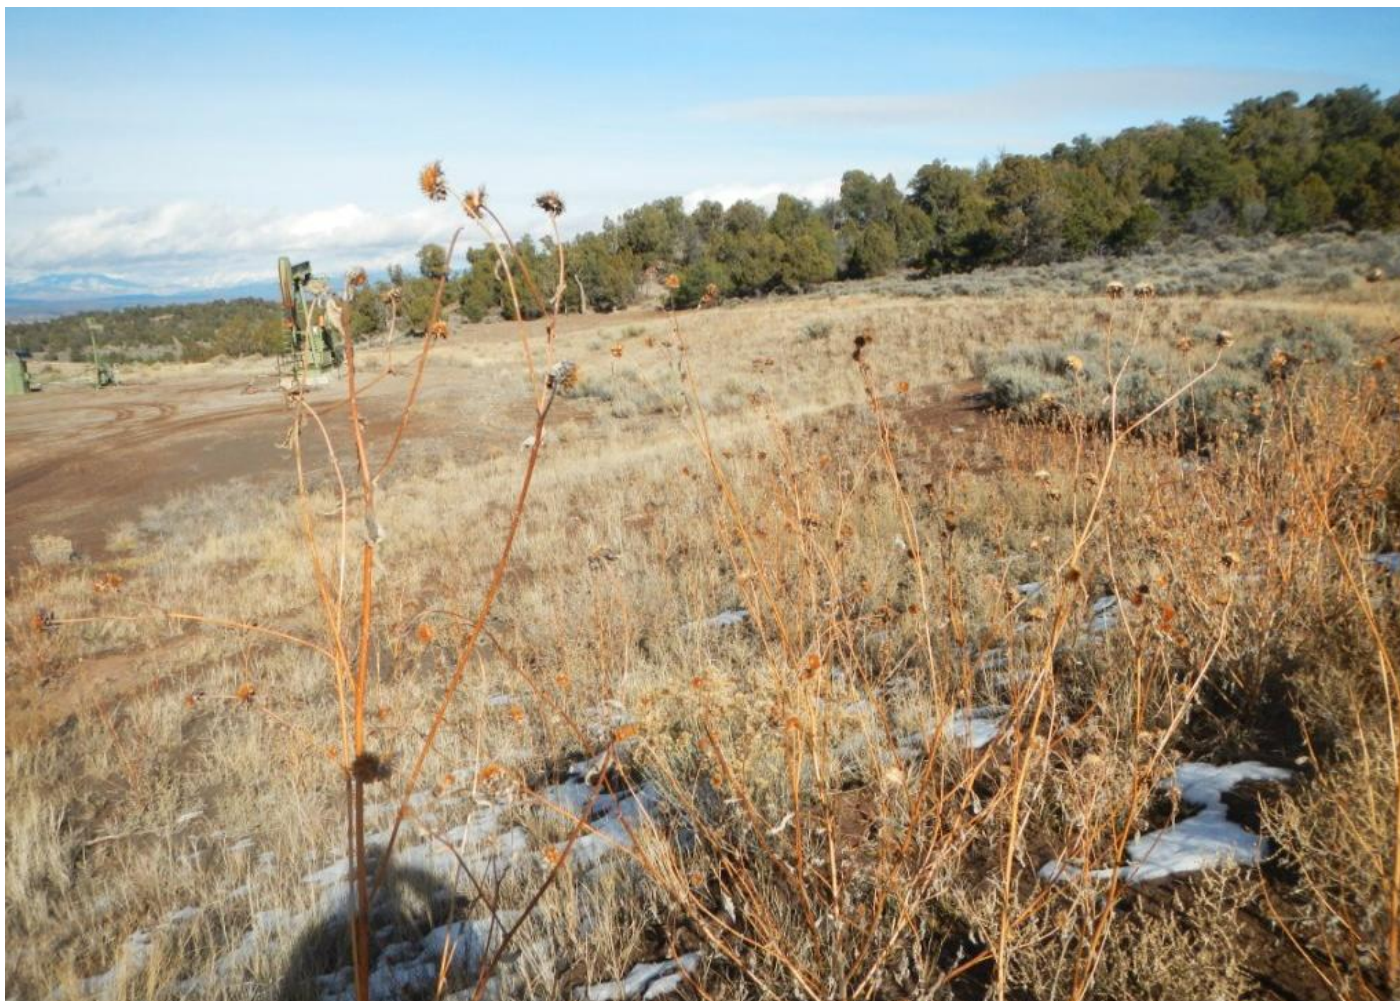
Photo 2. View of the project area from the southeastern portion of the project area facing northeastward.

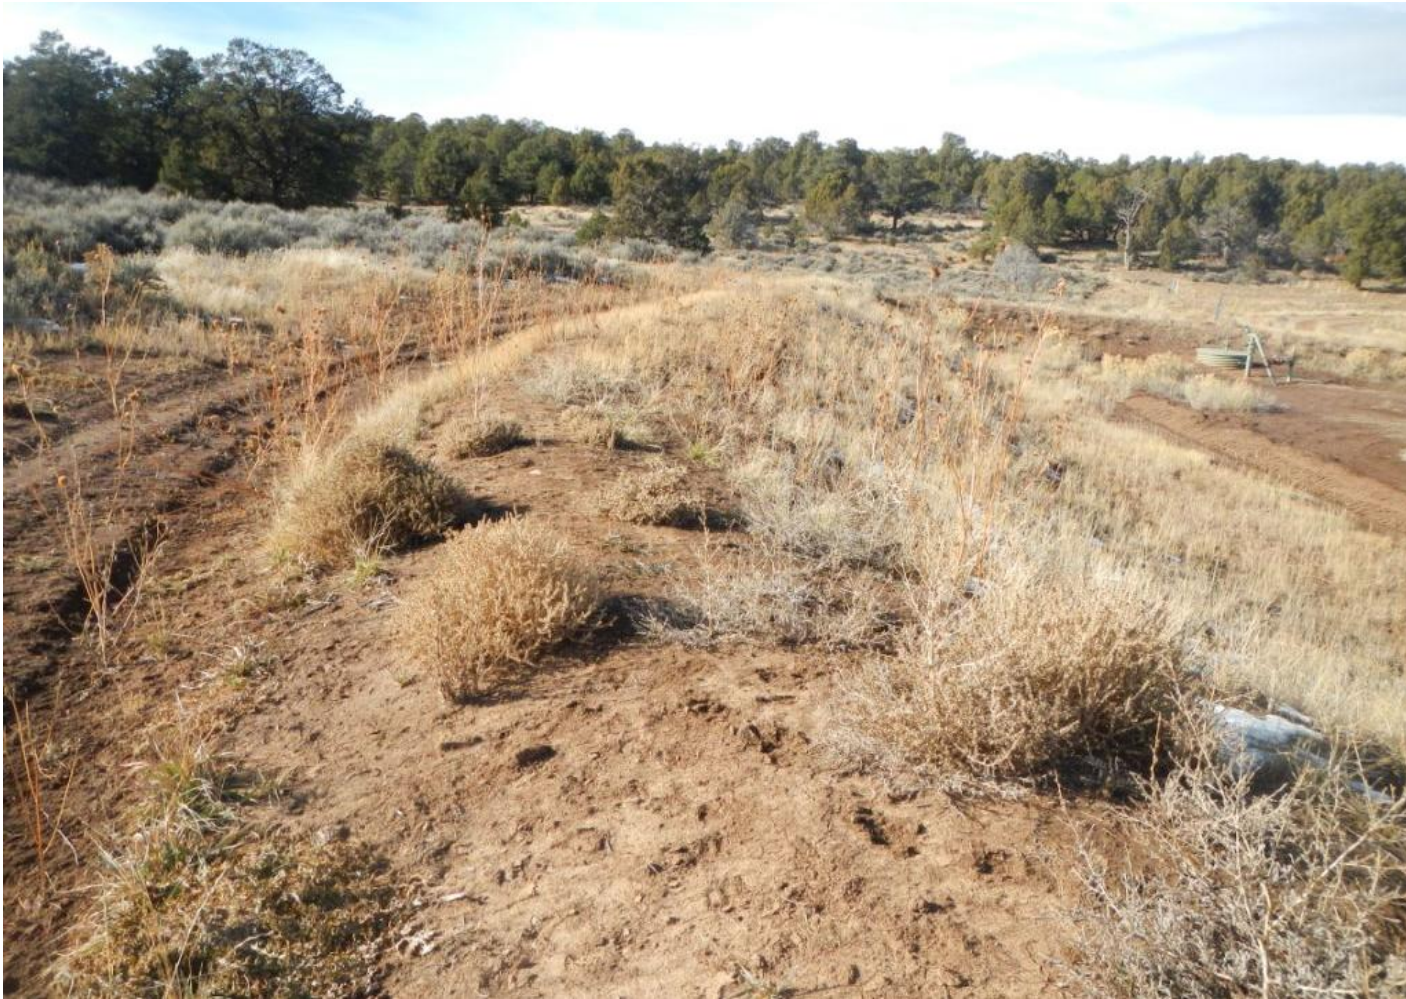
Photo 3. View of the southern portion of the project area from the southern corner facing westward.

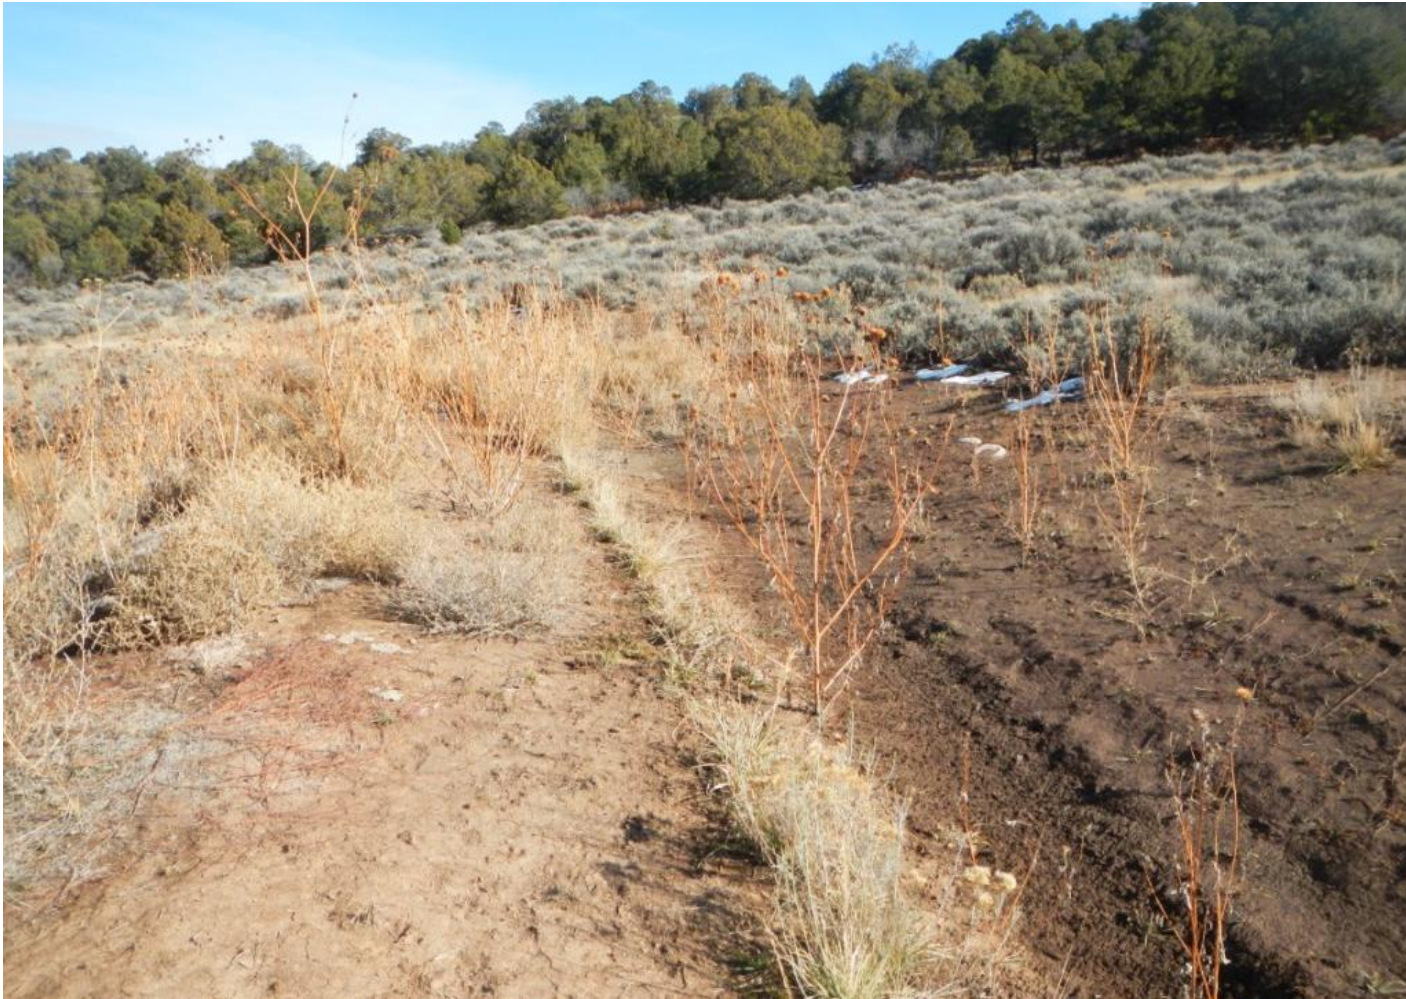
Photo 4. View of area in the southeastern portion of the project area where erosional channels and tunneling have been repaired.

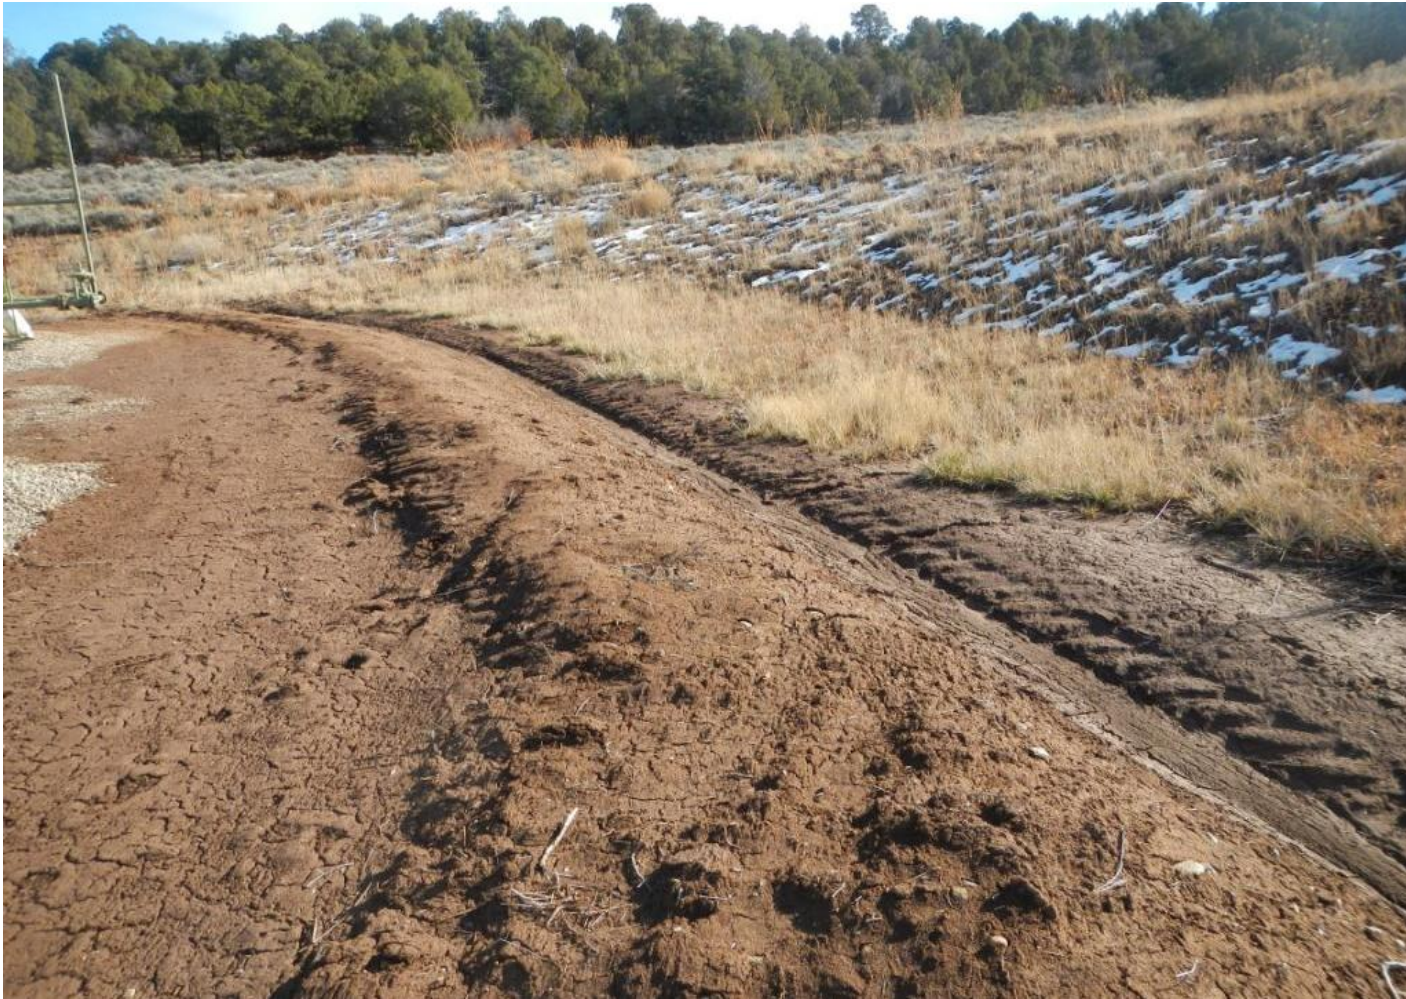
Photo 5. View diversion ditches recently maintained in the southern portion of the project area.

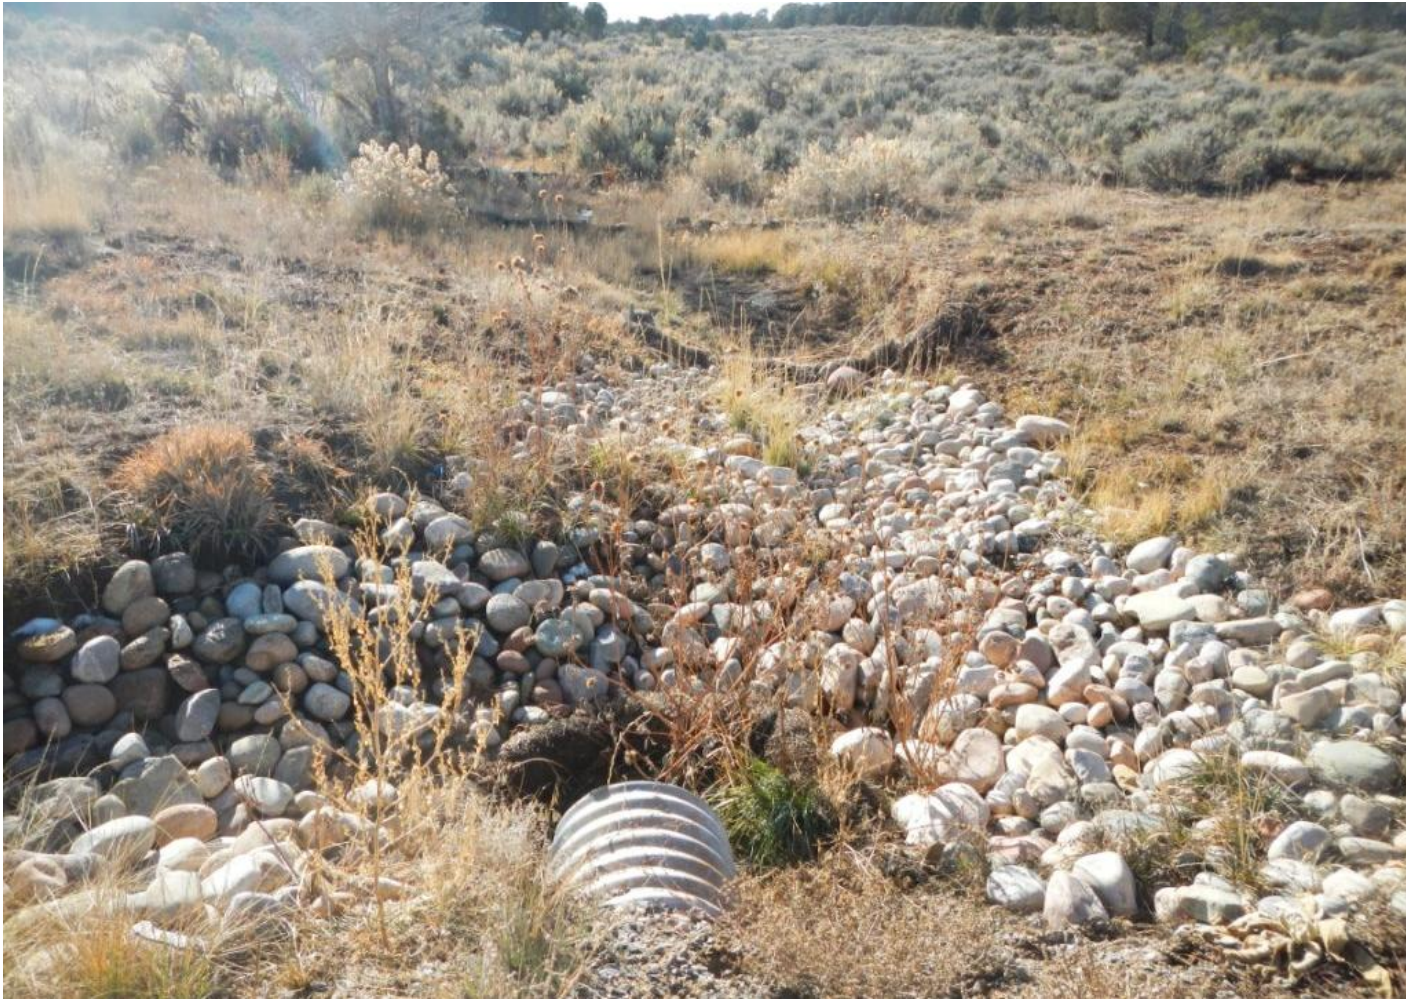
Photo 6. View of cobble armouring installed around the culvert near the entrance of the project area.

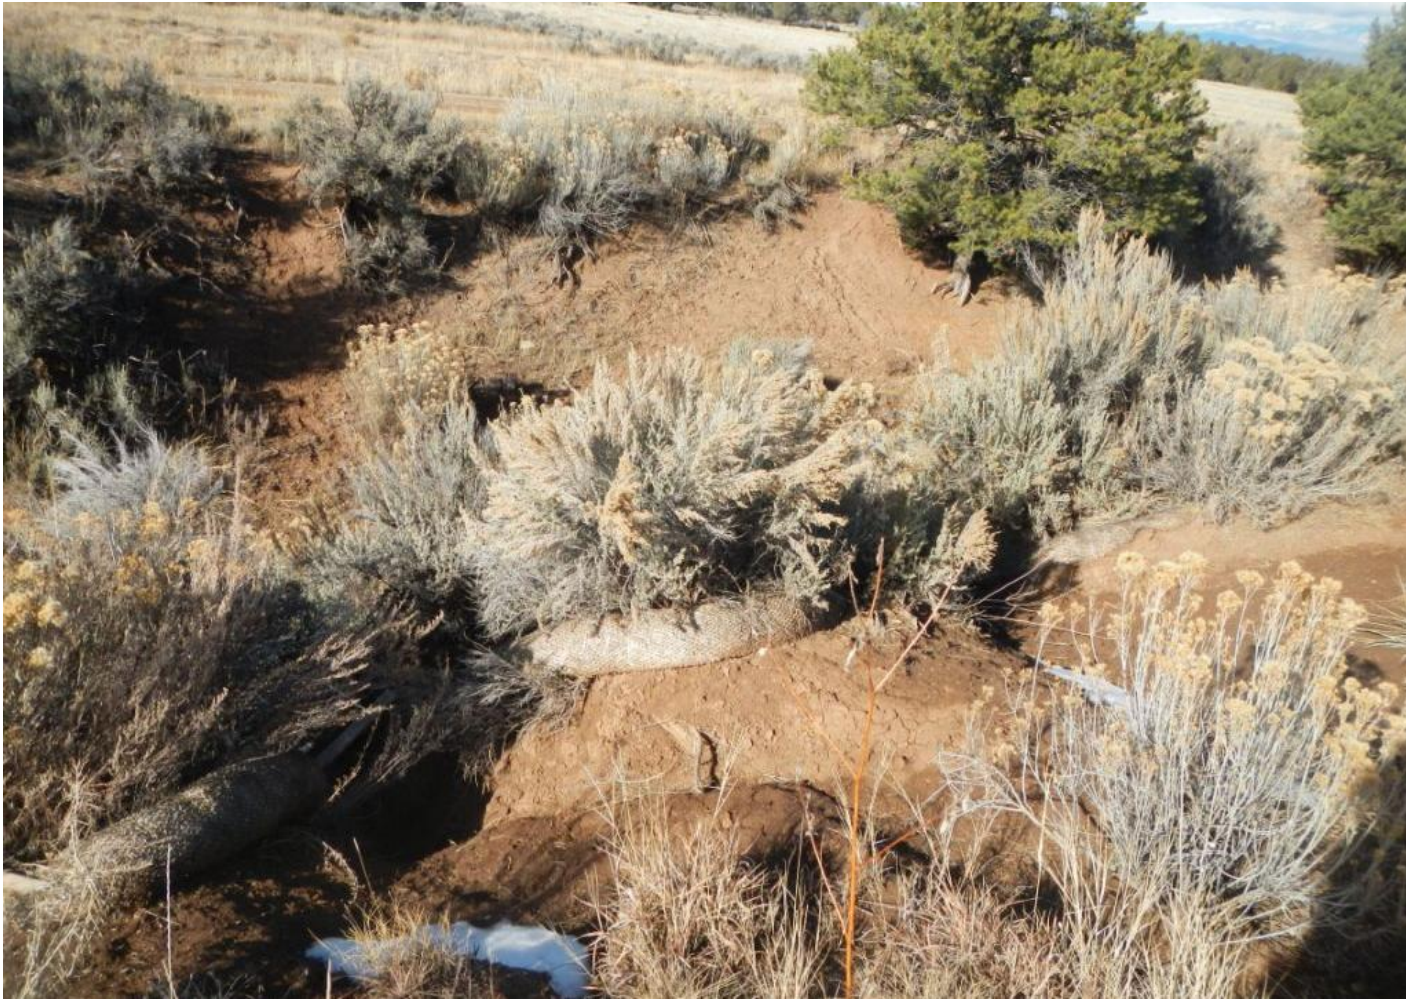
Photo 7. View of area along the western edge of the project area where wattles have failed and additional stormwater controls are needed.

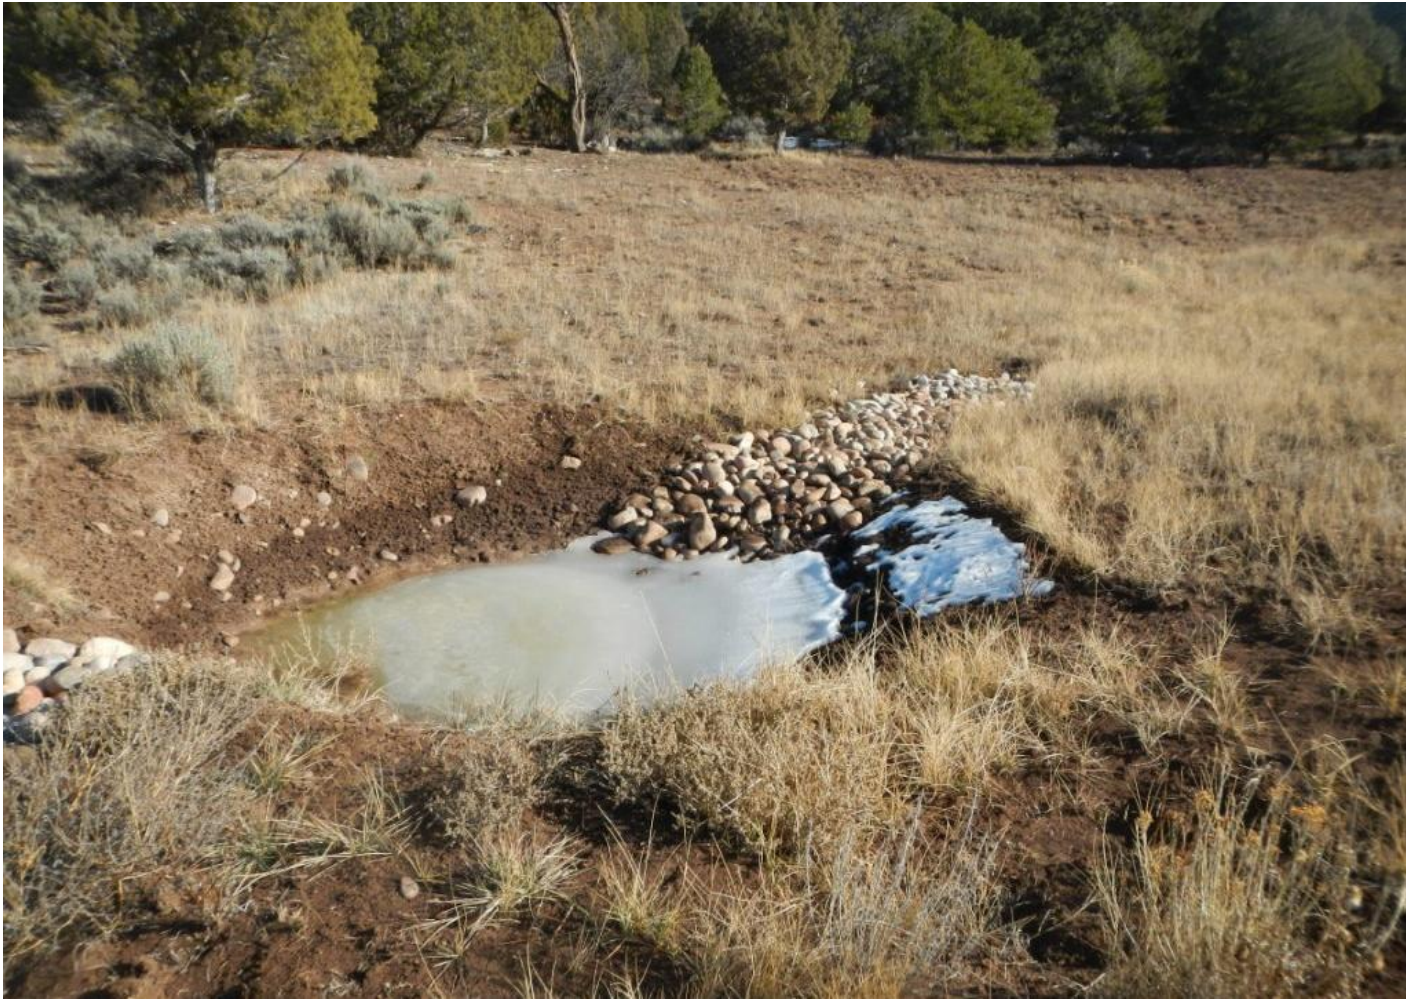
Photo 8. View of newly installed silt trap in the northern portion of the project area. Overflow and a portion of diversion channel are lined with cobble.
