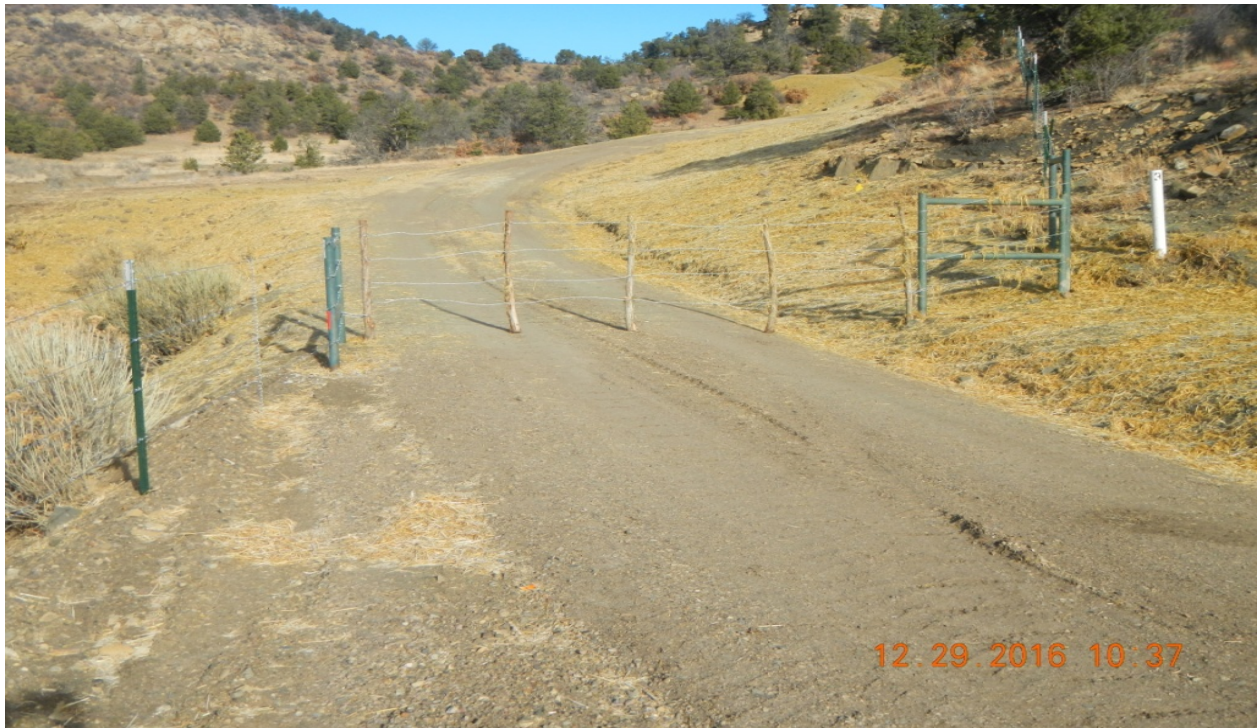
**photo 1:** Facing north toward the beginning of the access road.

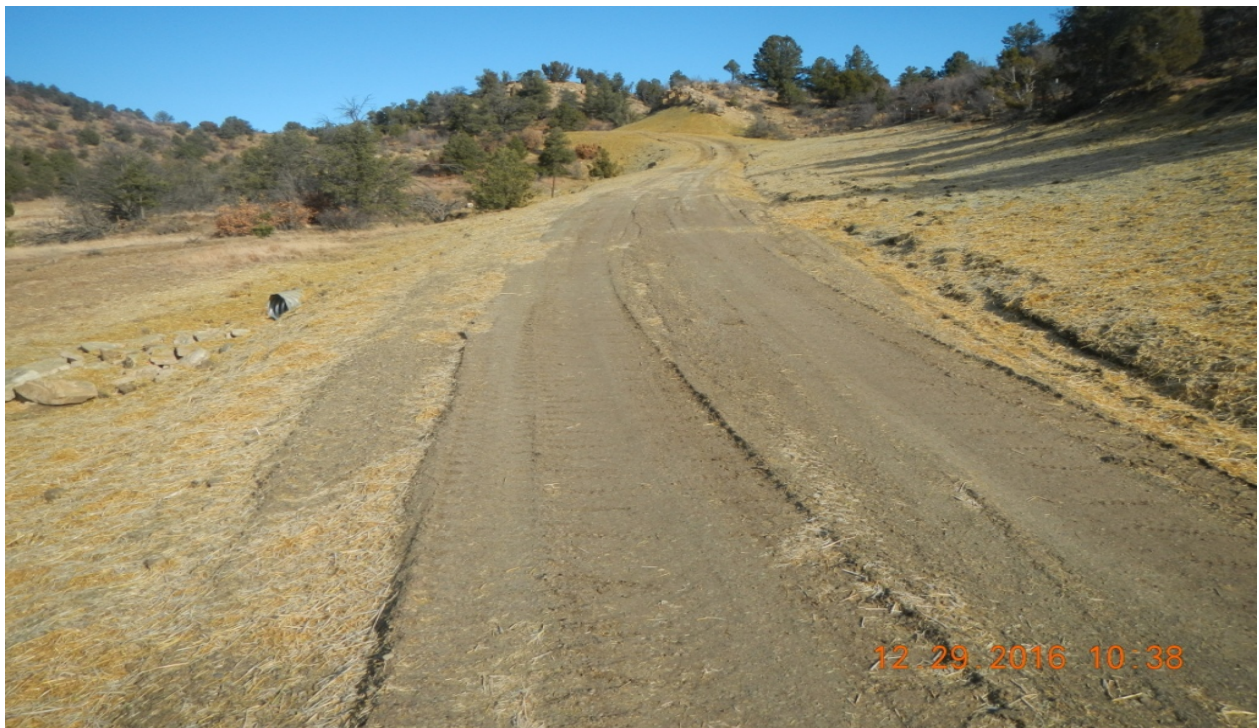
**photo 2:** Facing north along the access road.

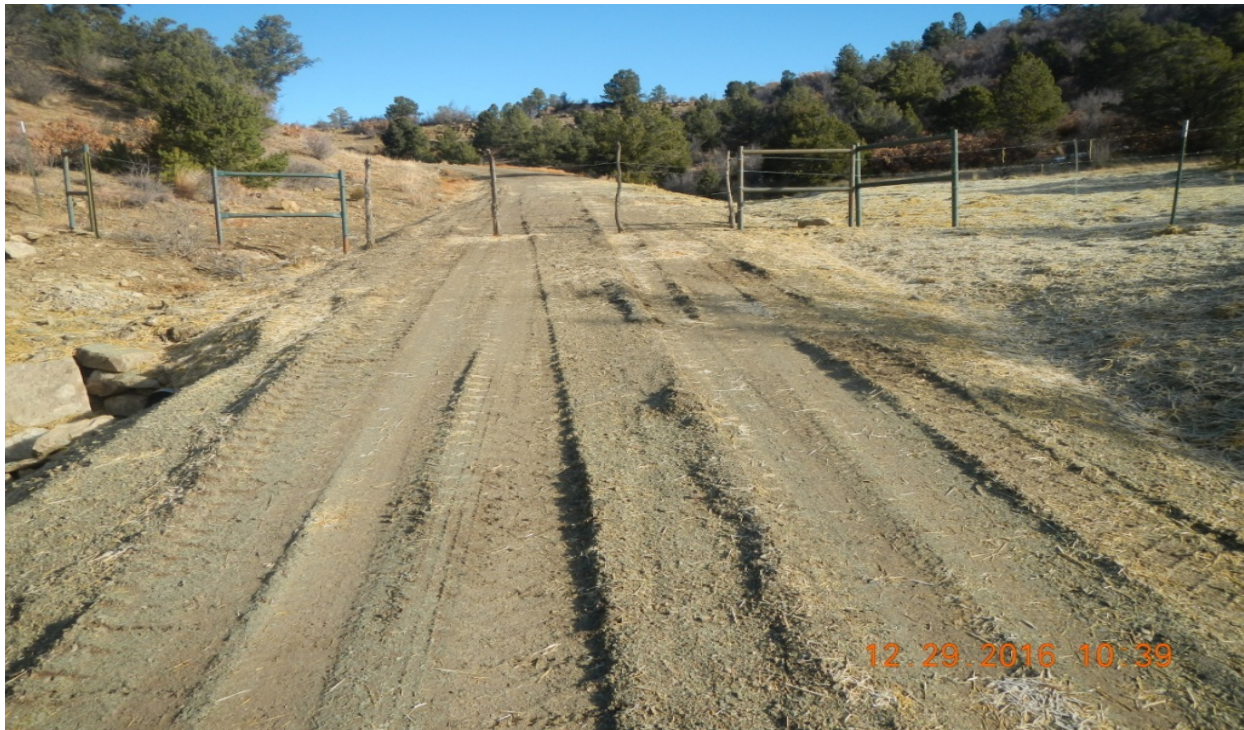
**photo 3:** Facing northeast at the second gate along the access road.

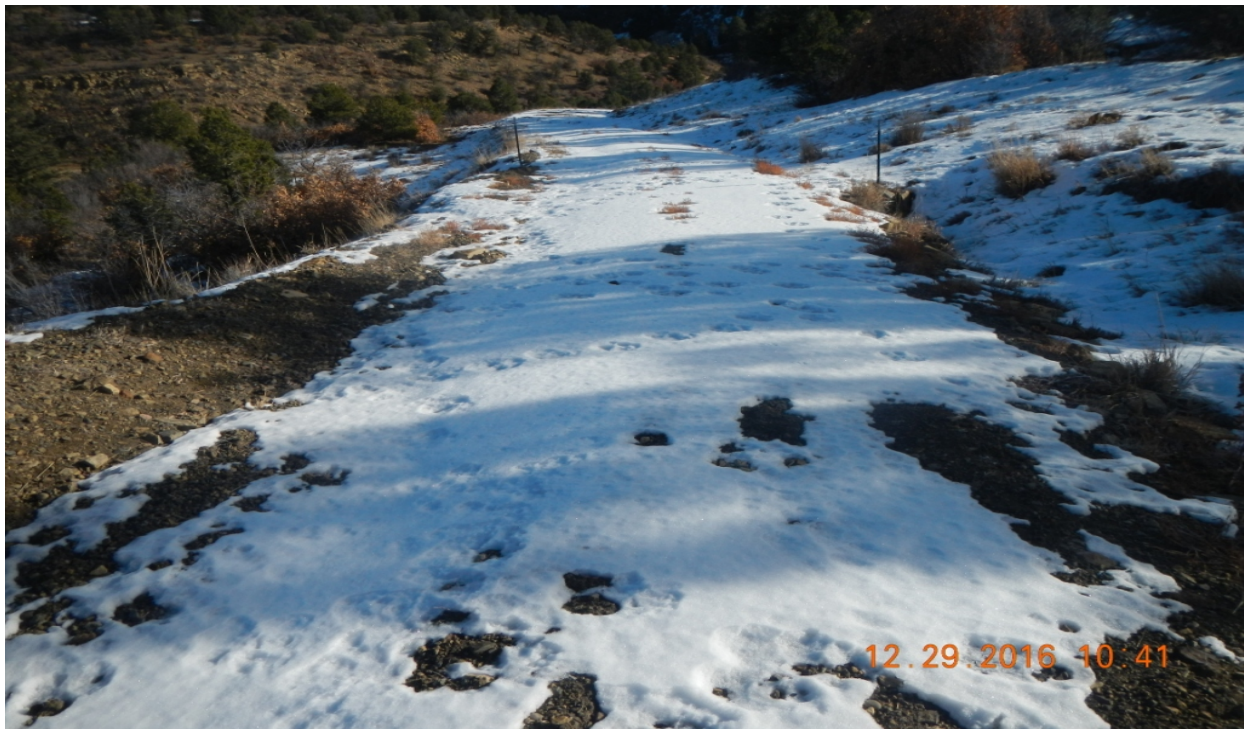
**photo 4:** Facing east along the access road.

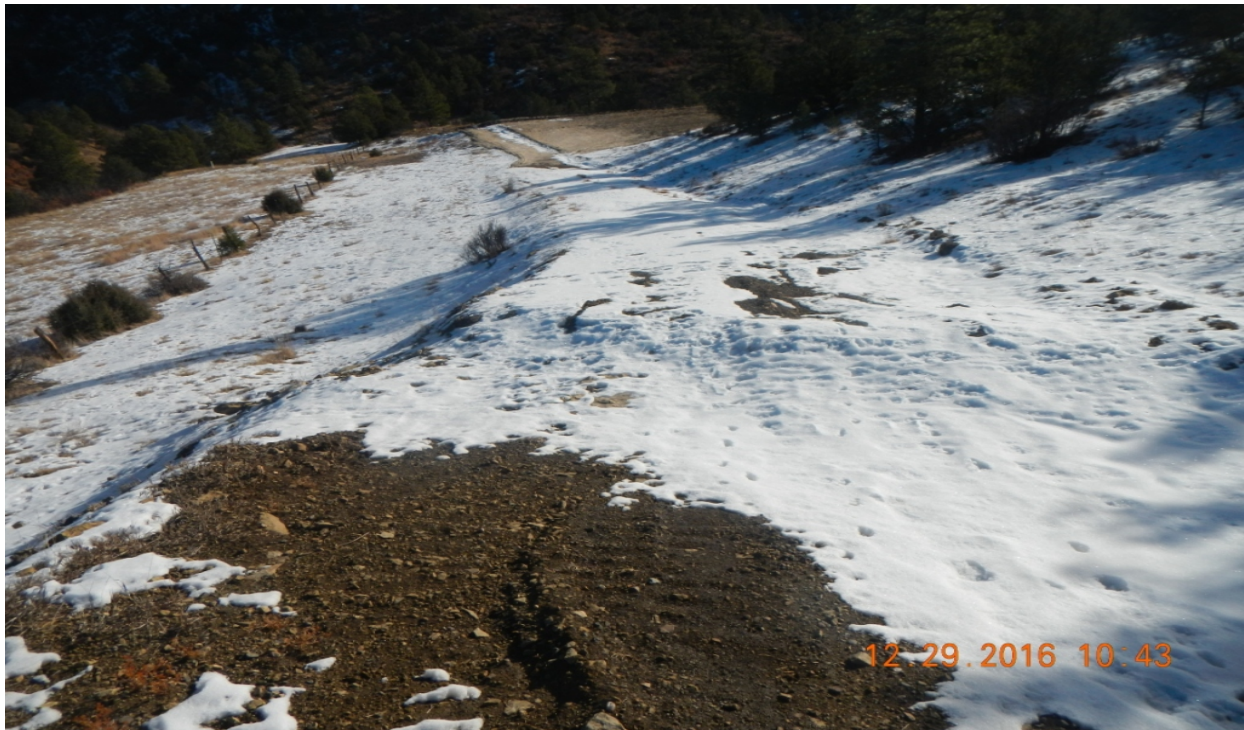
**photo 5:** Facing east along the access road toward the location.

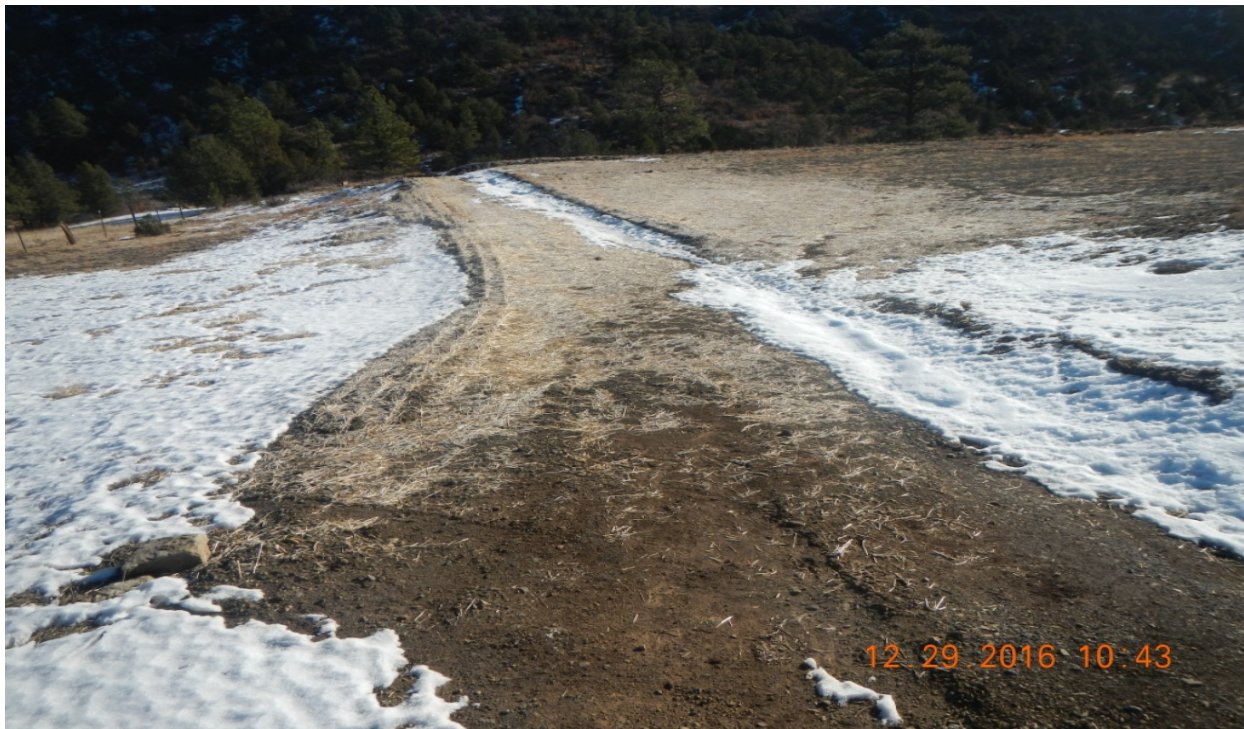
**photo 6:** Facing east toward the location.

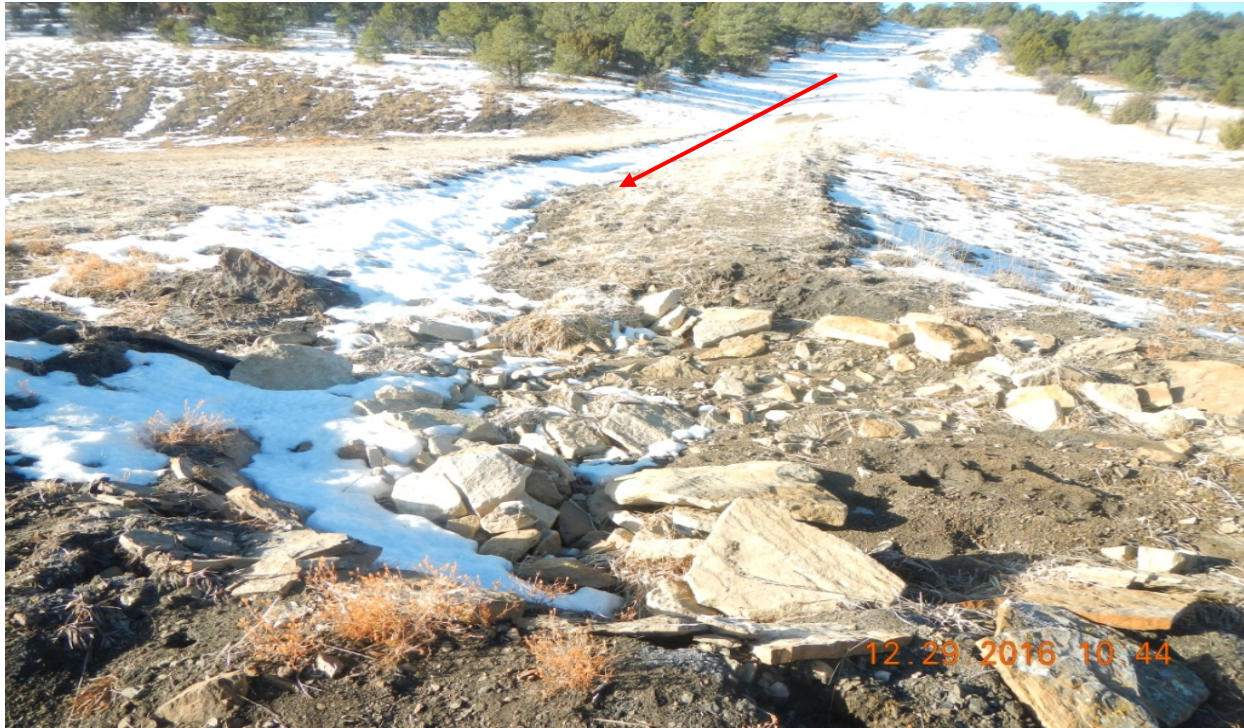
**photo 7:** The sediment trap at the northeast side of the location is filled in with sediment. Diversion ditch indicated by the red arrow directs stormwater from the access road to this sediment trap.

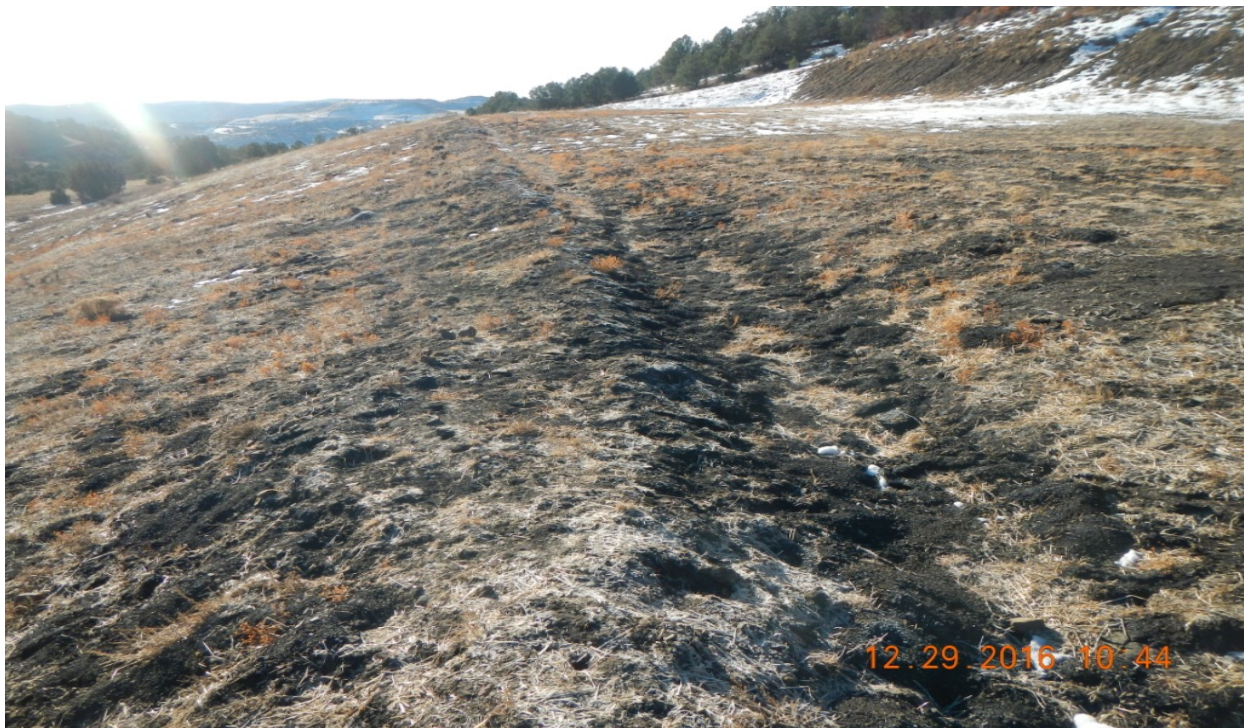
**photo 8:** Facing south toward the location along the fill slope. Desirable vegetation does not appear to be established along the fill slope.

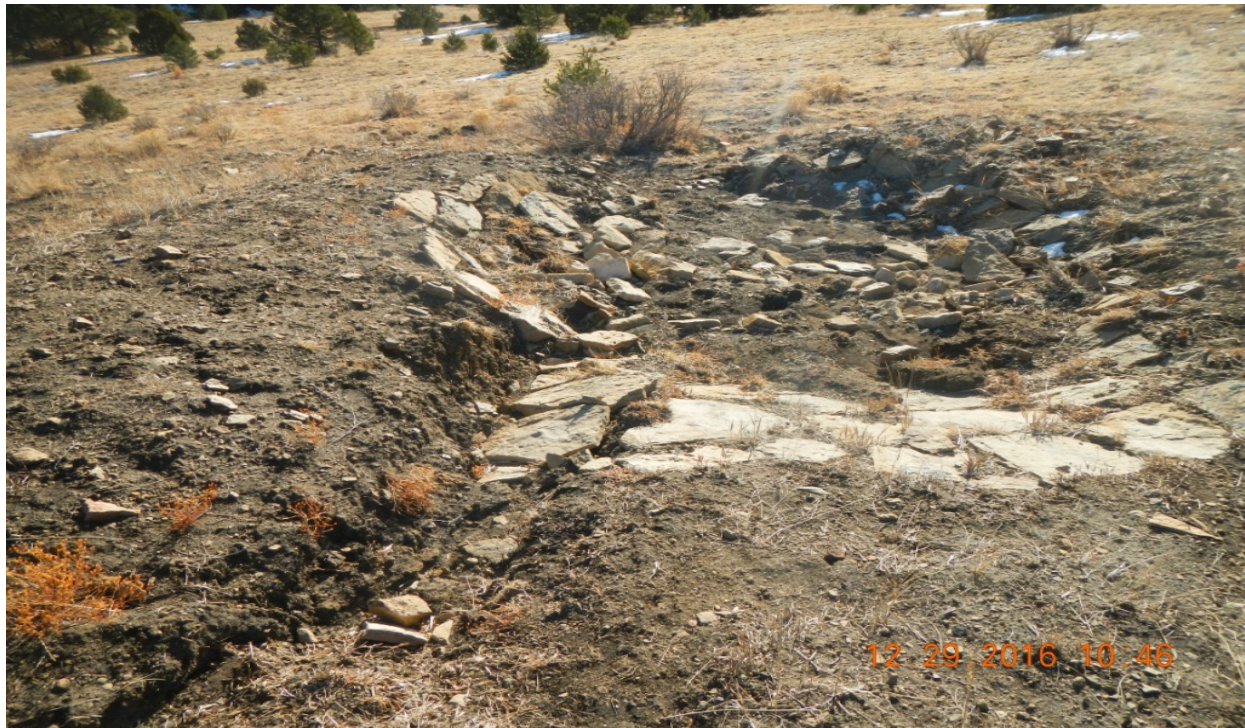
**photo 9:** The sediment trap at the southeast corner is filled in with sediment.

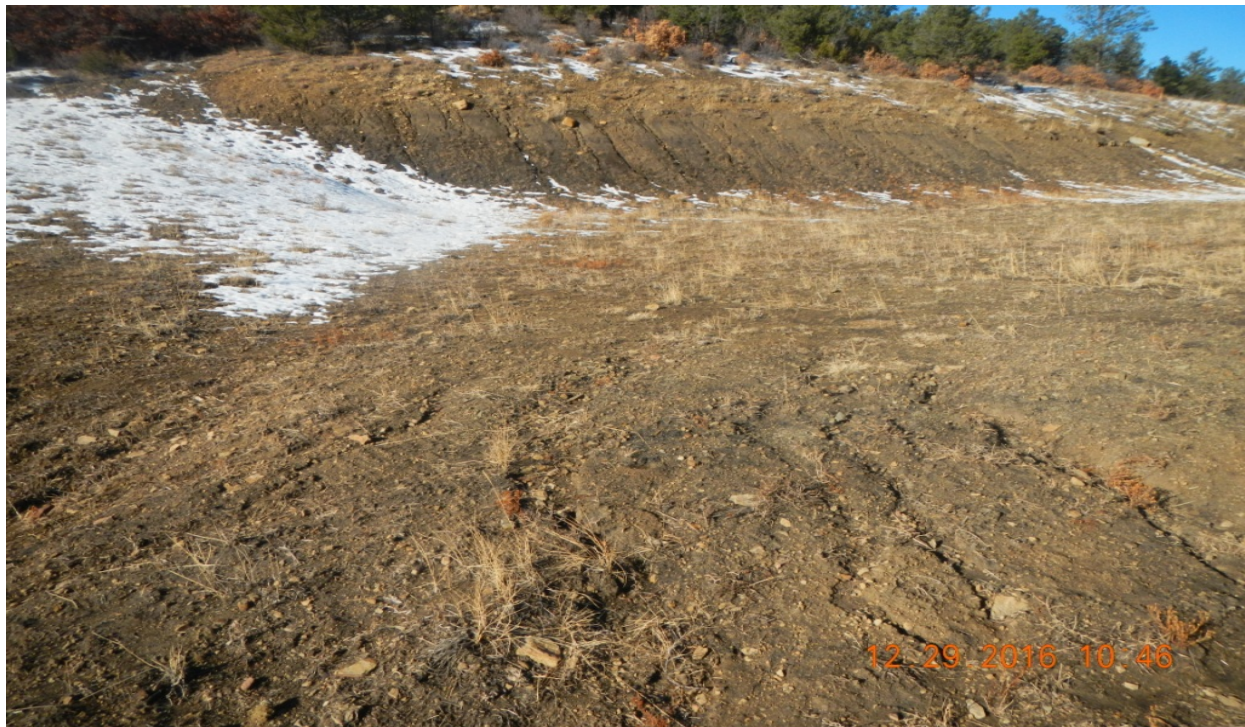
**photo 10:** South side of the location facing west toward the cut slope.

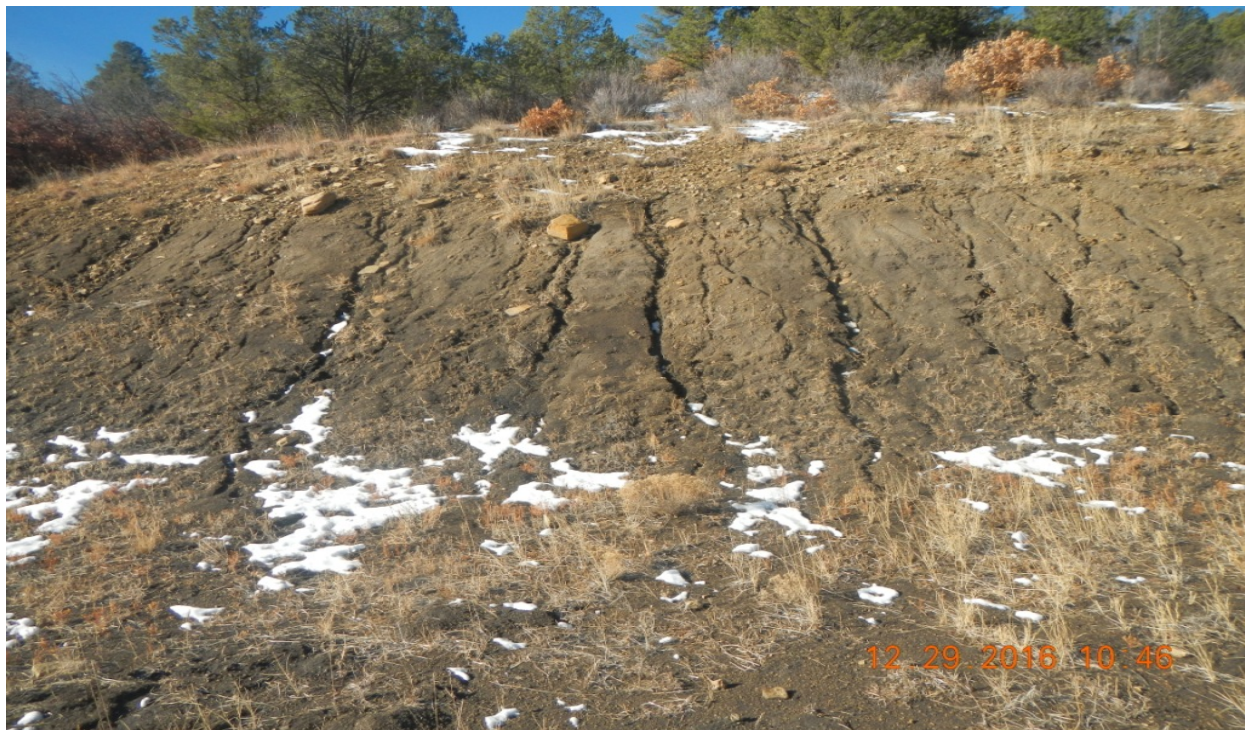
**photo 11:** There are signs of erosion along the west cut slope.

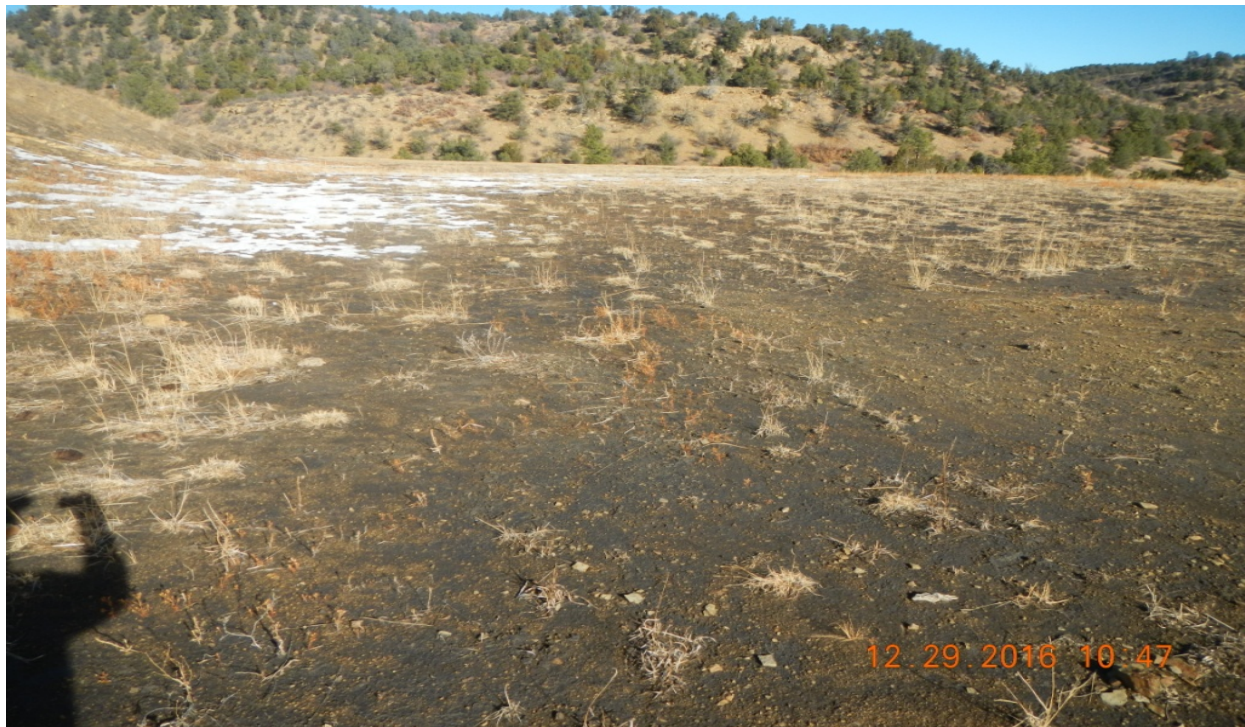
**photo 12:** South side of the location facing north.
