Reclamation Inspection

01/09/2017

Operator: Atlas Resources LLC

Location ID: 421361

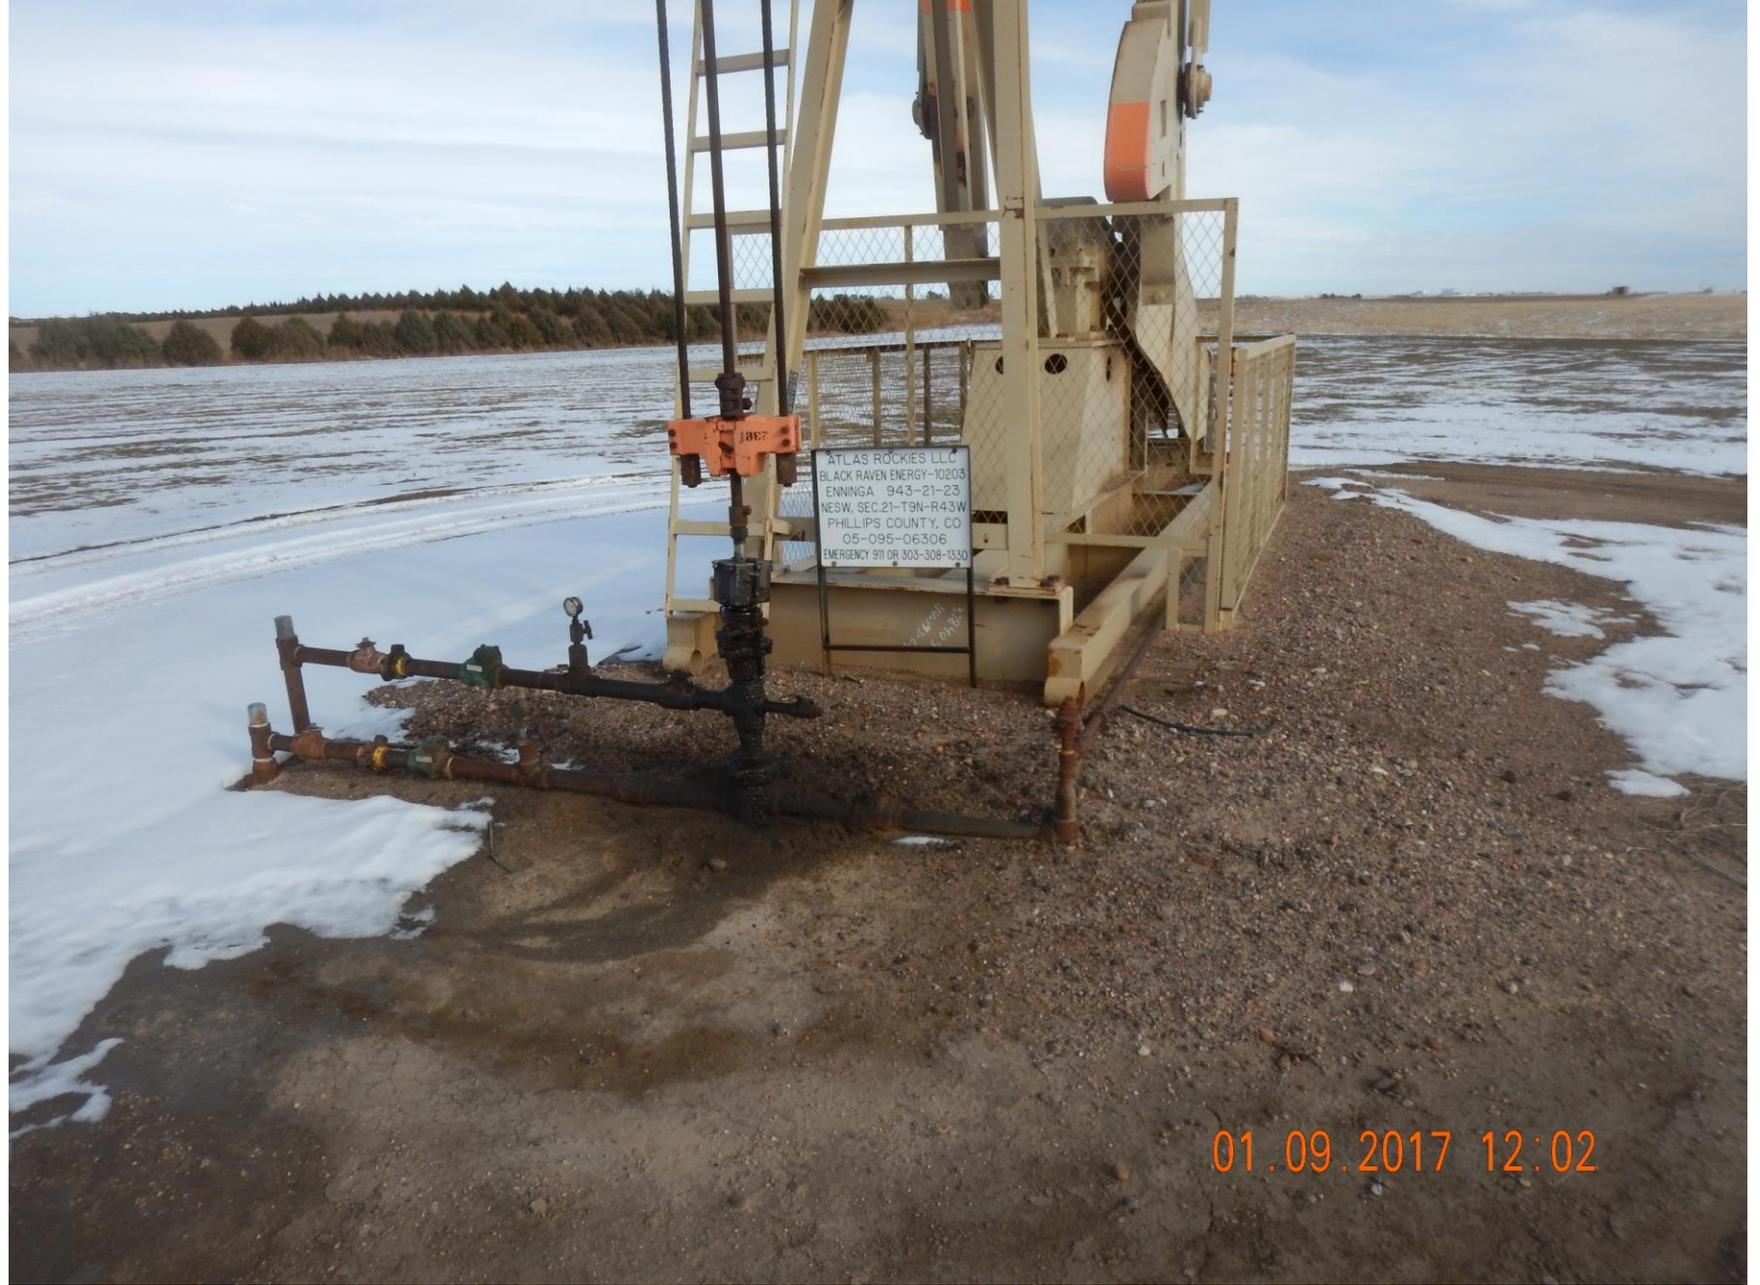
Figure 1: Photo of well.

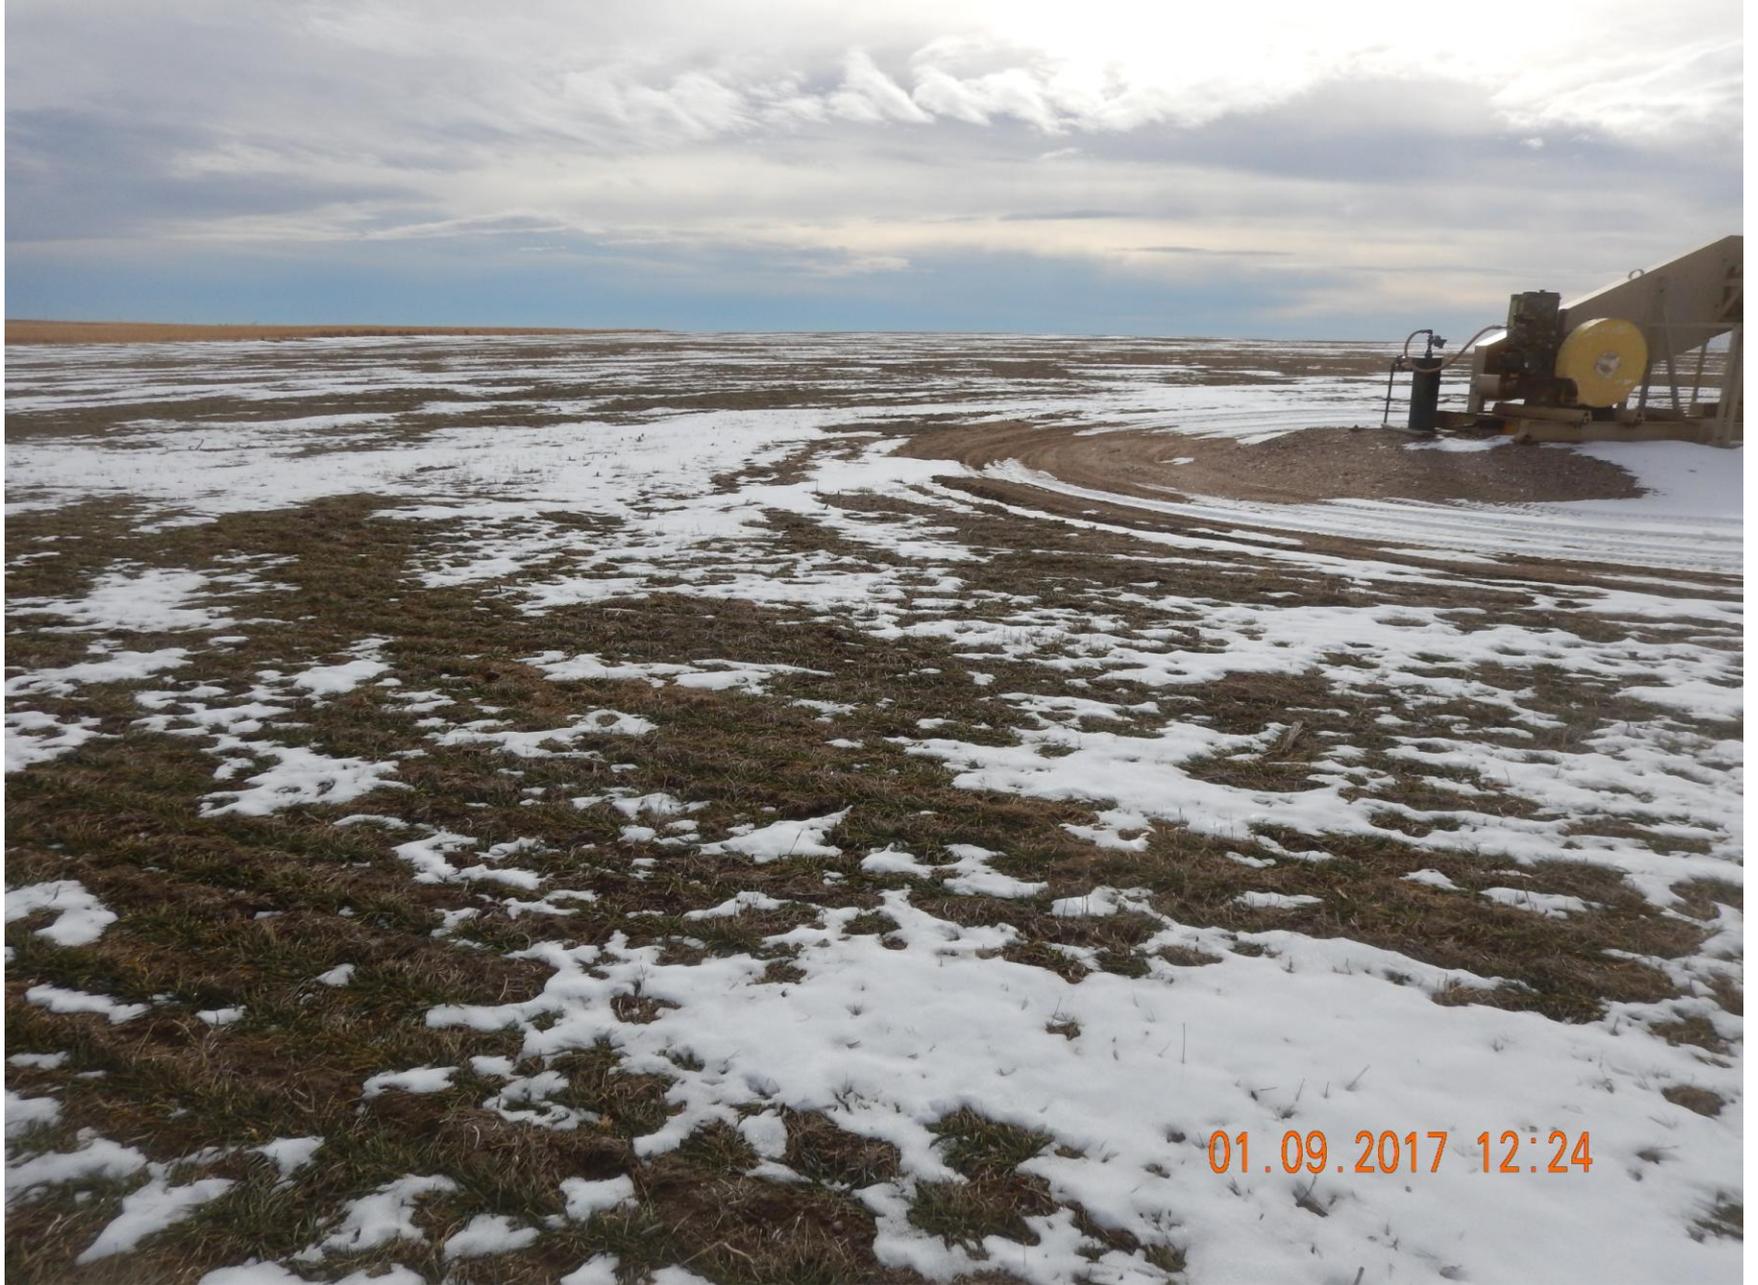
Figure 2: Photo taken from the northeast end of the location, facing south. Photo shows interim and project areas.

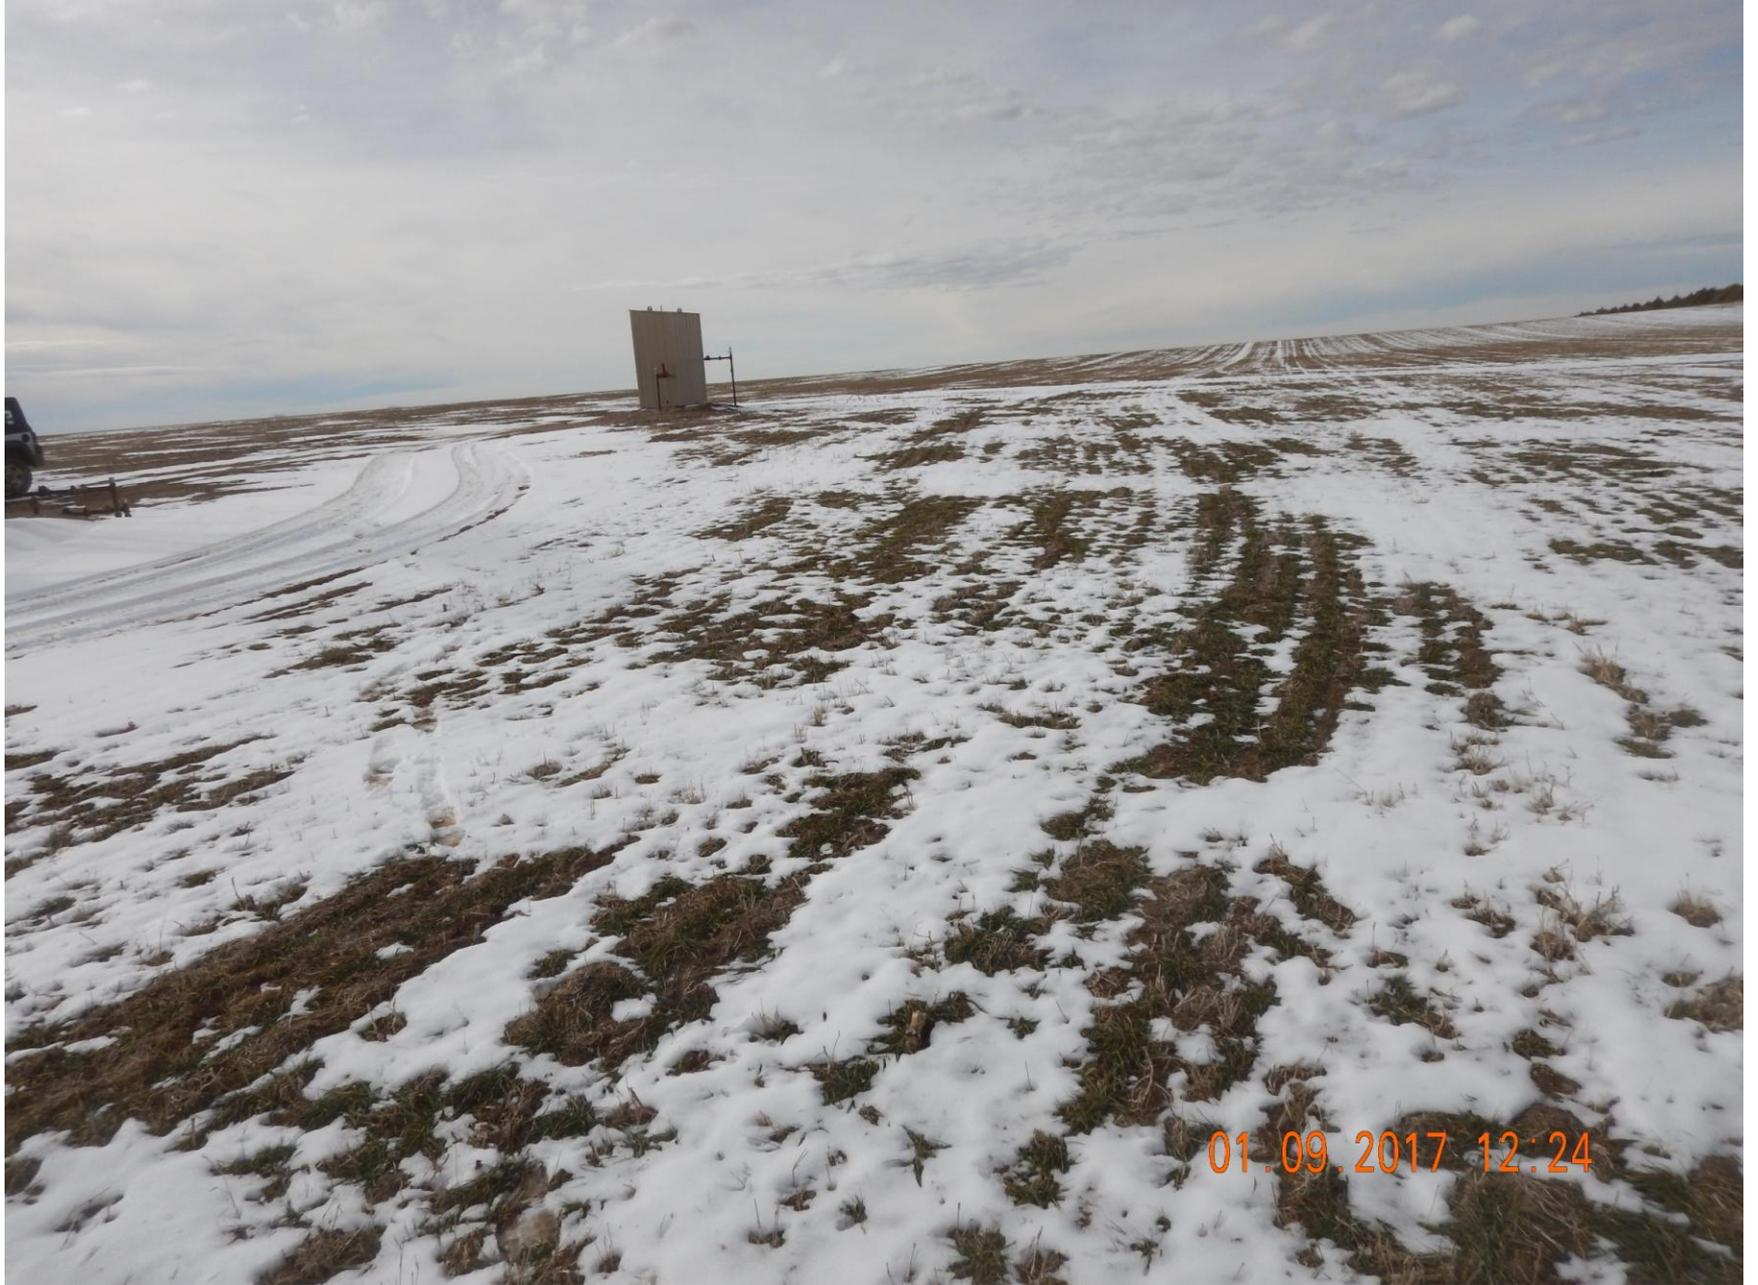
Figure 3: Photo taken from the northeast end of the location, facing west Photo shows interim and project areas.

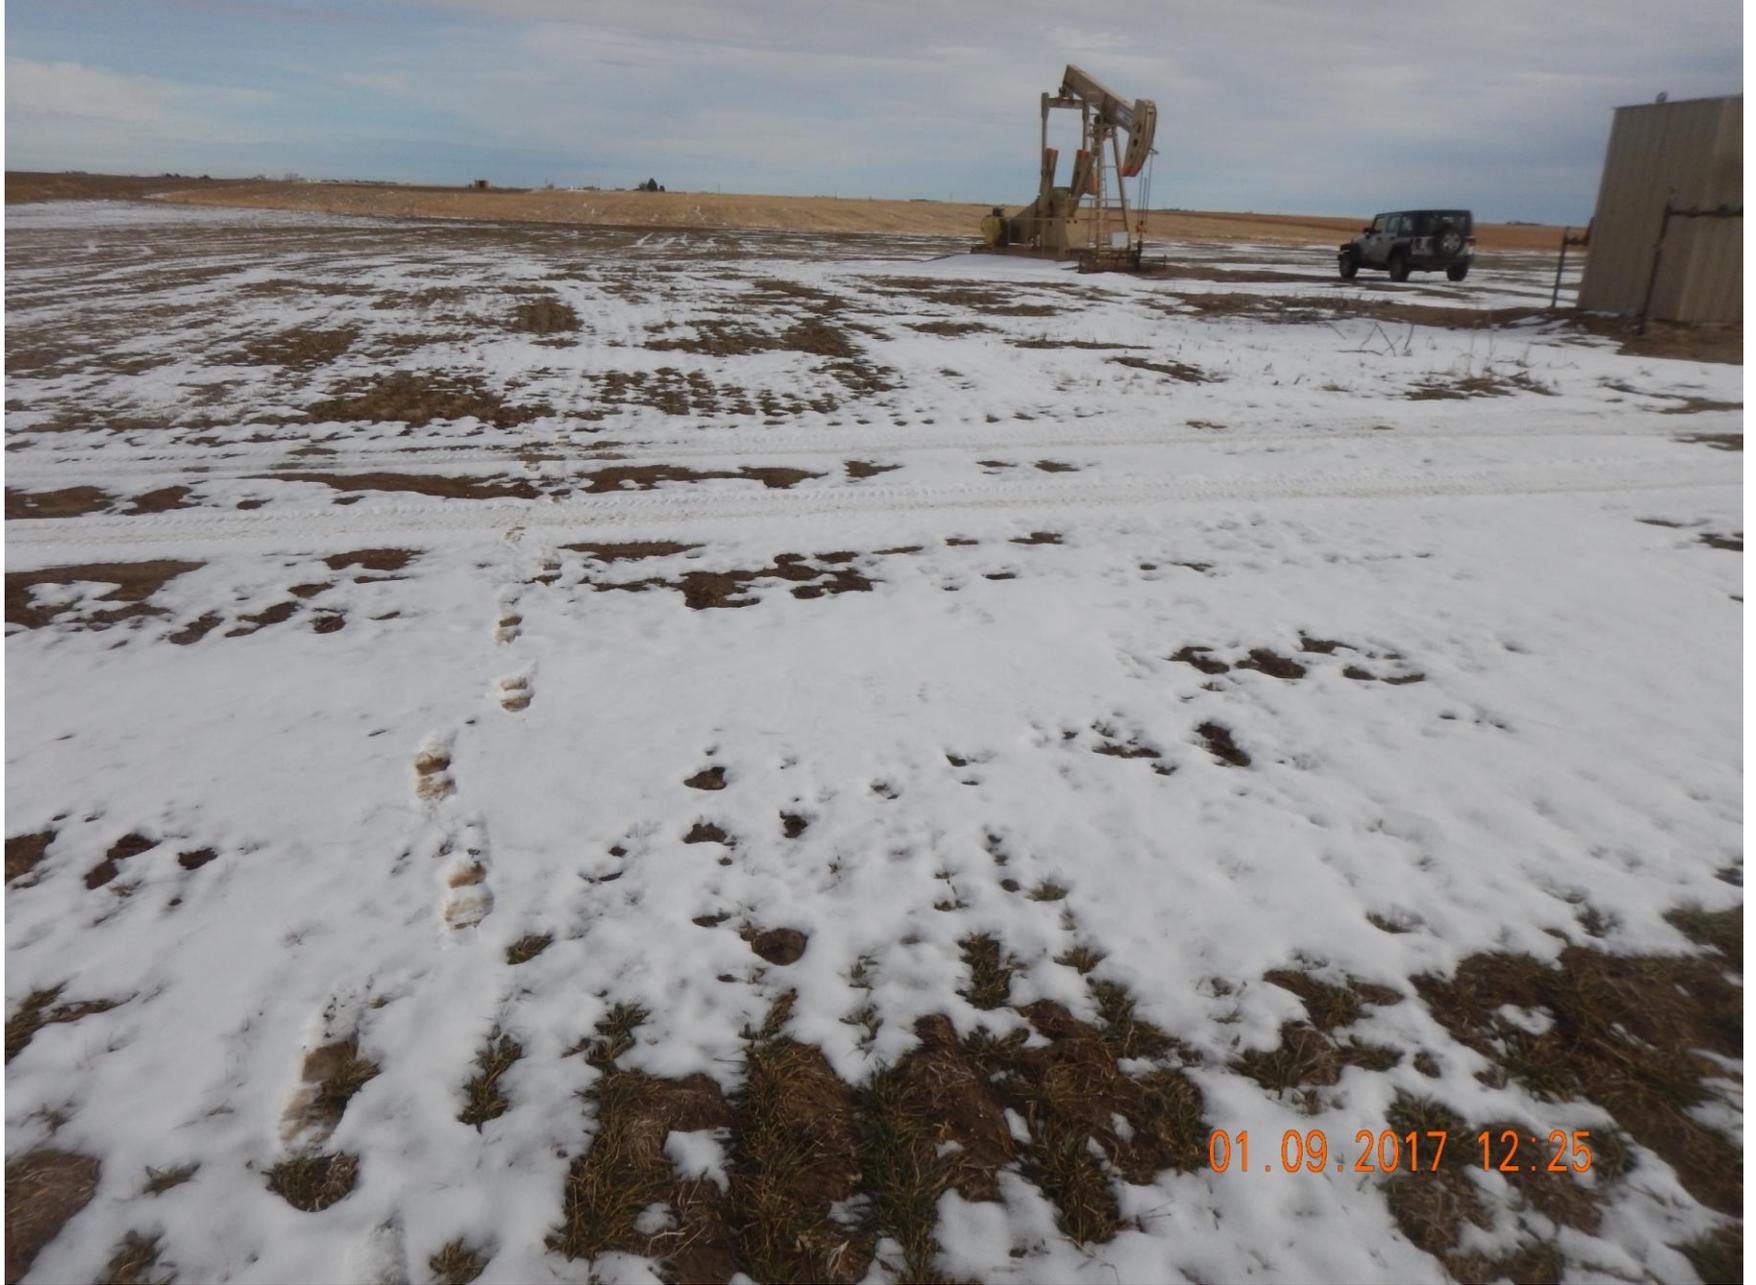
Figure 4: Photo taken from the northwest end of the location, facing east. Photo shows interim and project areas.

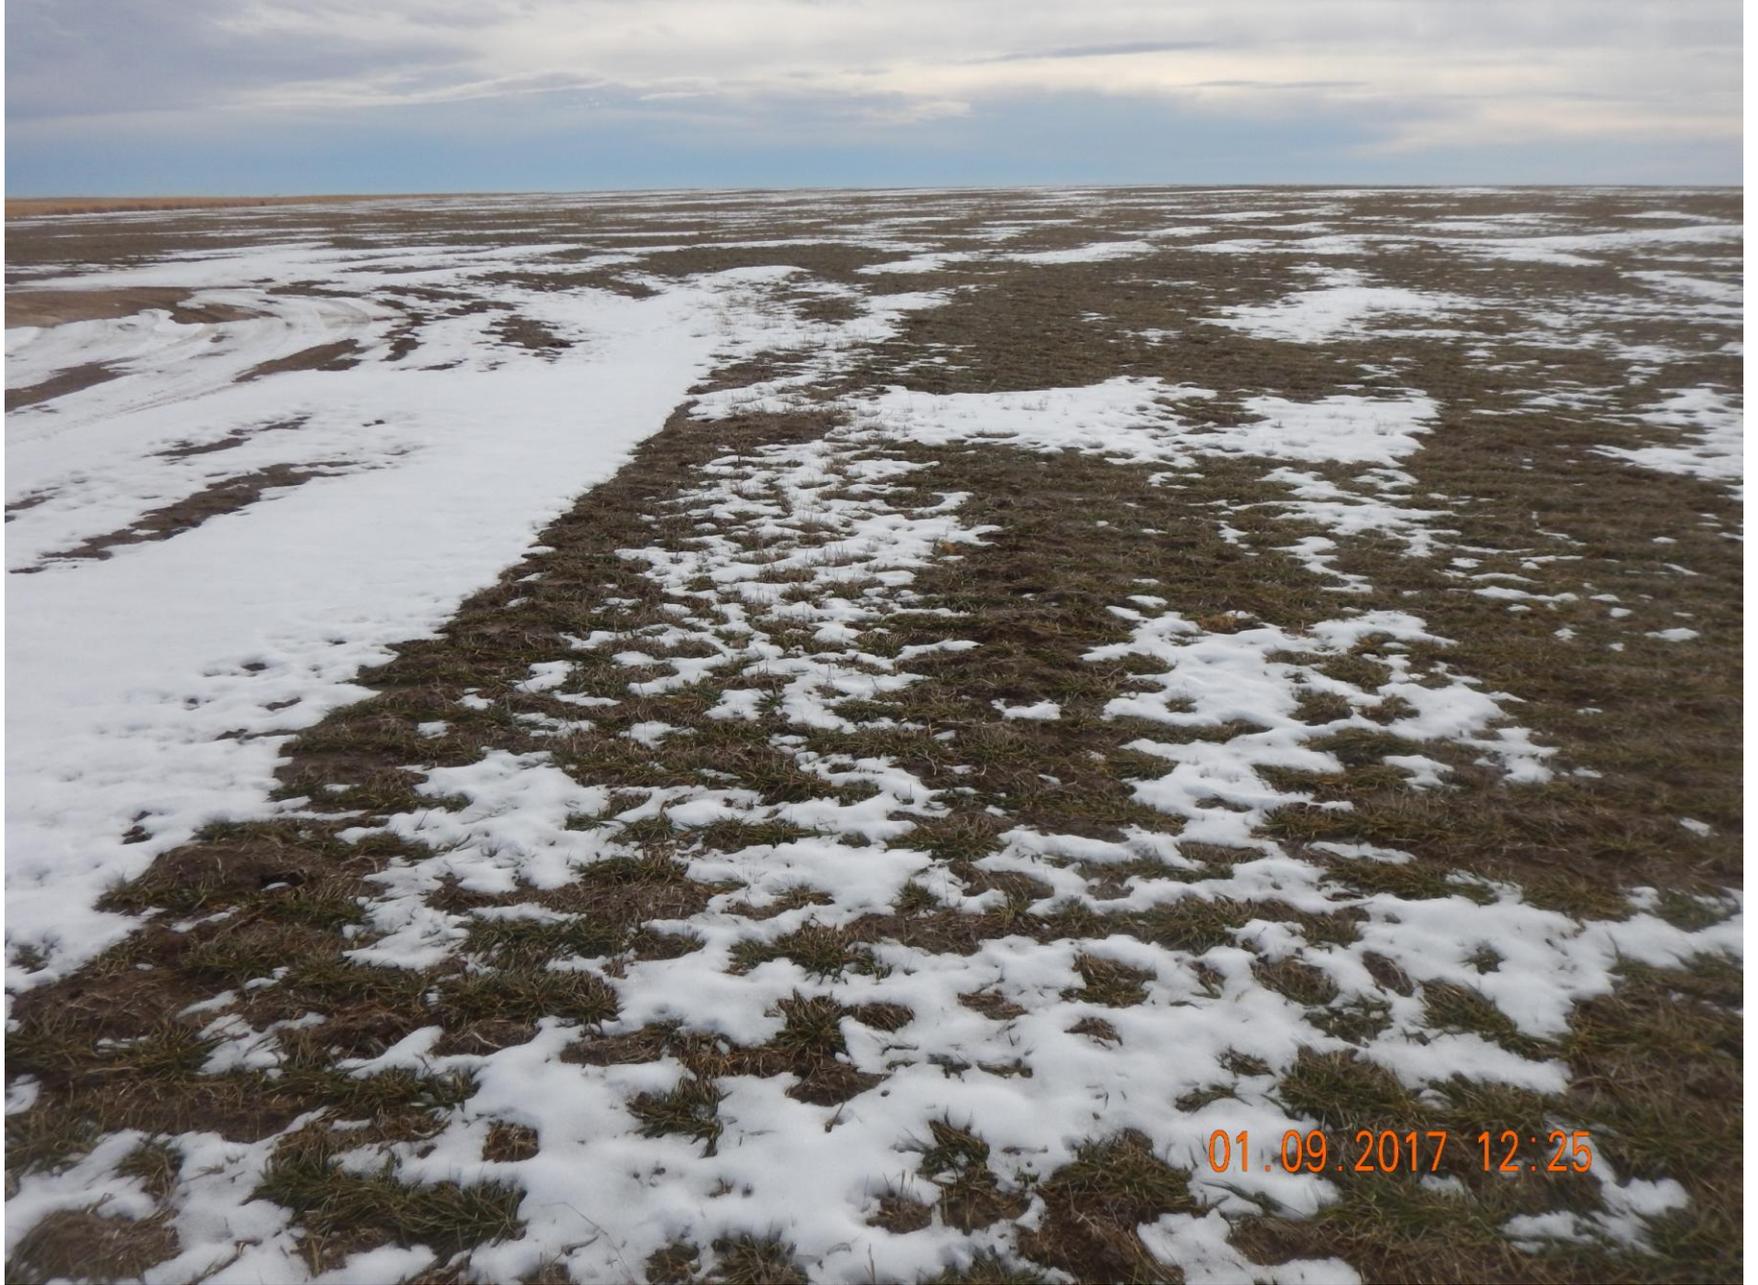
Figure 5: Photo taken from the northwest end of the location, facing south. Photo shows interim and project areas.

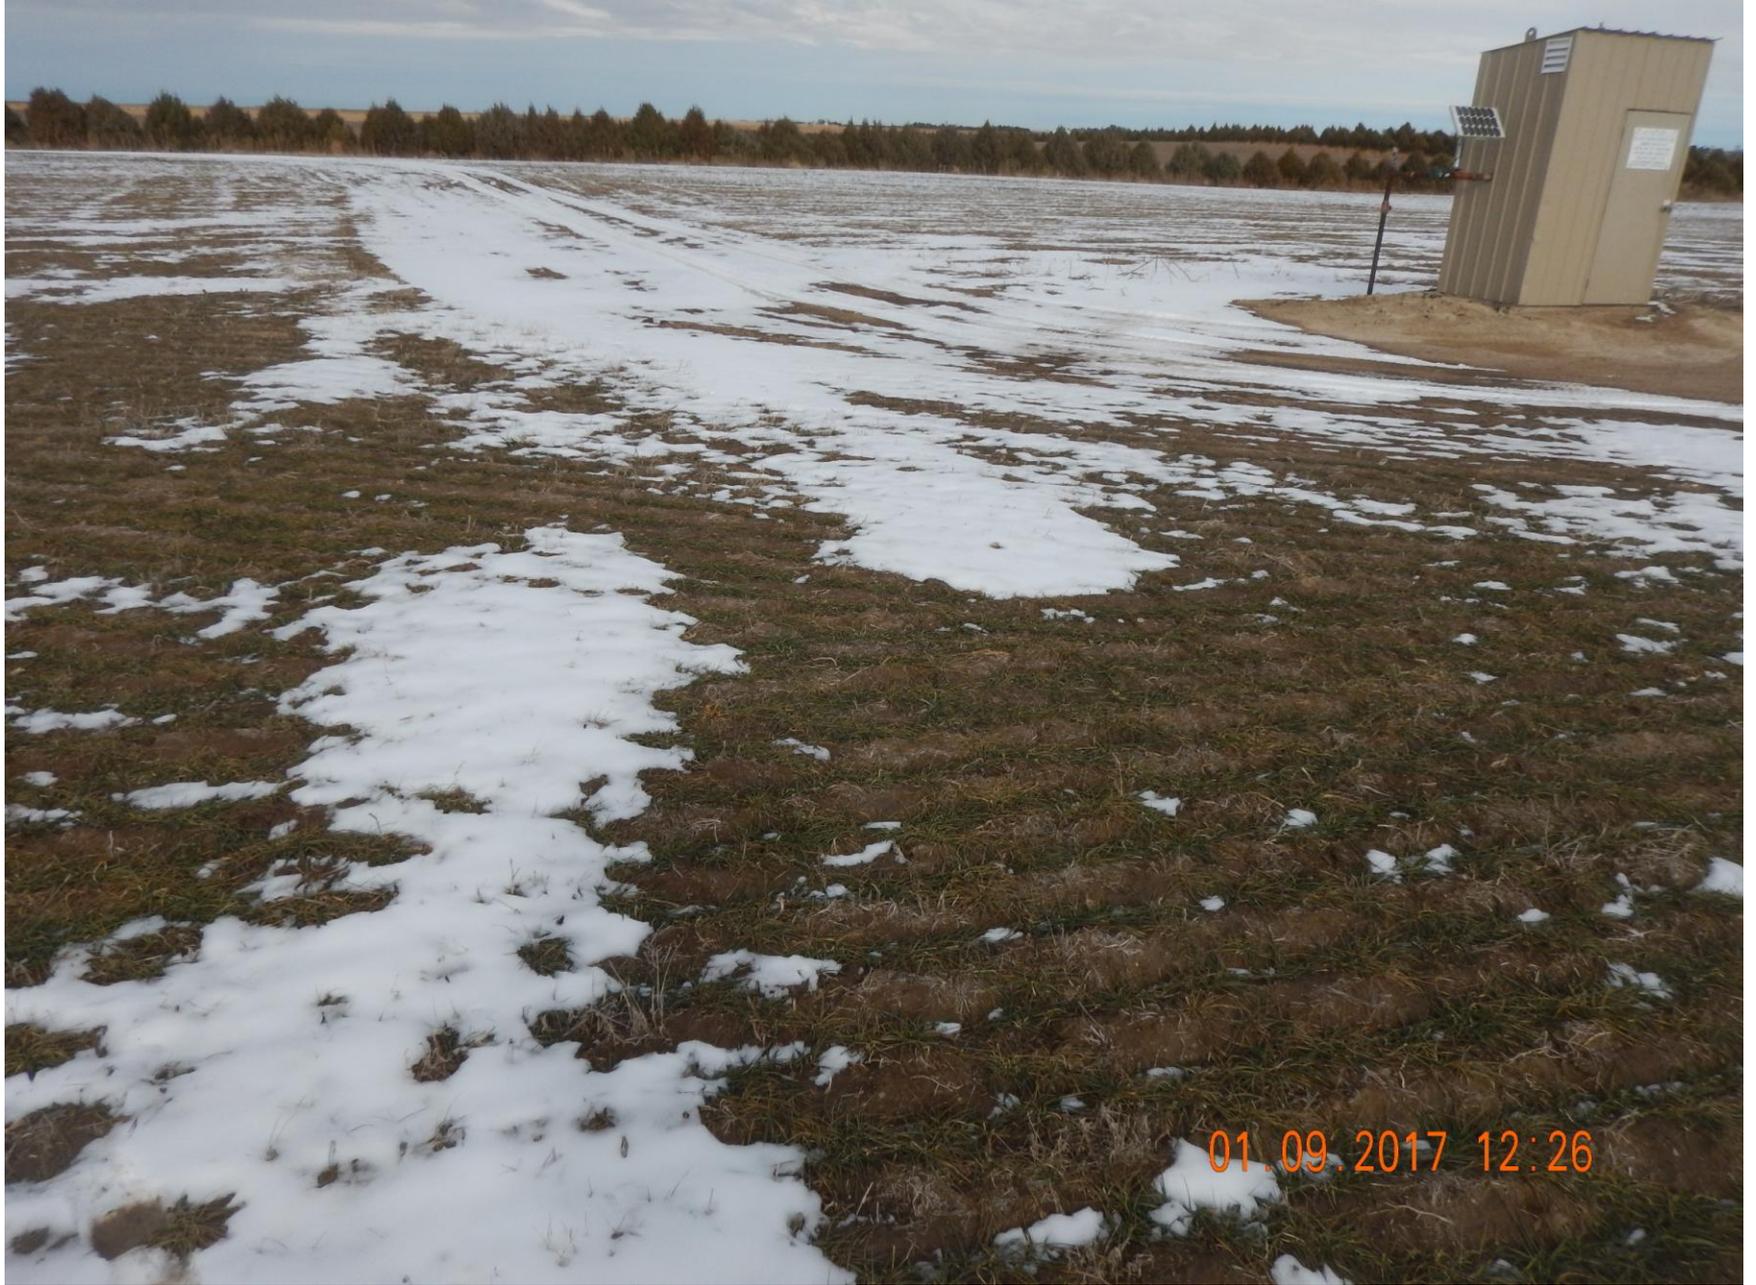
Figure 6: Photo taken from the southwest end of the location, facing north. Photo shows interim and project areas.

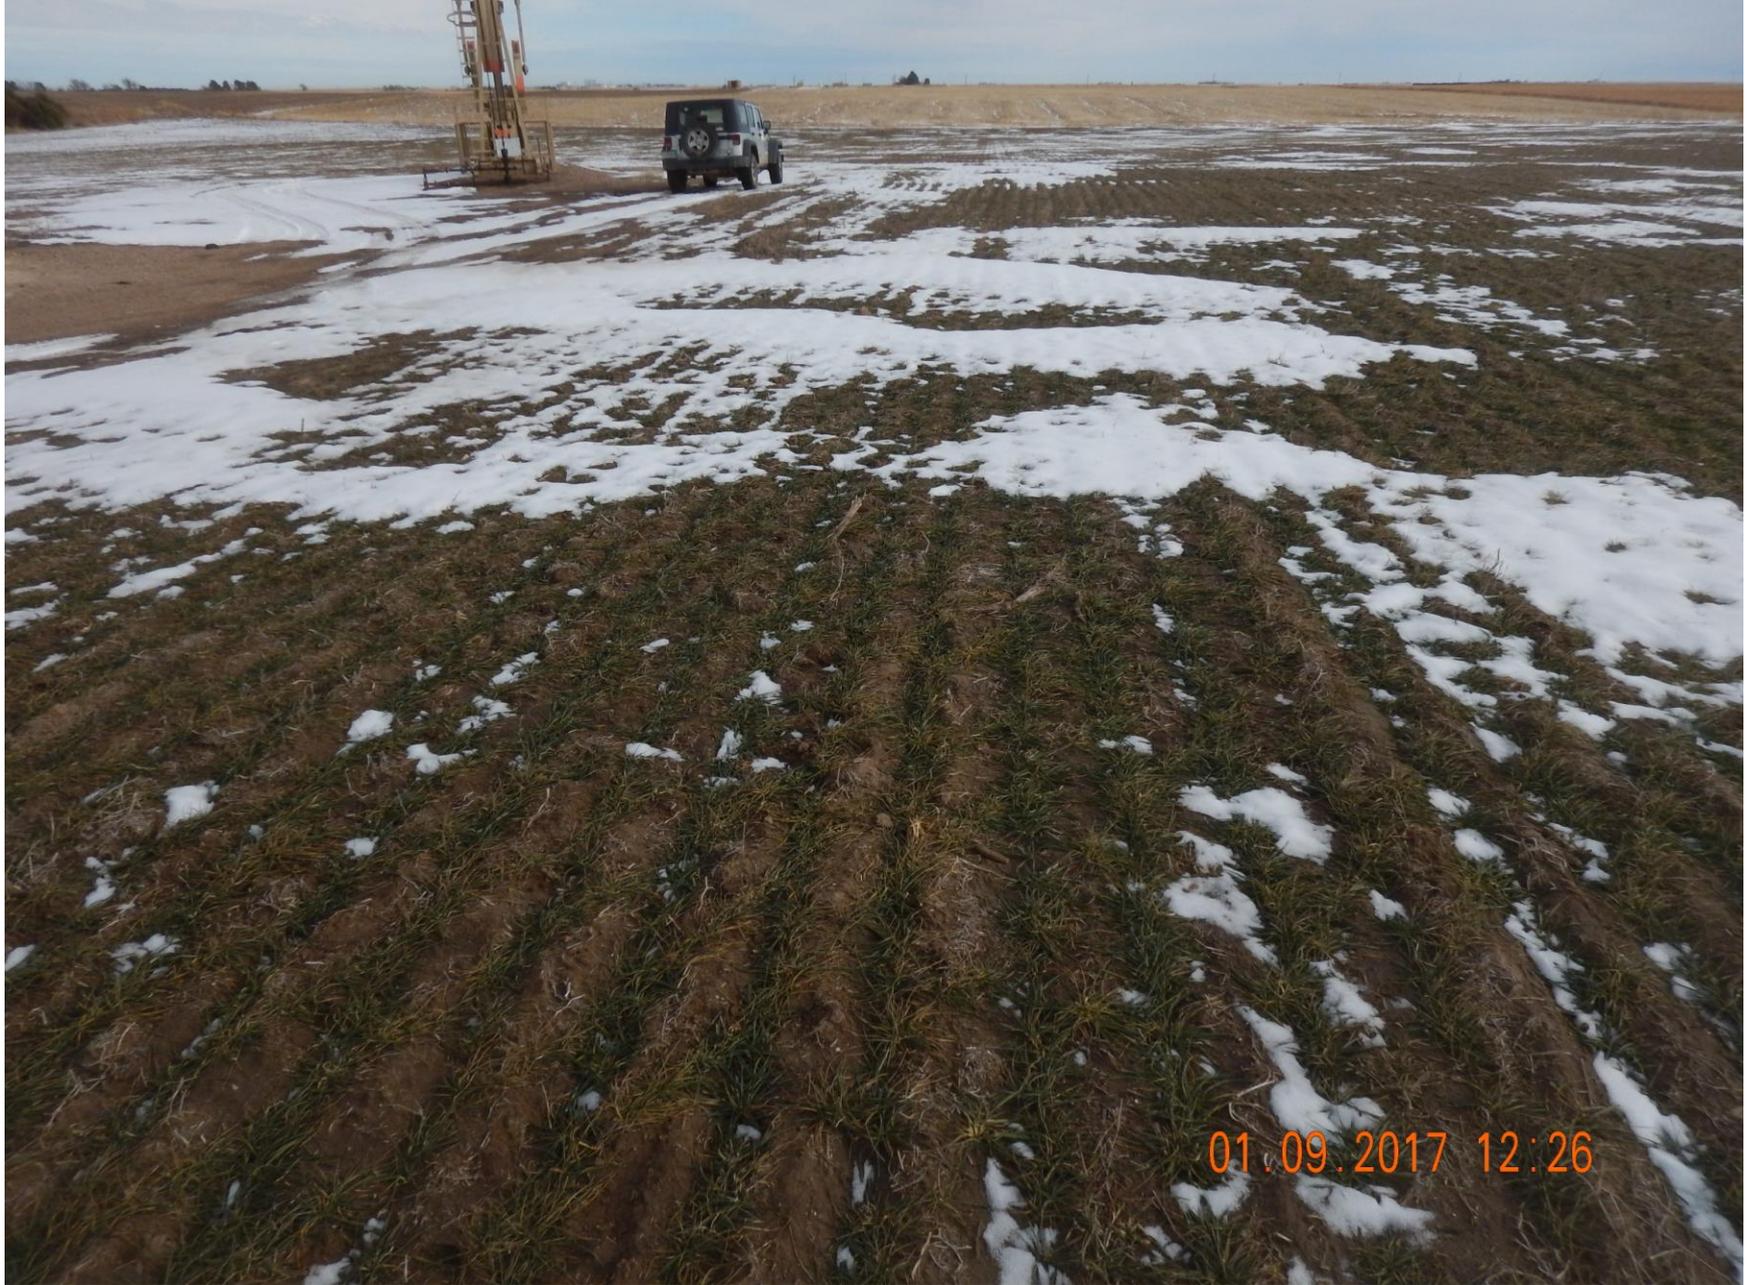
Figure 7: Photo taken from the southwest end of the location, facing east. Photo shows interim and project areas.

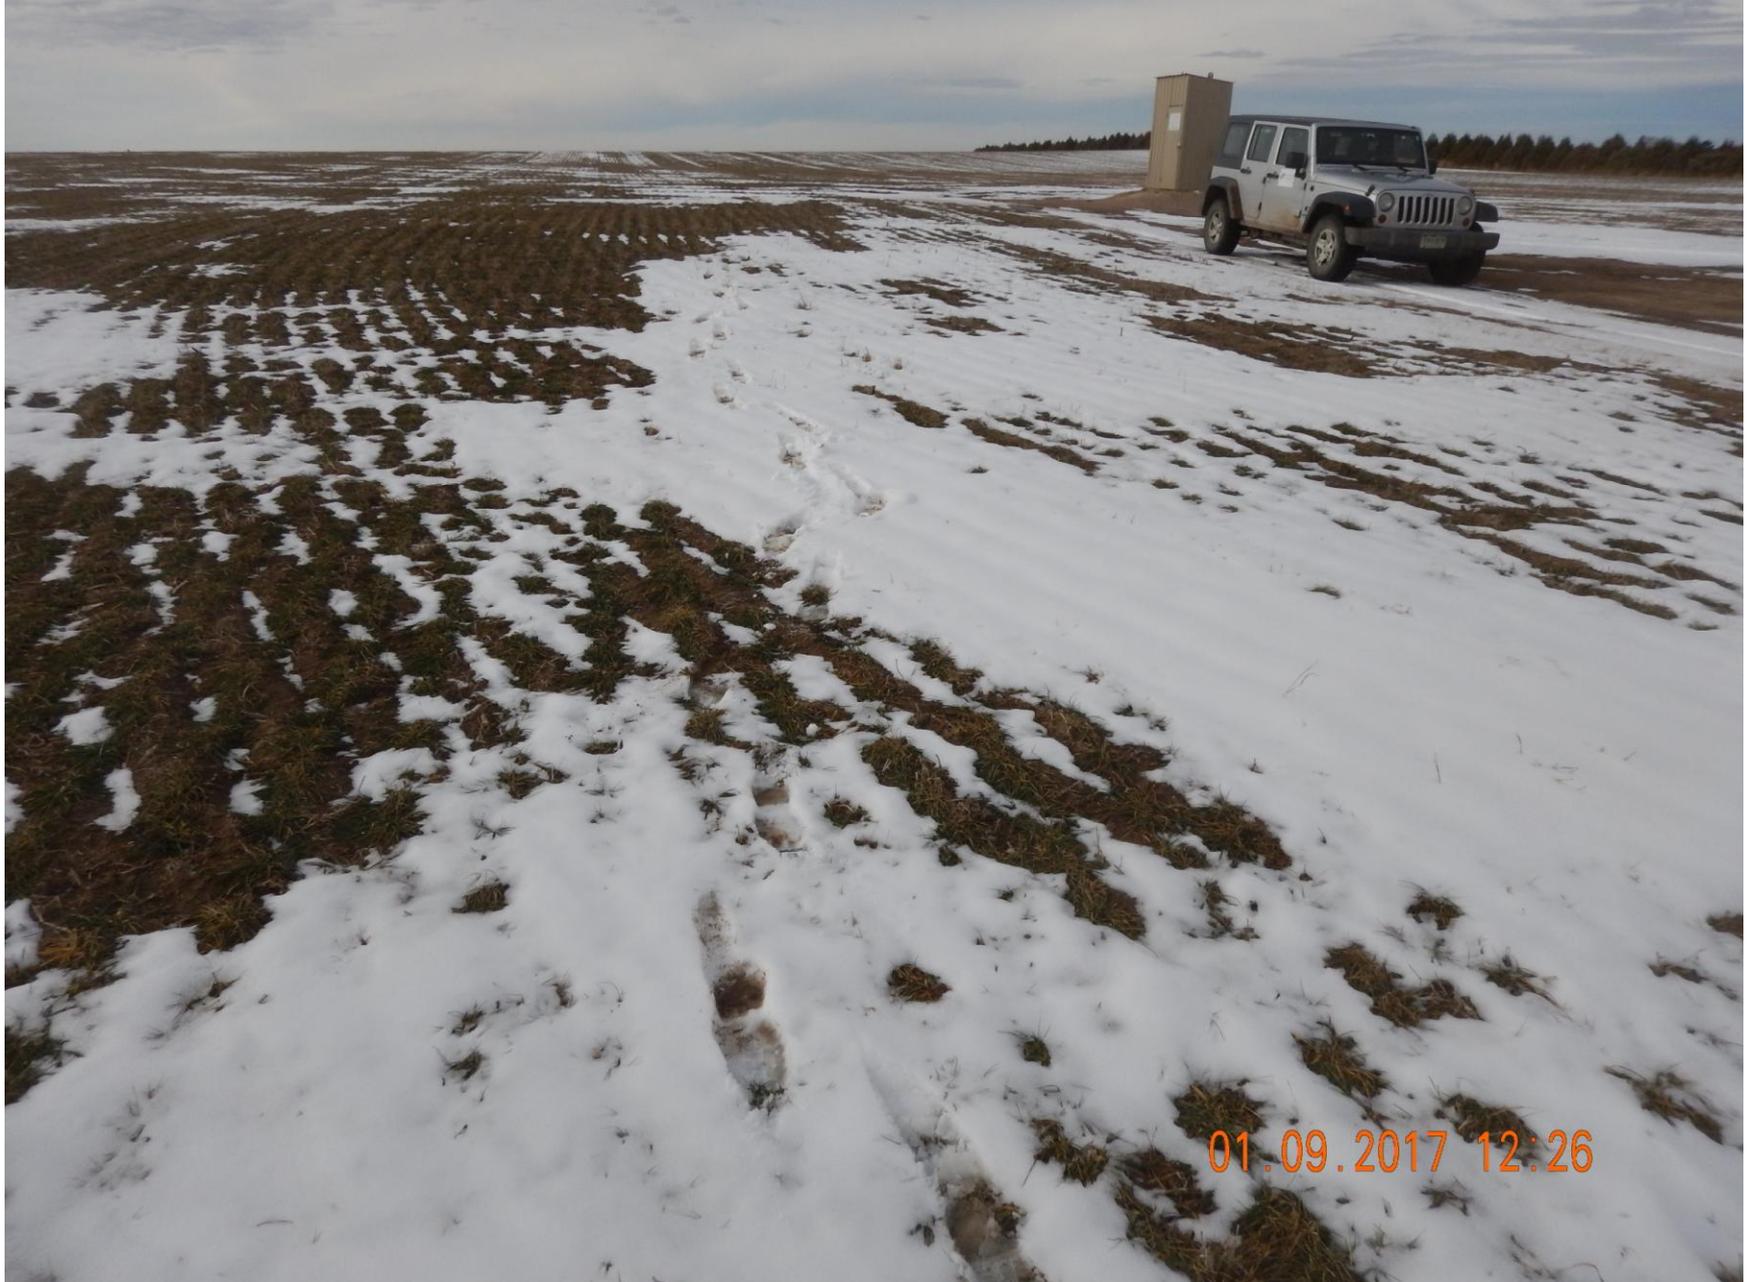
Figure 8: Photo taken from the southeast end of the location, facing west. Photo shows interim and project areas.

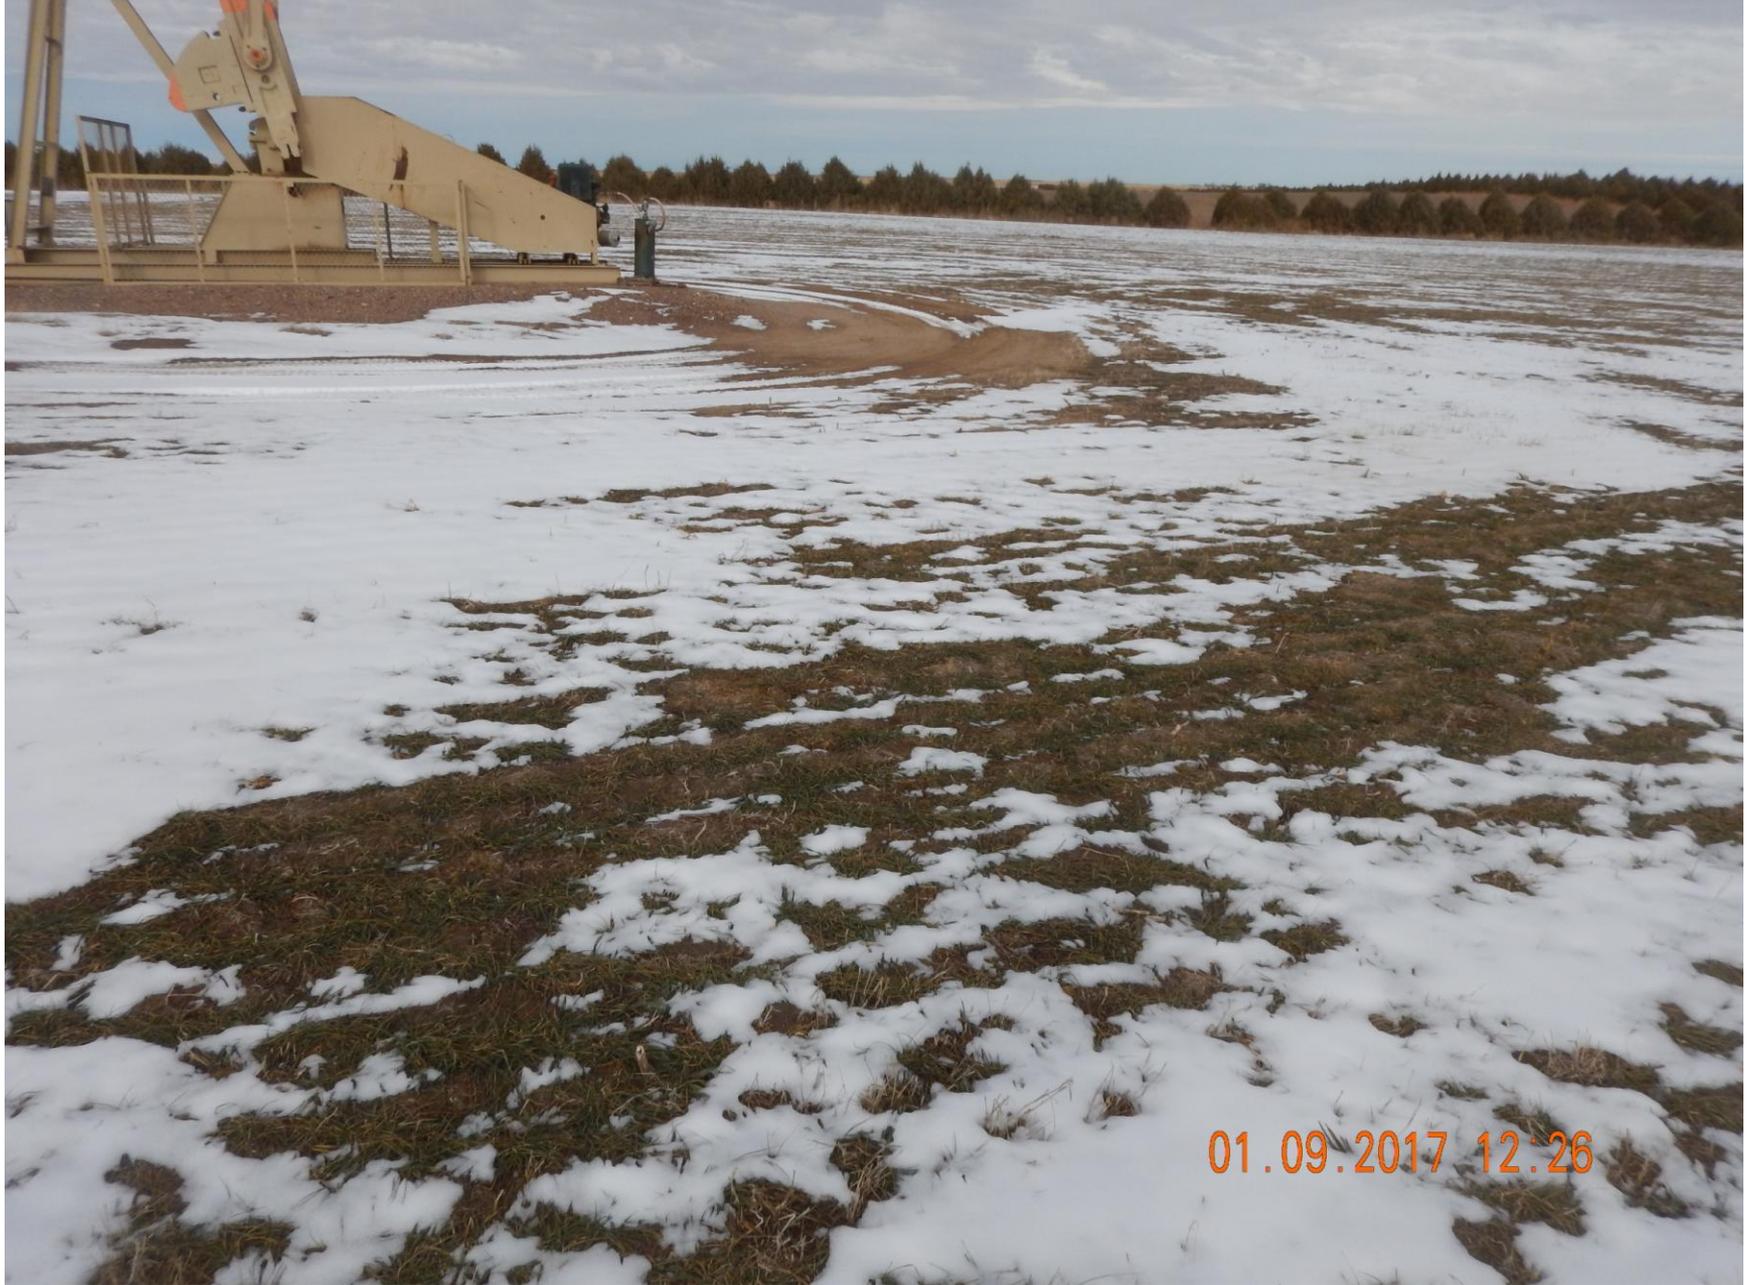
Figure 9: Photo taken from the southeast end of the location, facing north. Photo shows interim and project areas.

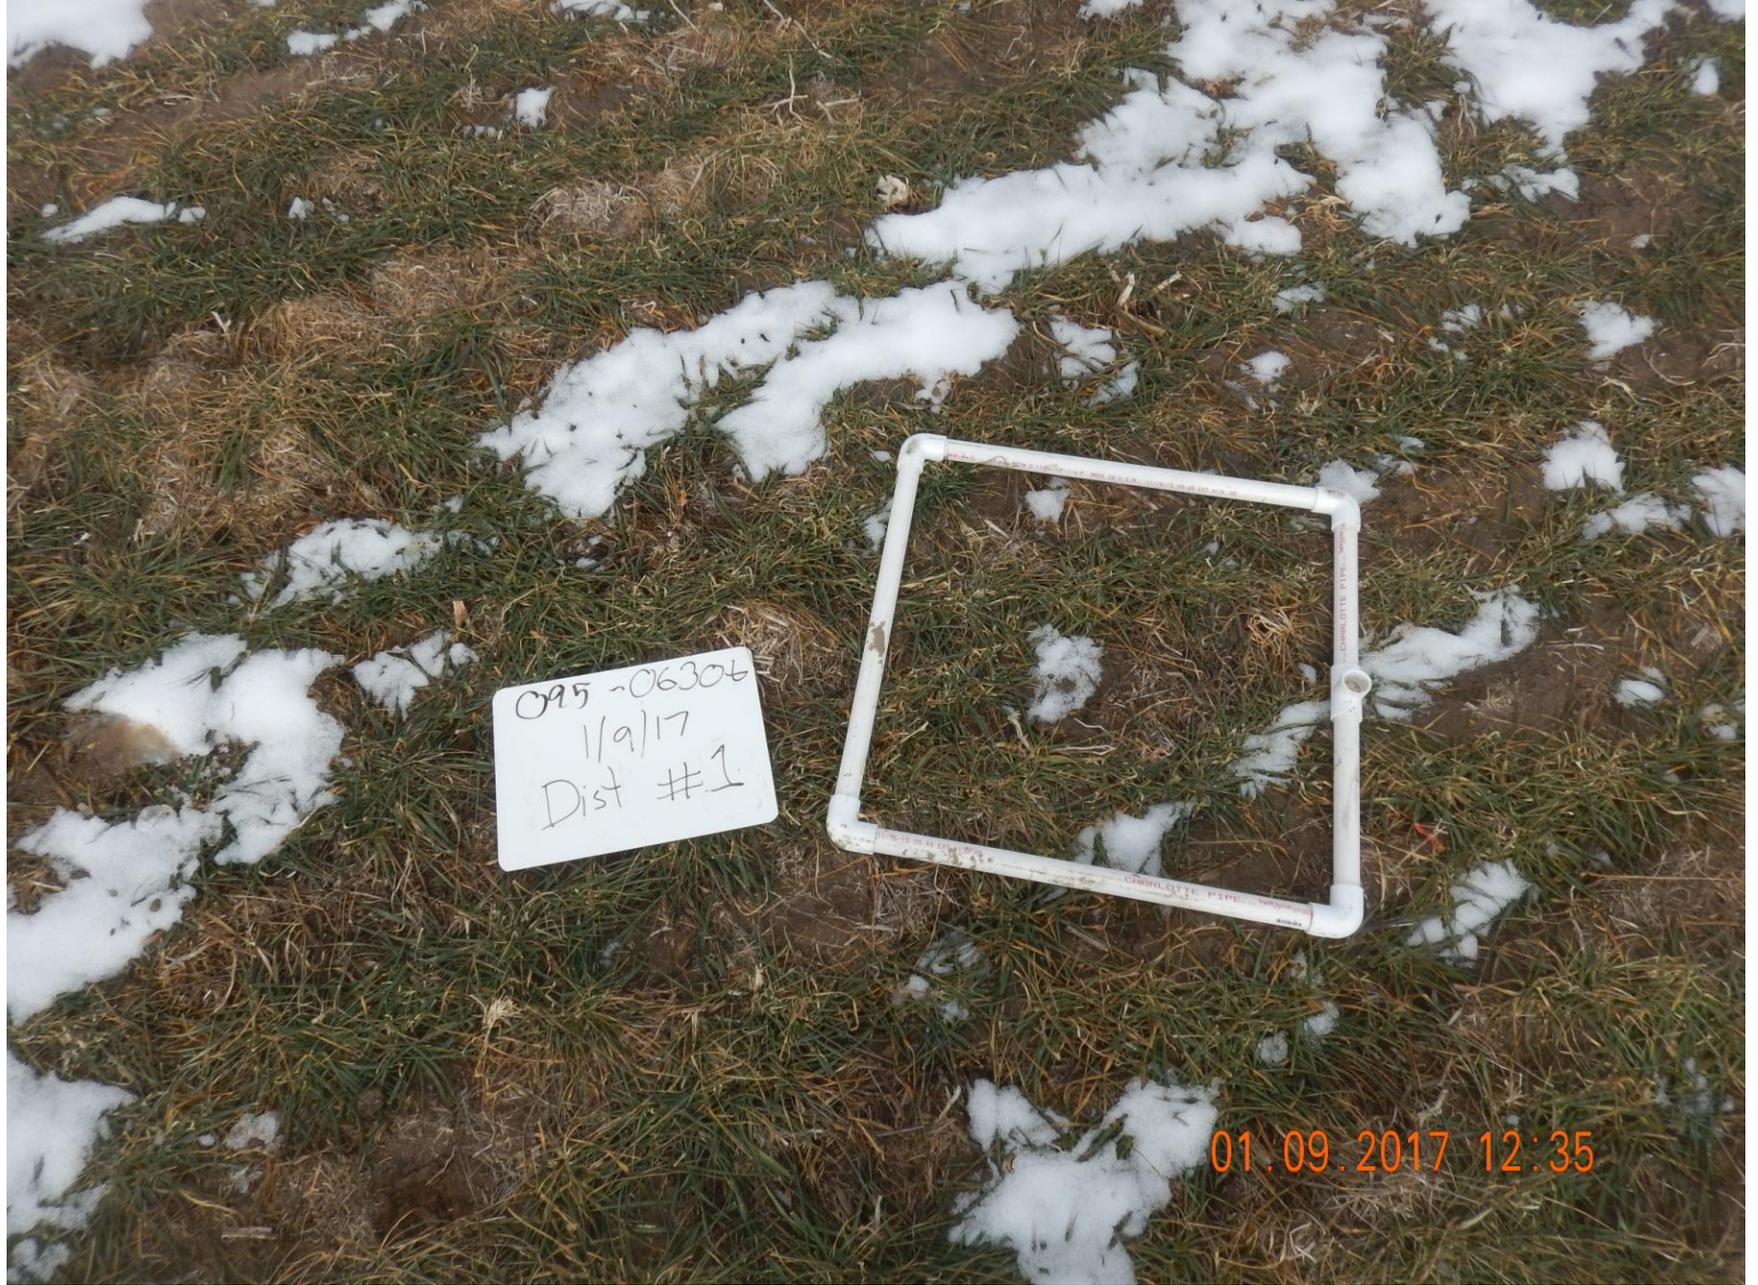
095-06306
1/9/17
Dist #1

Figure 10: Photo taken from the southeast end of the interim area. Photo shows disturbance quadrat #1
