Reclamation Inspection

01/09/2017

Operator: Atlas Resources LLC

Location ID: 421361

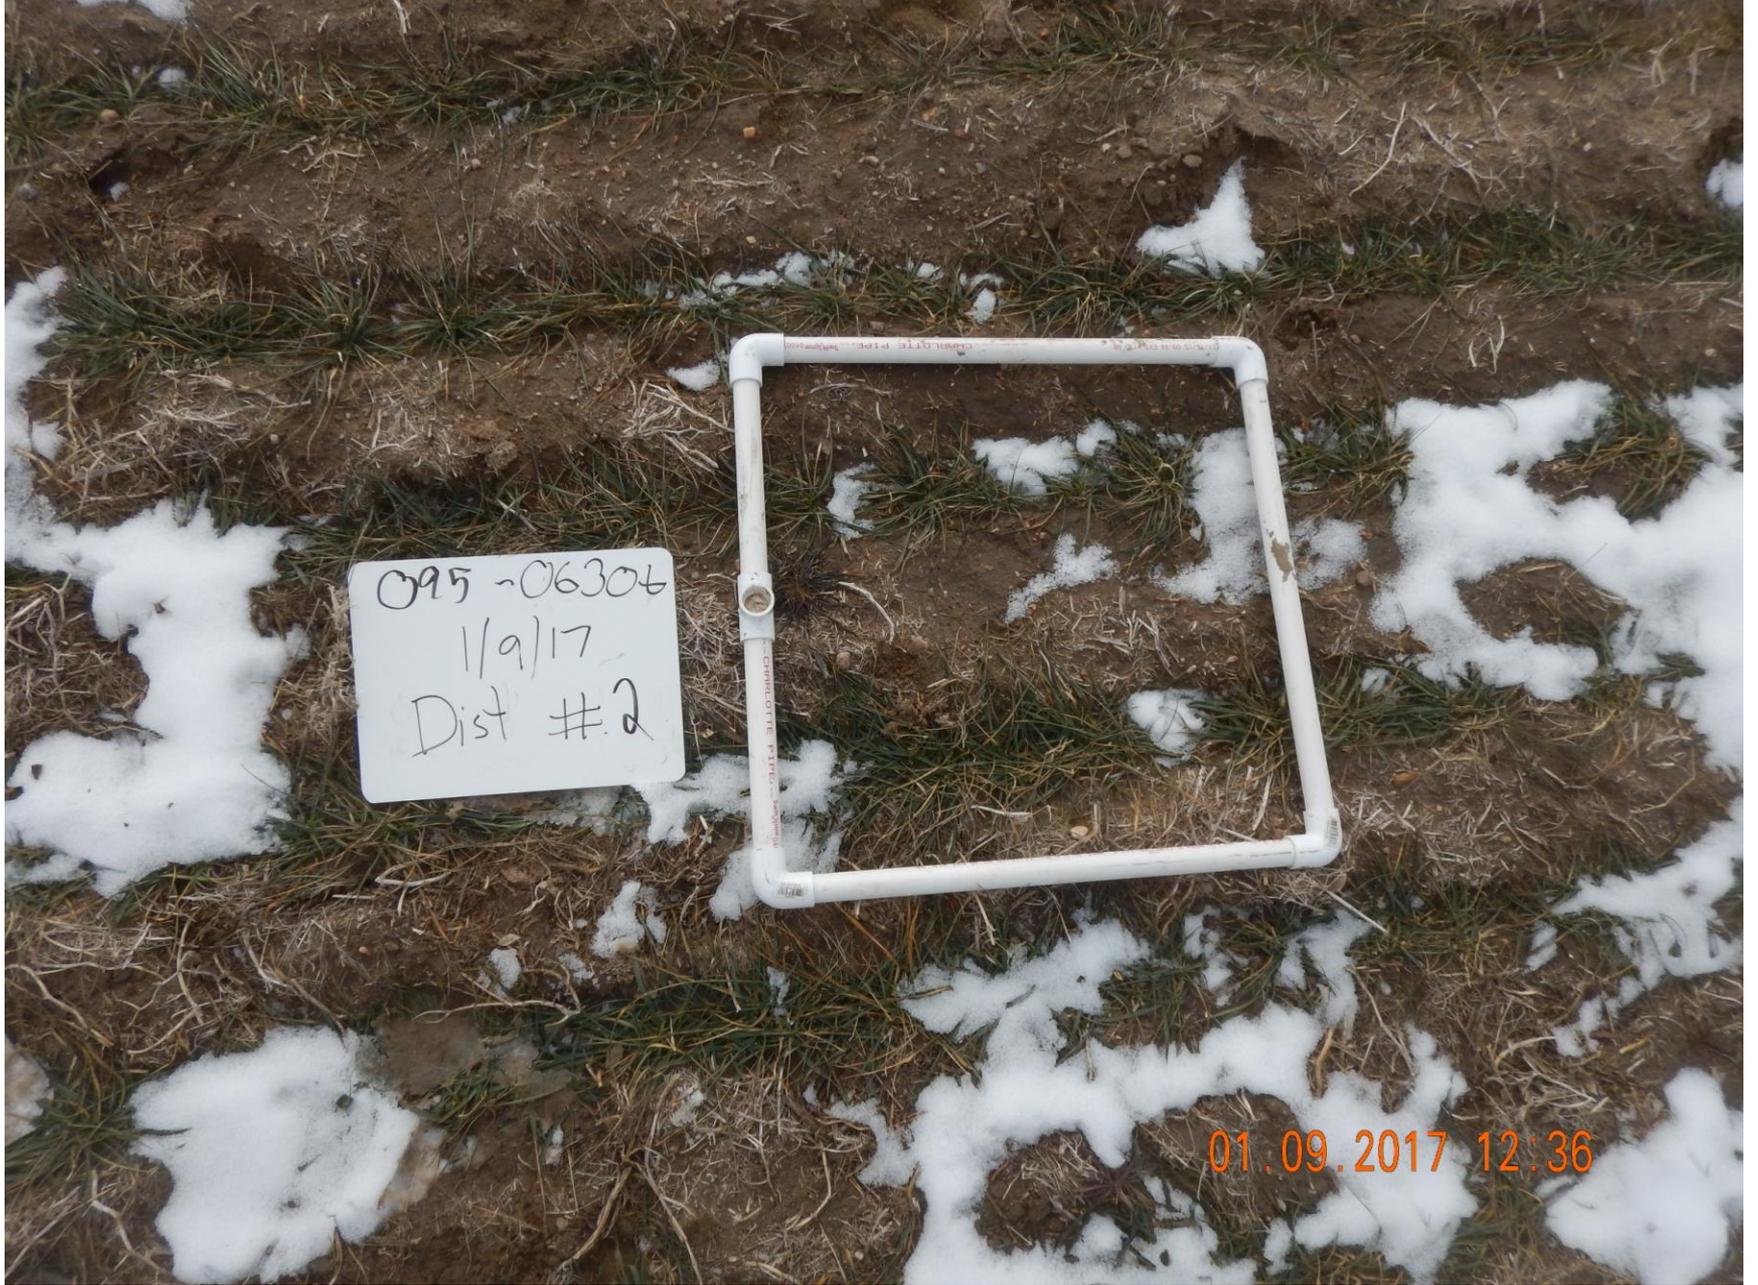
095-06306
1/9/17
Dist #2

Figure 11: Photo taken from the north end of the interim area. Photo shows disturbance quadrat #2

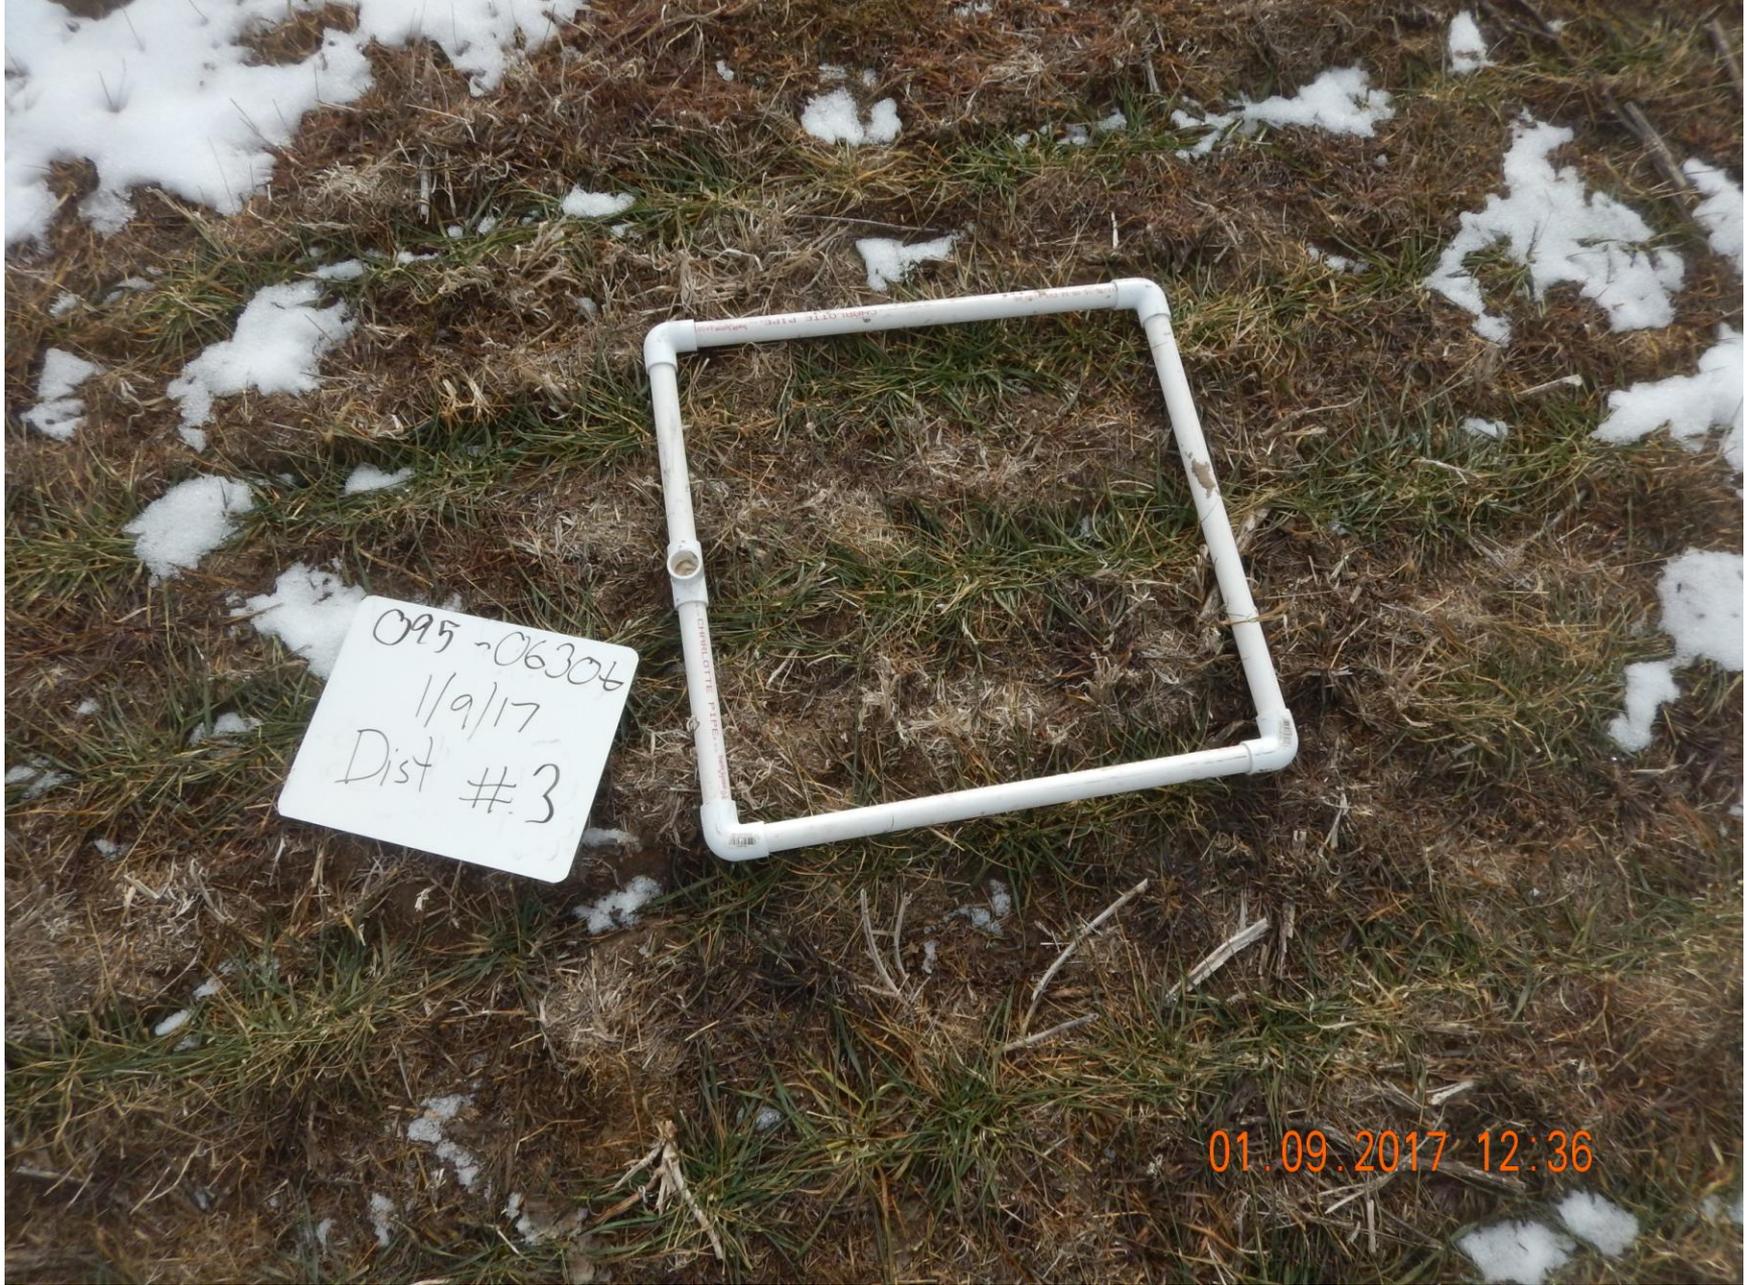
Figure 12: Photo taken from the west end of the interim area. Photo shows disturbance quadrat #3

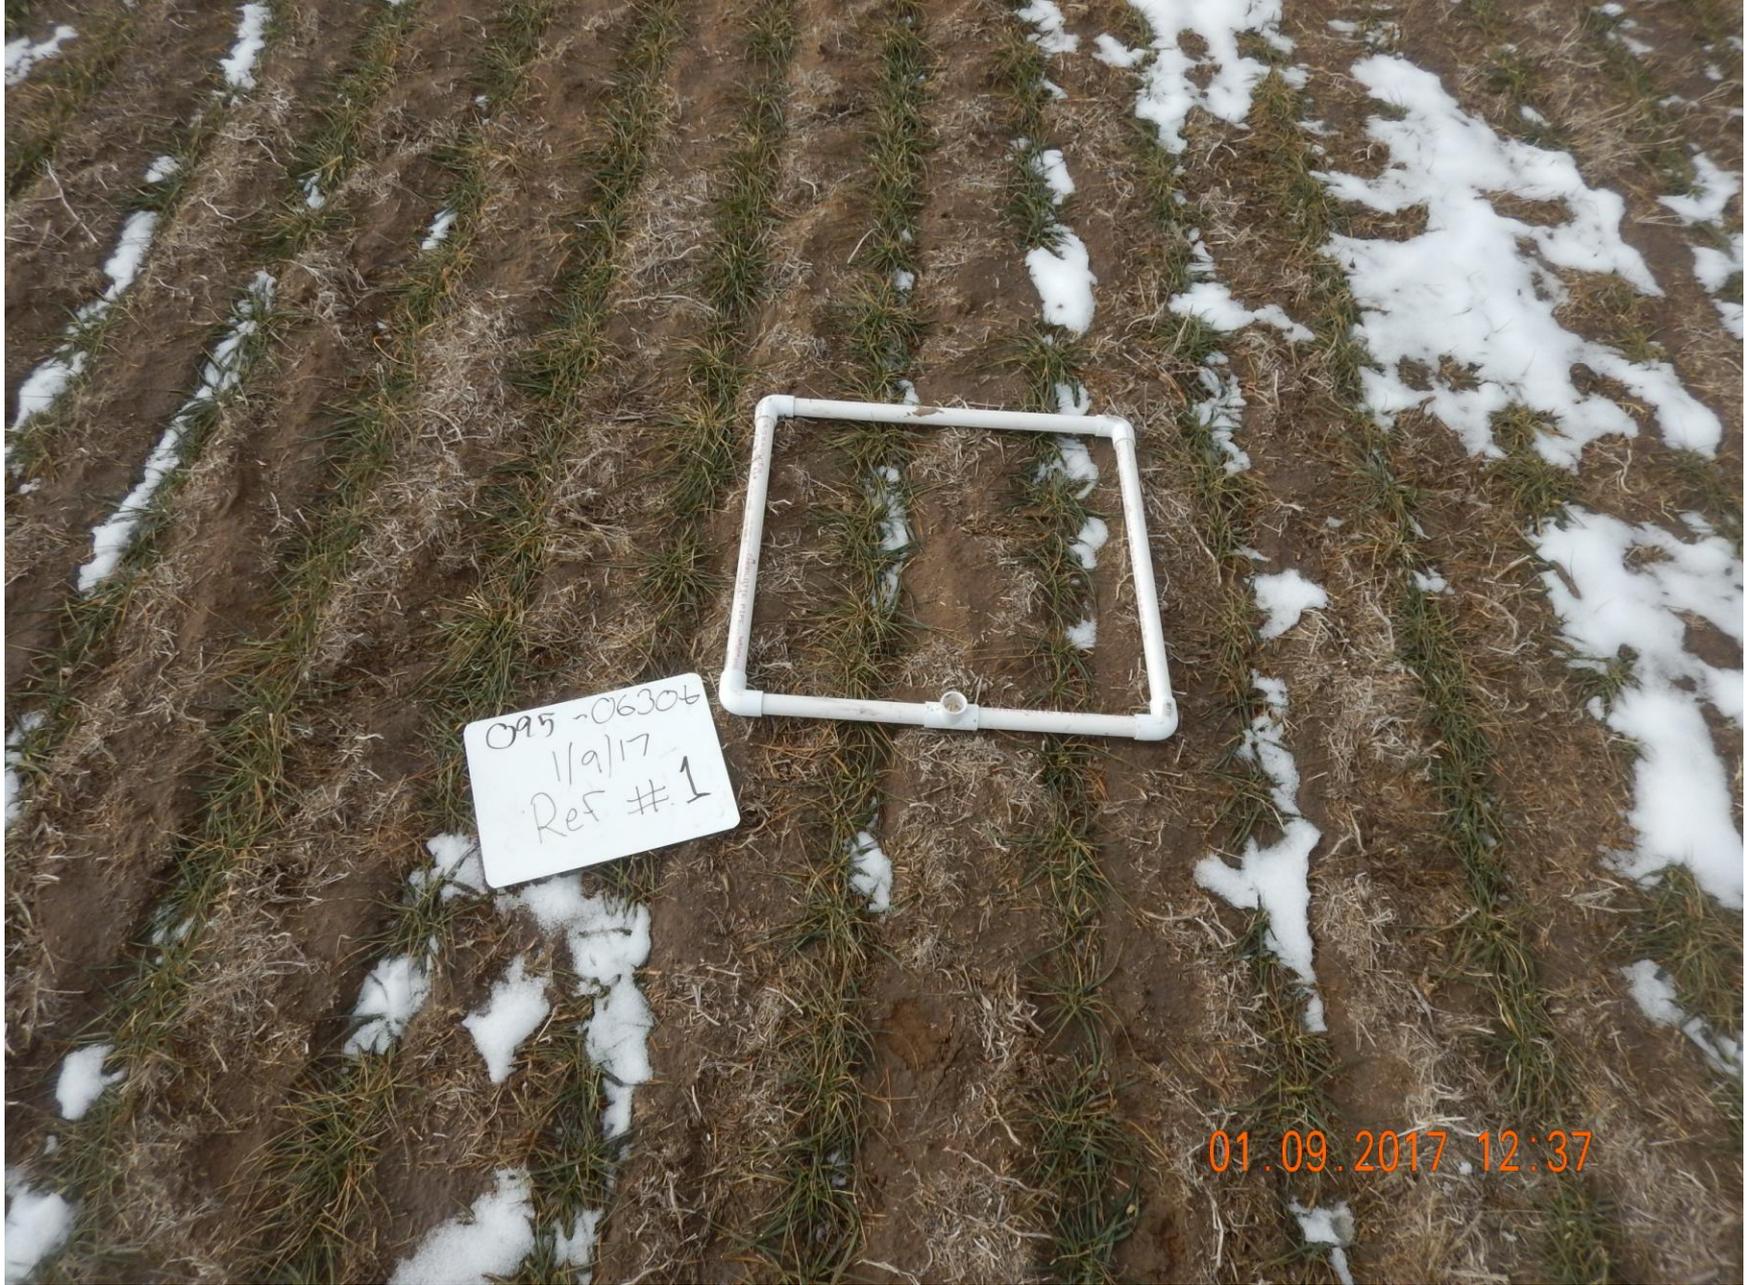
Figure 13: Photo taken from the reference area, west of the location. Photo shows Reference quadrat #1

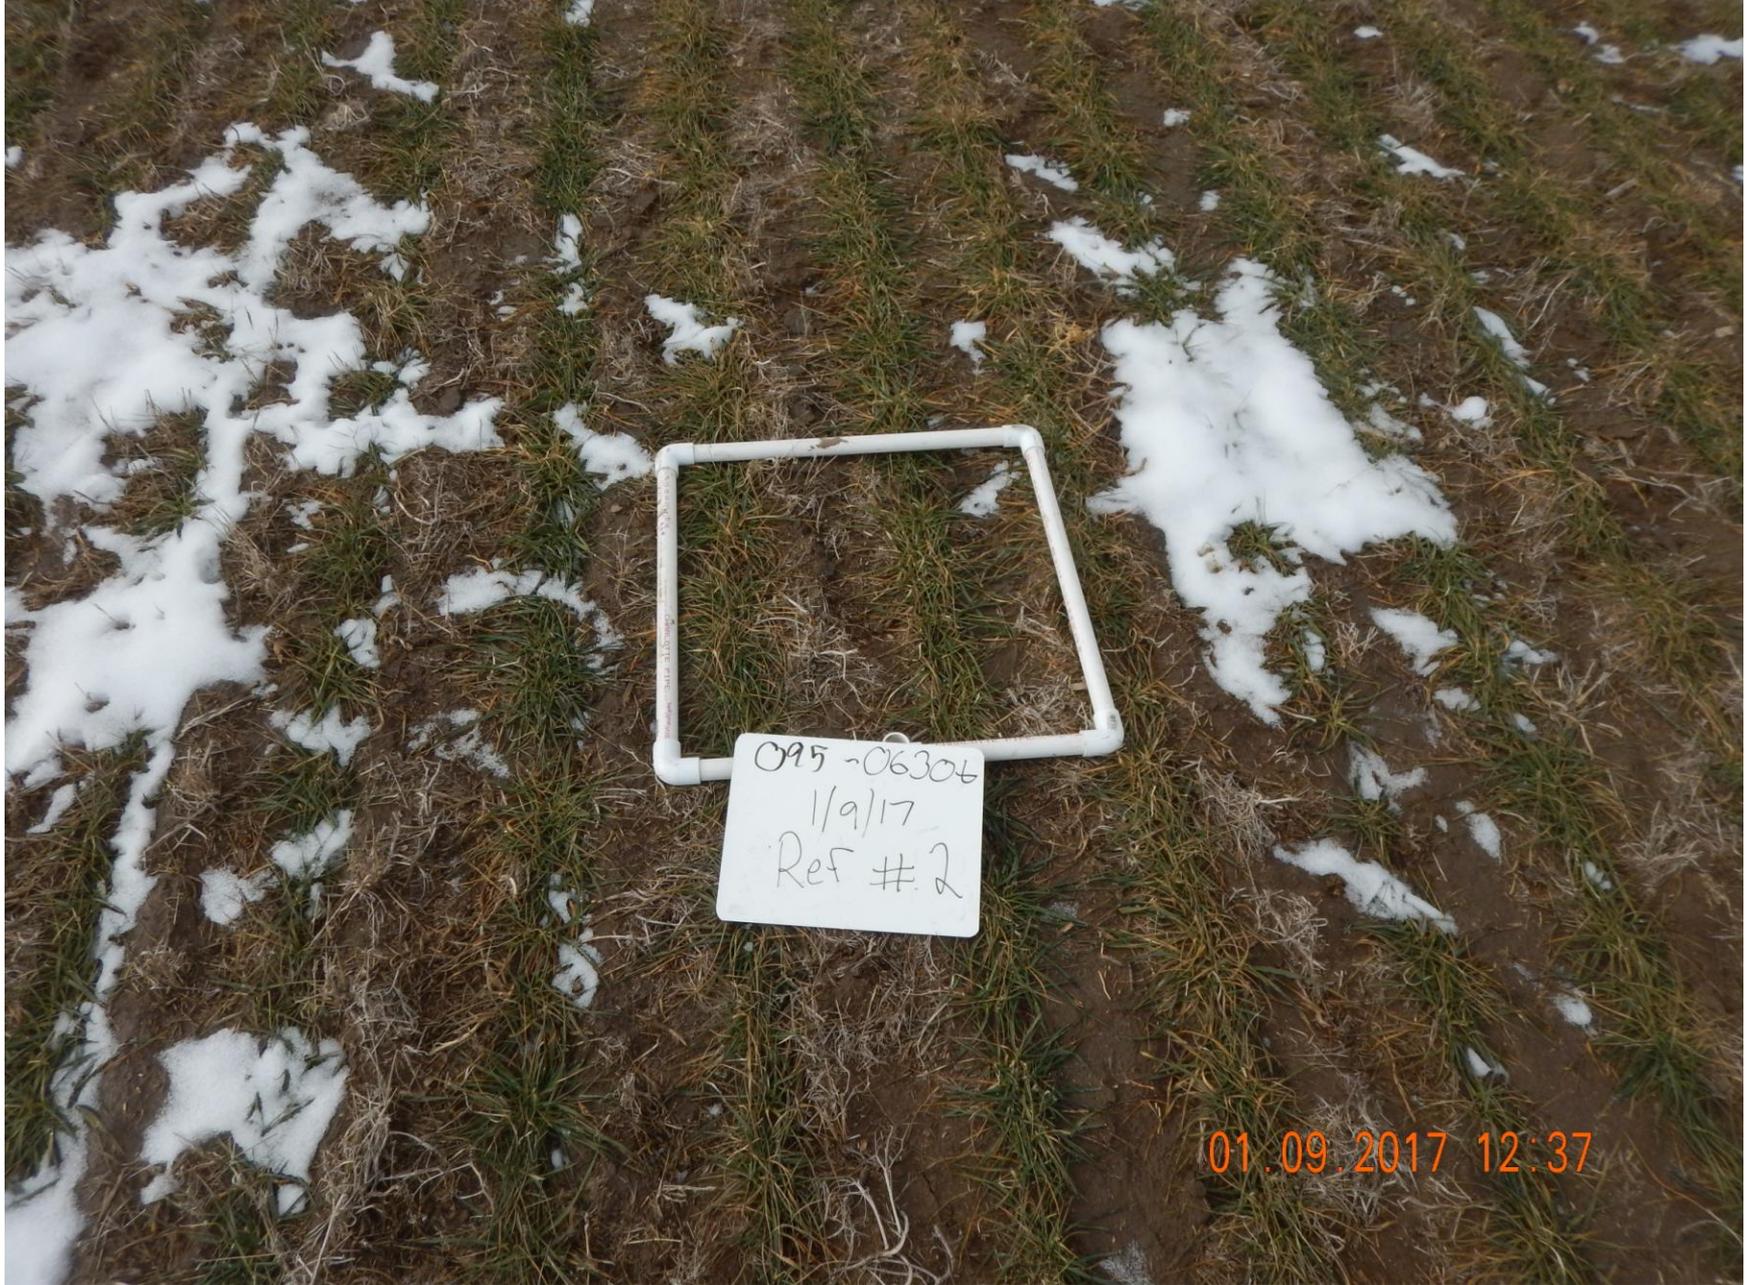
Figure 14: Photo taken from the reference area, north of the location. Photo shows Reference quadrat #2

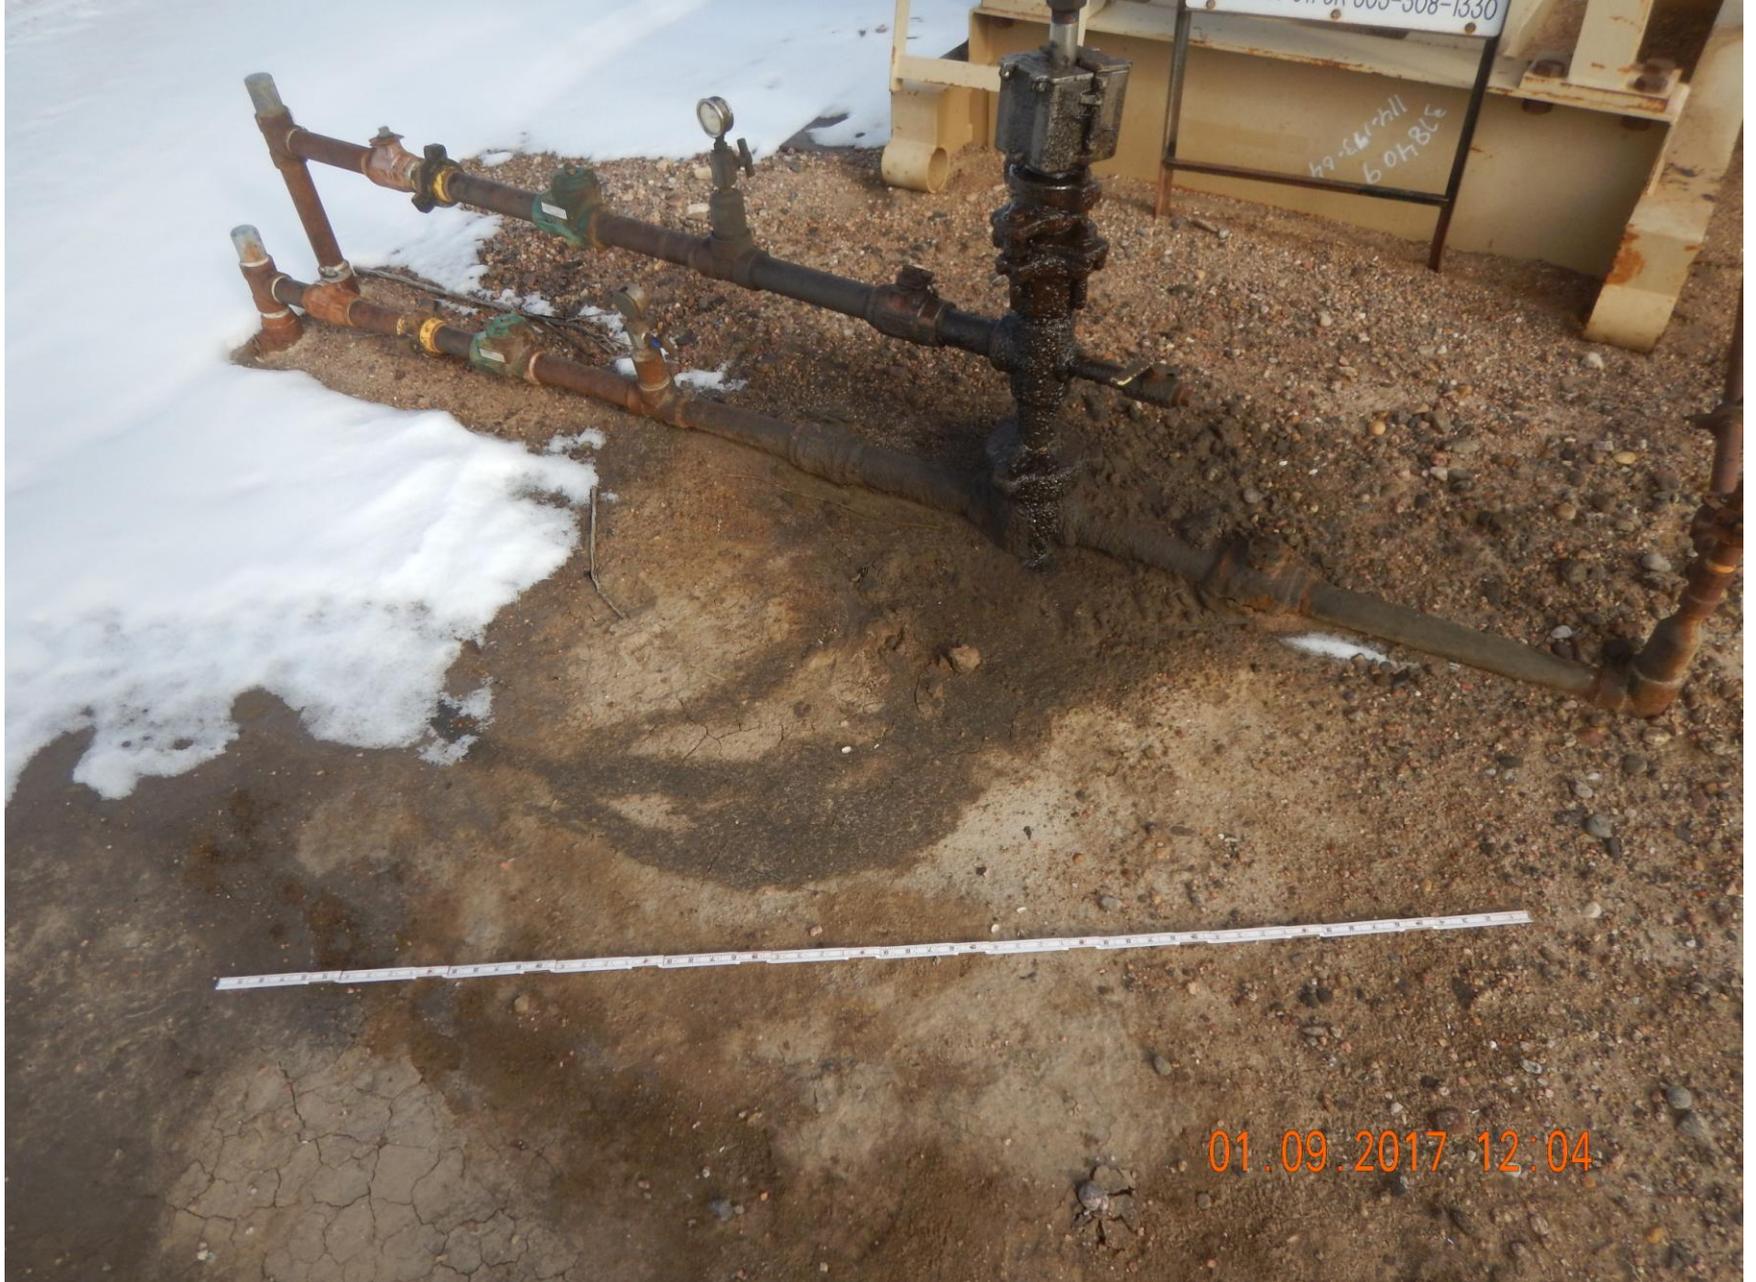
Figure 15: Photo taken at the well head. Photo shows discolored soil. Discolored soil appears to be being transported away from well via stormwater. Soil will need to be cleaned. 6 foot measuring stick for reference.
