Interim Reclamation and Stormwater Inspection

COLORADO
Oil & Gas Conservation
Commission
Department of Natural Resources

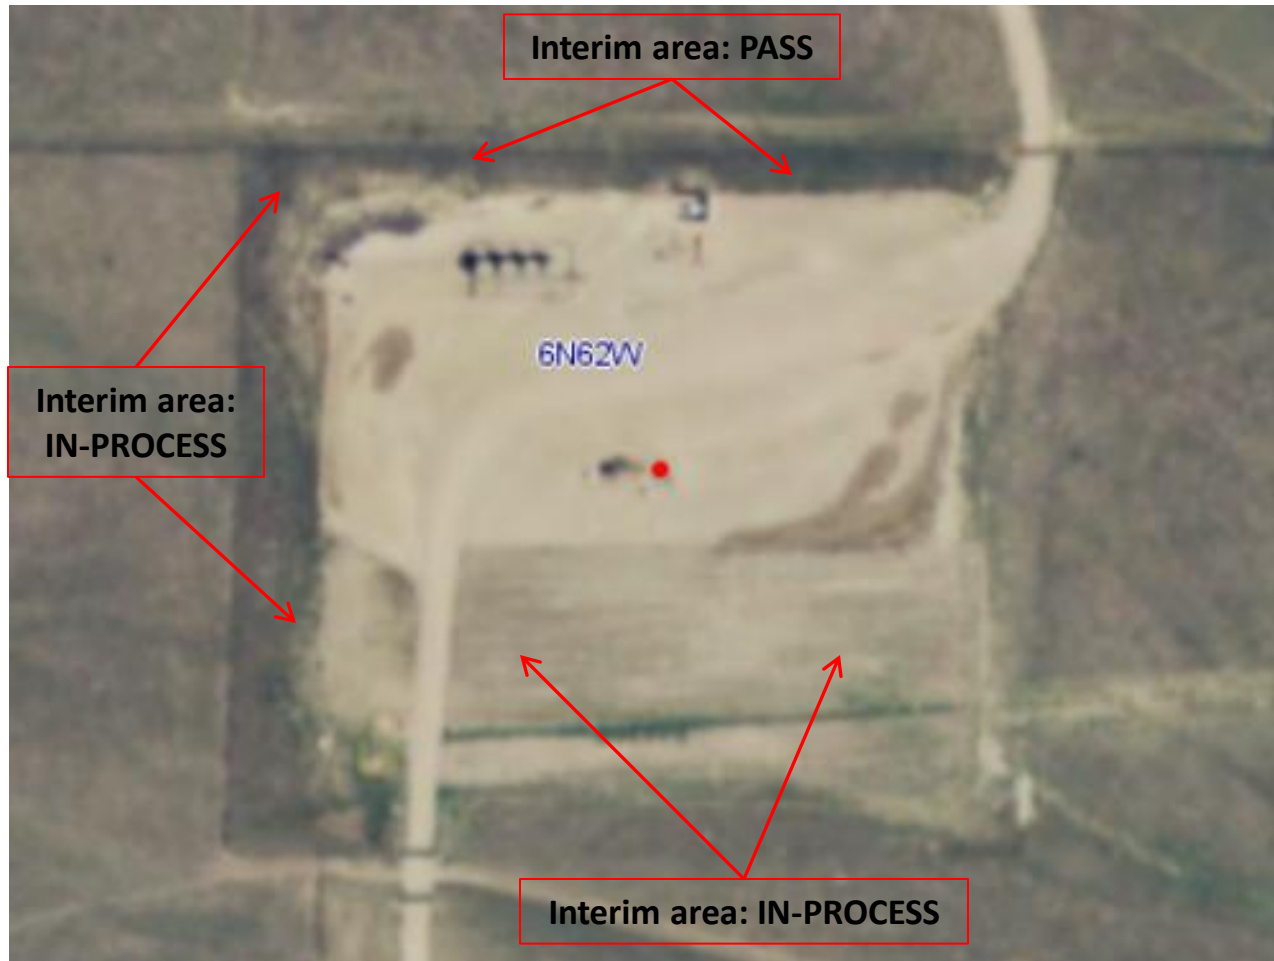
Aerial imagery taken 2015 using COGCC GISOnline illustrating interim reclamation areas.

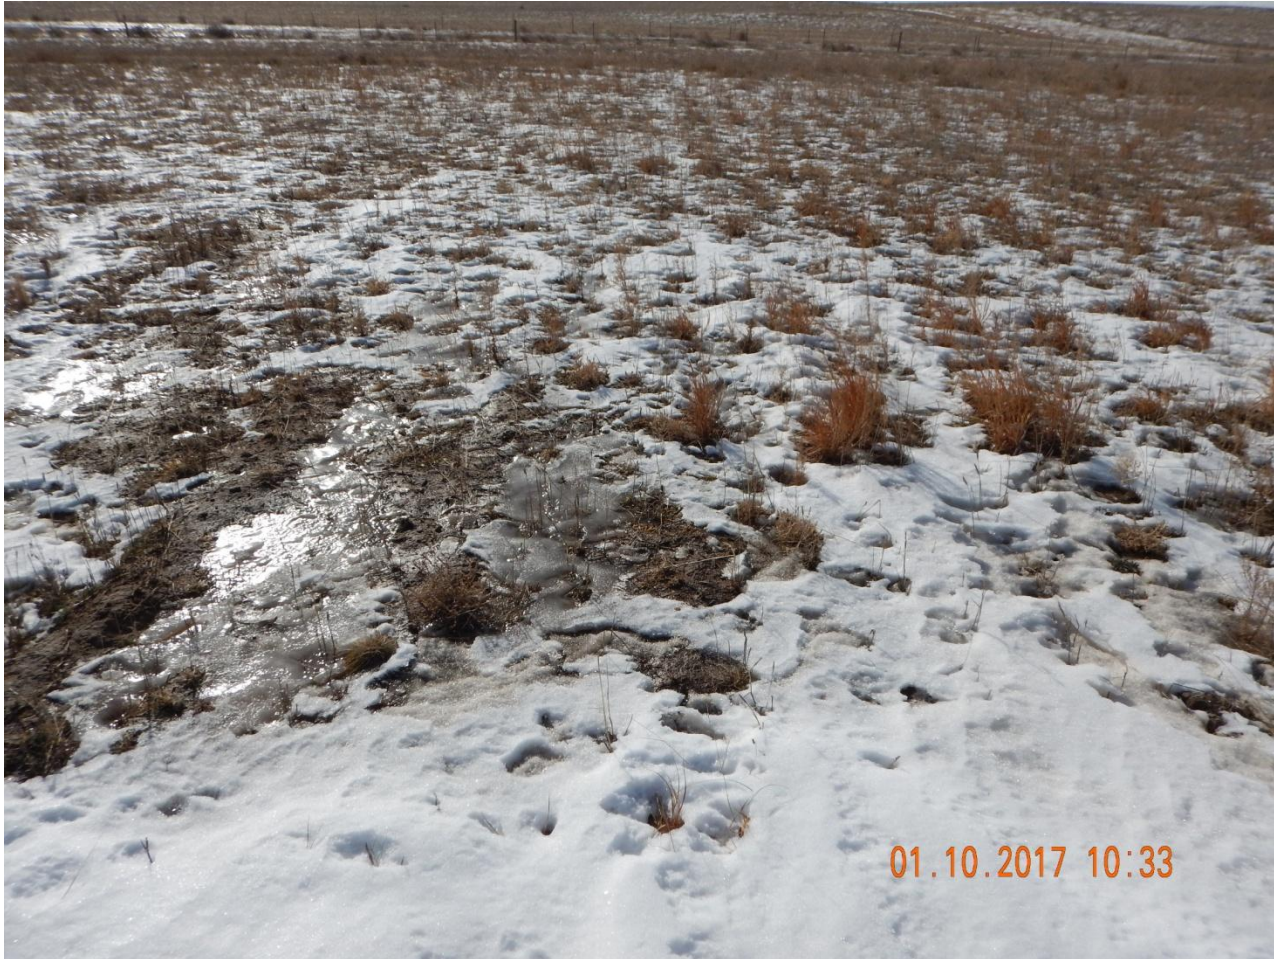
Photo 1. Photo taken from the southern interim area, facing South. The southern interim area is progressing towards reflective percent plant cover of reference areas. However, areas do have weedy, annual plant species like Kochia that remain dominant. Location will be inspected in the future to comply with Rule 1003 standards.

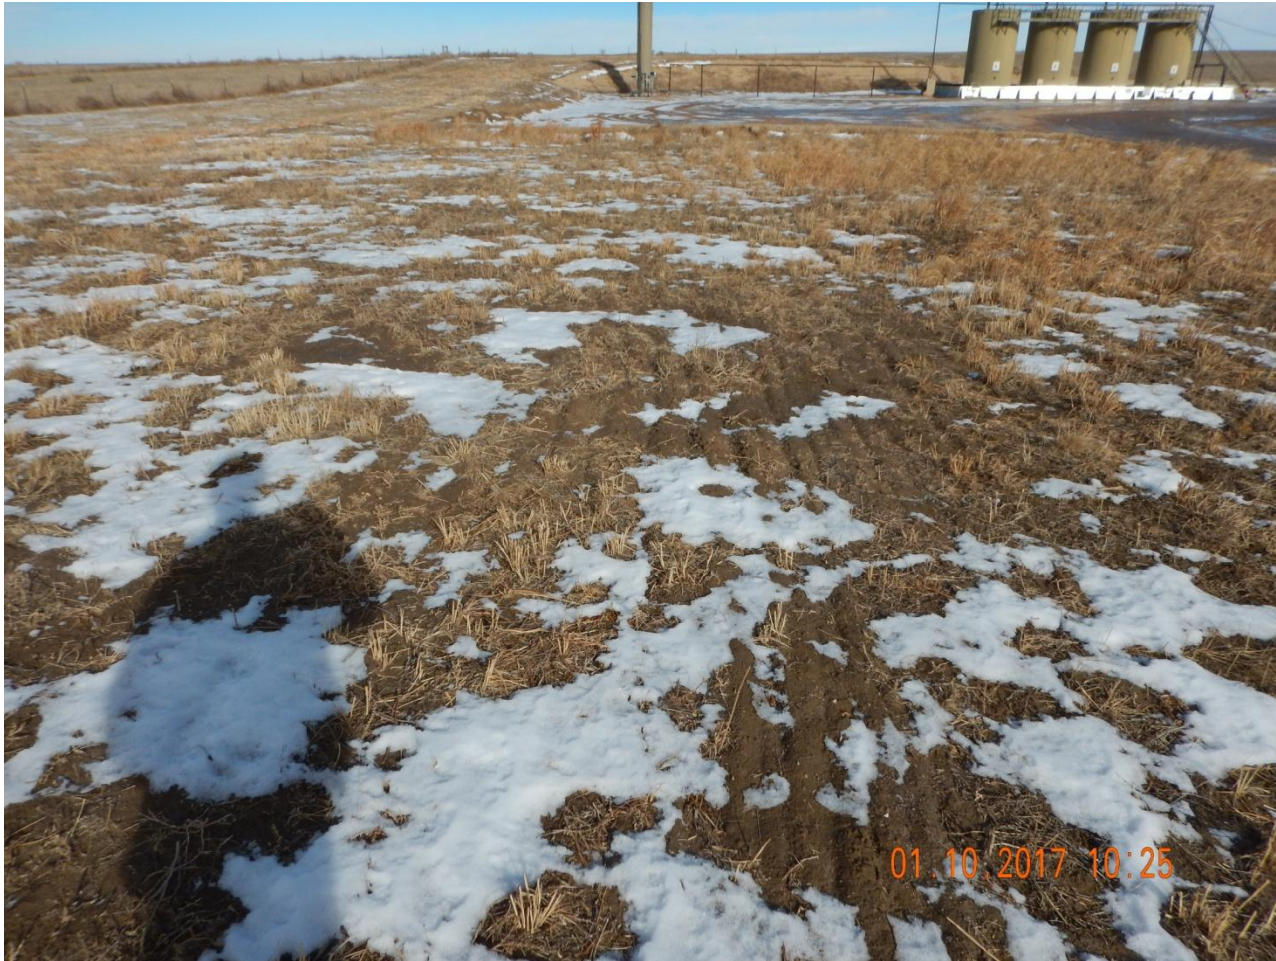
Photo 2. Photo taken from the southwest interim area, facing North. The southwest interim area is progressing towards reflective percent plant cover of reference areas. Location mowed to control undesirable weedy species like Kochia.

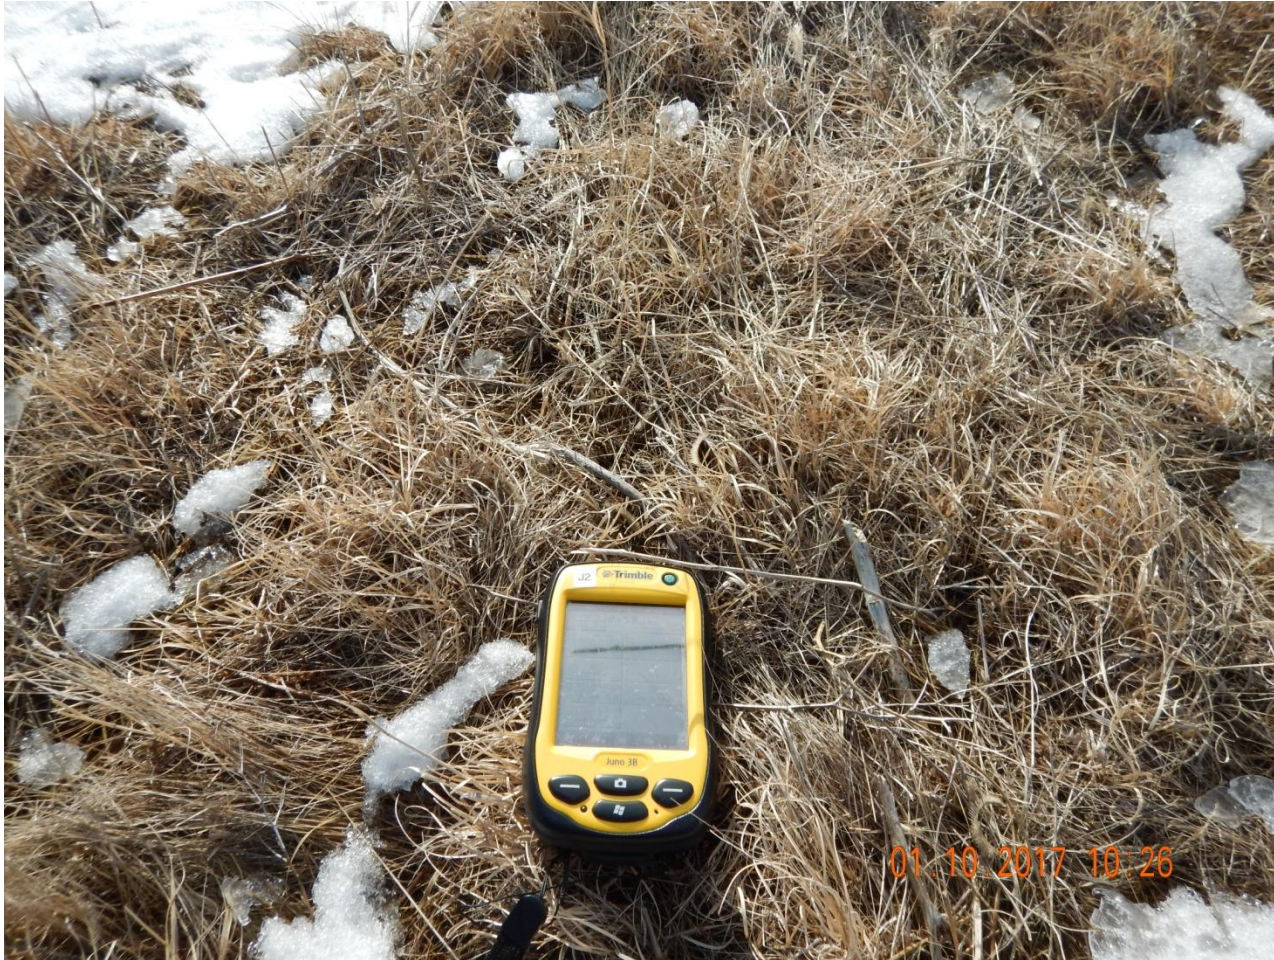
Photo 3. Photo taken from the southwest interim. Photo illustrating native, perennial vegetative growth, primarily blue grama (*Bouteloua gracilis*).

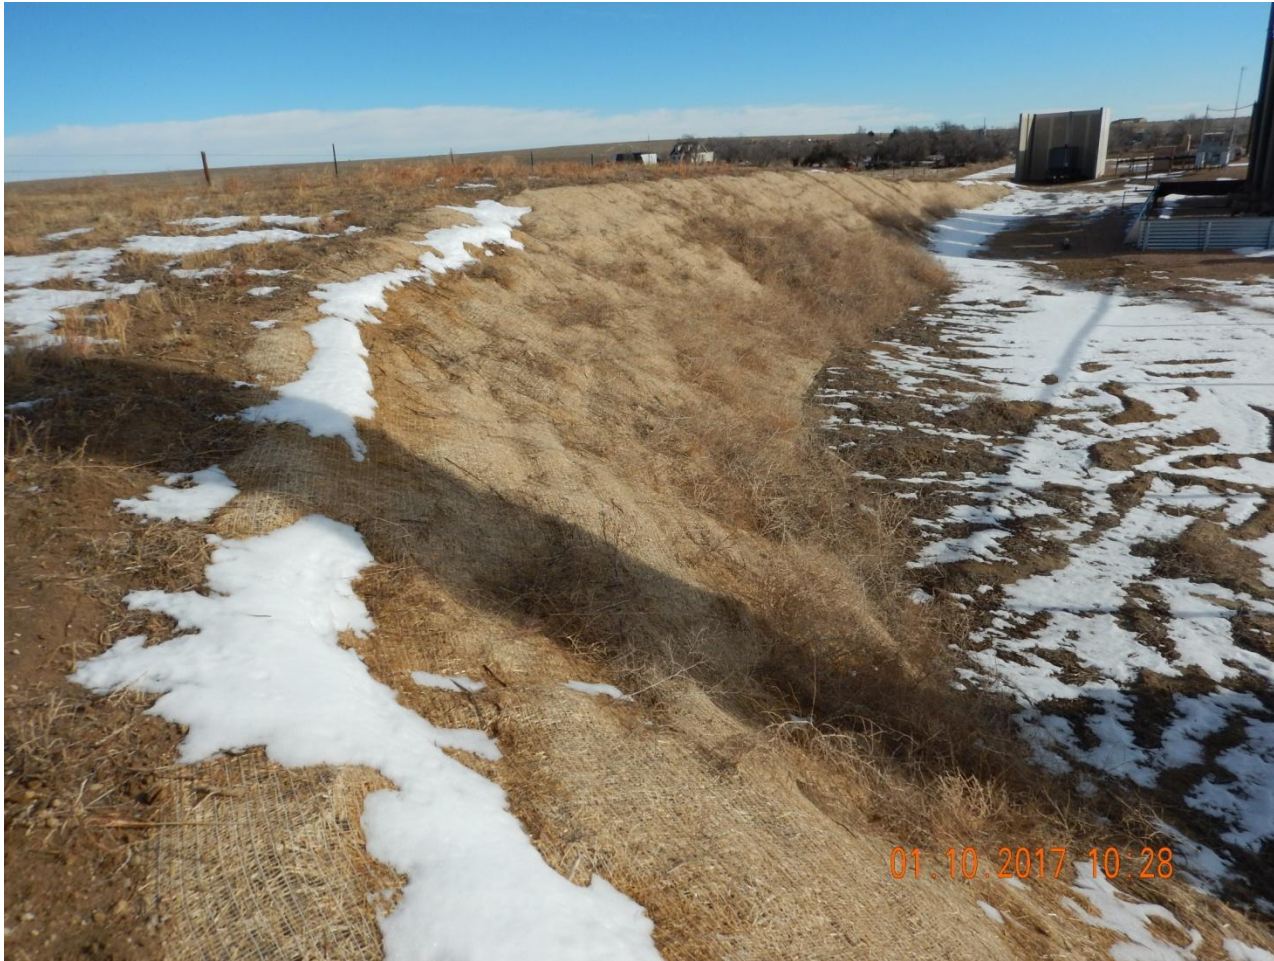
Photo 4. Photo taken from the northwest location, facing East. Cut slope appears to be stabilized using a blanket even though no observable plant growth has established.

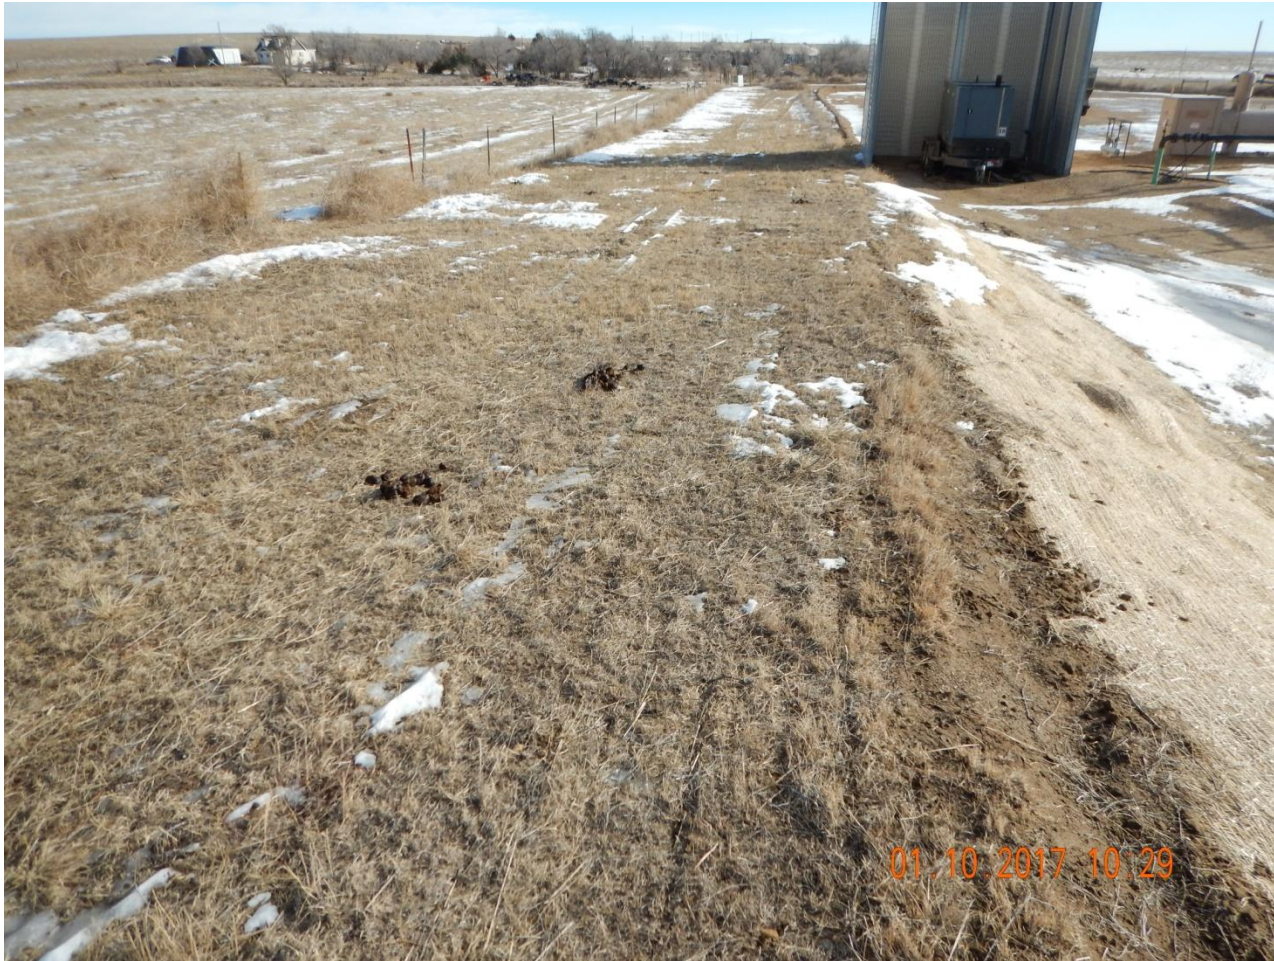
Photo 5. Photo taken from the northern interim area, facing East. The interim area appears to have sufficient vegetative cover that is reflective of reference areas.

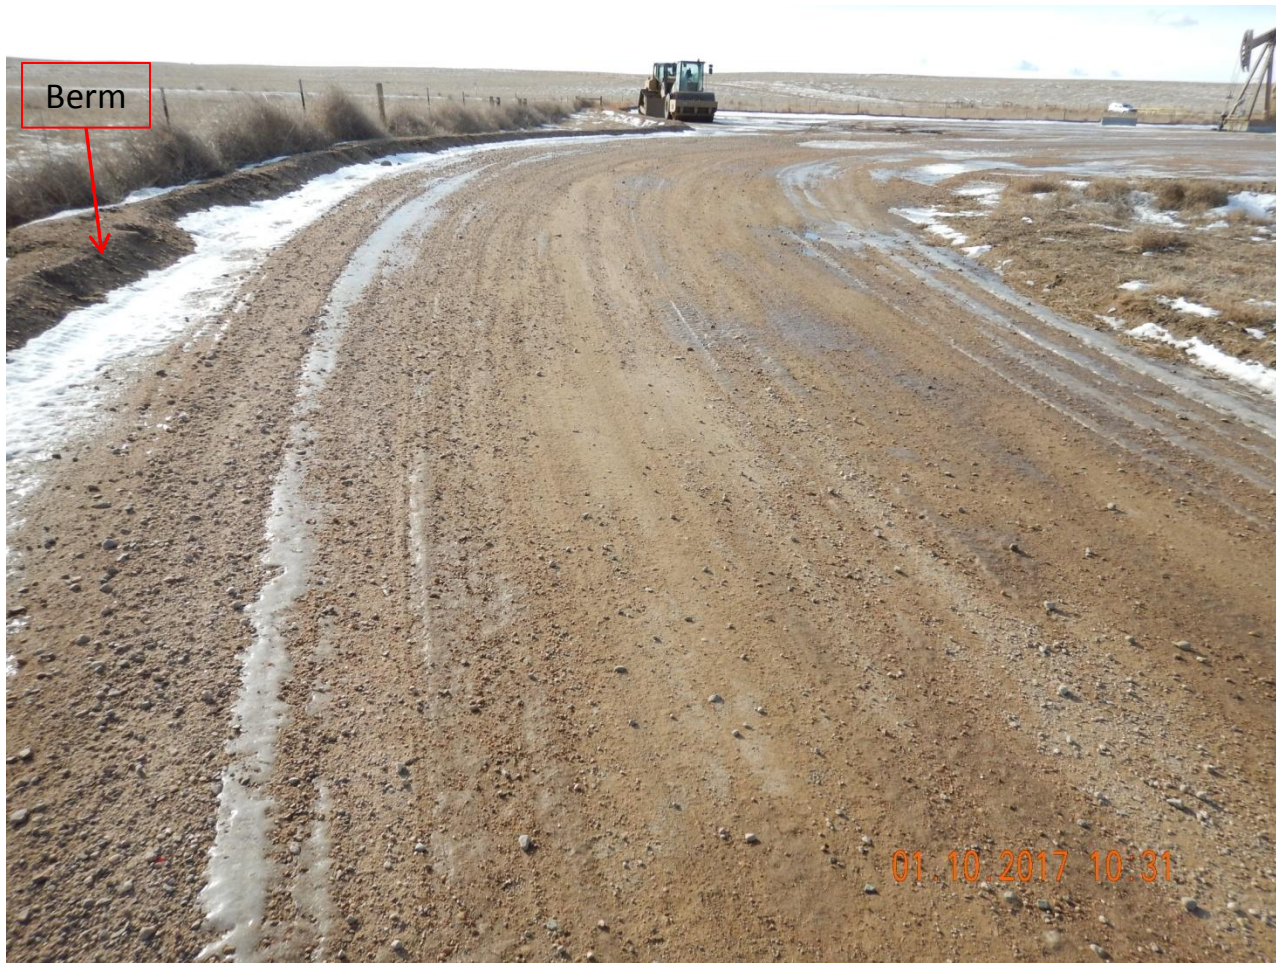
Photo 6. Photo taken from entrance of location, facing South. Location has a berm ~12" in height built around the southern and eastern perimeter of the location. However, no structural stormwater BMP was observed at the potential discharge point which would appear to be at the entrance.

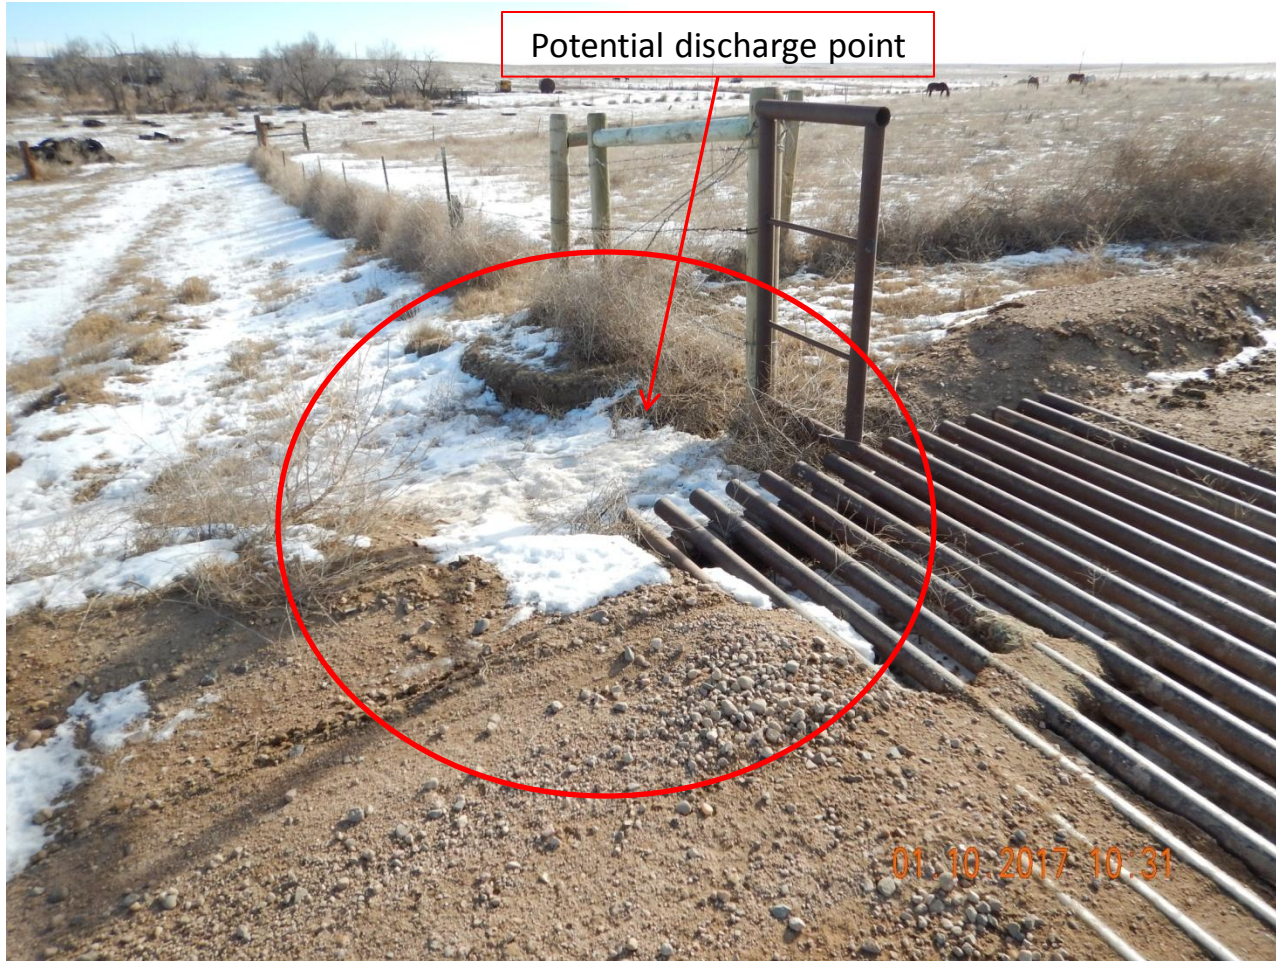
Photo 7. Photo taken from entrance of location, facing East. Location has a berm ~12" in height built around the southern and eastern perimeter of the location. However, no structural stormwater BMP was observed at the potential discharge point which would appear to be at the entrance.
