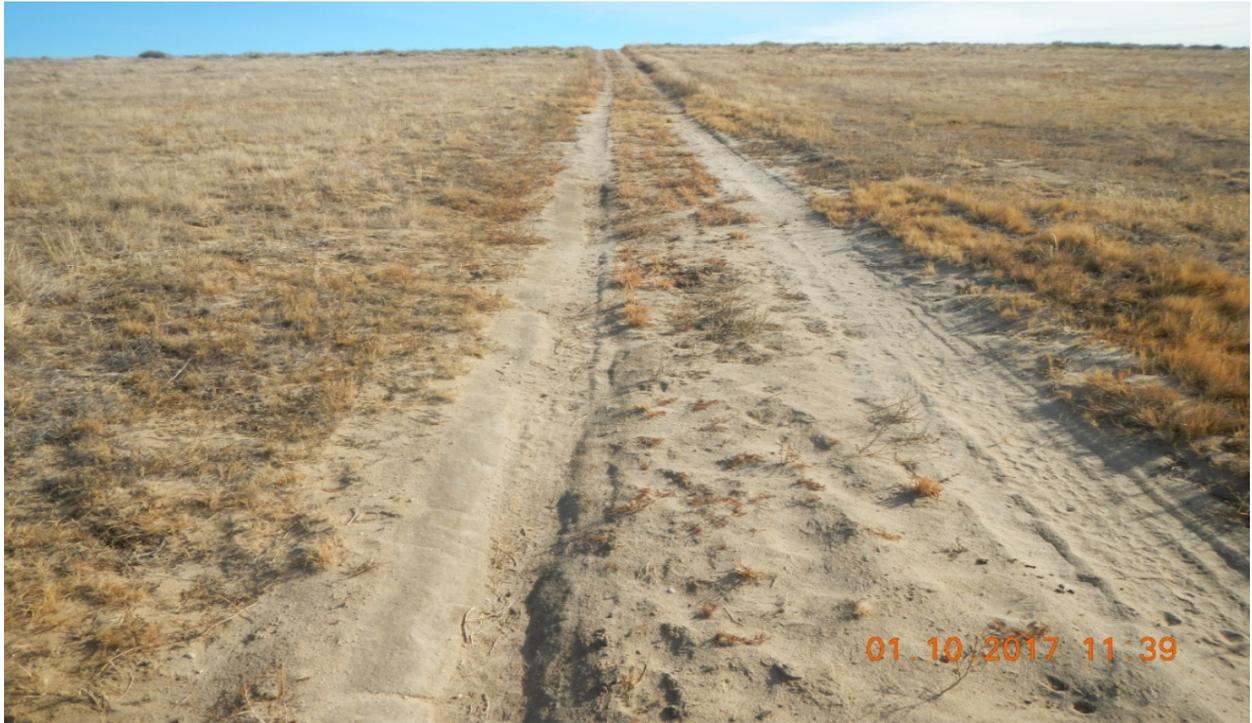
photo 1: Facing east at the beginning of the access road which is not included in the variance request.

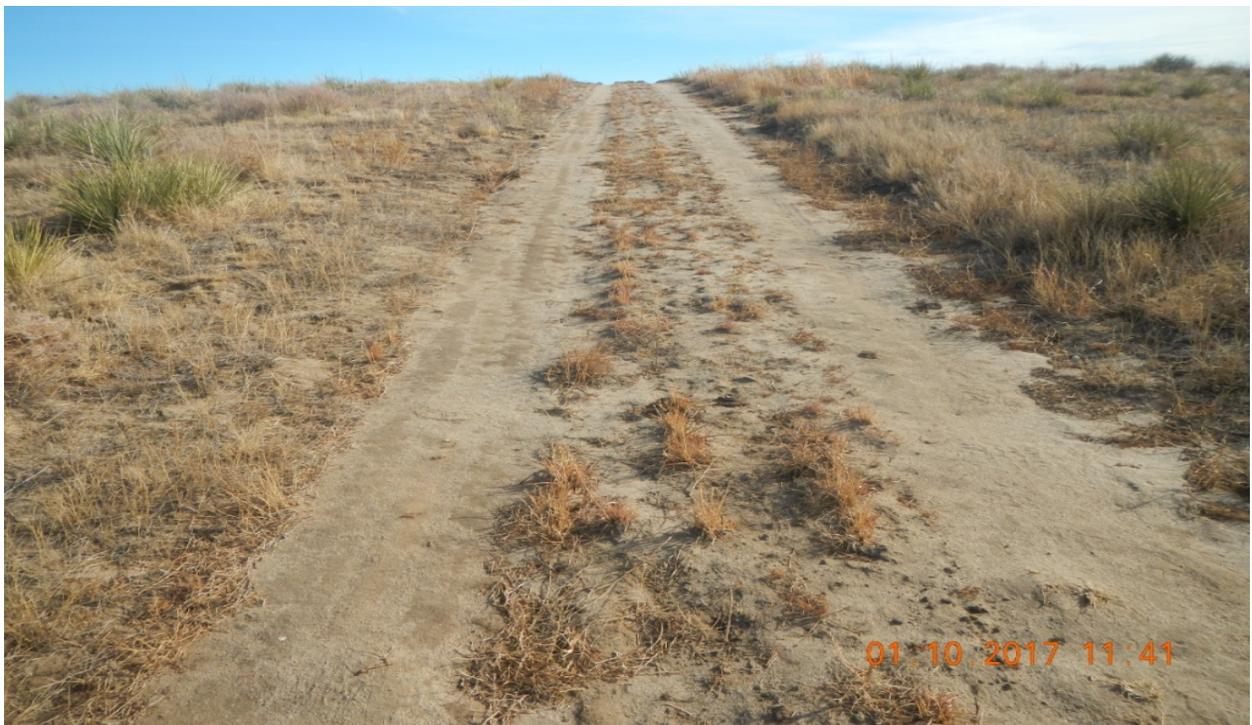
photo 2: Facing east along the access road.

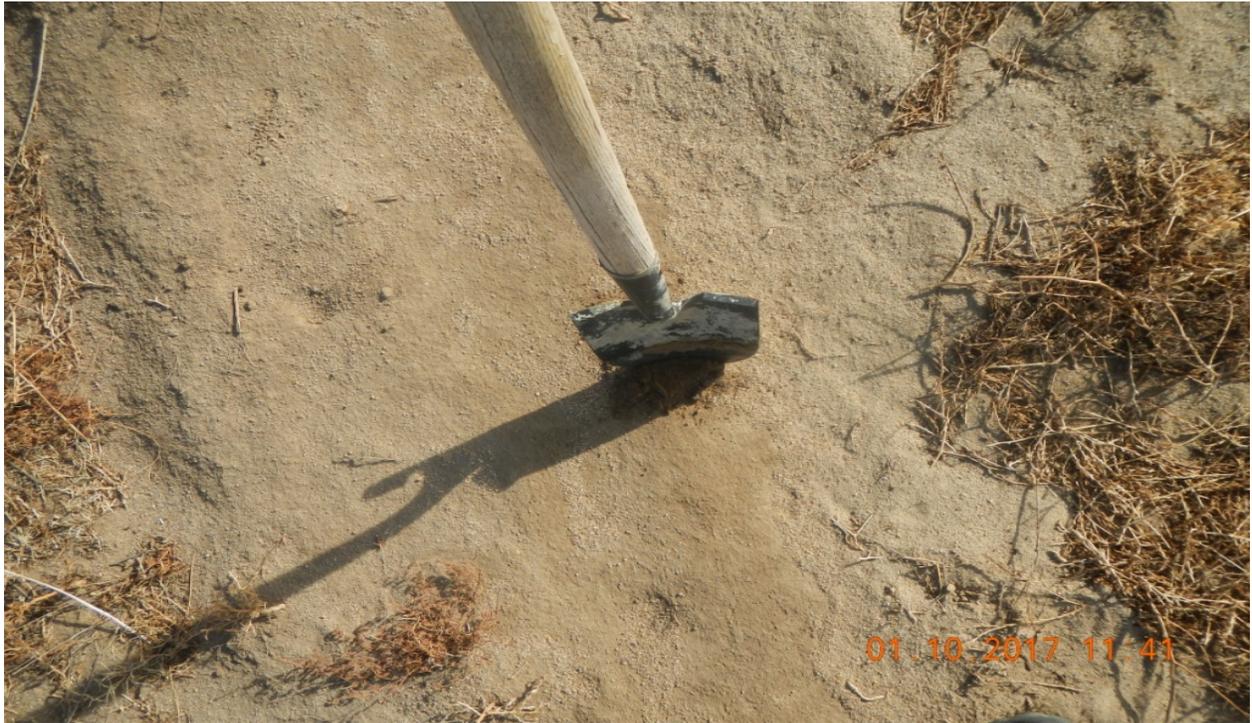
photo 3: The soils along the access road are compacted and vegetation is not adequately establishing.

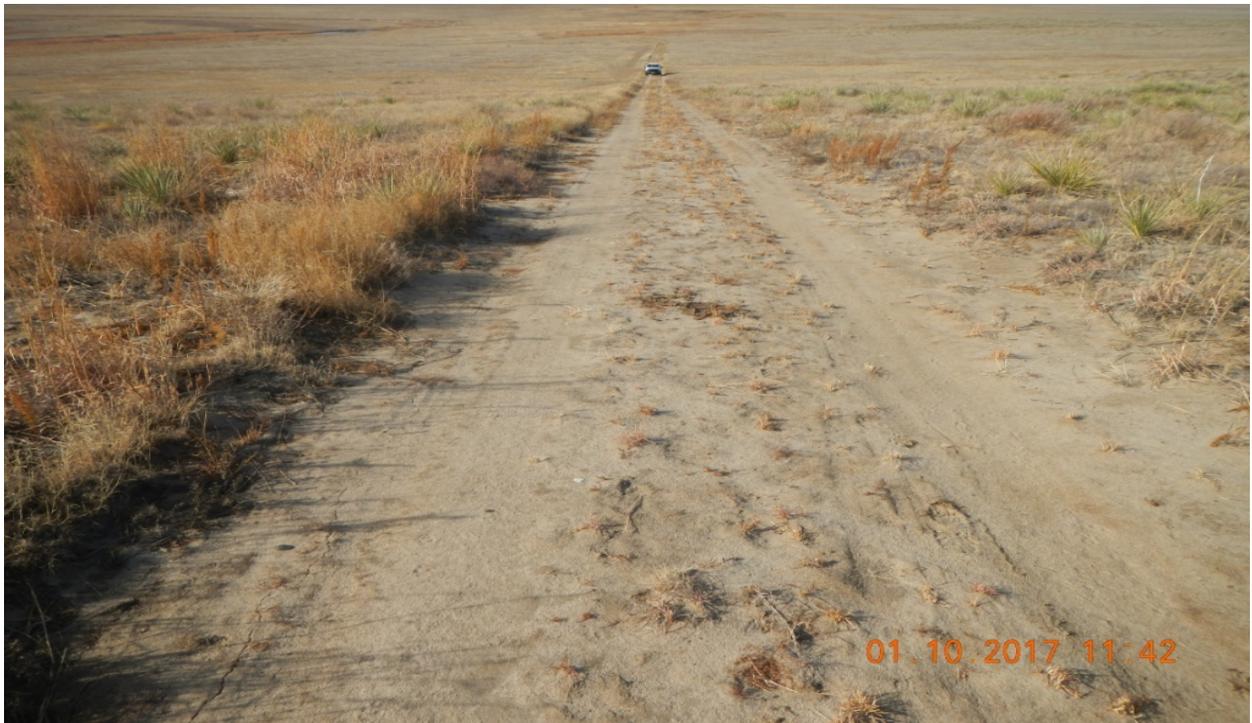
photo 4: Facing back toward the west along the access road.

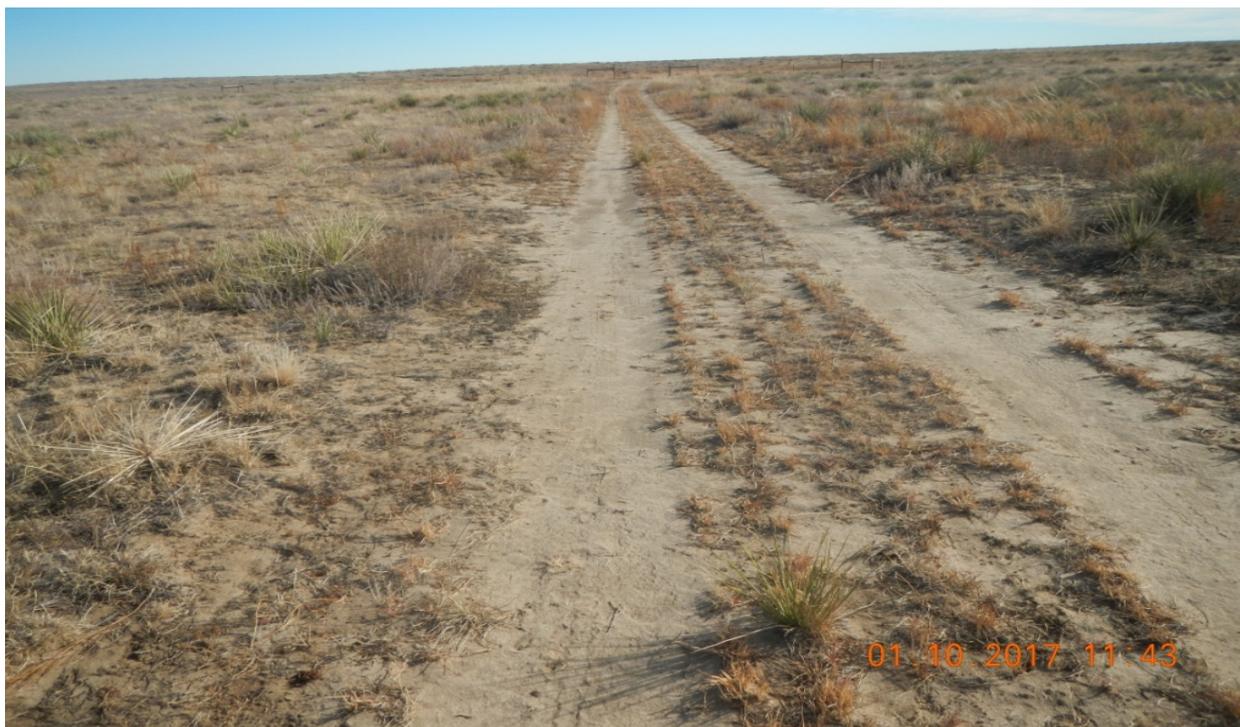
photo 5: Facing east along the access road.

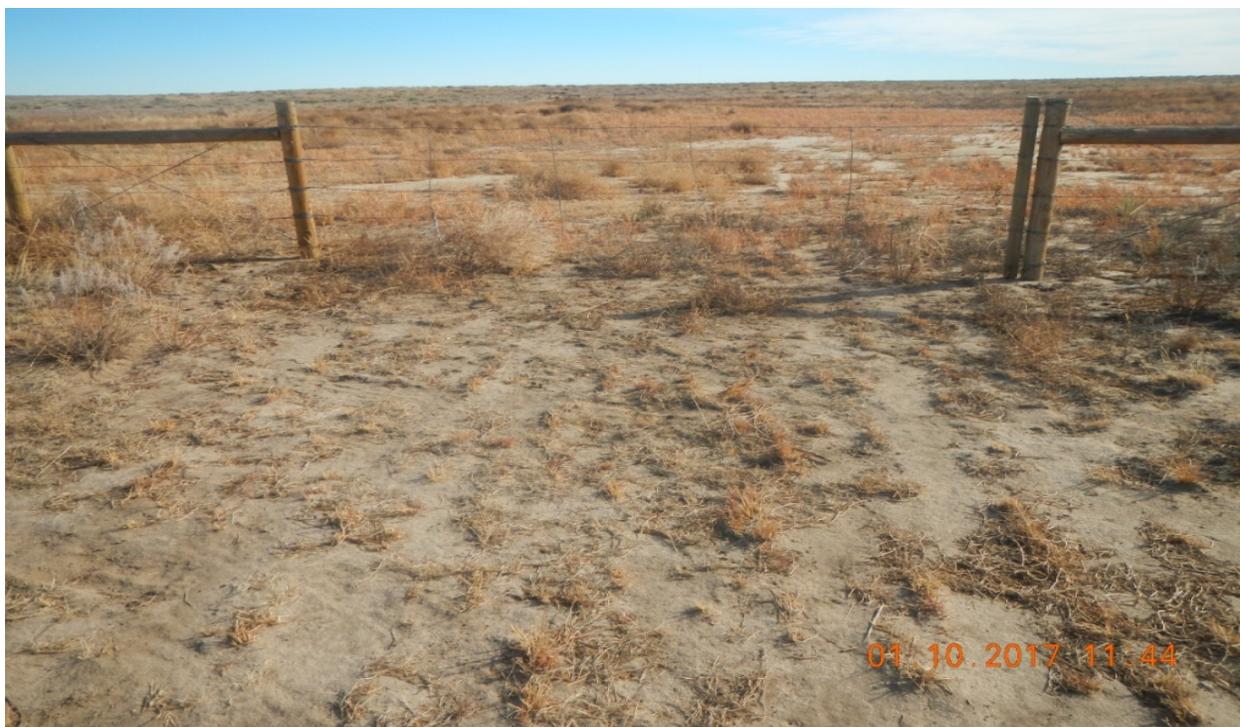
photo 6: Facing east toward the location which has a perimeter fence.

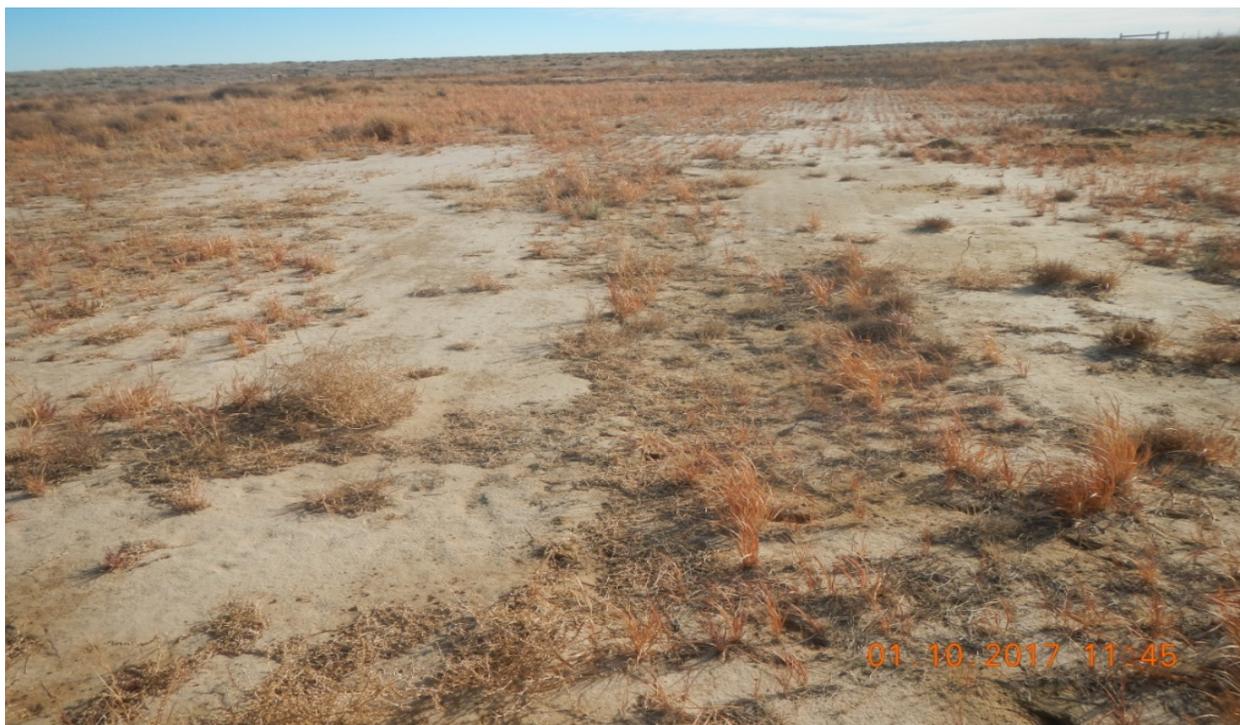
photo 7: Facing east toward the location.

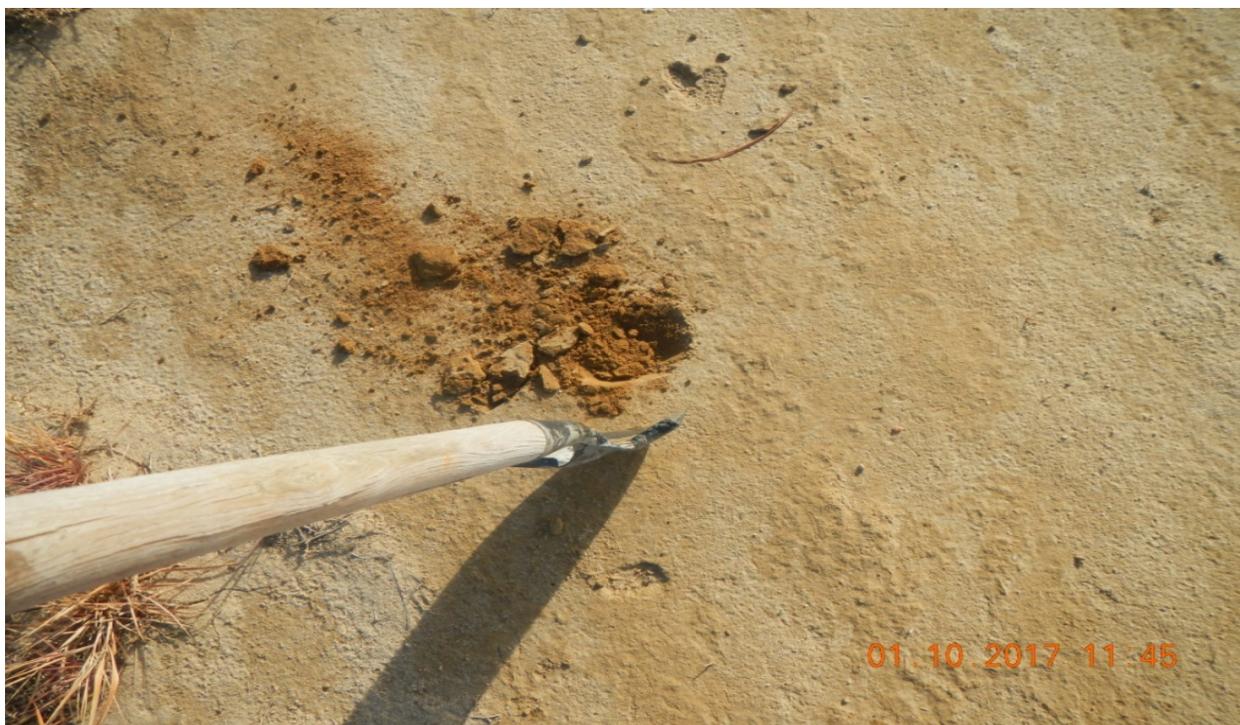
photo 8: There are areas of the location which have compacted soils.

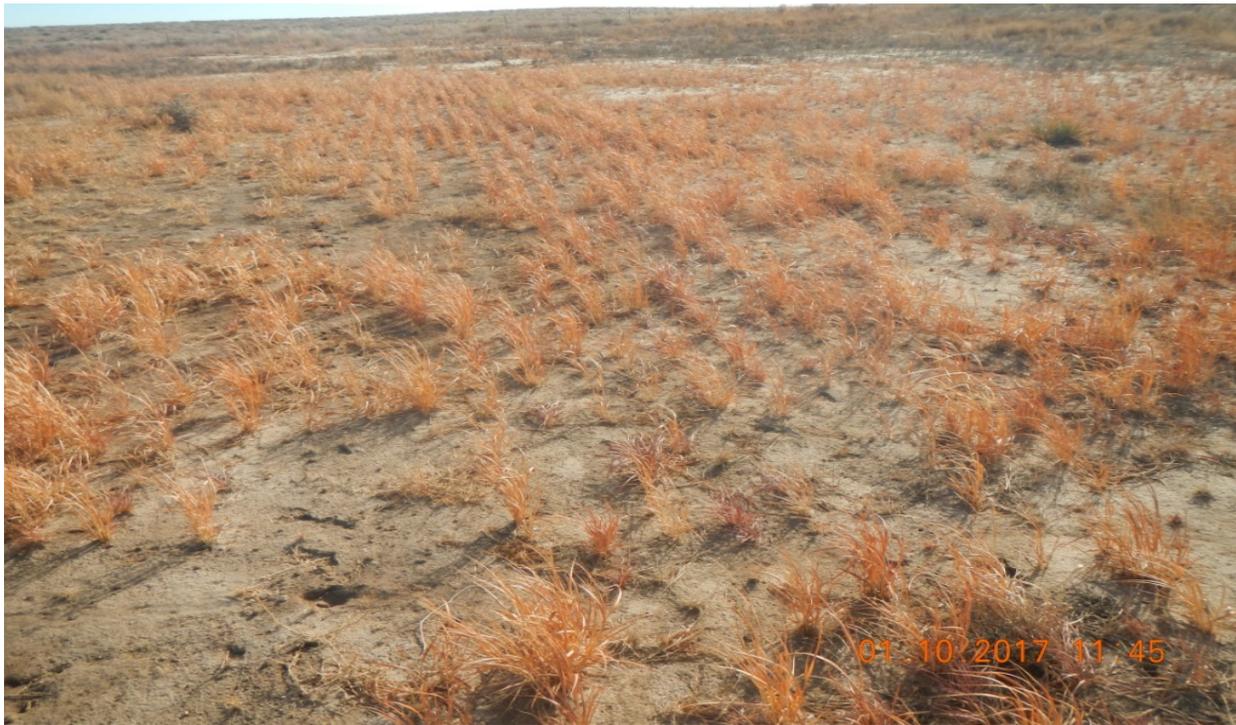
photo 9: There is desirable vegetation establishing at the center of the location.

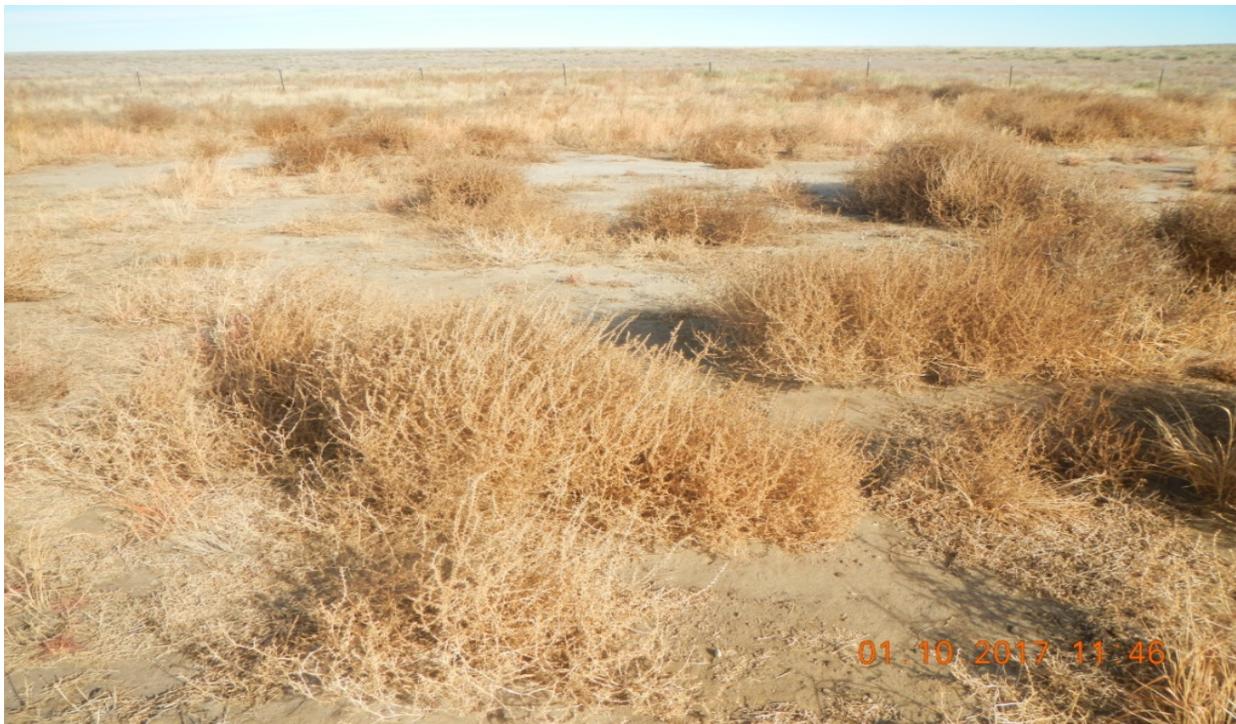
photo 10: Facing toward the north side of the location.

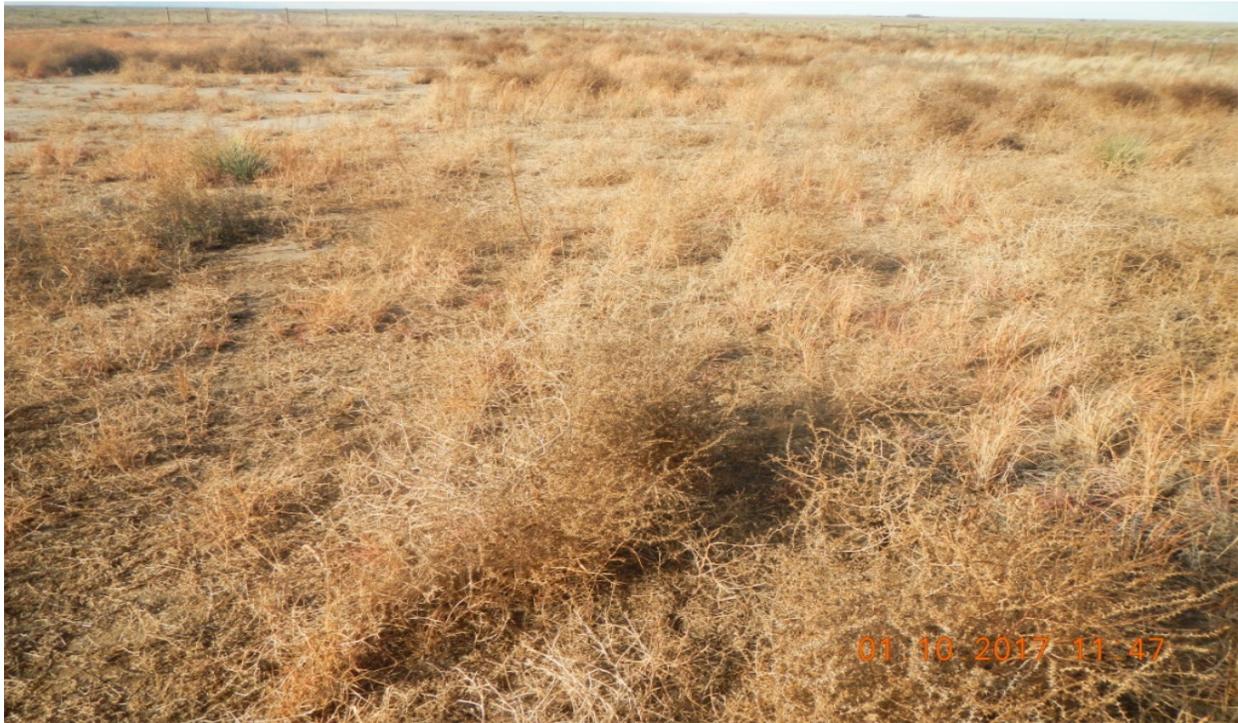
photo 11: North side of the location facing west. There is predominantly undesirable vegetation growth (Russian thistle) in this area.

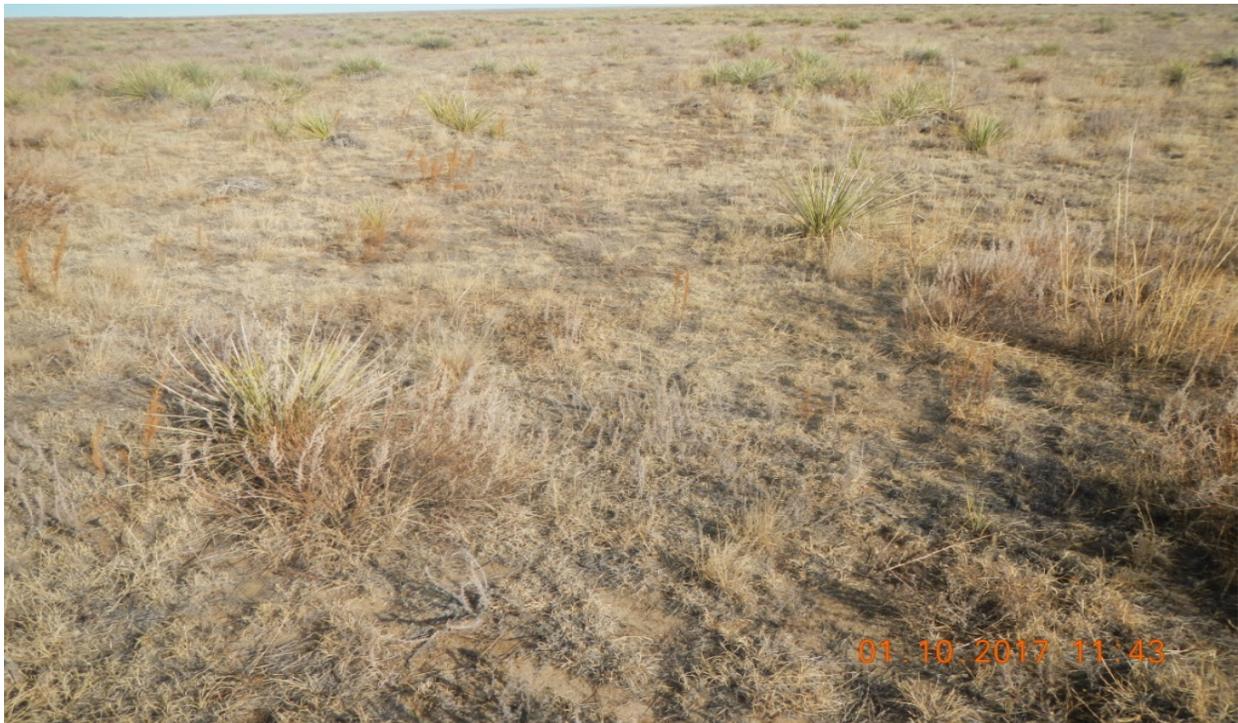
photo 12: Facing north toward the surrounding undisturbed pasture.
