Reclamation Inspection

01/12/2017

Operator: Whiting

Location ID: 433999

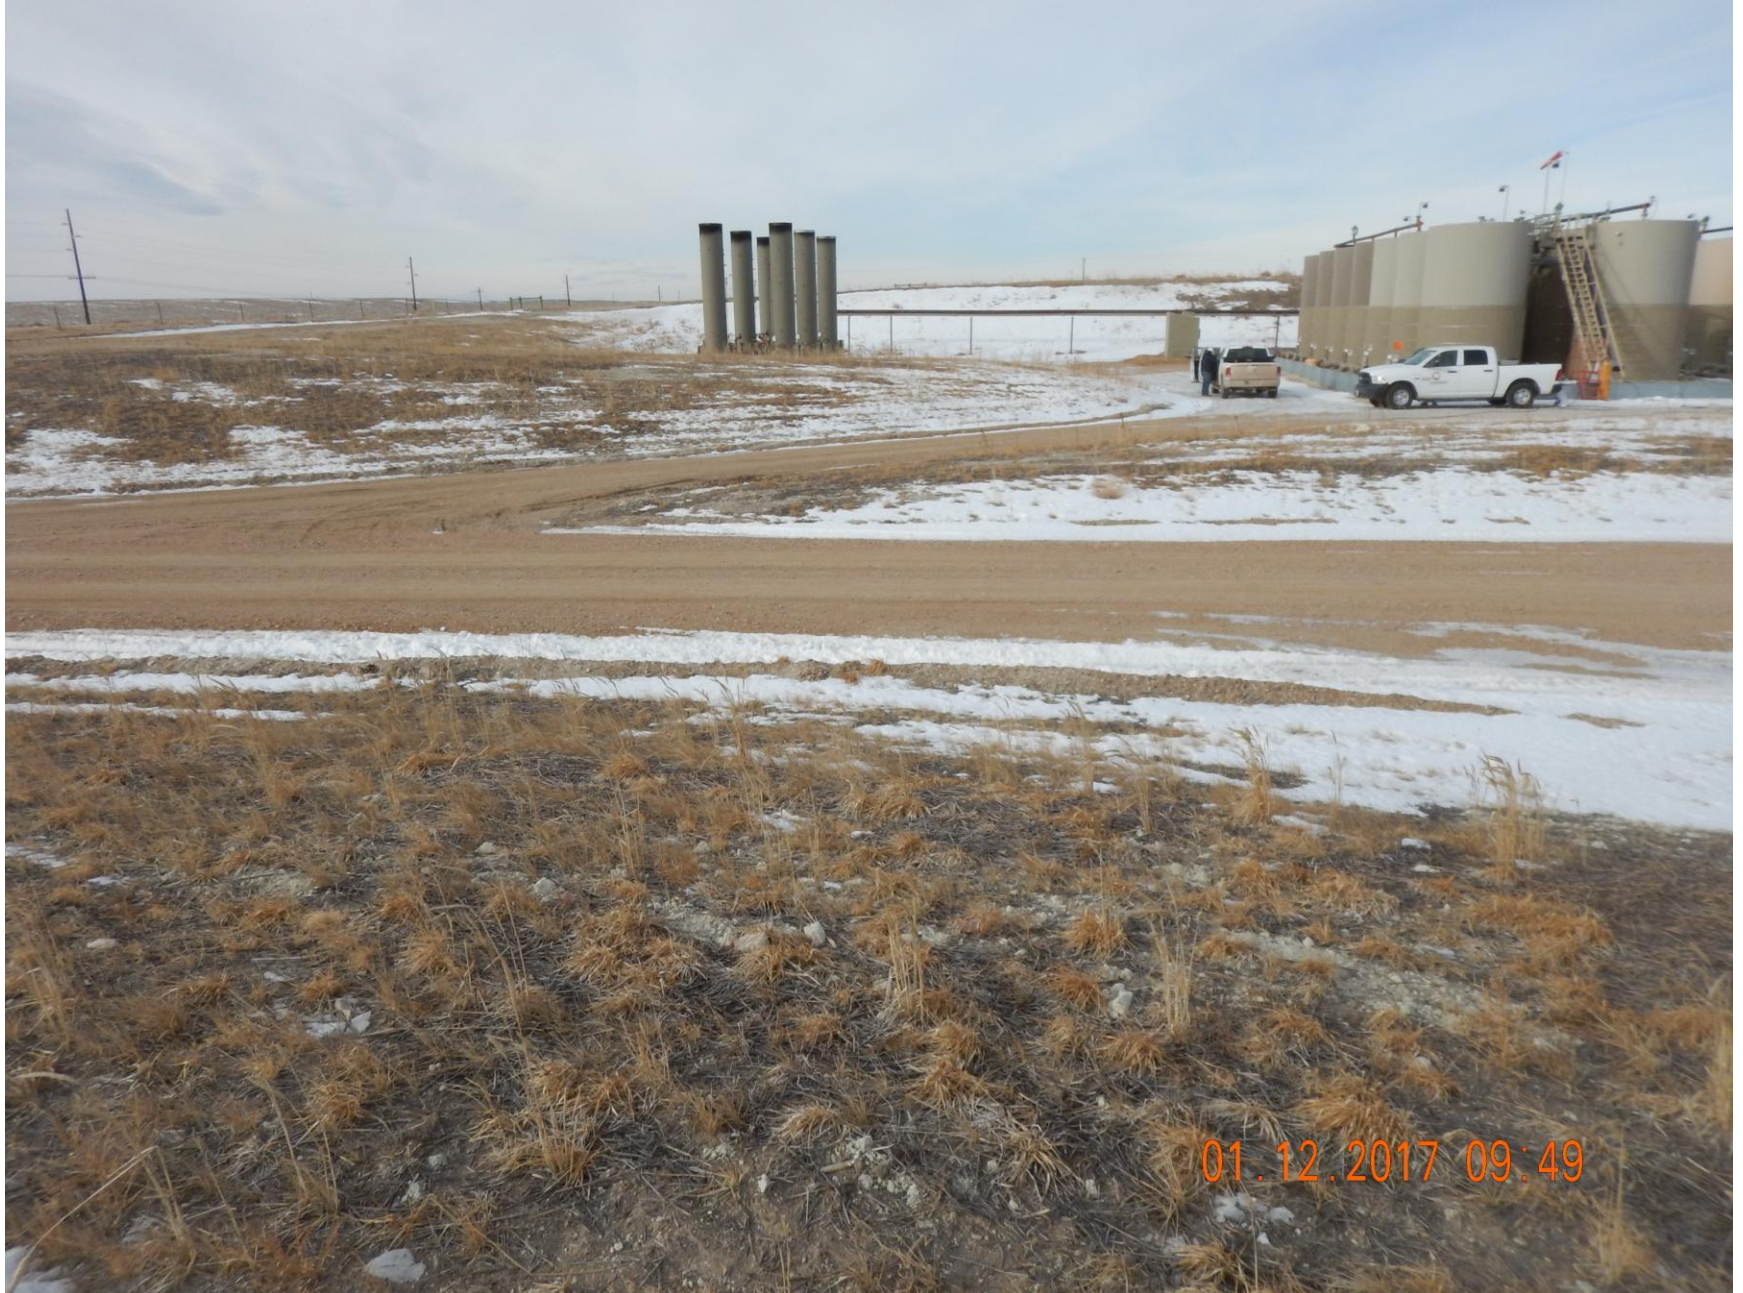
Figure 1: Photo taken from the south end of the location, facing west. Photo shows interim and production areas.

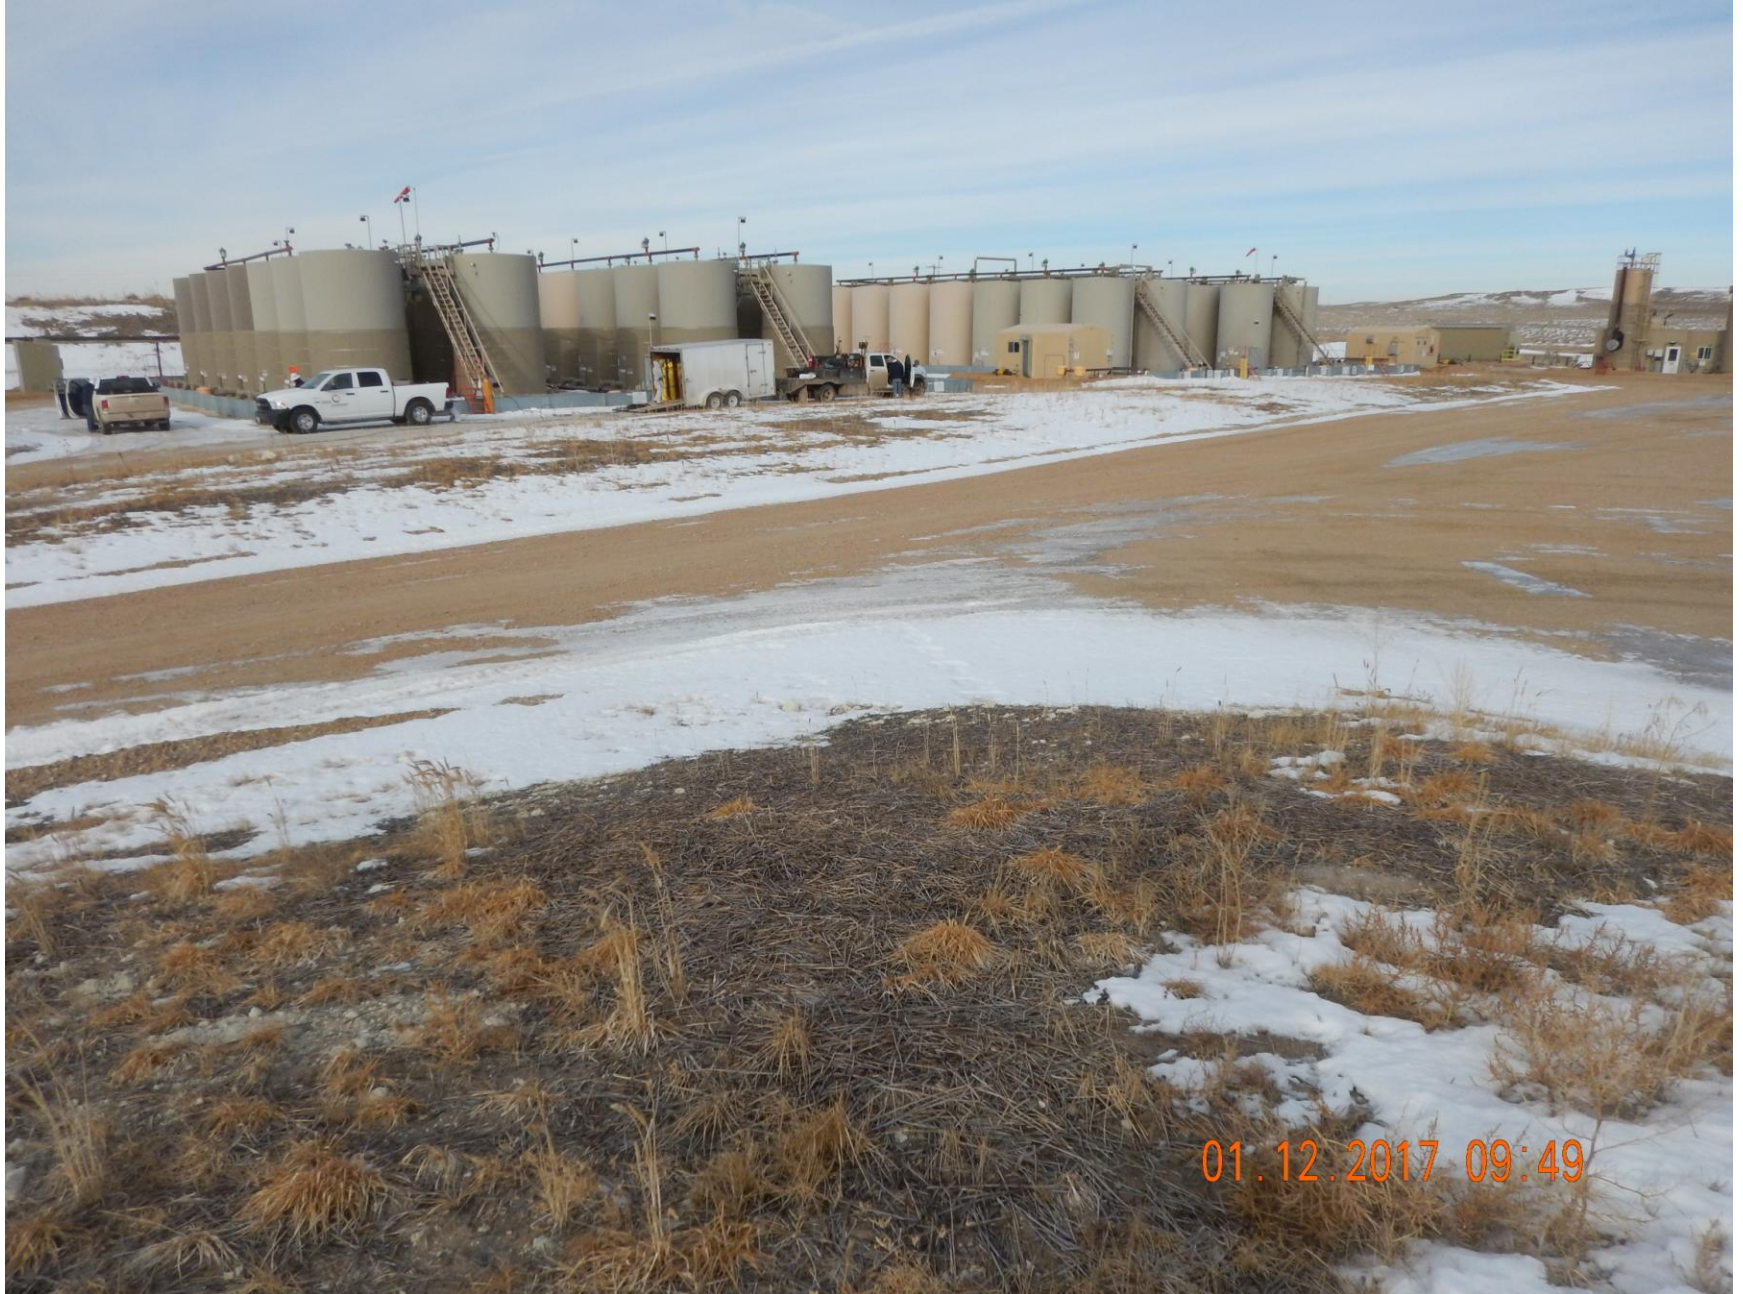
Figure 2: Photo taken from the south end of the location, facing northwest. Photo shows interim and production areas. Center of image shows 56, 400 bbl tanks on location (28 produced water, 28 crude)

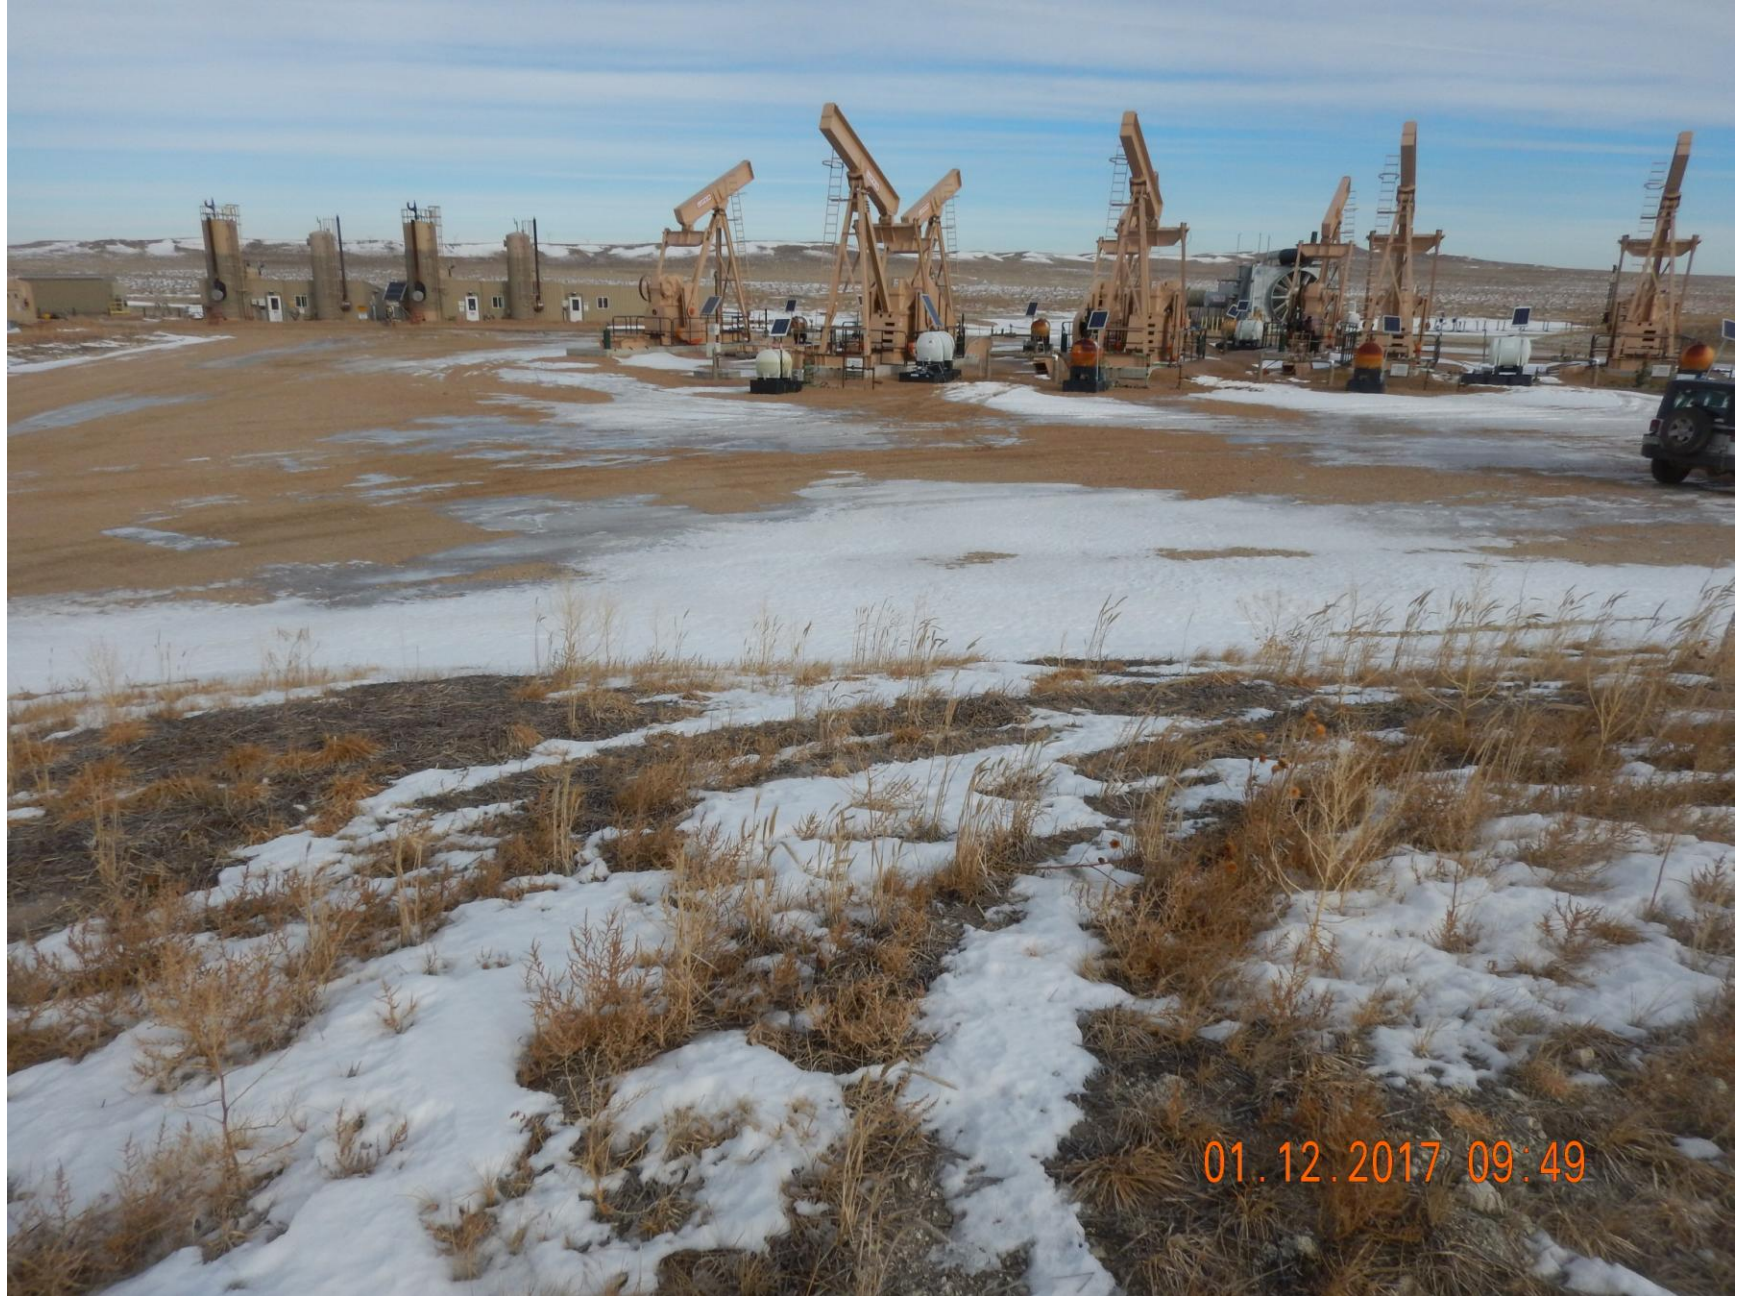
Figure 3: Photo taken from the south end of the location, facing north. Photo shows interim and production areas. Center right of photo shows 8 pump jacks/wells on location, back left shows 4 vertical heater treaters.

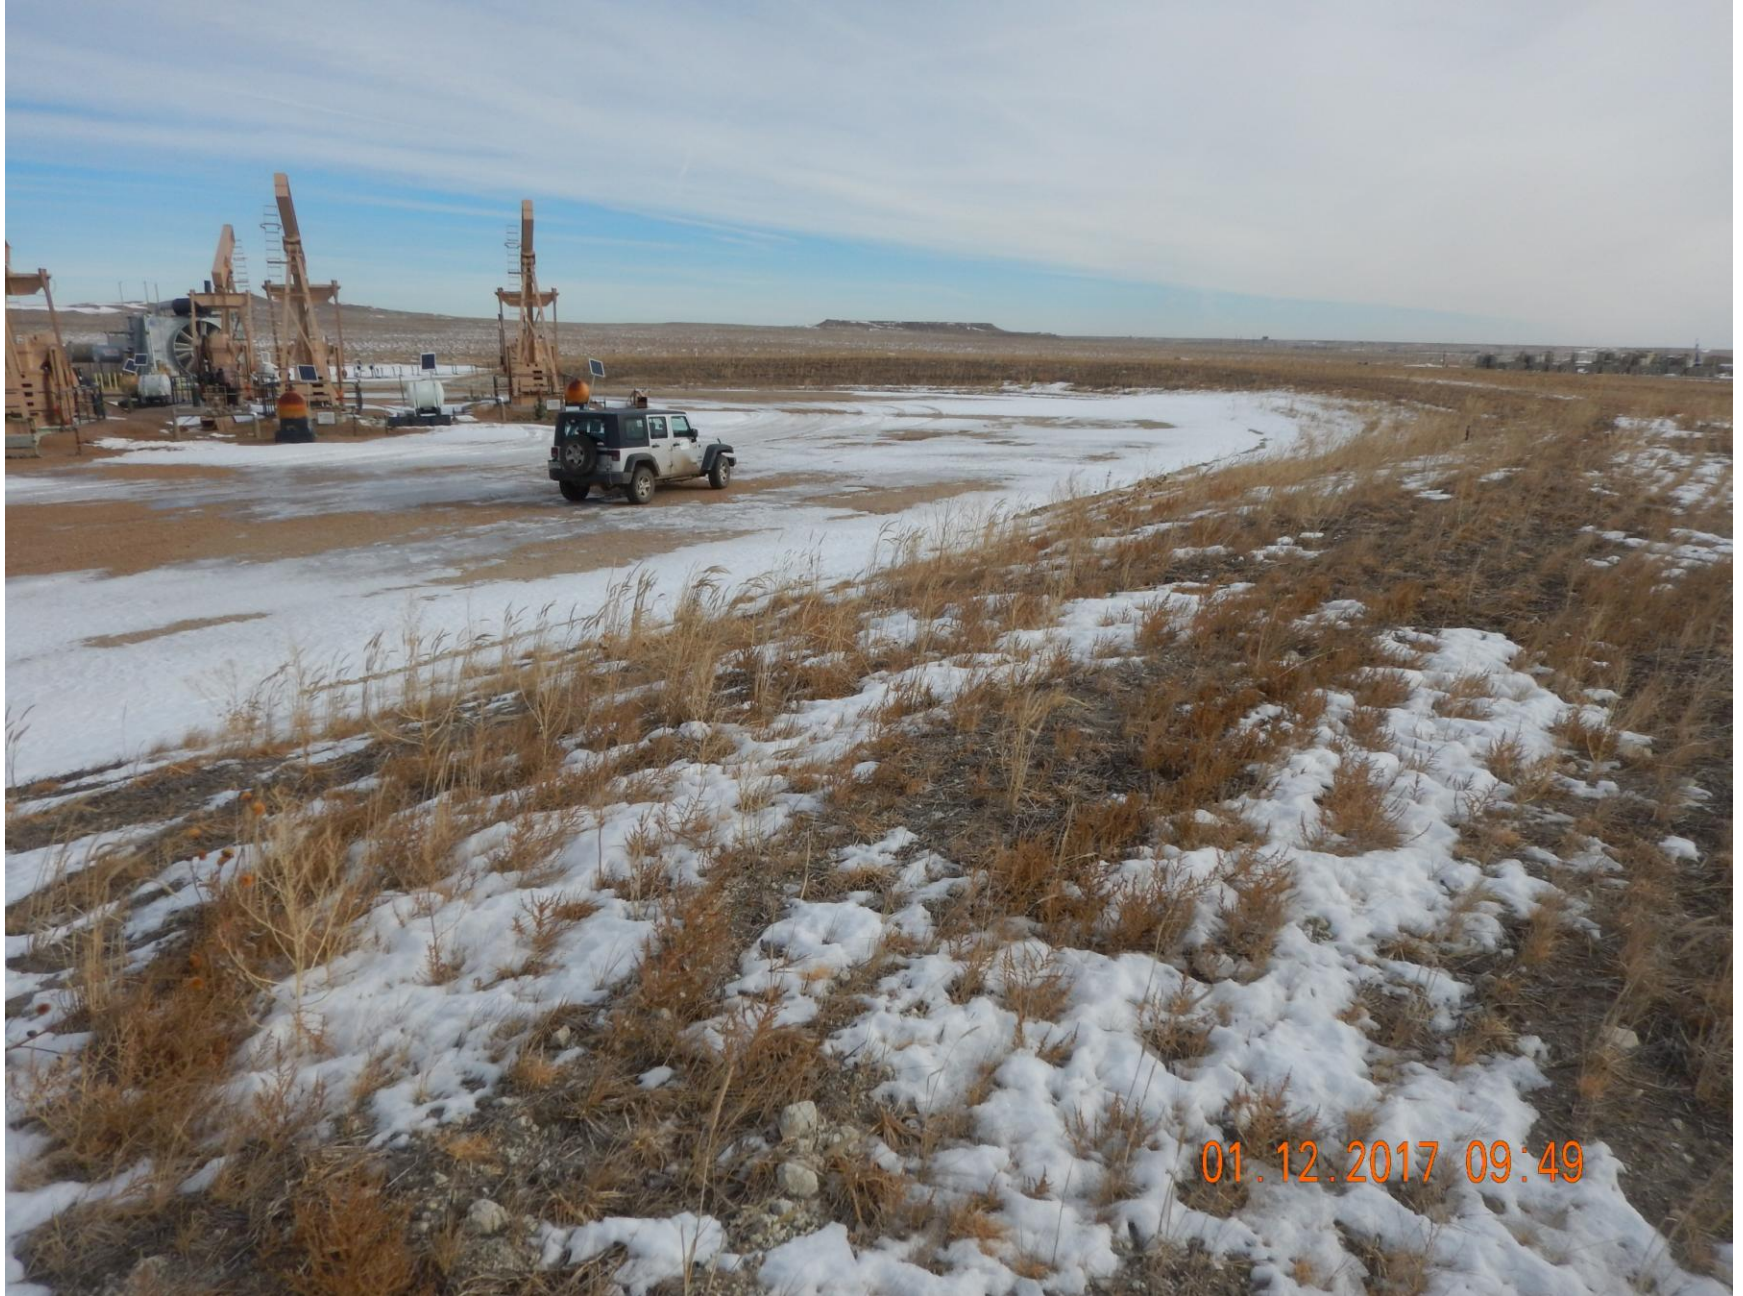
Figure 4: Photo taken from the south end of the location, facing northeast. Photo shows interim and production areas.

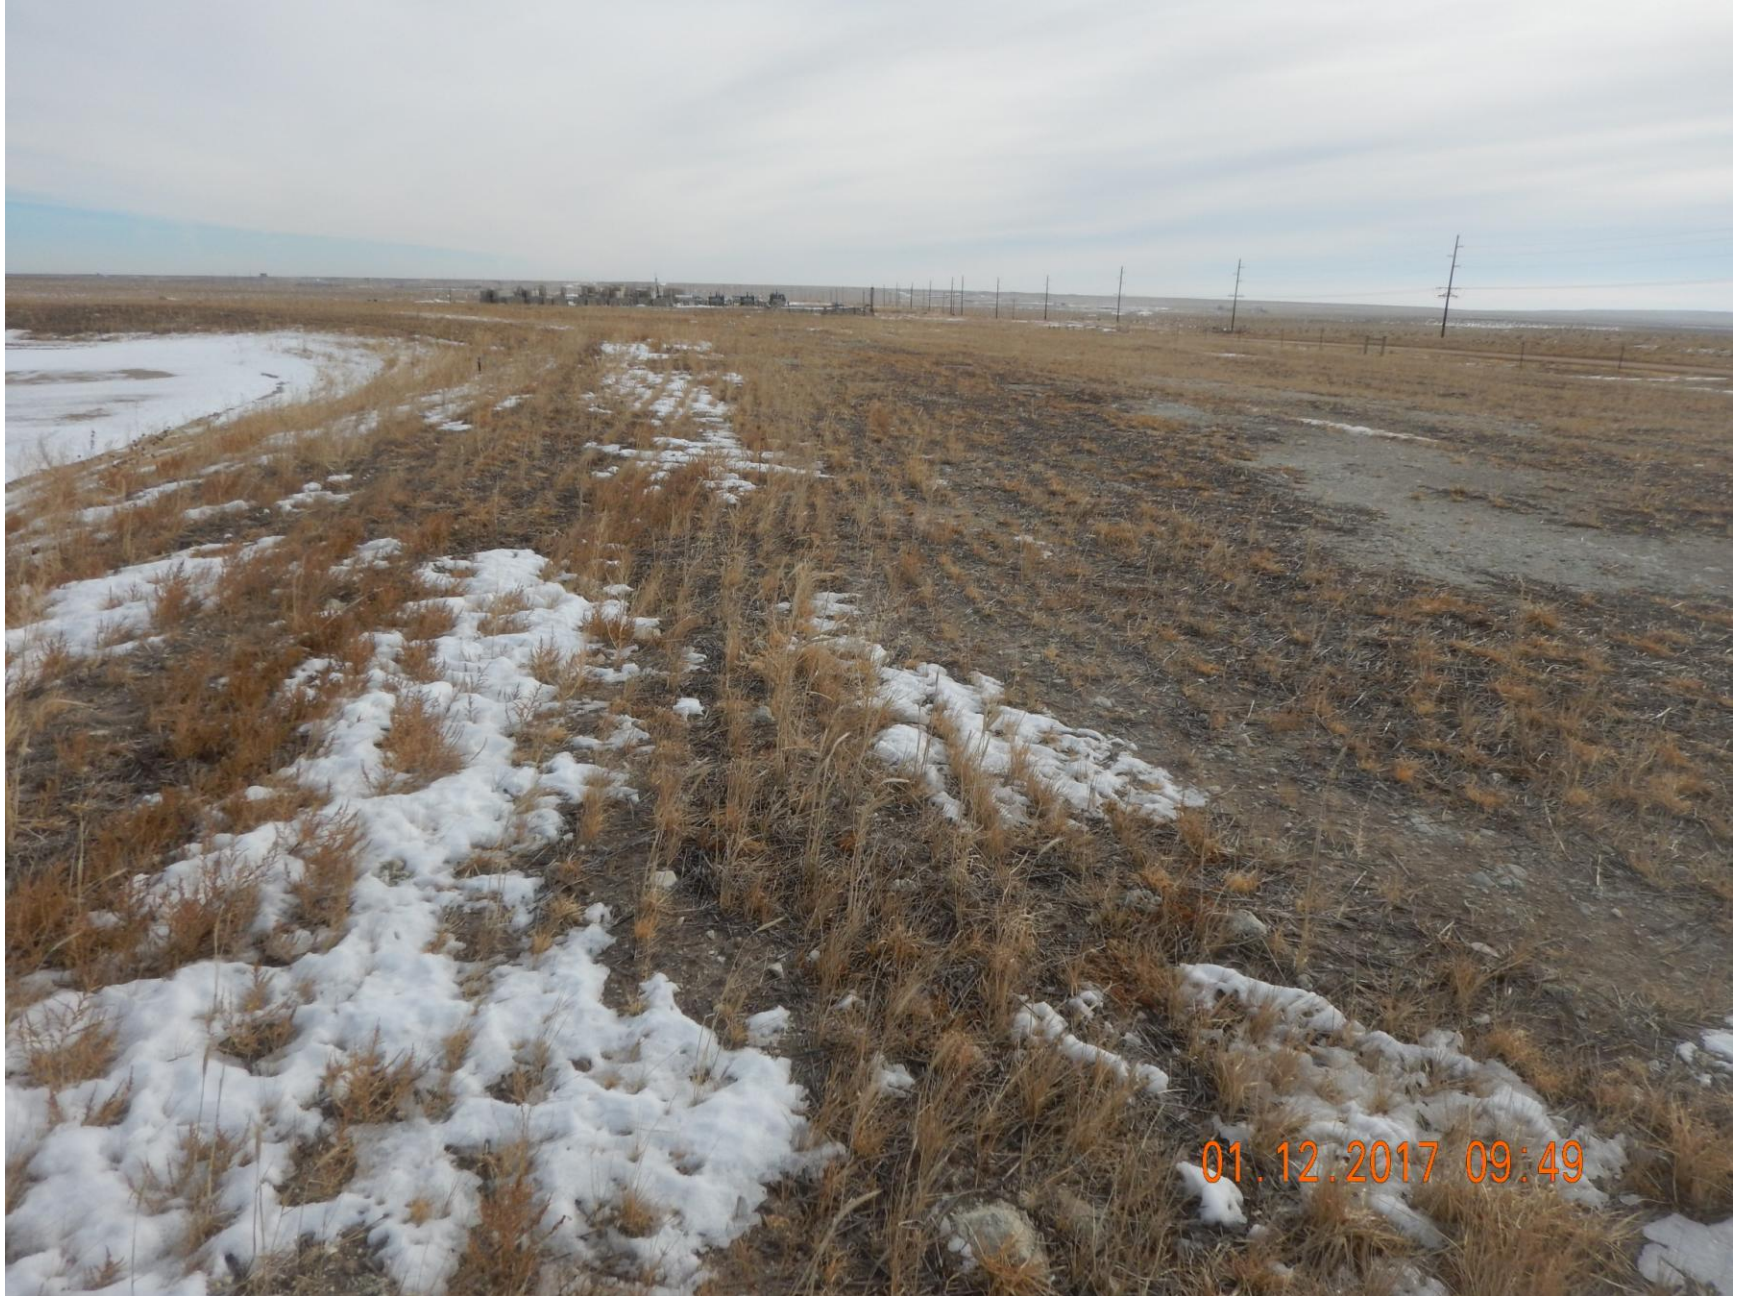
Figure 5: Photo taken from the south end of the location, facing east. Photo shows interim and production areas.

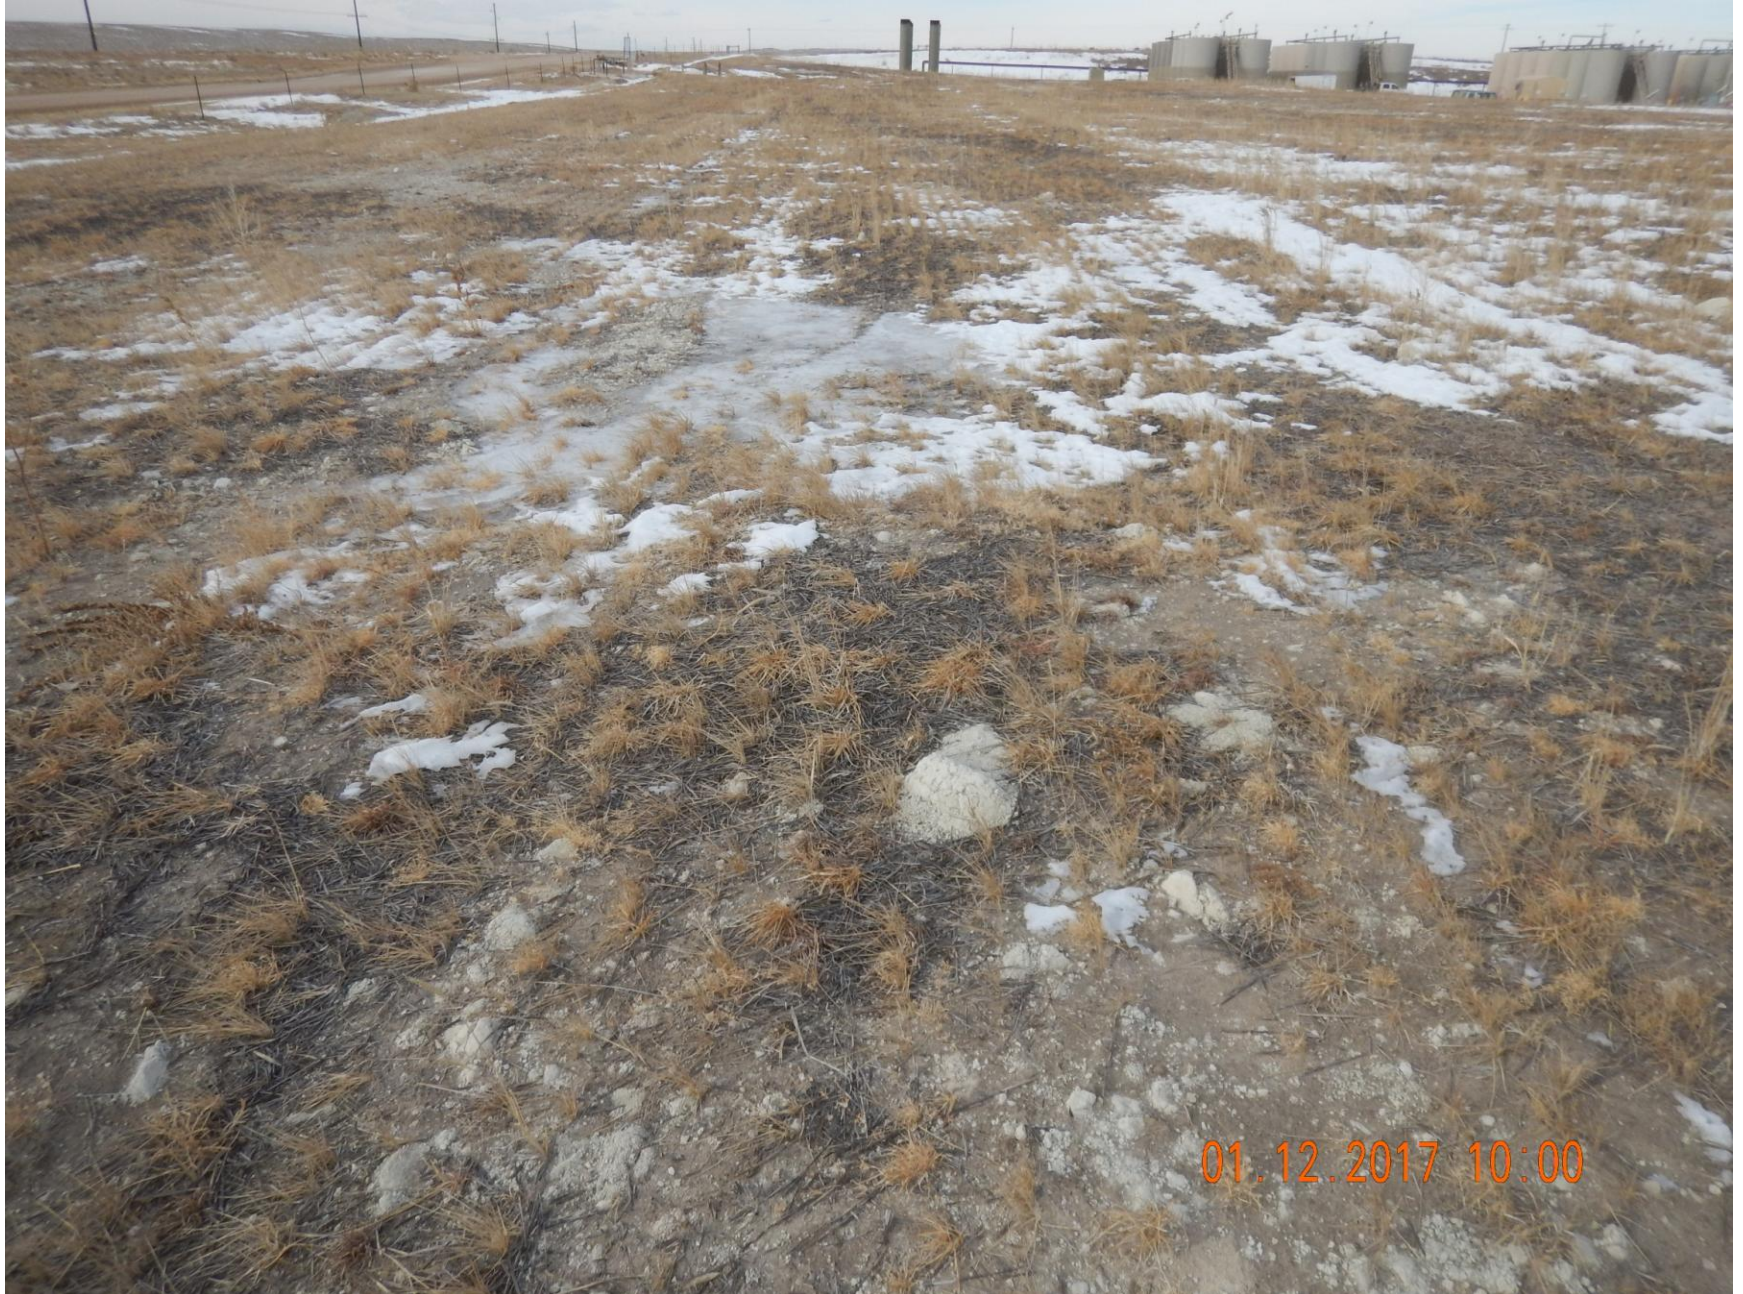
Figure 6: Photo taken from the southeast corner of the interim area, facing west. Photo shows vegetation over the interim area. One growing season has passed, IR in process however areas of the interim consists of sparse vegetation and/or exposed soil, and may require additional seeding/reclamation work.

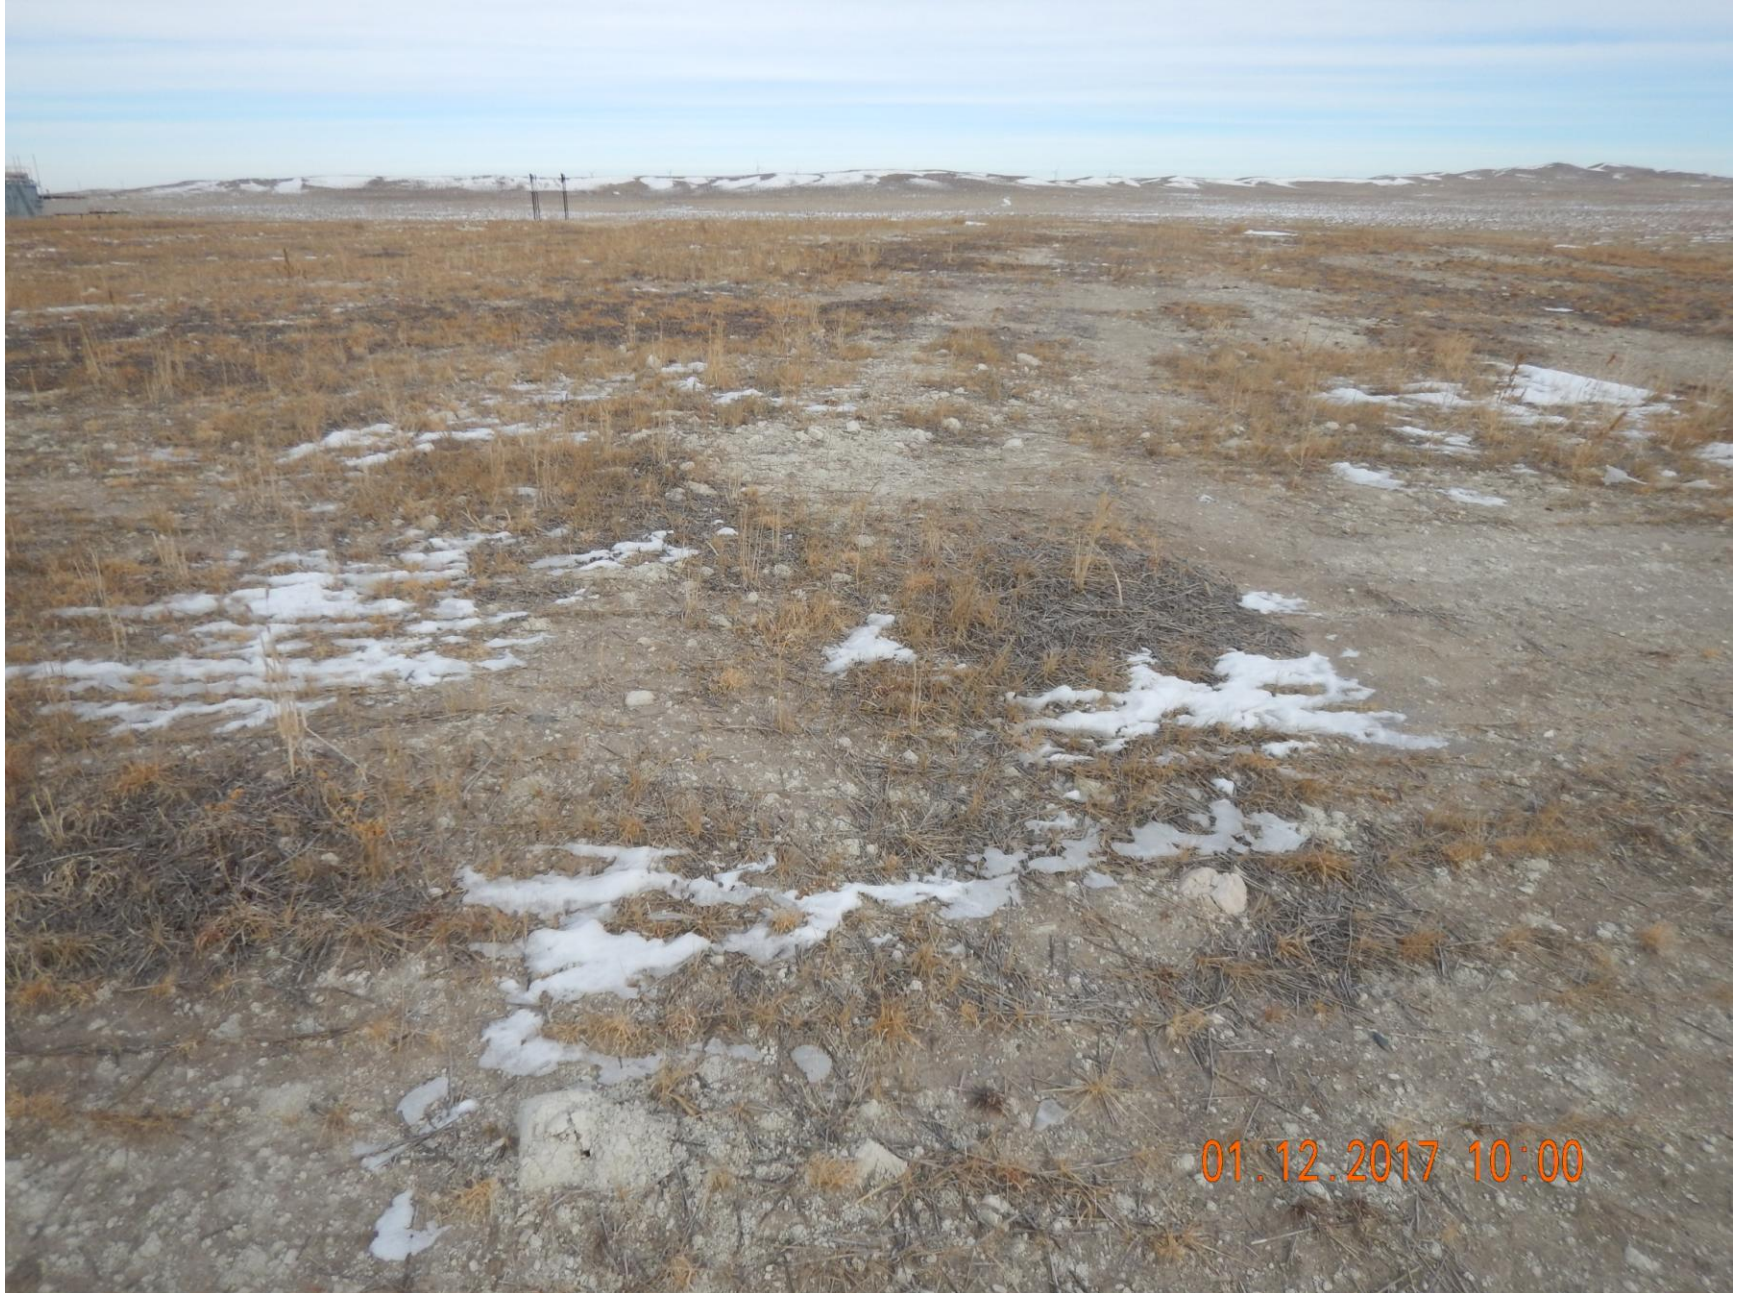
Figure 7: Photo taken from the southeast corner of the interim area, facing north. Photo shows vegetation over the interim area. One growing season has passed, IR in process however areas of the interim consists of sparse vegetation and/or exposed soil, and may require additional seeding/reclamation work.

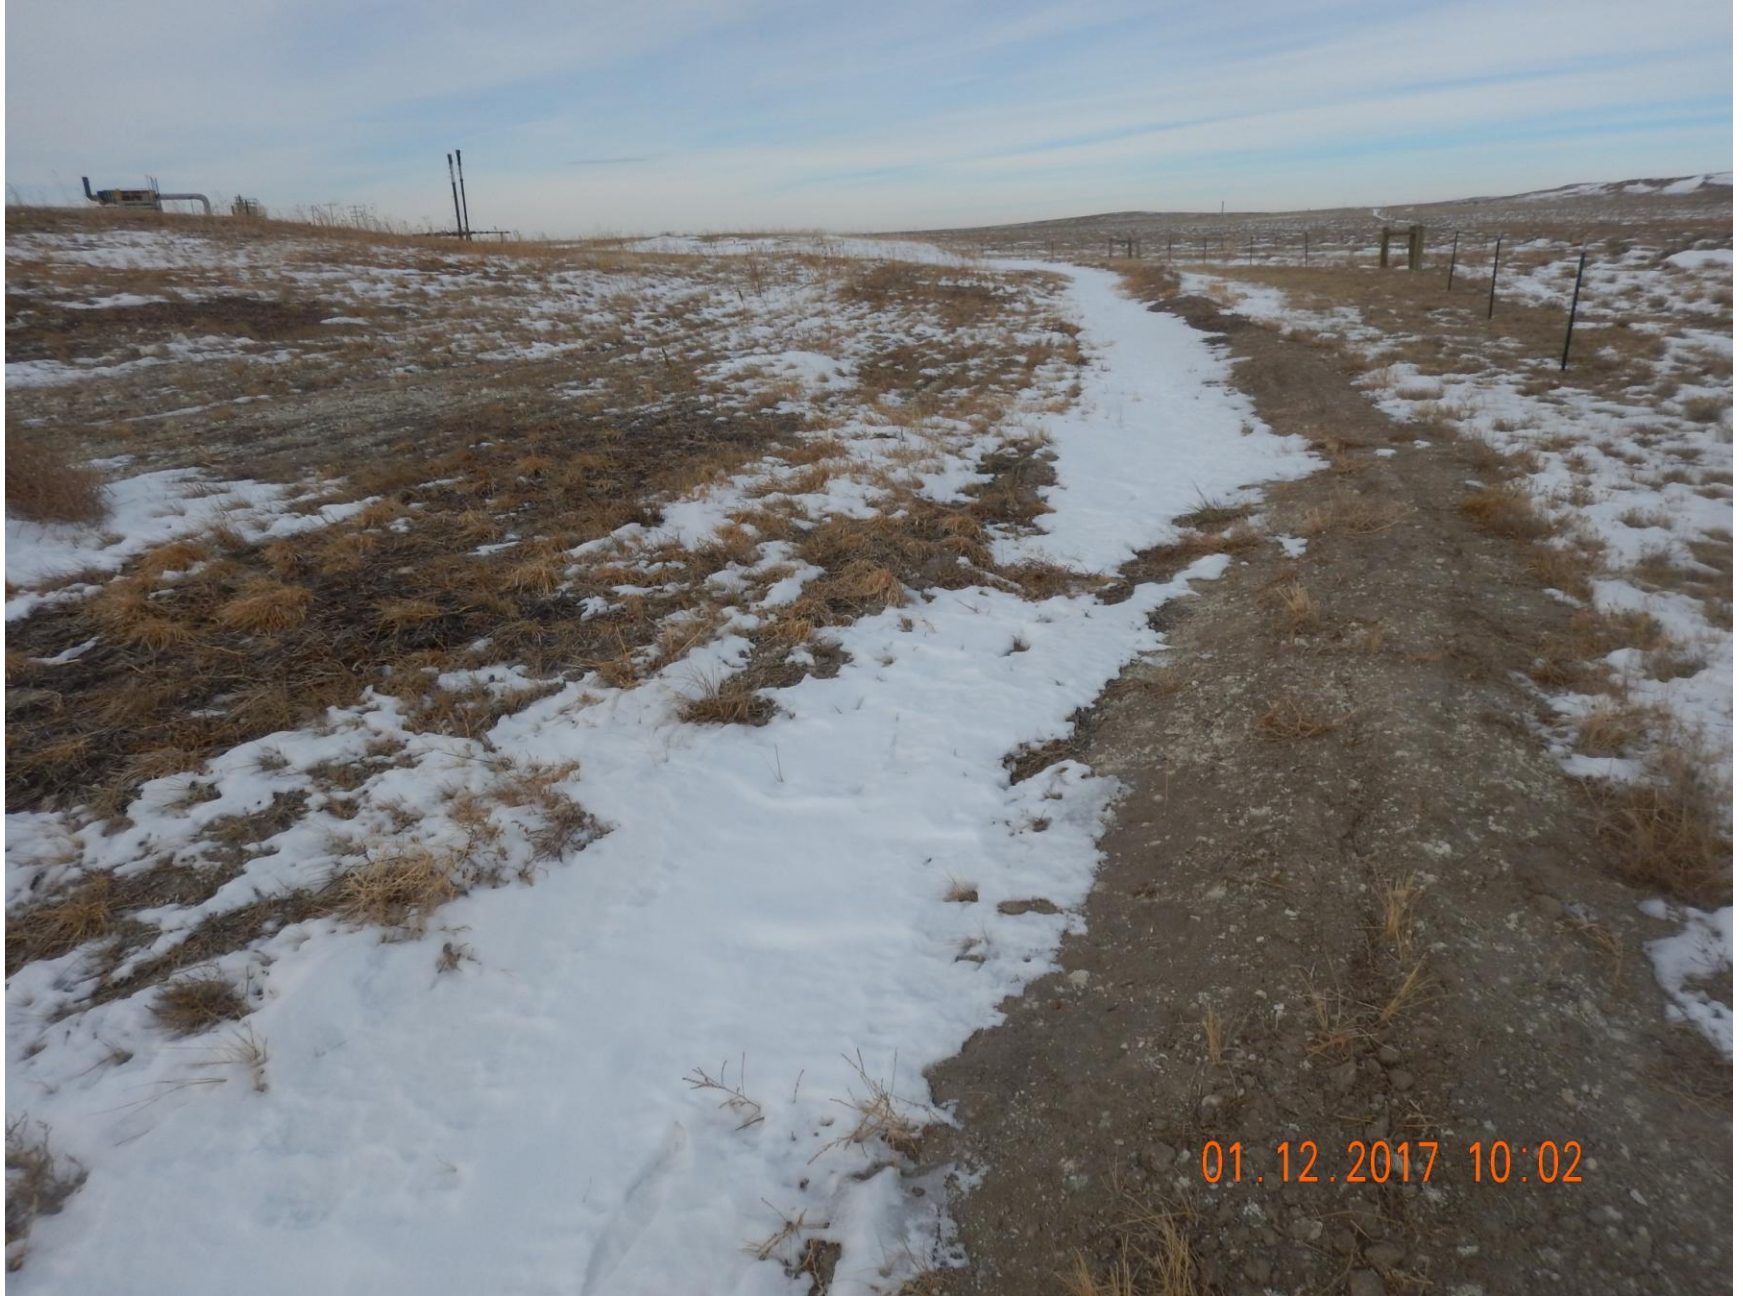
Figure 8: Photo taken from the northeast corner of the interim area, facing west. Photo shows stormwater and sediment control ditch on perimeter of the interim area.

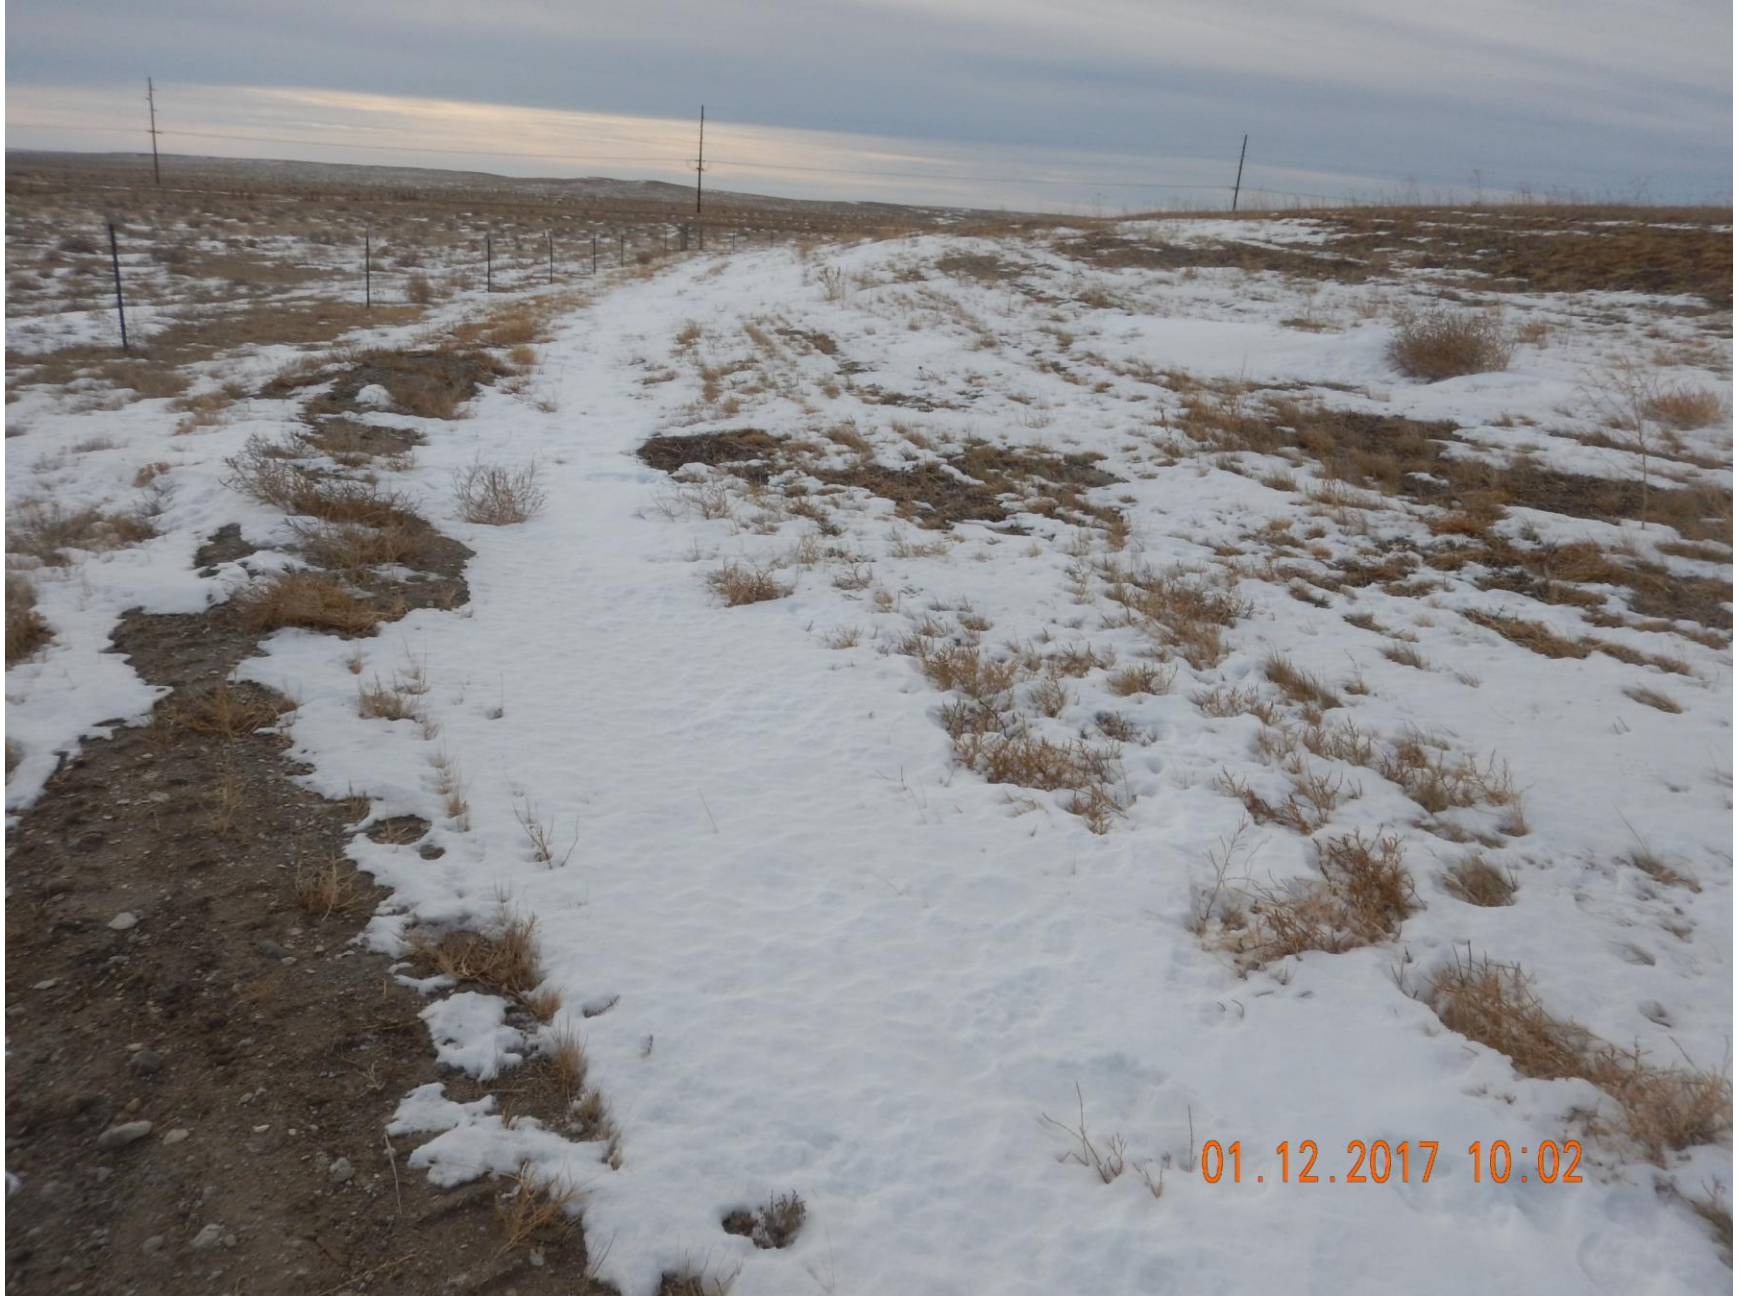
Figure 9: Photo taken from the northeast corner of the interim area, facing south. Photo shows stormwater and sediment control ditch on perimeter of the interim area.

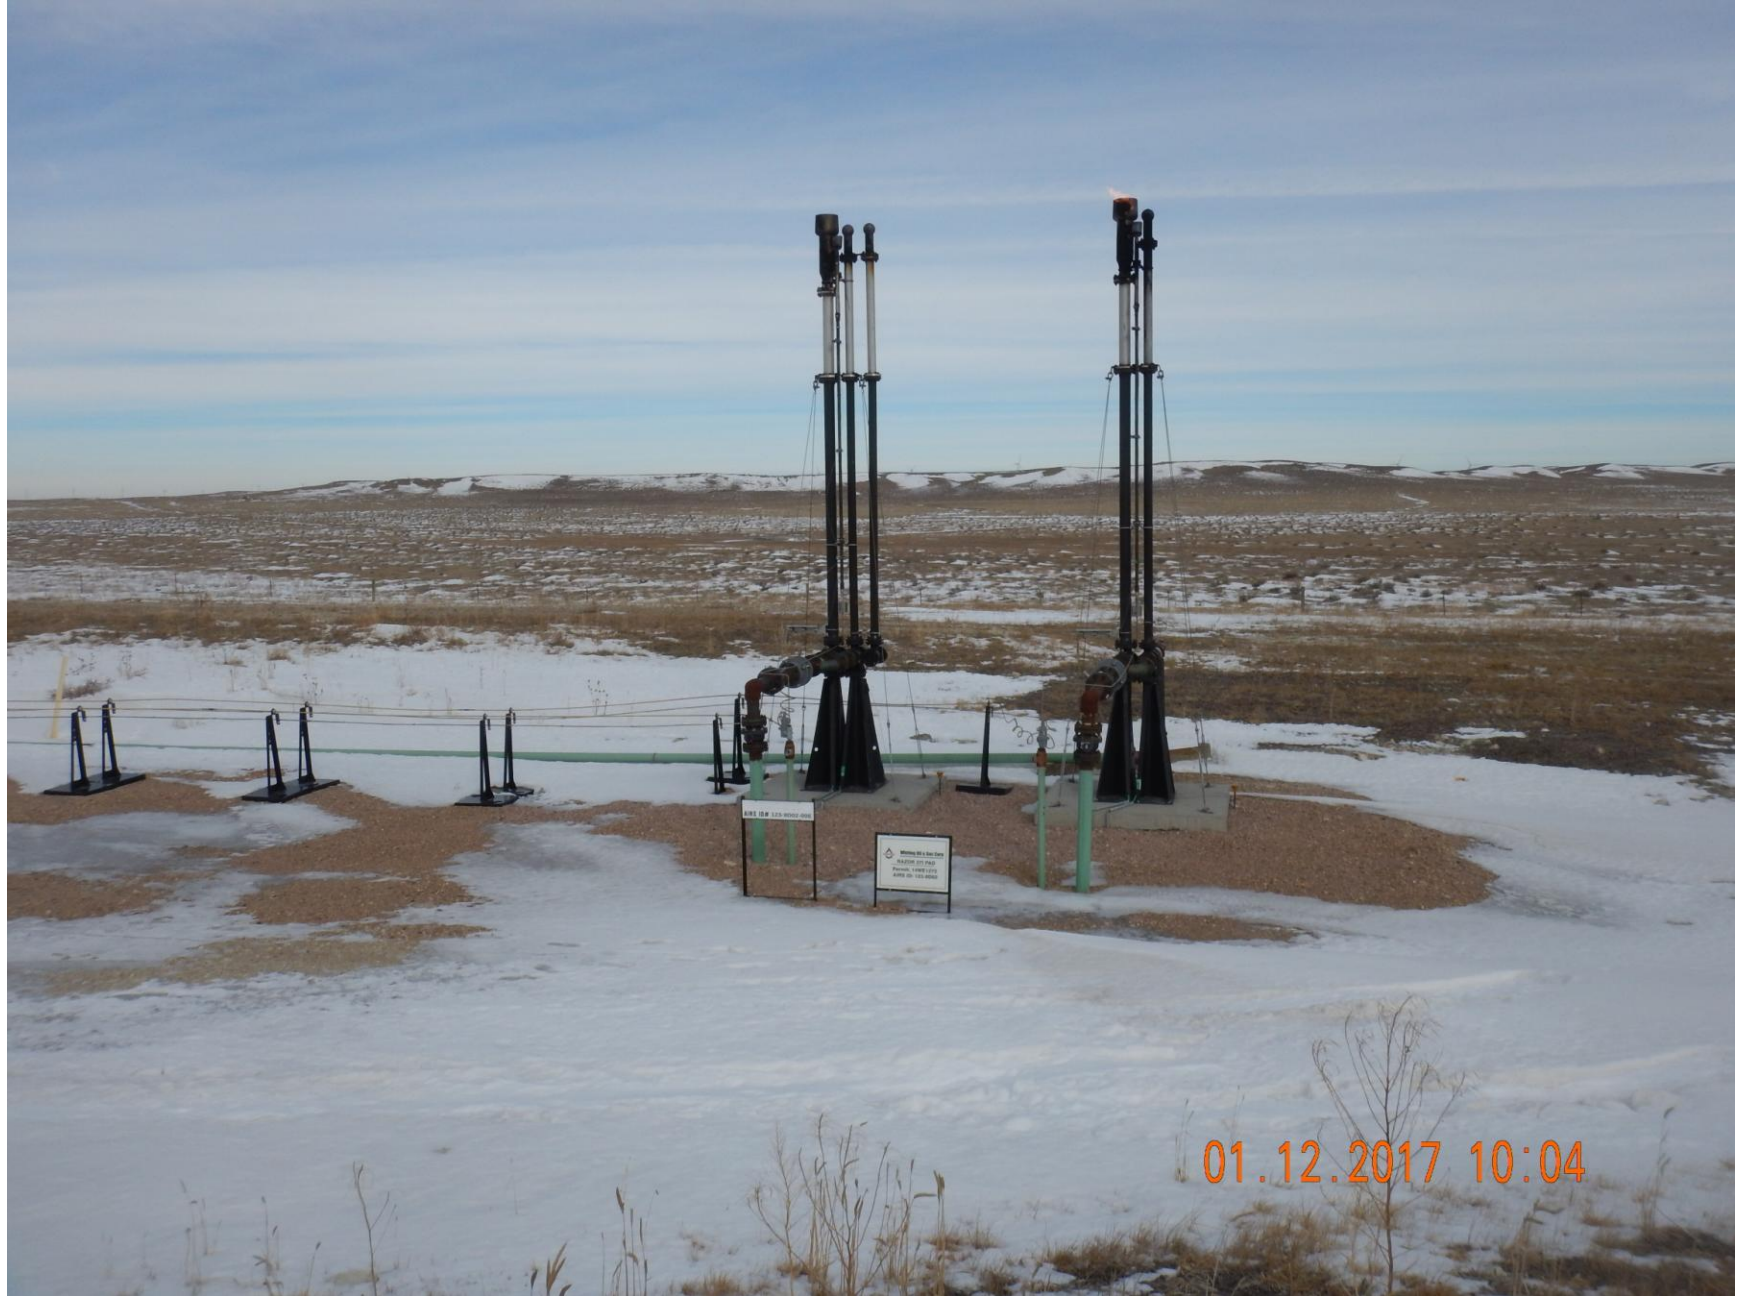
Figure 10: Photo taken from the northeast end of the production area, facing north. Photo shows two field flares.
