Reclamation Inspection

01/12/2017

Operator: Whiting

Location ID: 433999

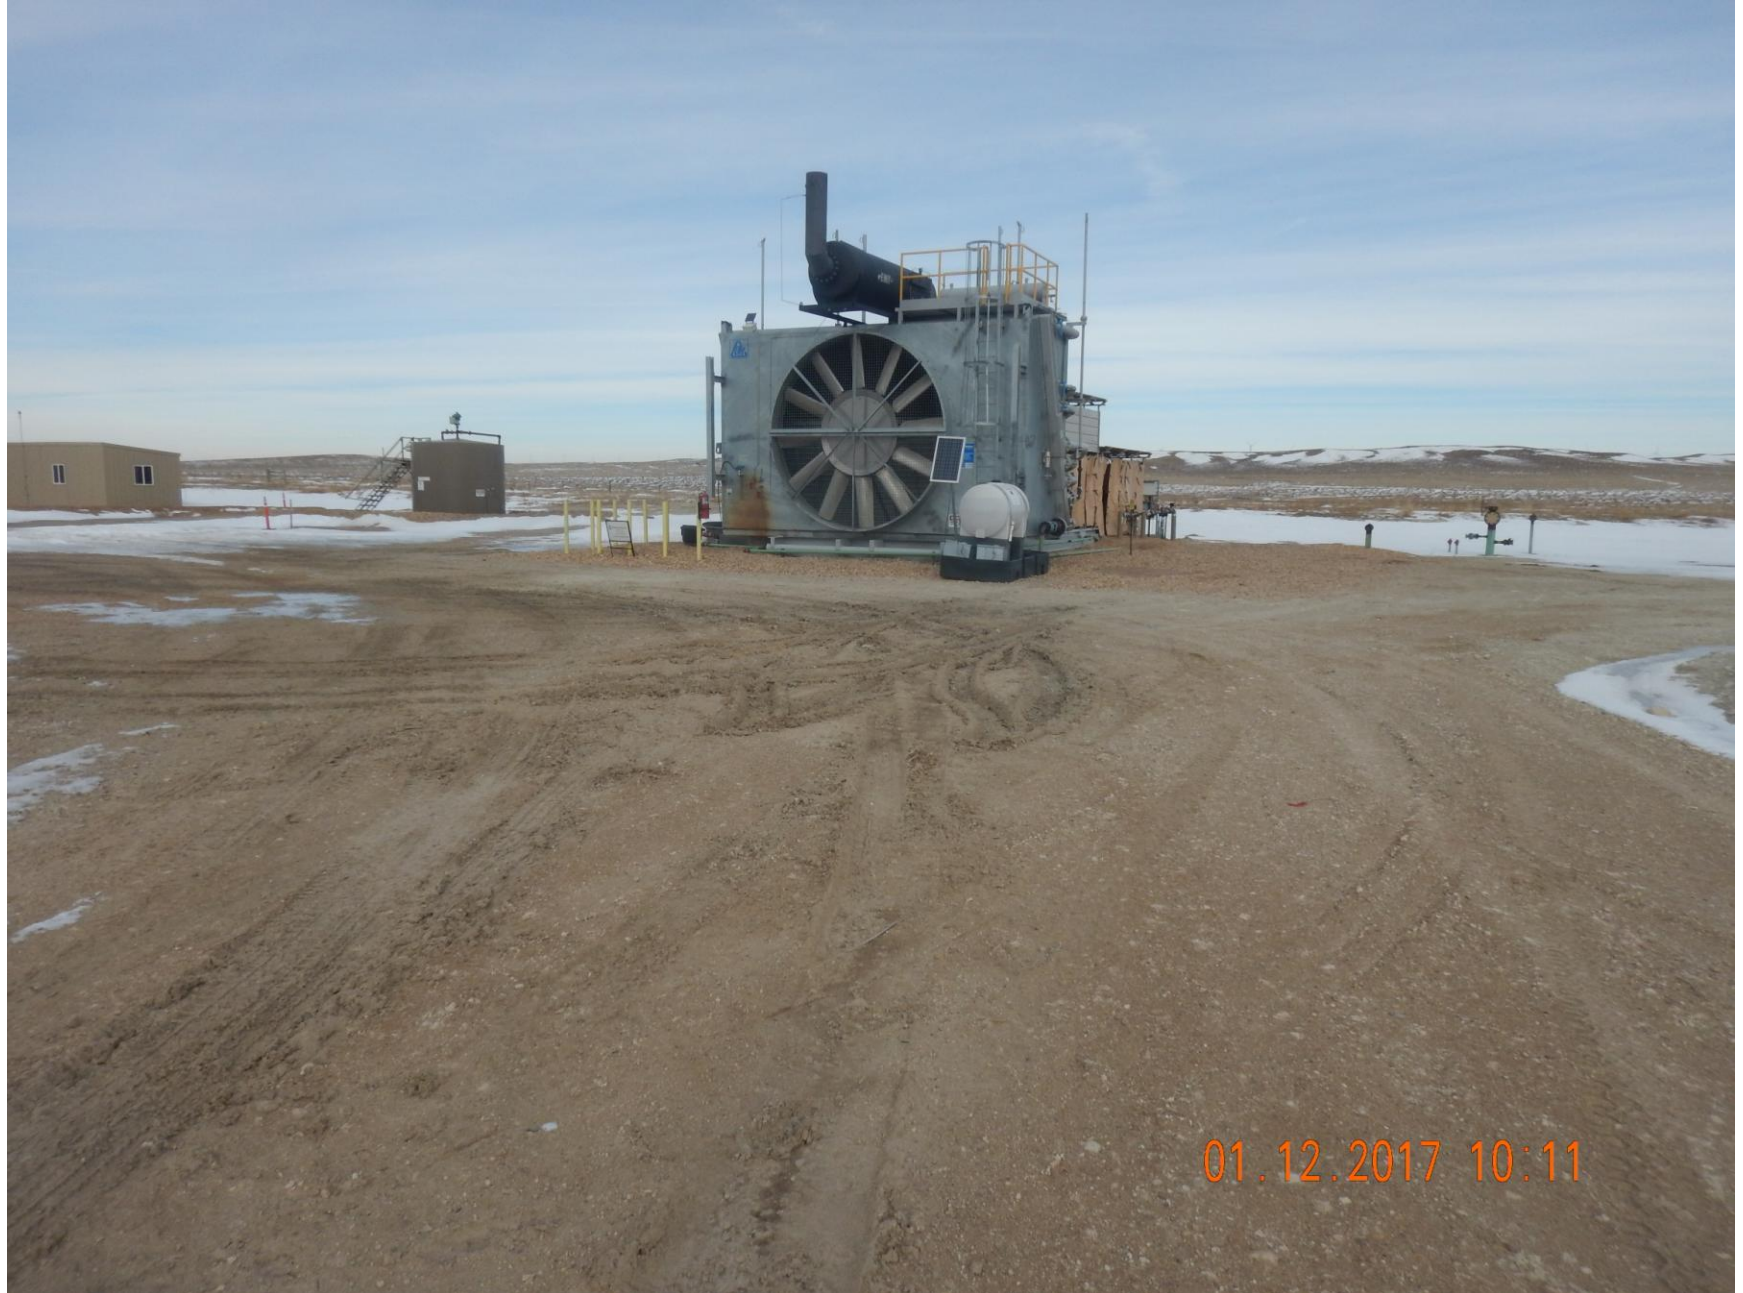
Figure 11: Photo taken from the northeast end of the production area, facing northwest. Photo shows compressor

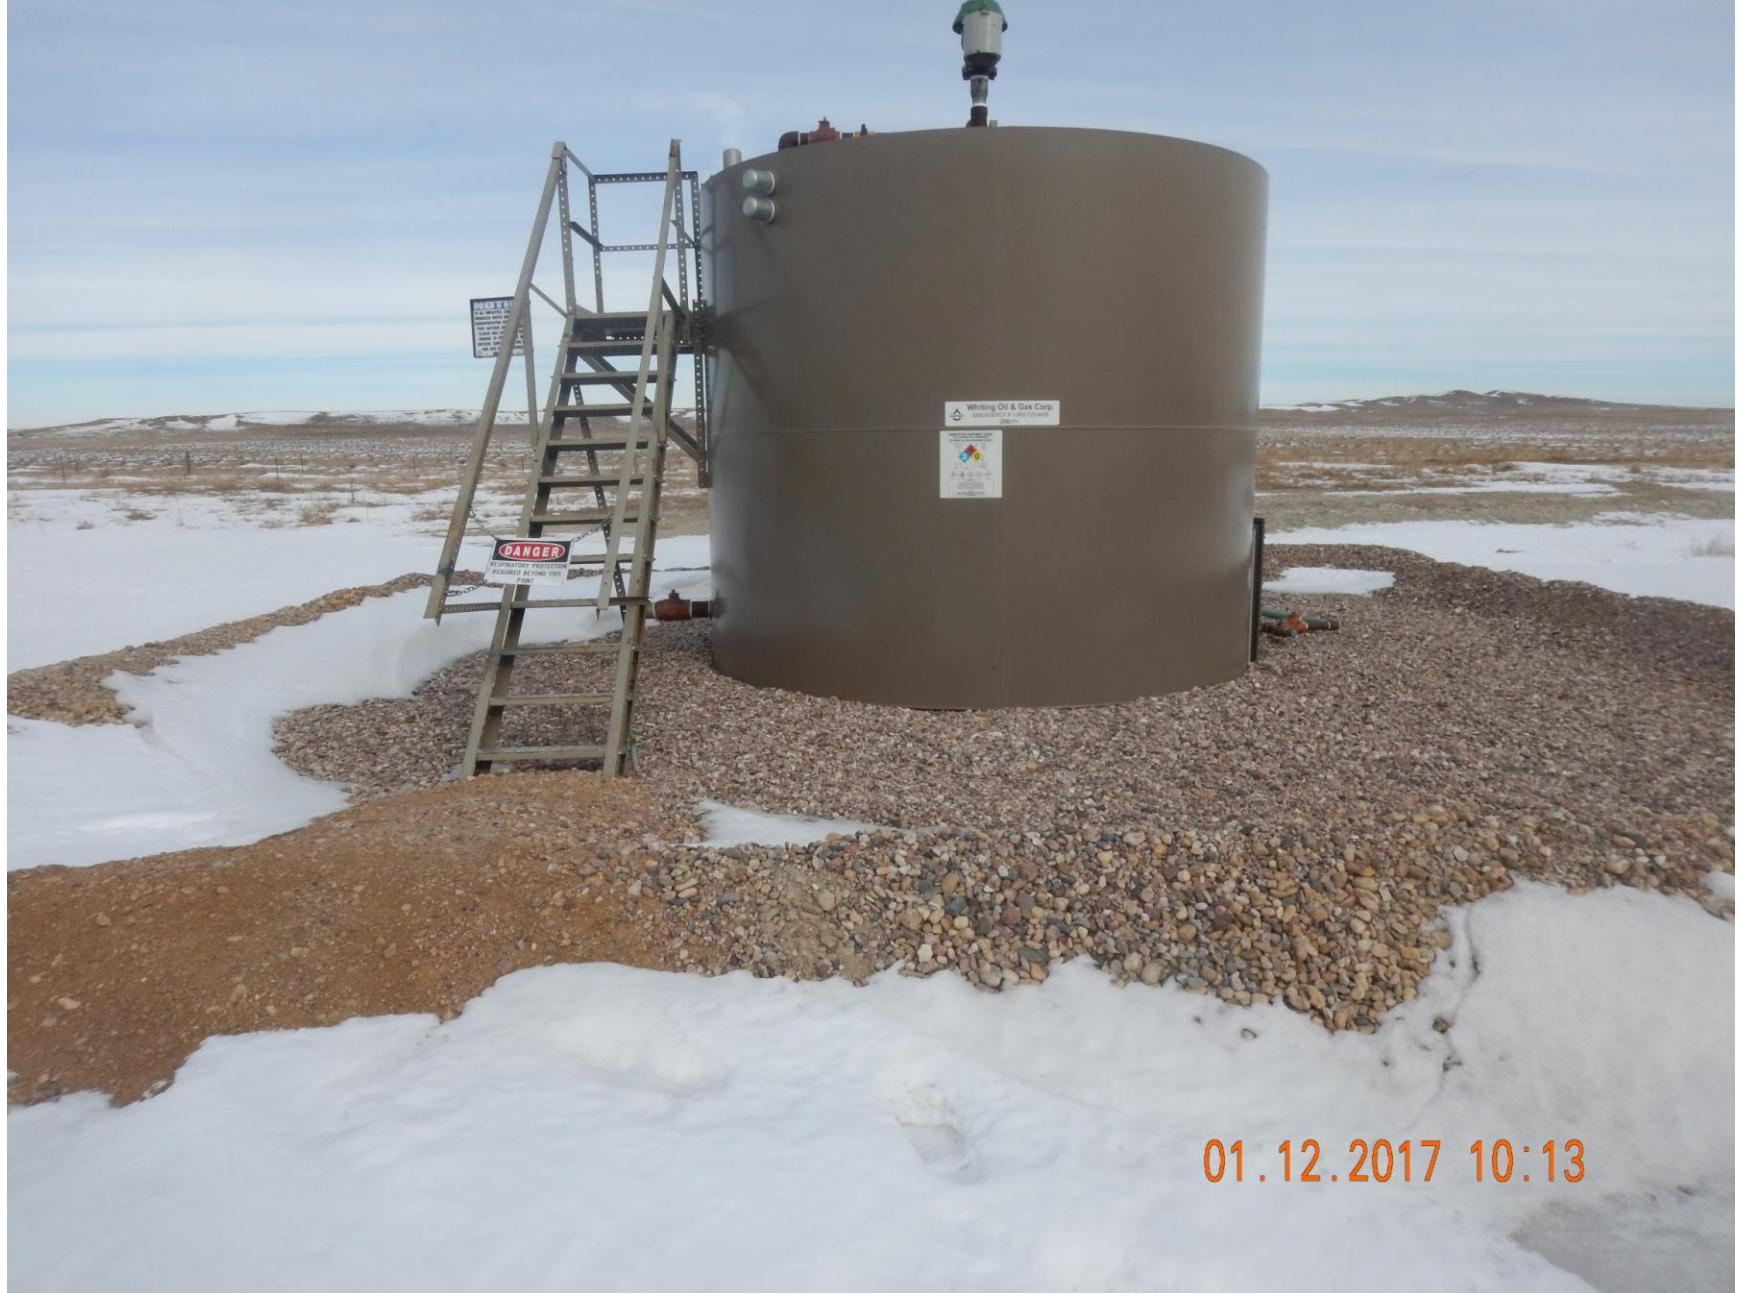
Figure 12: Photo taken from the north end of the location, facing north. Photo shows 200 bbl condensate tank. Berm in proper functioning condition.

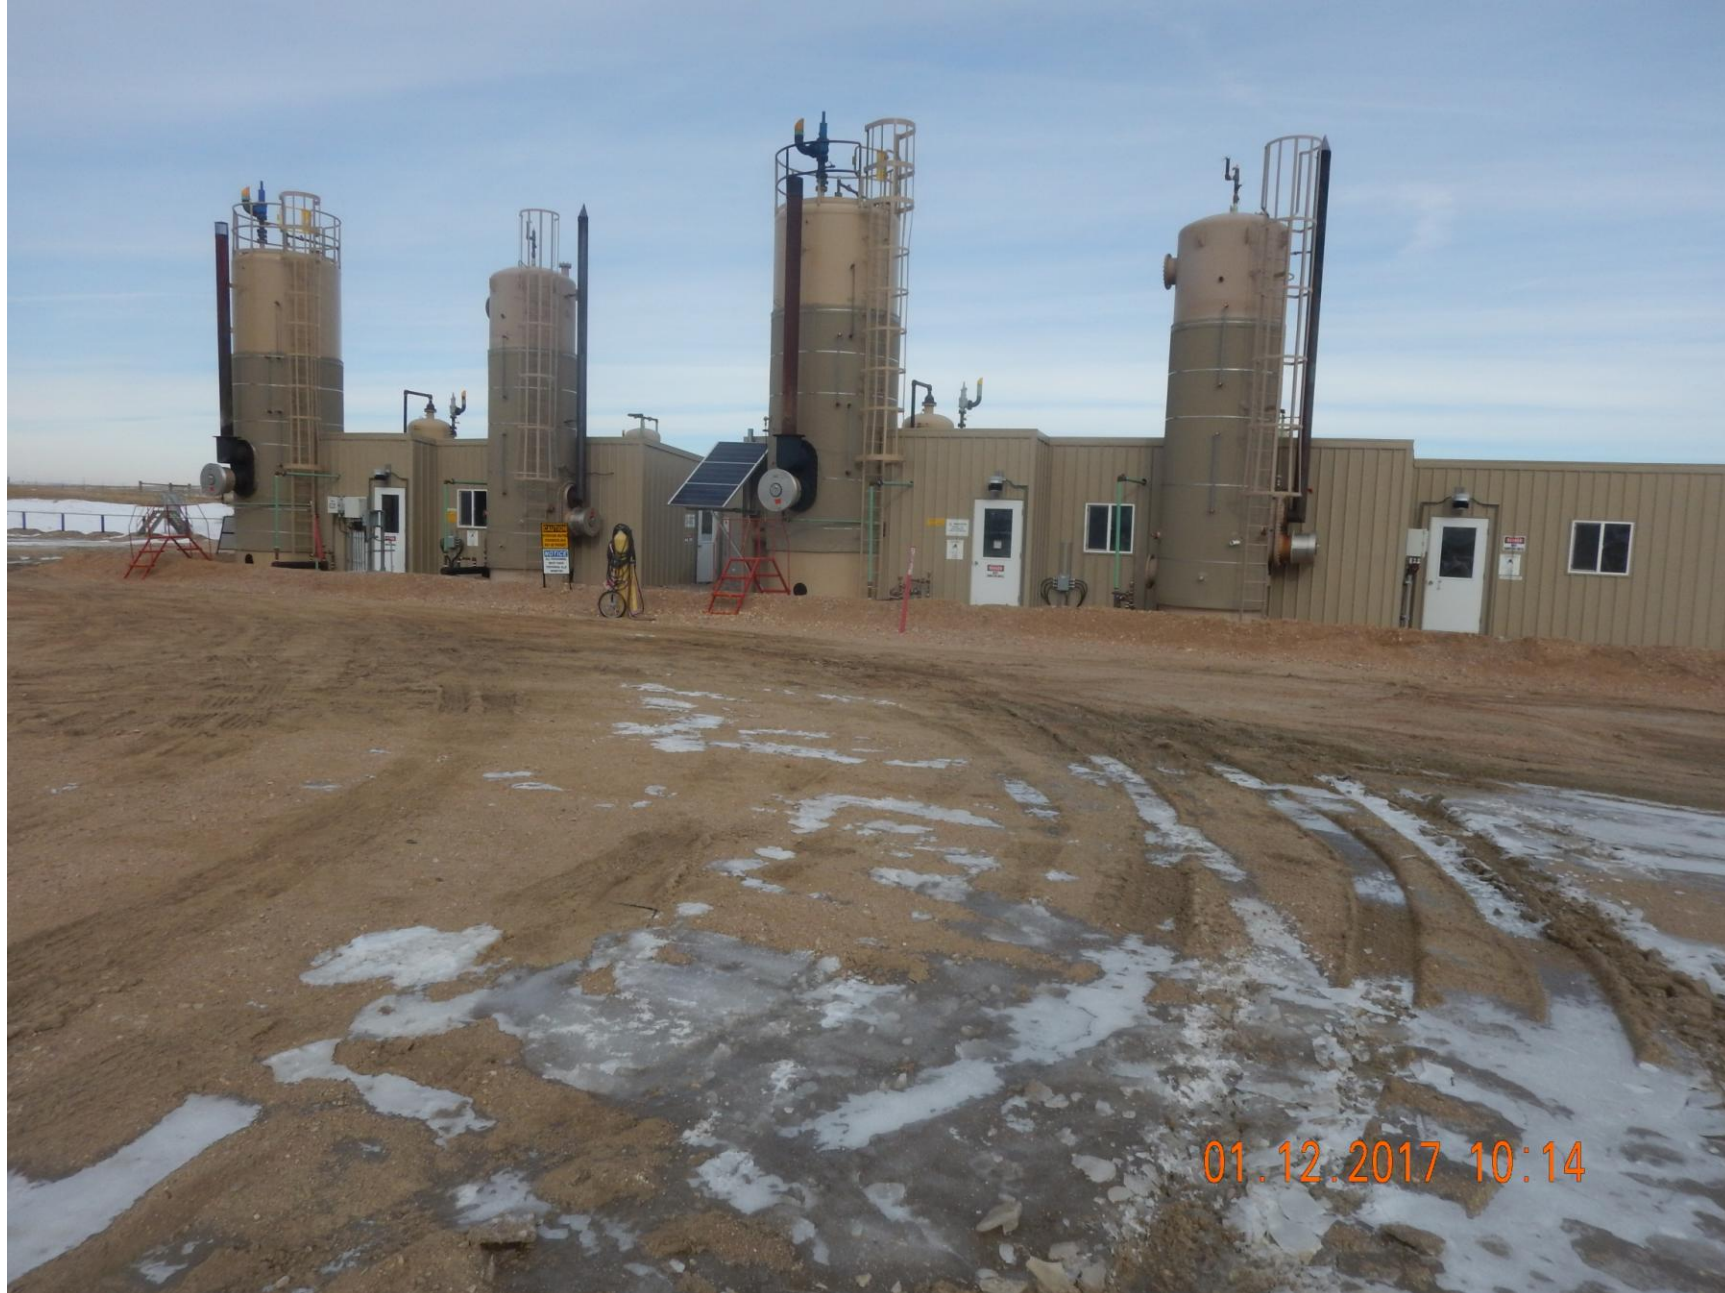
Figure 13: Photo taken from the north end of the location, facing north. Photo shows 4 vertical heater treaters.

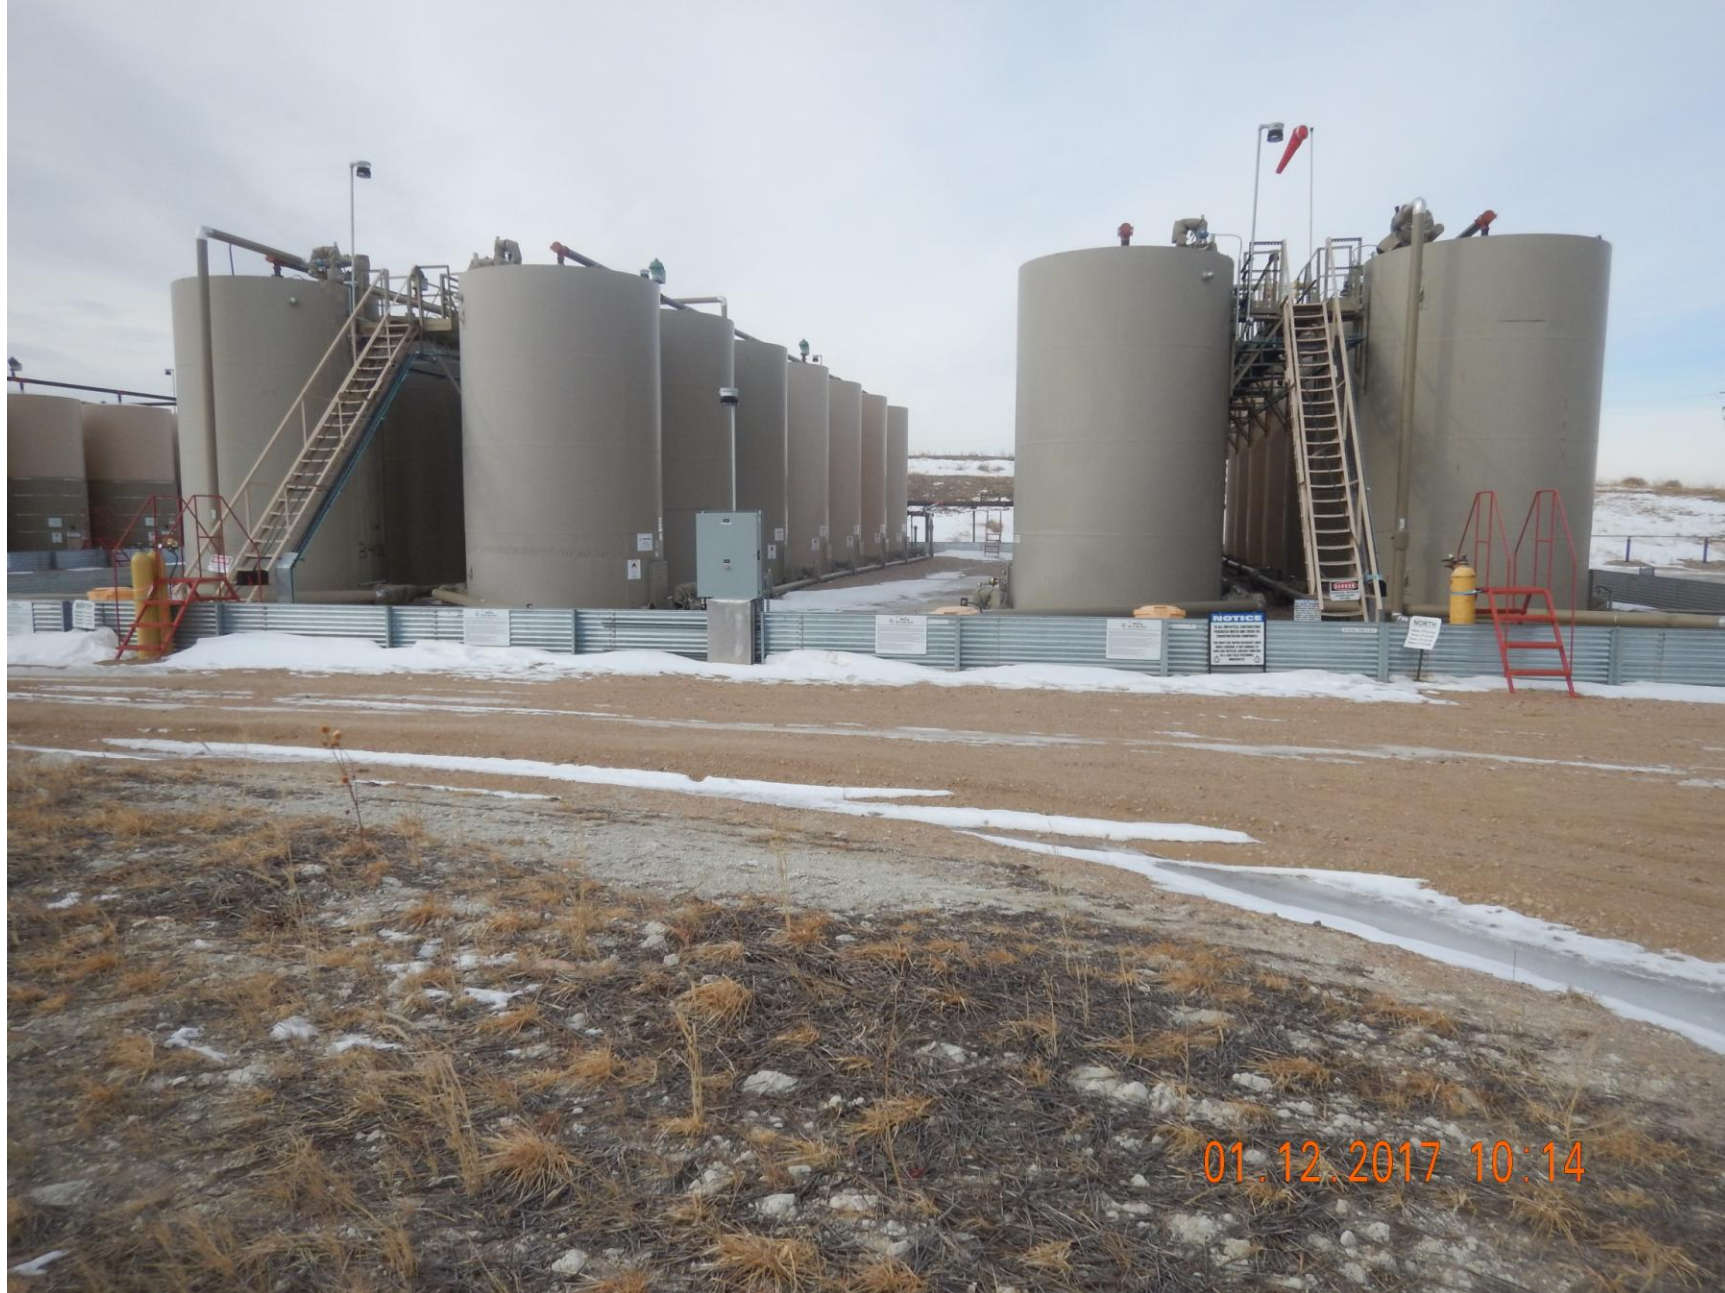
Figure 14: Photo taken from the west end of the location, west north. Photo shows 28, 400 bbl crude oil tanks.

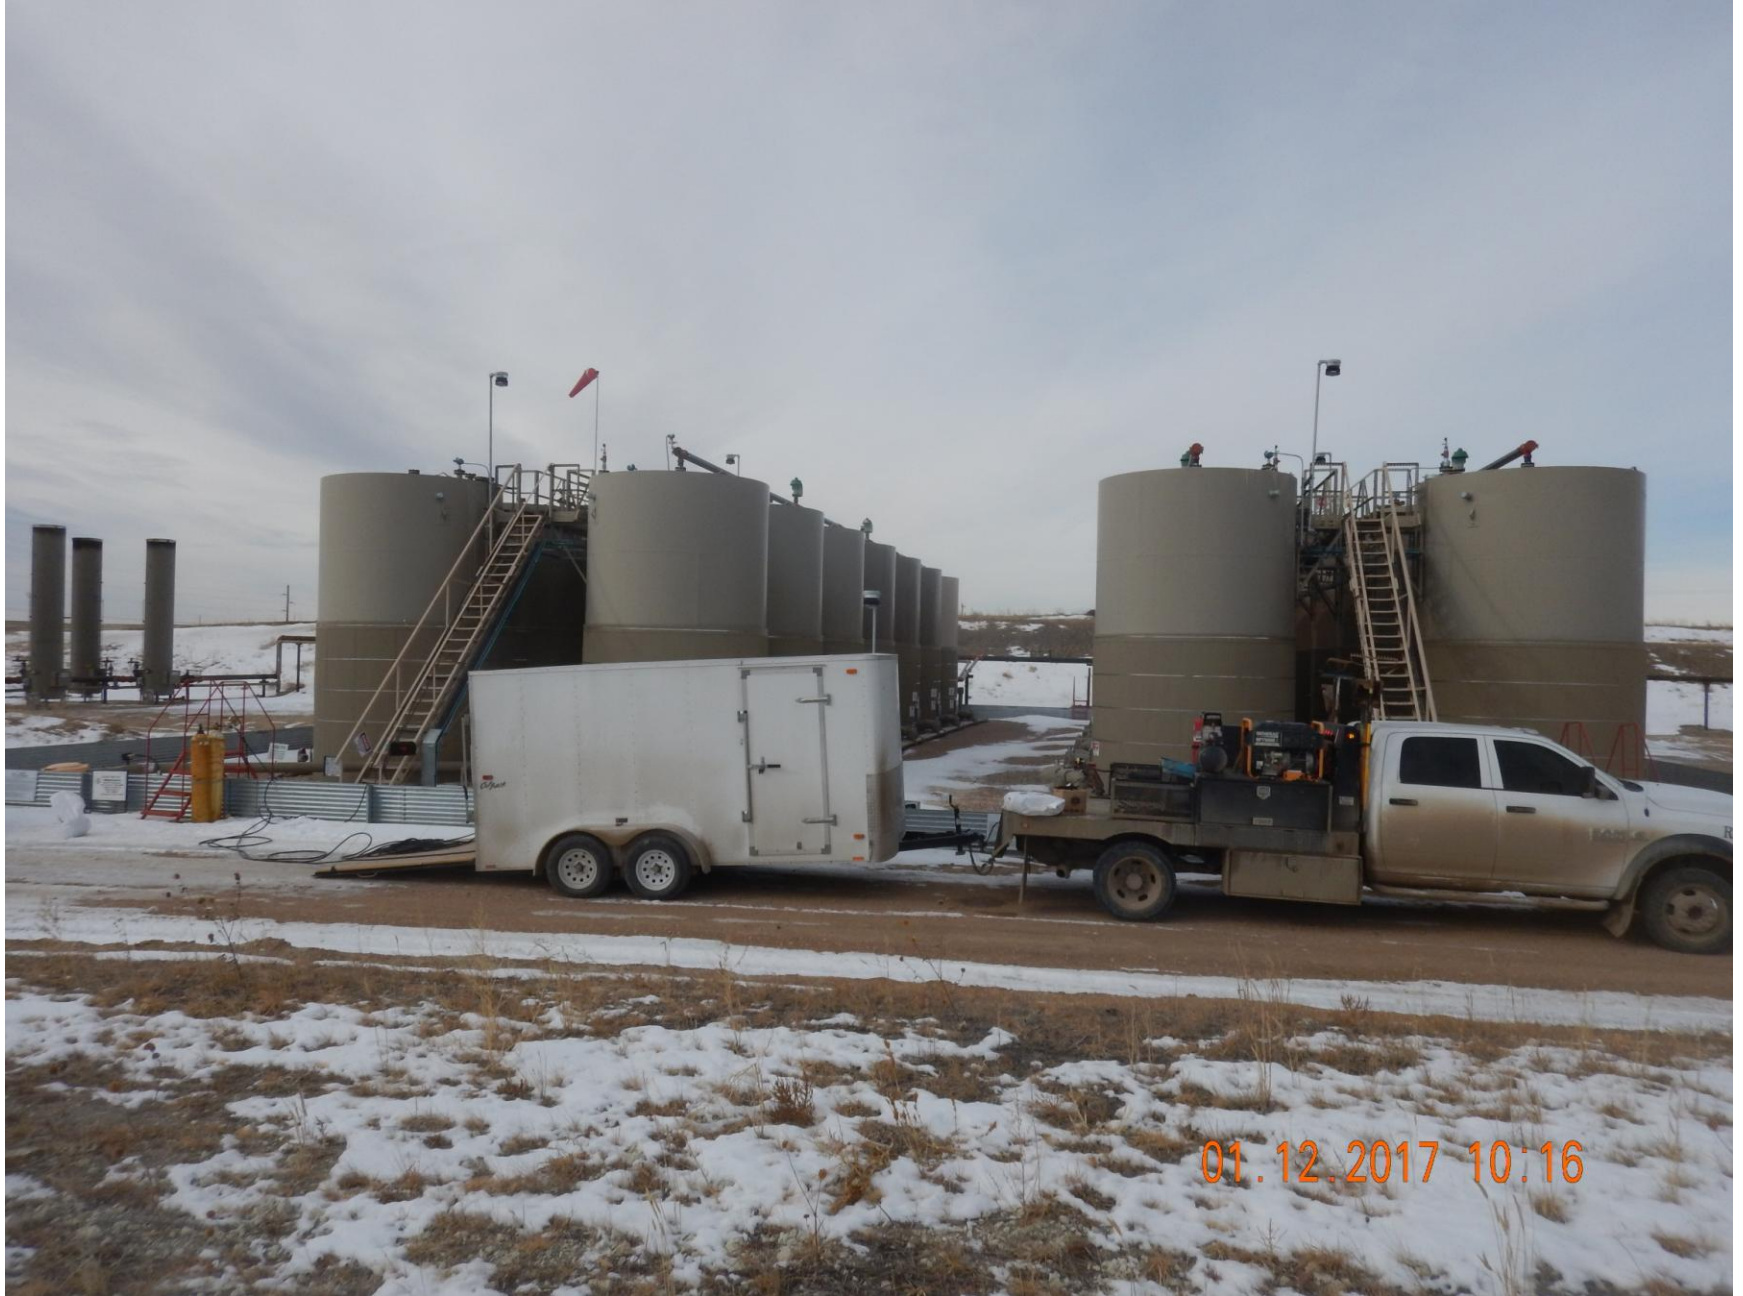
Figure 15: Photo taken from the west end of the location, west north. Photo shows 28, 400 bbl produced water tanks.

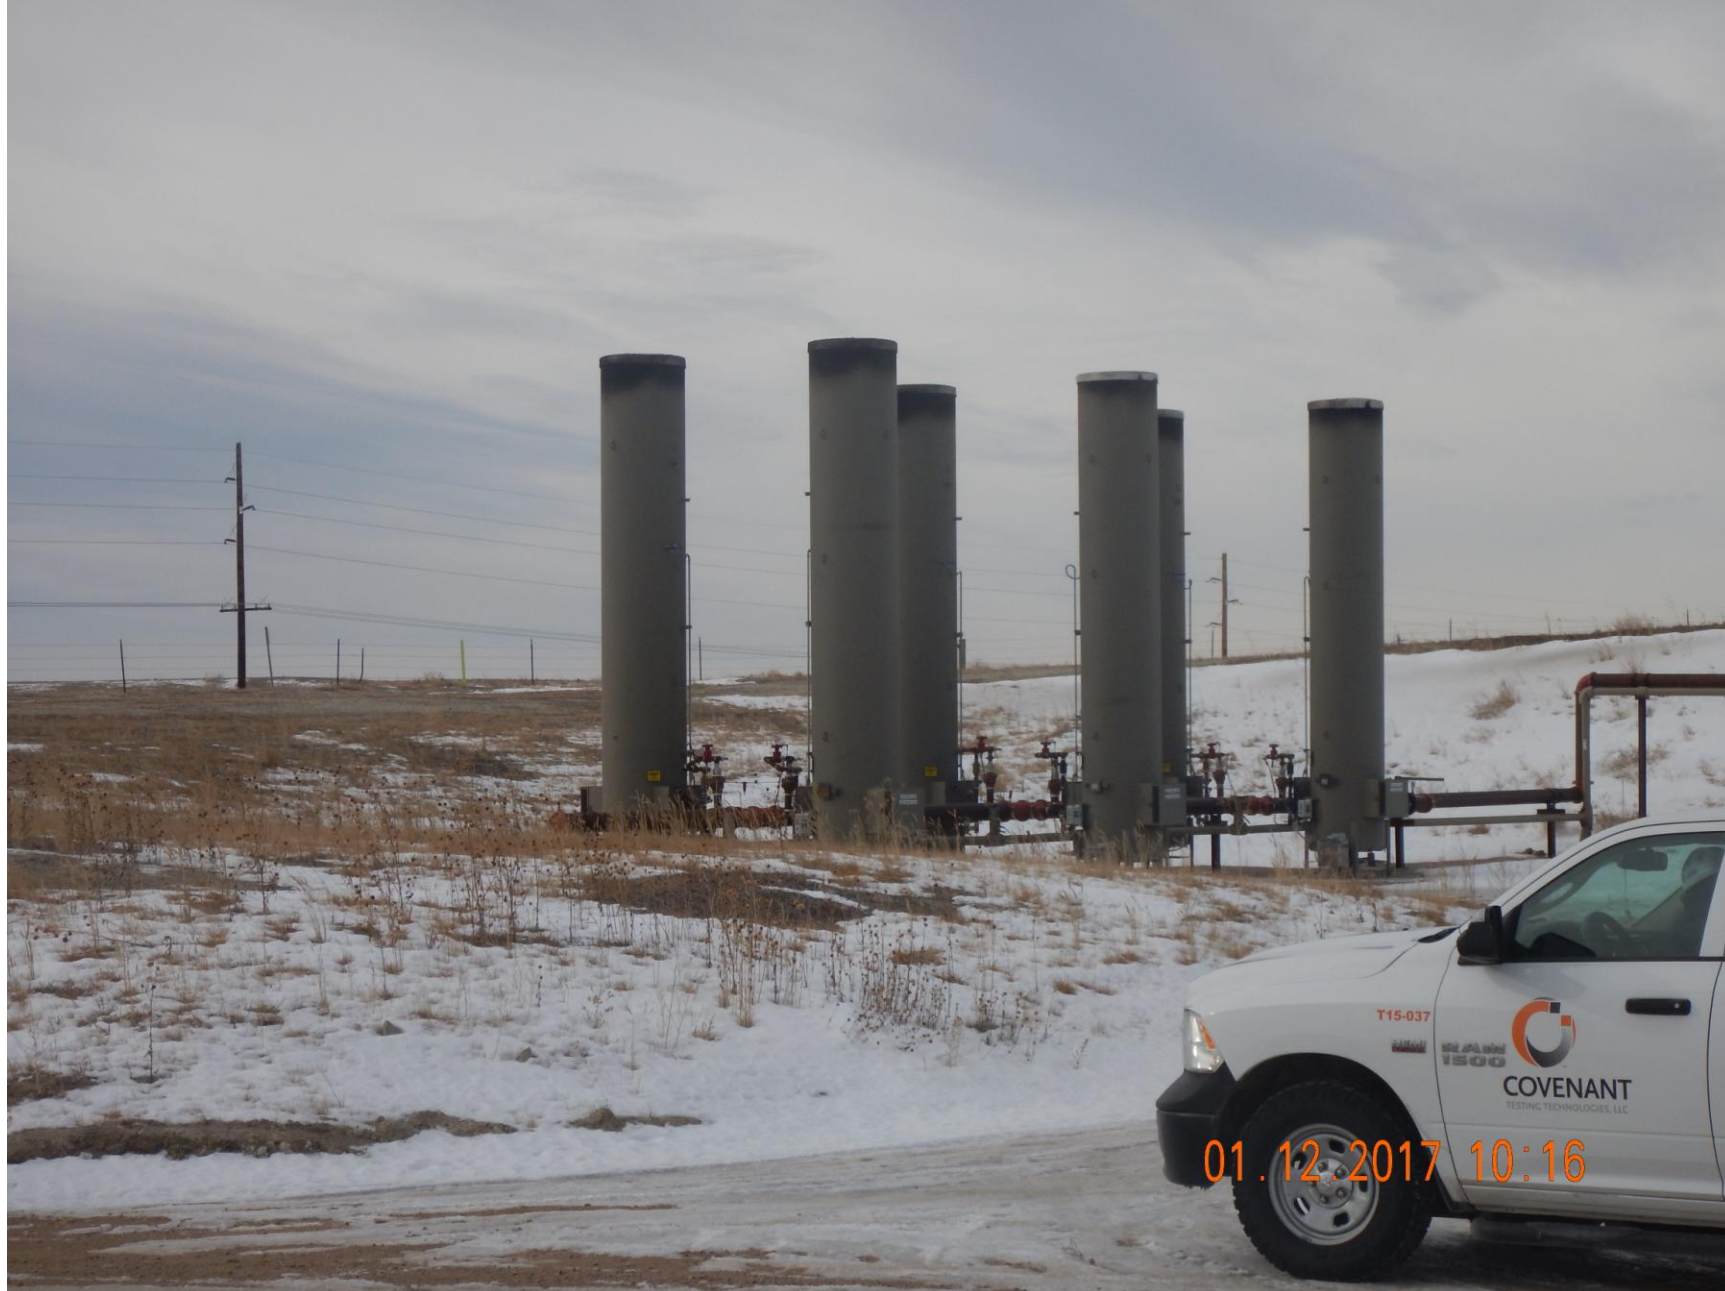
Figure 16: Photo taken from the southwest end of the location, facing west. Photo shows 6 emission control devices.

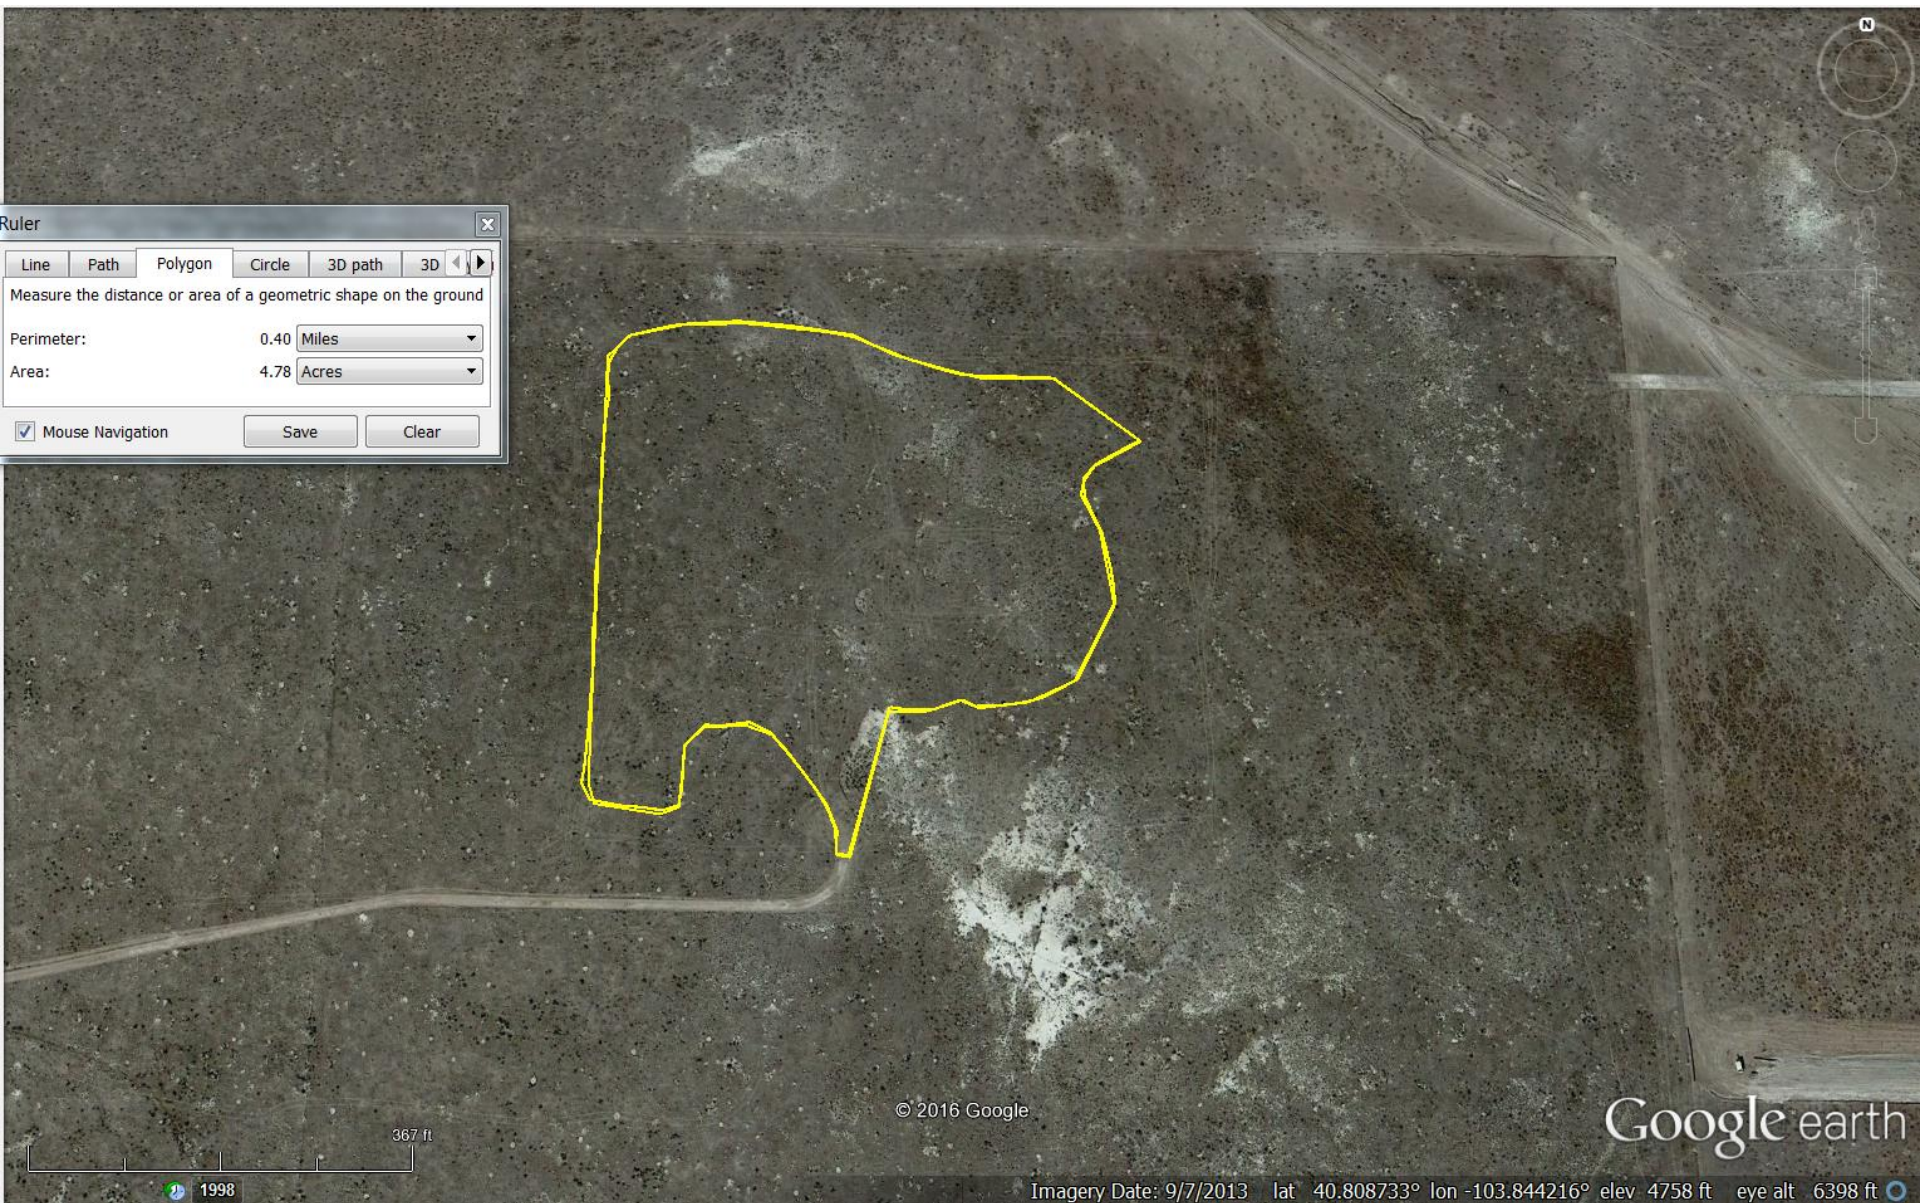
Figure 17: 2013 Google Earth imagery. Yellow polygon represents the current perimeter of the production area (confirmed by GPS on the ground). Current size of production area is 4.78 acres. Approved 2A doc. #400426385 stated production area post interim reclamation would be 3.4 acres.
