Interim Reclamation and Stormwater Inspection

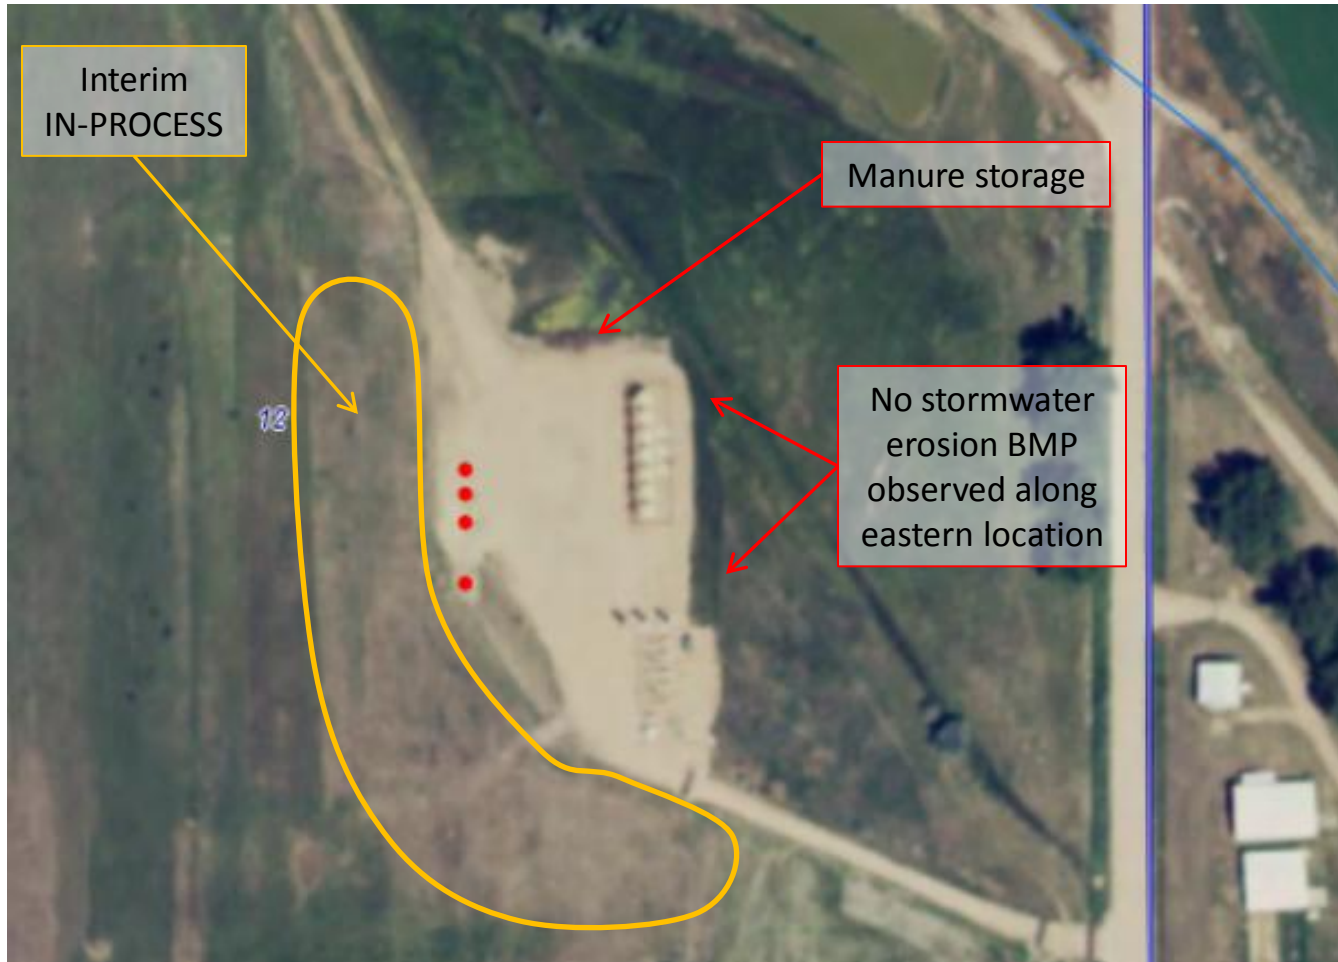
Aerial imagery using COGCC GISOnline database of the Shoemaker AA07-65HN location overview. Portions of the western interim reclamation area are IN-PROCESS and lack uniform vegetative growth- refer to Photo 3. Manure storage along the north pad needs to be removed. Manure appears to be discharging into a Freshwater Emergent Wetland- refer to the following aerial imagery.

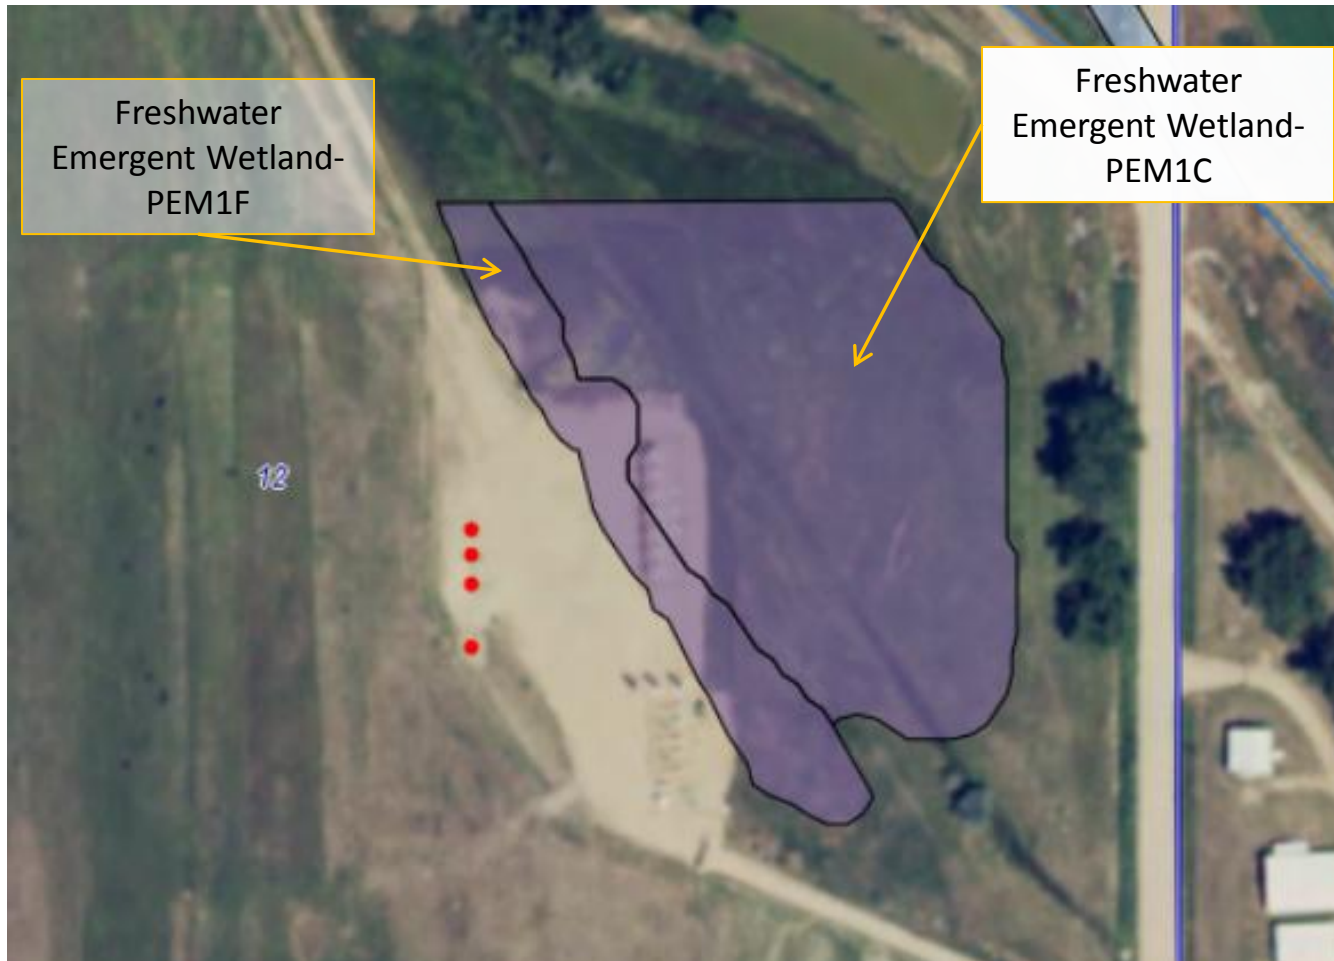
Aerial imagery using COGCC GISOnline illustrating National Wetlands Inventory data. Two types of Freshwater Emergent Wetland are classified for this region- PEM1F and PEM1C.

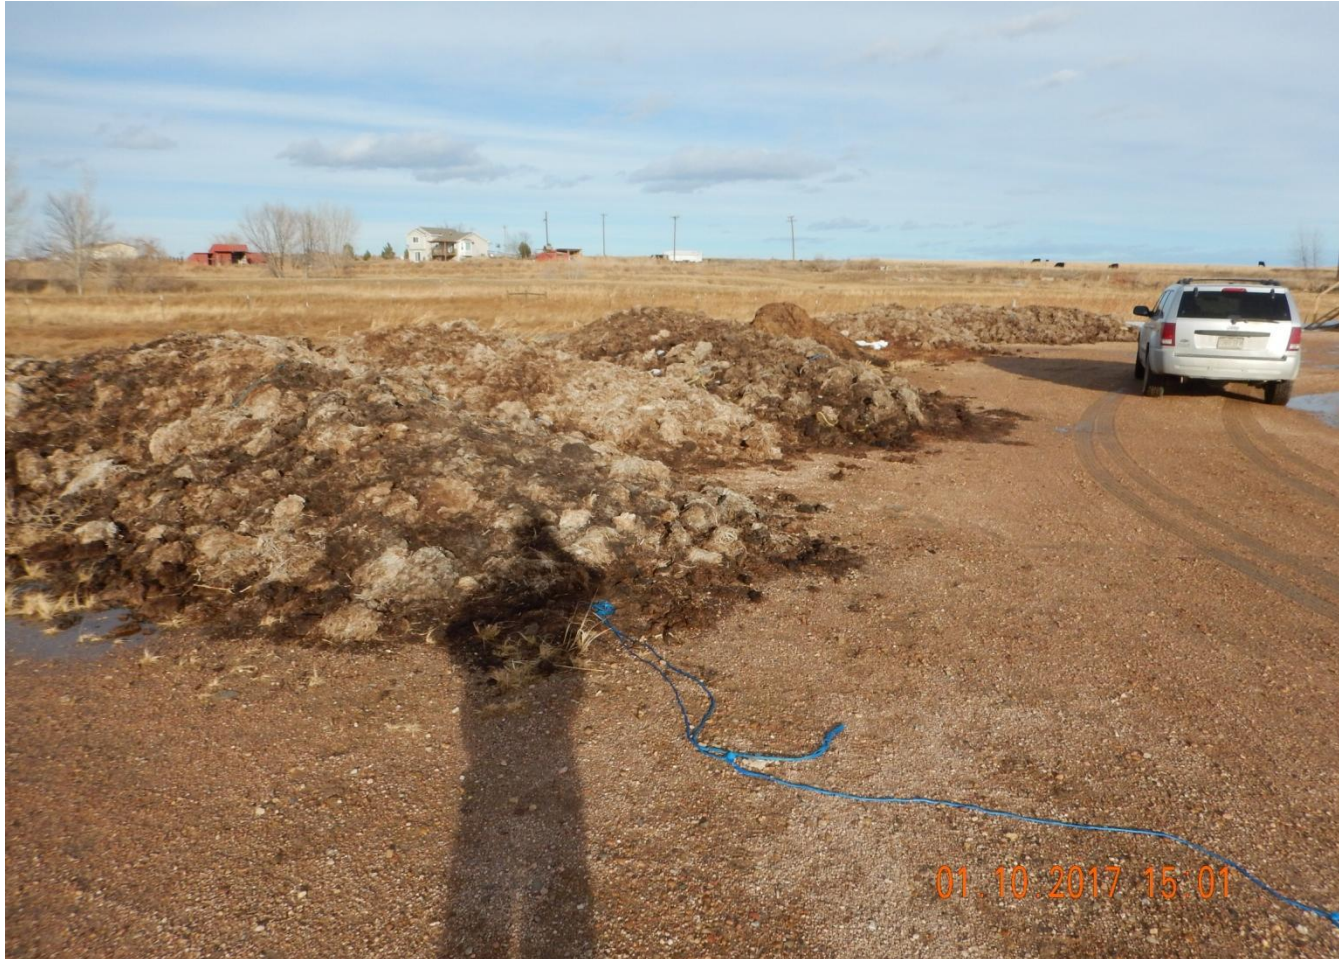
Photo 1. Photo taken from the northern pad location, facing East. Need to remove all manure from location. Manure appears to be discharging into a Freshwater Emergent Wetland.

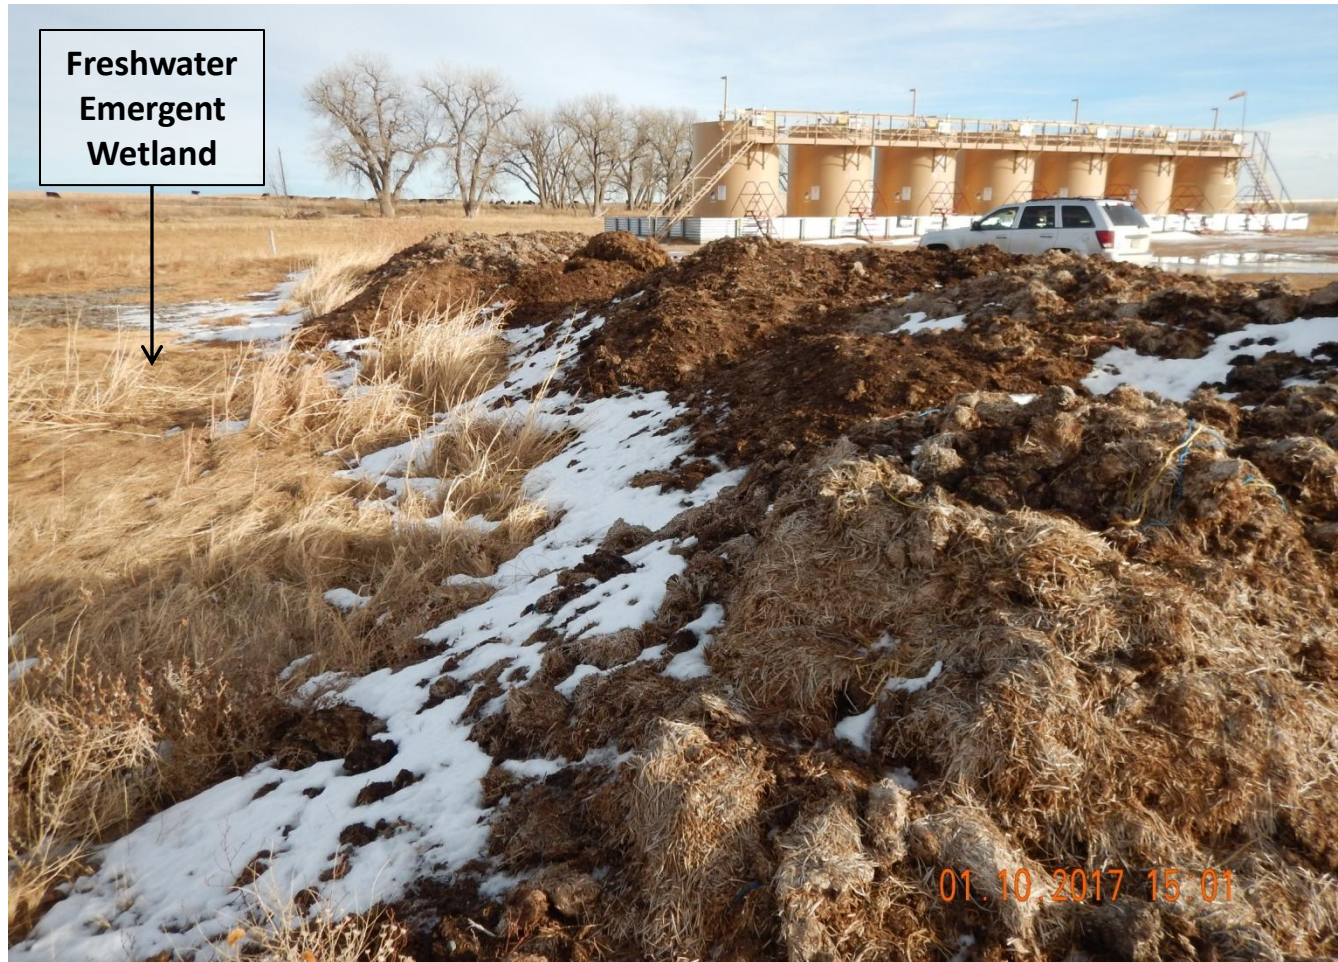
Photo 2. Photo taken from the northern pad location, facing Southeast. Need to remove all manure from location. Manure appears to be discharging into a Freshwater Emergent Wetland.

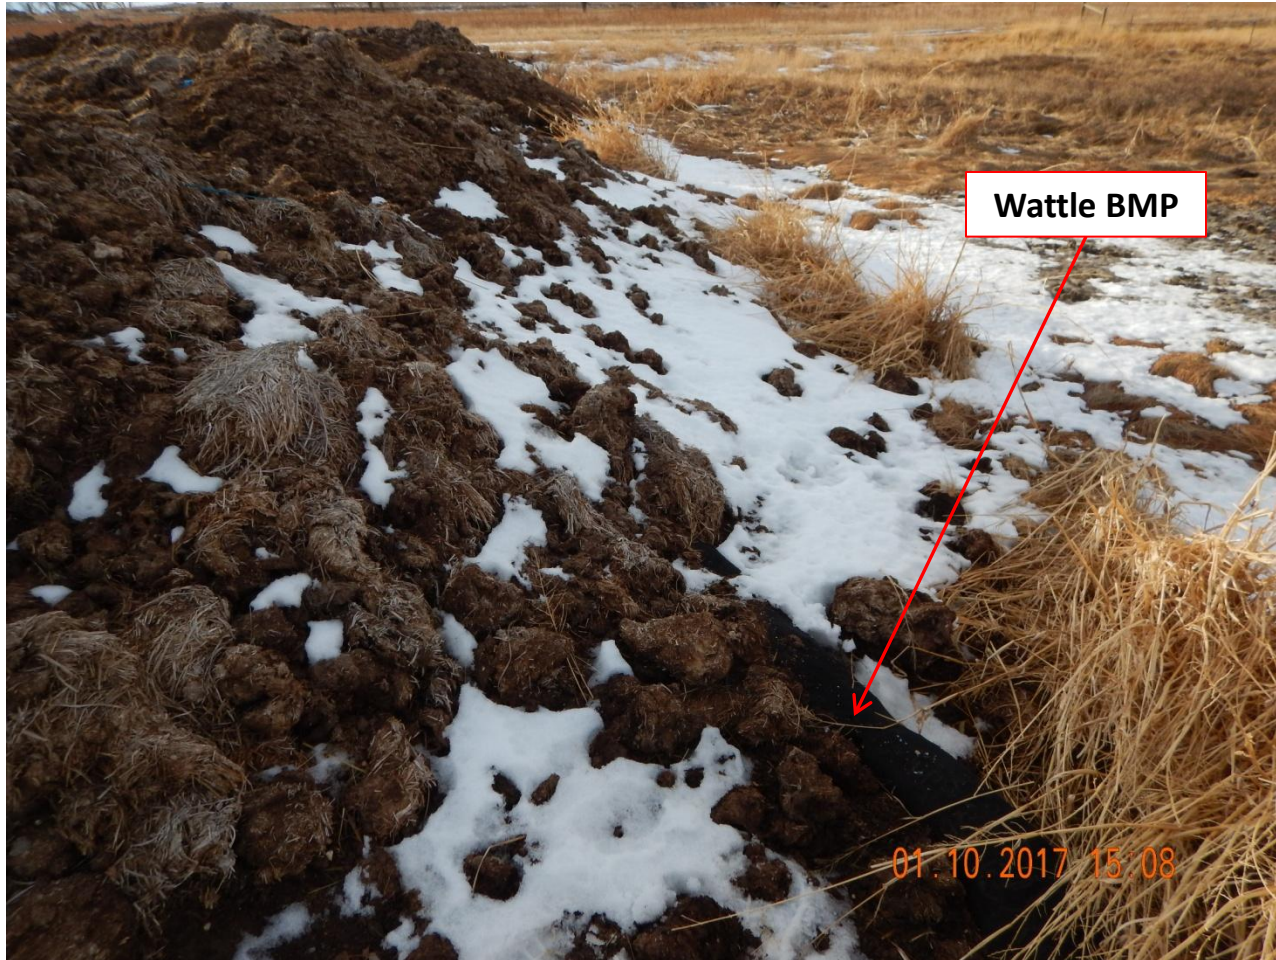
Photo 3. Photo taken from the northeast location, facing West. Appears manure was placed over wattle BMP for location.

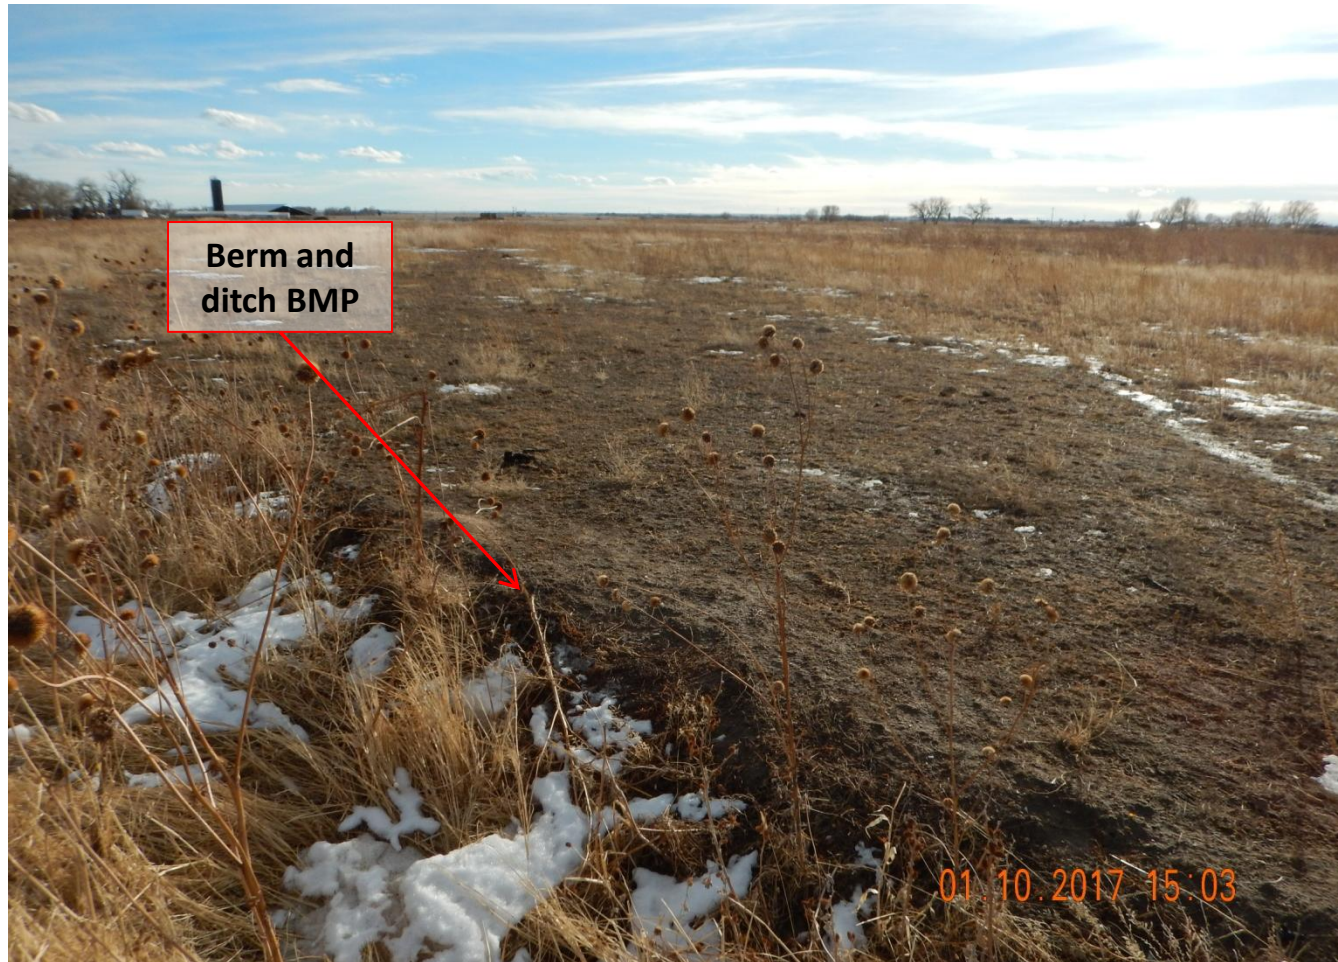
Photo 4. Photo taken from the western interim reclamation area, facing South. Portions of the interim reclamation area do not have uniform vegetative growth, like this photo illustrates. Berm and ditch BMP observed along the western interim area.
