Reclamation and Stormwater Inspection

01/18/2017

Operator: Foundation Energy #10112

Location ID: 330865

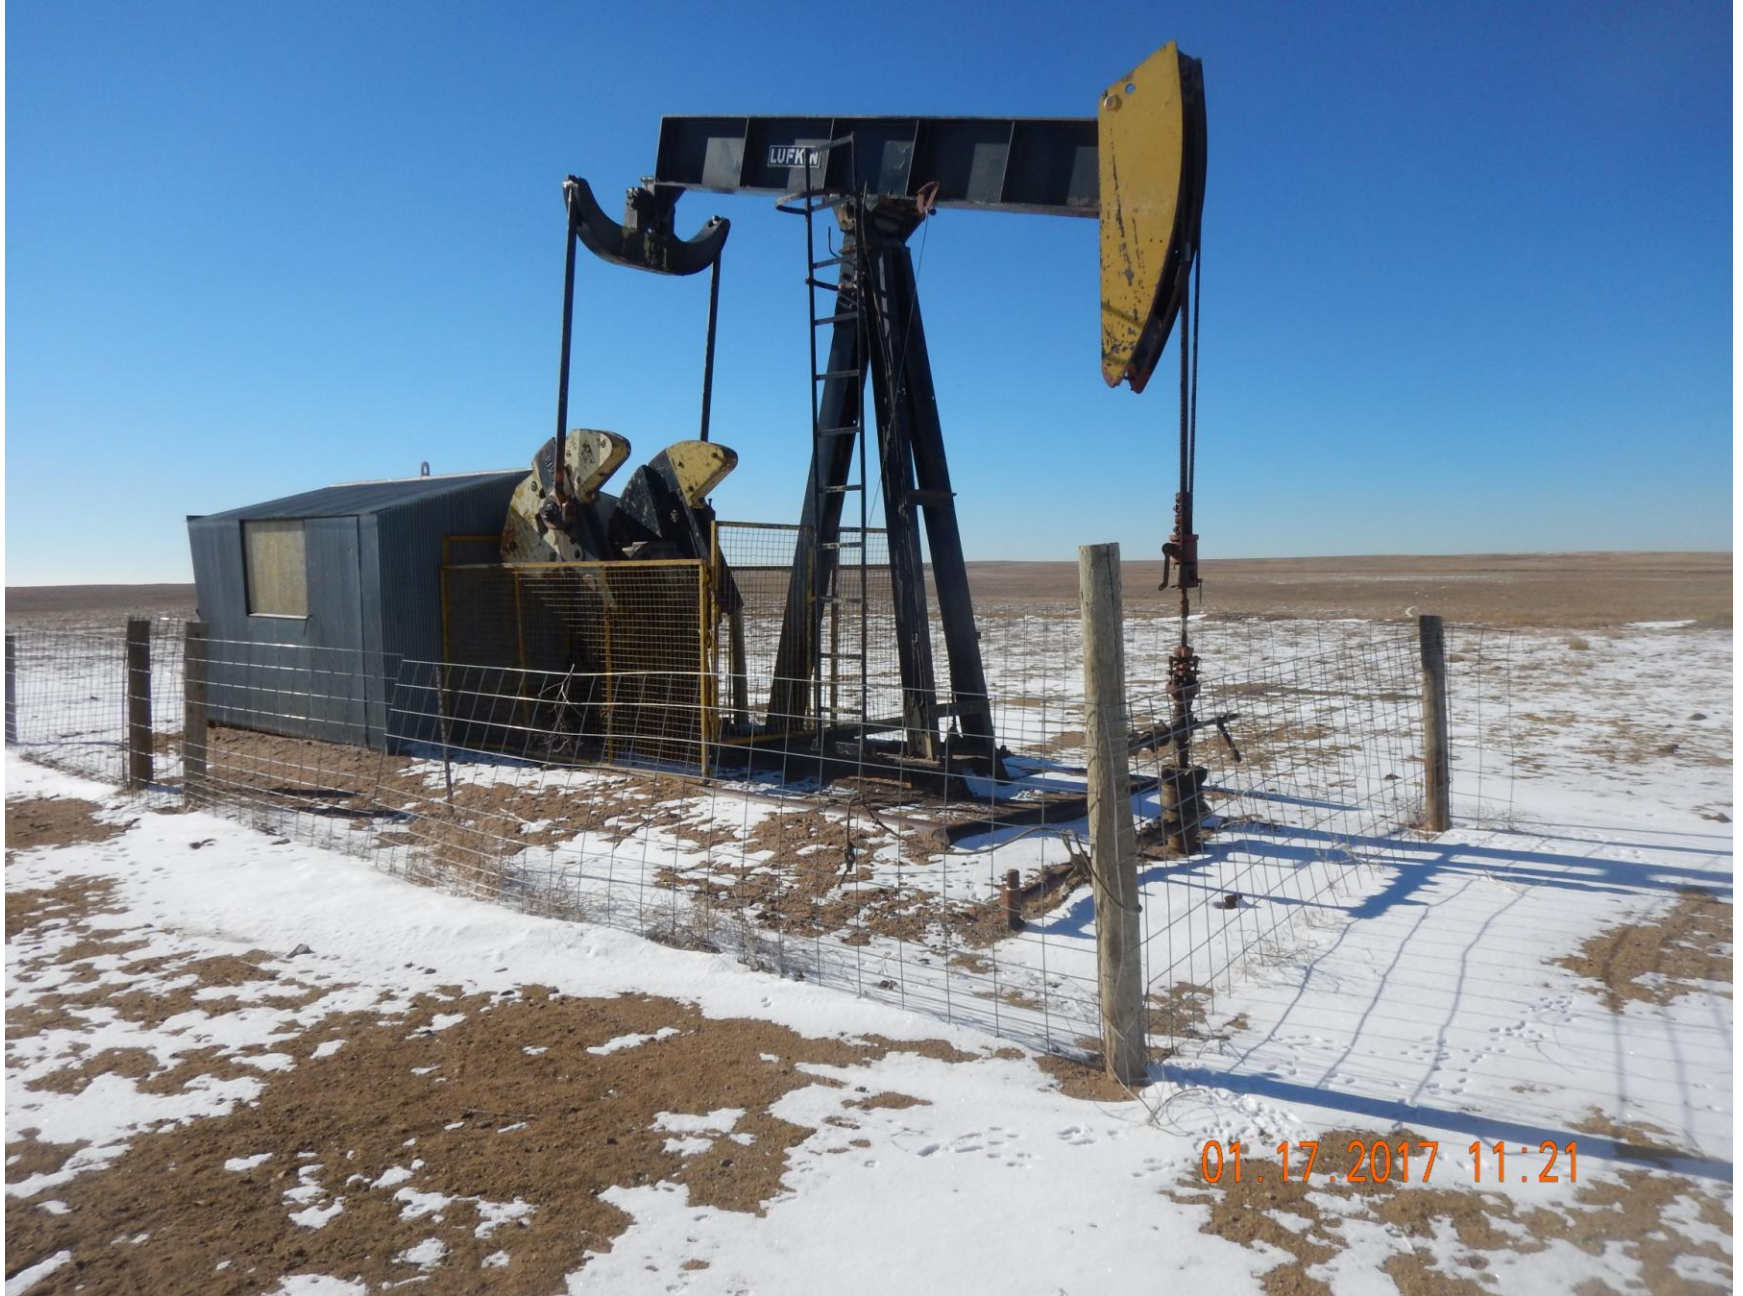
Figure 2: Photo taken from the location, facing west. Photo of pump-jack and well. Photo shows sign missing at wellhead.

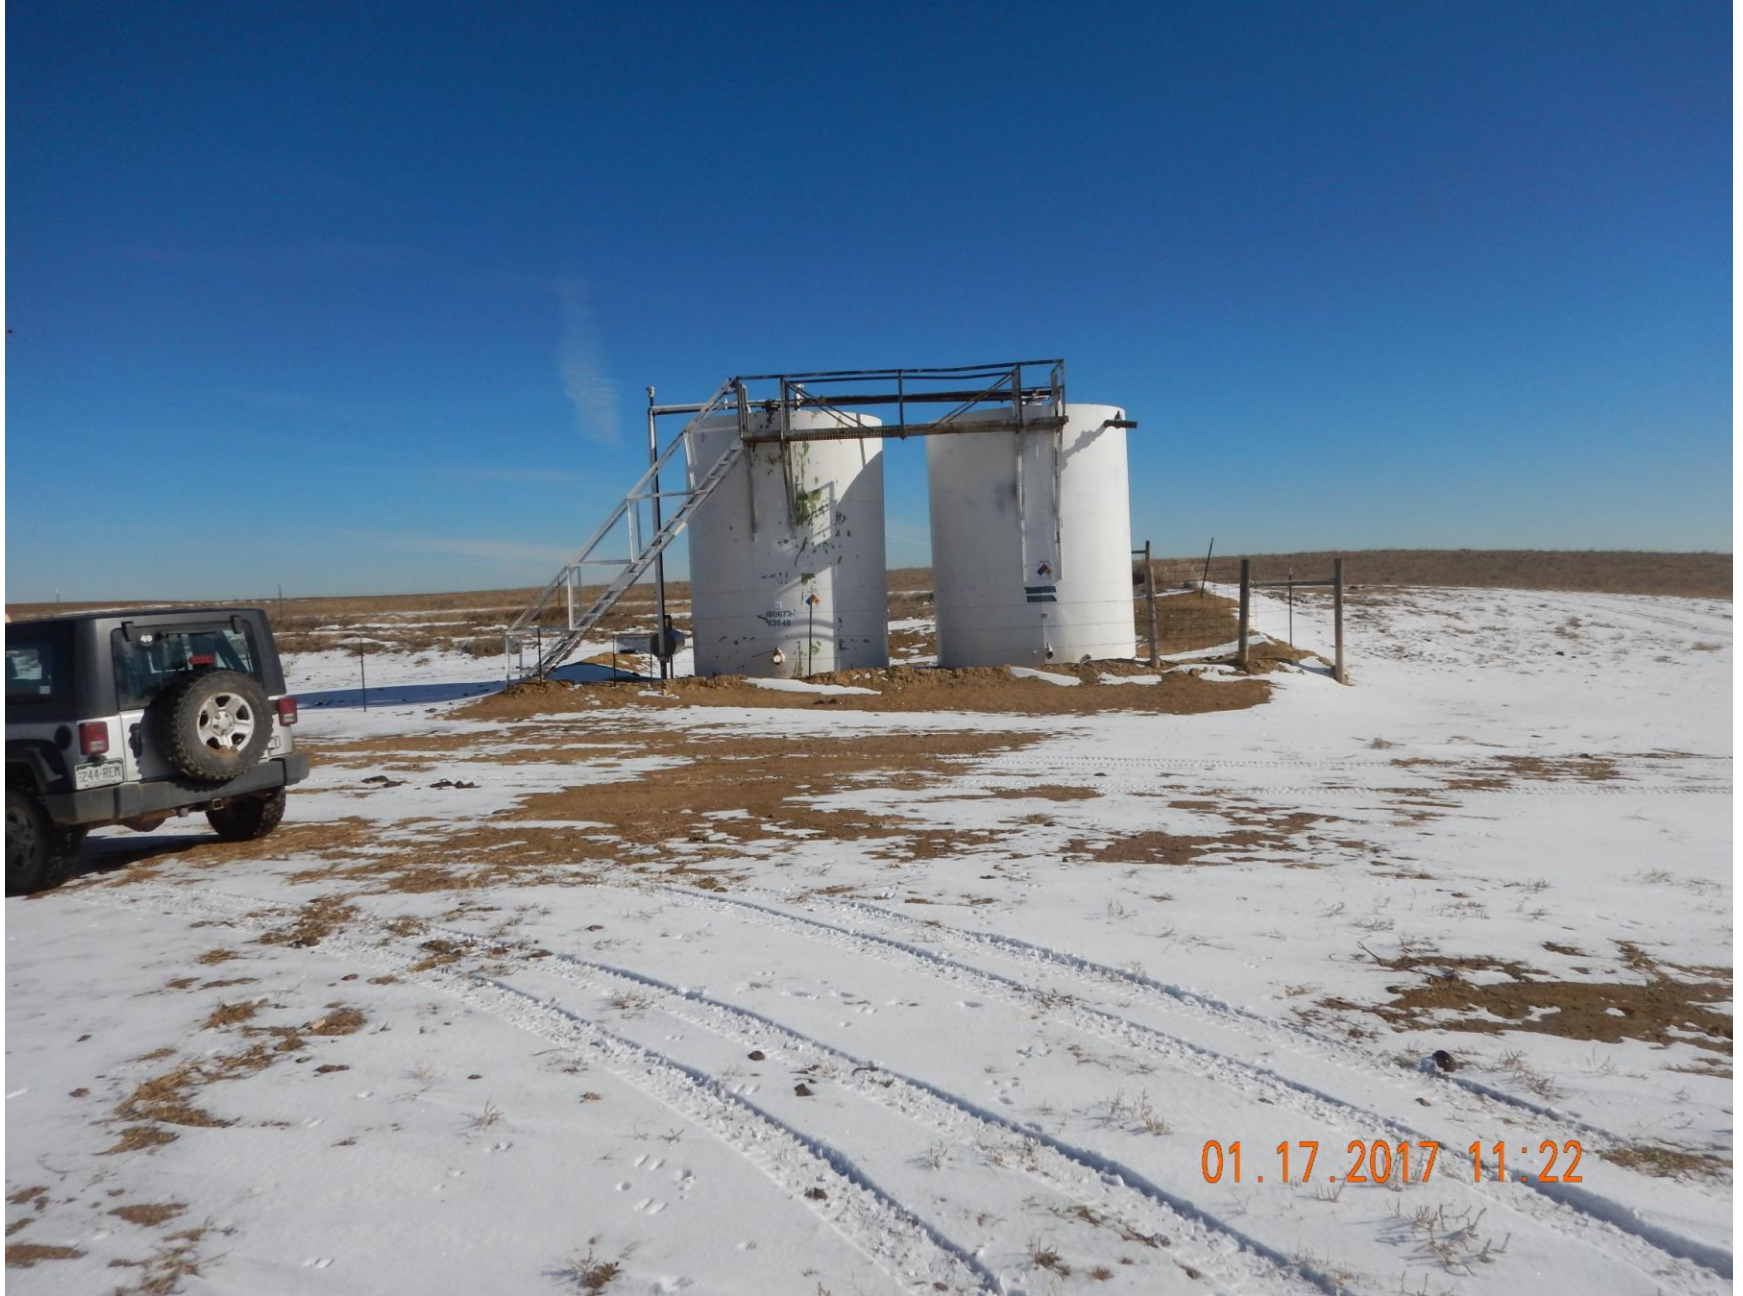
Figure 3: Photo taken from the location, facing east. Photo shows two tanks on the location. Photo also shows area where access road enters the location (right of photo).

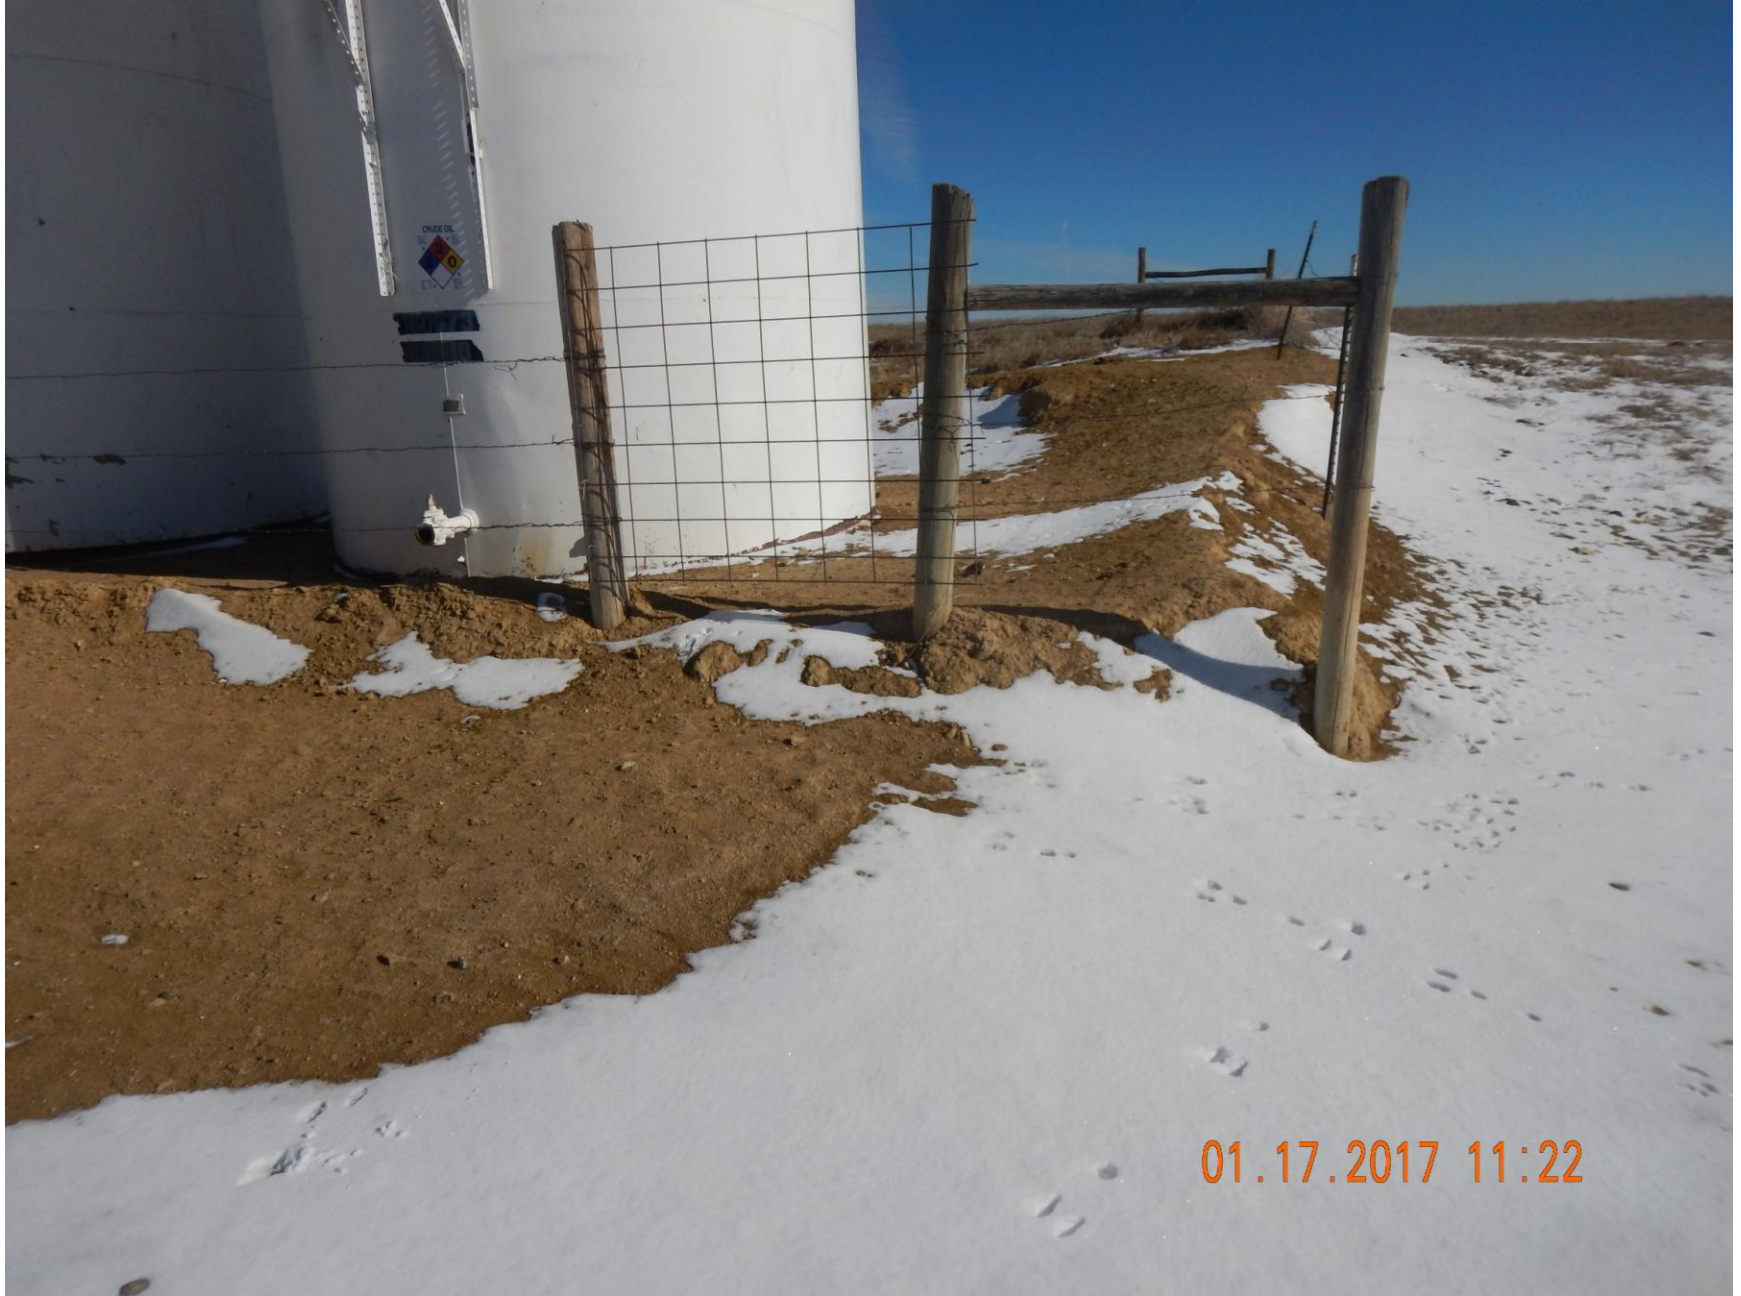
Figure 4: Photo taken from the southwest corner of the tank battery, facing east. Photo shows the earthen berm used as secondary containment is insufficient and unmaintained.

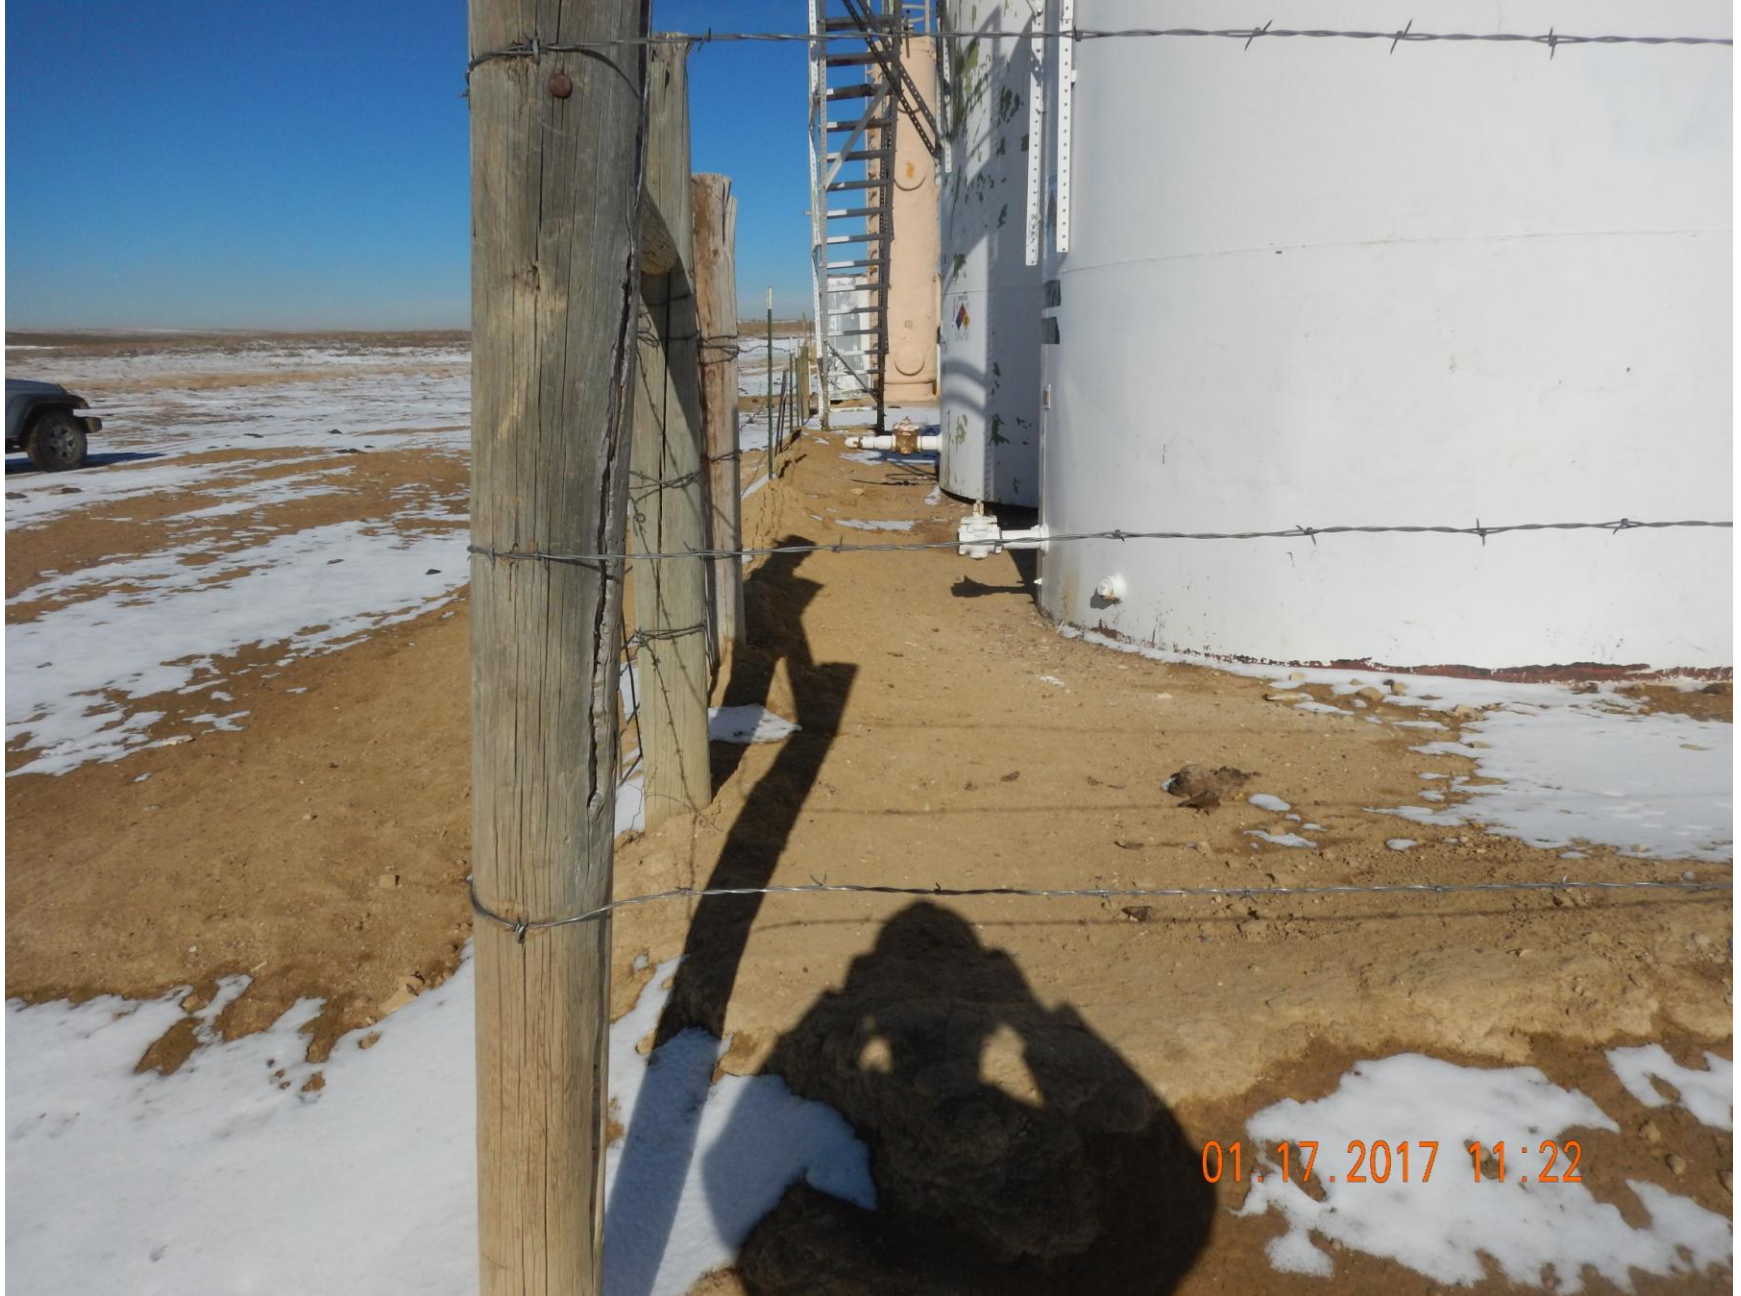
Figure 5: Photo taken from the southwest corner of the tank battery, facing north. Photo shows the earthen berm as secondary containment is insufficient and unmaintained.

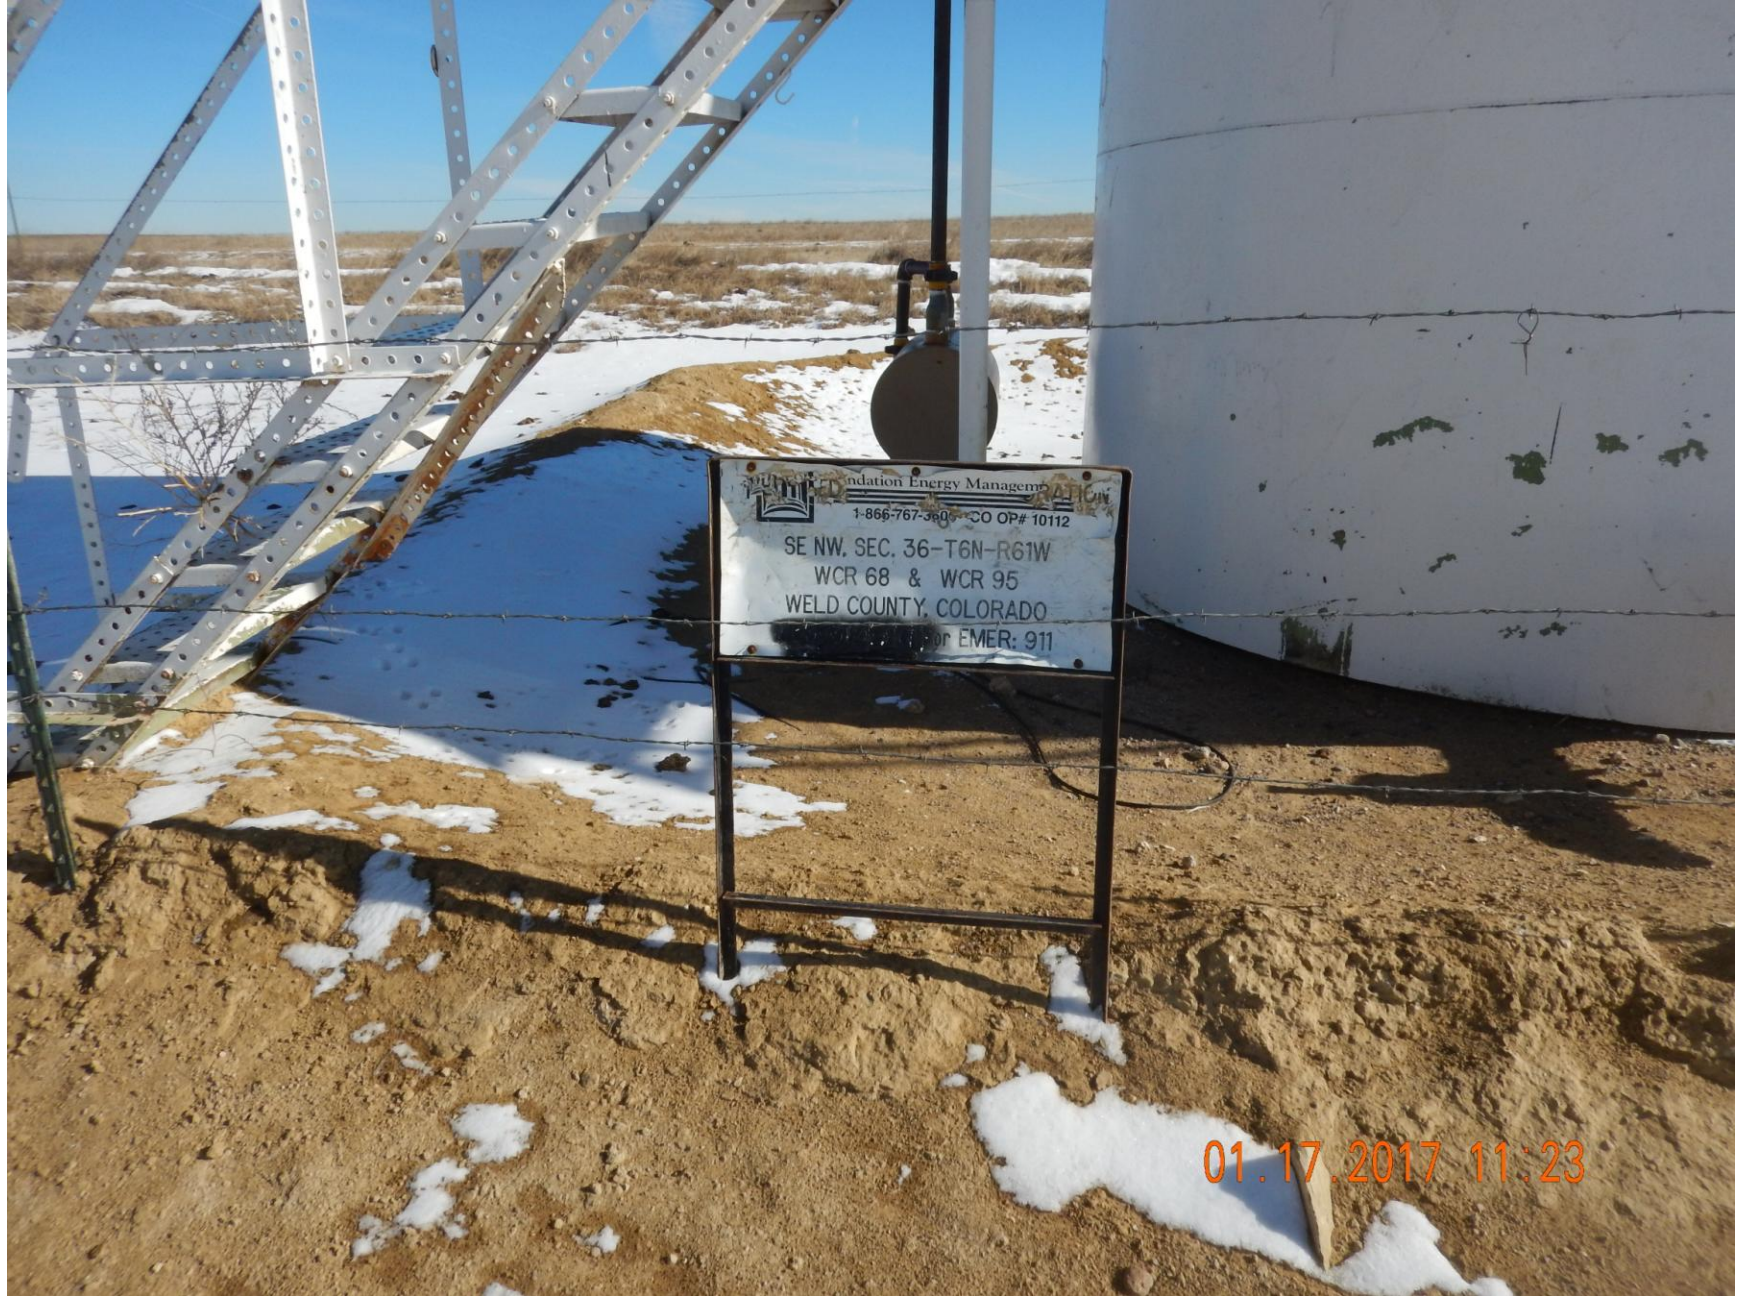
Figure 6: Photo taken from the tank battery, facing east. Photo shows sign has deteriorated in such a manner that the operator contact information is illegible.

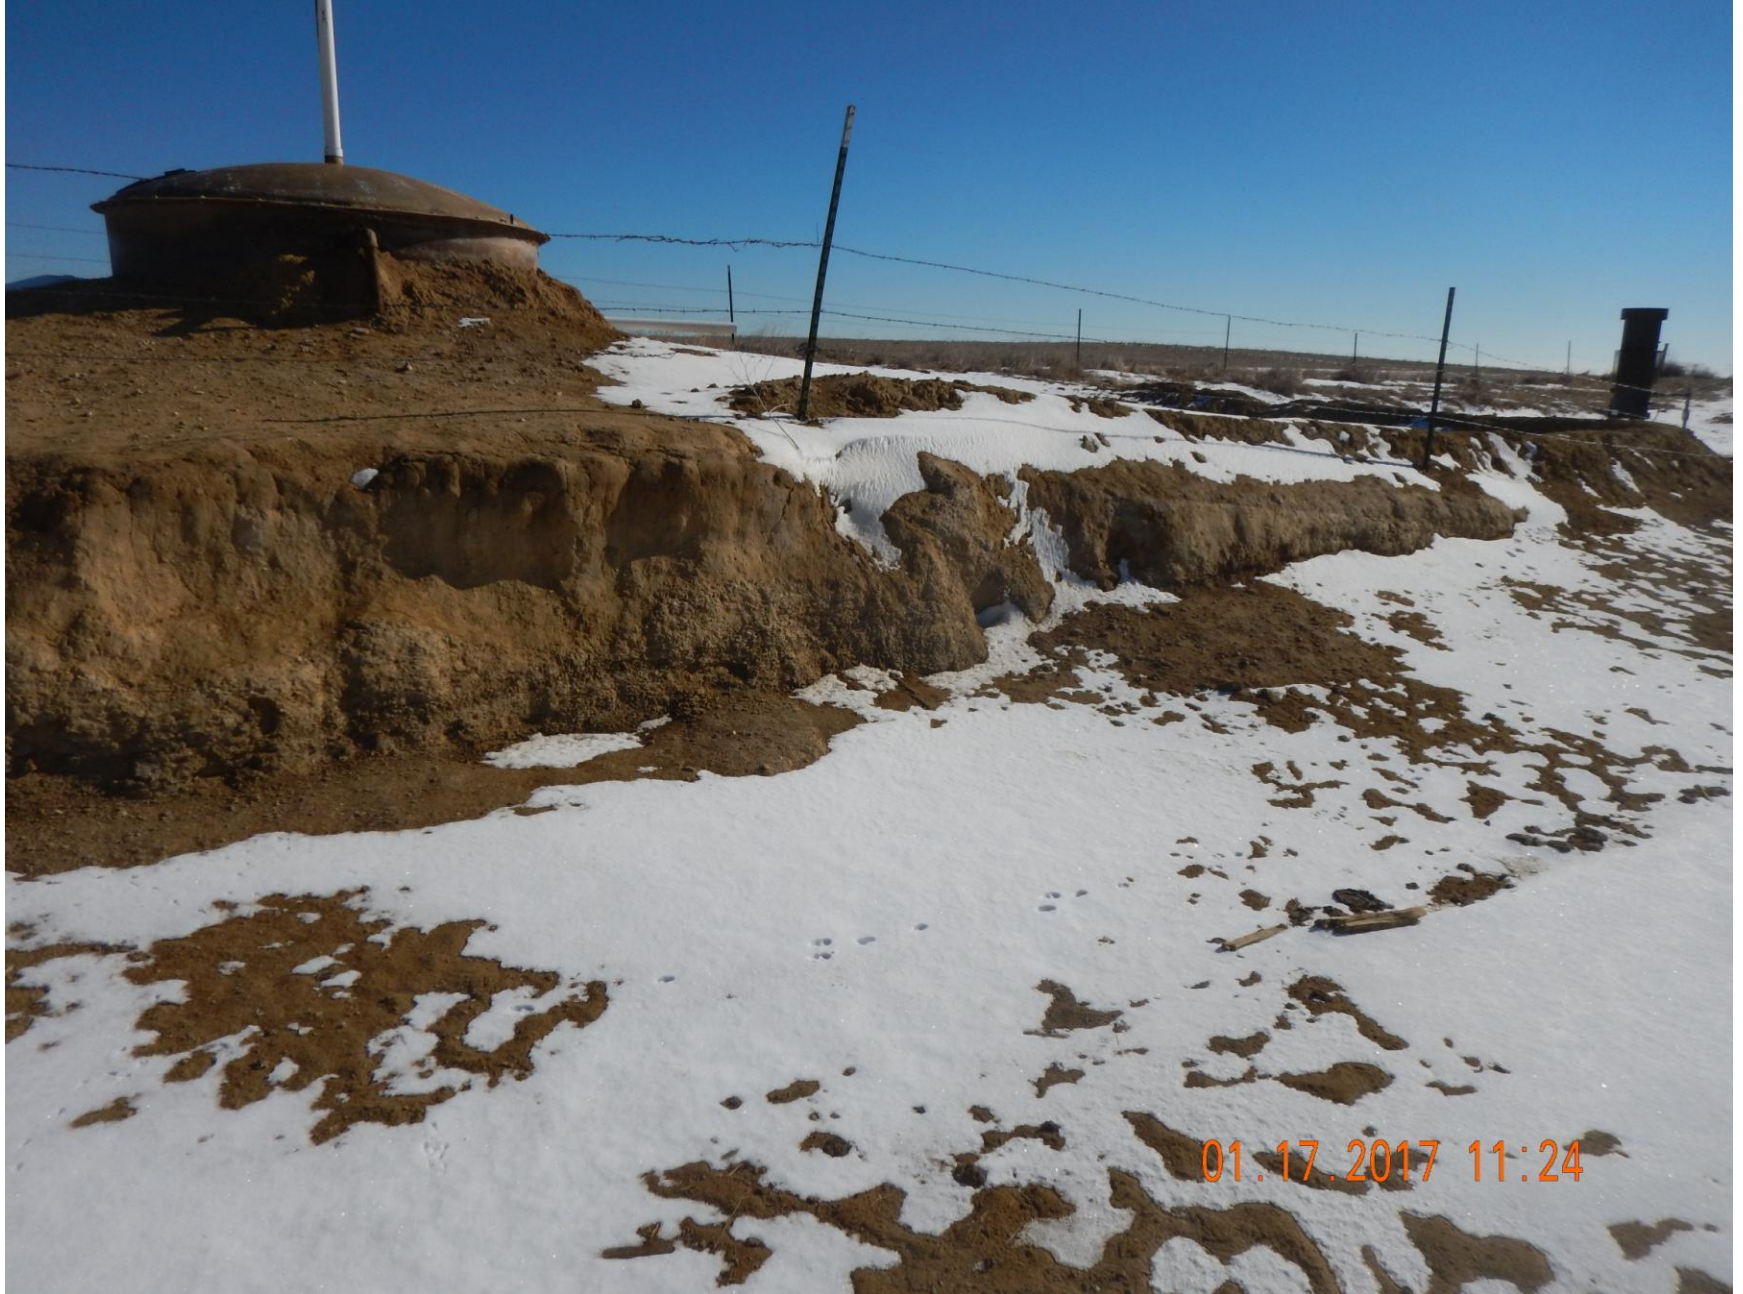
Figure 7: Photo taken from the northeast end of the location, facing southeast. Photo shows skim pit.

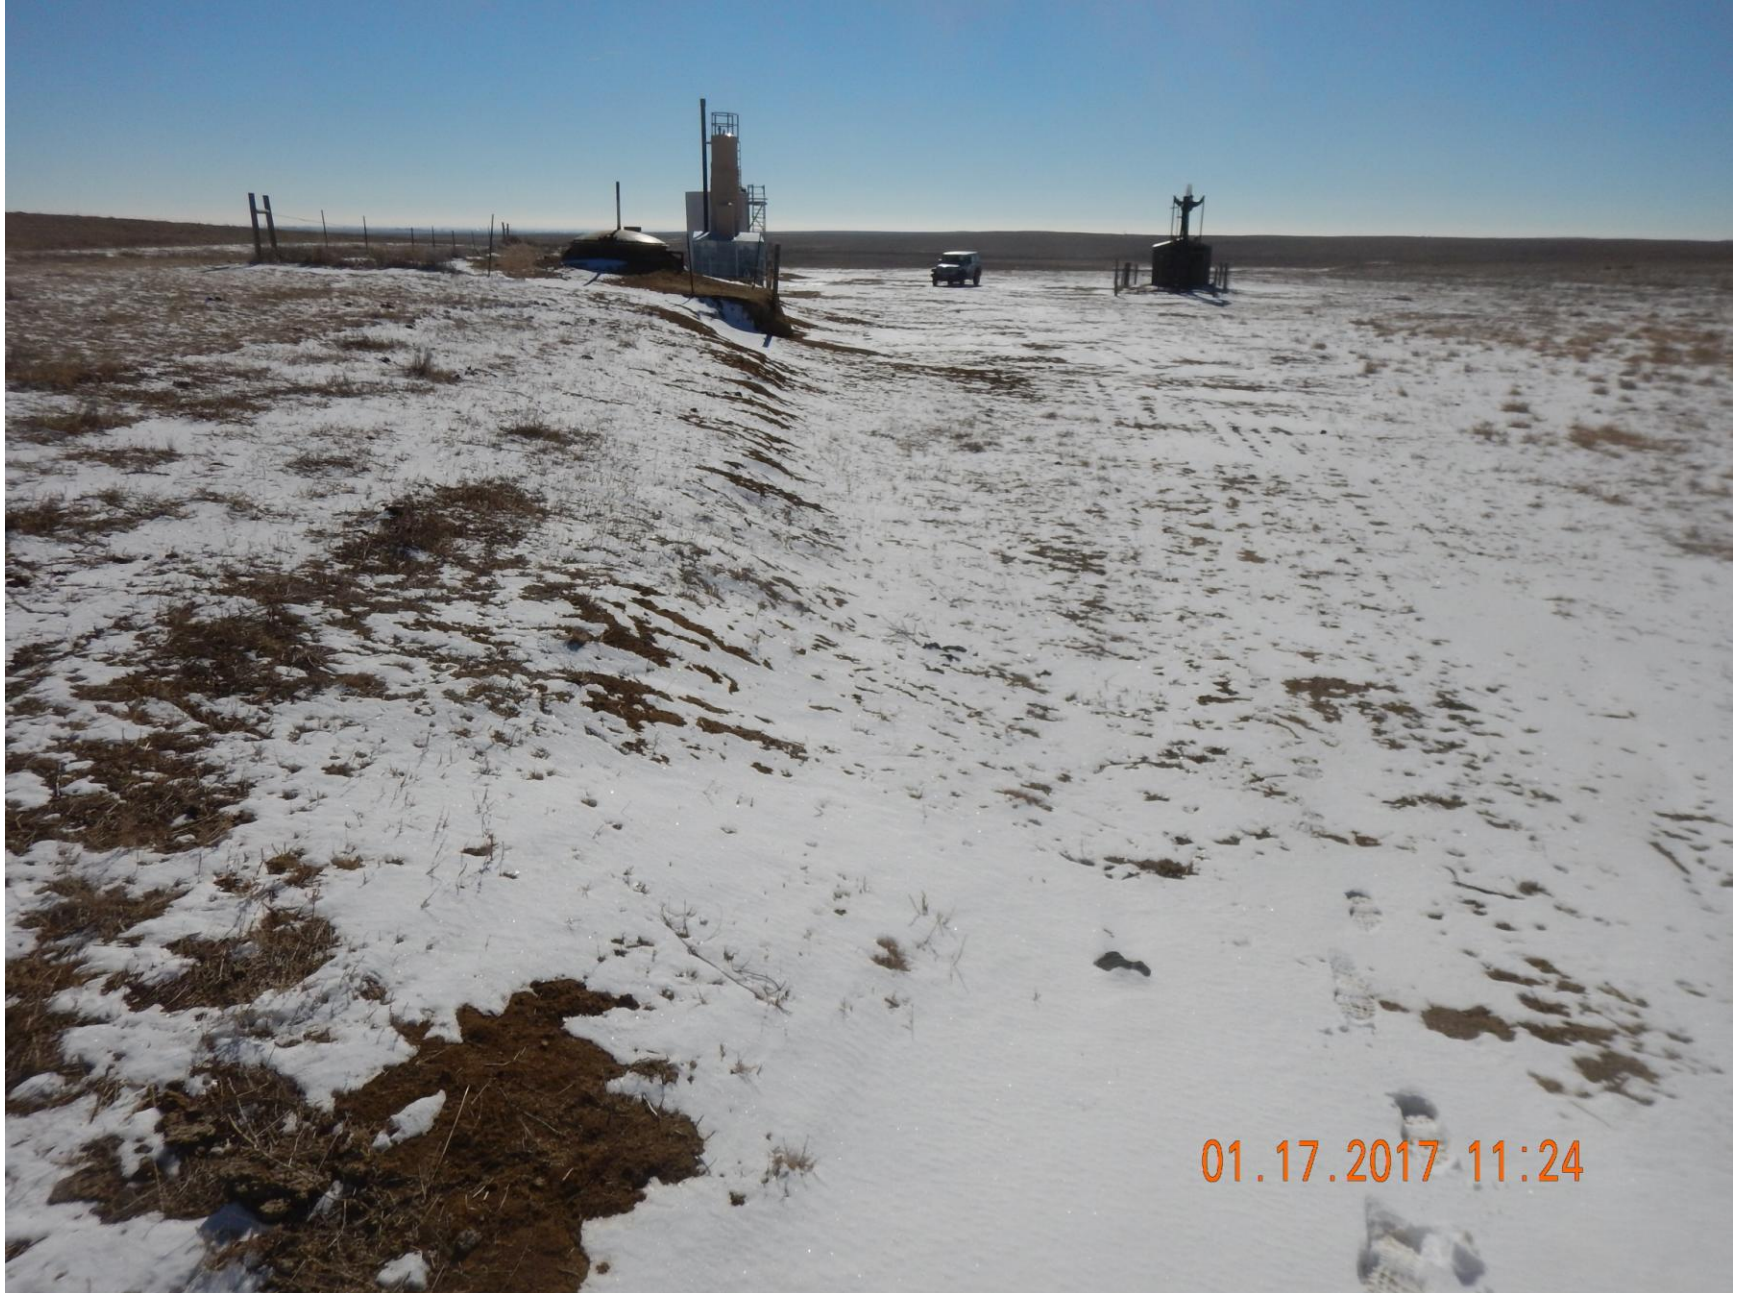
Figure 8: Photo taken from the northeast corner of the location, facing south. Photo shows location and interim area. Note road passing through area of location.

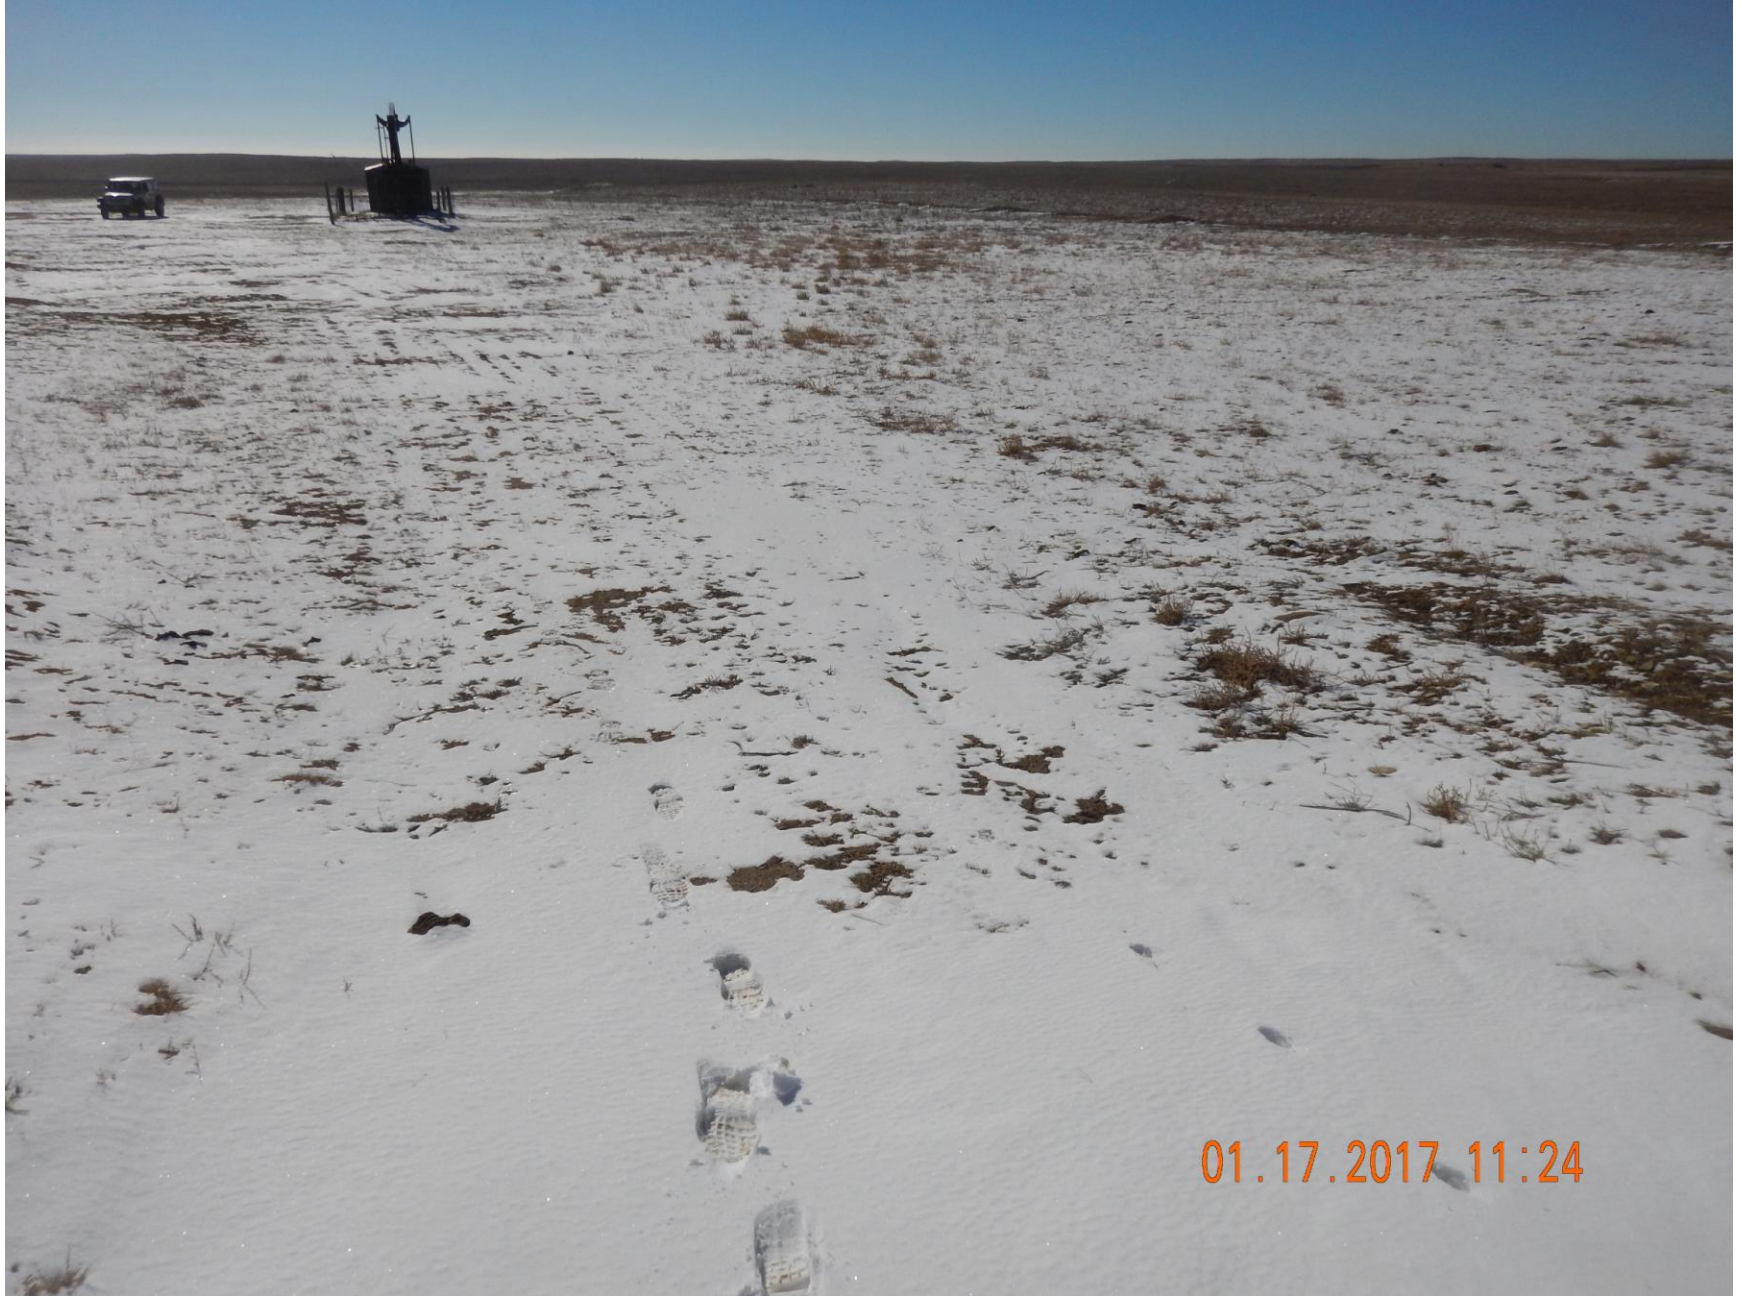
Figure 9: Photo taken from the northwest corner of the location, facing southwest. Photo shows the interim reclamation area. Note vegetation seen in photo predominantly undesirable weedy species such as russian thistle.

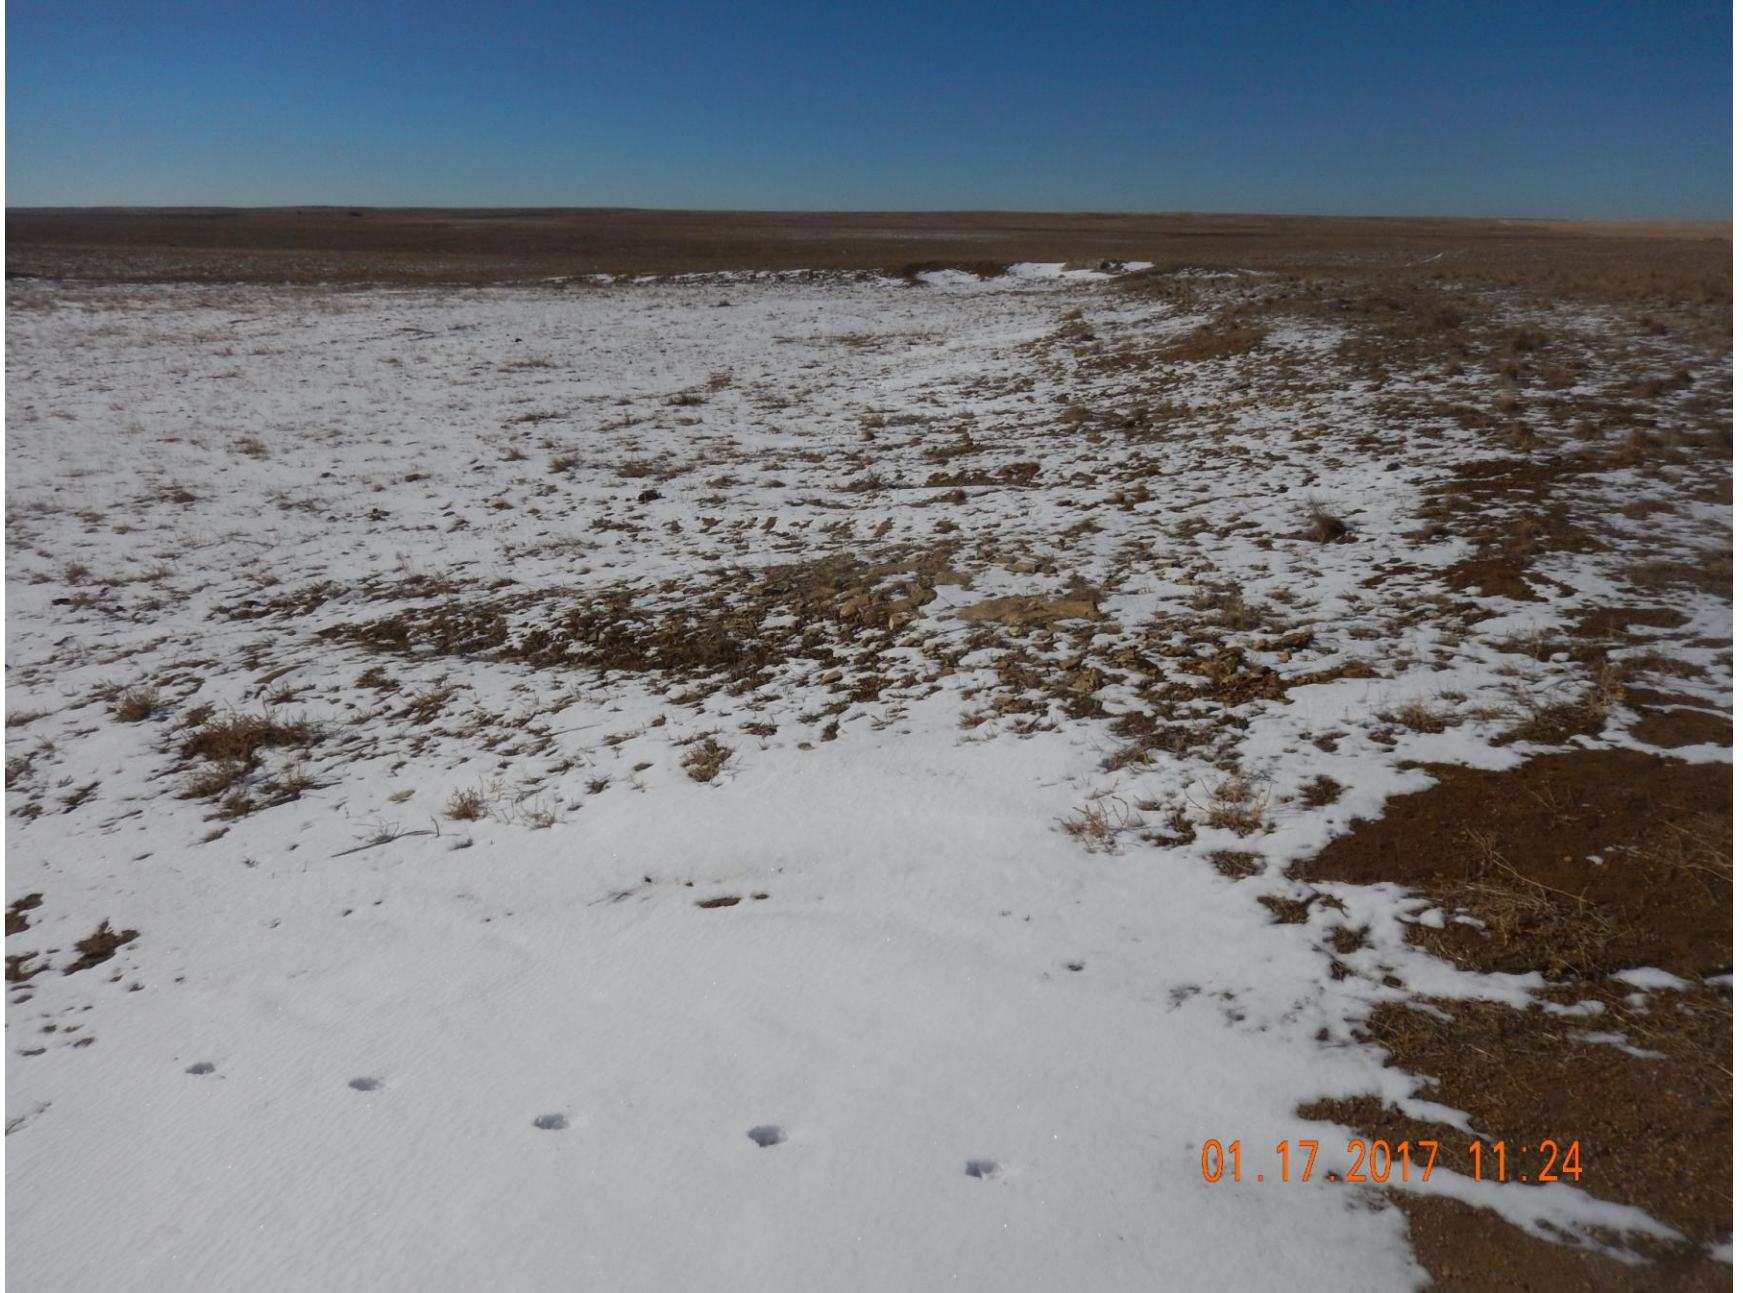
Figure 10: Photo taken from the northwest corner of the location, facing west. Photo shows the interim reclamation area. Note vegetation seen in photo predominantly undesirable weedy species such as russian thistle

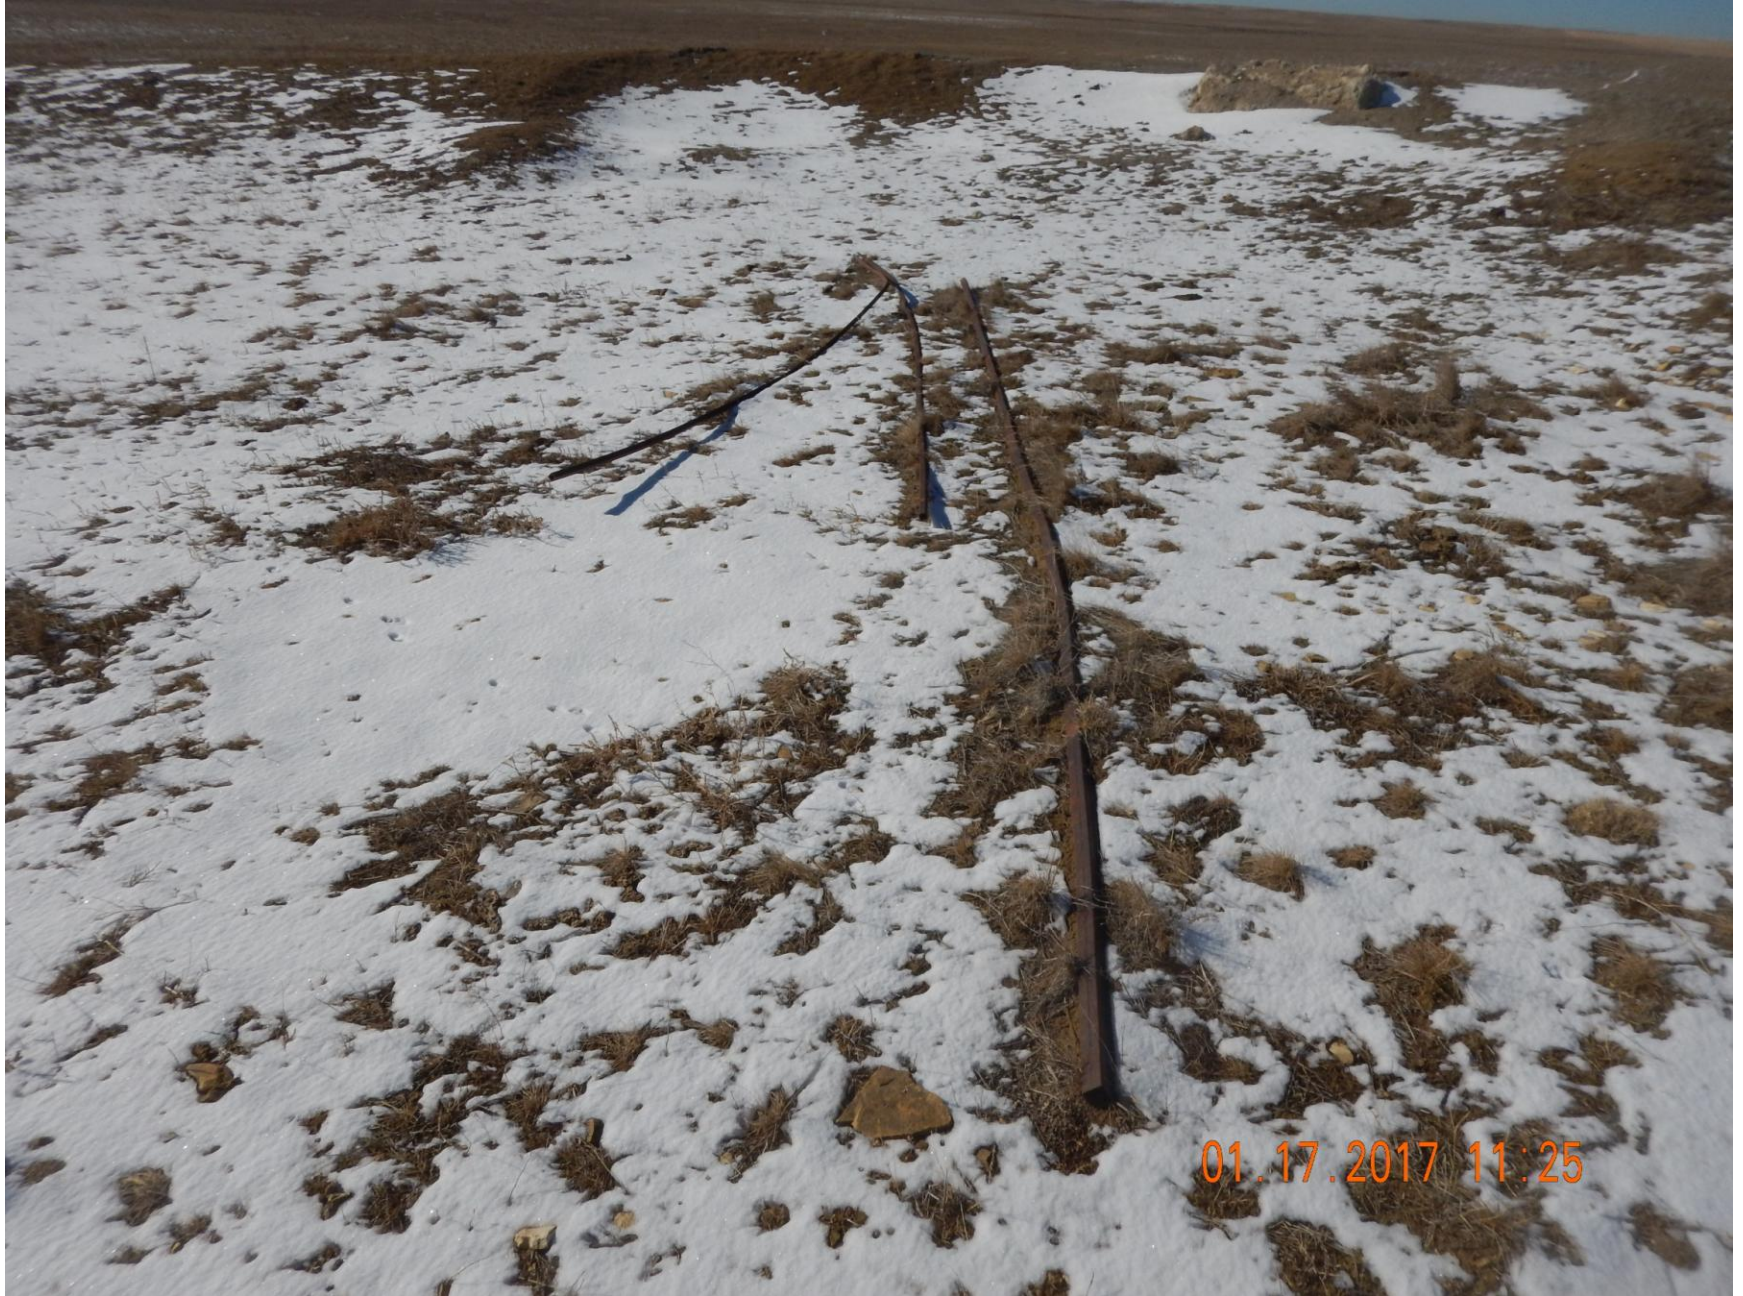
Figure 11: Photo taken from the northwest corner of the location. Photo shows square iron tubing being stored. This needs to be removed and properly stored/disposed.
