Reclamation and Stormwater Inspection

01/18/2017

Operator: Foundation Energy #10112

Location ID: 330865

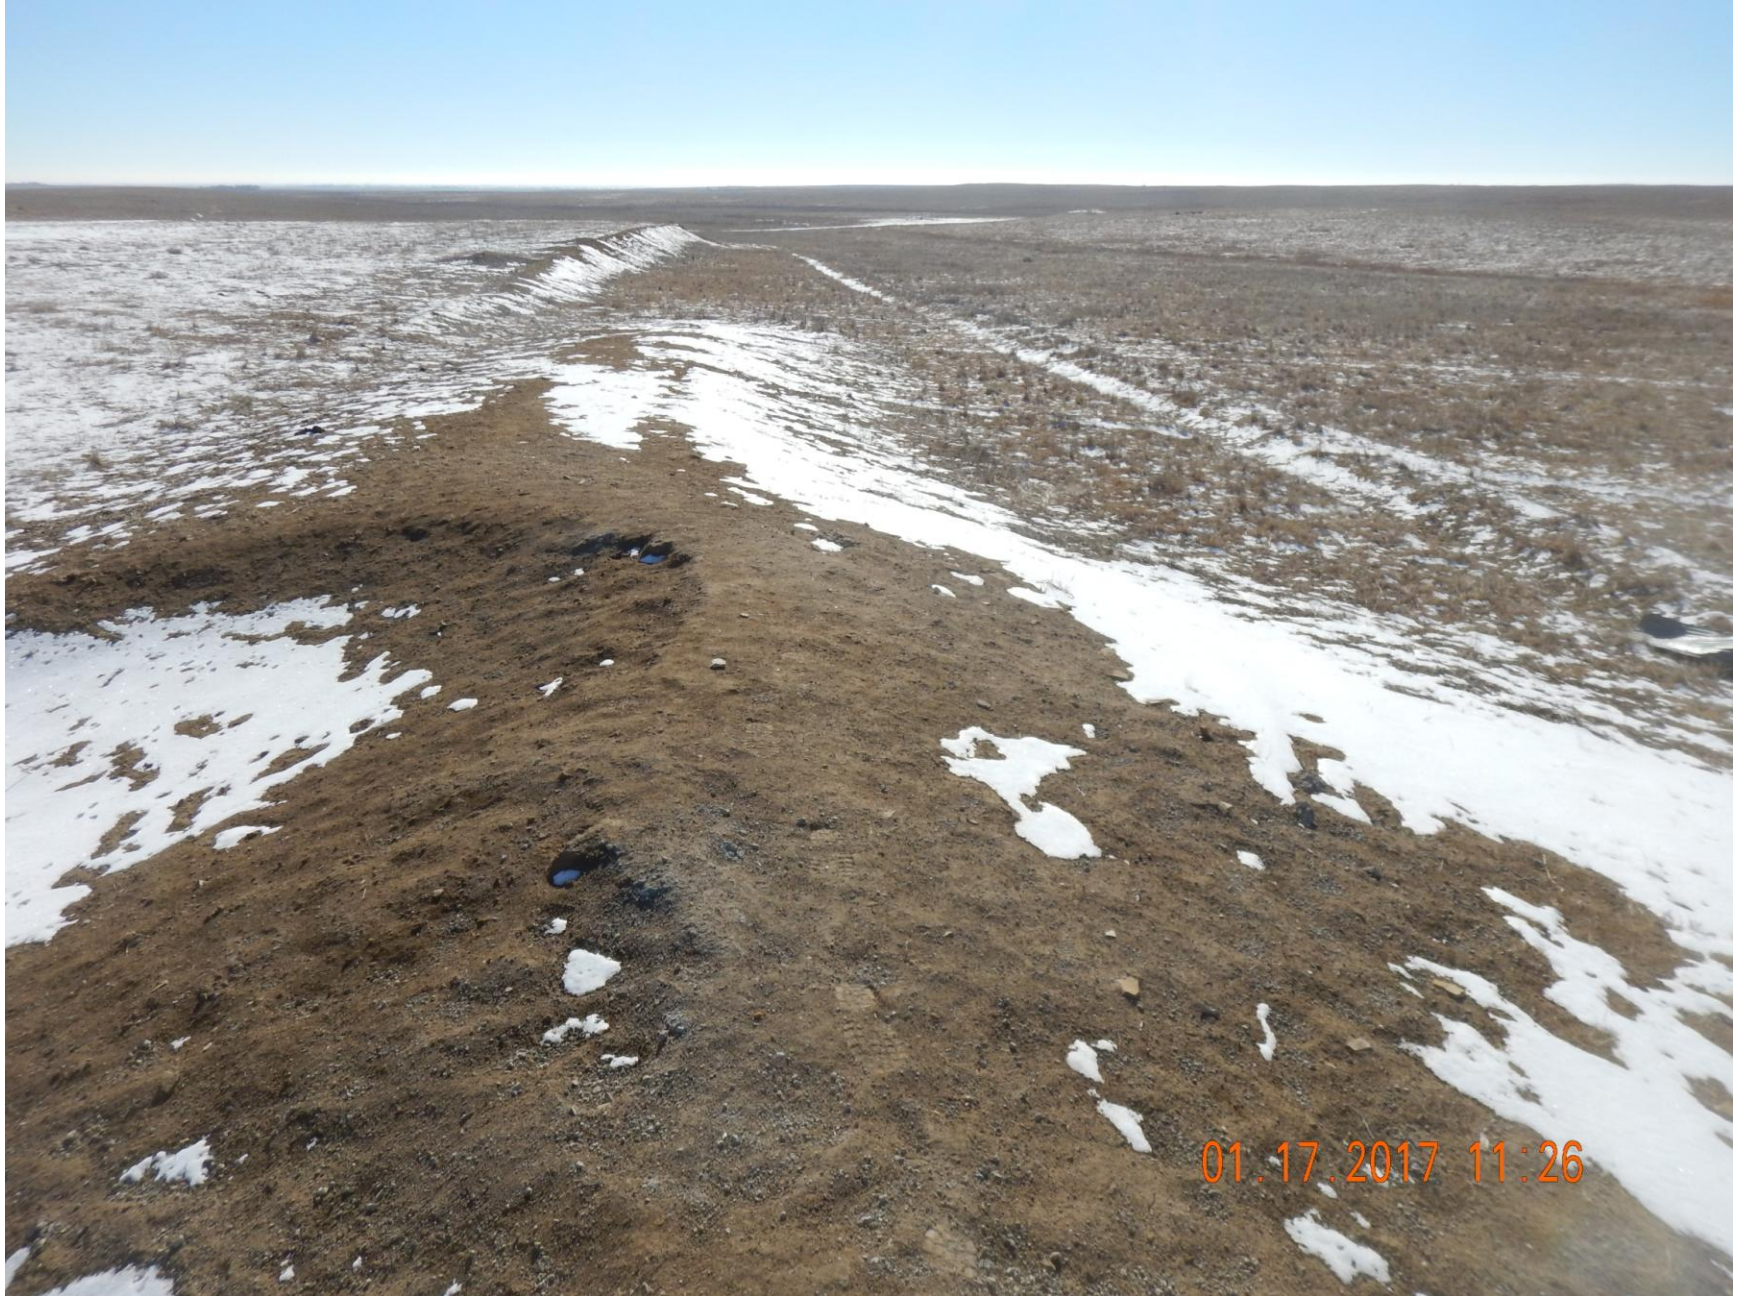
Figure 12: Photo taken from the northwest corner of the location, facing south. Photo shows areas not needed for production have not been reclaimed, including re-contouring.

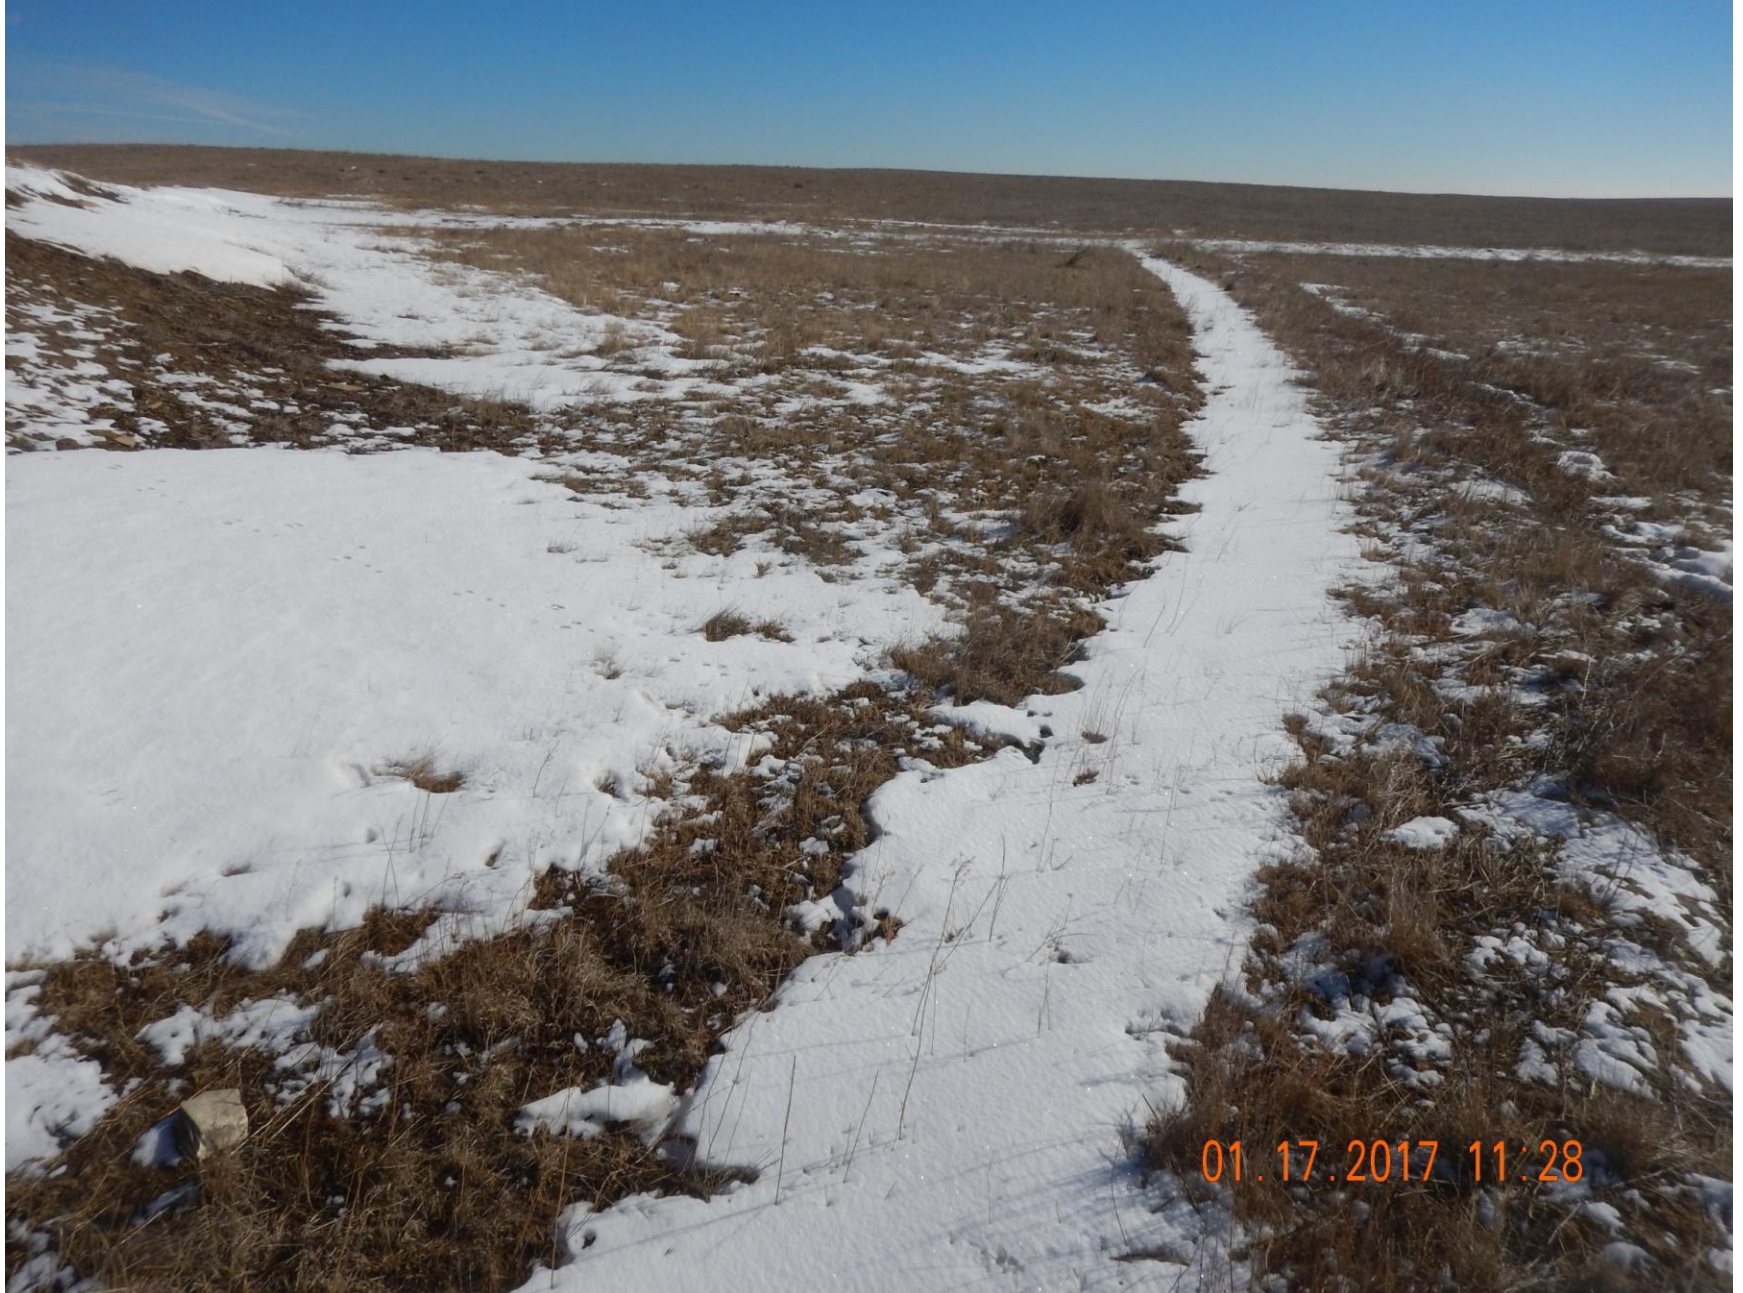
Figure 13: Photo taken from the southwest corner of the location, facing east. Photo shows stormwater ditch located on the western and southern perimeter of the location.

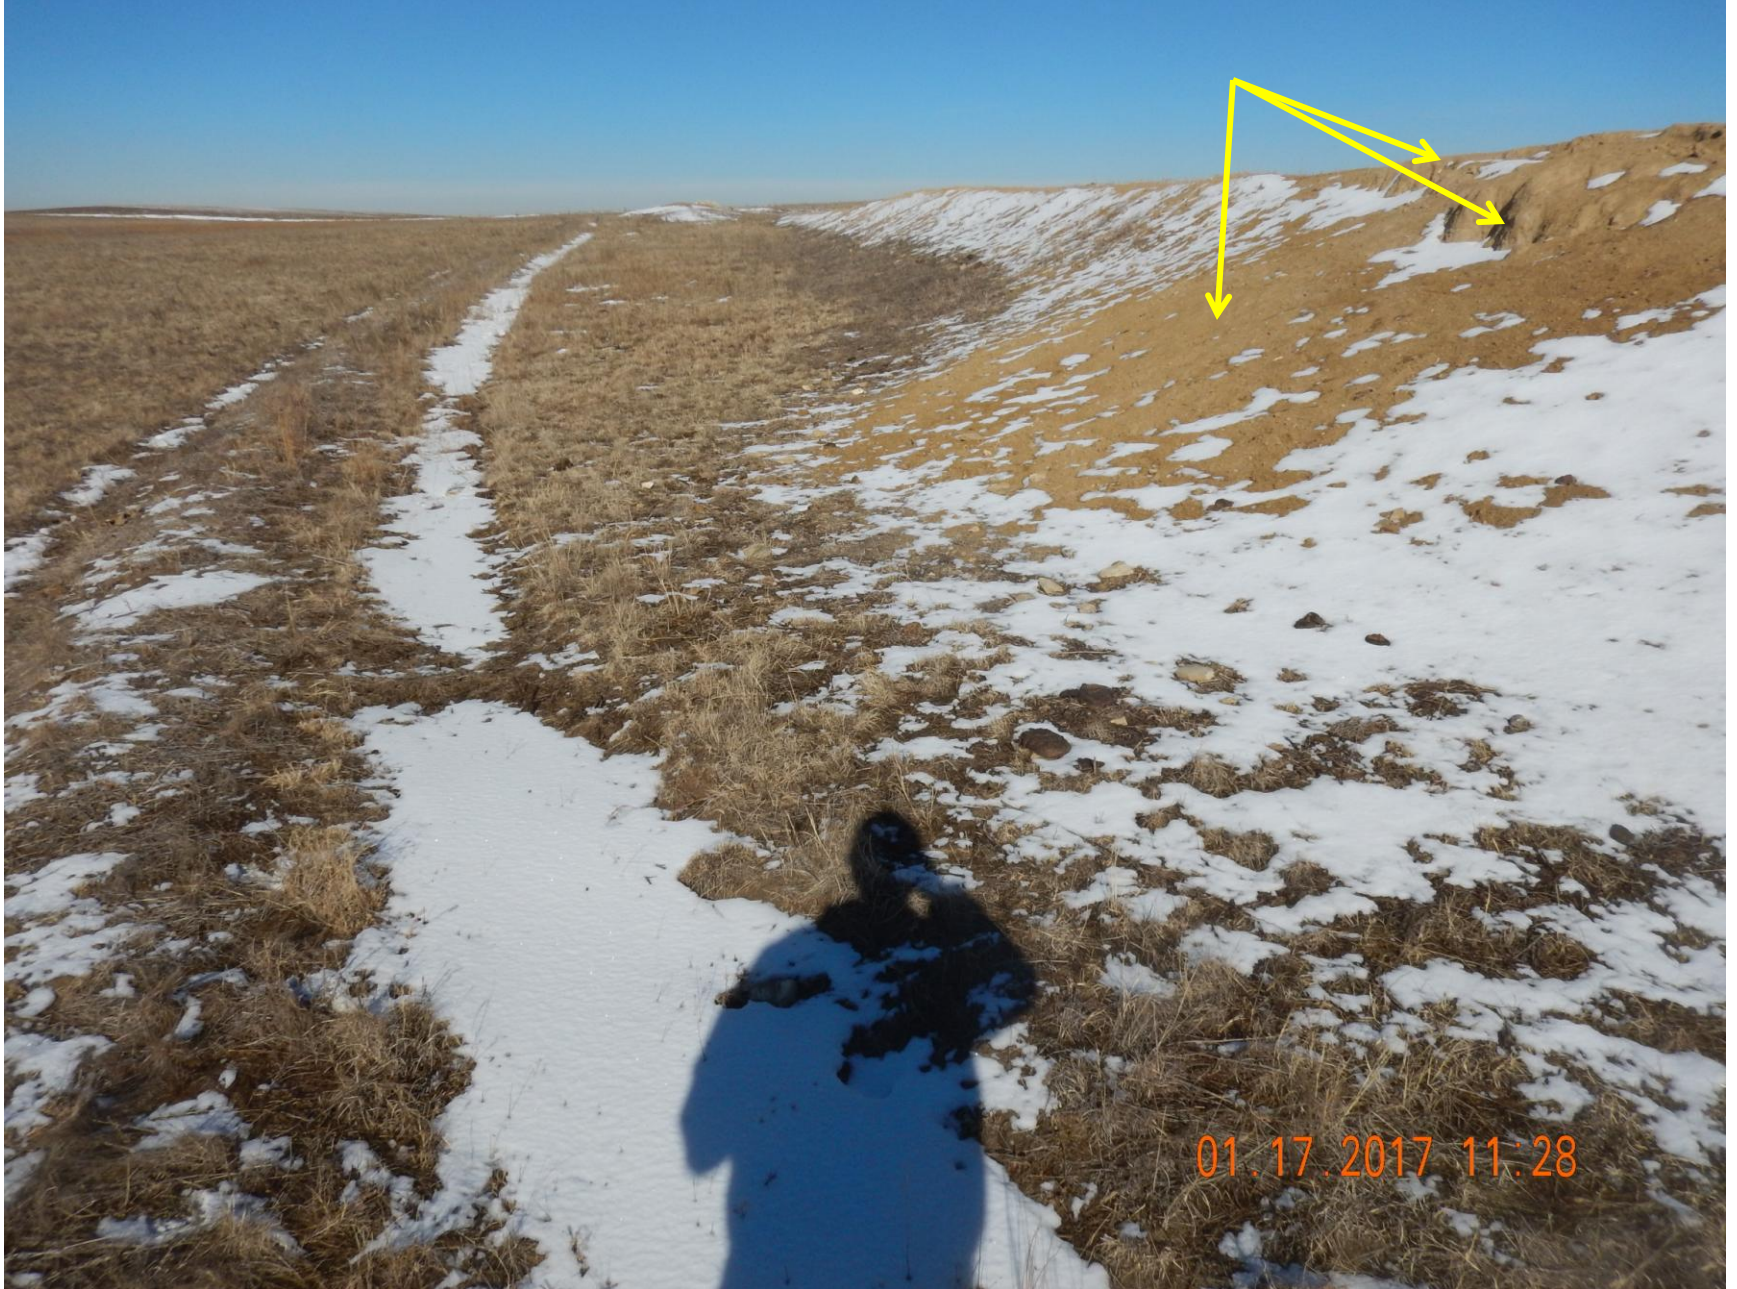
Figure 14: Photo taken from the southwest corner of the location, facing north. Photo shows stormwater ditch located on the western and southern perimeter of the location. Note erosion occurring on slope of the location to the right of the photos (yellow arrow). Photo also shows location has not been recontoured.

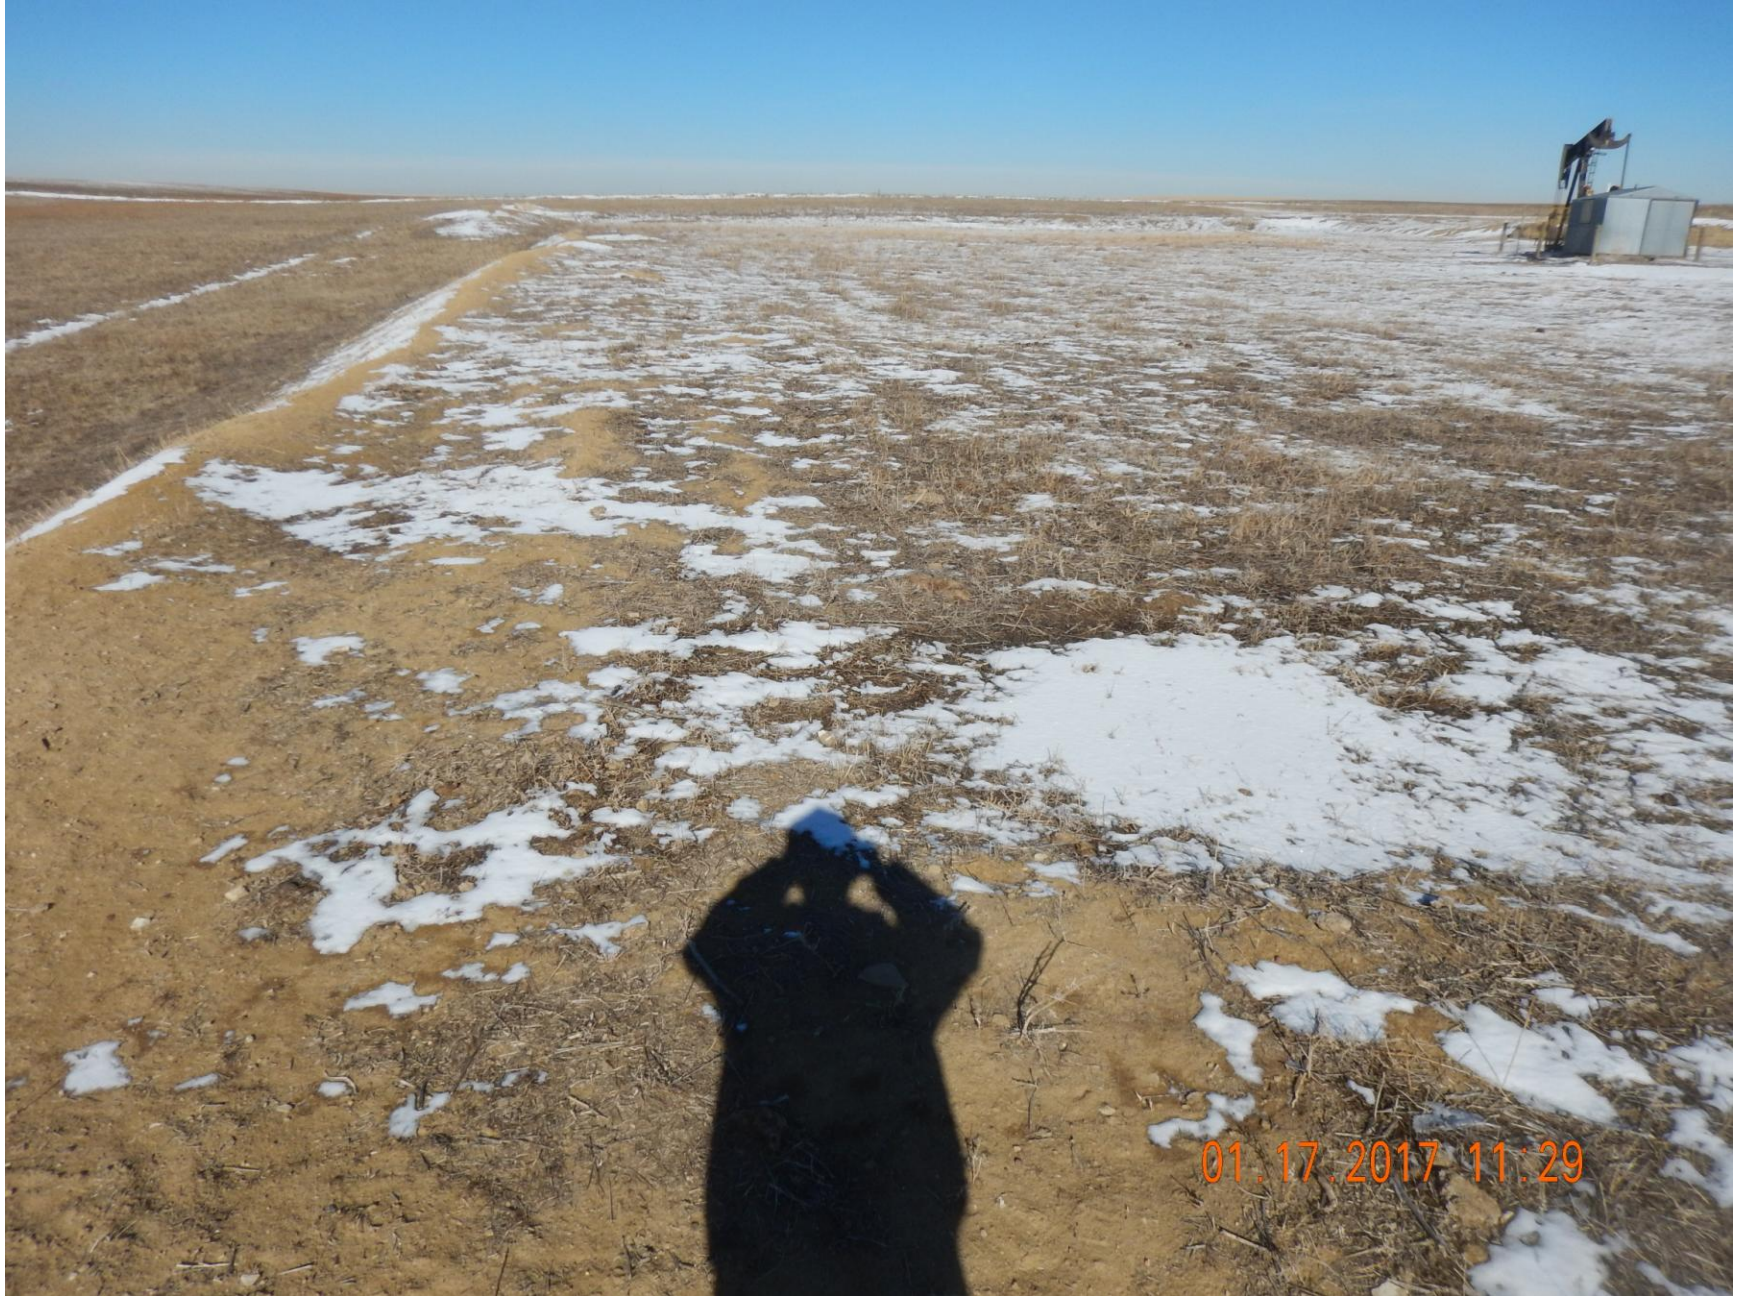
Figure 15: Photo taken from the southwest corner of the location, facing north. Photo shows large areas of the location that do not appear to be needed for production have not been reclaimed. Note vegetation on location predominantly undesirable weedy species such as russian thistle. Photo also shows location has not been recontoured.

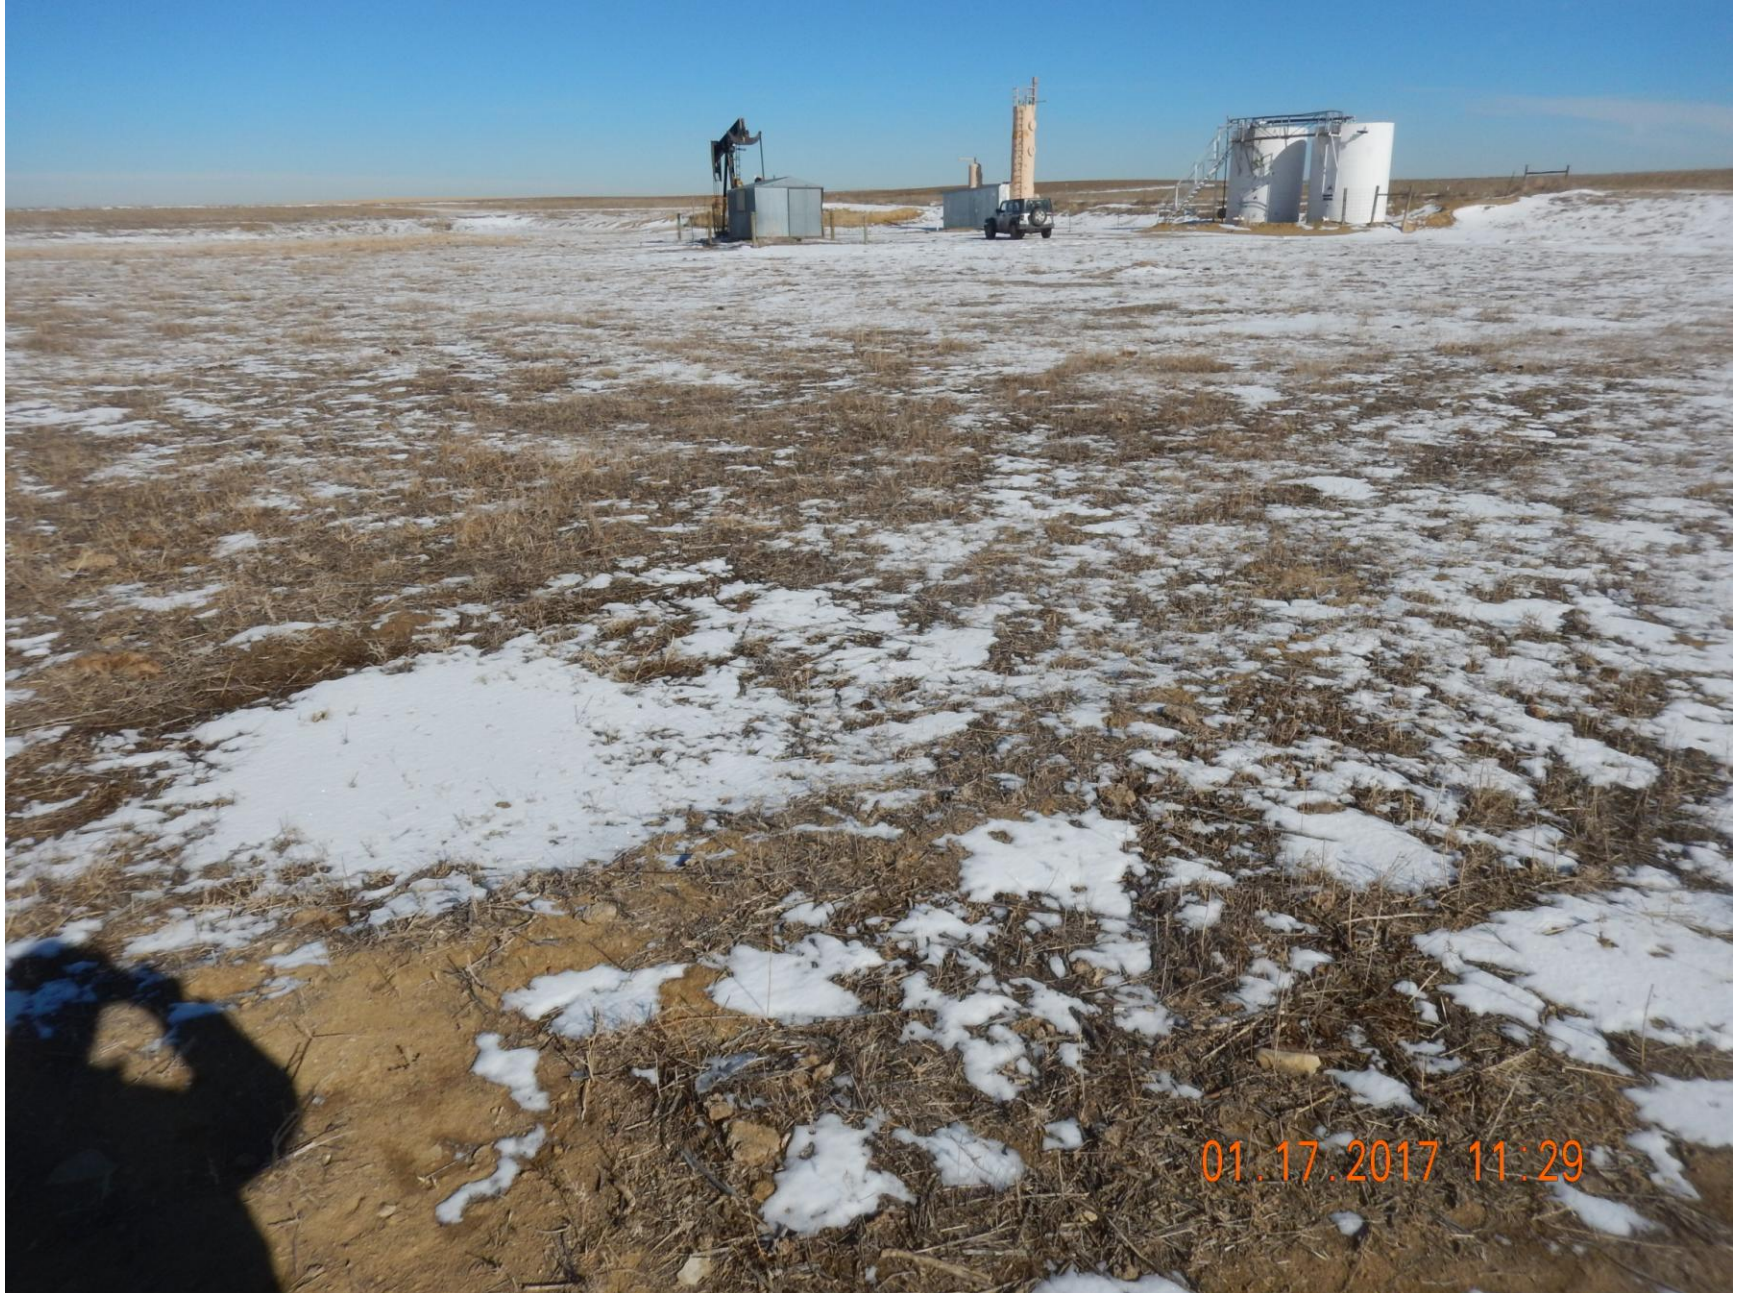
Figure 16: Photo taken from the southwest corner of the location, facing northeast. Photo shows large areas of the location that do not appear to be needed for production have not been reclaimed. Note vegetation on location predominantly undesirable weedy species such as russian thistle.

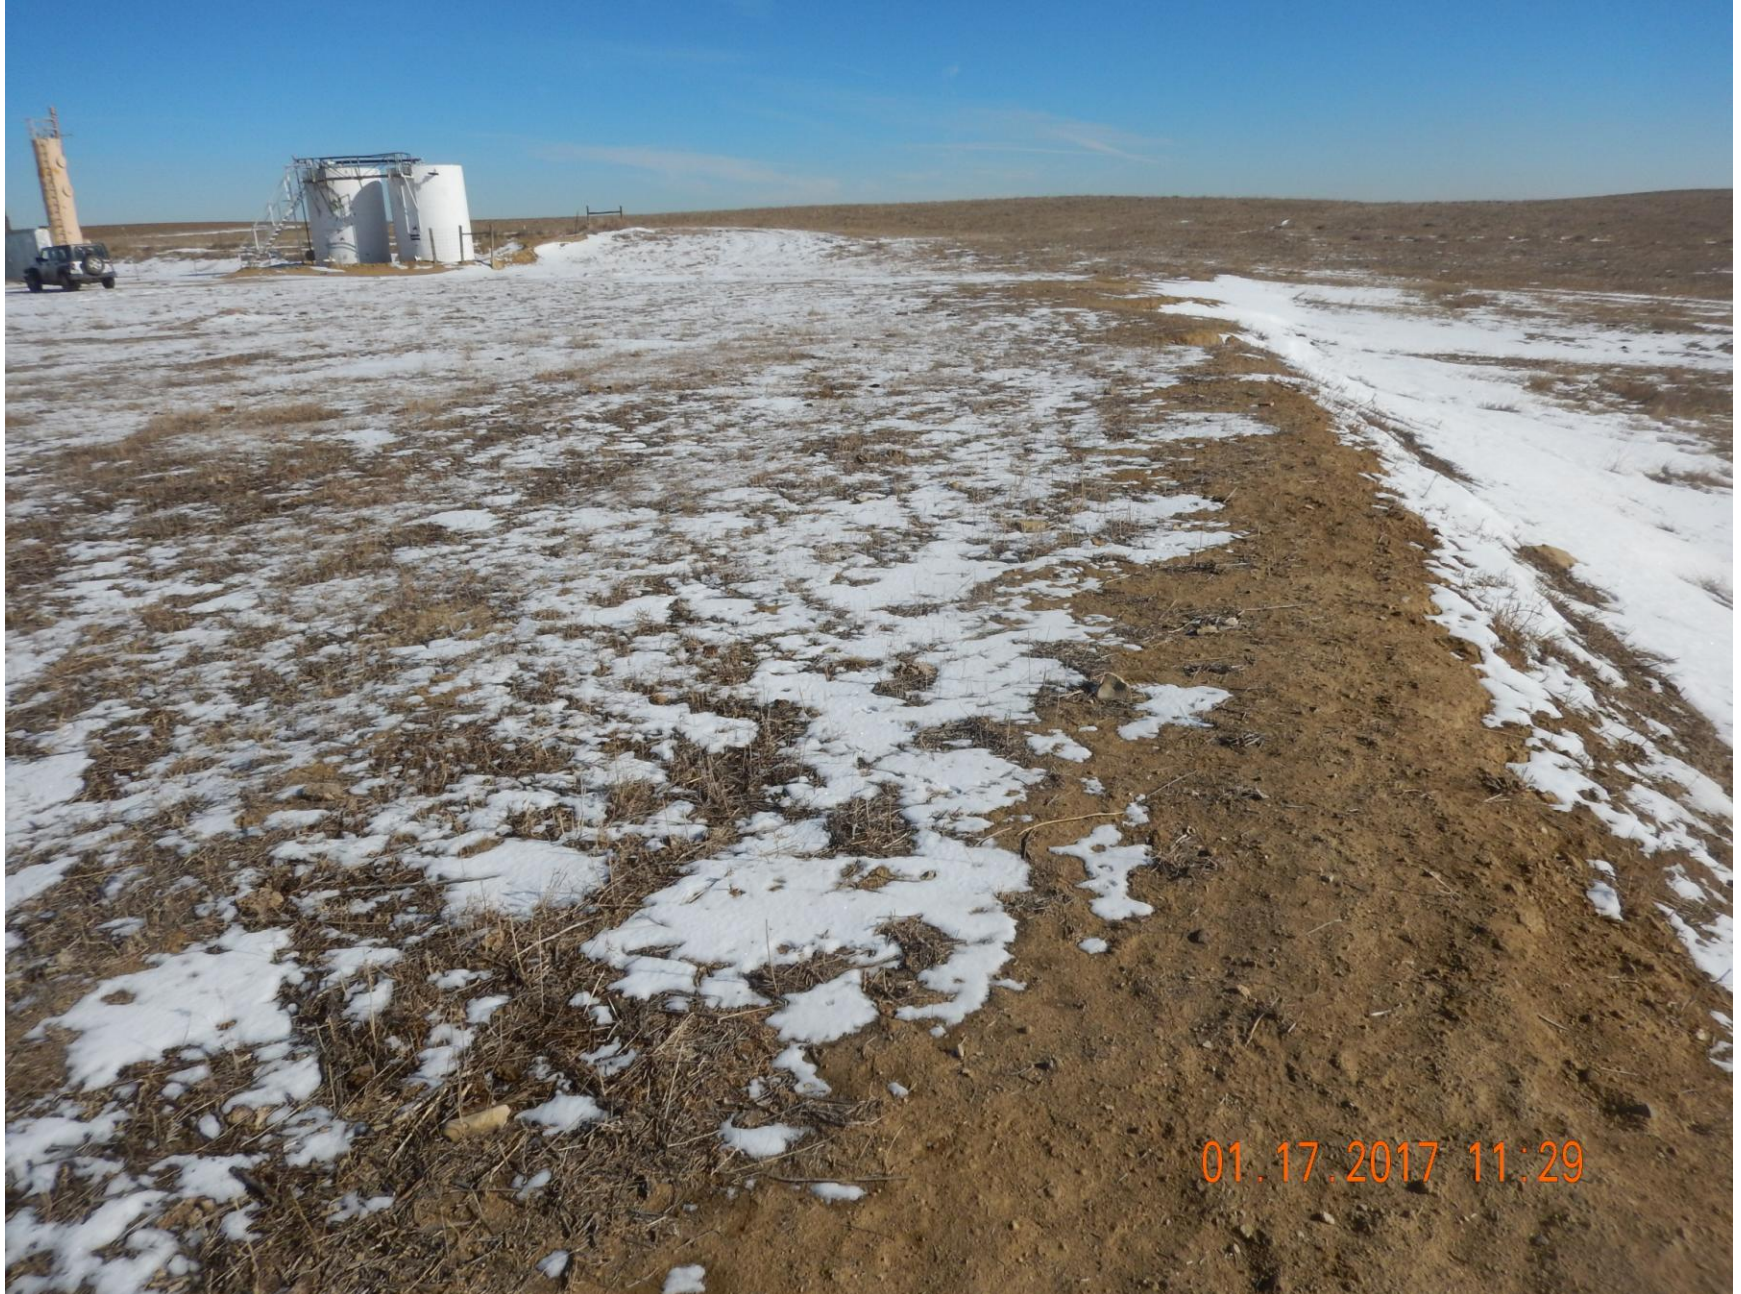
Figure 17: Photo taken from the southwest corner of the location, facing east. Photo shows large areas of the location that do not appear to be needed for production have not been reclaimed. Note vegetation on location predominantly undesirable weedy species such as russian thistle. Photo also shows location has not been recontoured.

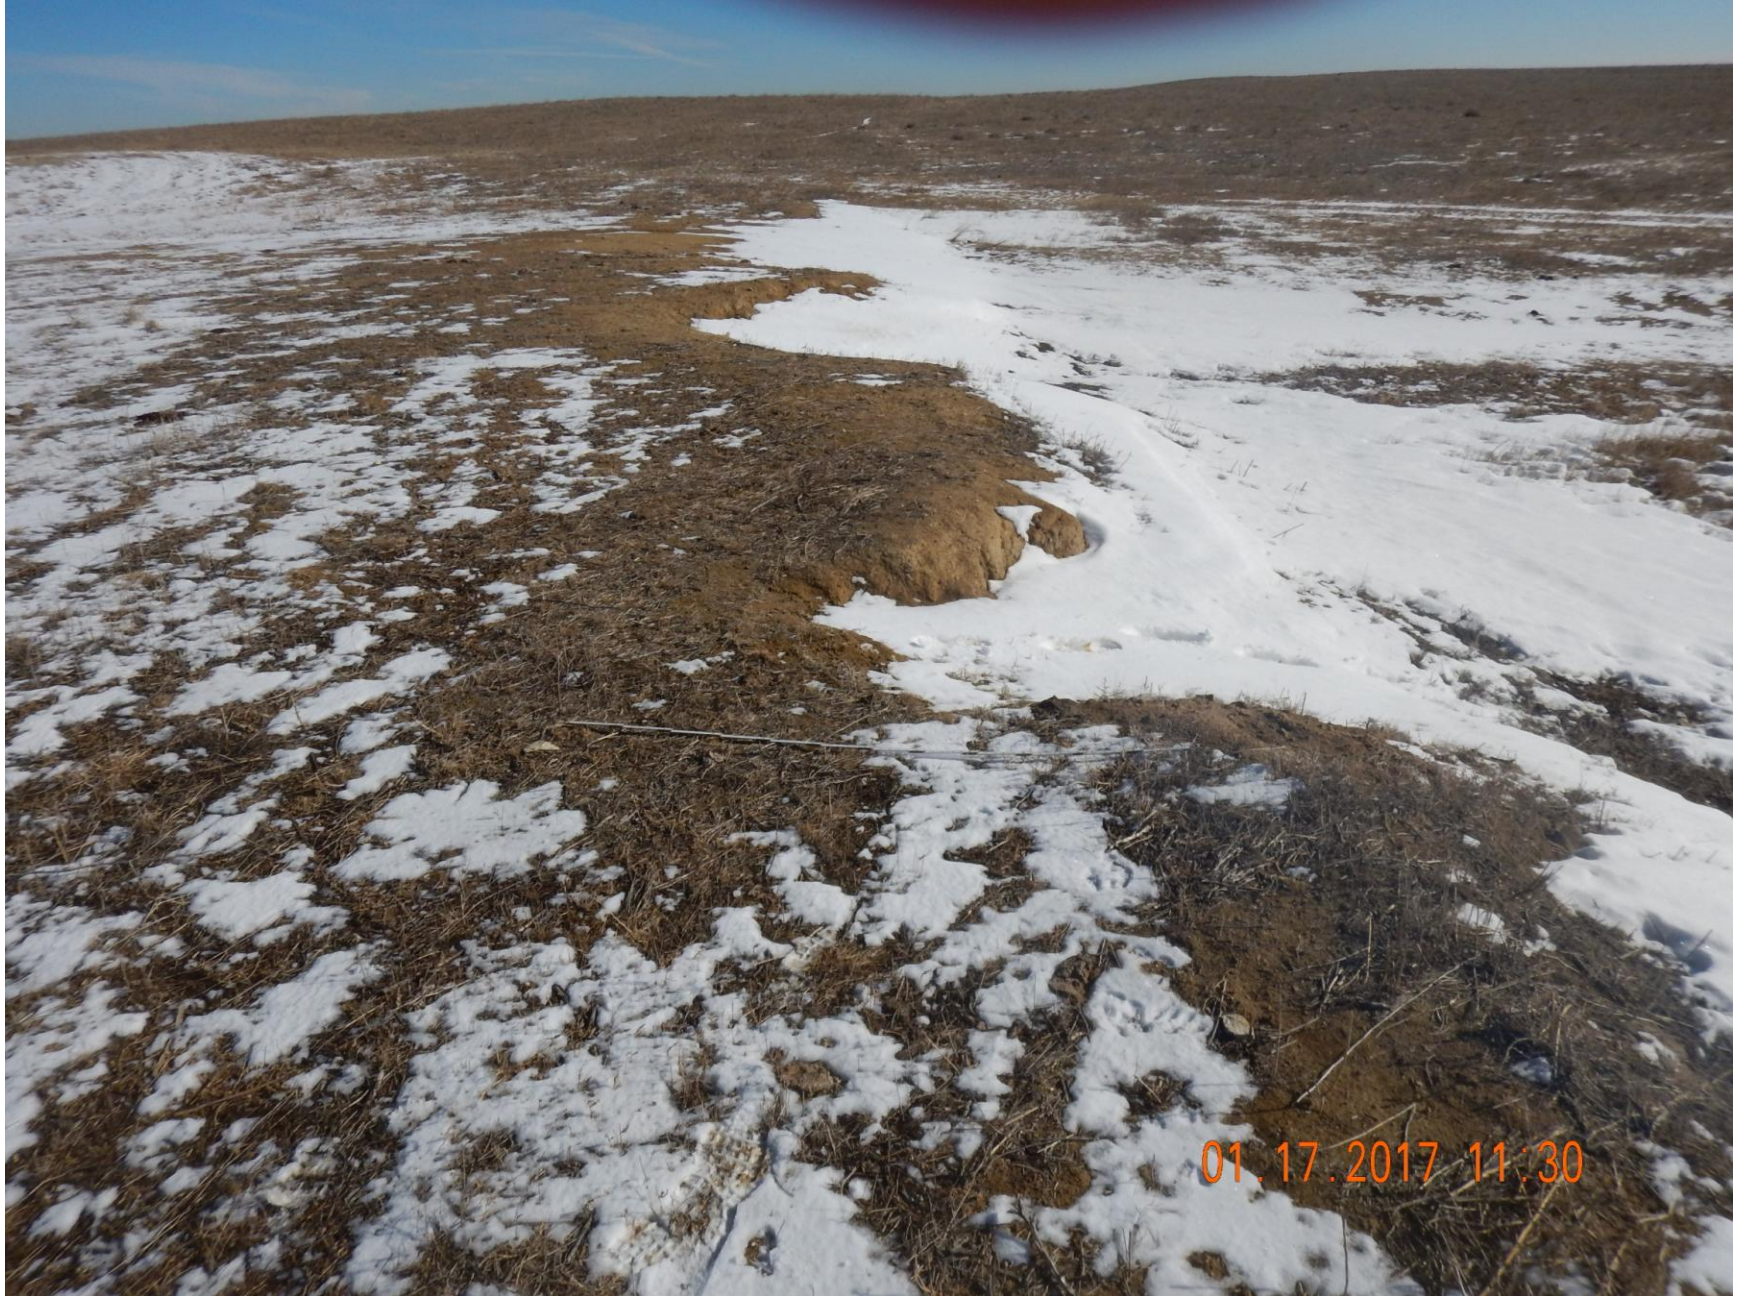
Figure 18: Photo taken from the south end of the location, facing east. Photo shows areas of the location experiencing degradation due to erosion.

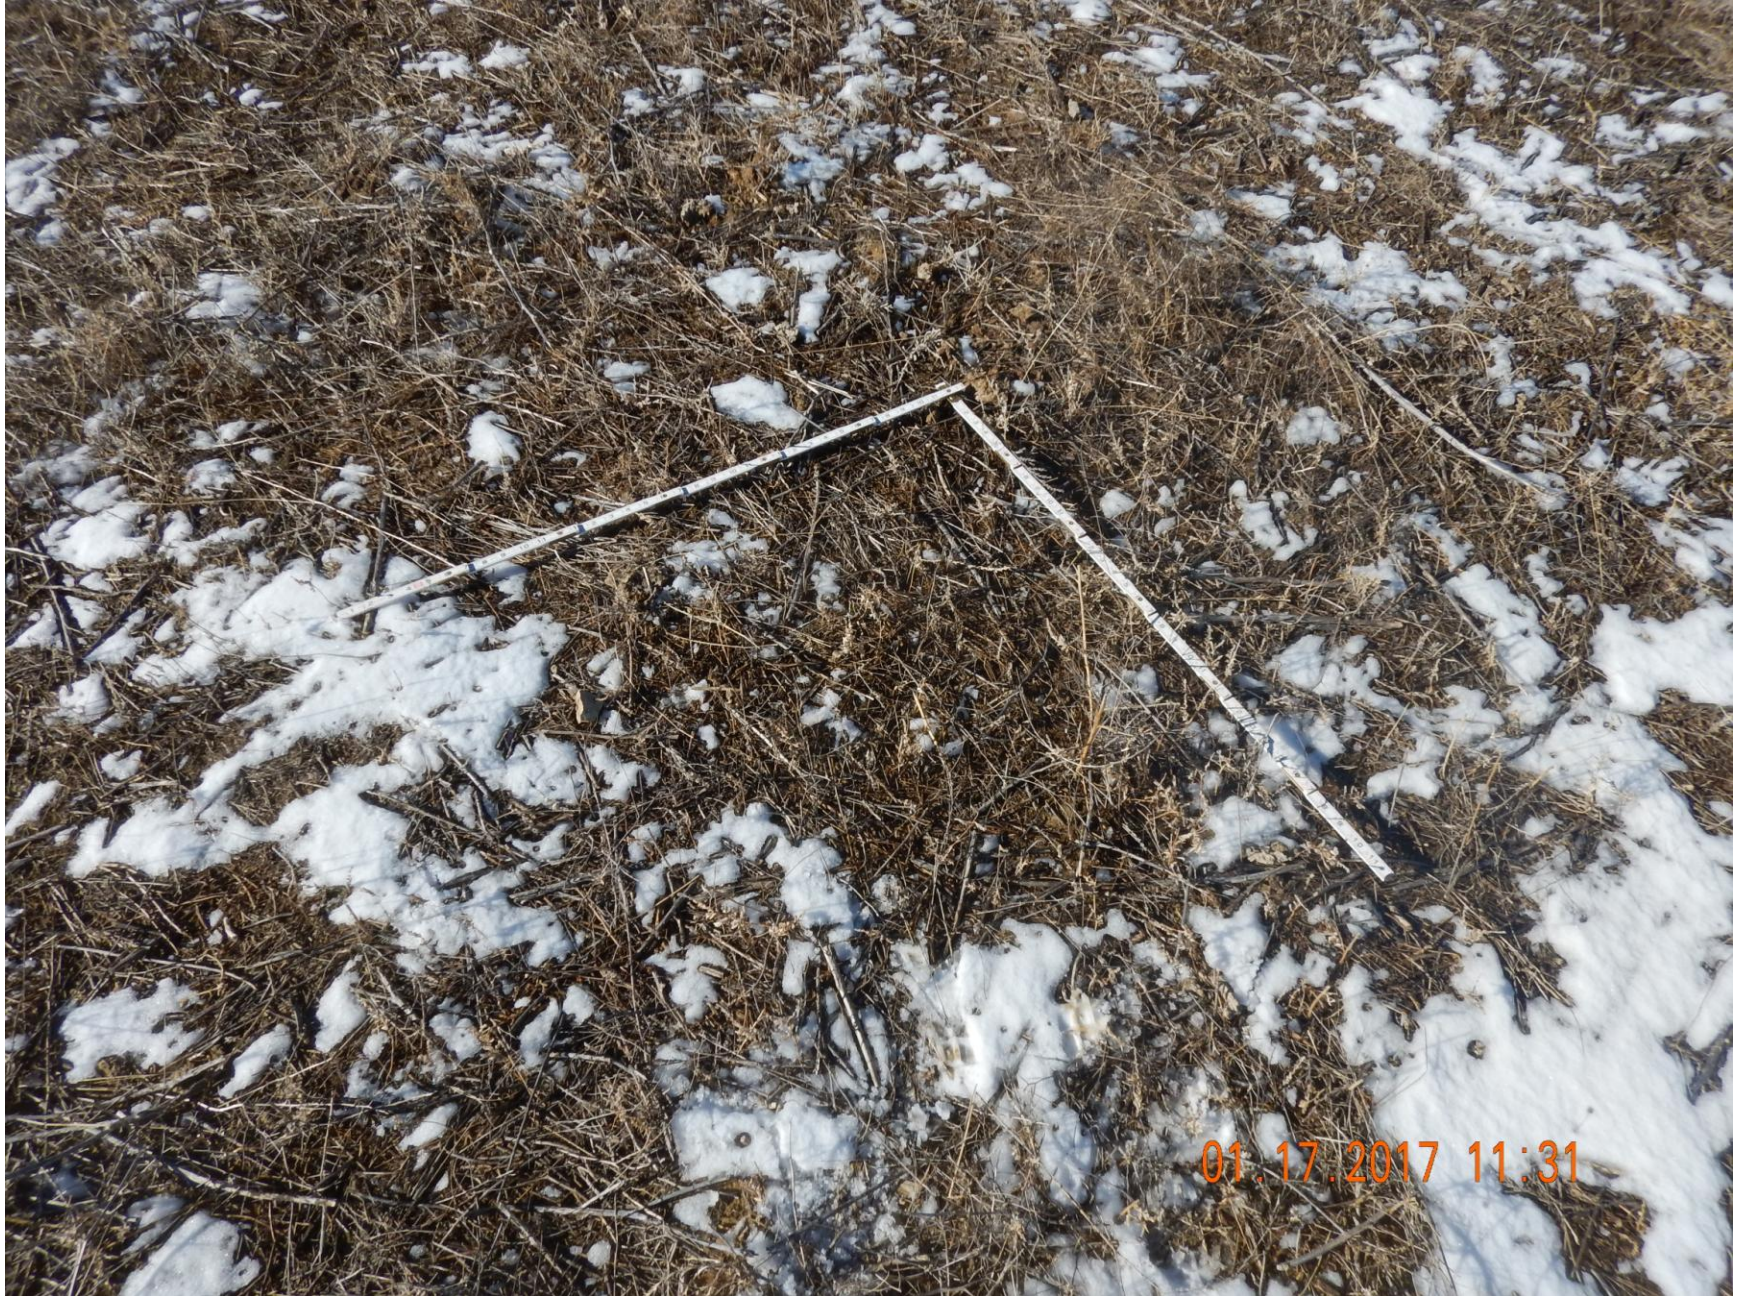
Figure 19: Photo taken from the southwest end of the location. Photo shows vegetation over the location. Note vegetation predominantly undesirable weedy species such as russian thistle.

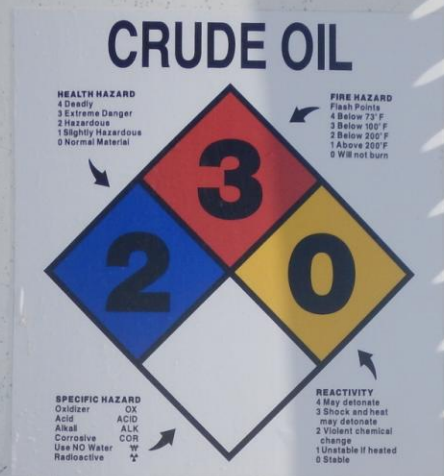
Figure 20: Photo taken from the southern tank. Photo shows a placard has been placed on the tank since inspection doc. #684901990. However tank missing 1) Name of operator, 2) Operator's emergency contact number and 3) Tank capacity.

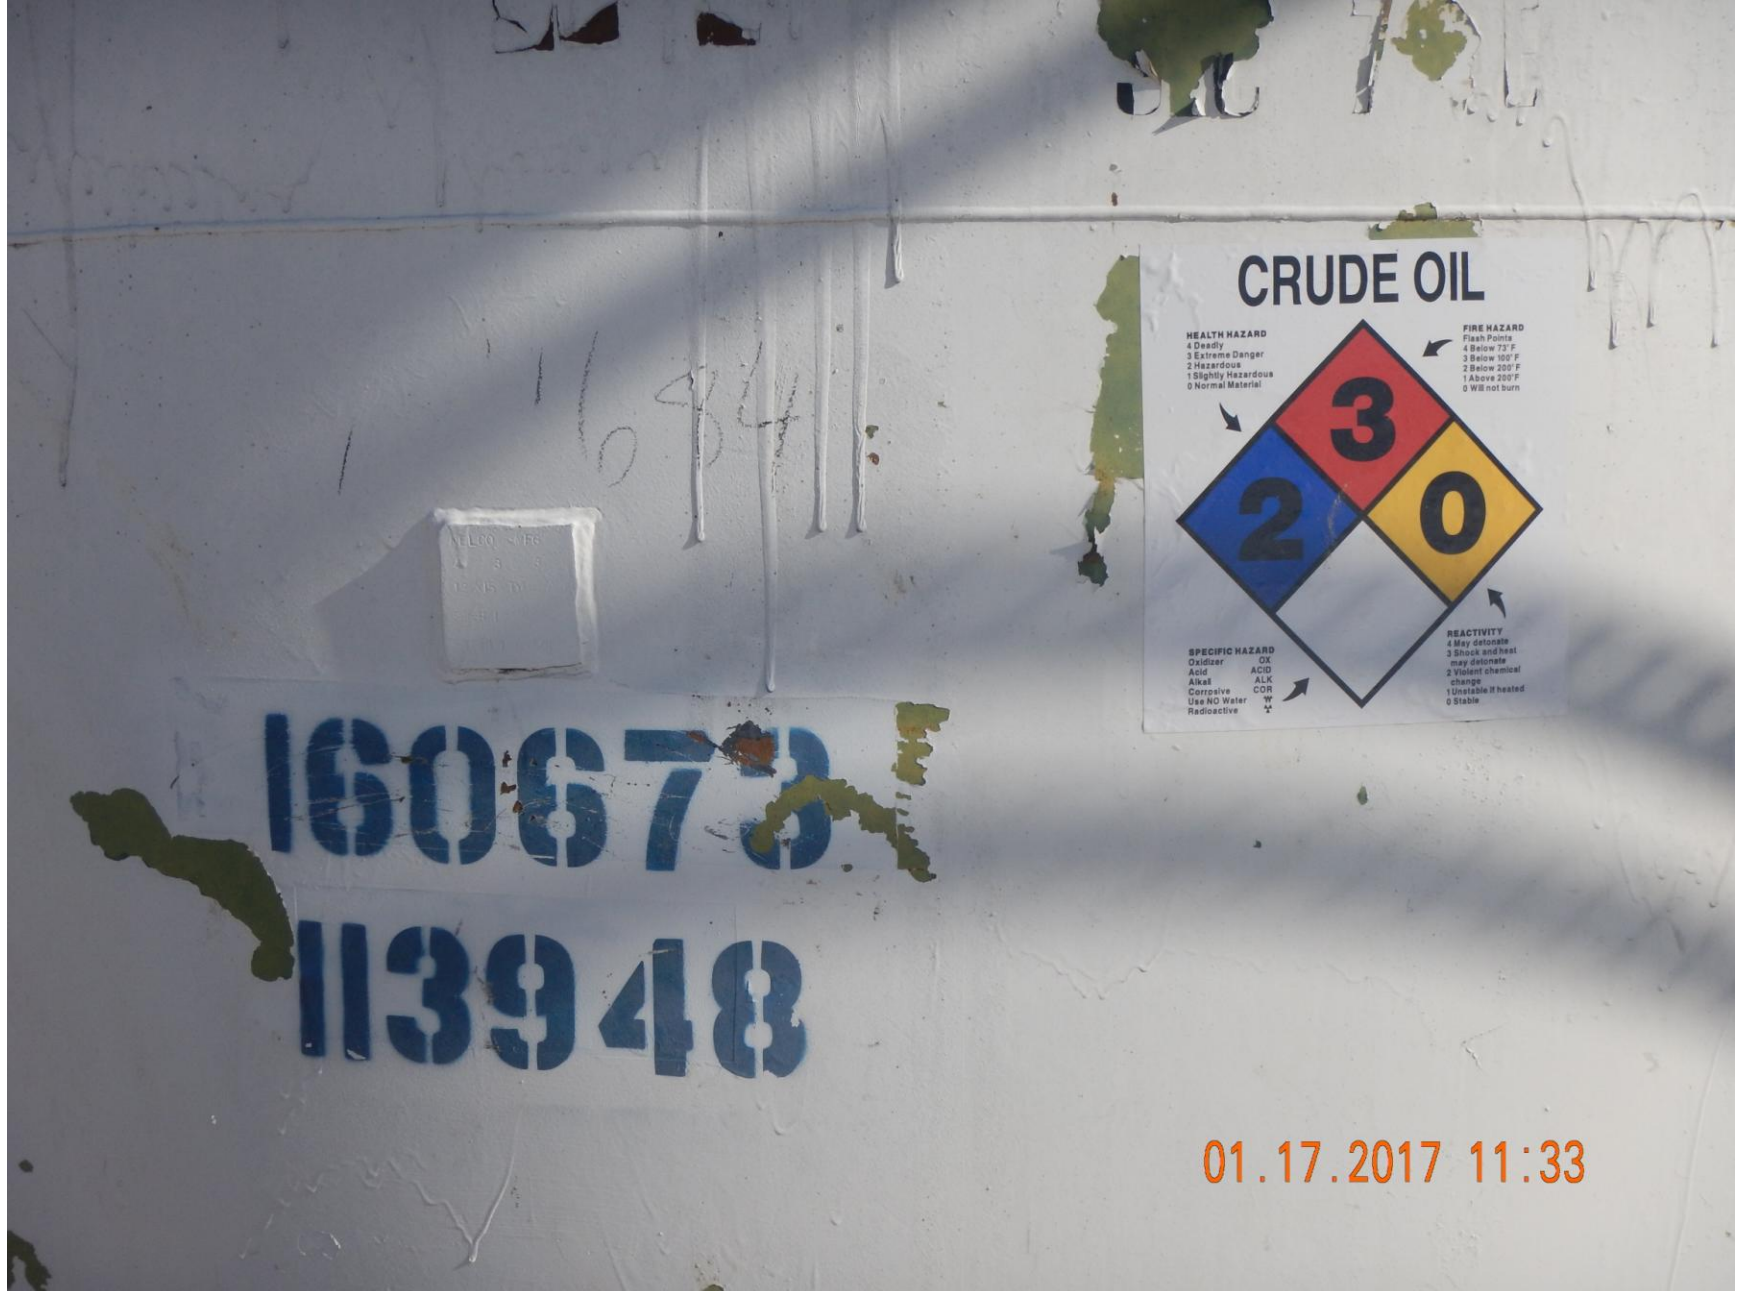
Figure 21: Photo taken from the northern tank. Photo shows a placard has been placed on the tank since inspection doc. #684901990. However tank missing 1) Name of operator, 2) Operator's emergency contact number and 3) Tank capacity.
