Reclamation and Stormwater Inspection

01/18/2017

Operator: Foundation Energy #10112

Location ID: 330865

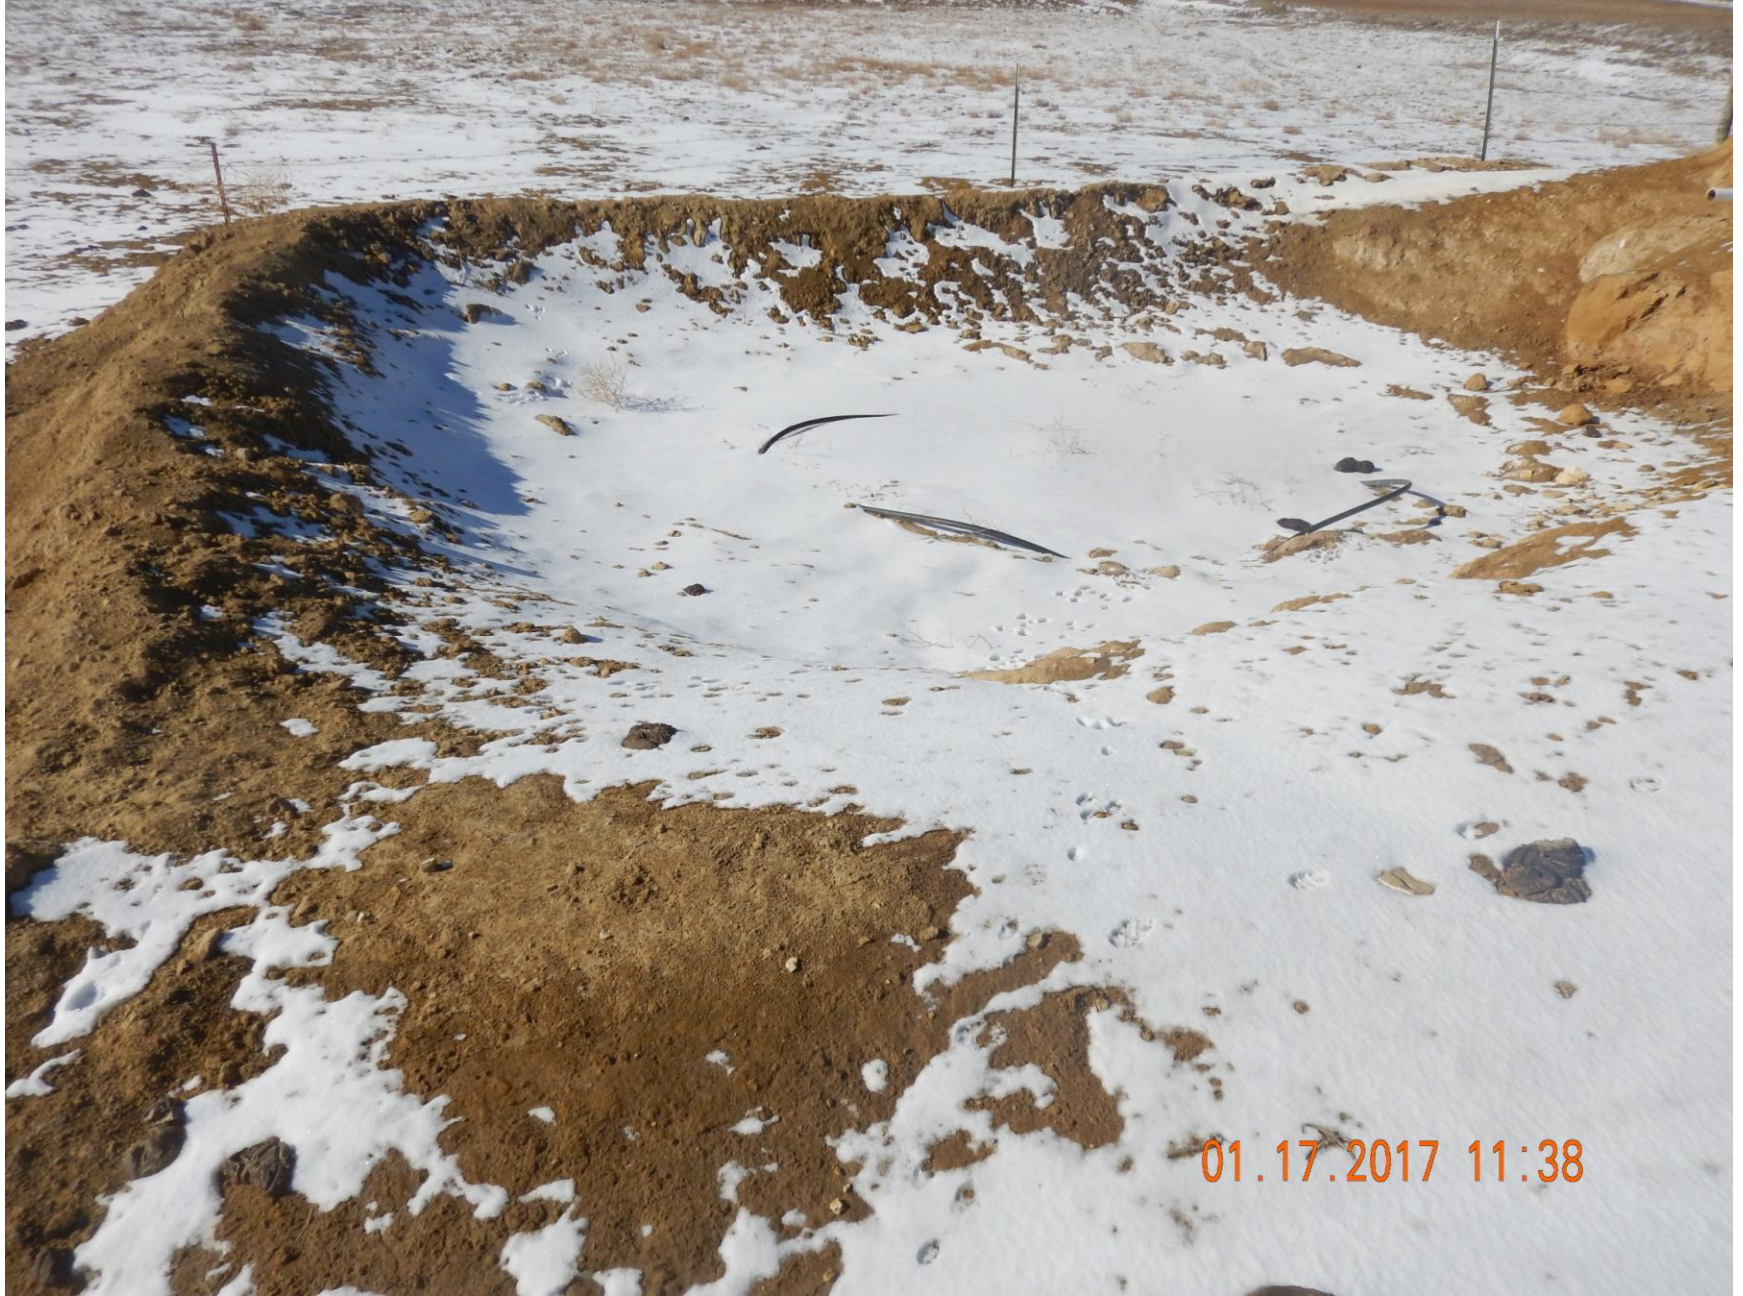
Figure 22: Photo taken from skim pit on the northeast end of the location, facing west.
