# Reclamation and Stormwater Inspection

01/18/2017

Operator: Bonanza Creek #8960

Location ID: 437240

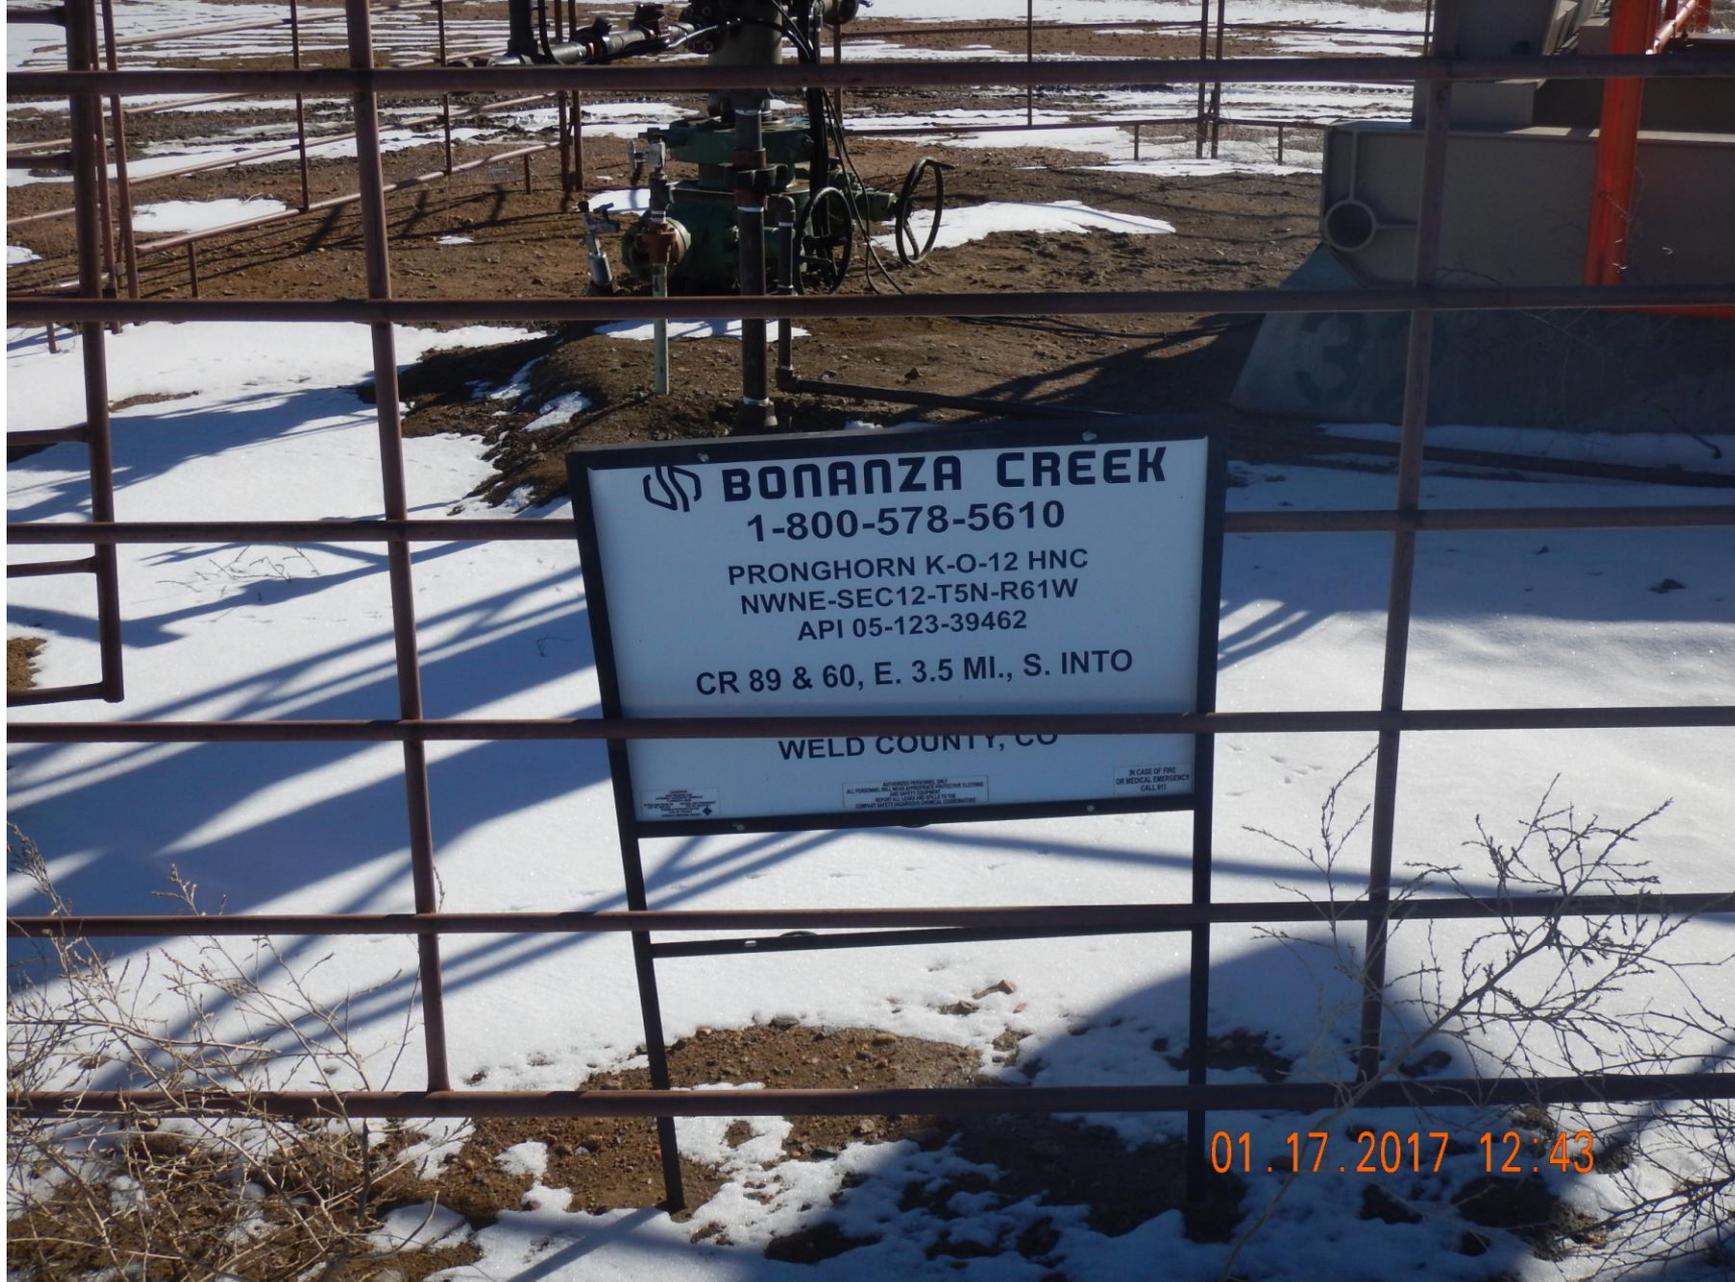
**Figure 1:** Photo taken from the pump jack/well. Photo shows sign at well.

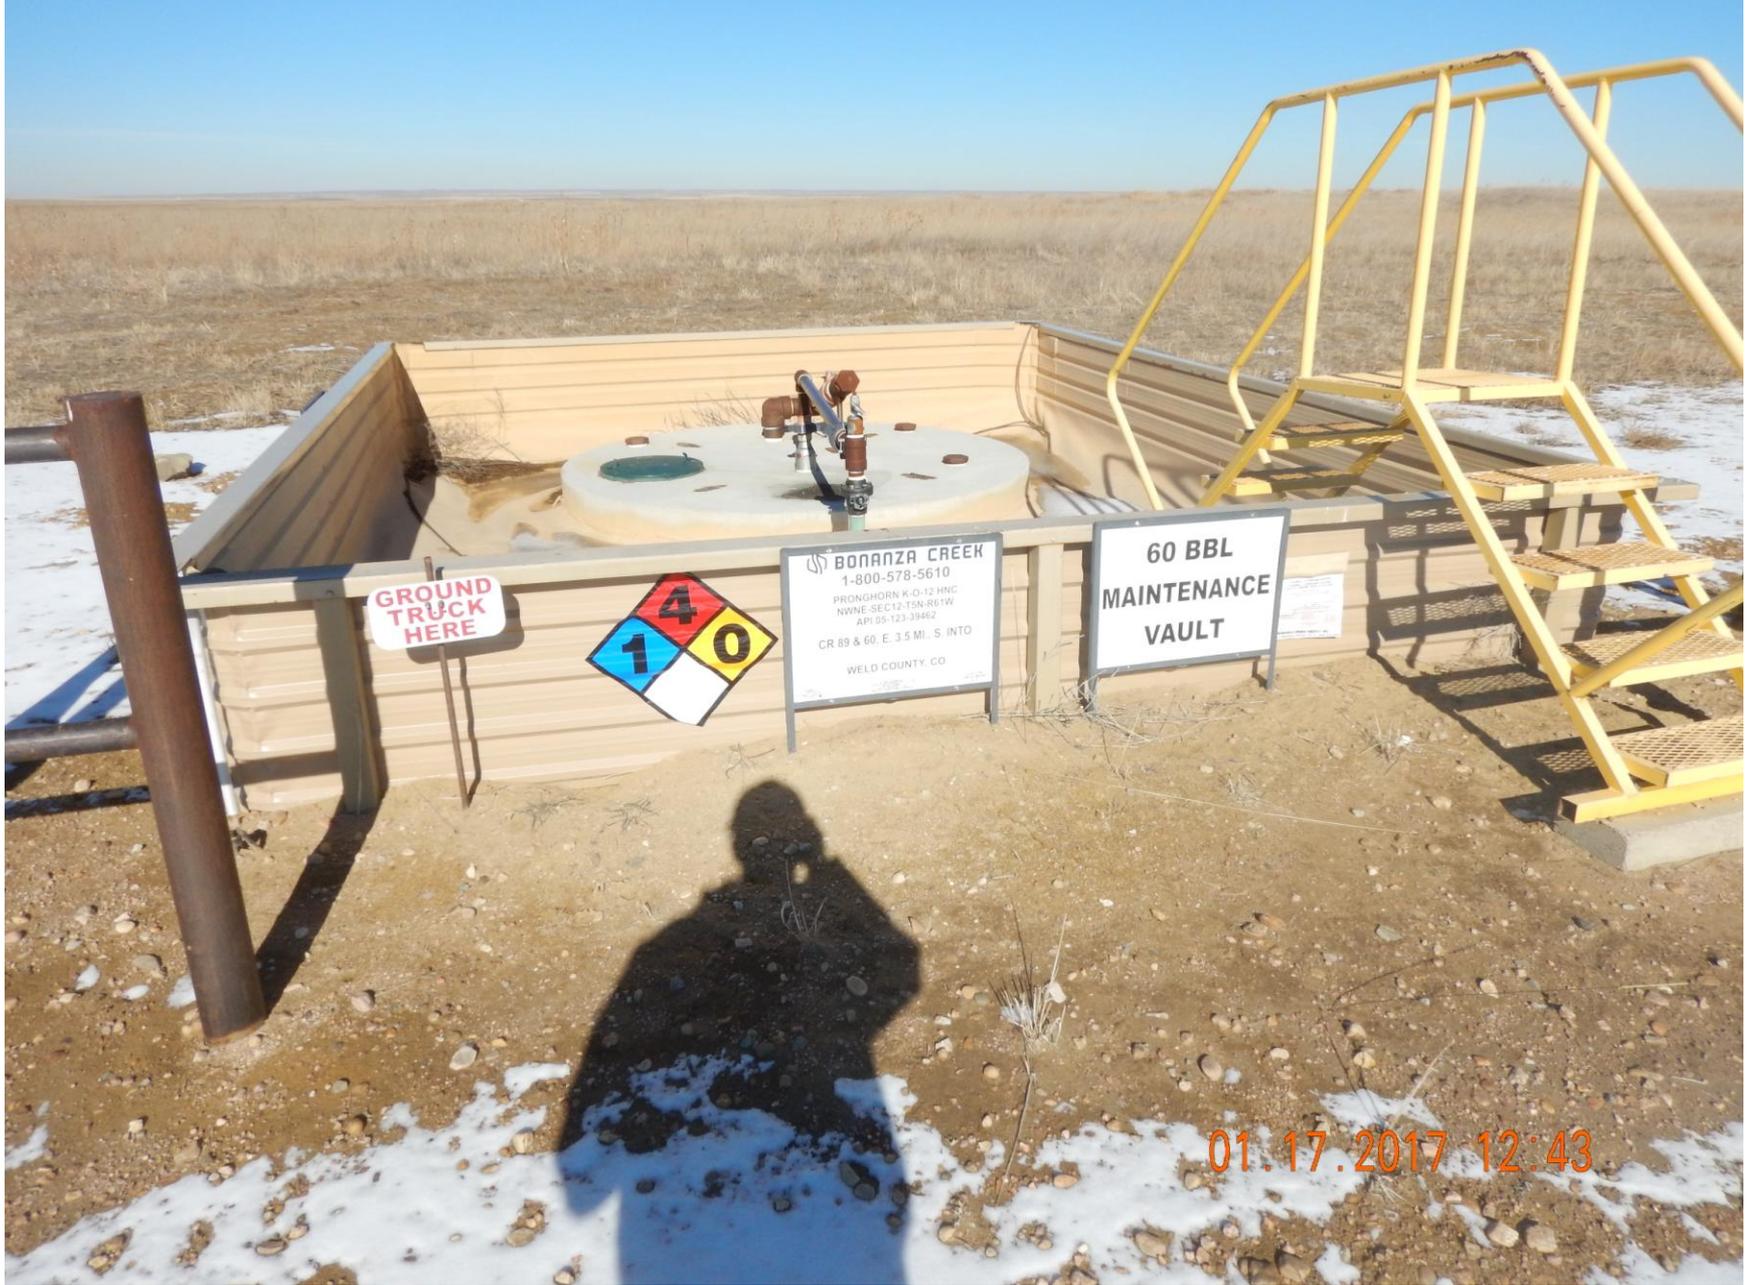
**Figure 2:** Photo taken from the north end of the location, facing north. Photo shows below ground 60 bbl “maintenance vault”

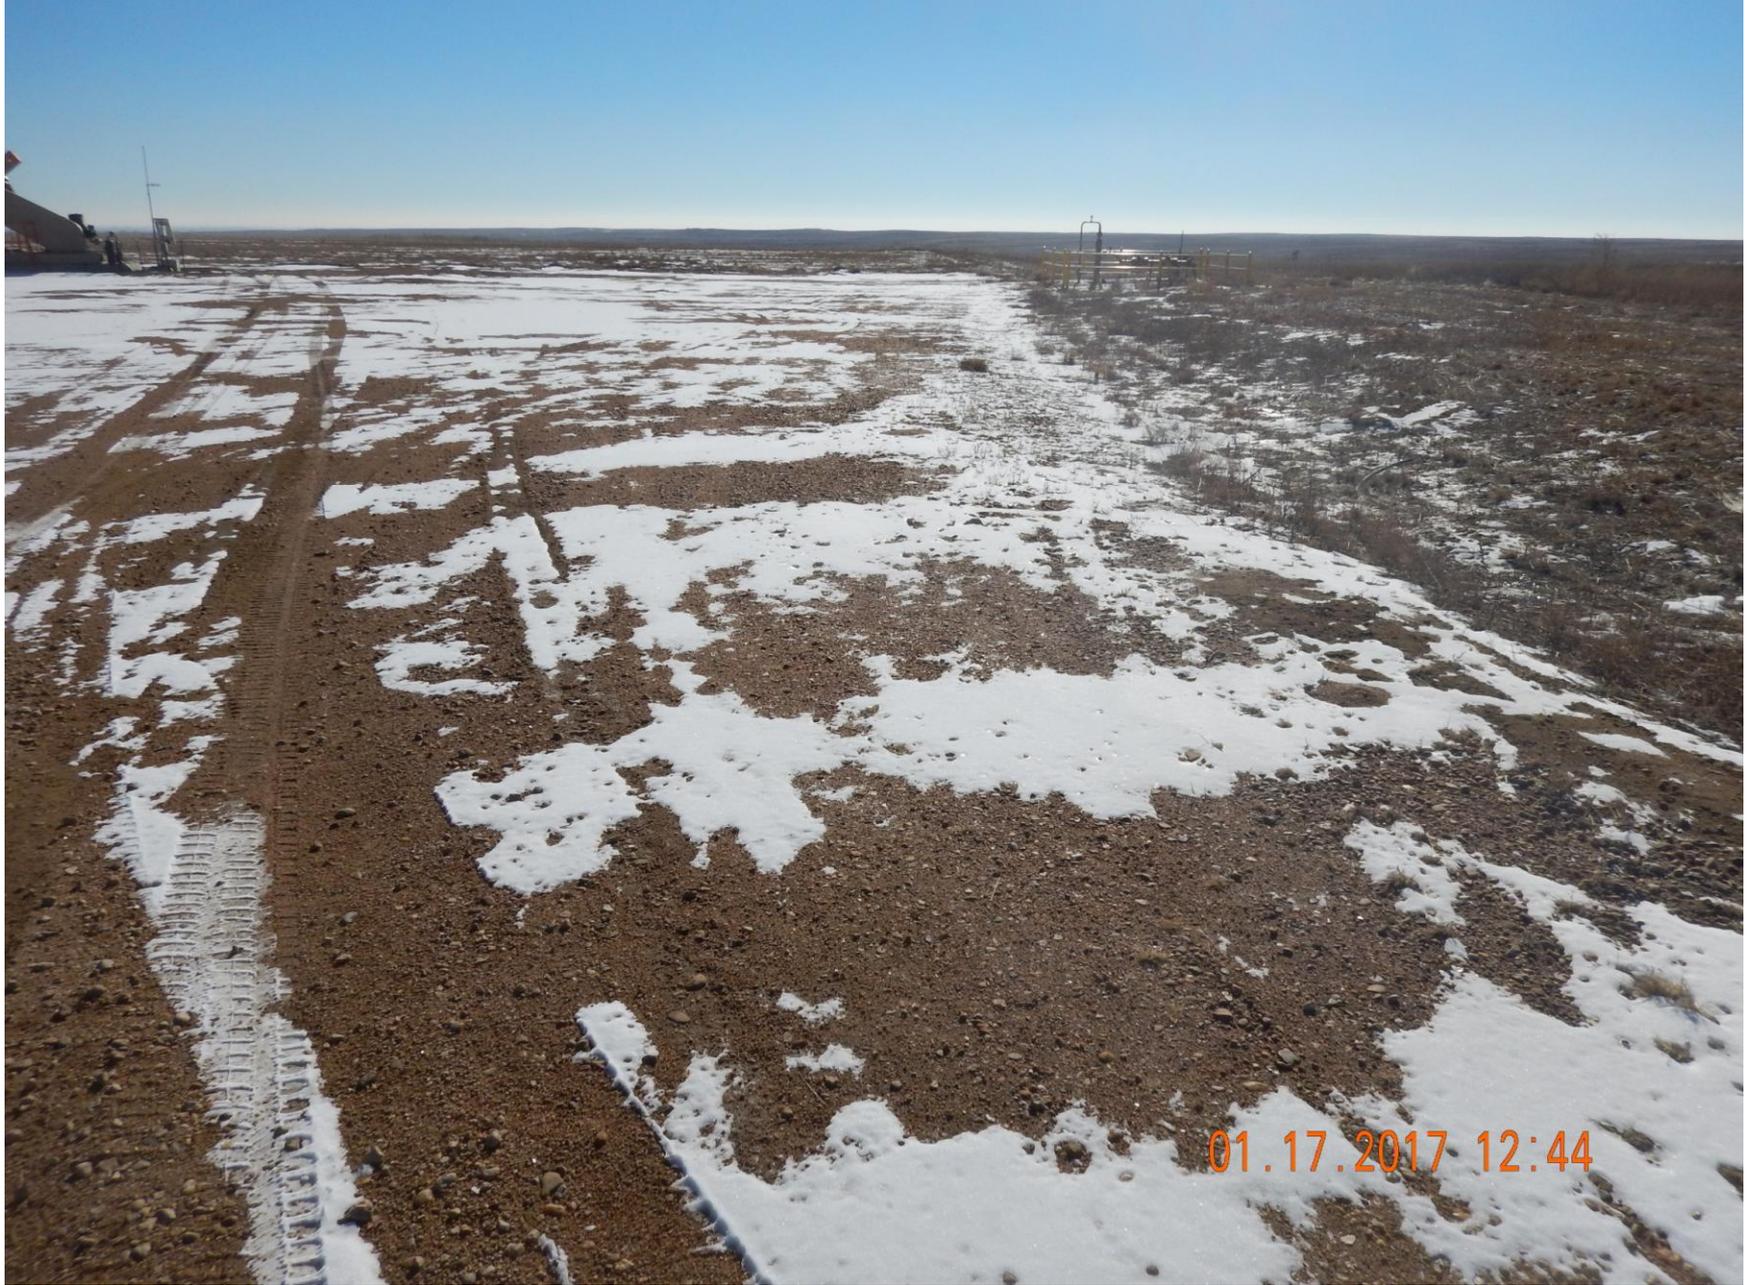
**Figure 3:** Photo taken from the northwest end of the location, facing south. Photo shows interim and productions areas.

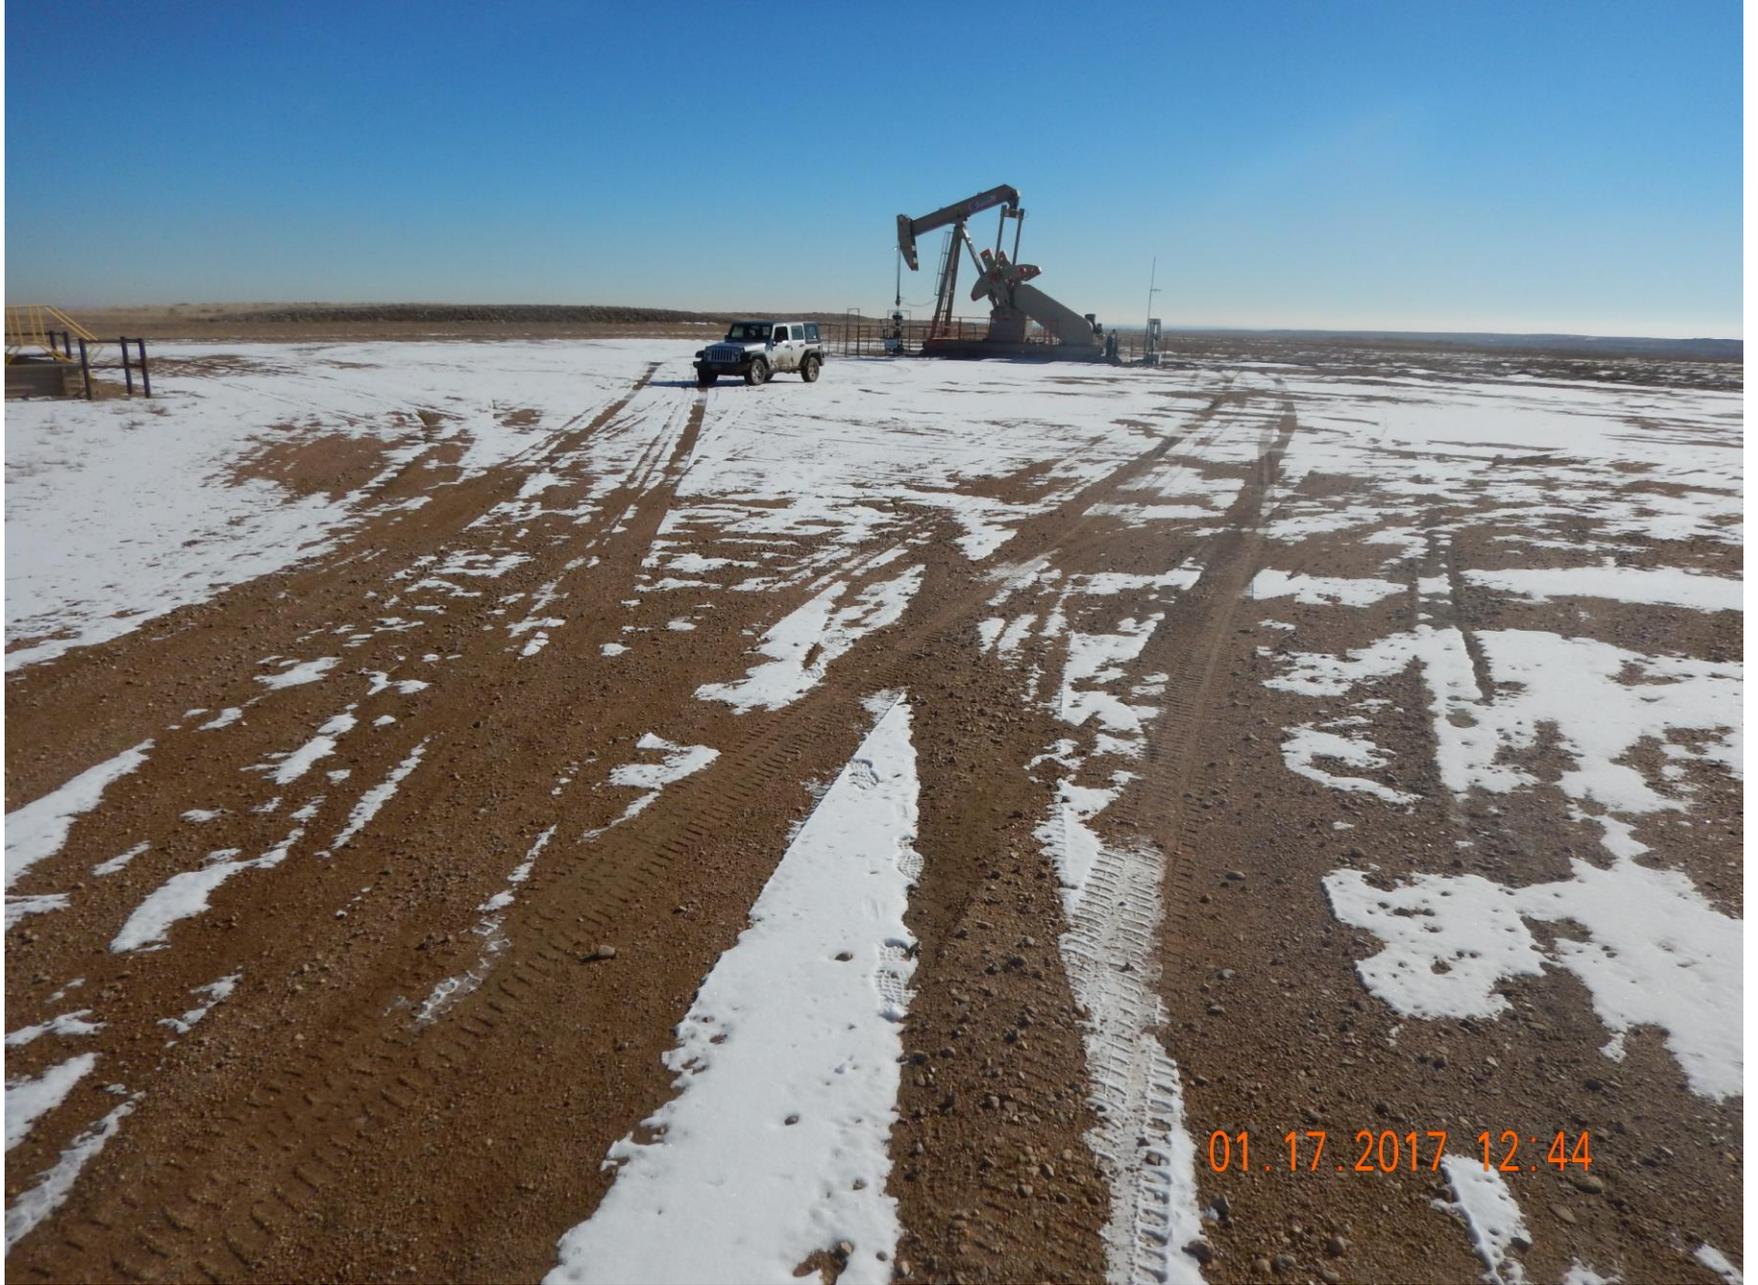
**Figure 4:** Photo taken from the northwest end of the location, facing southeast. Photo shows interim and productions areas.

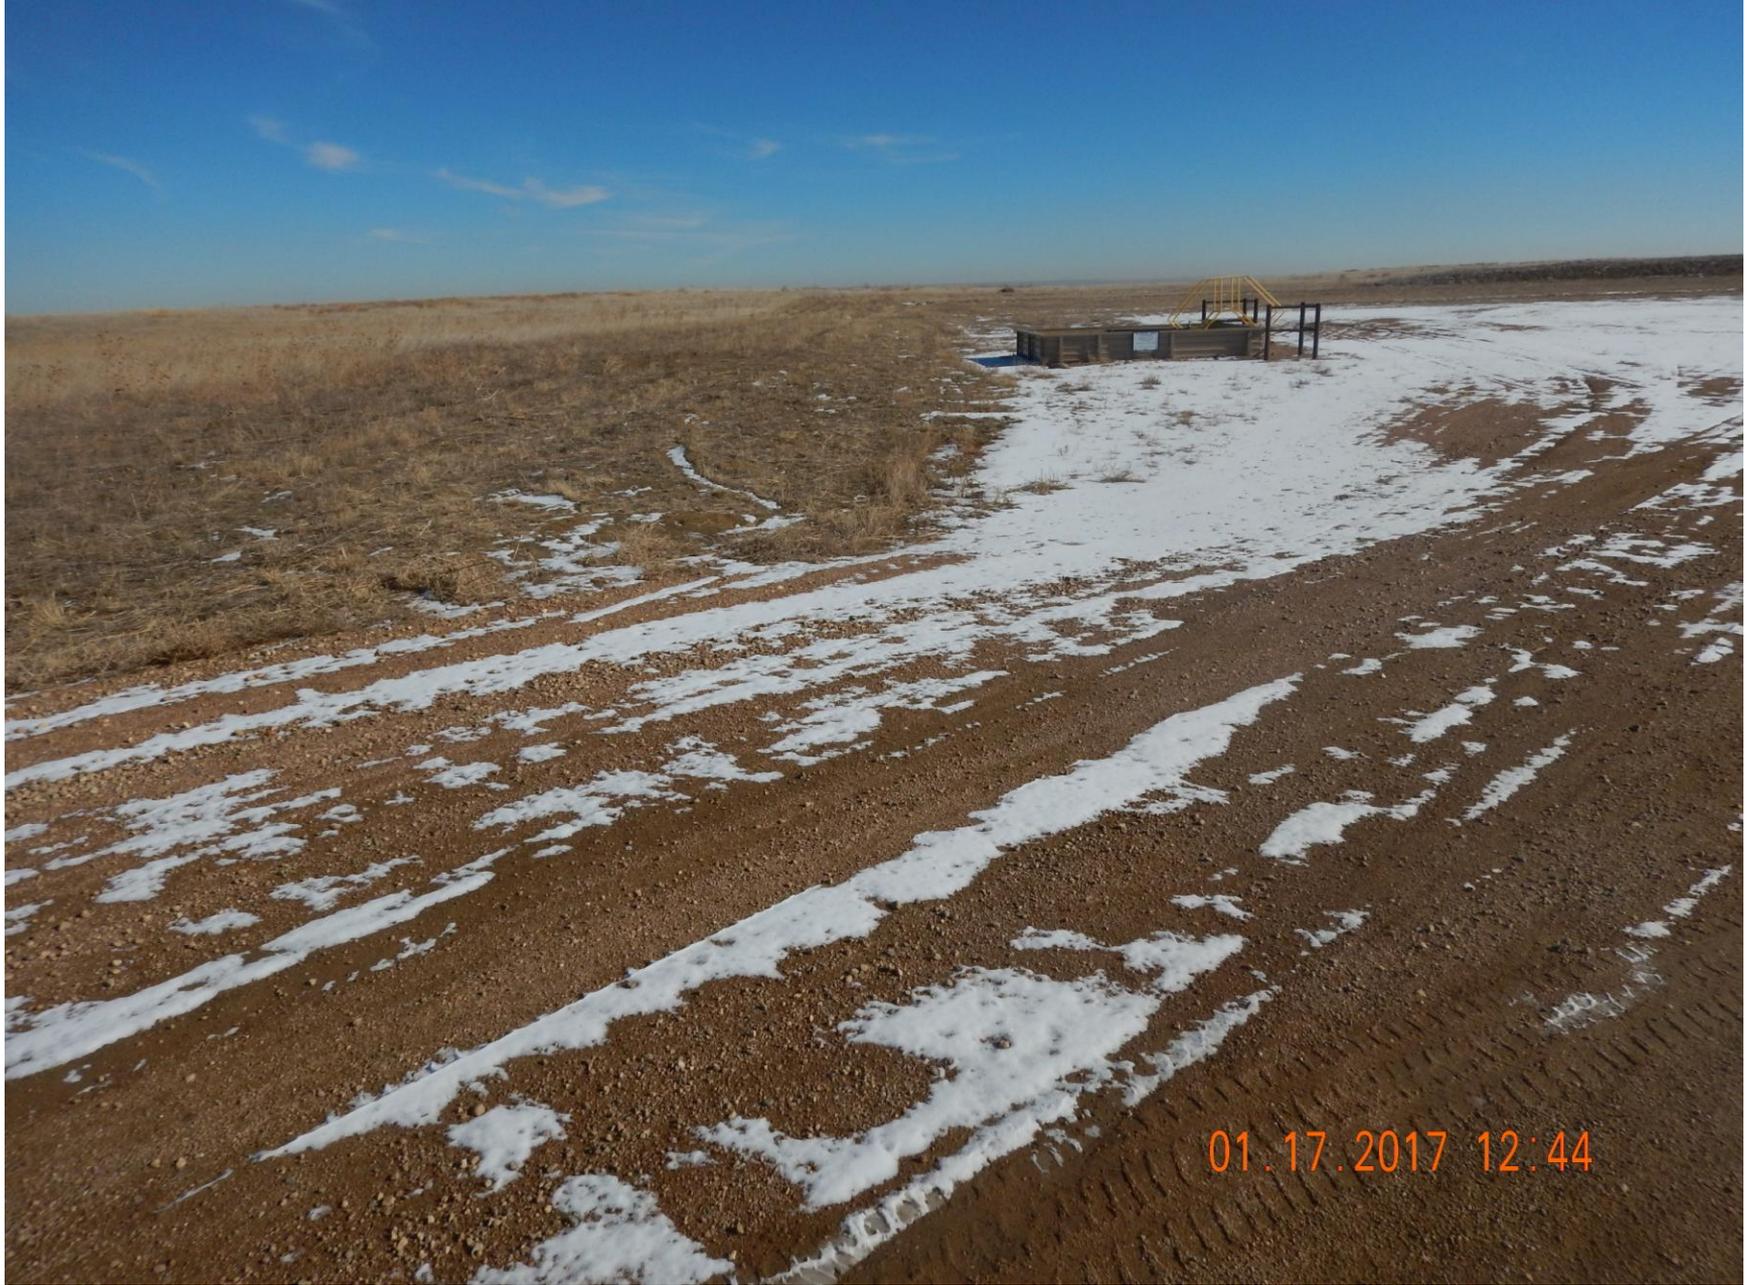
**Figure 5:** Photo taken from the northwest end of the location, facing east. Photo shows interim and productions areas.

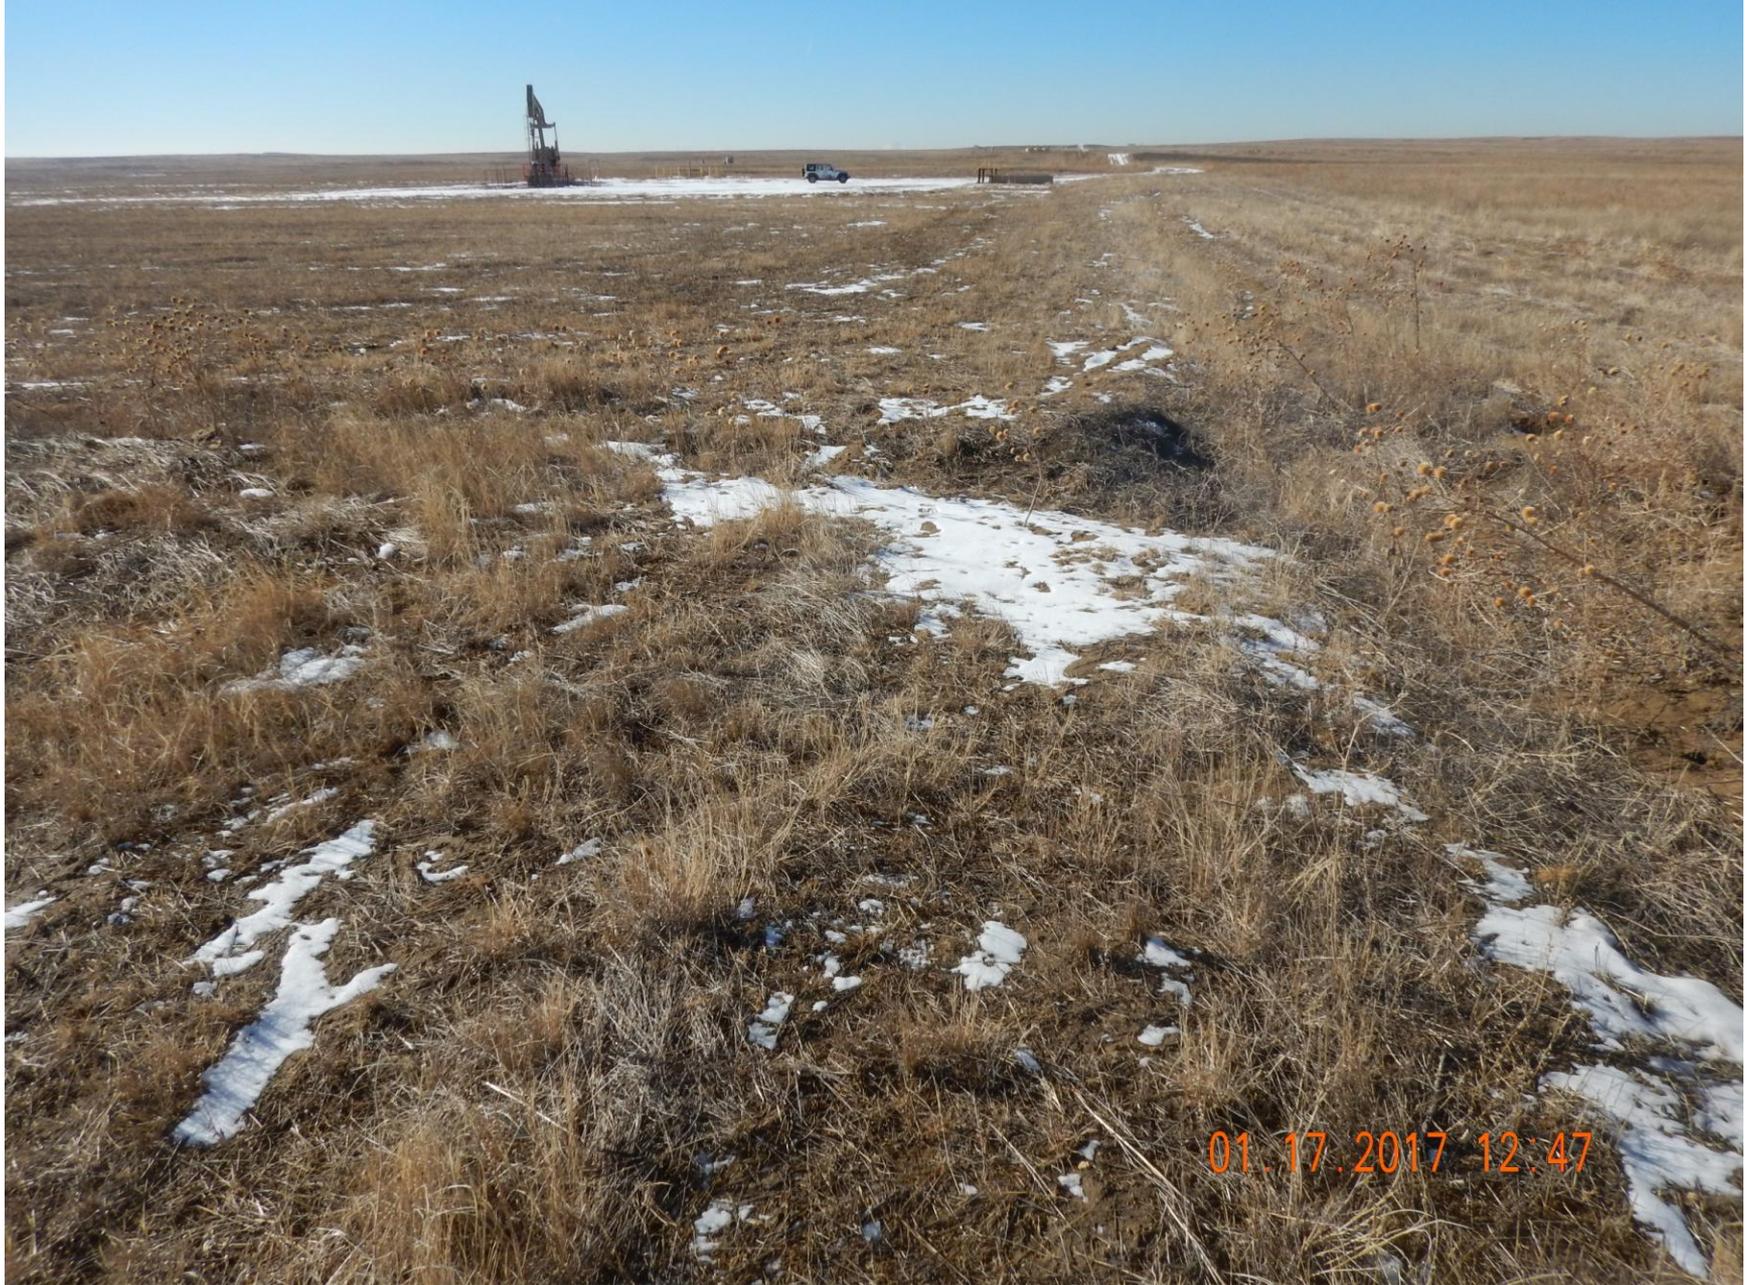
**Figure 6:** Photo taken from the northeast end of the location, facing west. Photo shows interim and productions areas.

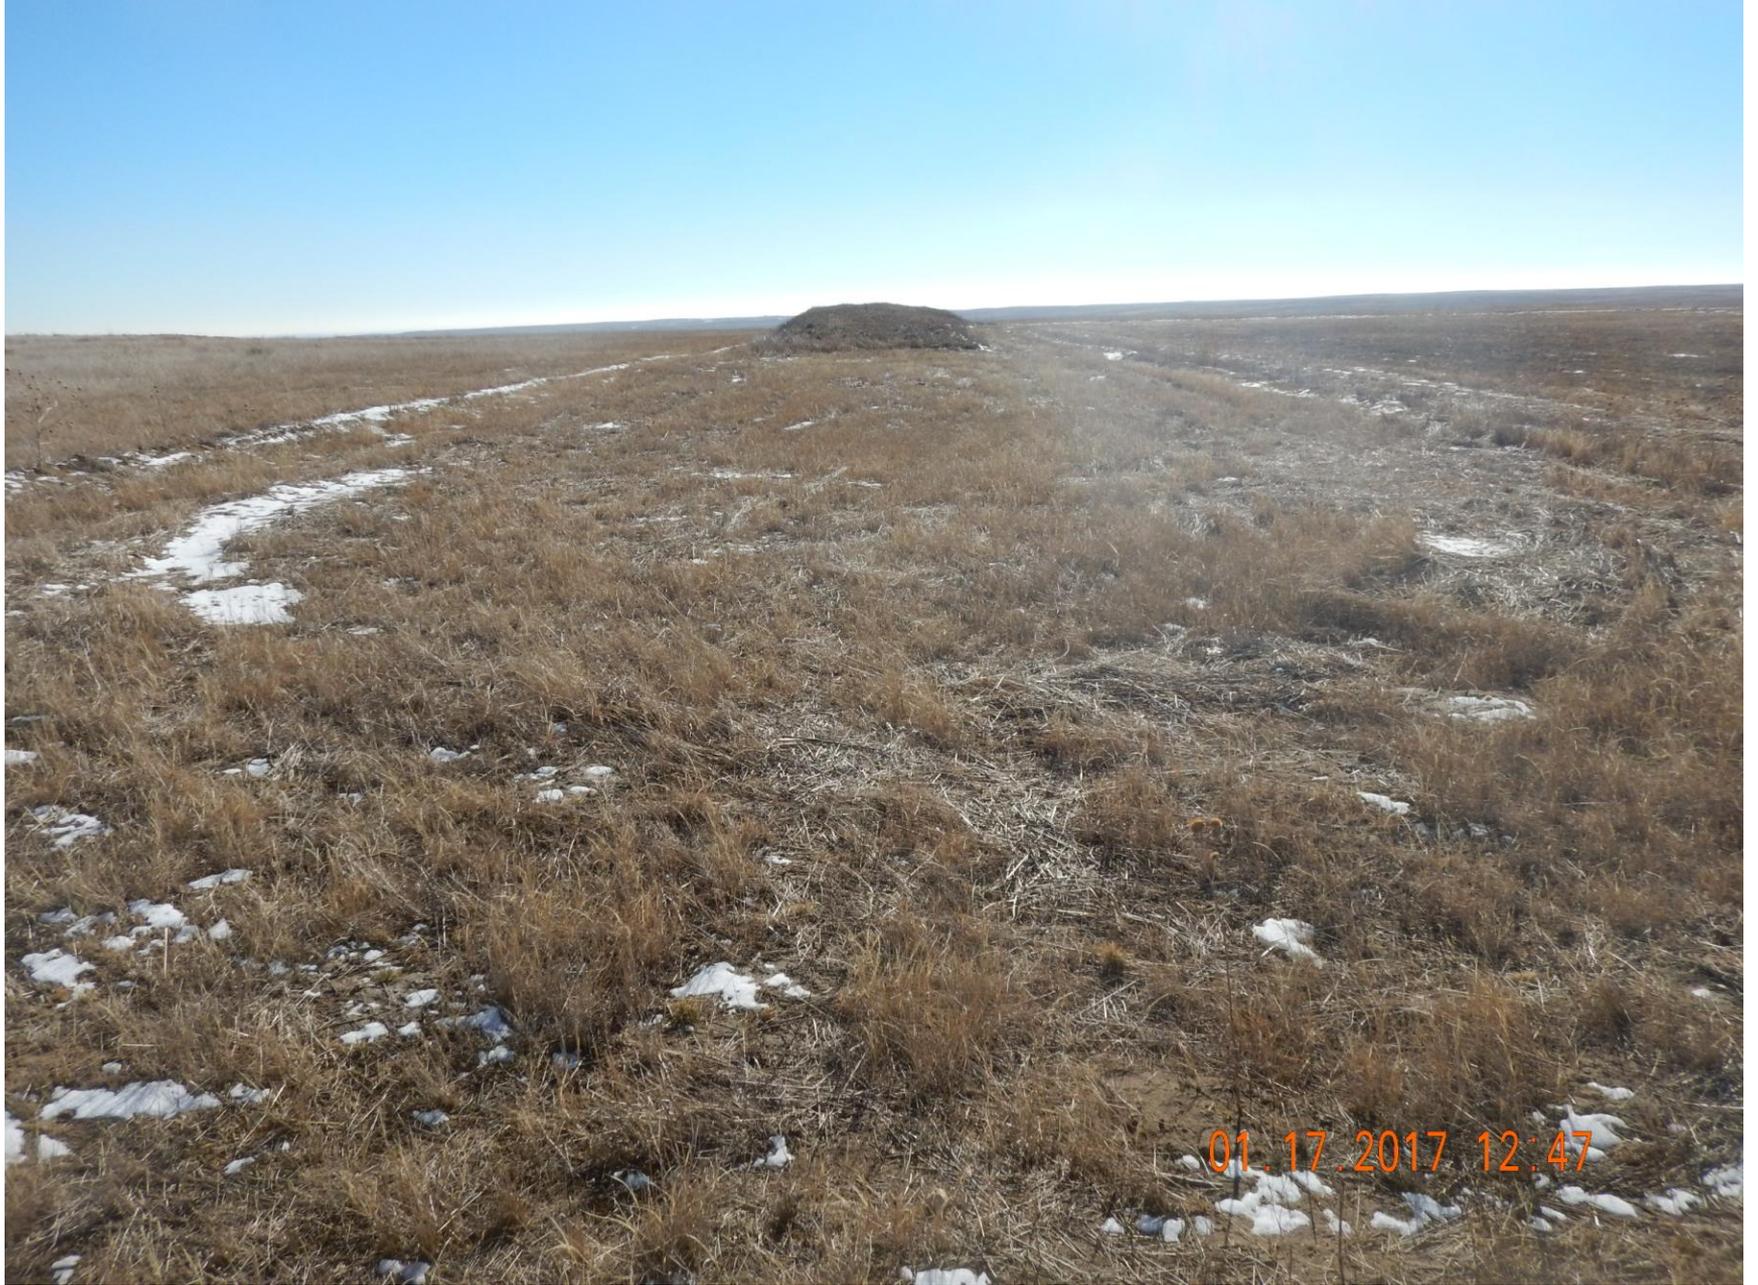
**Figure 7:** Photo taken from the northeast end of the location, facing west. Photo shows interim areas. Note topsoil stockpile center of photo.

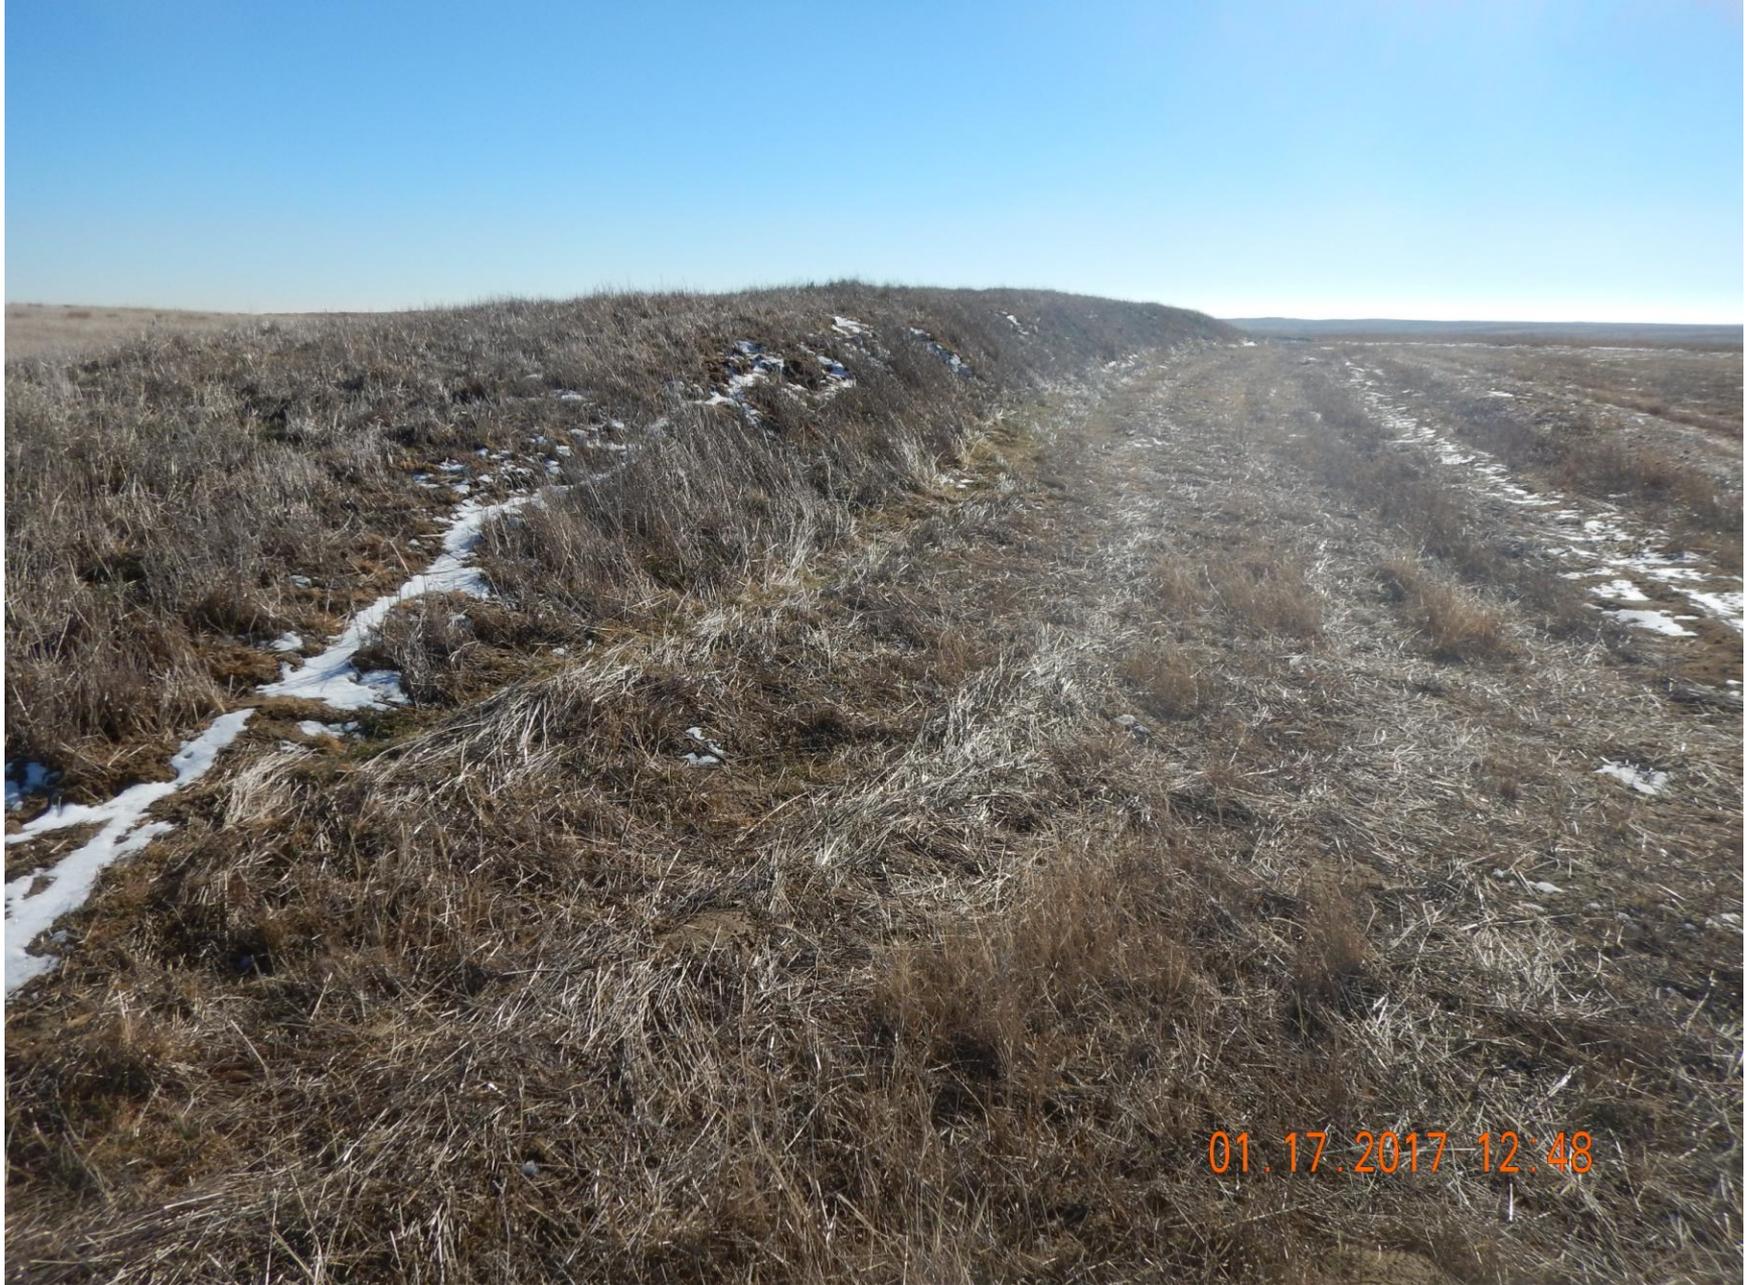
**Figure 8:** Photo taken from the east end of the location, facing south. Photo of soil stockpile.

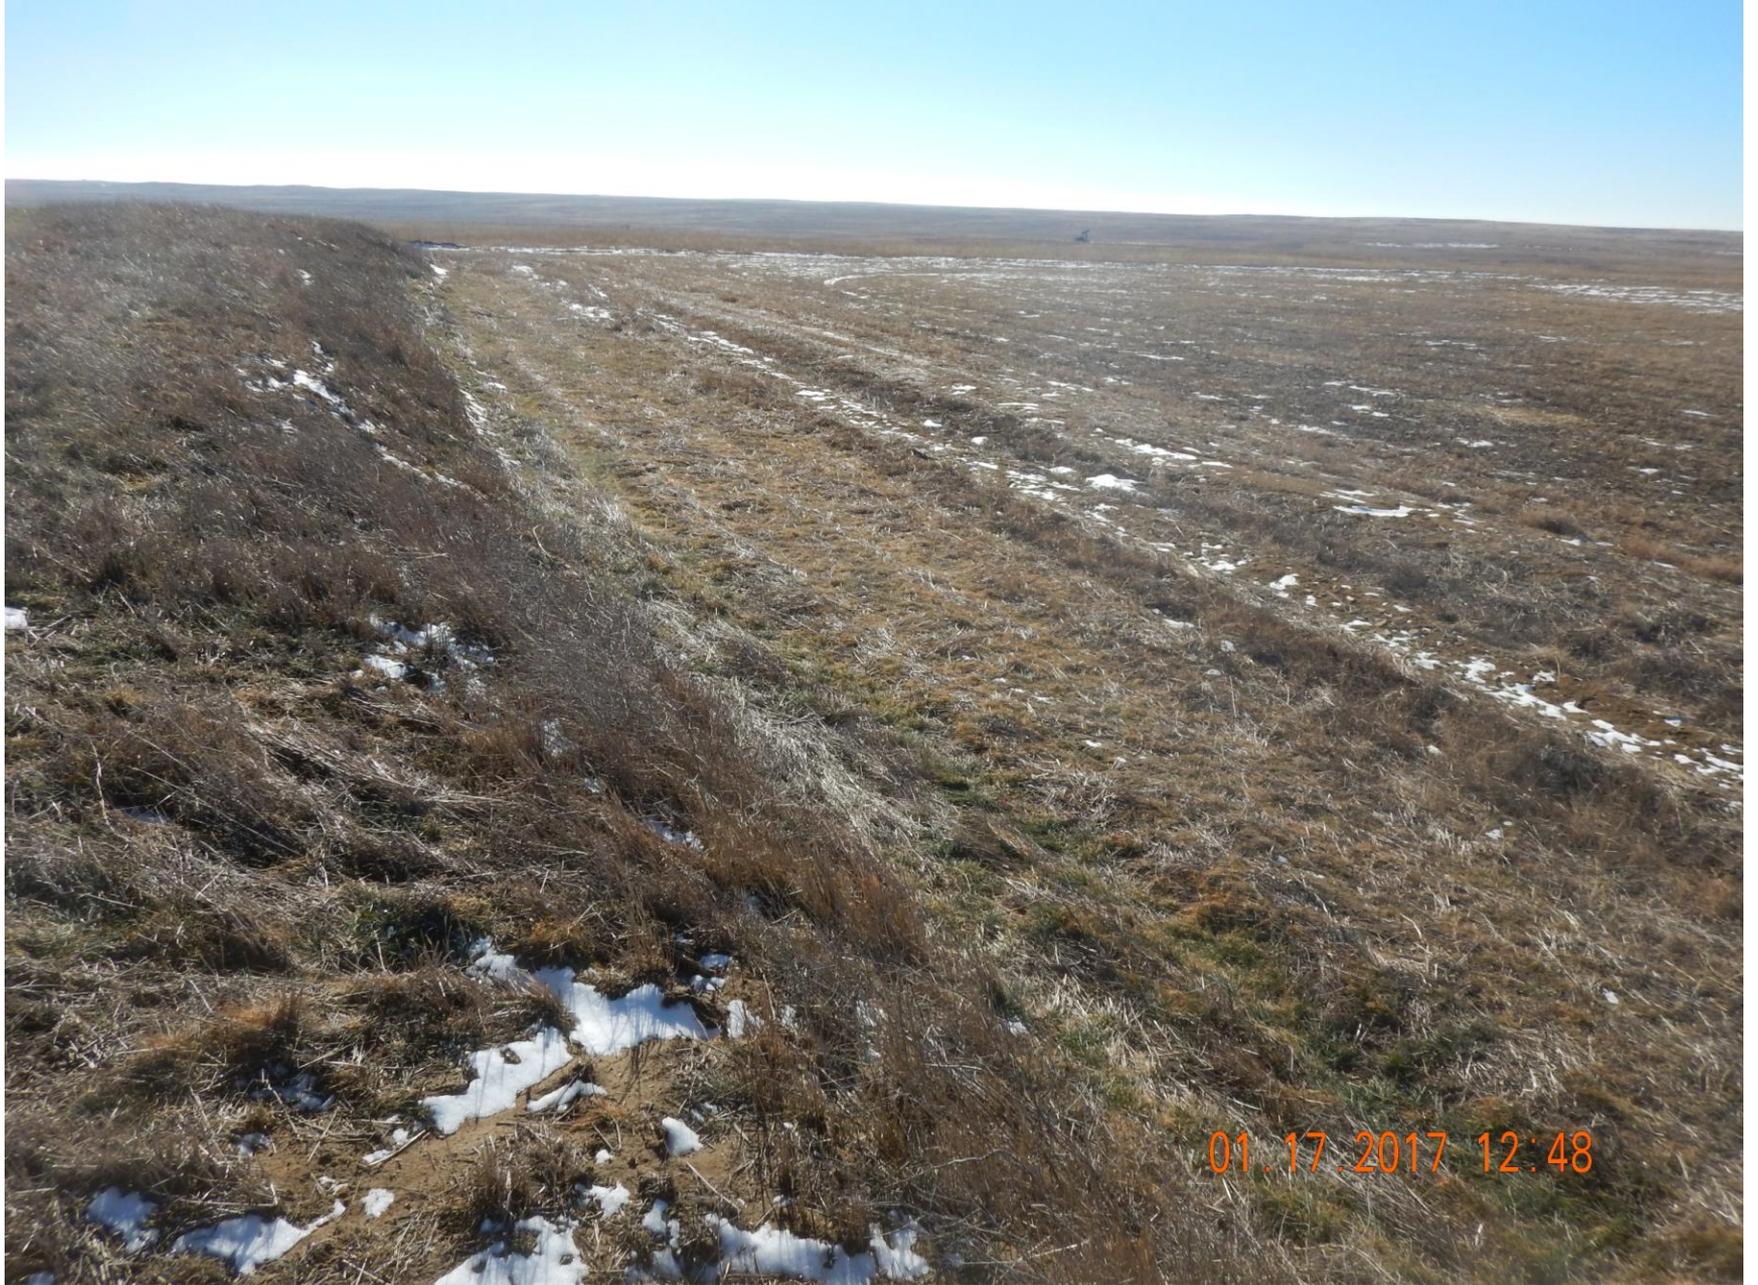
**Figure 9:** Photo taken from the soil stockpile on the east end of the location, facing southwest. Photo shows interim area.

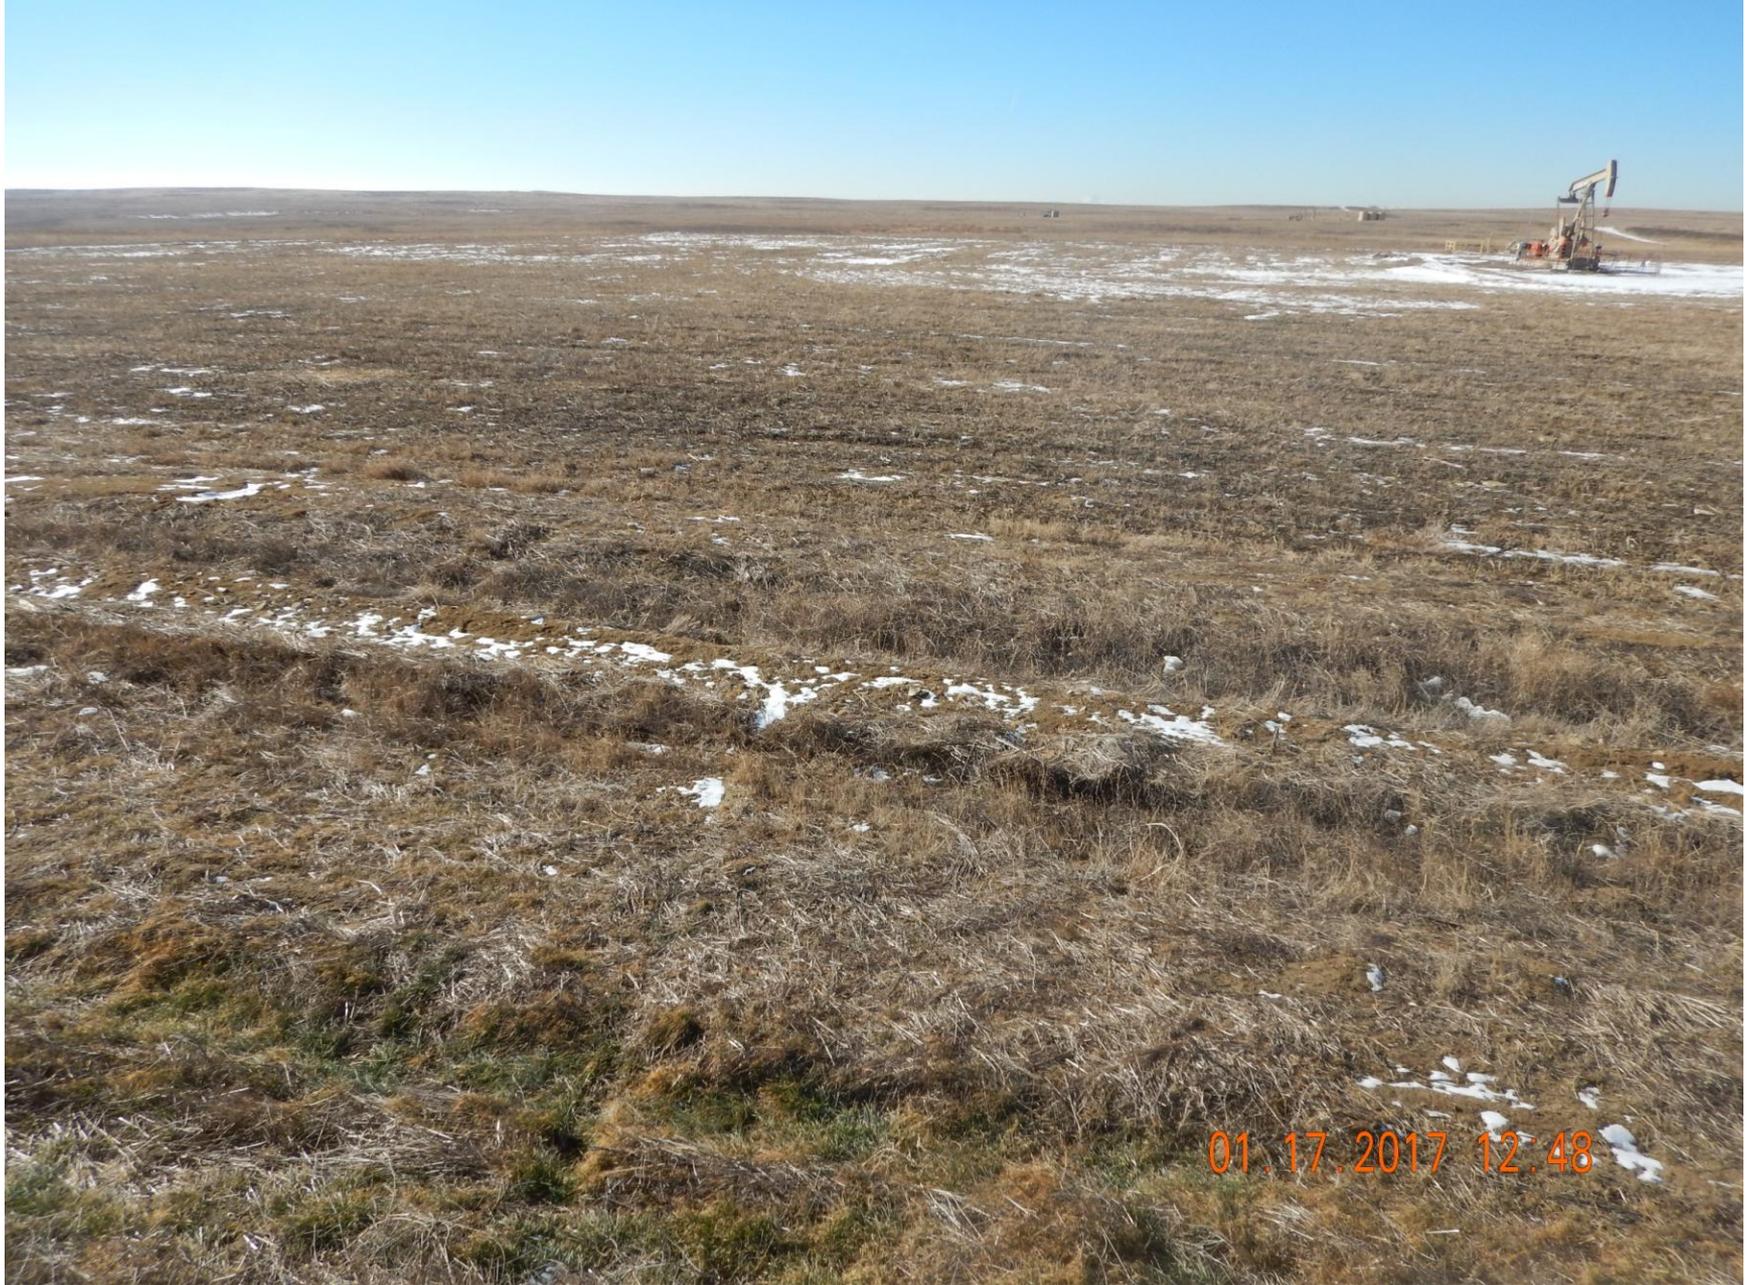
**Figure 10:** Photo taken from the soil stockpile on the east end of the location, facing southwest. Photo shows interim area and production area.
