# Reclamation and Stormwater Inspection

01/18/2017

Operator: Bonanza Creek #8960

Location ID: 437240

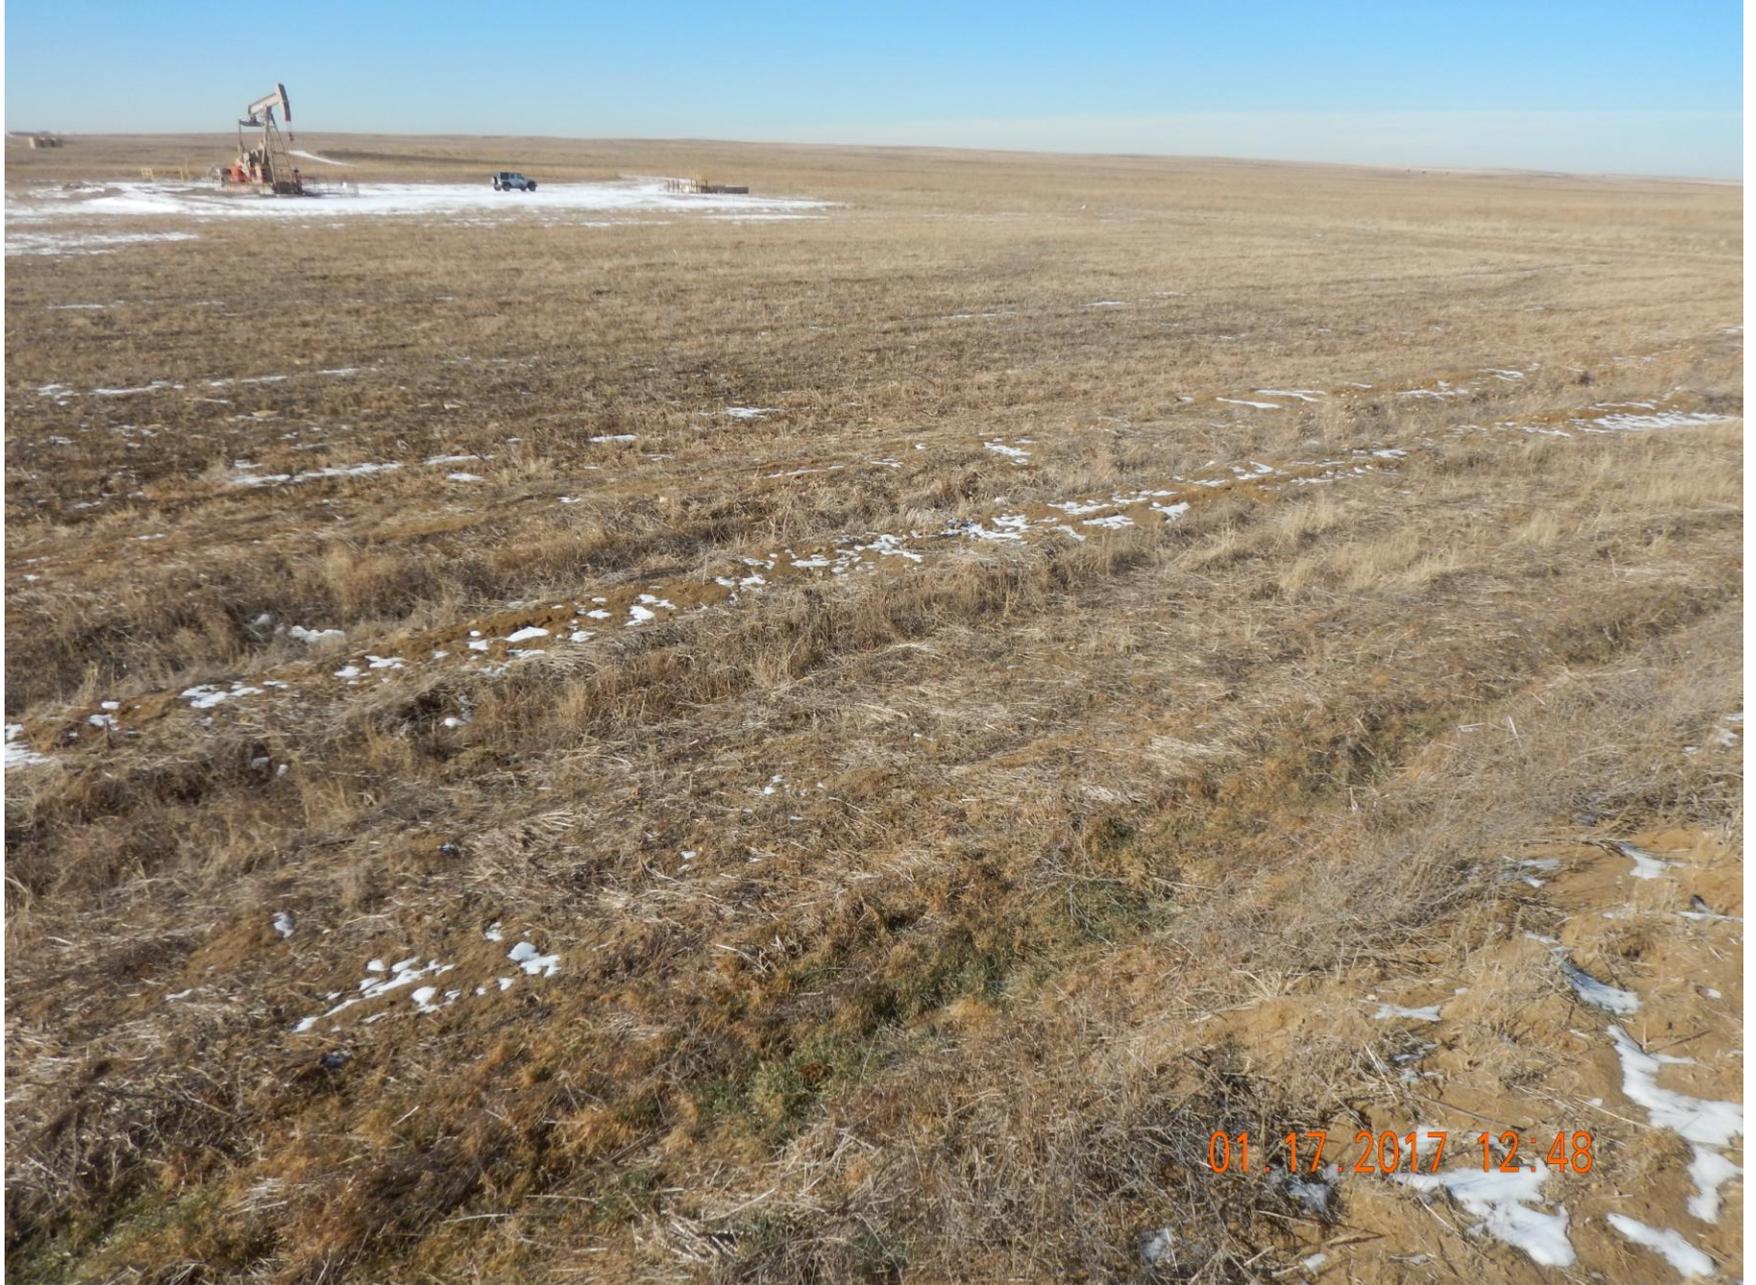
**Figure 11:** Photo taken from the soil stockpile on the east end of the location, facing northwest. Photo shows interim area and production area.

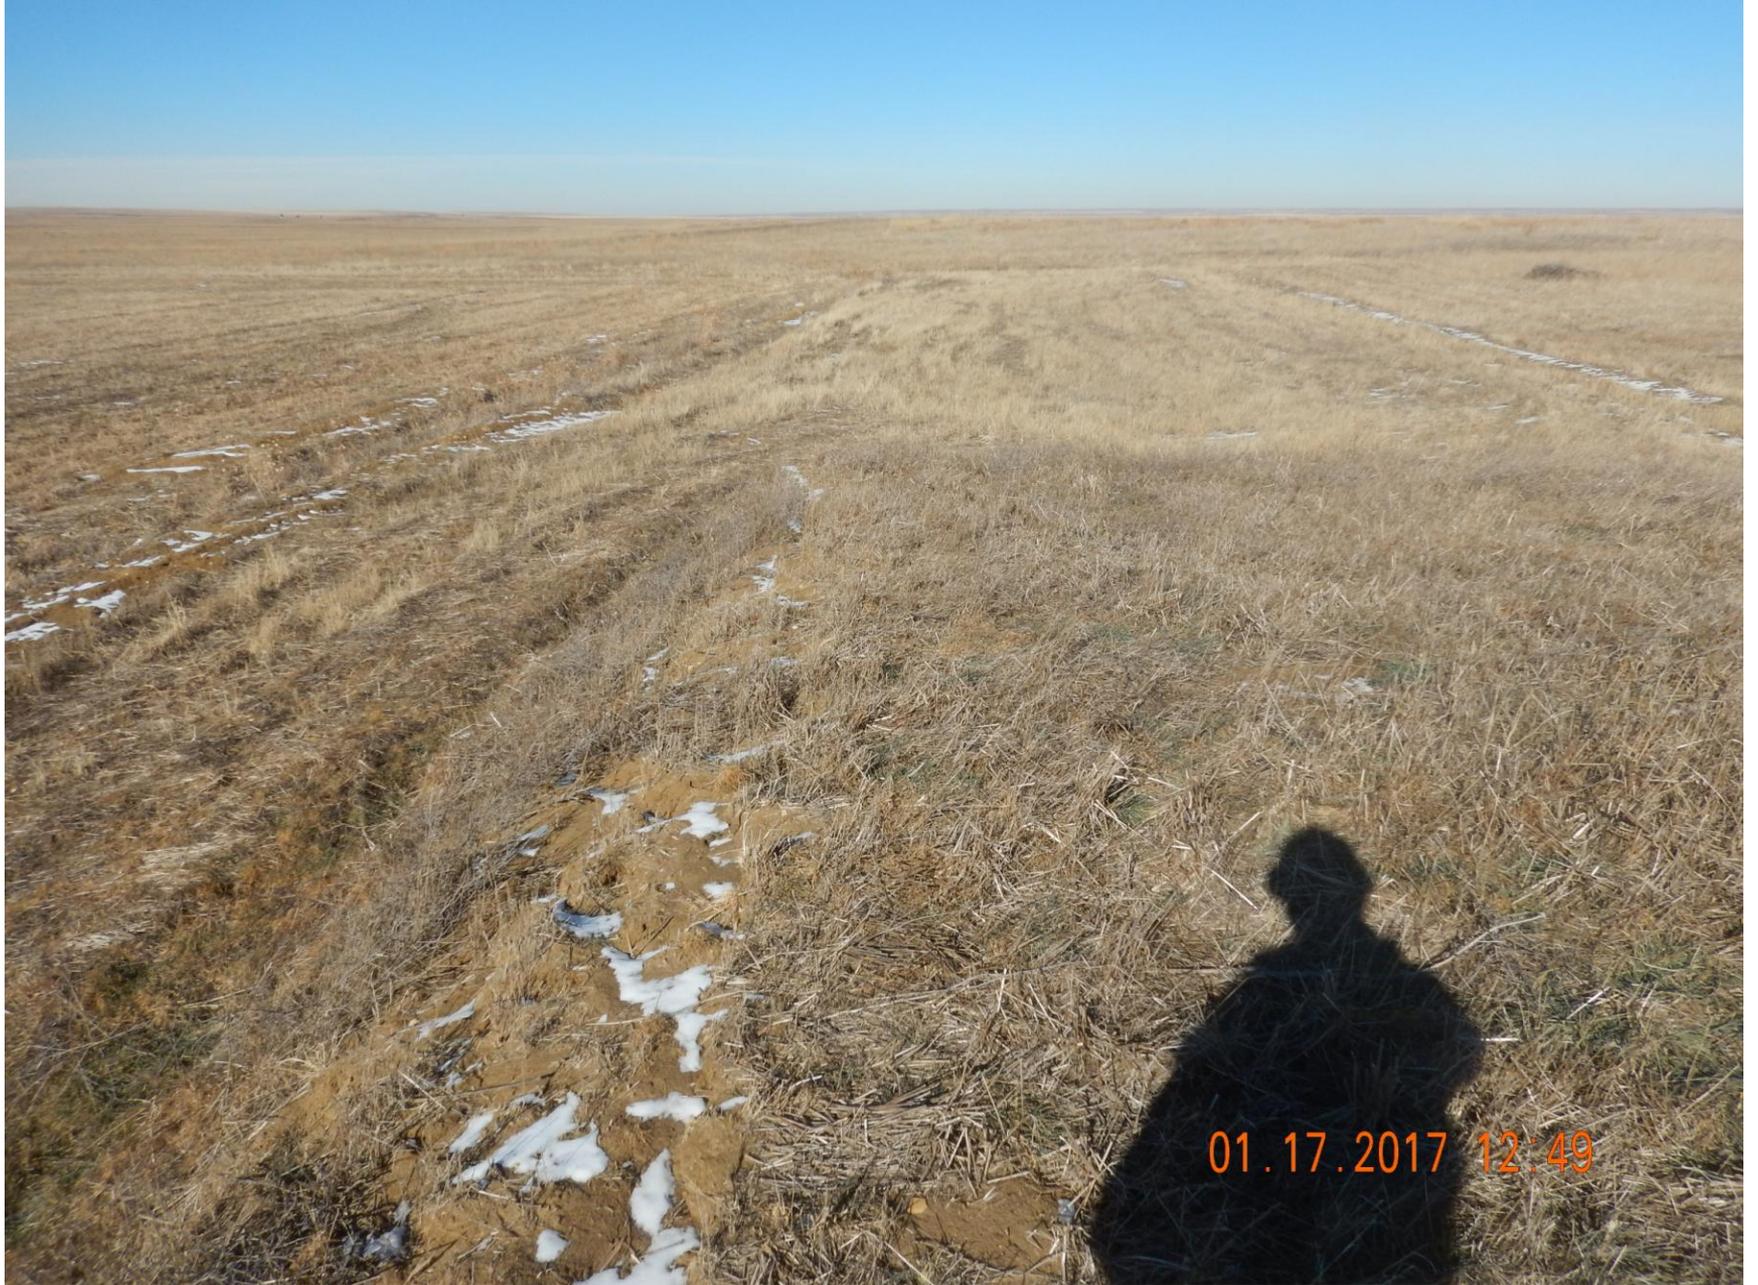
**Figure 12:** Photo taken from the soil stockpile on the east end of the location, facing north. Photo shows interim area.

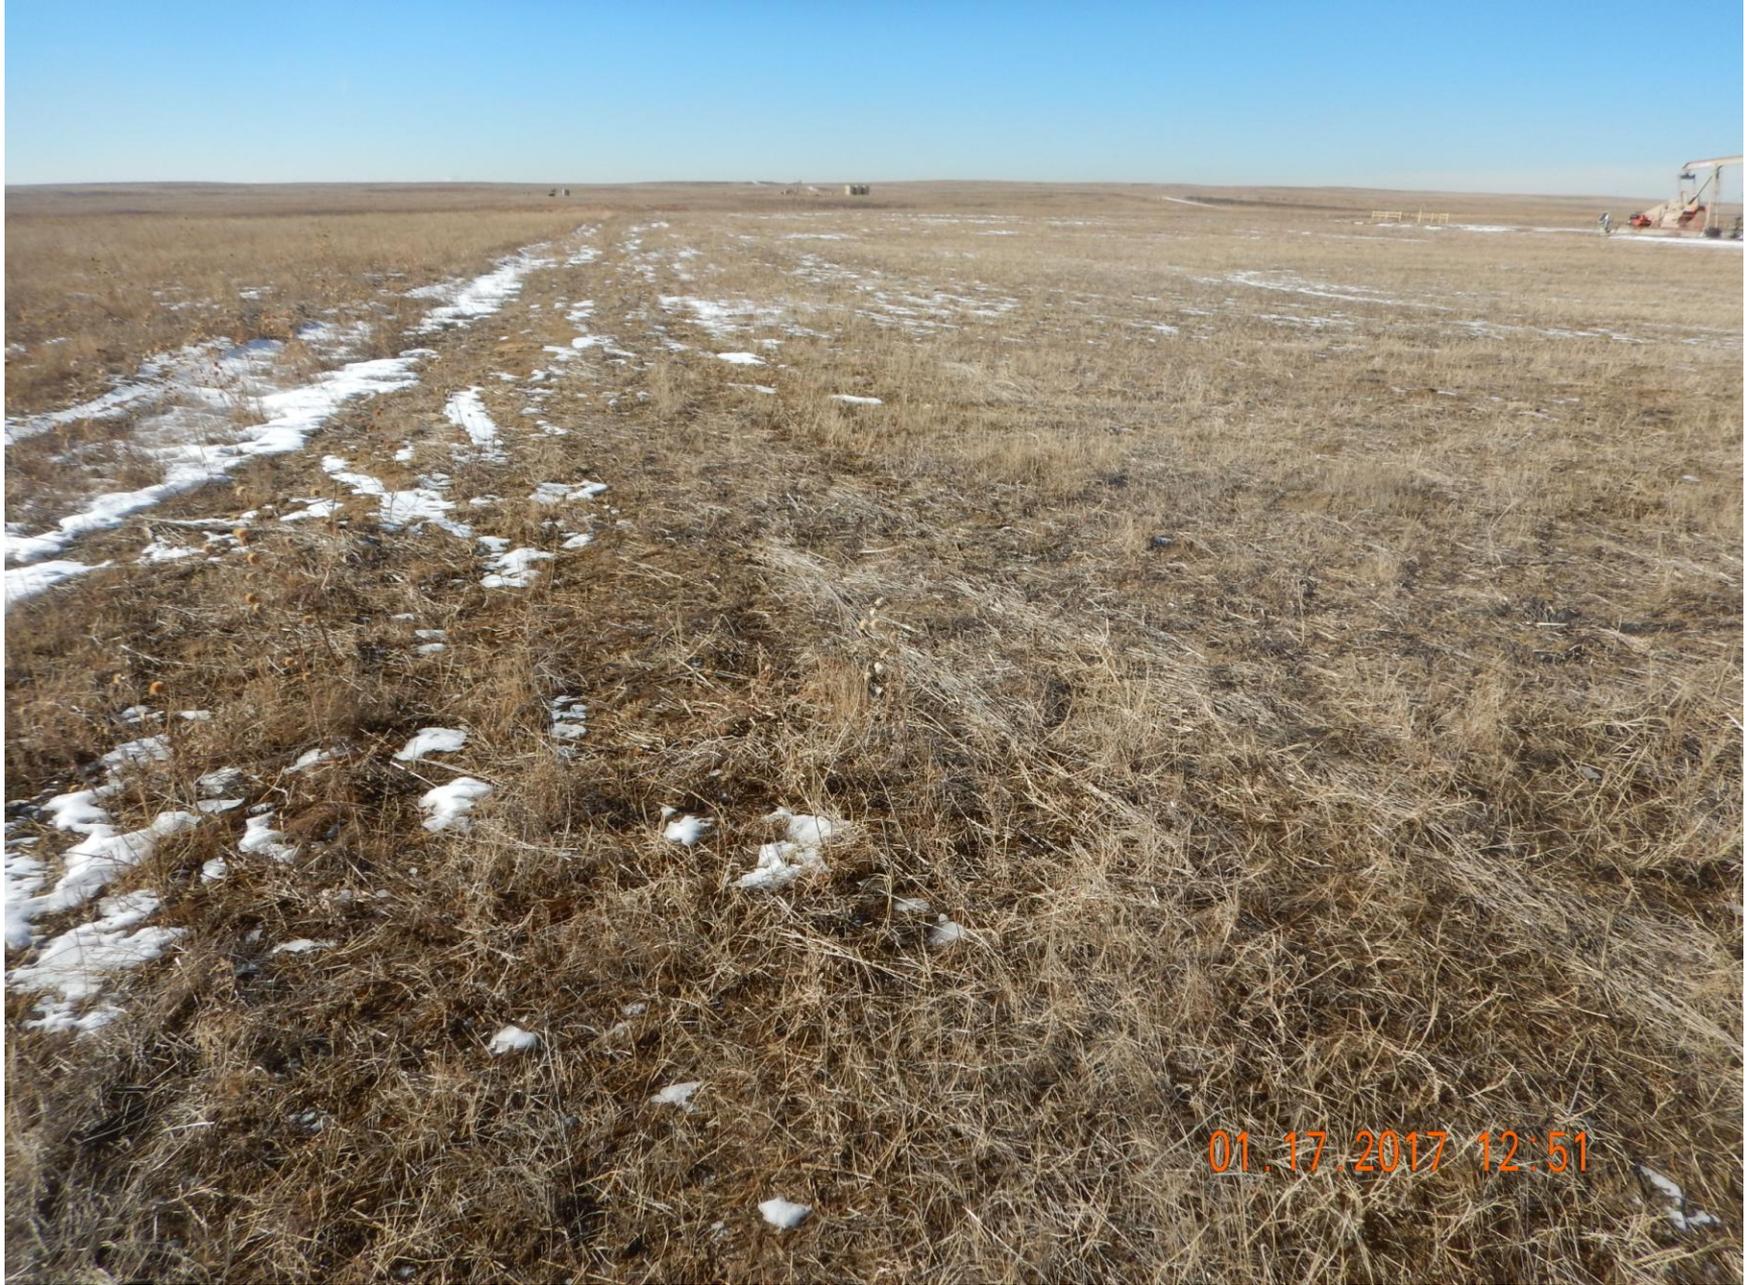
**Figure 13:** Photo taken from the southeast corner of the location, facing west. Photo shows interim and production areas.

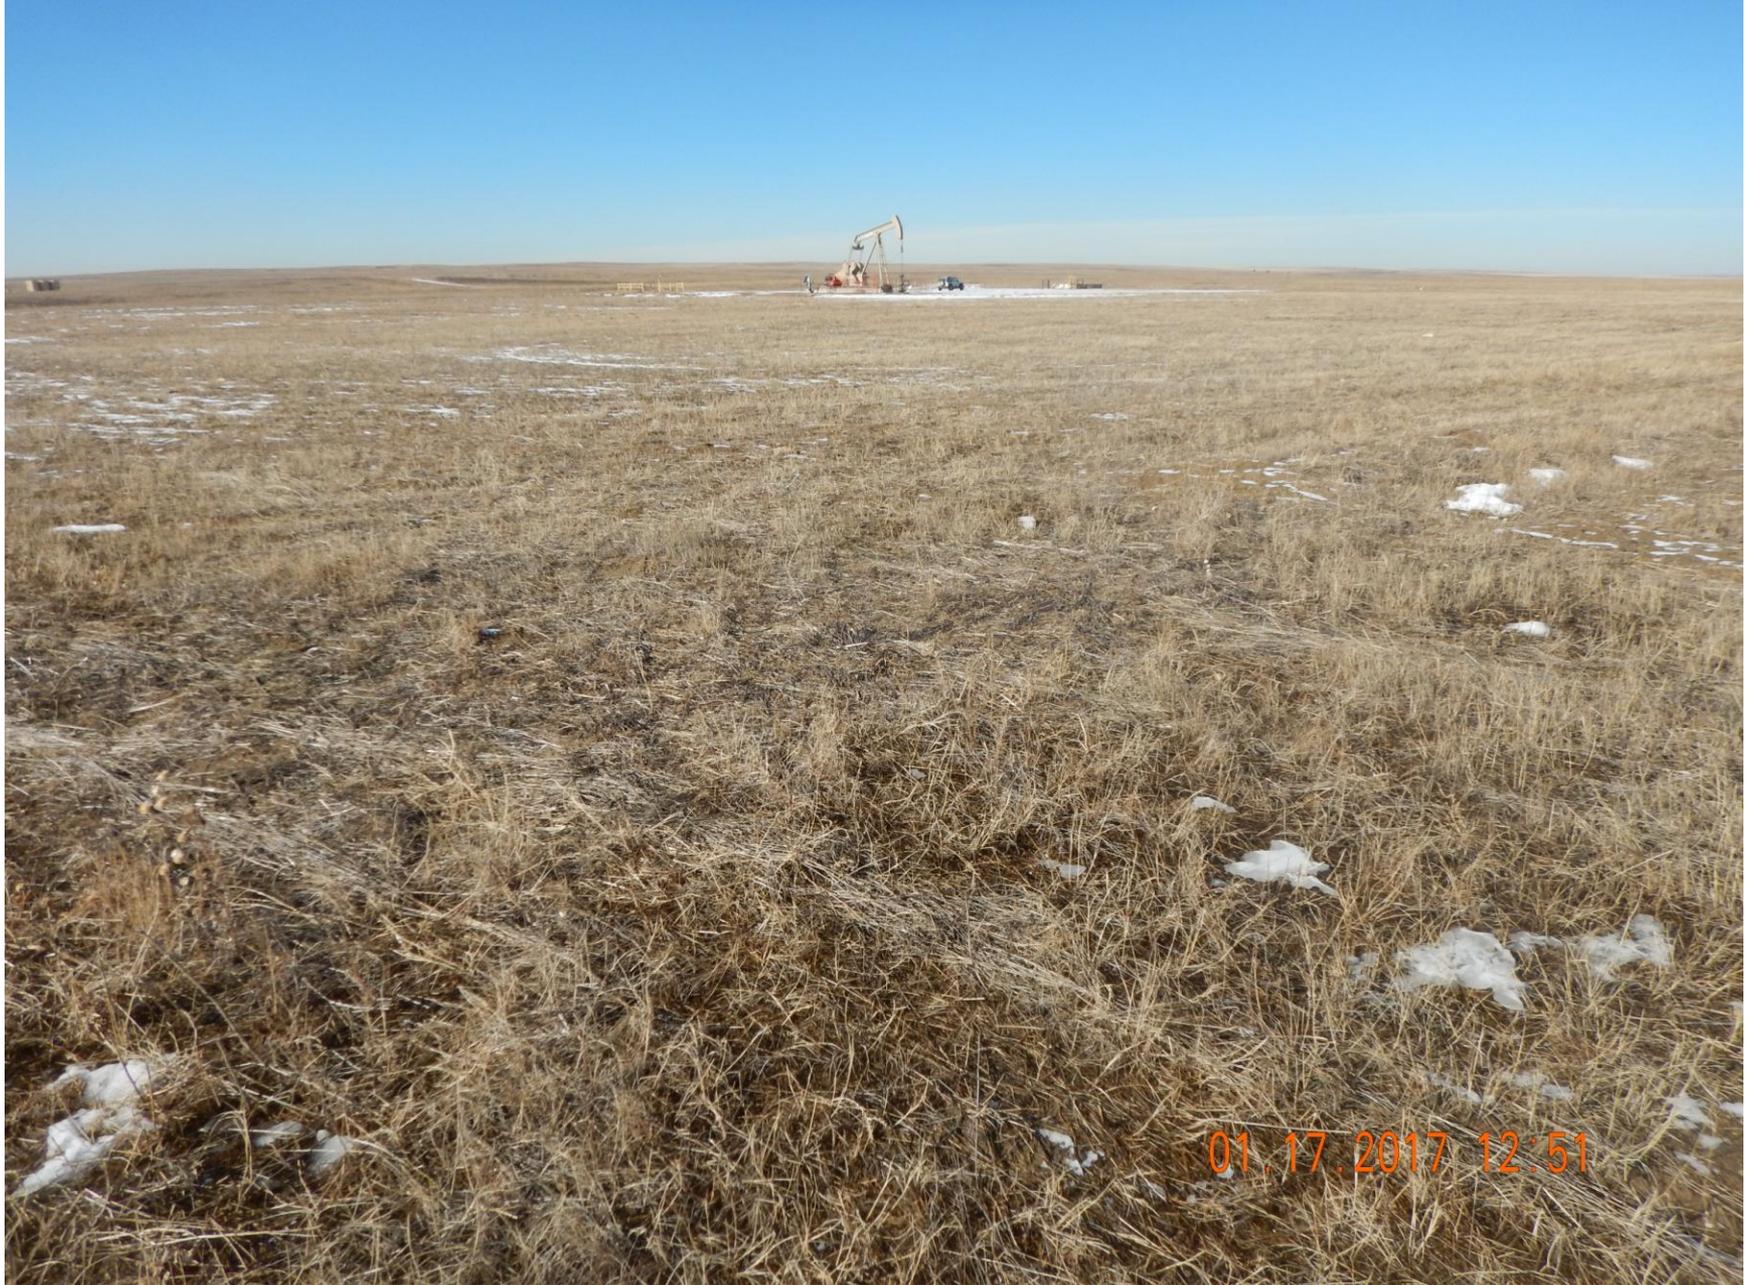
**Figure 14:** Photo taken from the southeast corner of the location, facing northwest. Photo shows interim and production areas.

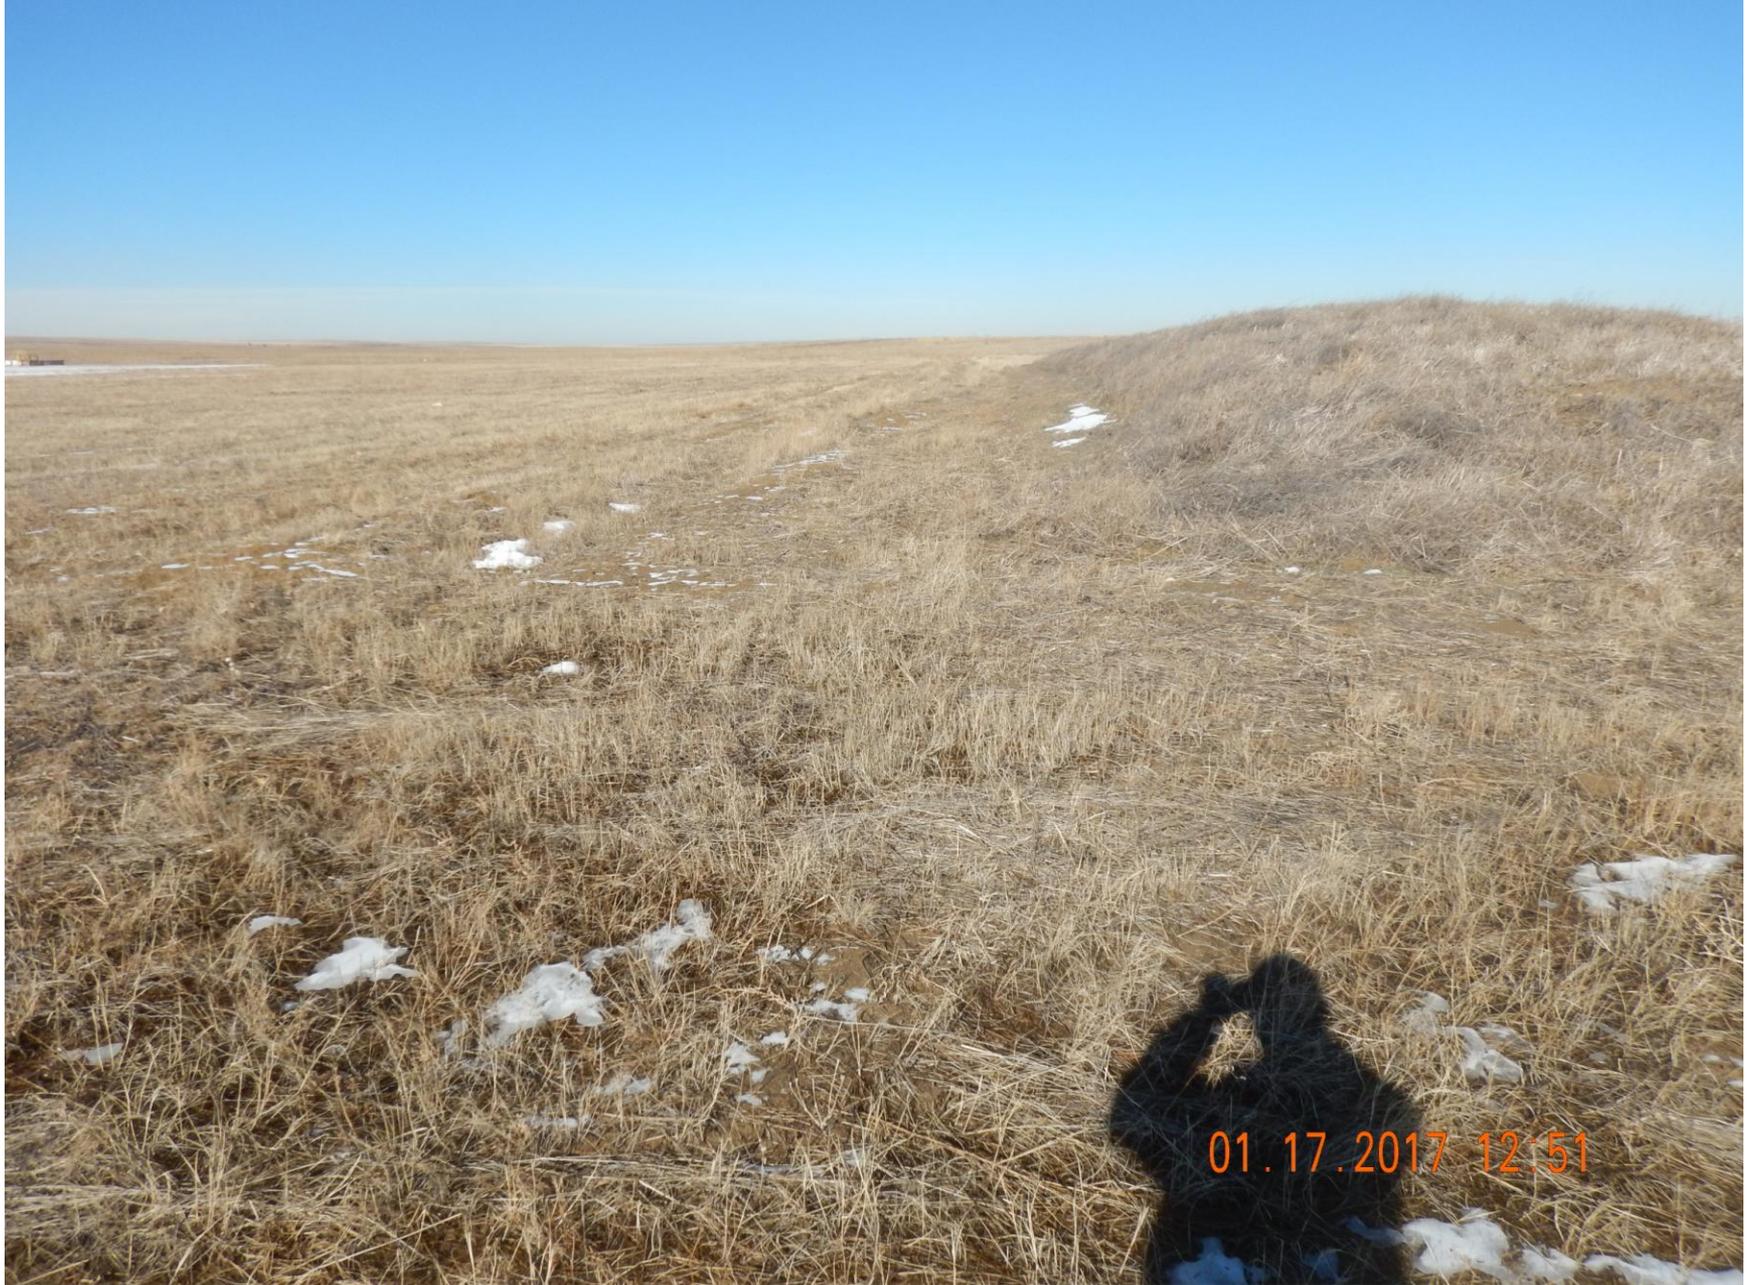
**Figure 15:** Photo taken from the southeast corner of the location, facing north. Photo shows interim areas.

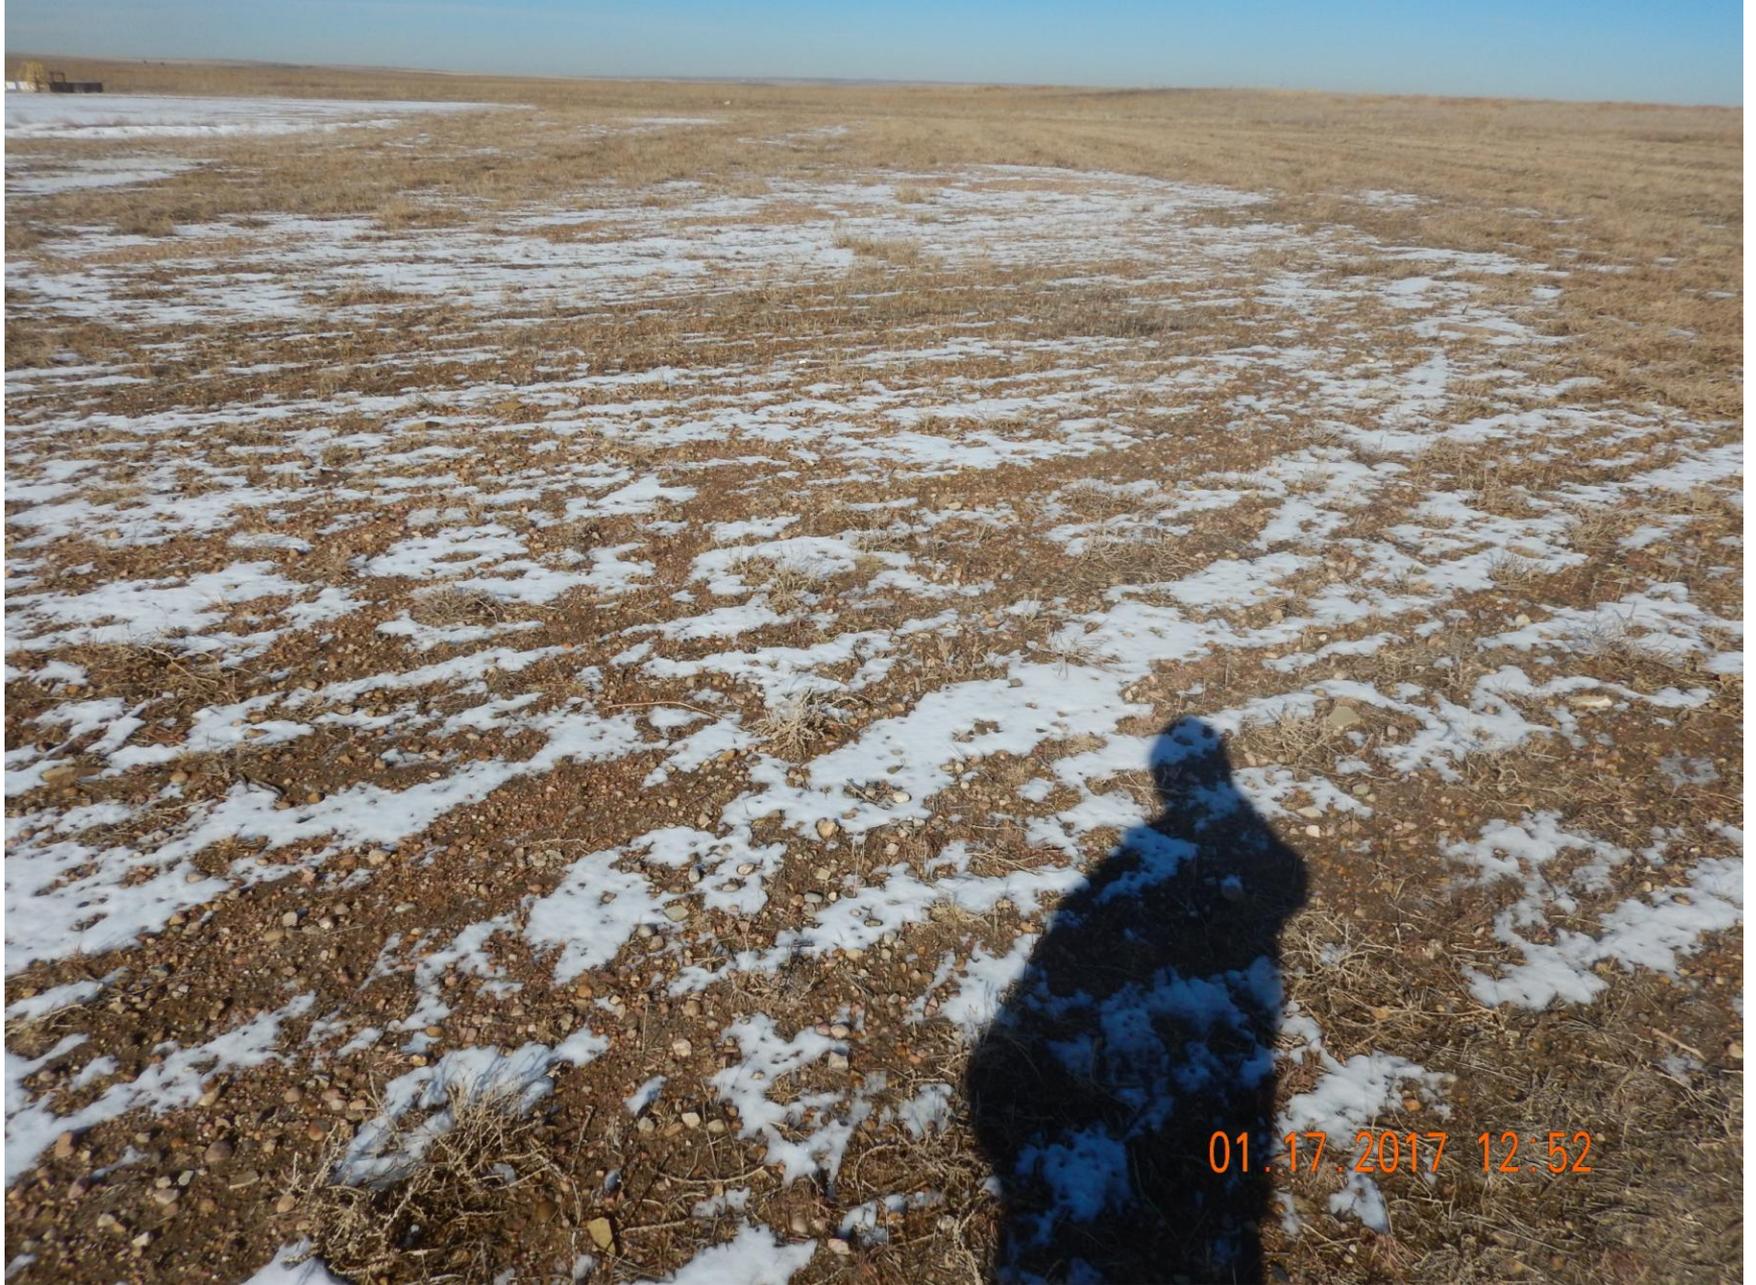
**Figure 16:** Photo taken from the interim area, east of the well, facing north. Photo shows large areas of the interim area where gravel remains and area remains unvegetated.

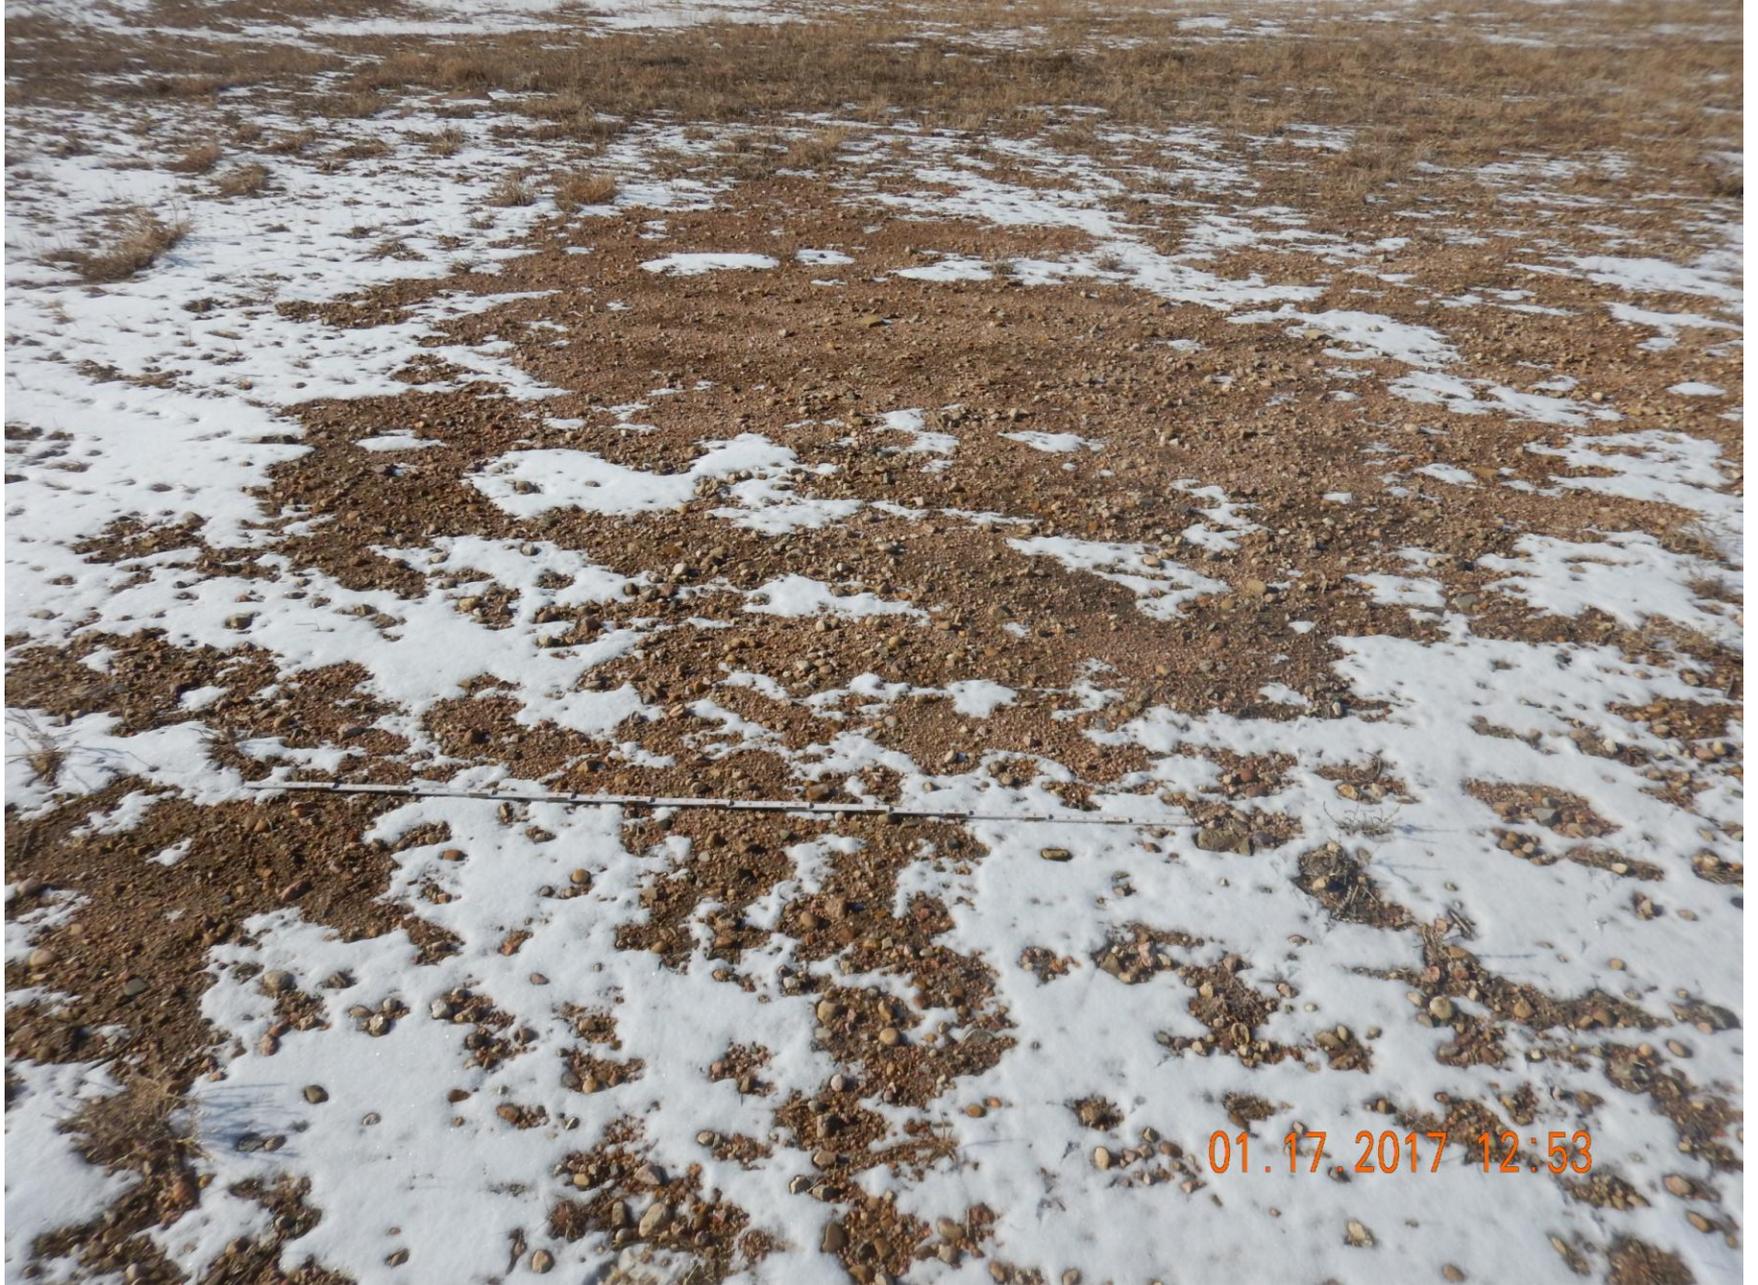
**Figure 17:** Photo taken from the interim area, east of the well. Photo shows large areas of the interim area where gravel remains and area remains unvegetated. 6 foot measuring stick for reference.

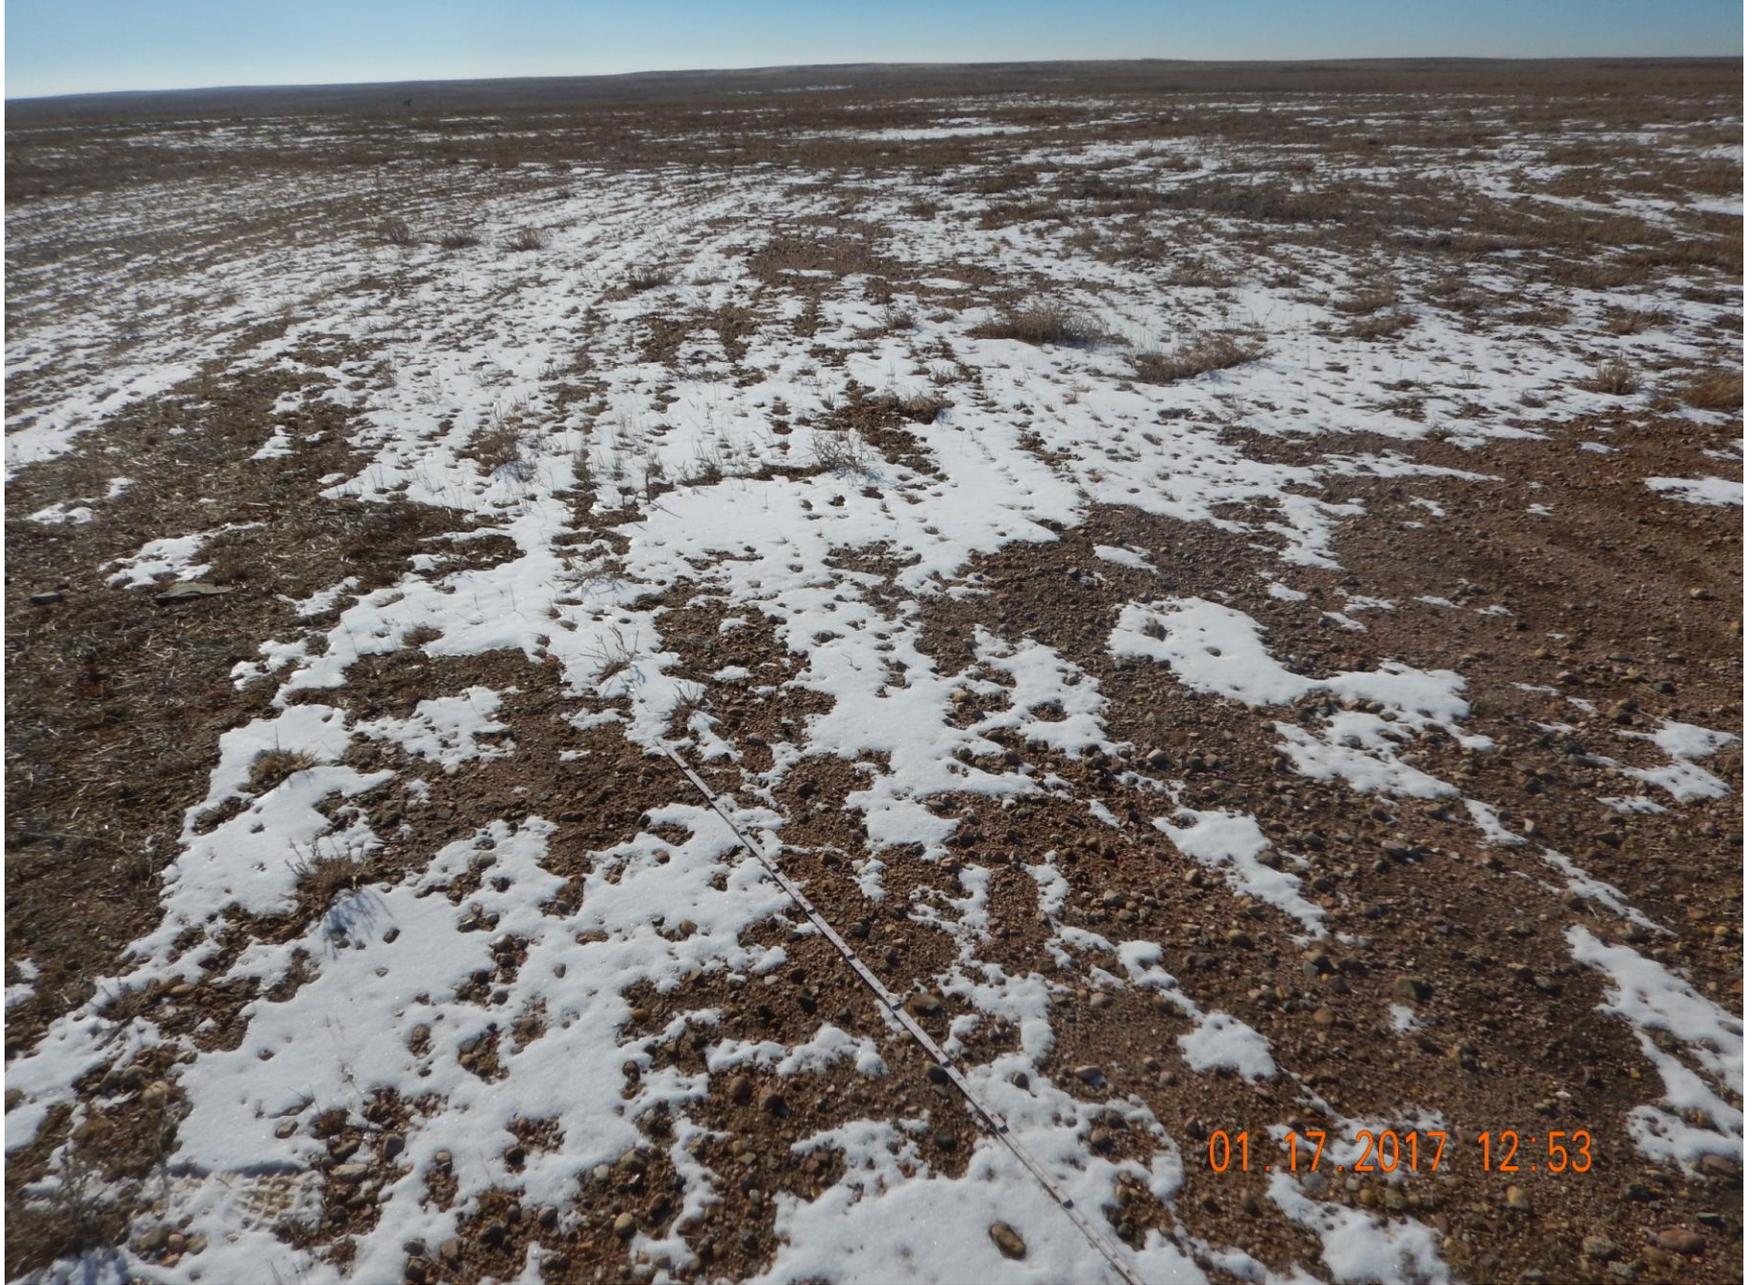
**Figure 18:** Photo taken from the interim area, east of the well. Photo shows large areas of the interim area where gravel remains and area remains unvegetated. 6 foot measuring stick for reference.

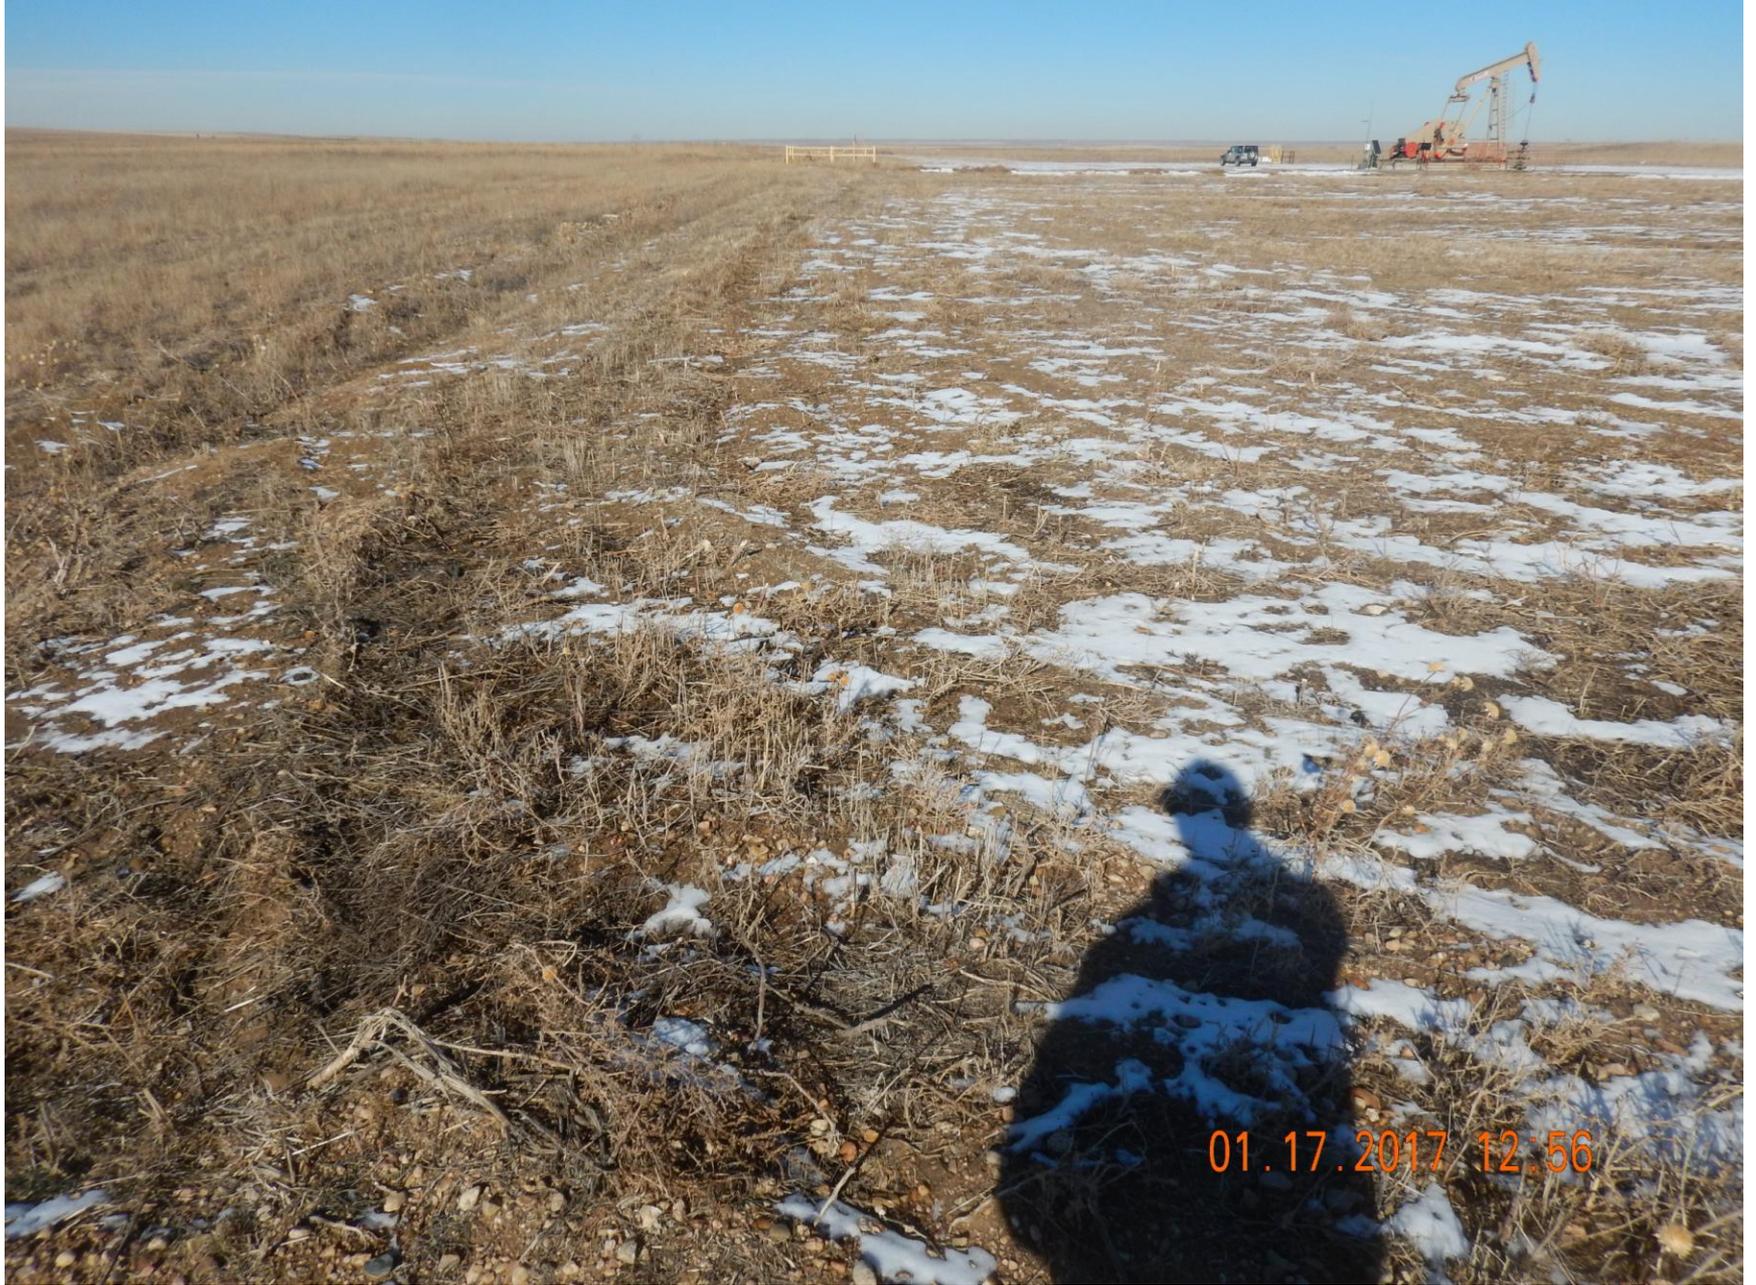
**Figure 19:** Photo taken from the southwest end of the location, facing north. Photo shows vegetation over the interim area.

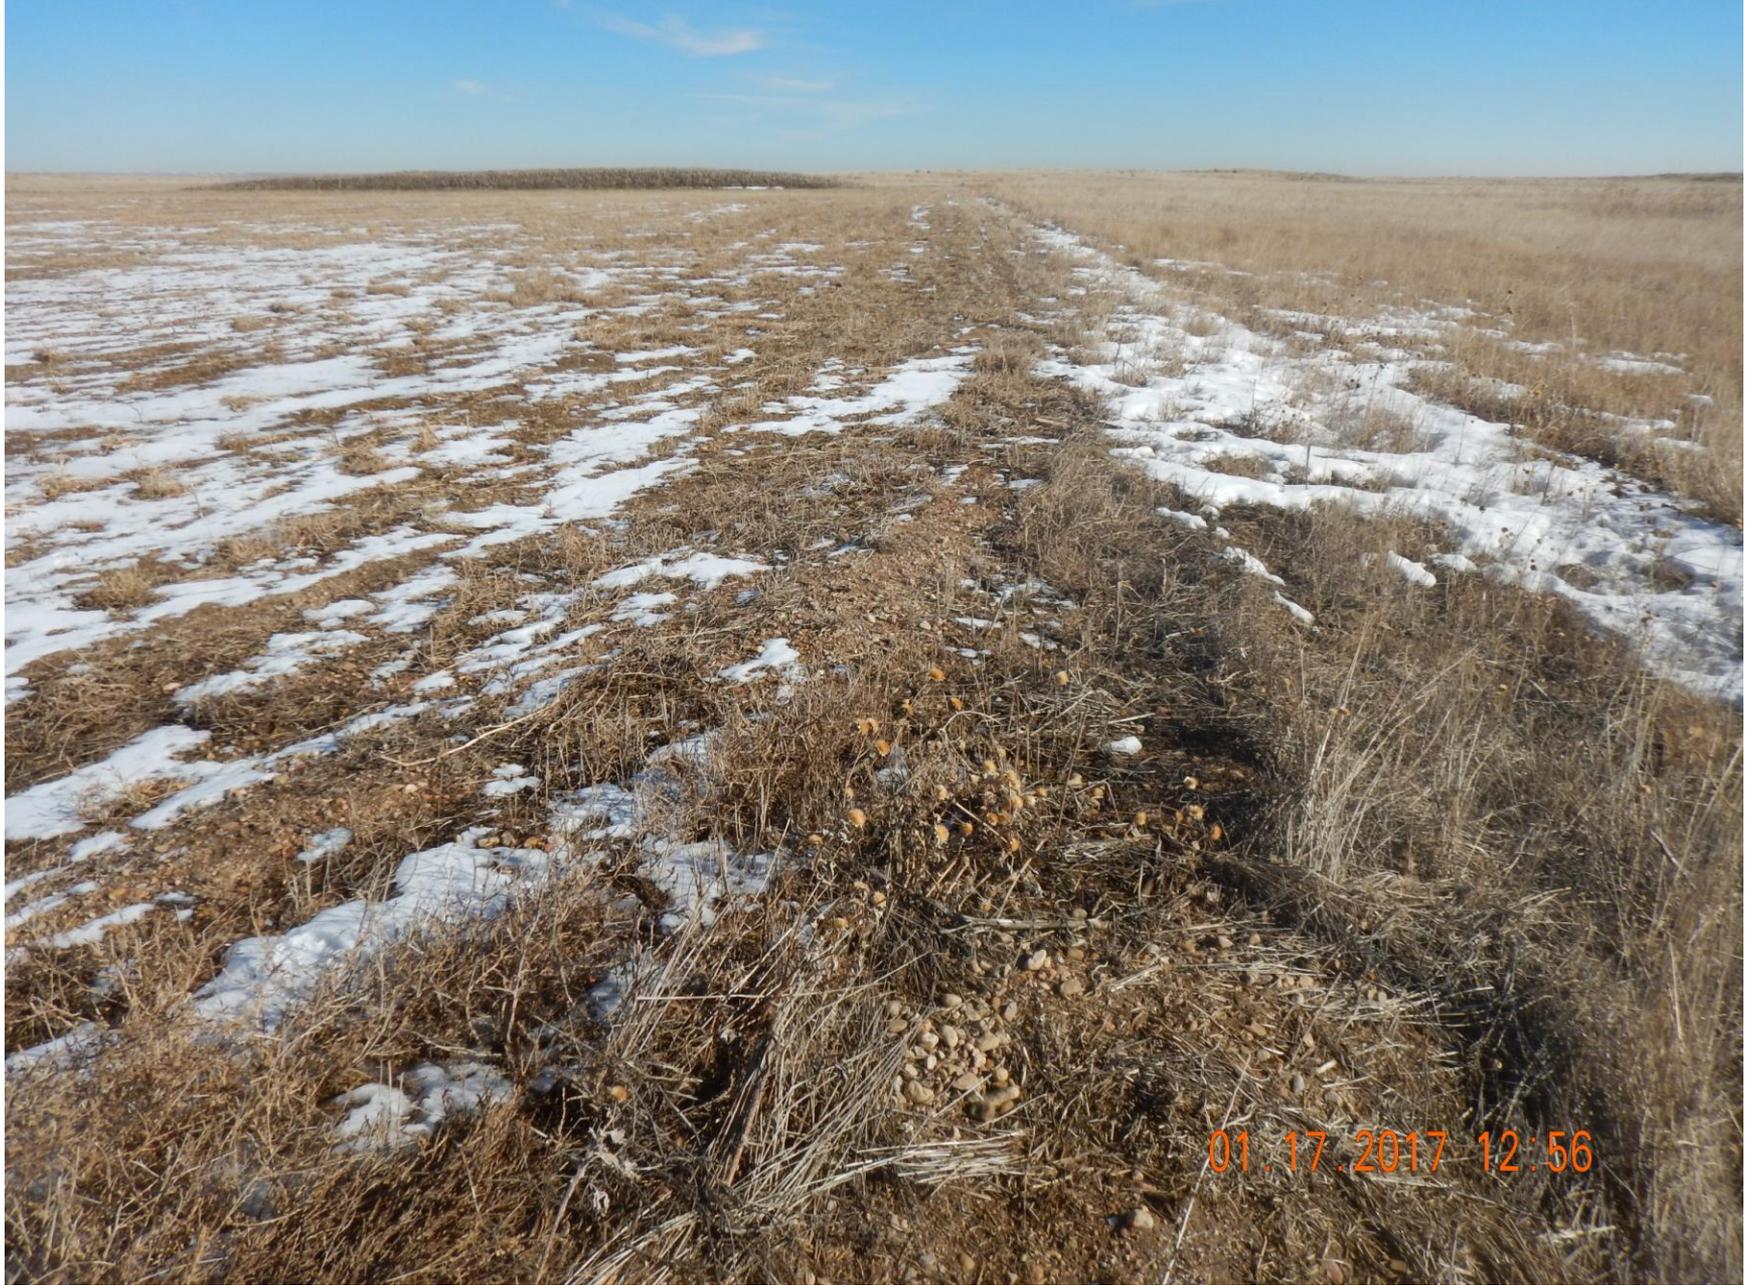
**Figure 20:** Photo taken from the southwest end of the location, facing east. Photo shows vegetation over the interim area.
