# Reclamation and Stormwater Inspection

01/18/2017

Operator: Bonanza Creek #8960

Location ID: 437240

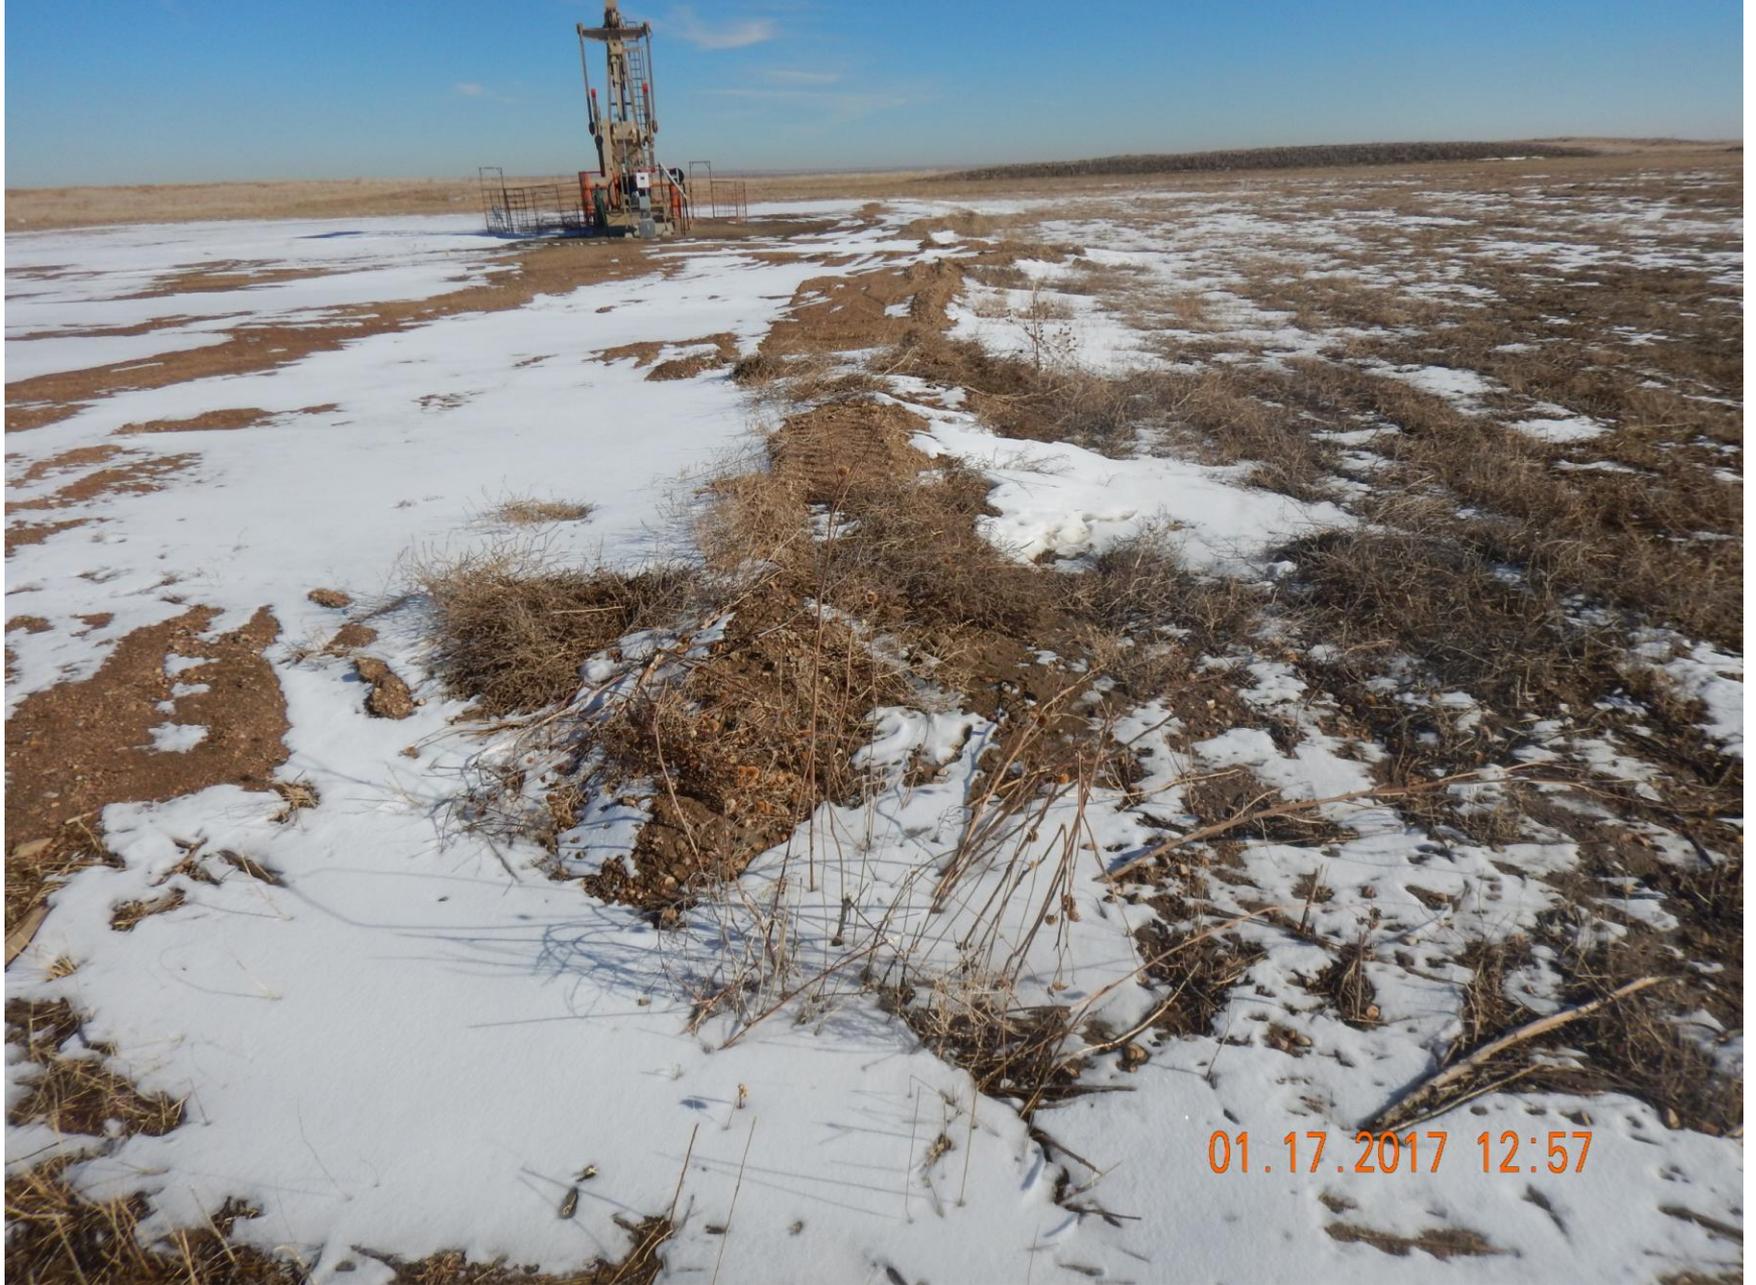
**Figure 21:** Photo taken from the southwest end of the production area, facing east. Photo shows where the production area ends and where the interim area begins on the south end of the location.
