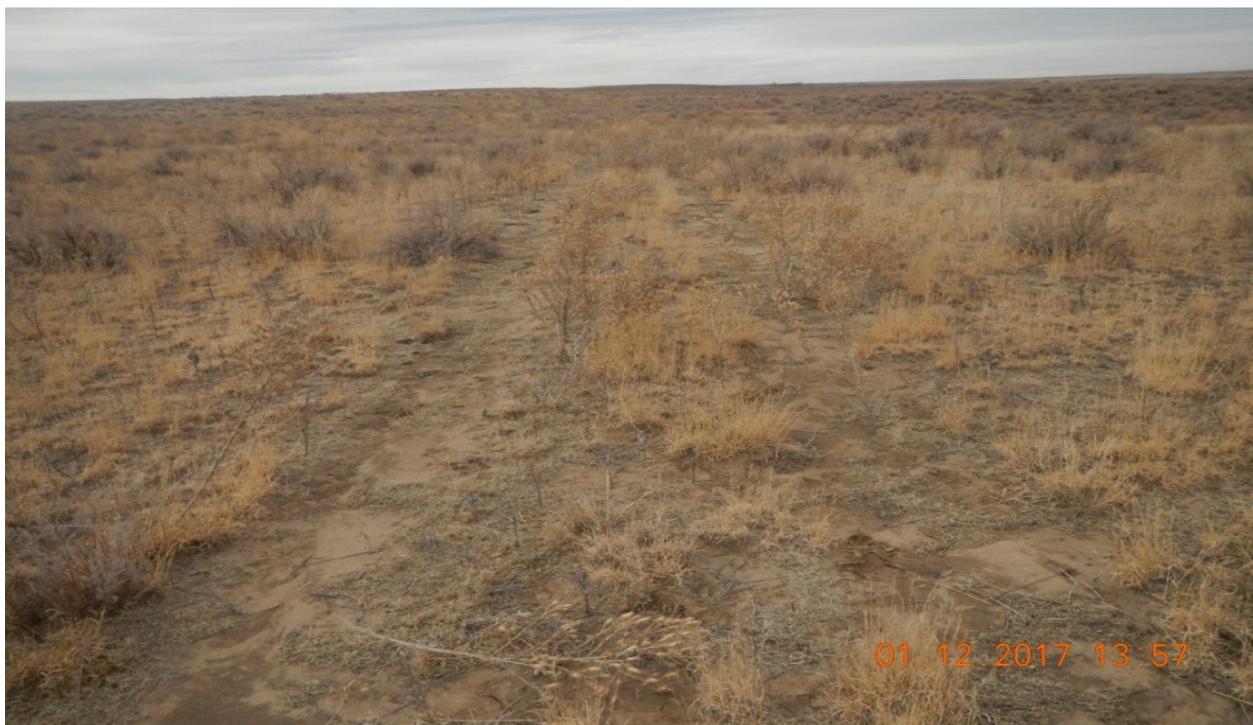
**photo 1:** Facing west along the former access road.

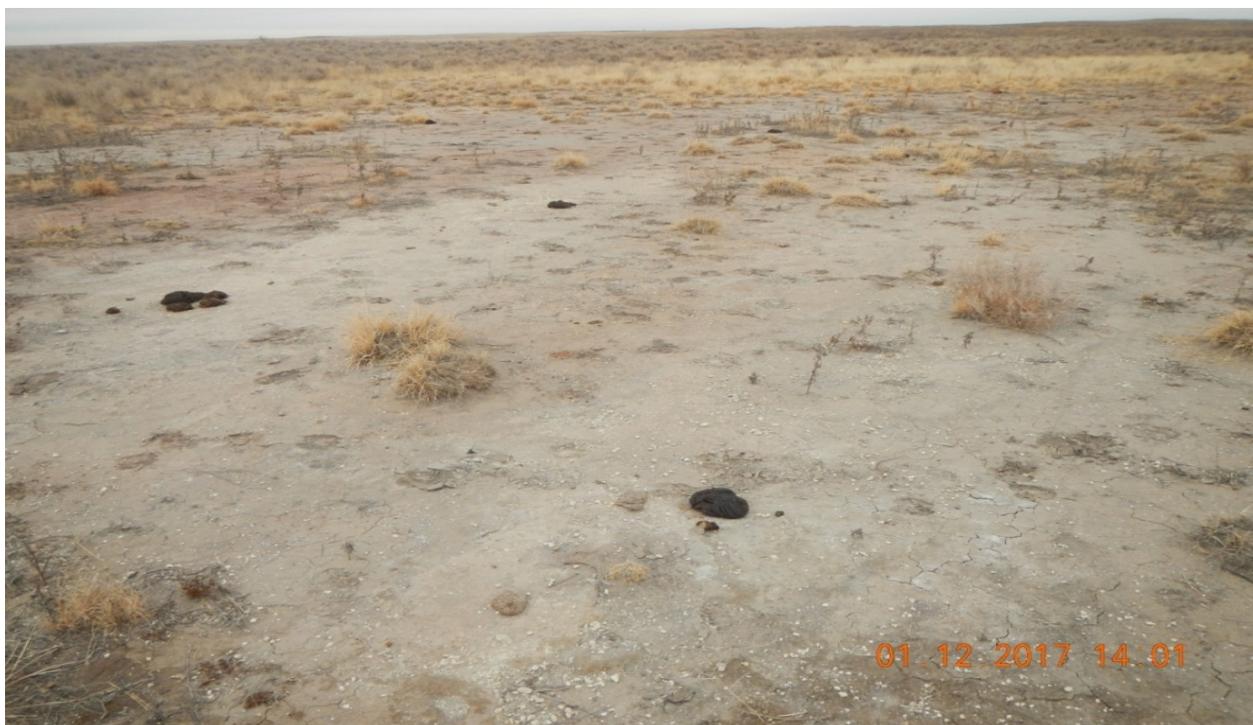
**photo 2:** Facing north toward the location. The vegetation has not adequately established in this area.

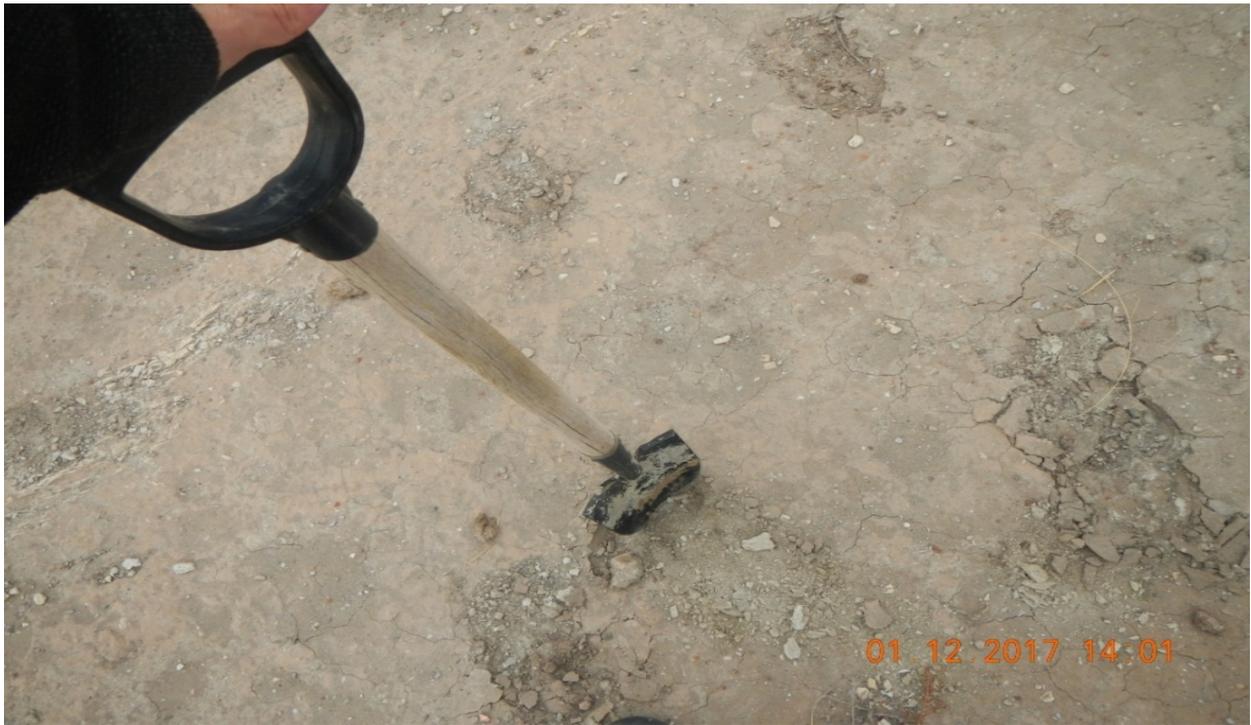
**photo 3:** The soils seemed to be compacted.

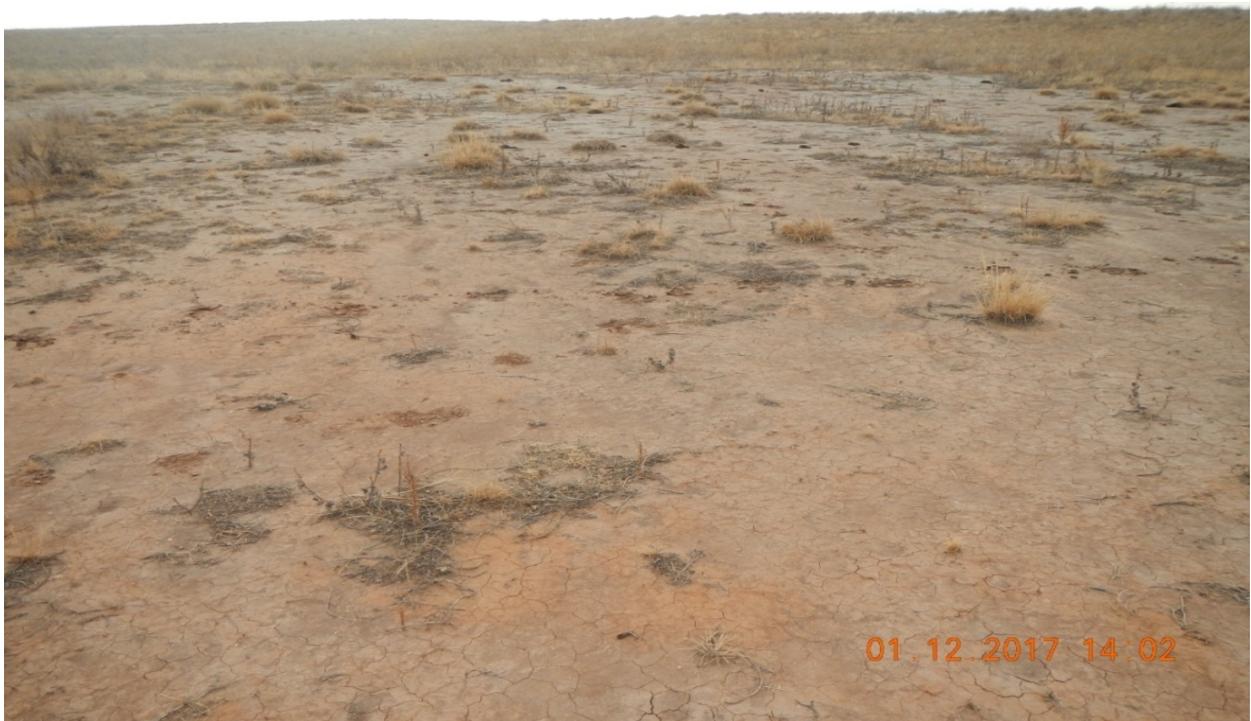
**photo 4:** South side of the location facing north. The vegetation has not adequately established in this area.
