Interim Reclamation and Stormwater Inspection- Overview

Interim Reclamation and Stormwater Inspection

COLORADO
Oil & Gas Conservation
Commission
Department of Natural Resources

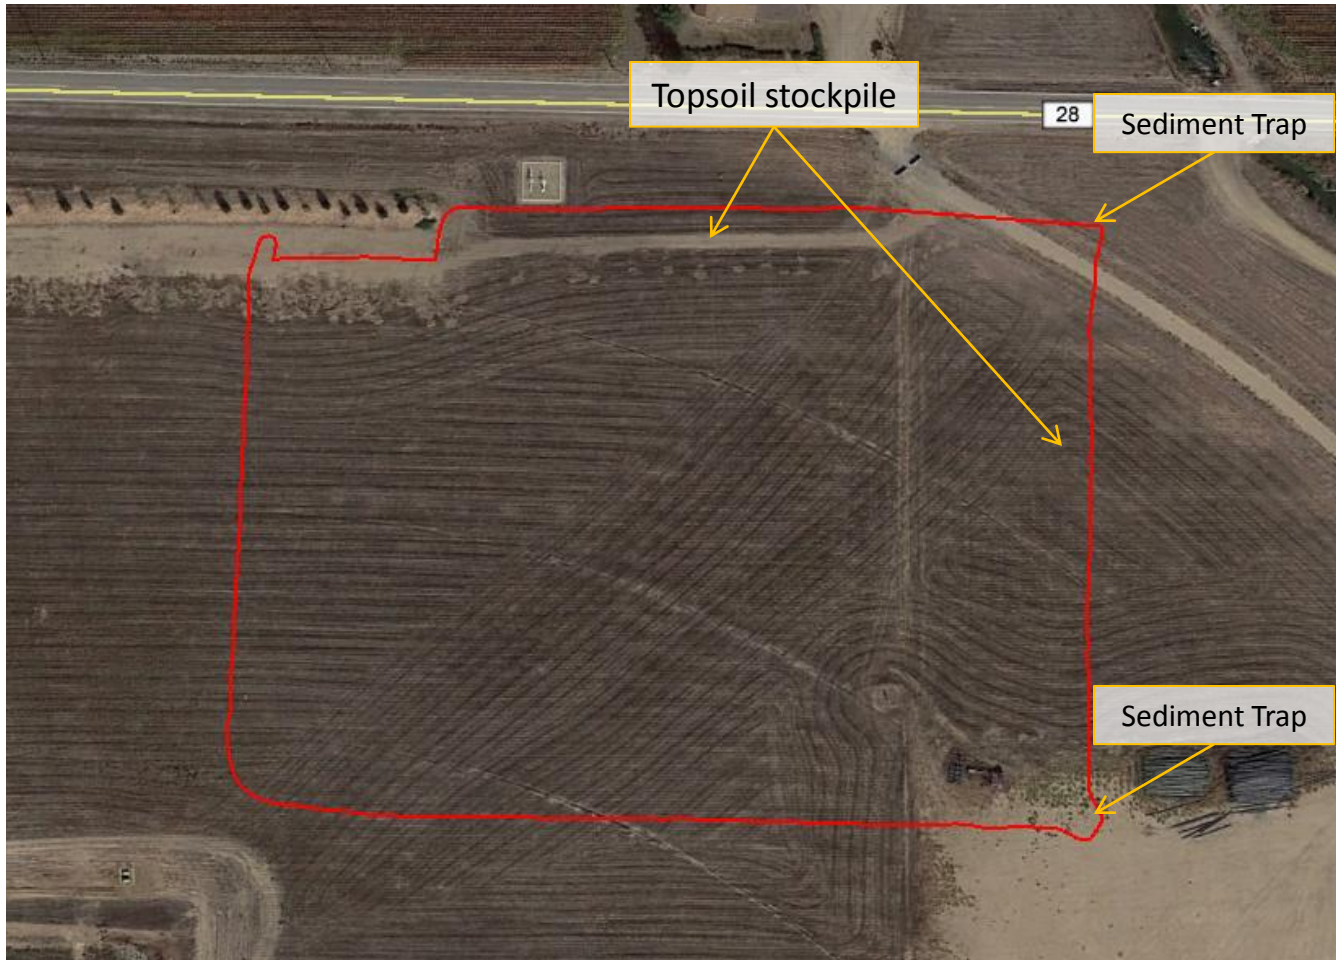
Google Earth aerial photo taken 10/9/2015 of the BBKB 37N-35HZ location. An area of 7.54 acres was mapped on 1/13/2017 using a Trimble Juno 3B handheld device. Perimeter of the area mapped and highlighted in red. Topsoil stockpile stored along the northern and eastern perimeter of location. Ditch and berm BMP installed along entire perimeter with two (2) sediment traps installed at the northeast and southeast corner of location.

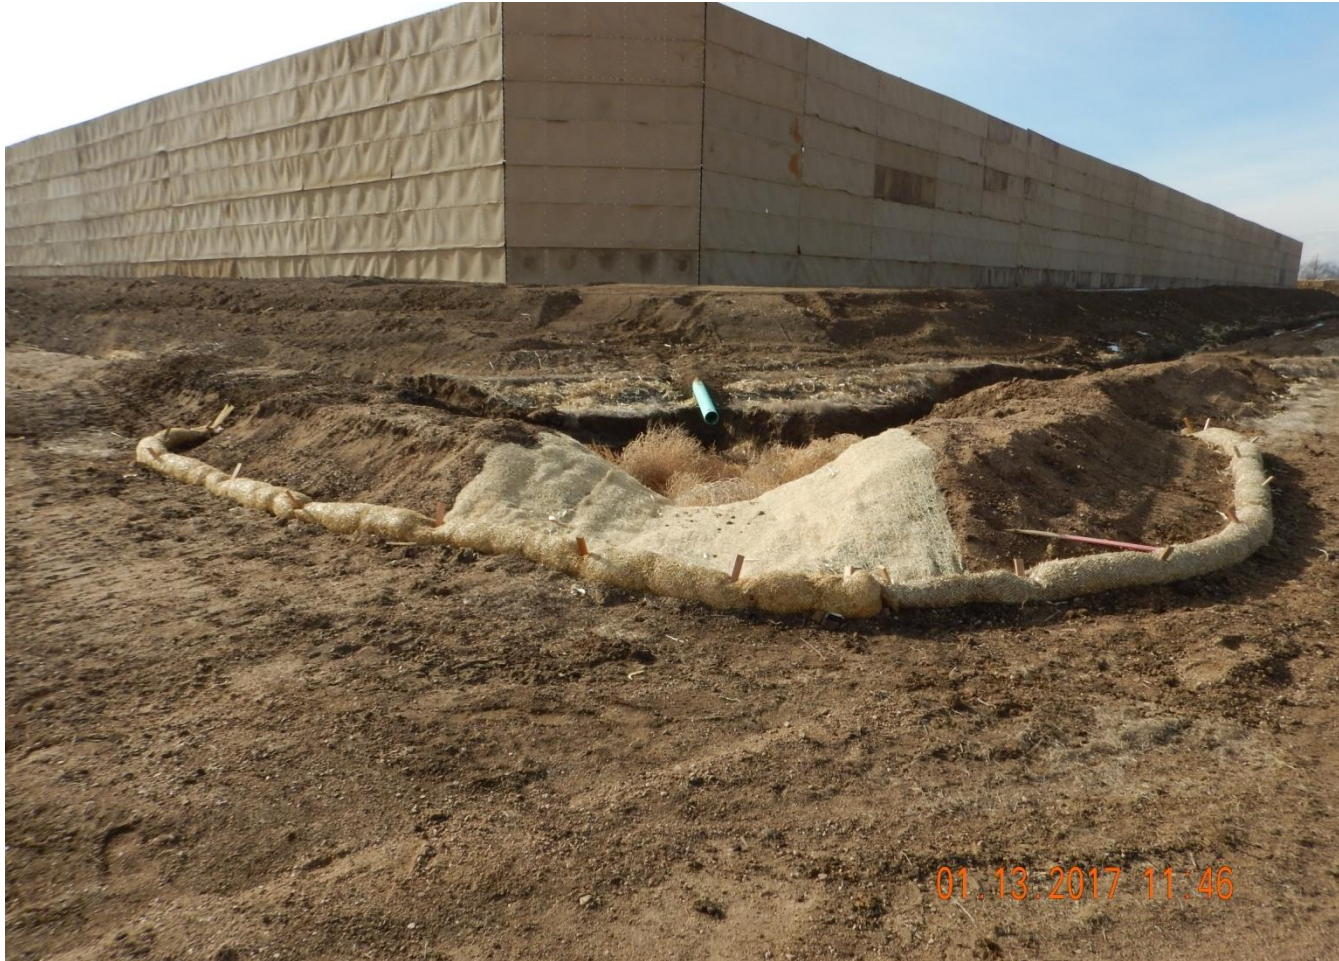
Photo 1. Photo taken from the northeast location, facing Southwest, towards the sediment trap.

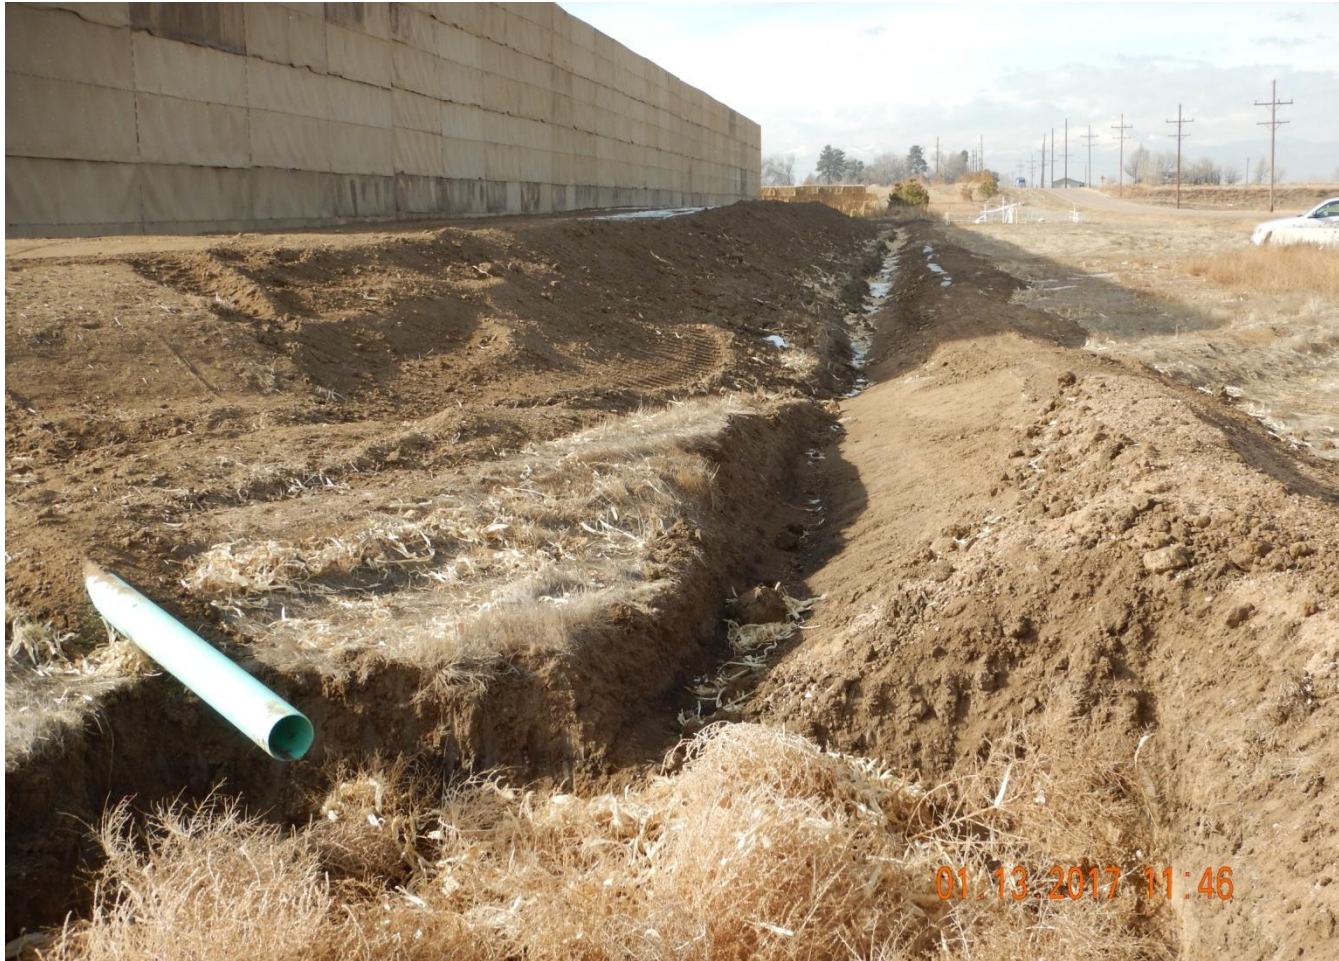
Photo 2. Photo taken from the northeast location, facing West. Ditch and berm installed around the entire perimeter of the location. Also, topsoil stockpile stored along northern and eastern perimeter of location.

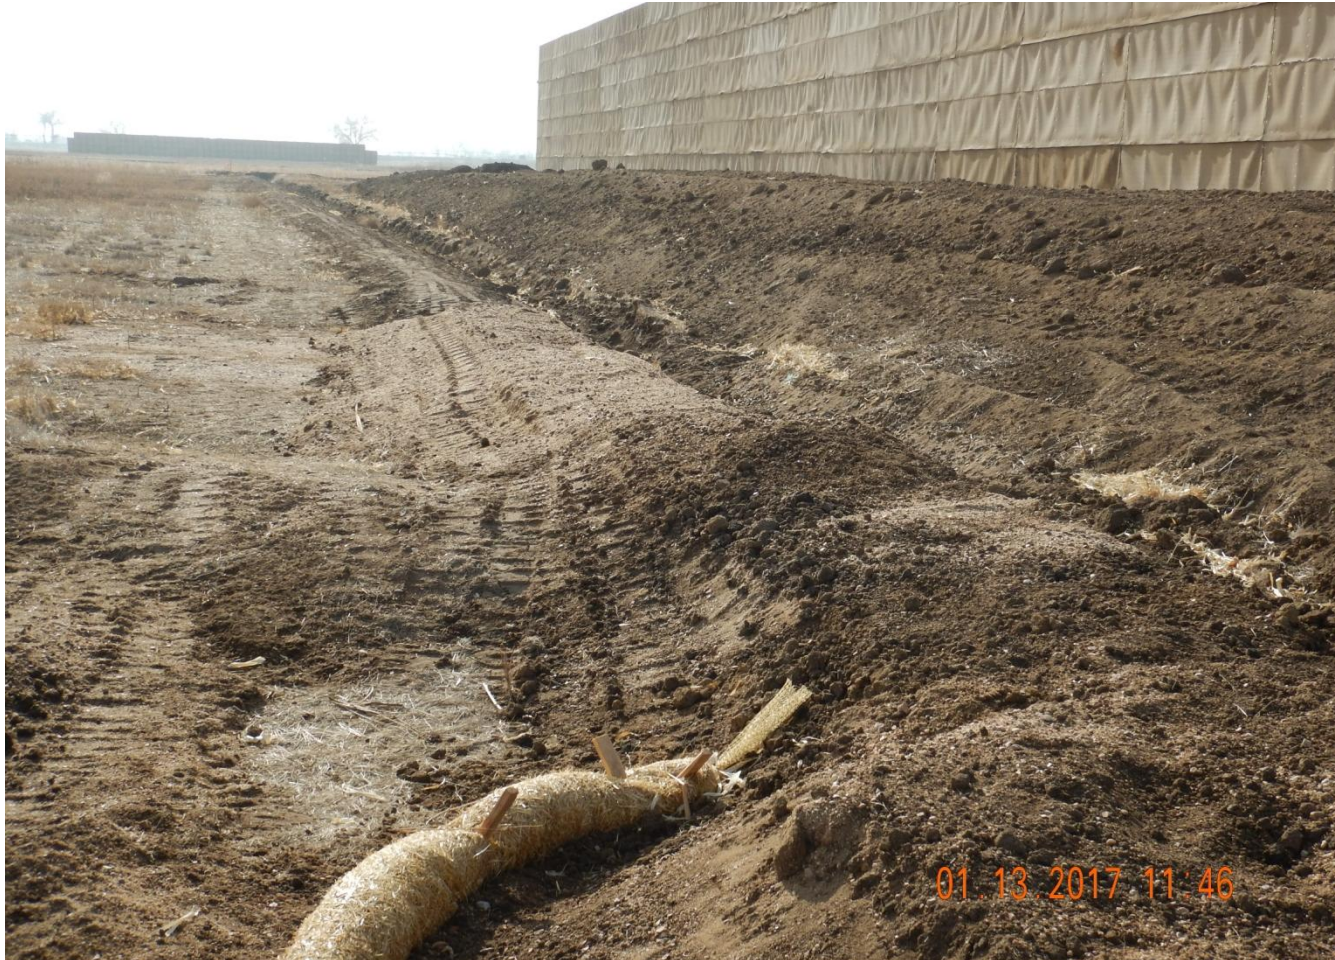
Photo 3. Photo taken from the northeast location, facing South. Ditch and berm installed around the entire perimeter of the location. Also, topsoil stockpile stored along eastern and northern perimeter of location.

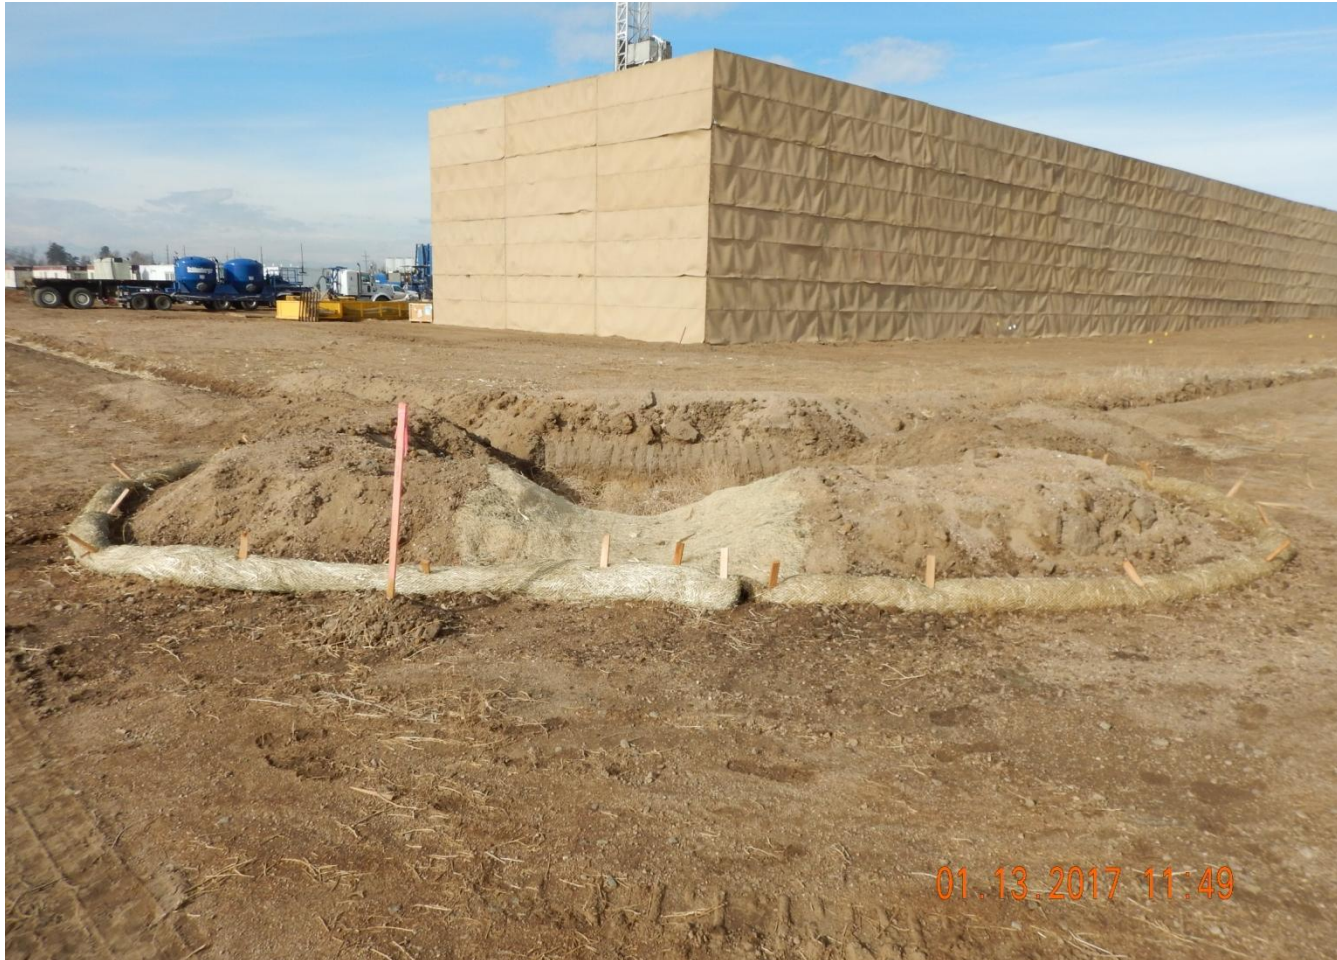
Photo 4. Photo taken from the southeast location, facing Northwest, towards the sediment trap.

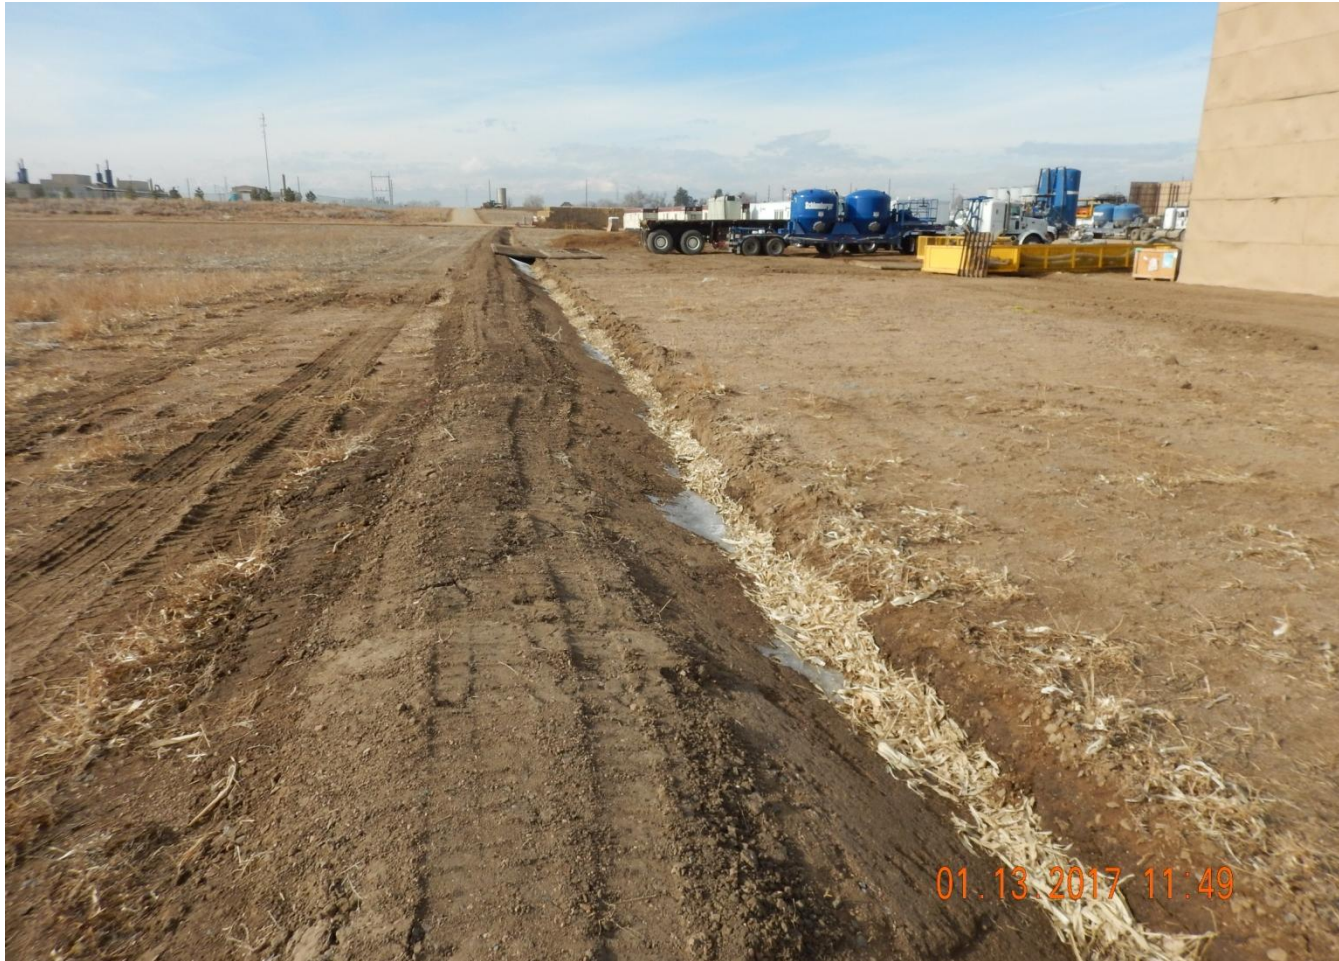
Photo 5. Photo taken from the southeast location, facing West. Ditch and berm installed around the entire perimeter of the location.

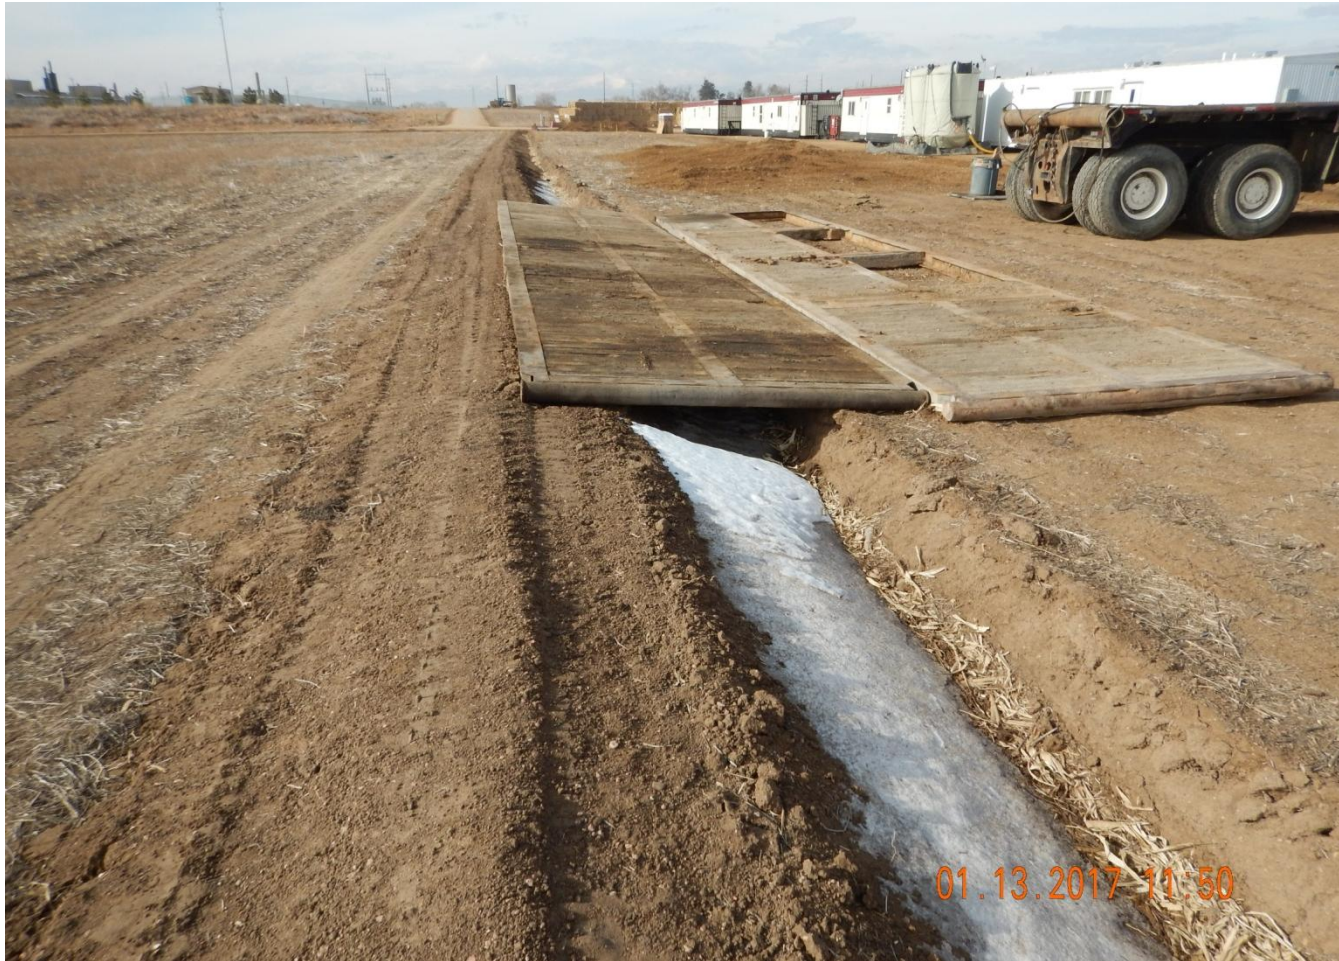
Photo 6. Photo taken from the southern location, facing West. Operator using ramps to access location with equipment to mitigate impacts to stormwater BMPs.

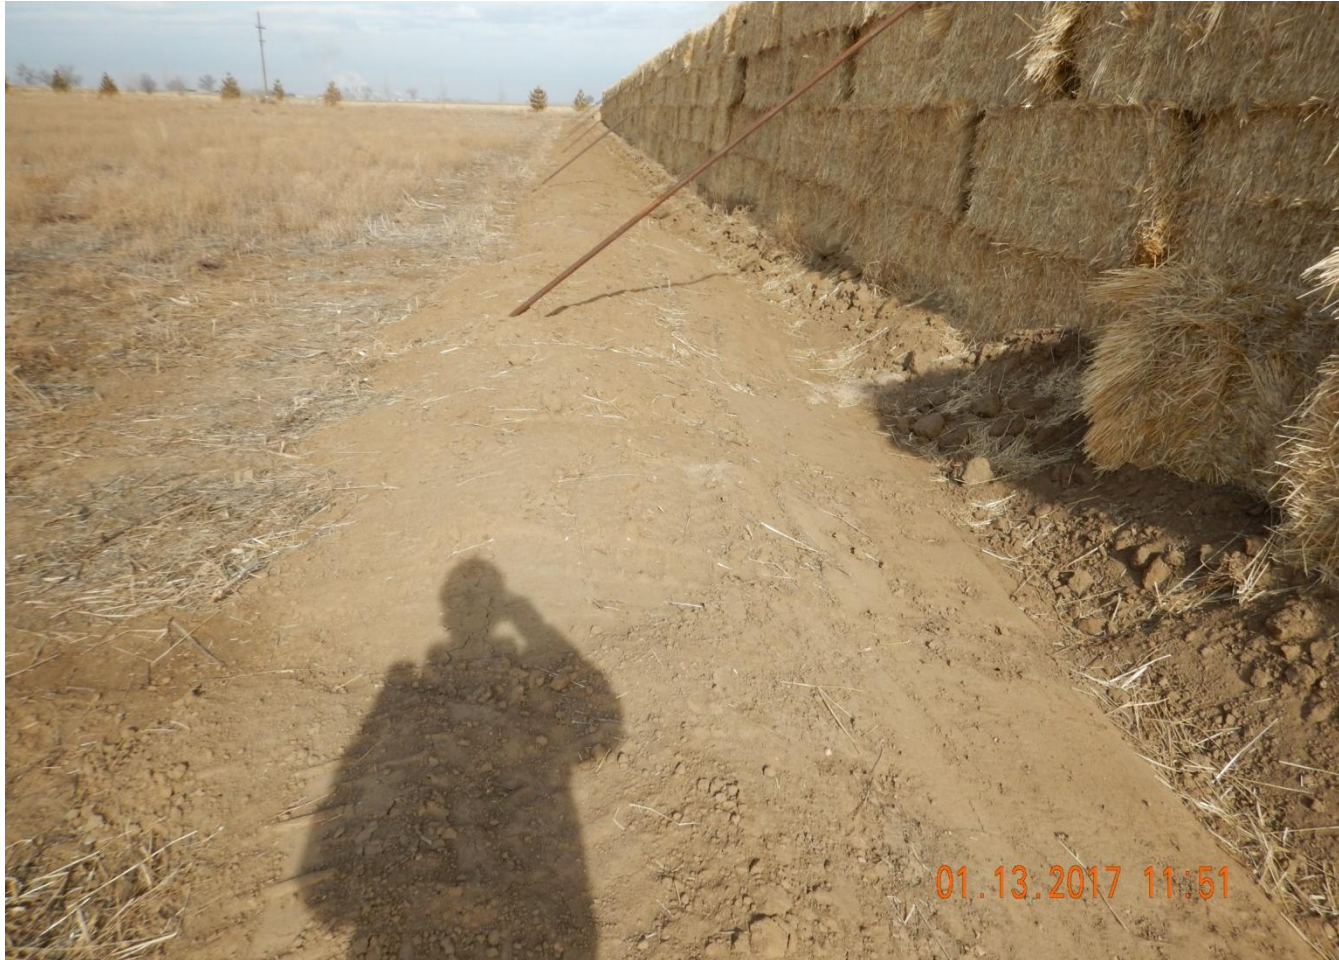
Photo 7. Photo taken from the southwest location, facing North. Ditch and berm installed around the entire perimeter of the location.

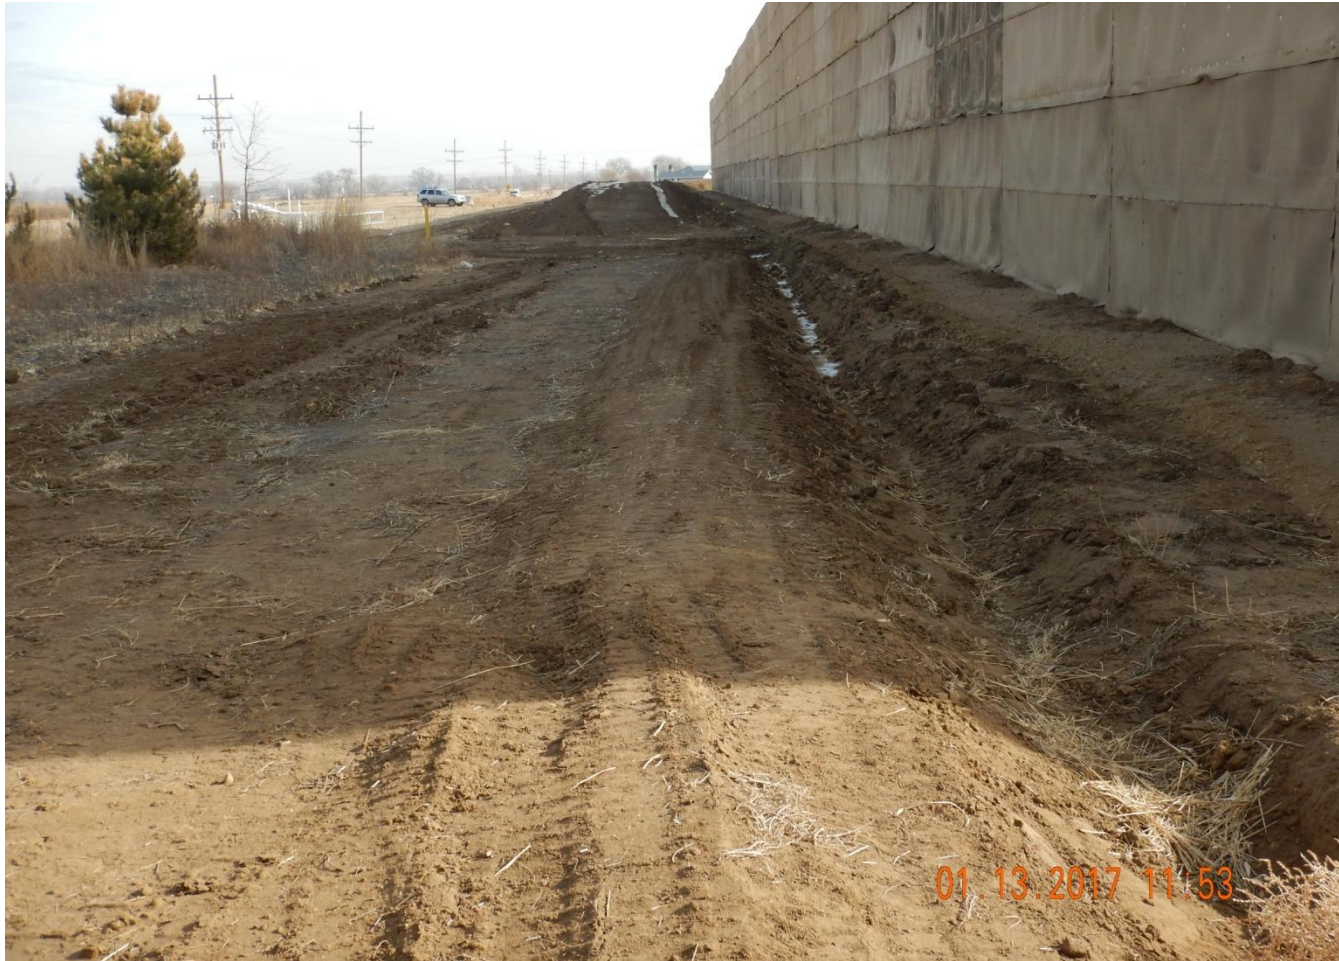
Photo 8. Photo taken from the northwest location, facing East. Ditch and berm installed around the entire perimeter of the location.
