Reclamation Inspection

01/19/2017

Operator: Burlington Resources/ConocoPhillips

Location ID: 436726

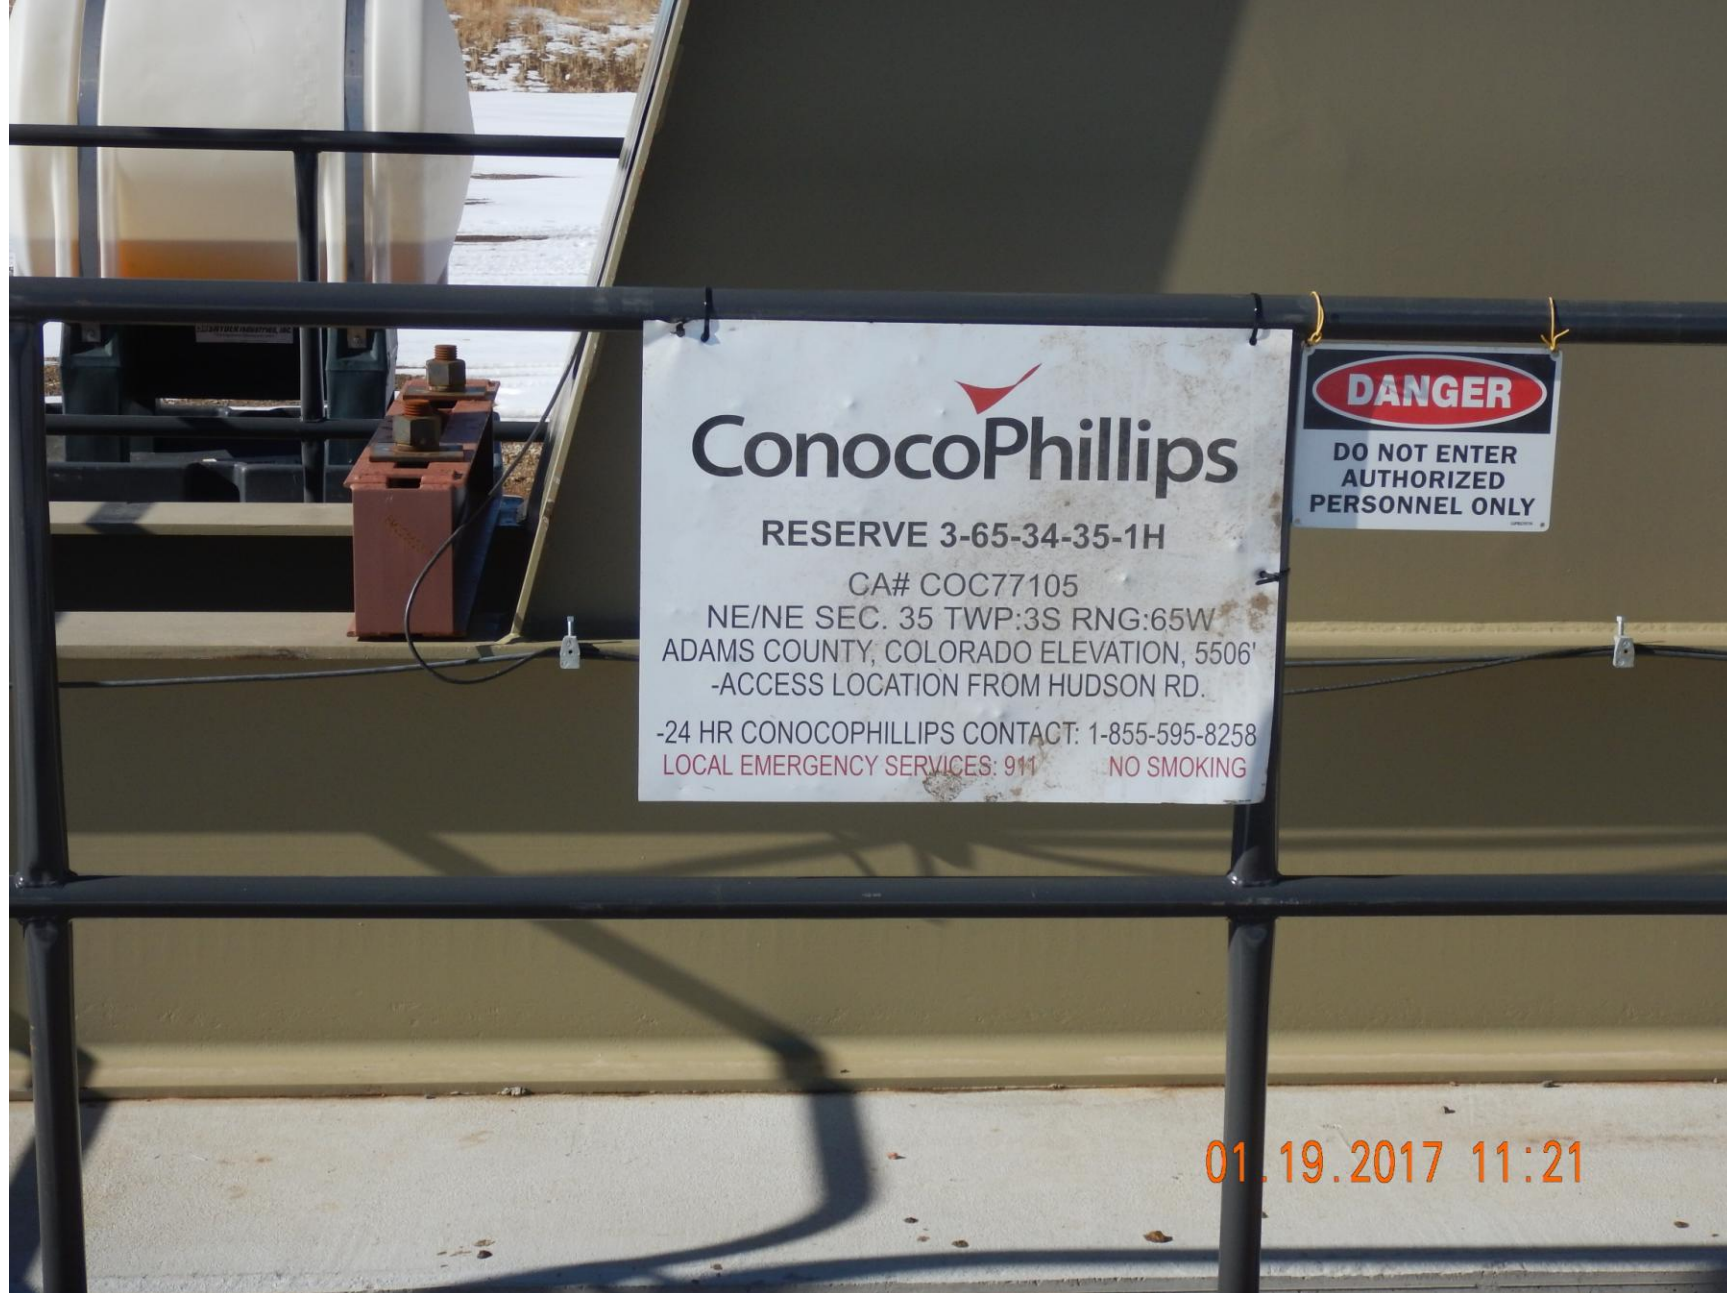
Figure 1: Photo of sign at pump jack.

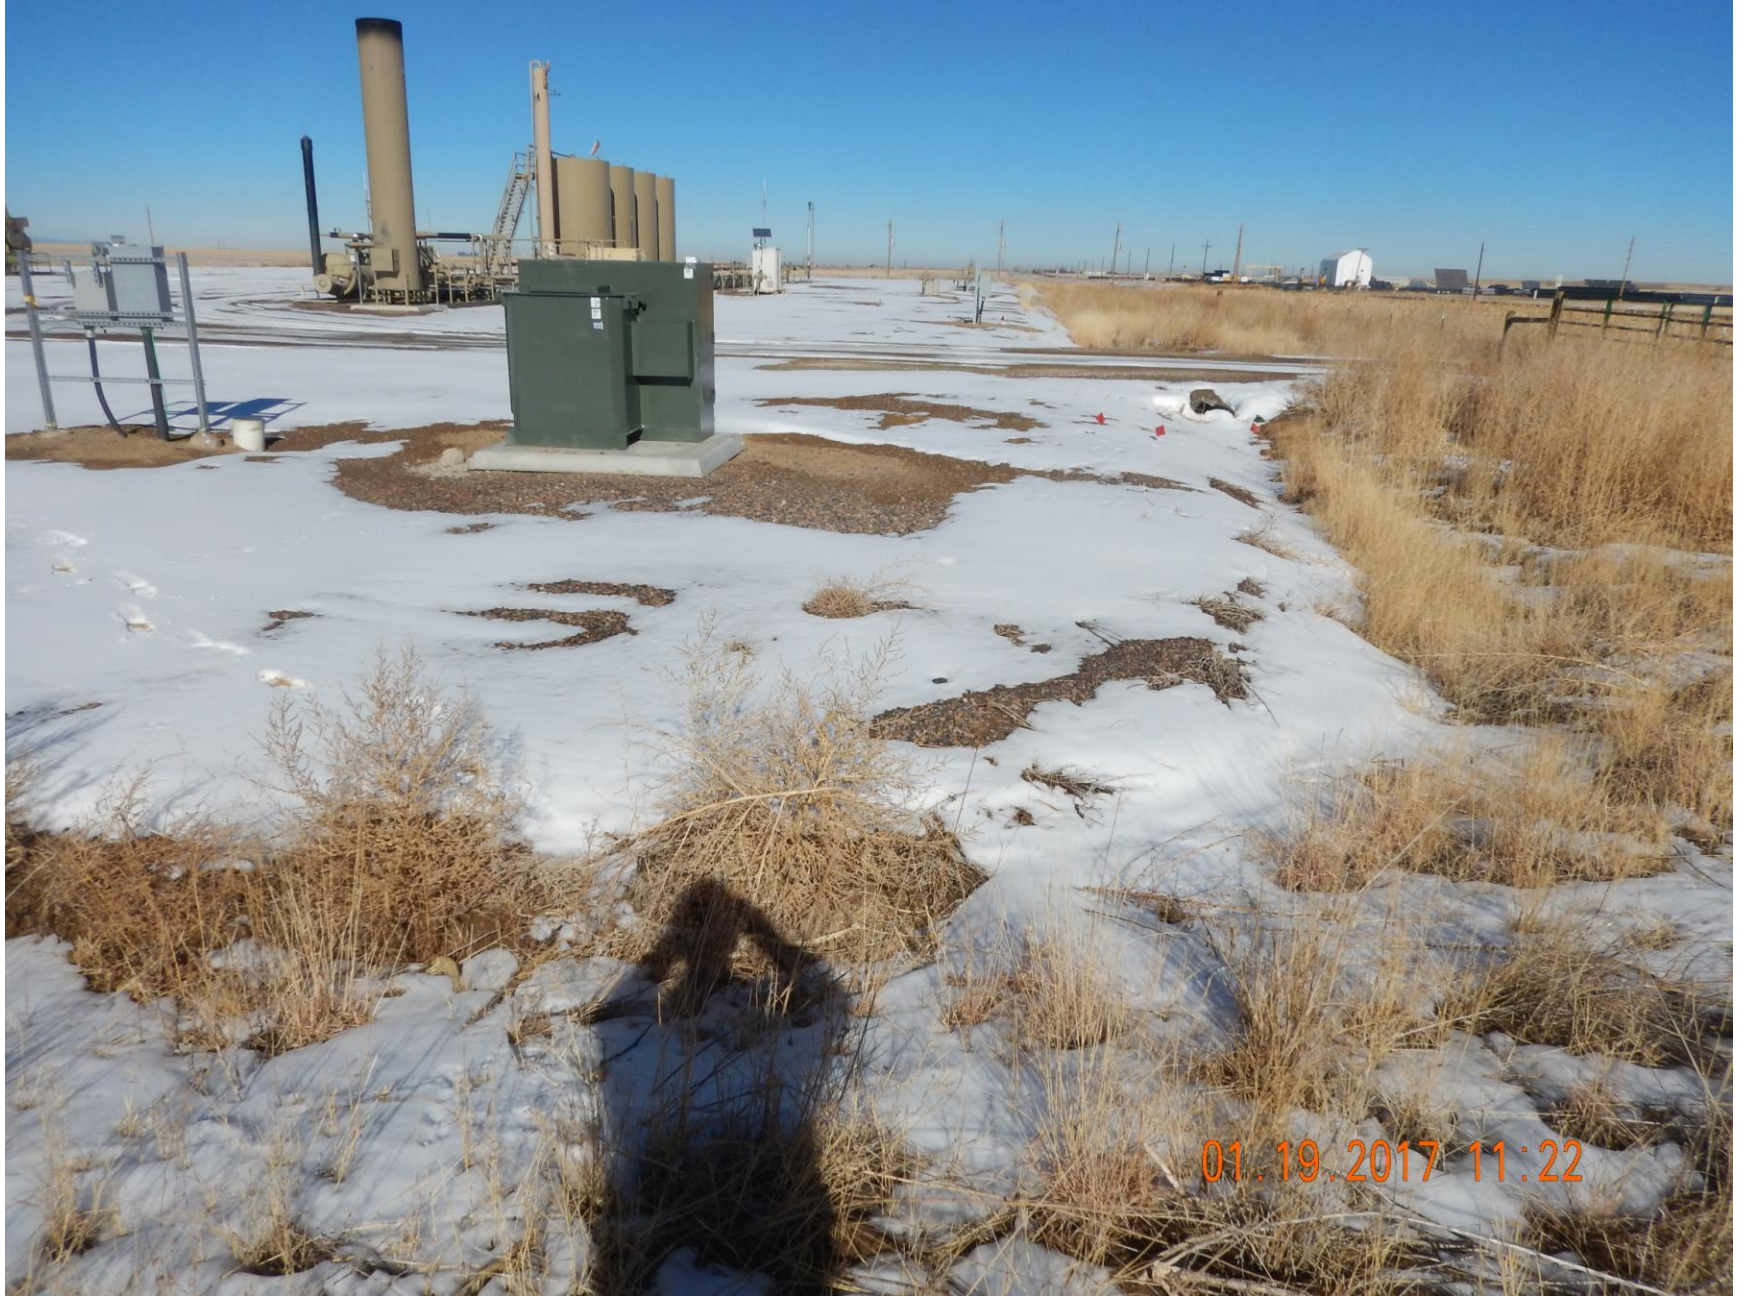
Figure 2: Photo taken from the southeast end of the location, facing north. Photo production and interim areas.

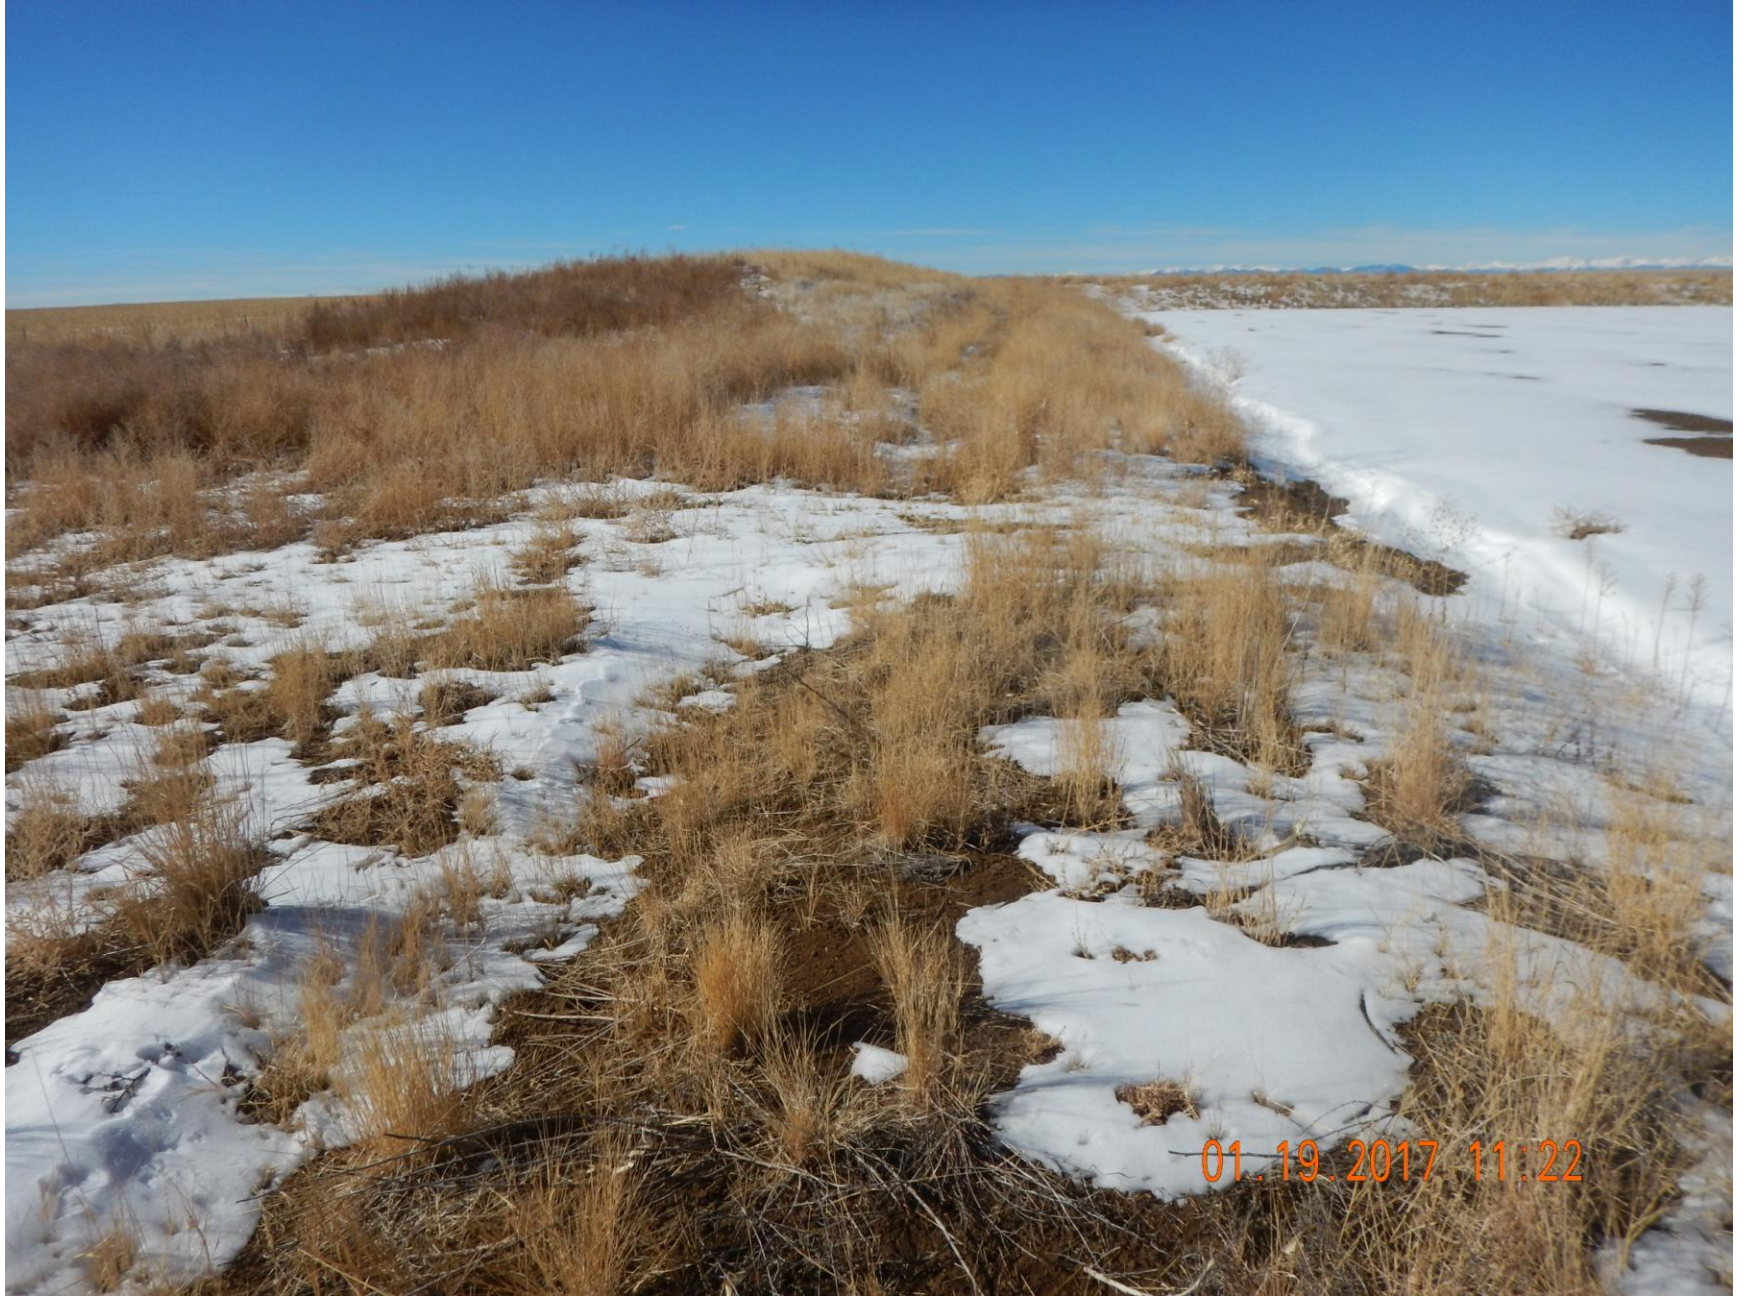
Figure 3: Photo taken from the southeast end of the location, facing west. Photo production and interim areas.

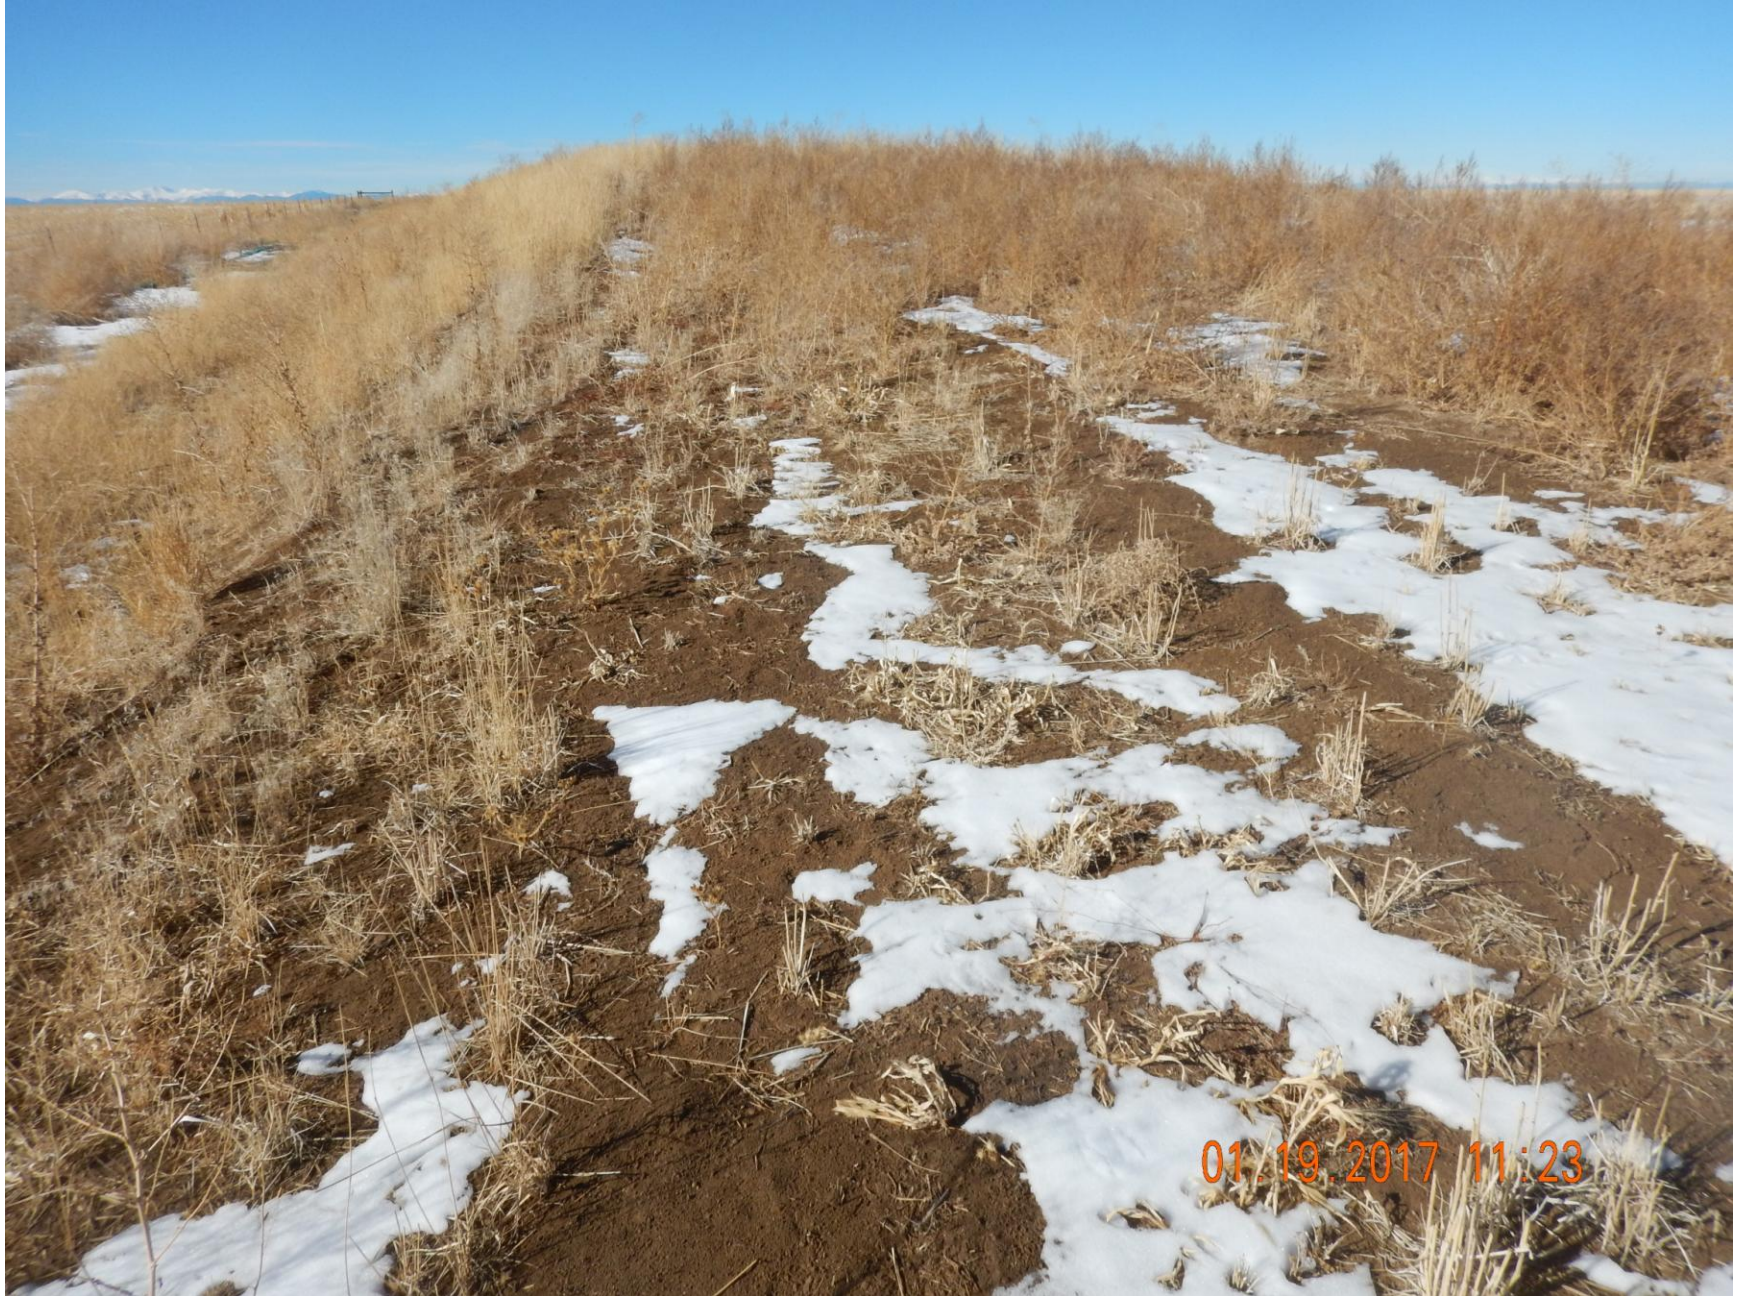
Figure 4: Photo taken from the south end of the location, facing west. Photo shows the topsoil stockpile.

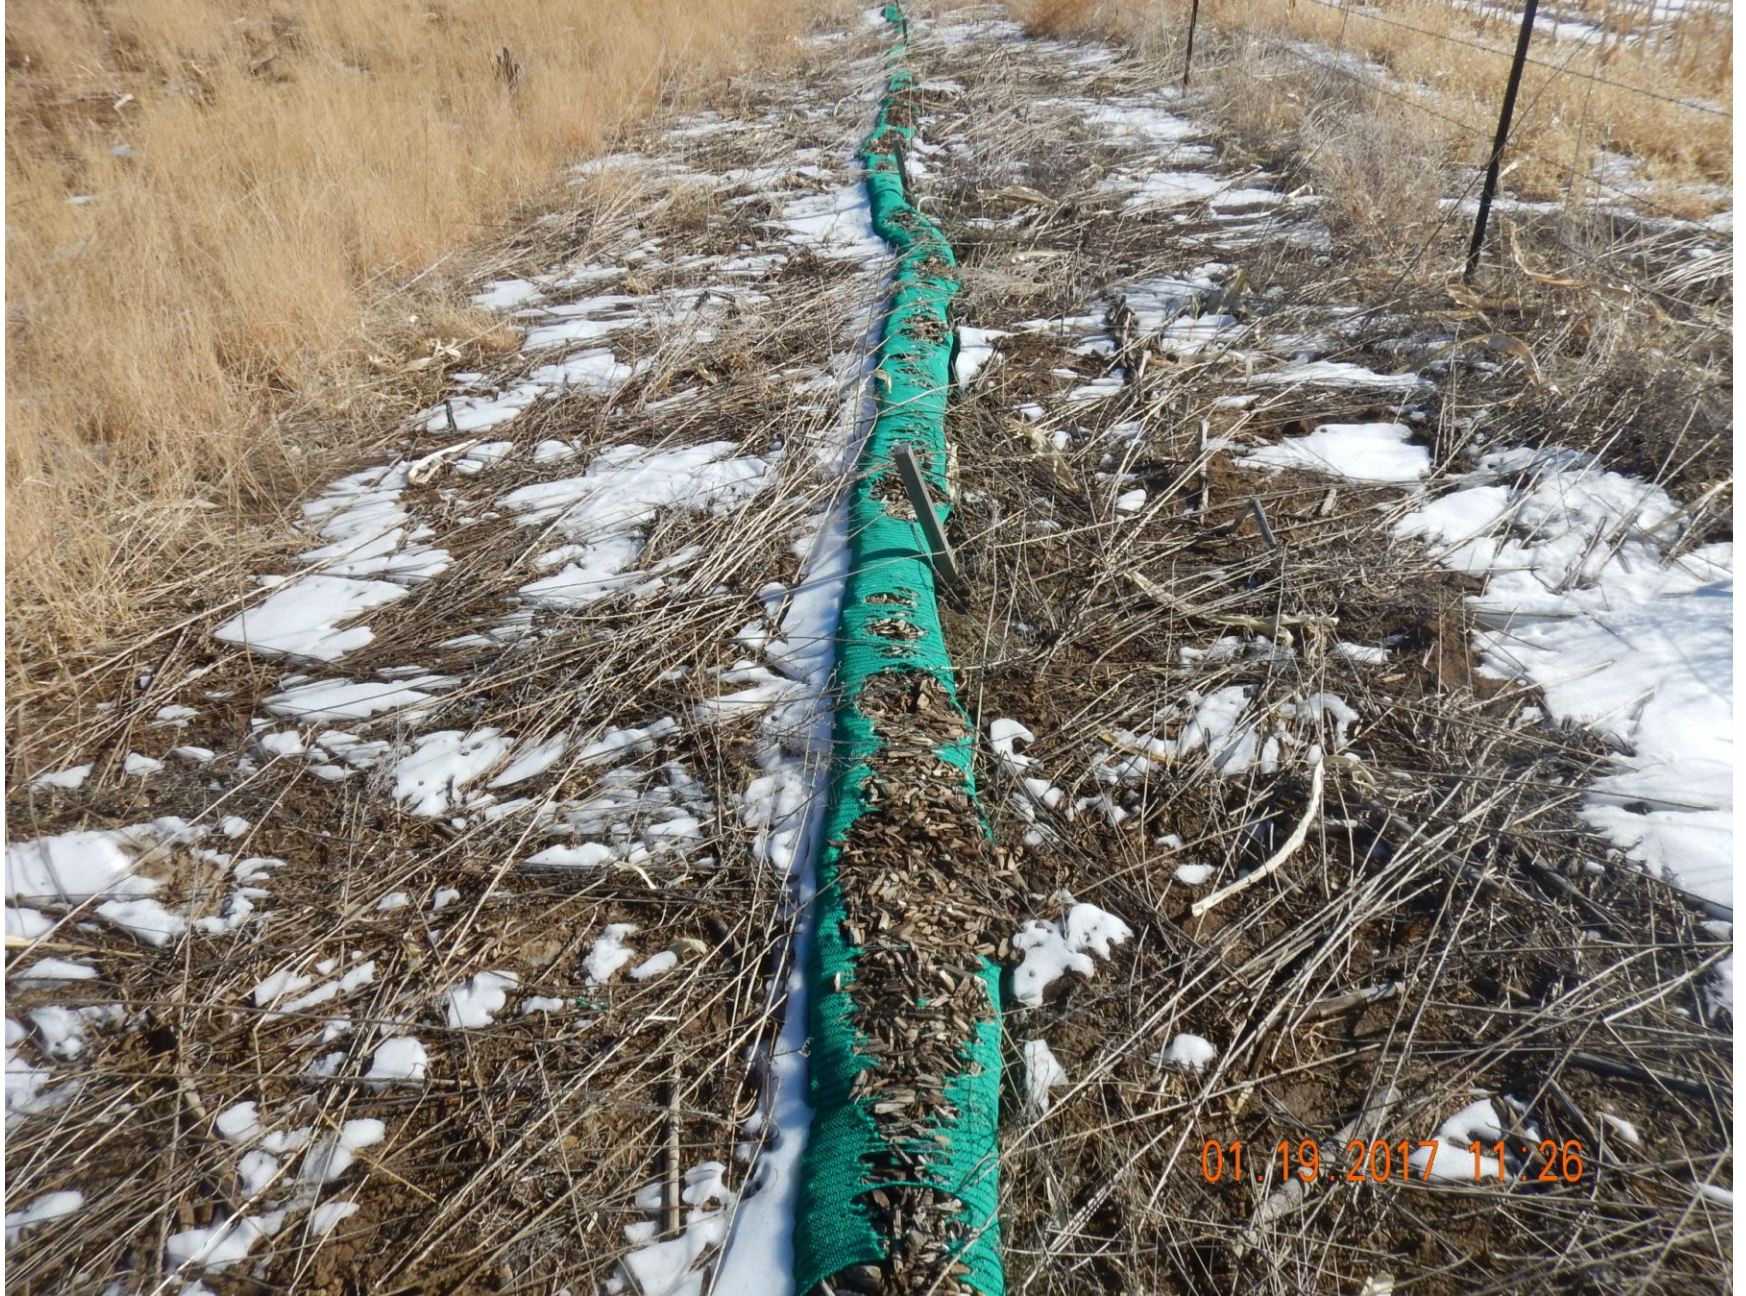
Figure 5: Photo taken from the south end of the location. Photo shows wattles used as stormwater and sediment control BMPs no longer in proper functioning condition.

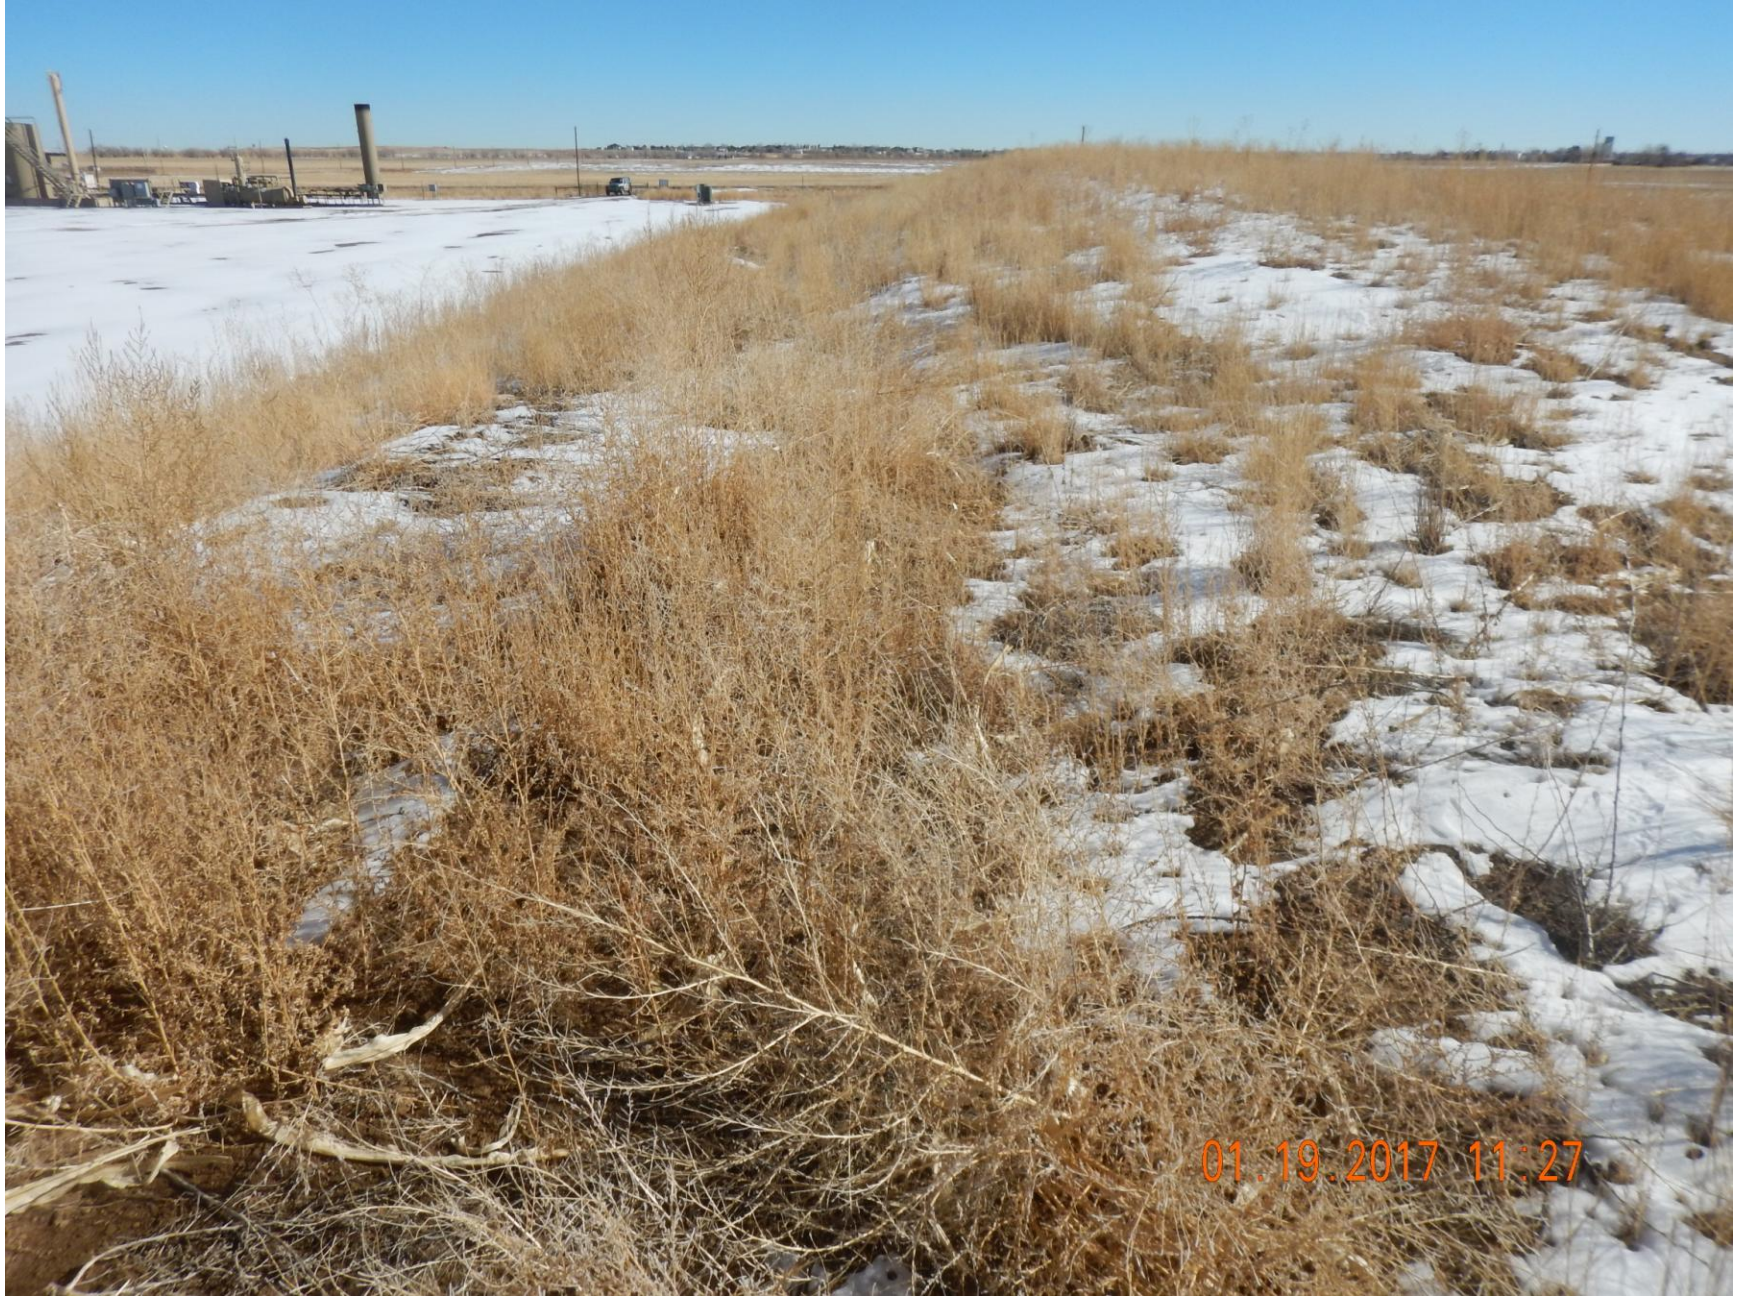
Figure 6: Photo taken from the southwest end of the location, facing east. Photo production and interim areas.

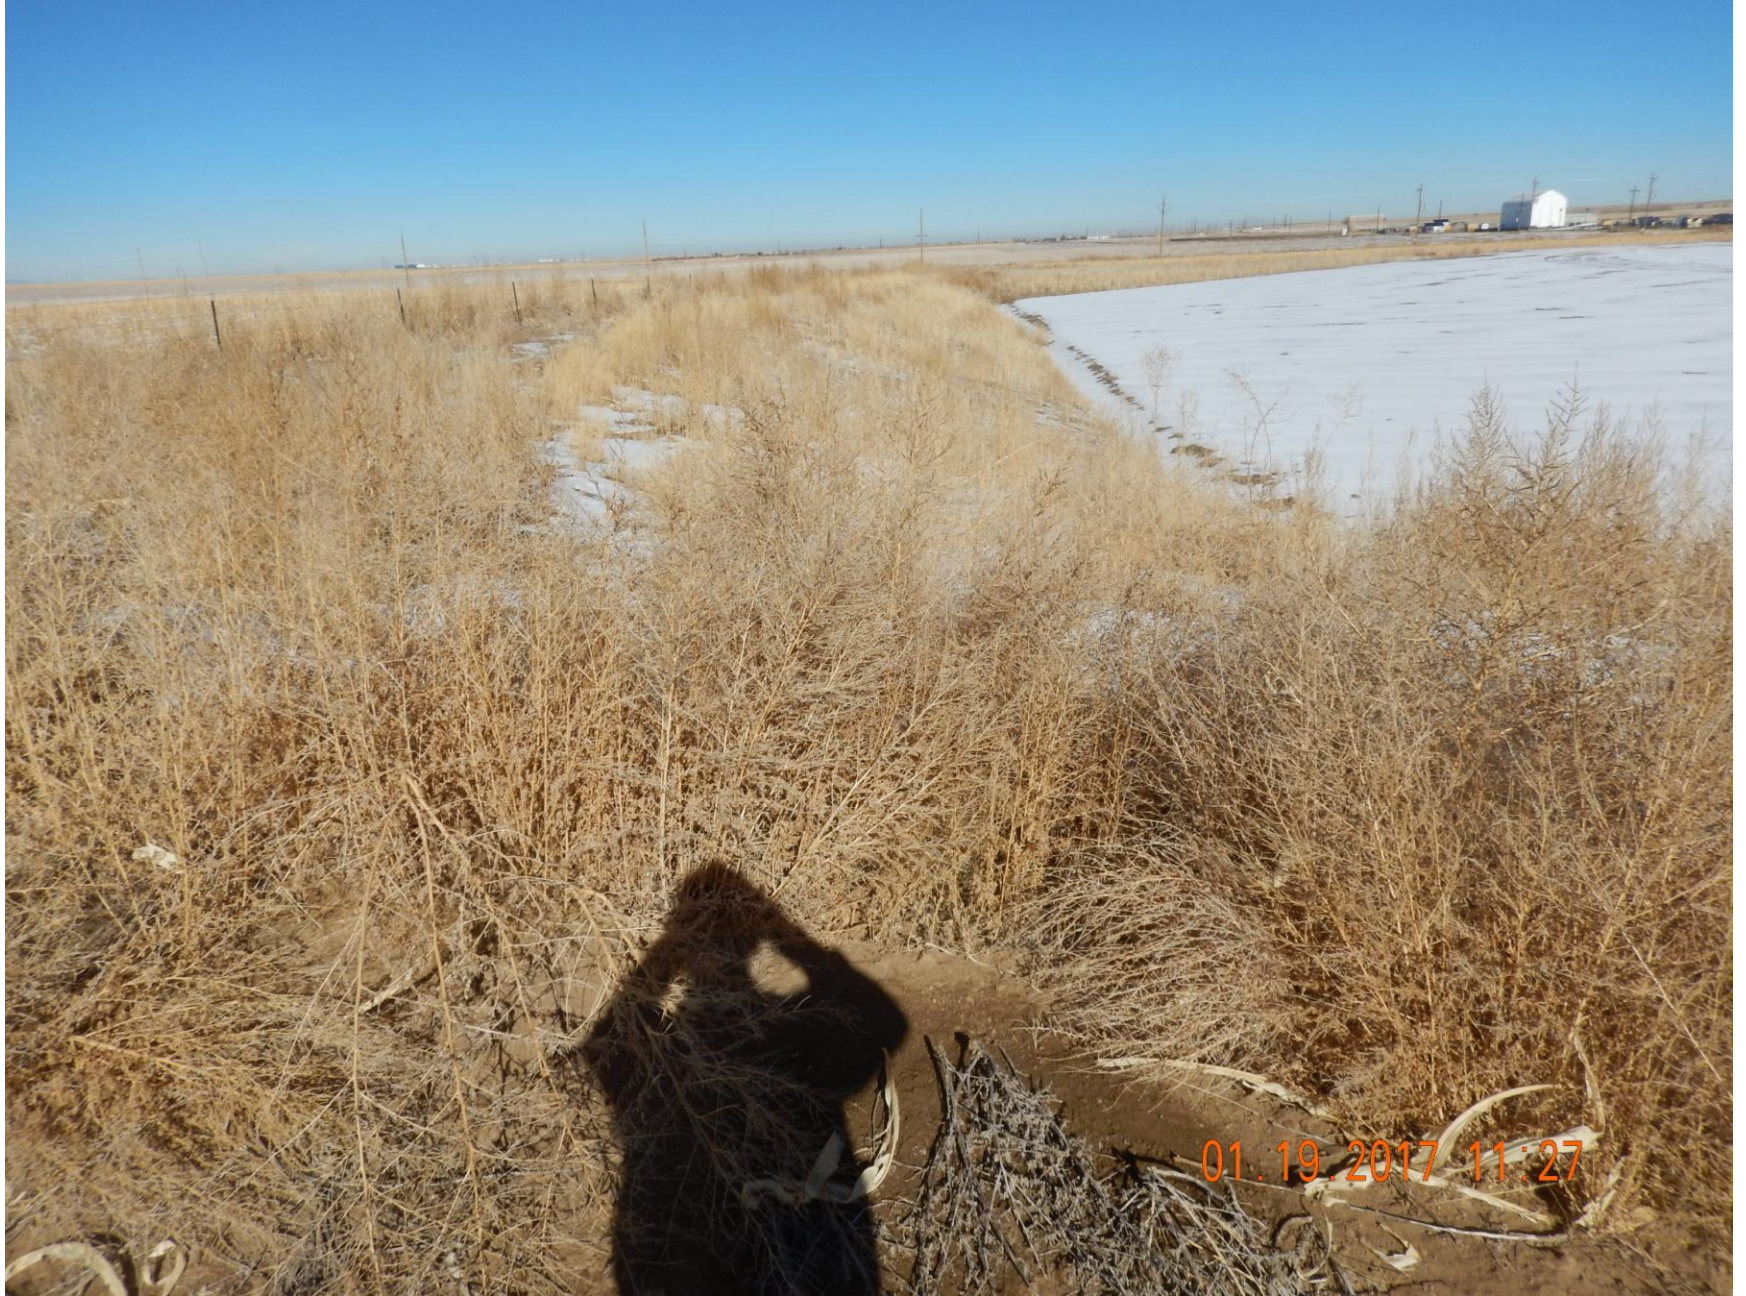
Figure 7: Photo taken from the southwest end of the location, facing east. Photo production and interim areas. Note, designated final land use cropland, interim areas have not been returned to it's final land use.

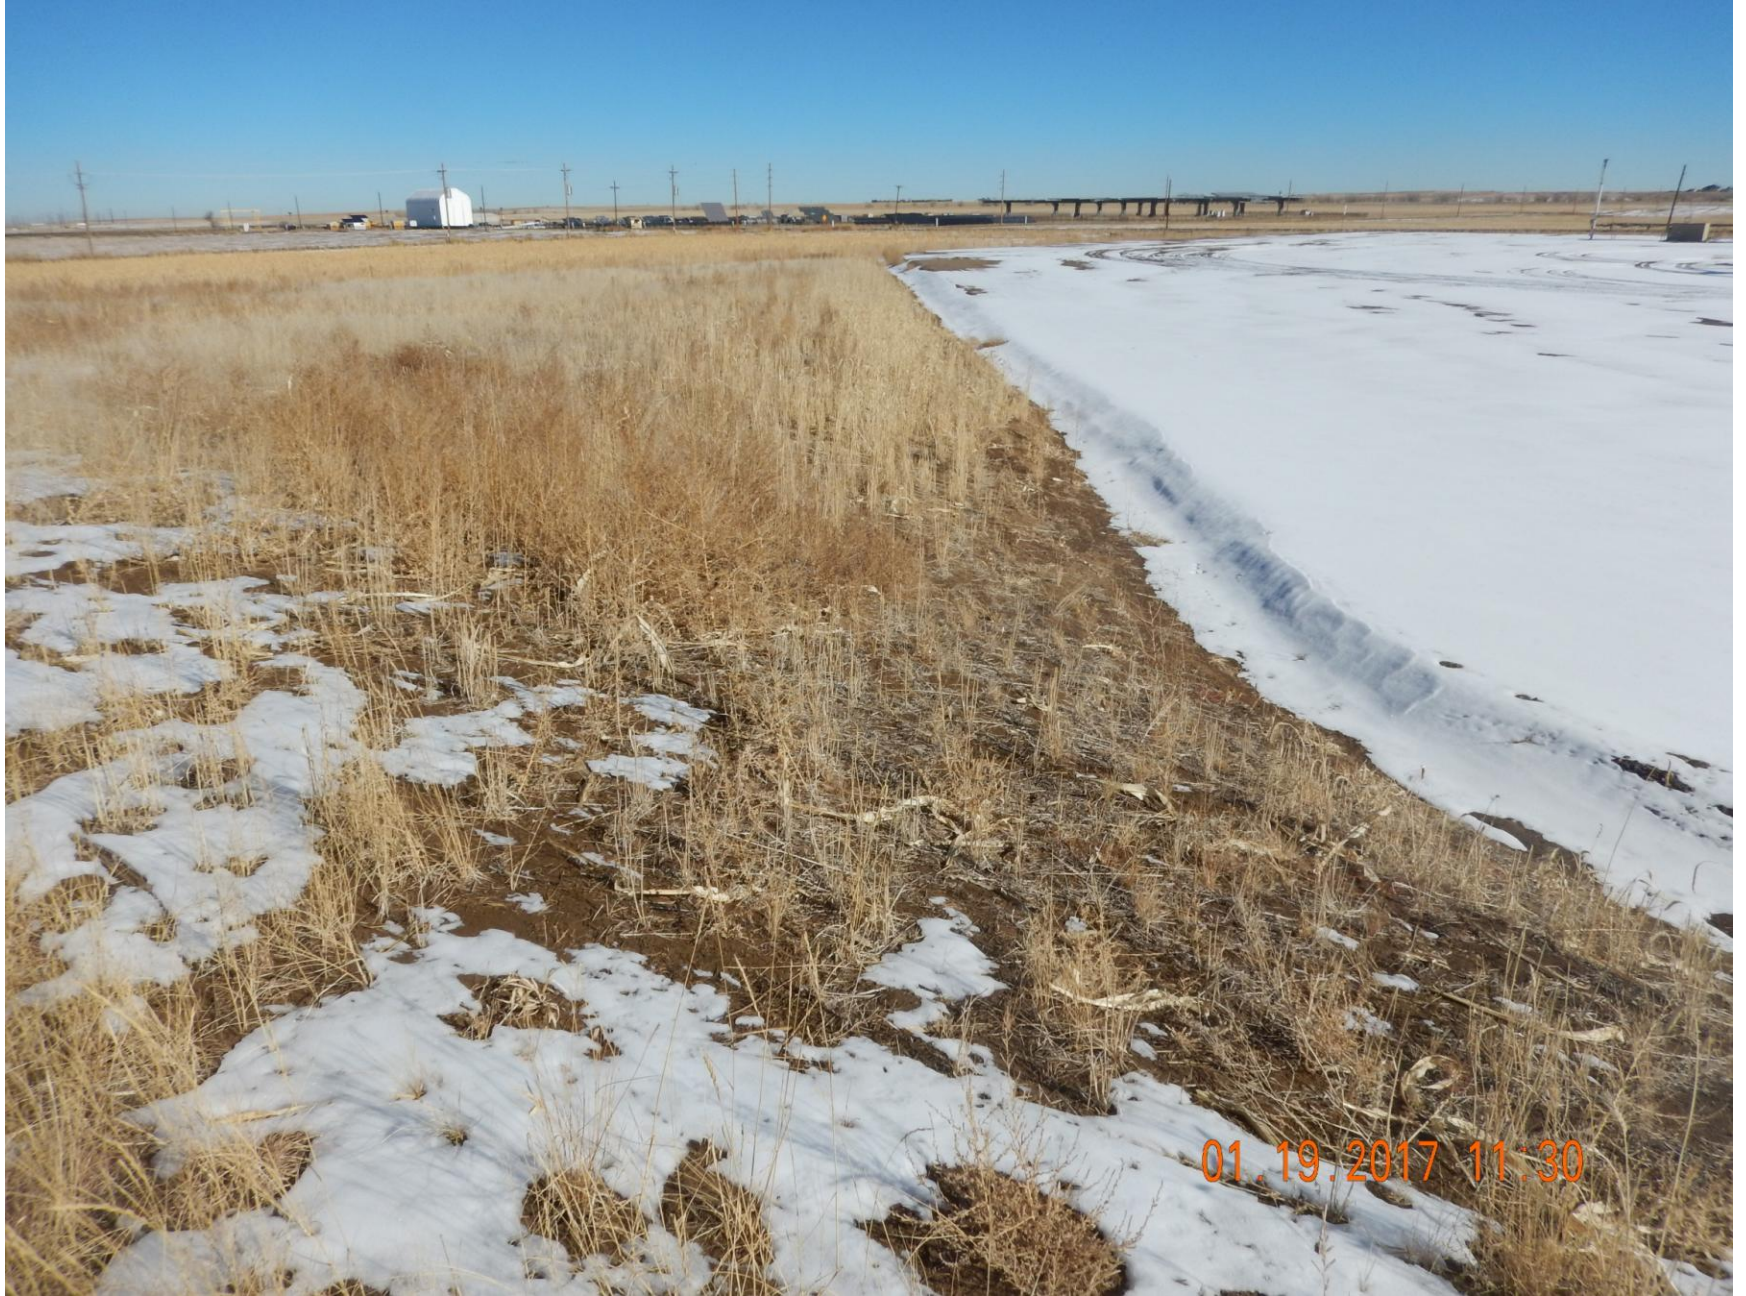
Figure 8: Photo taken from the west end of the location, facing northeast. Photo production and interim areas. Note, designated final land use cropland, interim areas have not been returned to it's final land use.

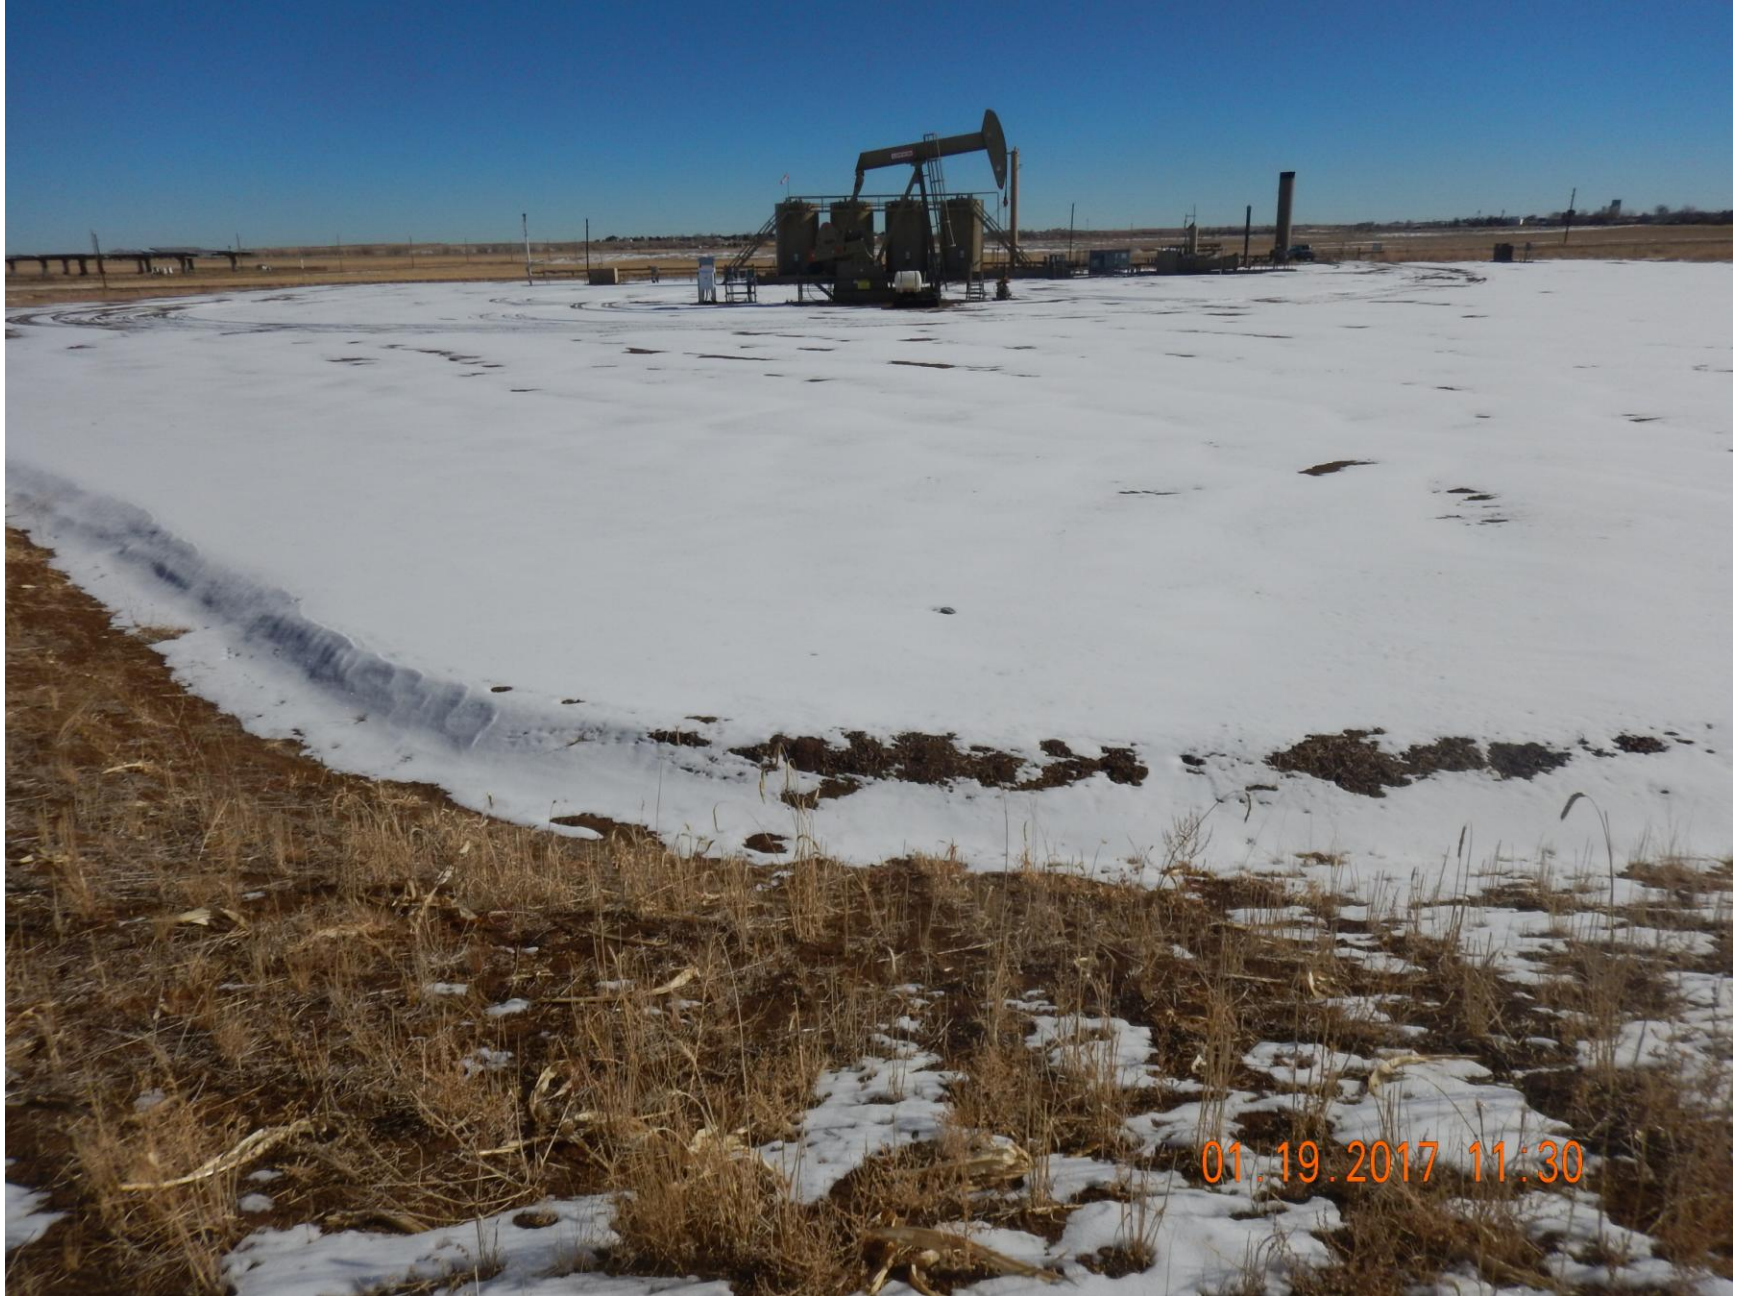
Figure 9: Photo taken from the west end of the location, facing east. Photo shows large areas of the location that do not appear to be necessary for production activities.

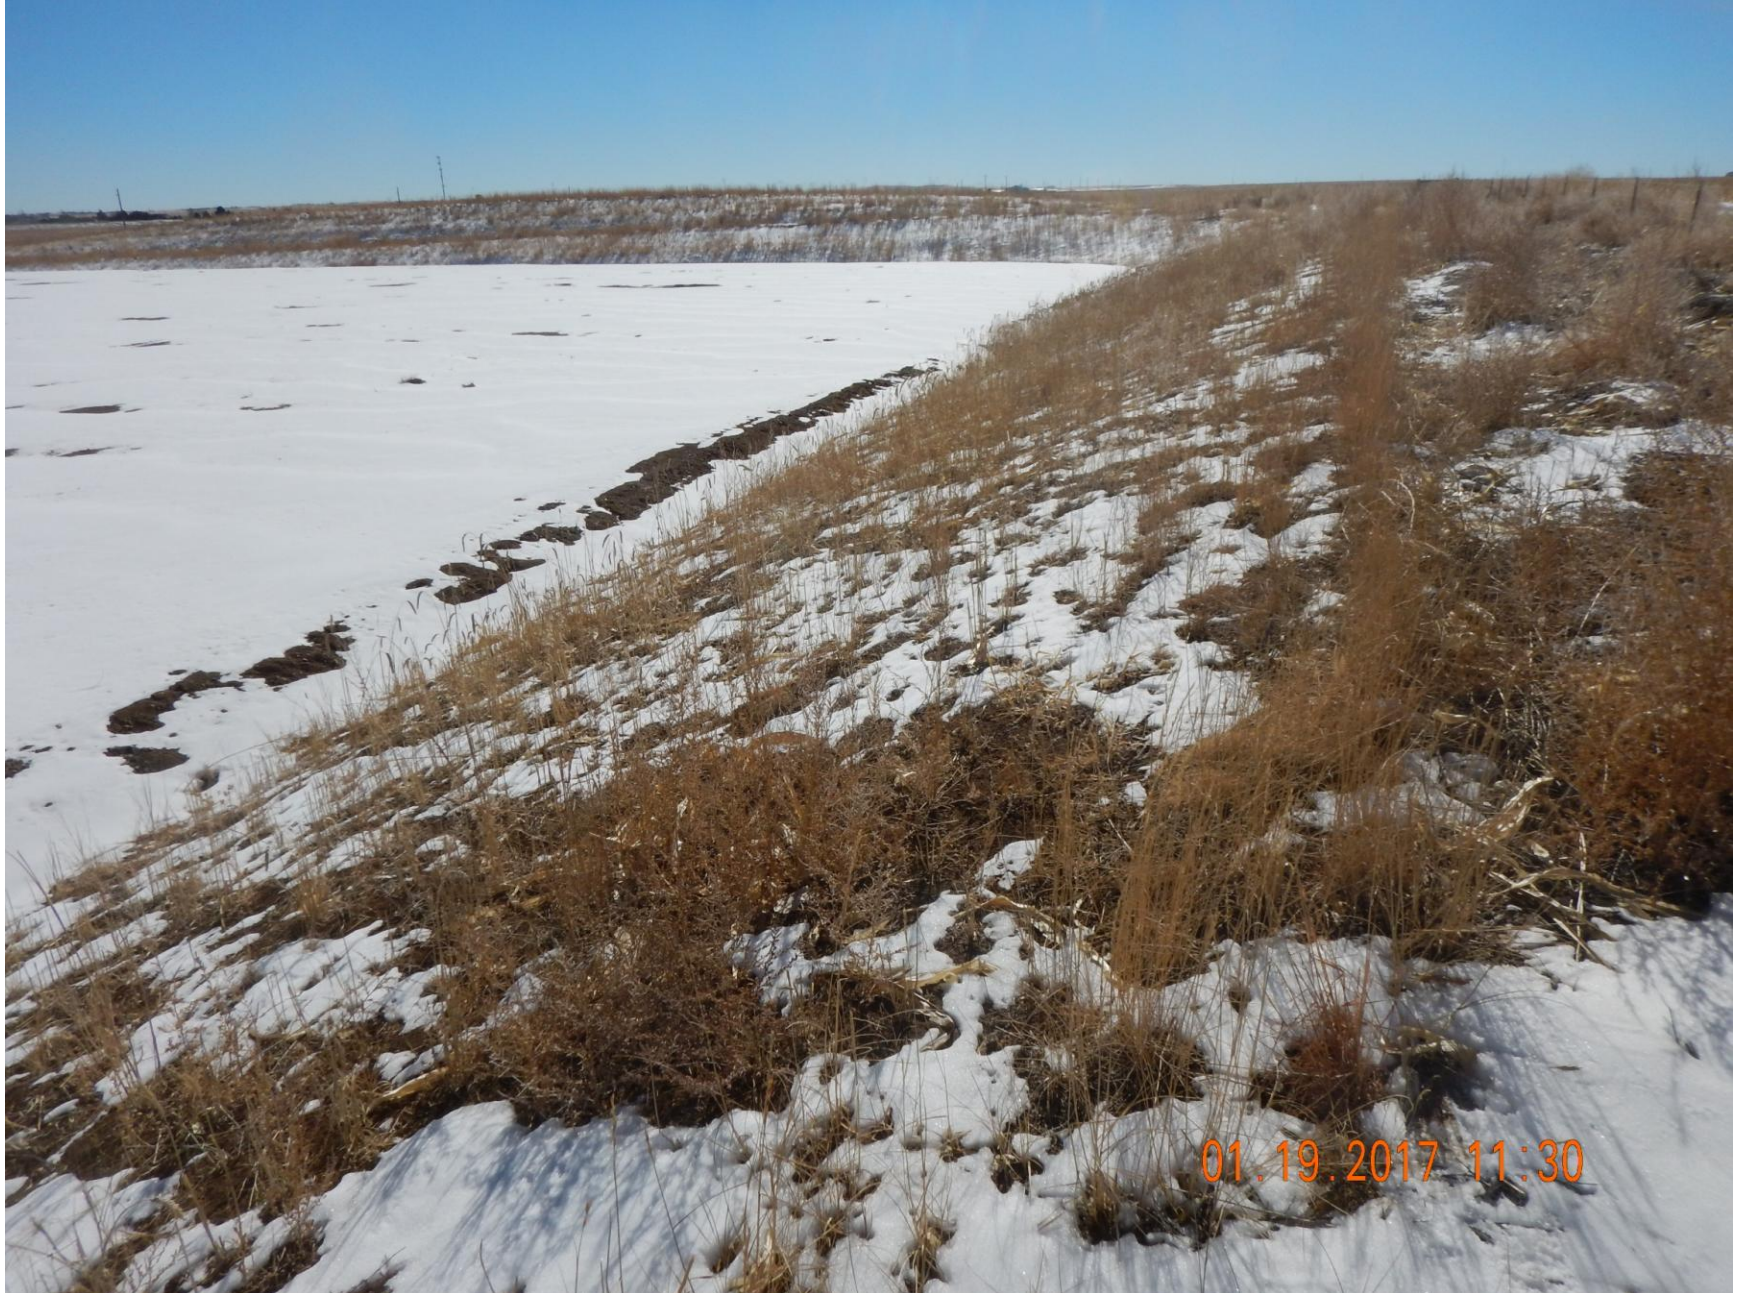
Figure 10: Photo taken from the west end of the location, facing south. Photo production and interim areas. Note, designated final land use cropland, interim areas have not been returned to it's final land use. Photo also shows large areas of the location that do not appear to be necessary for production activities.
