Reclamation Inspection

01/19/2017

Operator: Burlington Resources/ConocoPhillips

Location ID: 436726

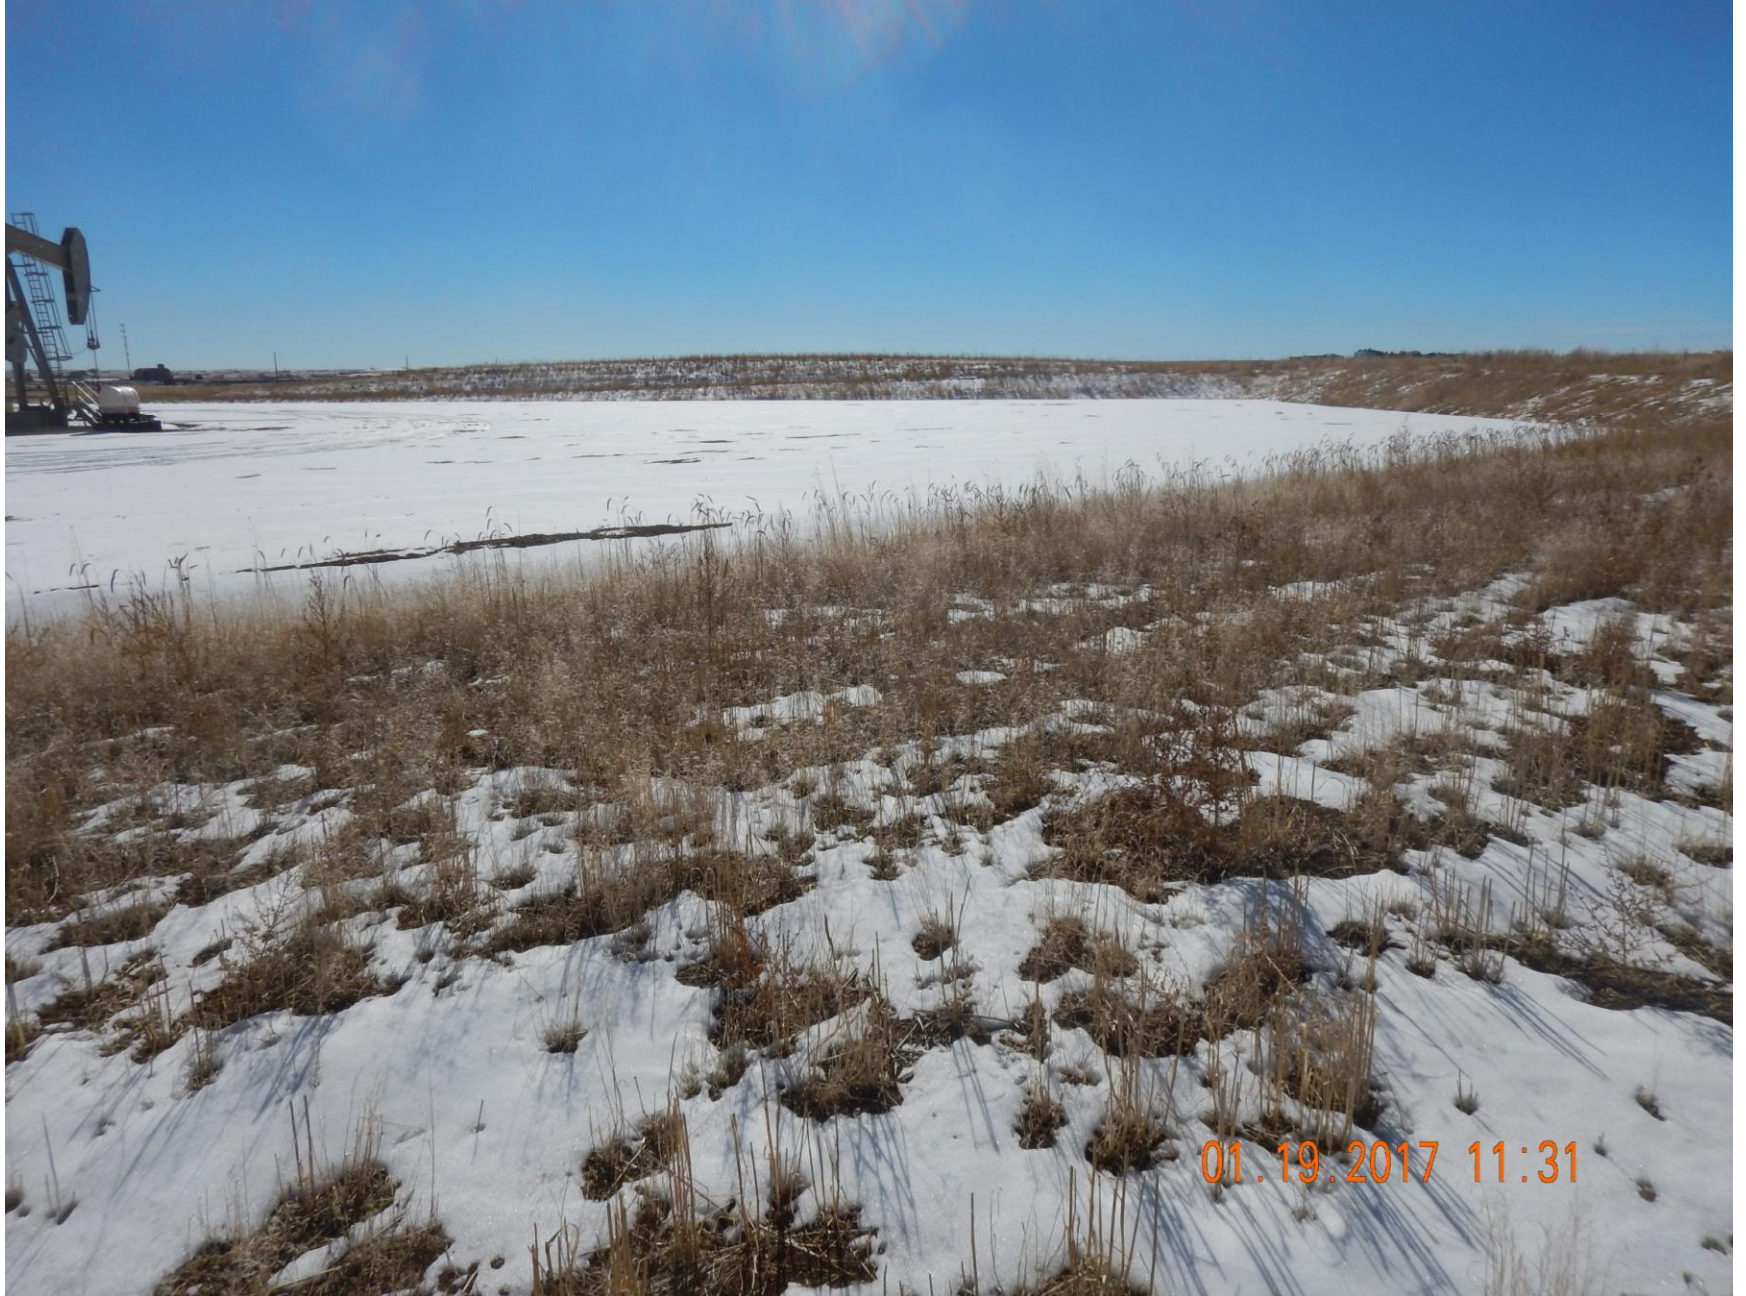
Figure 11: Photo taken from the northwest end of the location, facing south. Photo shows large areas of the location that do not appear to be necessary for production activities.

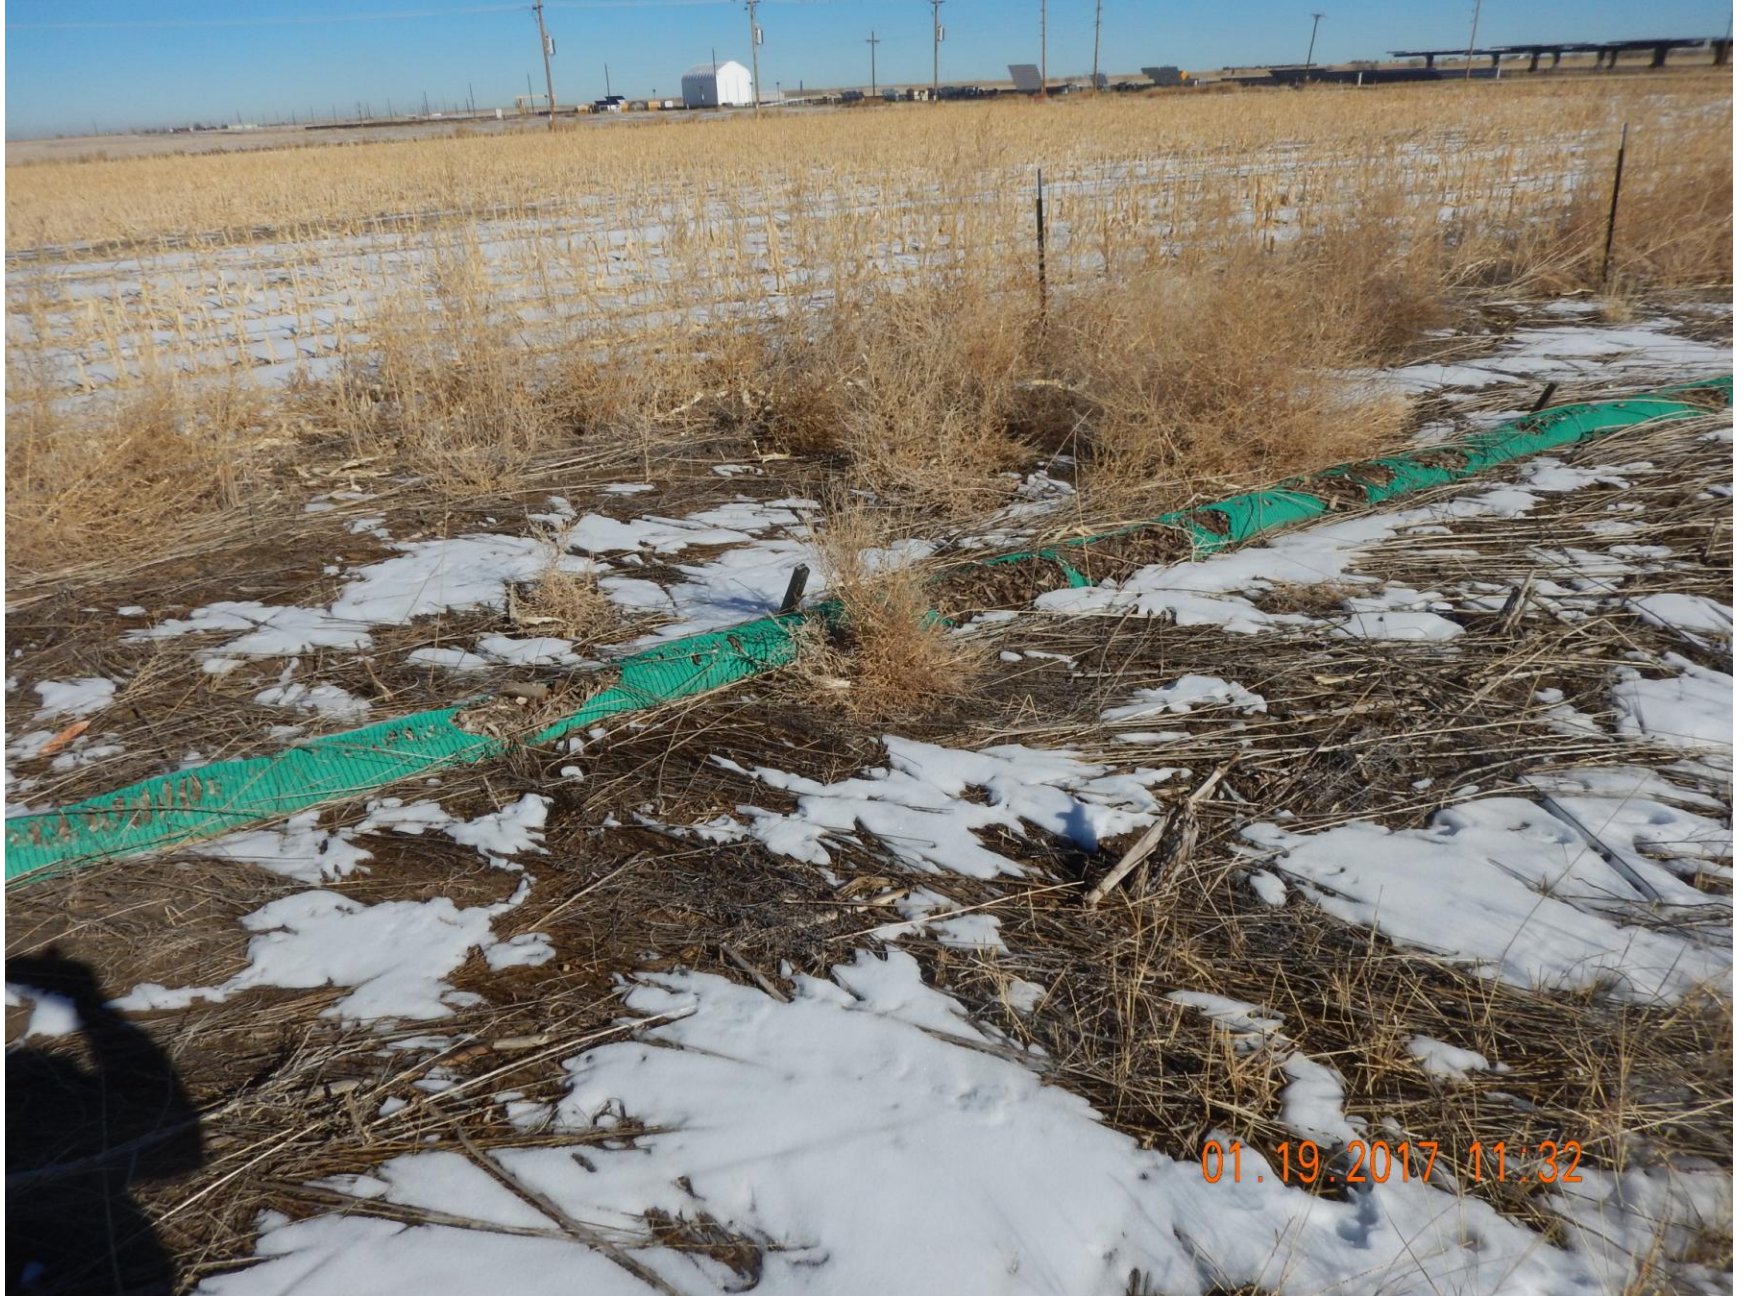
Figure 12: Photo taken from the north end of the location. Photo shows wattles used as stormwater and sediment control BMPs no longer in proper functioning condition.

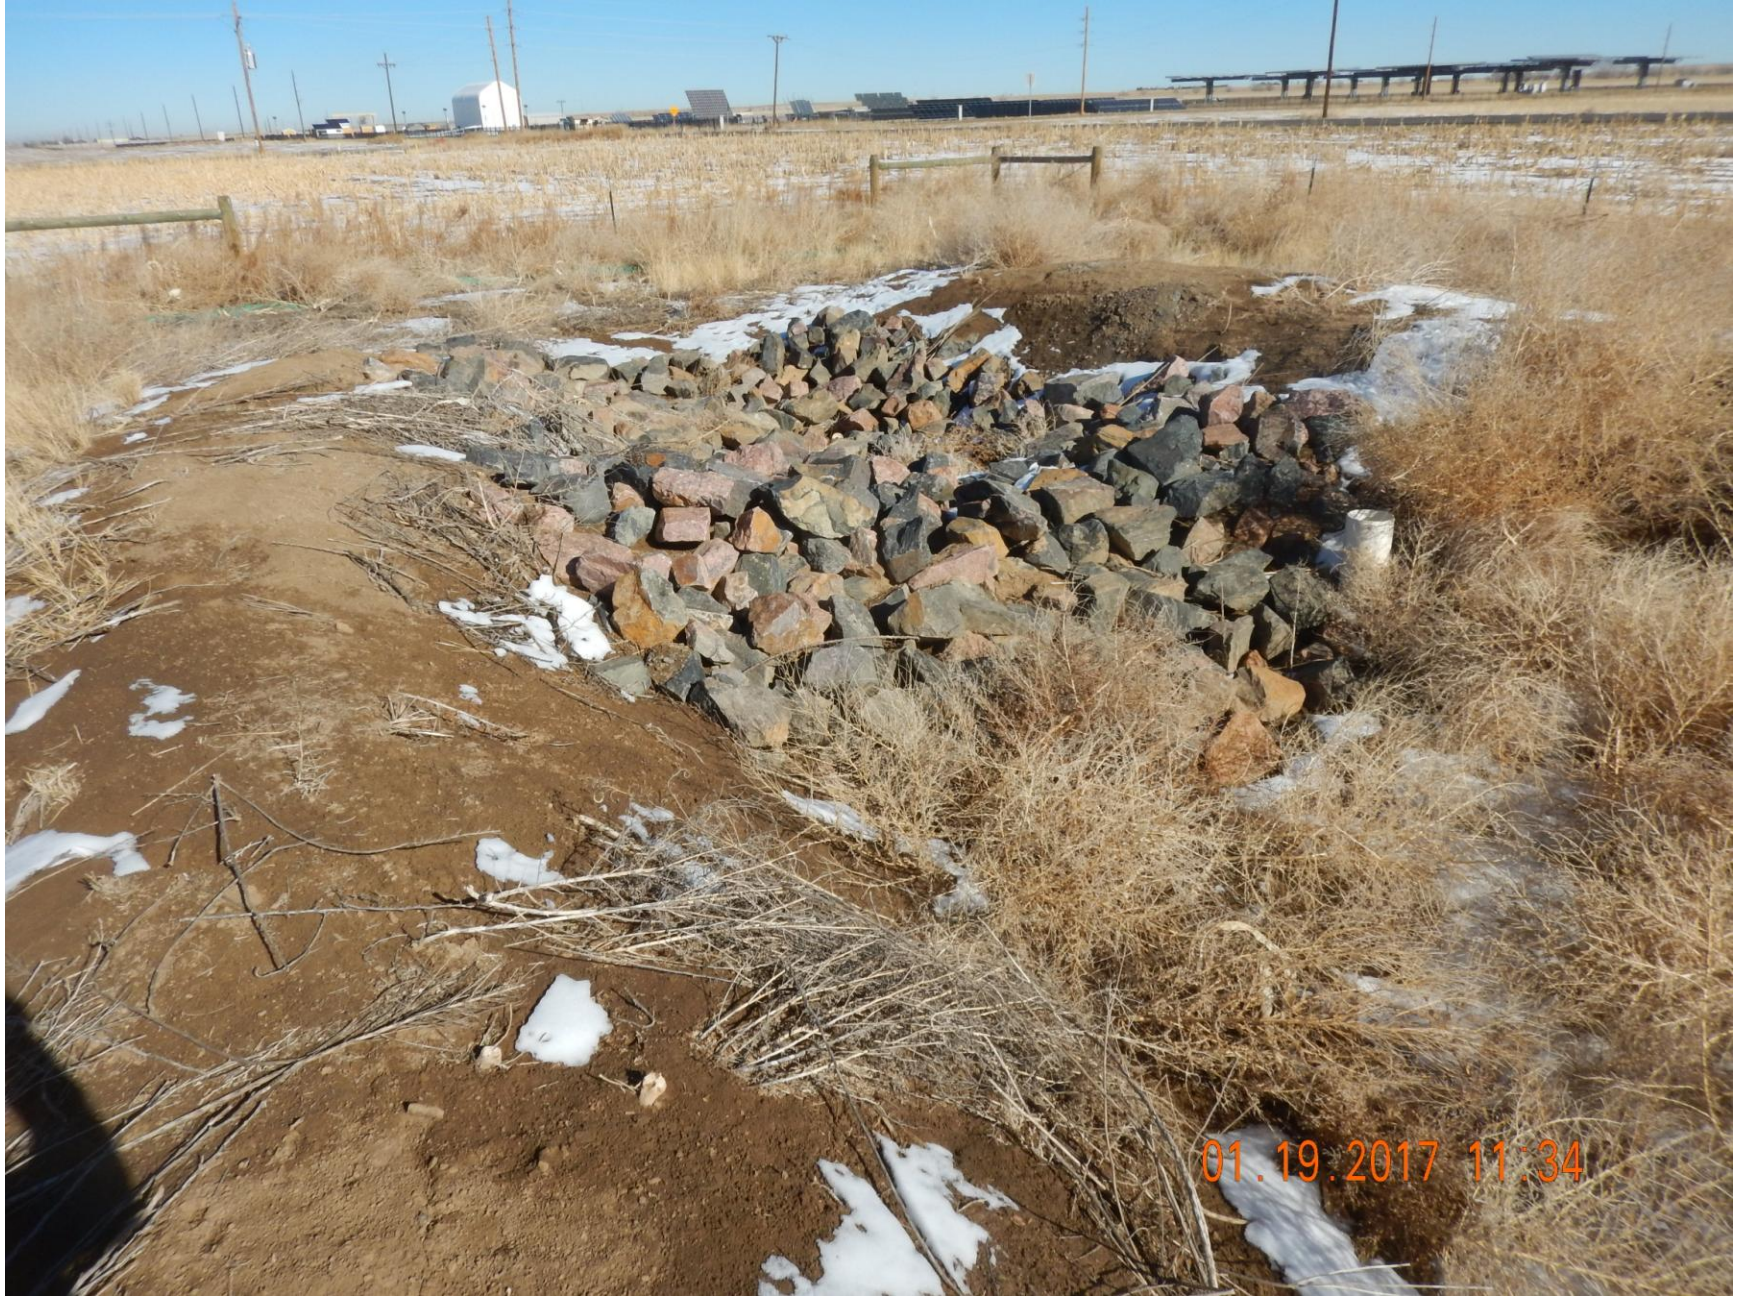
Figure 13: Photo taken from the northeast end of the location, facing northeast. Photo shows sediment trap.

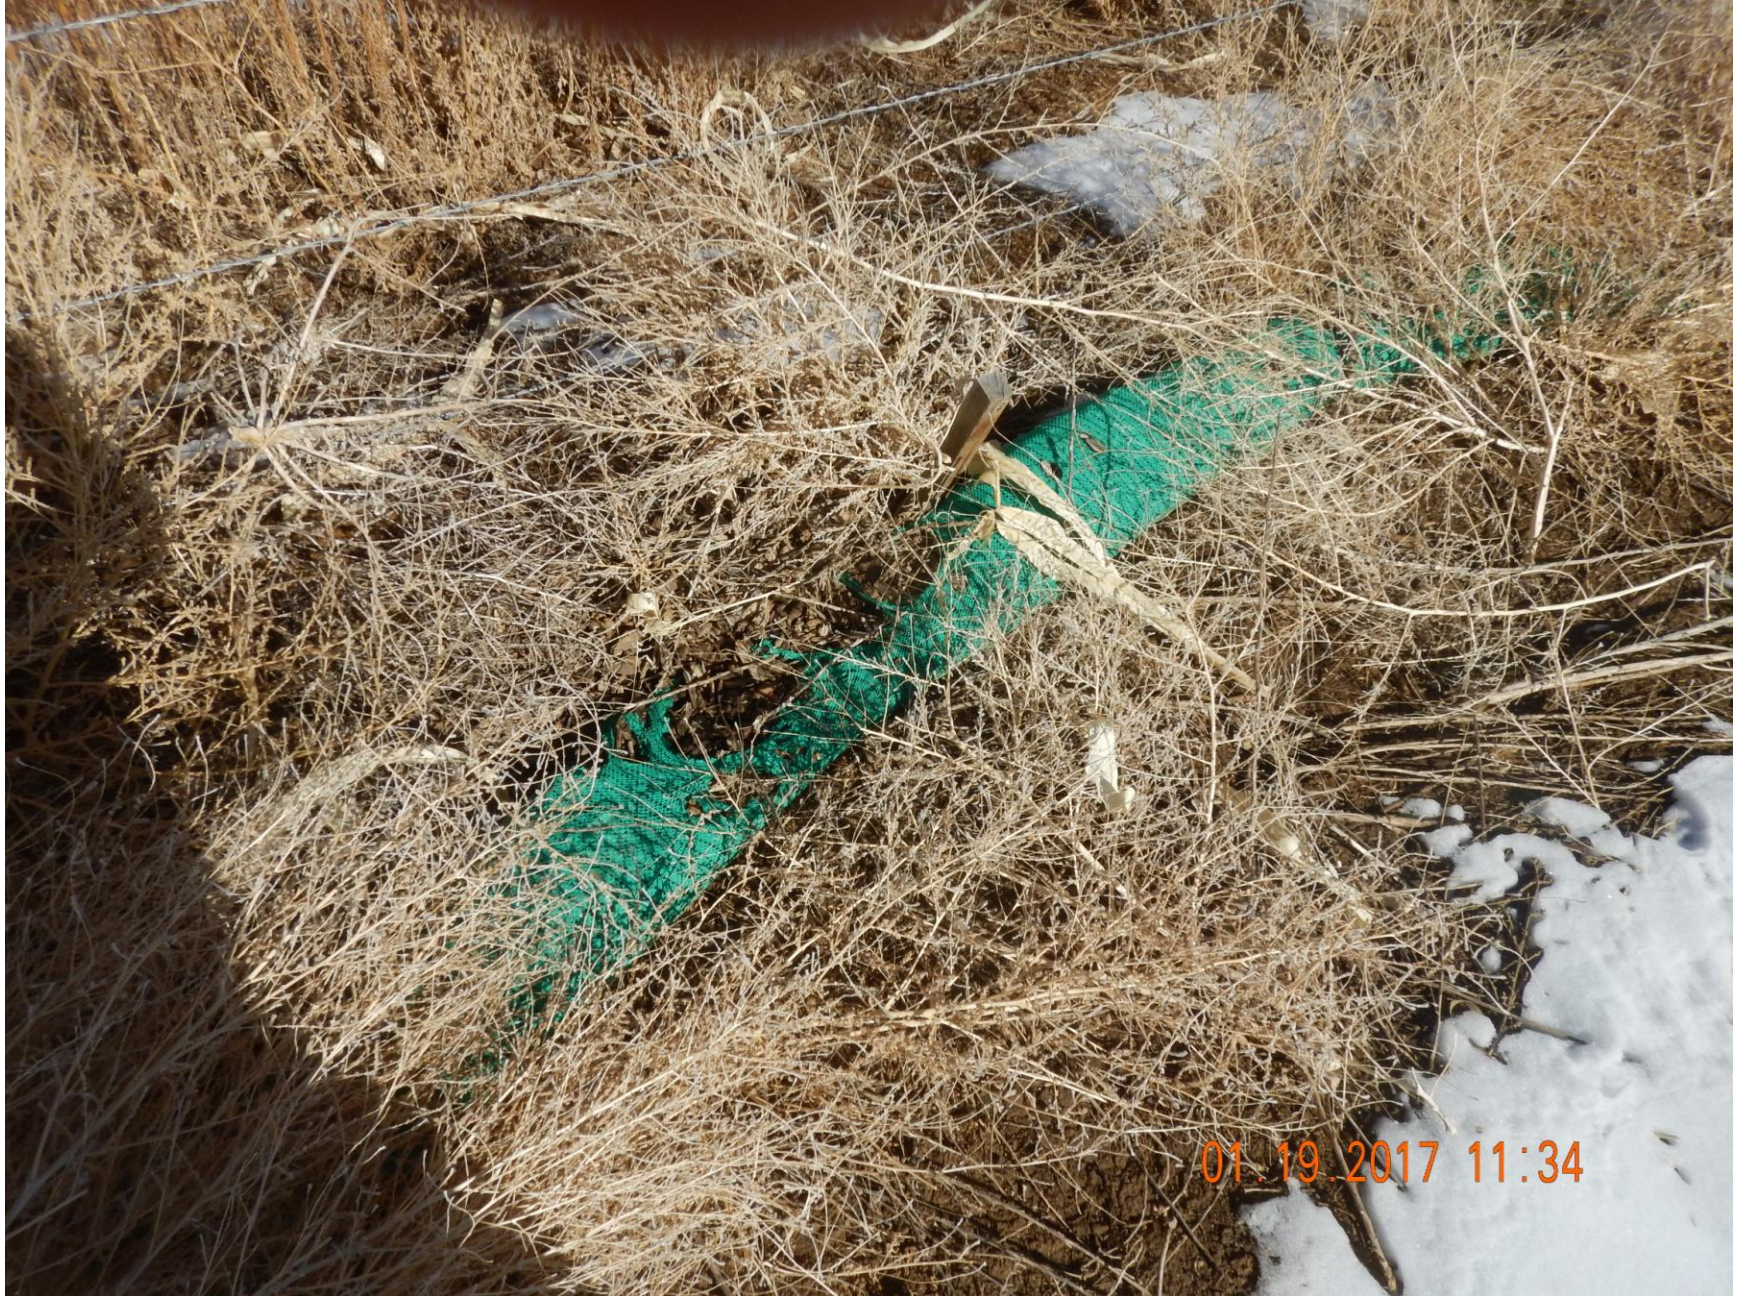
Figure 14: Photo taken from the northeast end of the location, next to sediment trap. Photo shows wattles used as stormwater and sediment control BMPs no longer in proper functioning condition.

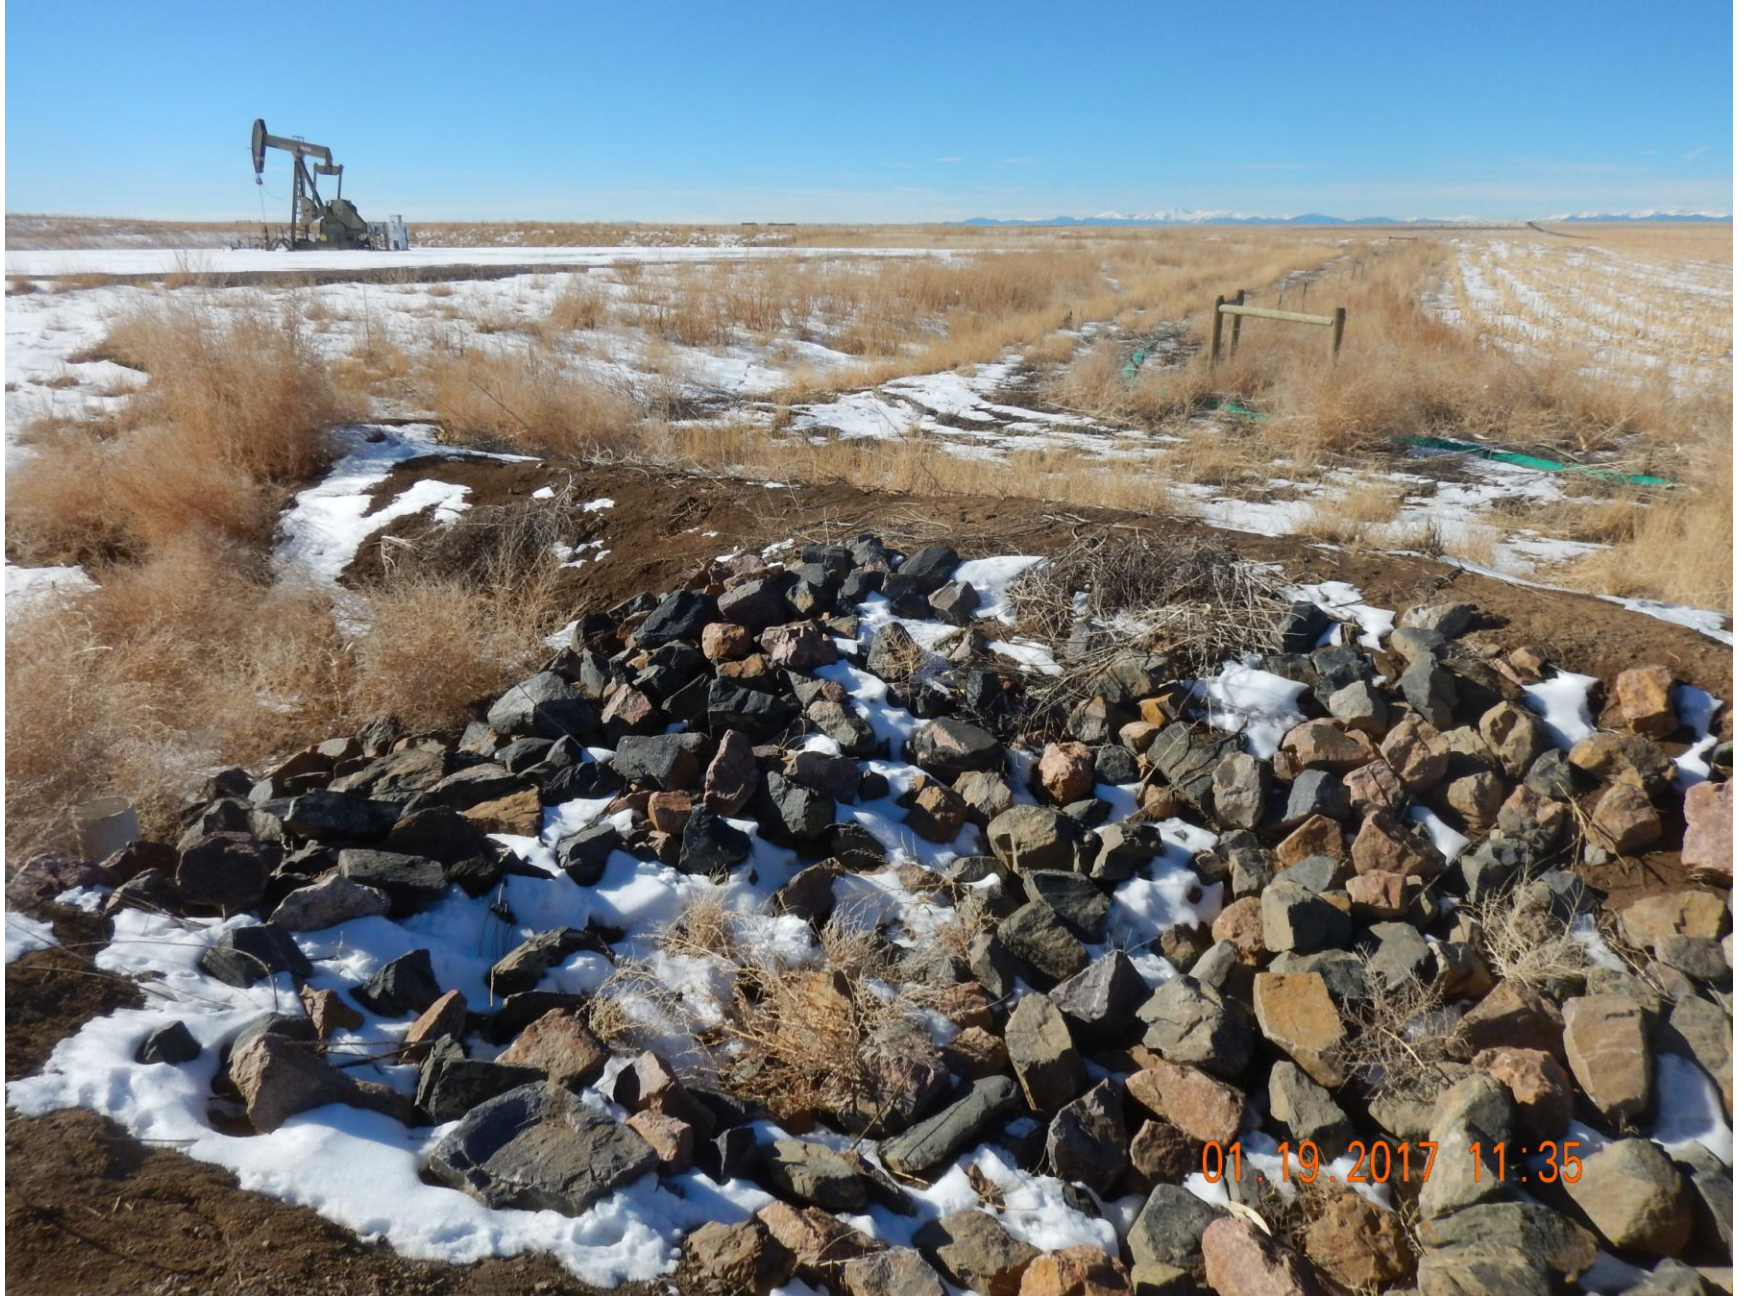
Figure 15: Photo taken from the northwest corner of the location, facing west. Photo shows interim and project areas.

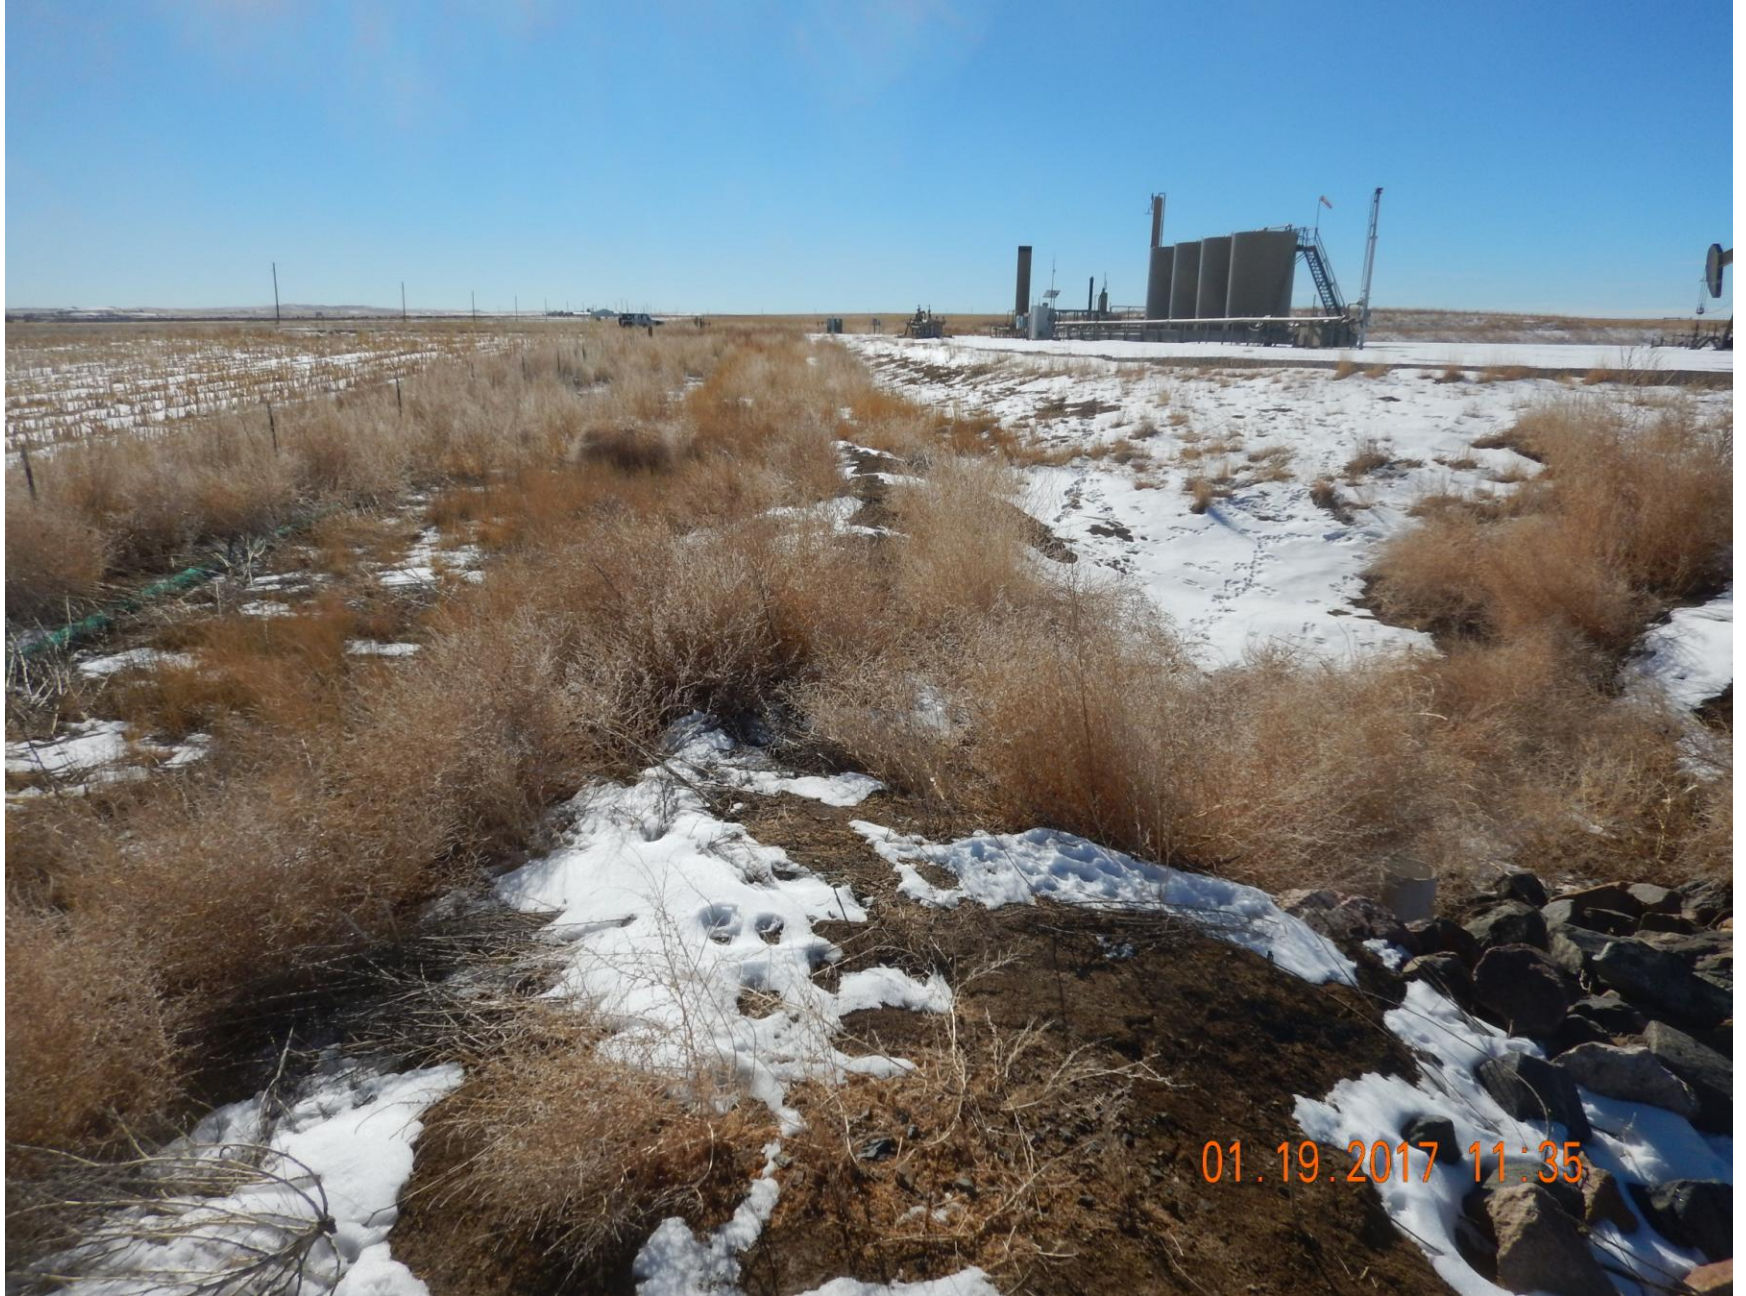
Figure 16: Photo taken from the northwest corner of the location, facing south. Photo shows interim and project areas.

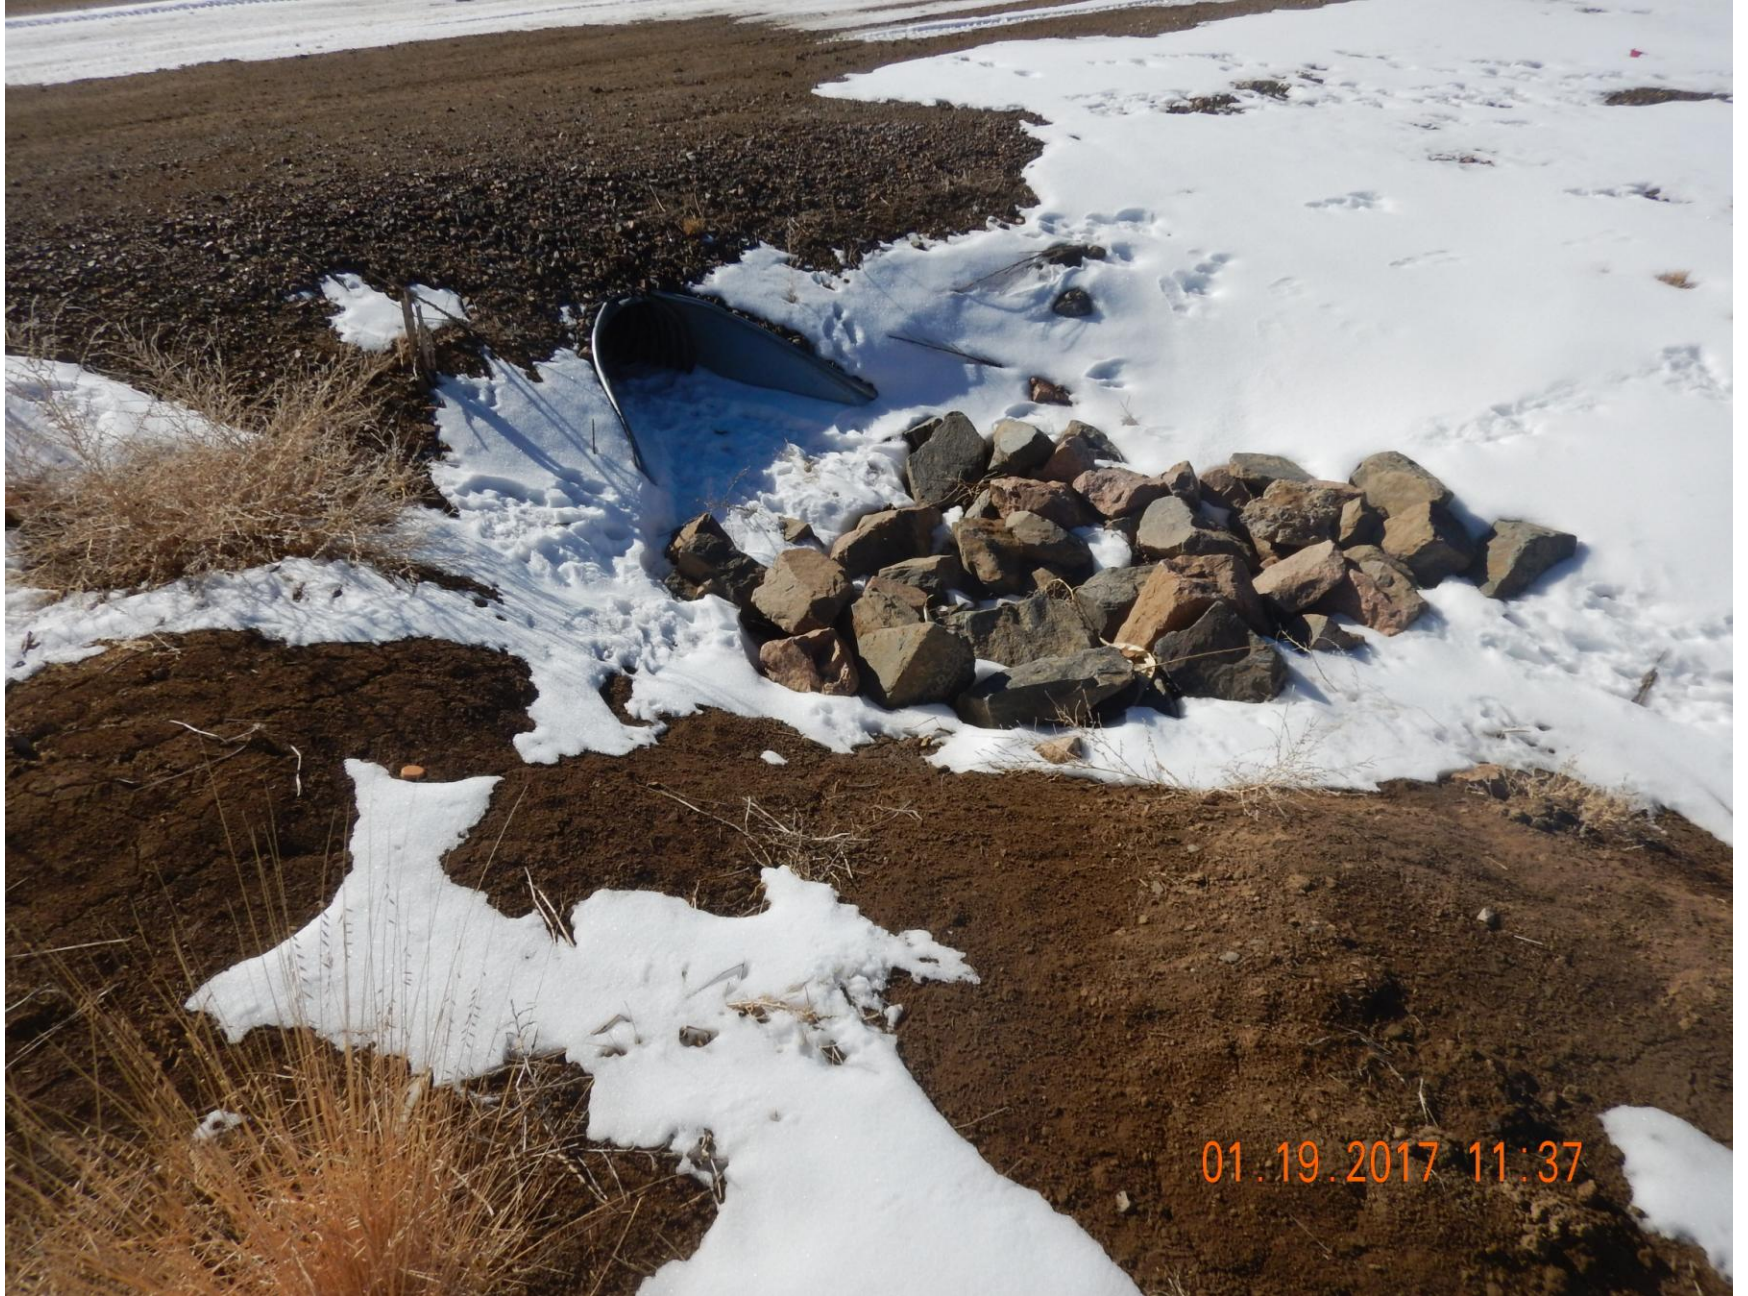
Figure 17: Photo taken from the east end of the location at access road. Photo shows culvert.

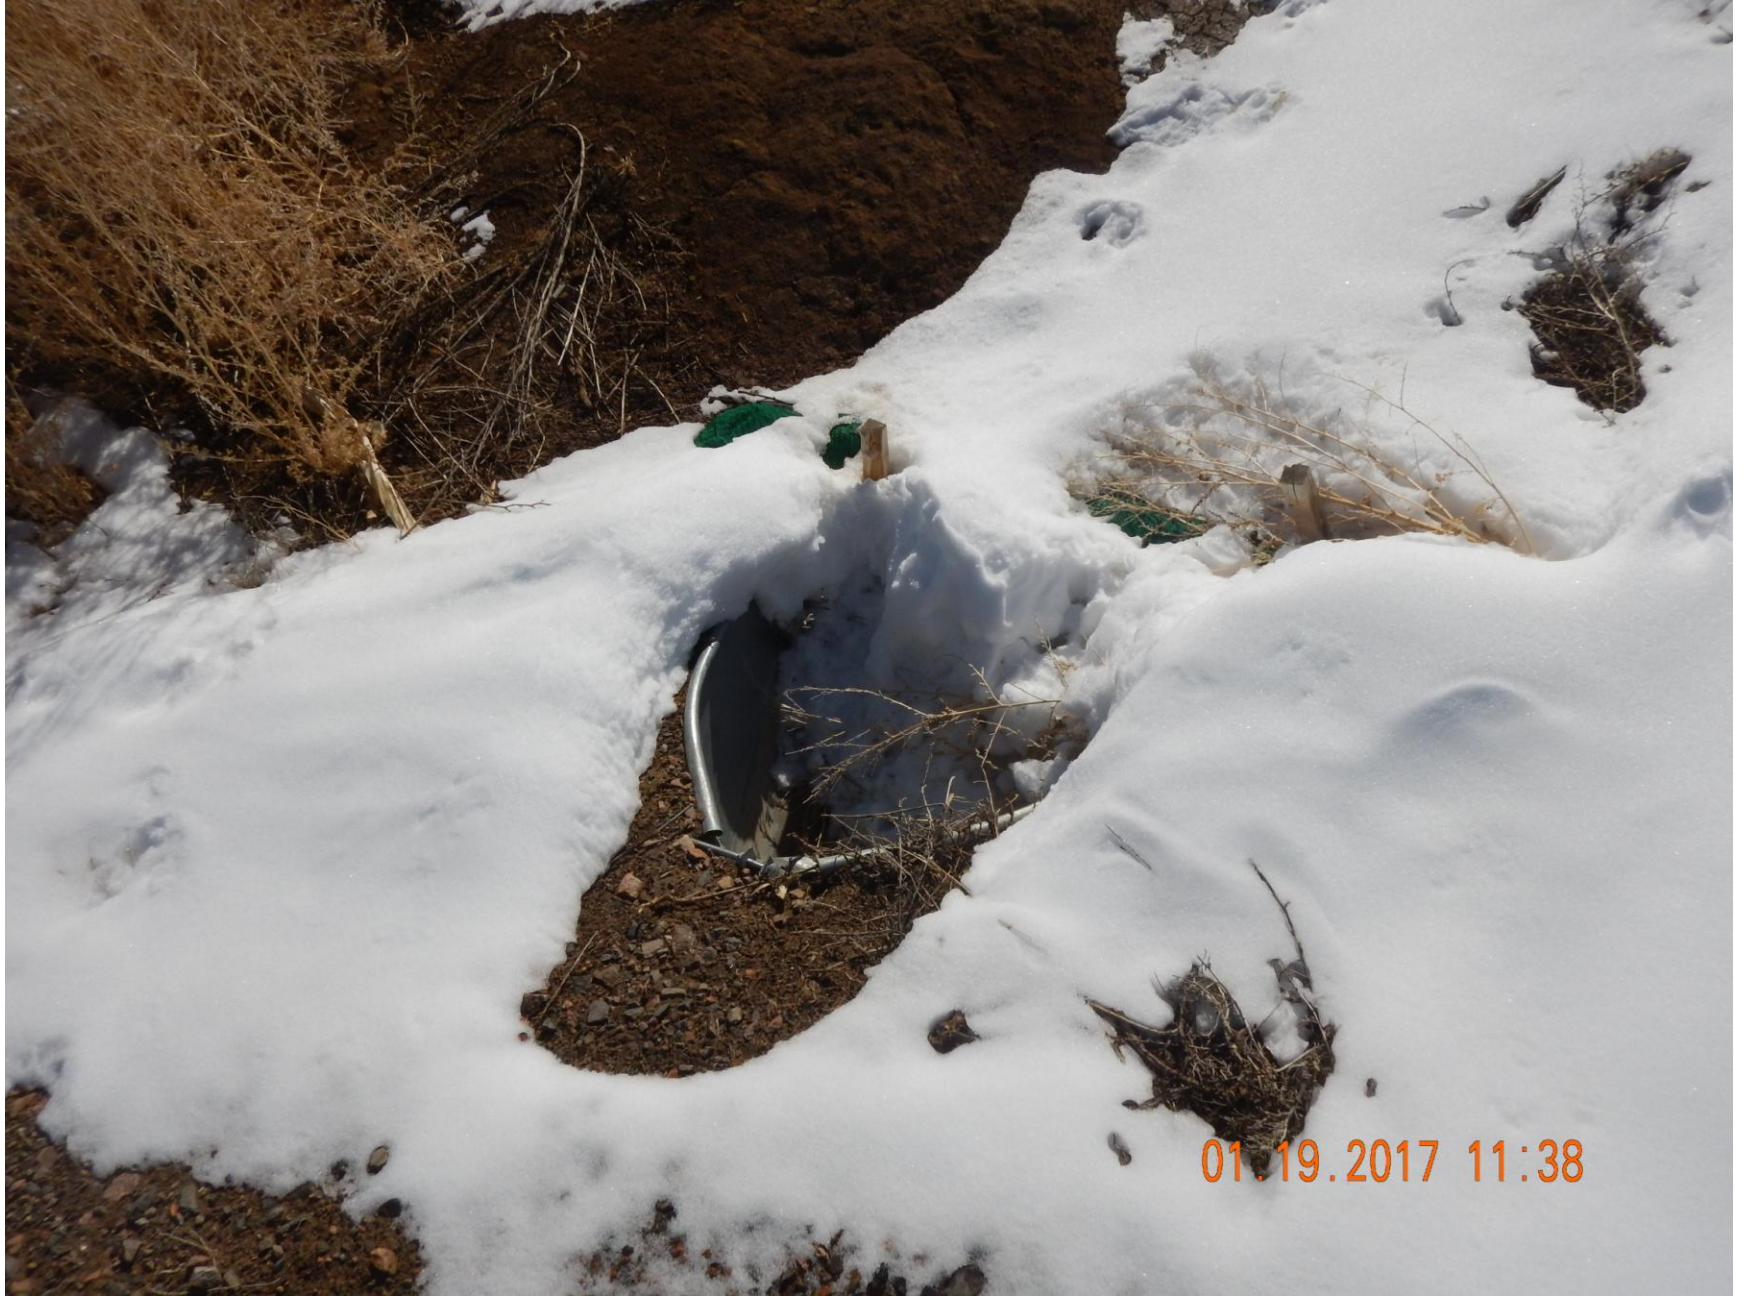
Figure 18: Photo taken from the east end of the location at access road. Photo shows culvert

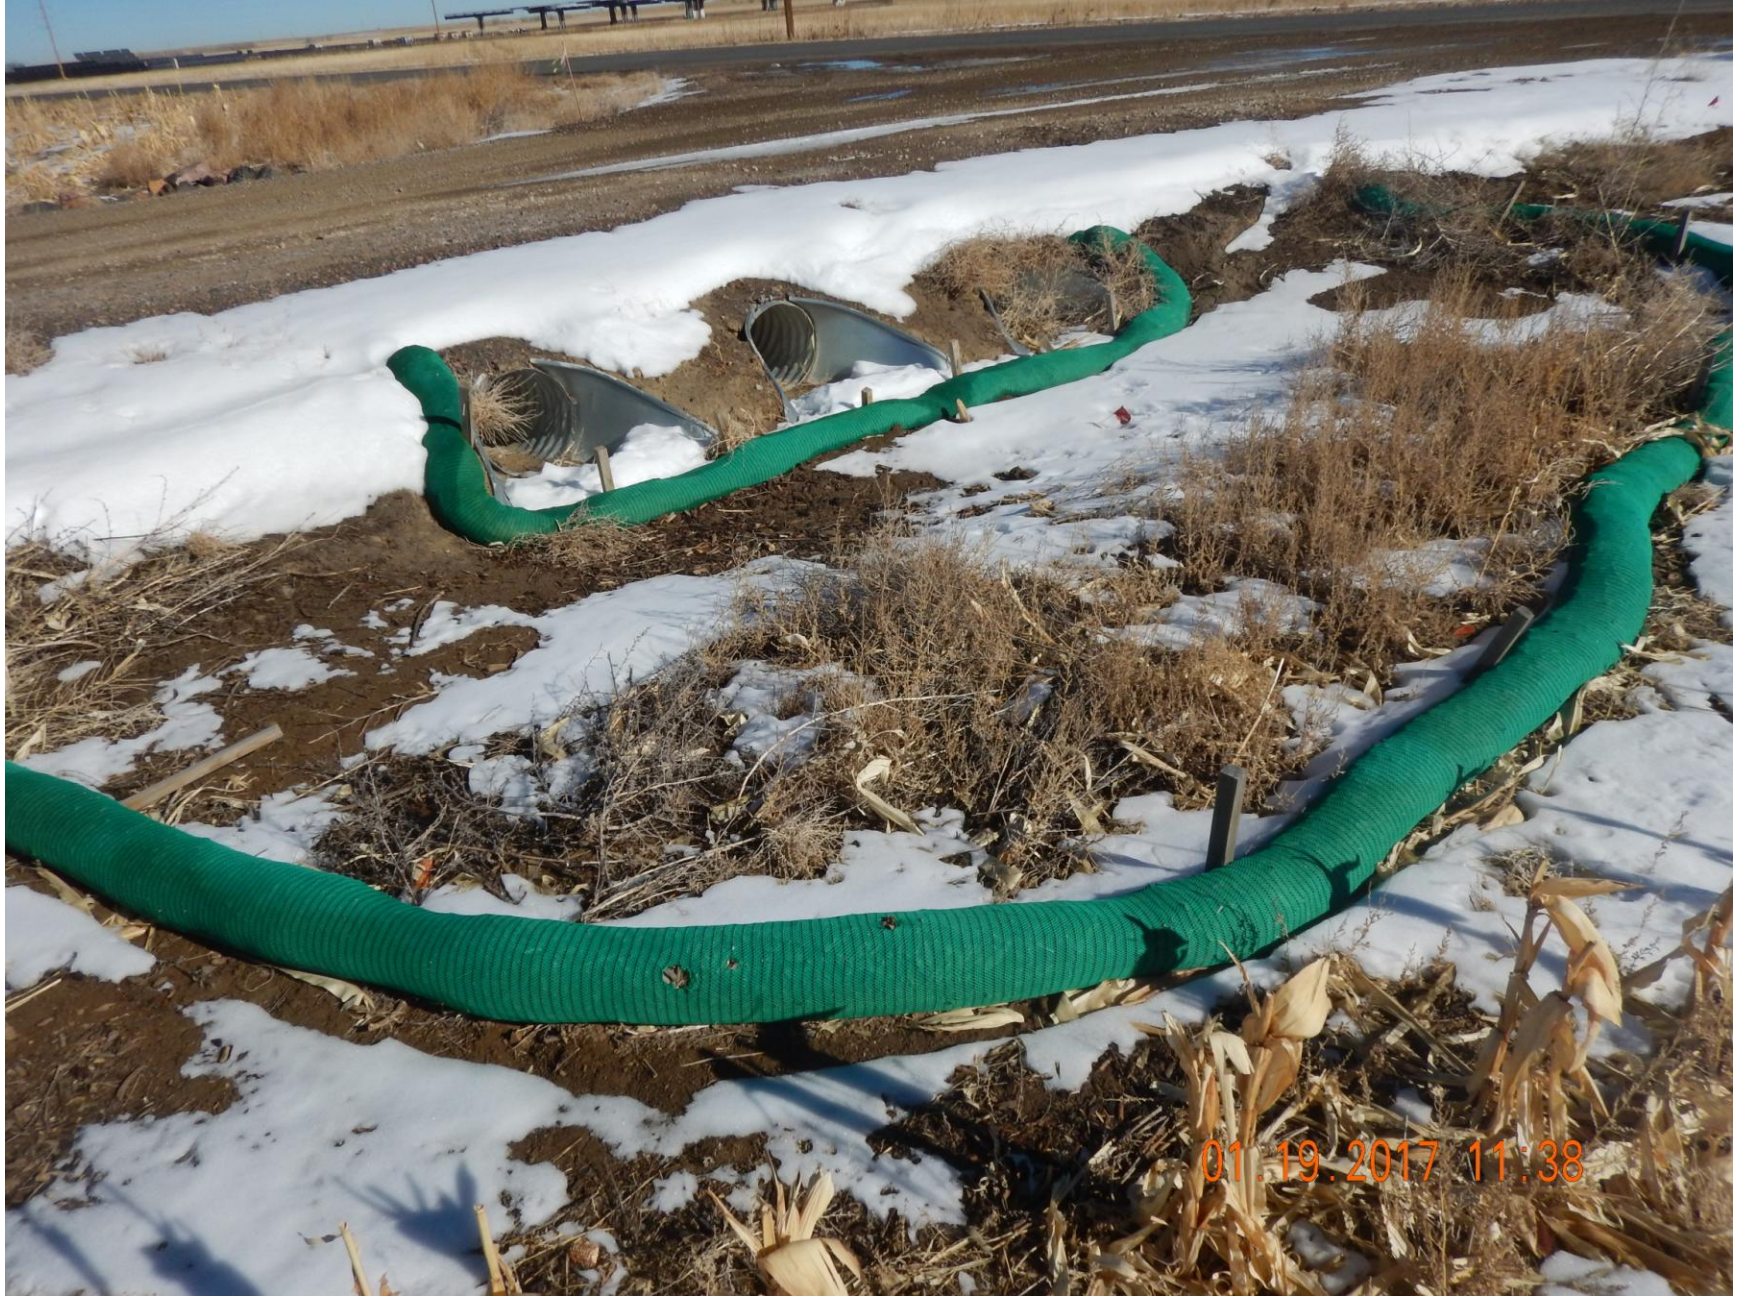
Figure 19: Photo taken from the access road near the country road, east .Photo shows culvert and stormwater BMPs

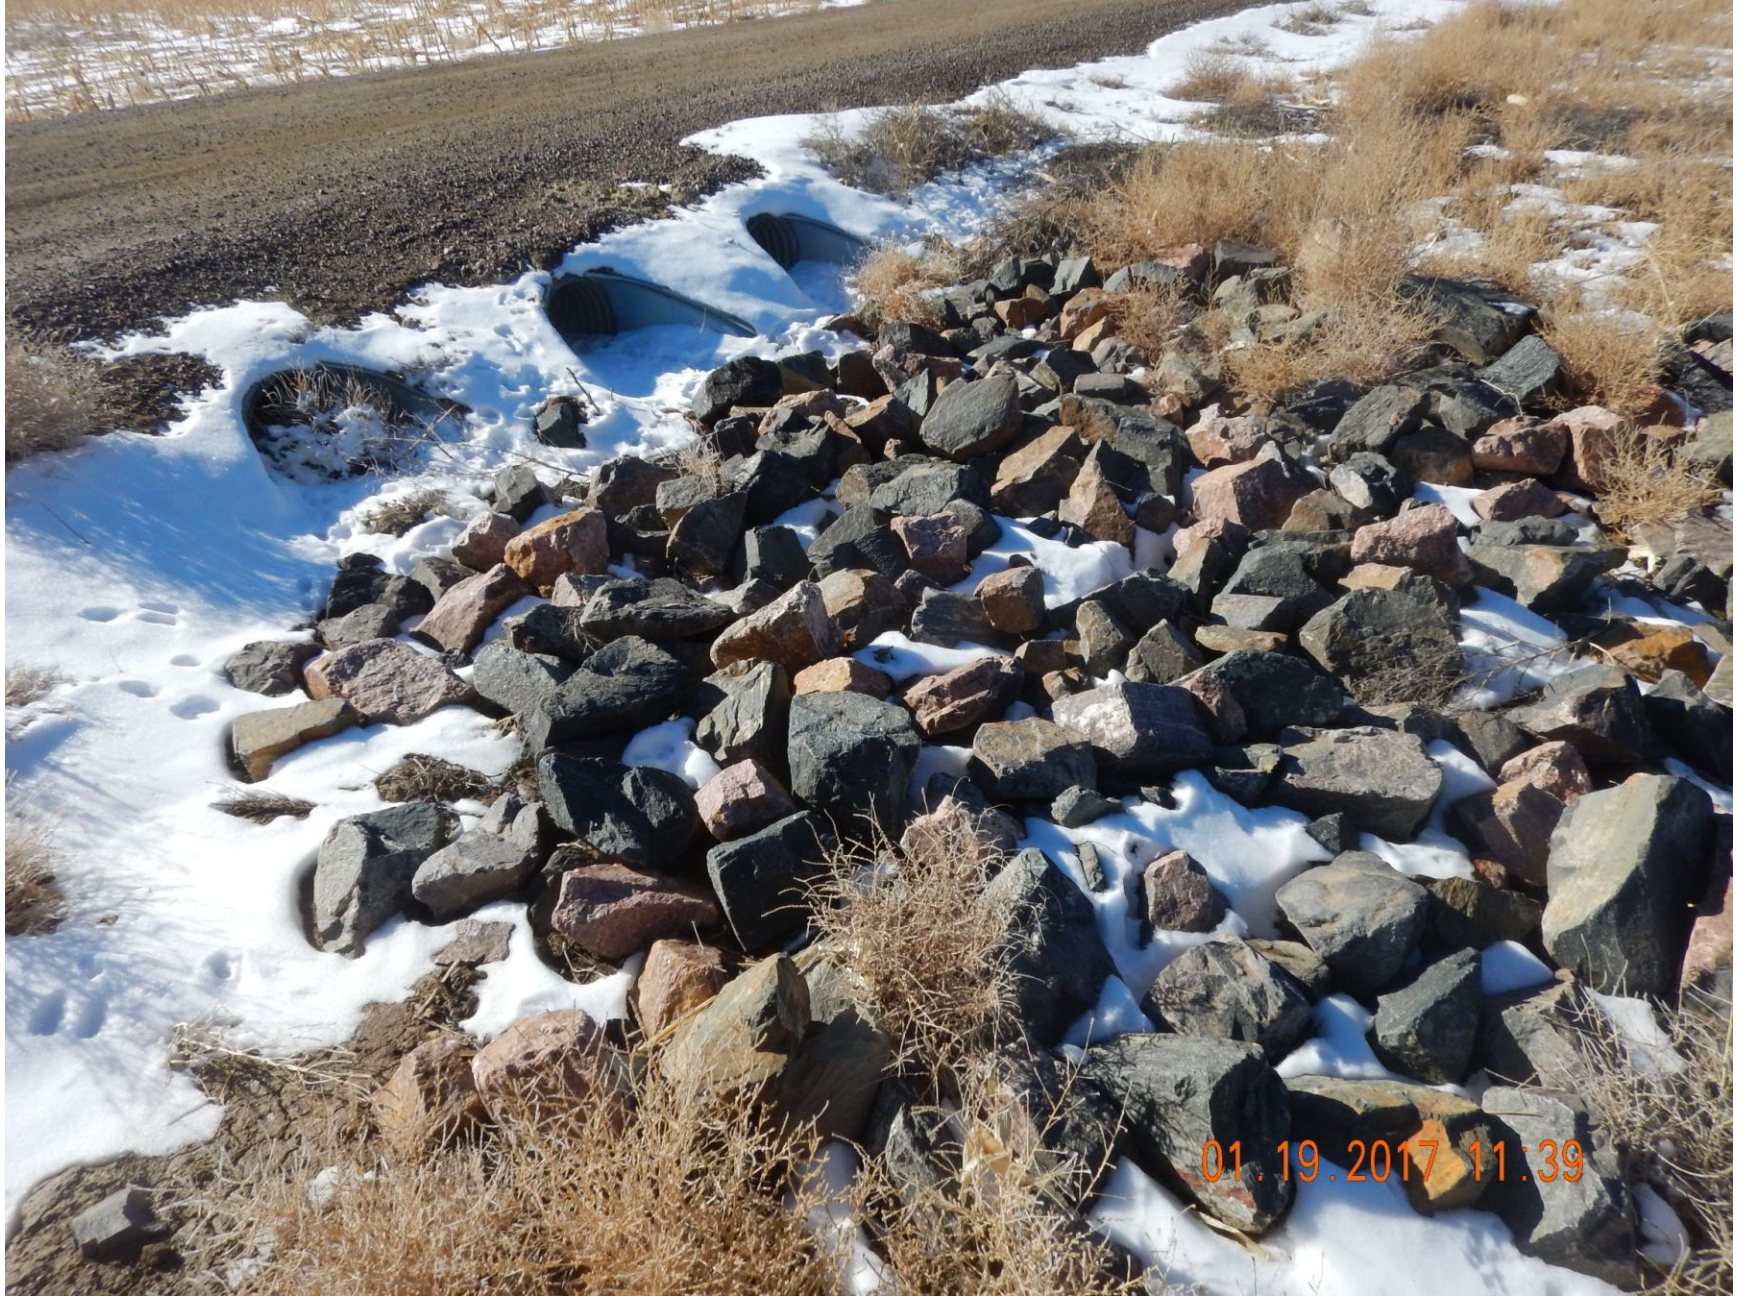
Figure 20: Photo taken from the access road near the country road, east .Photo shows culvert and stormwater BMPs
