Fox Engineering Solutions, Inc.

Re: SG 31-32-796 Smith Gulch – Hydrotest Results
NEW ¼ Section 32, Township 7 South, Range 96 West, 6th P.M. Garfield County, CO

Hydrostatic Pit Testing

SG 31-32-796 (Smith Gulch) Completions Pit

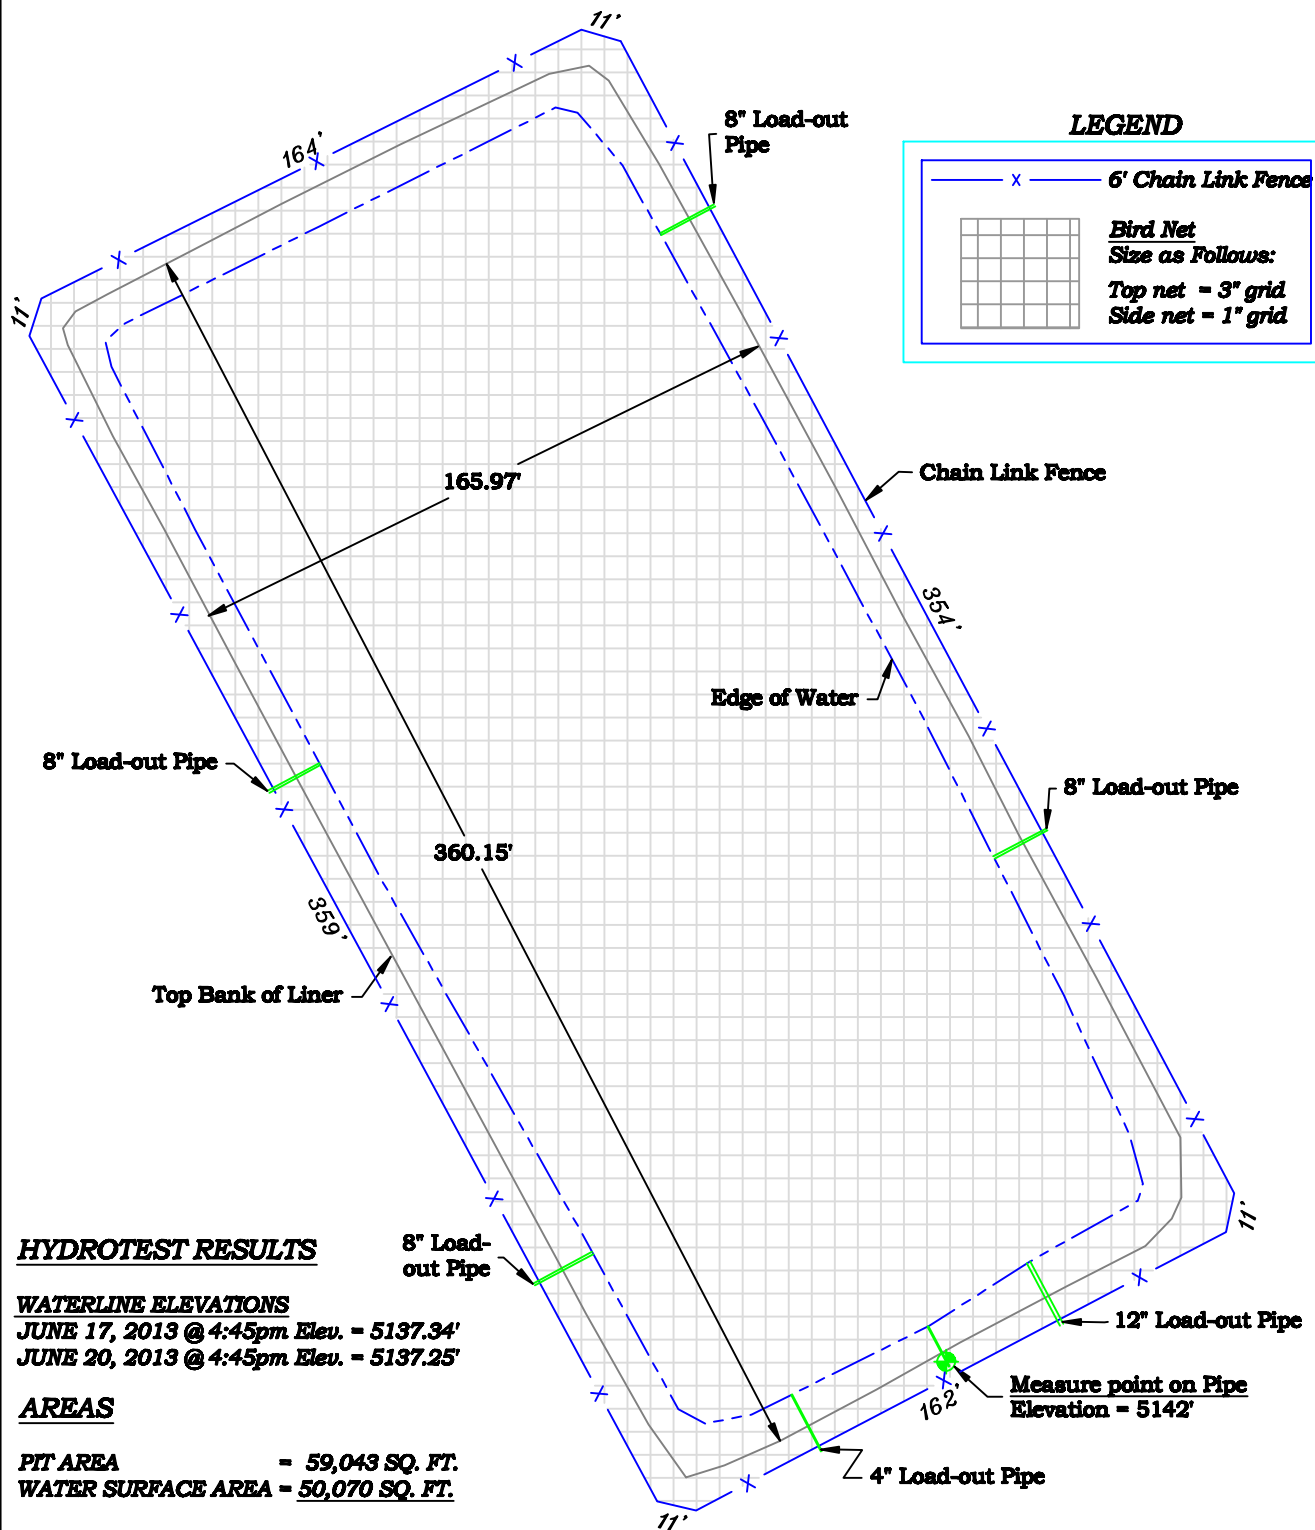
Hydro-test Exhibit Prepared for:

WATERLINE ELEVATIONS

JUNE 17, 2013 @ 4:45pm Elev. = 5137.34'

JUNE 20, 2013 @ 4:45pm Elev. = 5137.25'

AREAS

PIT AREA = 59,043 SQ. FT.

WATER SURFACE AREA = 50,070 SQ. FT.

TRIBUTARY AREA = 8,973 SQ. FT.
