Stormwater Inspection

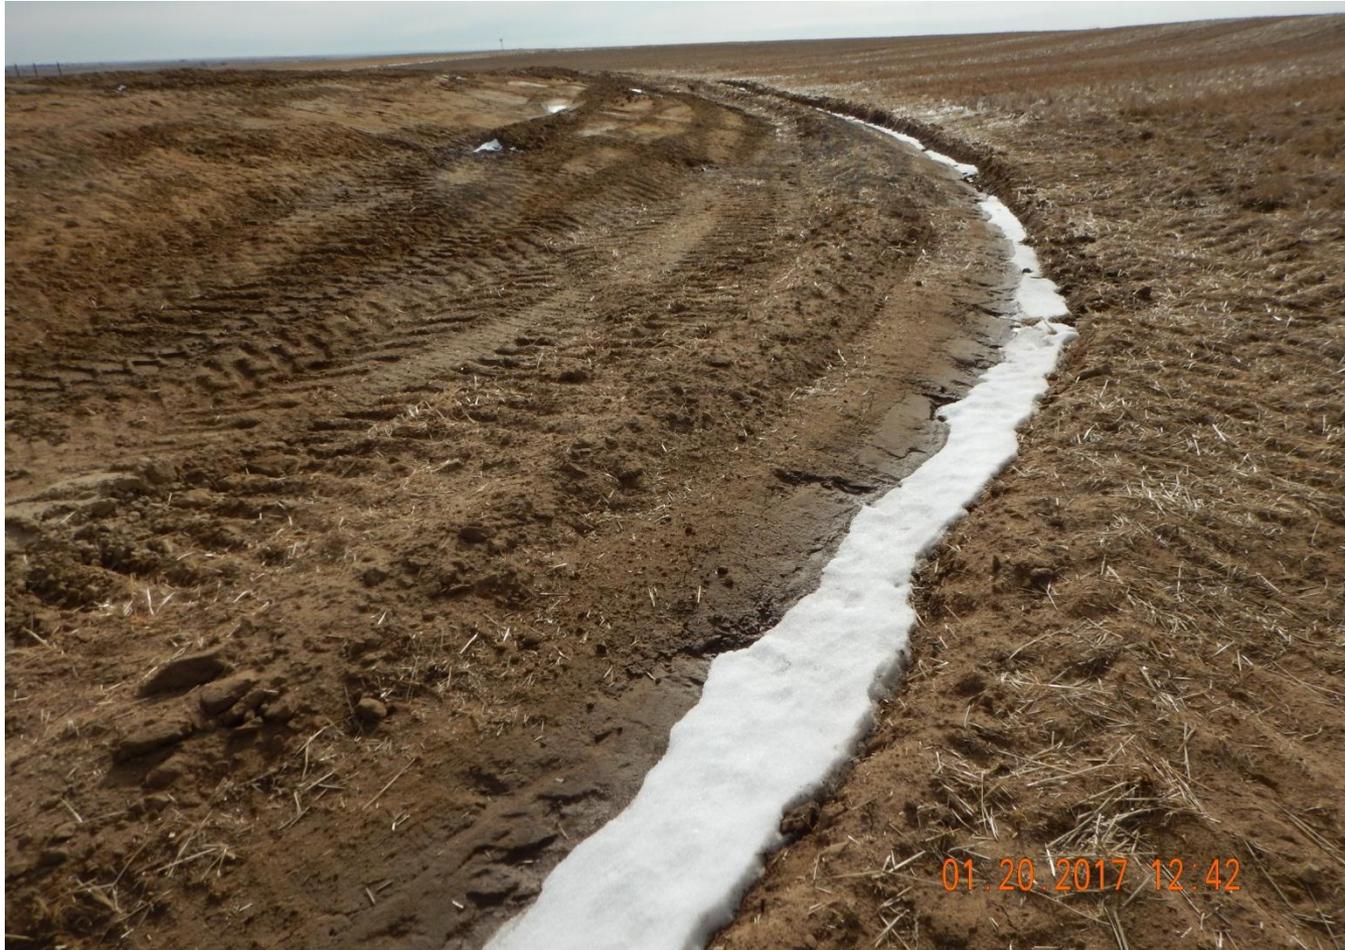
Photo 1. Photo taken from the northwest location, facing South. Insufficient BMP installed around perimeter of location (i.e., swallow ditch) with no, to minimal unconsolidated berm. BMP appears to be in the same condition as the previous inspection.

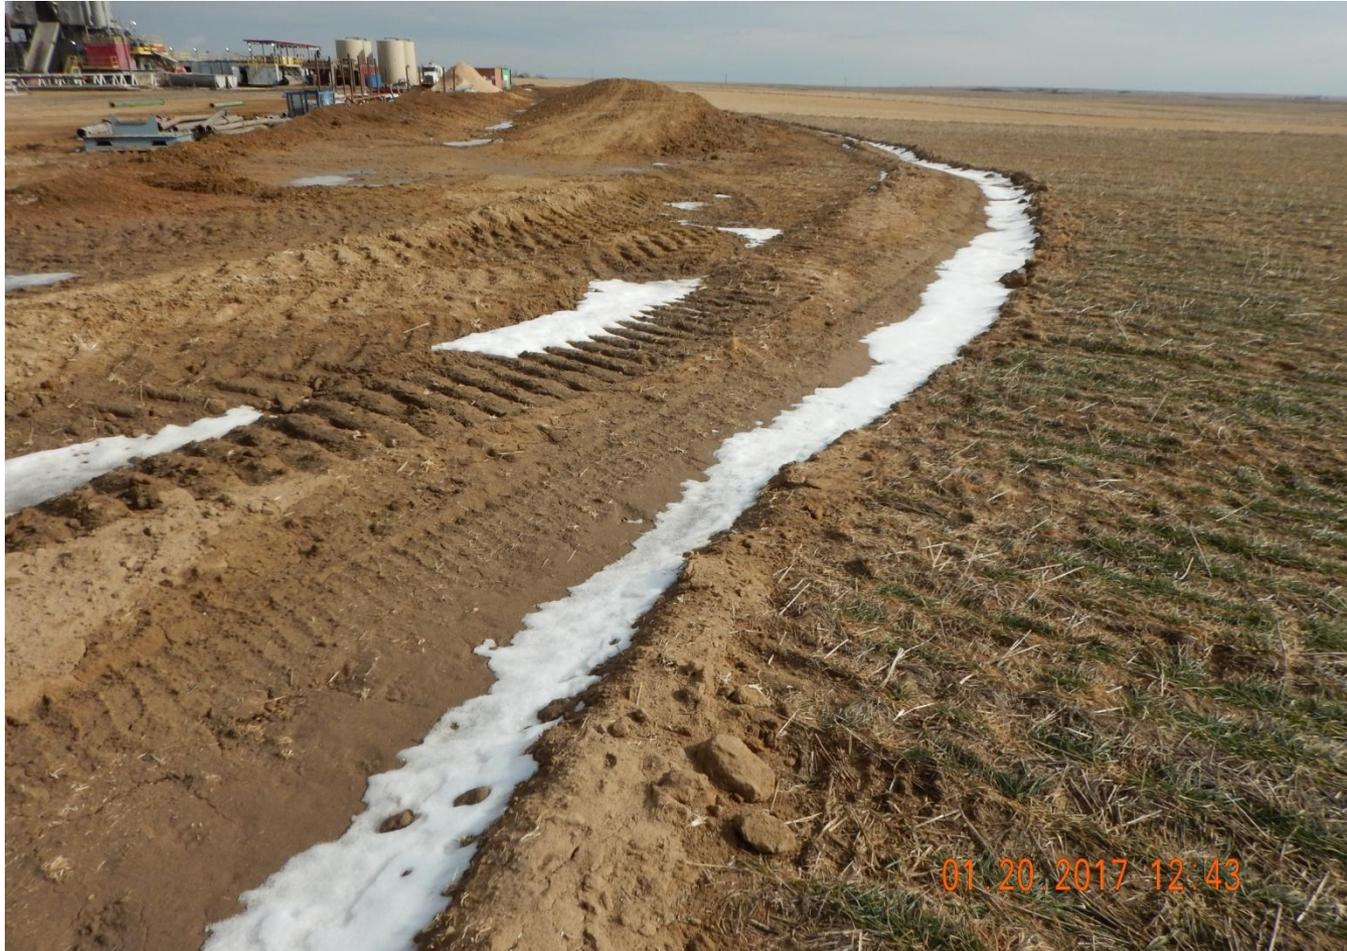
Photo 2. Photo taken from the southwest location, facing East. Insufficient BMP installed around perimeter of location (i.e., swallow ditch) with no, to minimal unconsolidated berm. BMP appears to be in the same condition as the previous inspection.

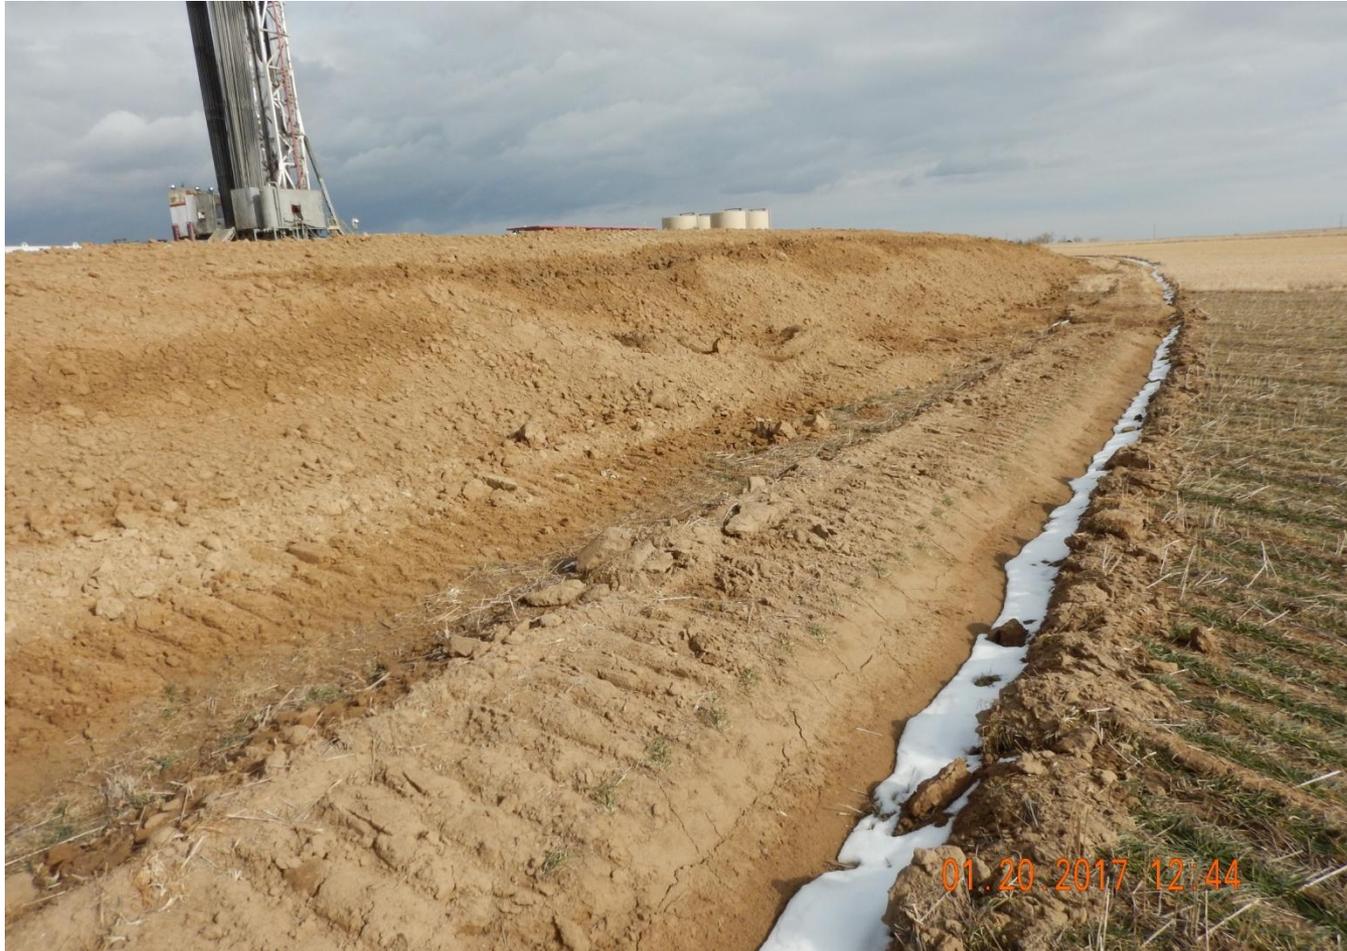
Photo 3. Photo taken from the southern location, facing East. Insufficient BMP installed around perimeter of location (i.e., swallow ditch) with no, to minimal unconsolidated berm. BMP appears to be in the same condition as the previous inspection.

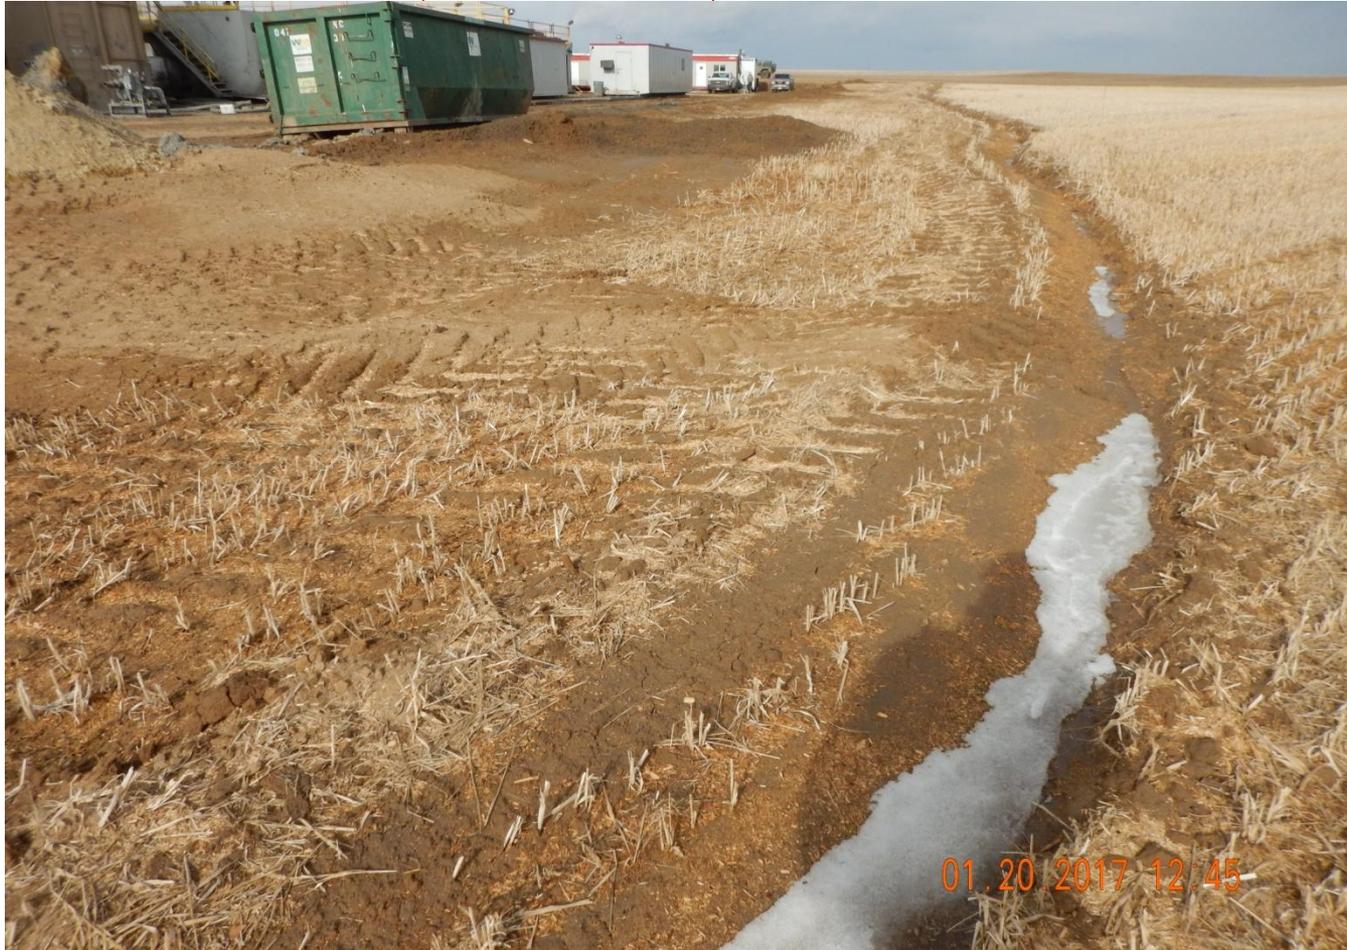
Photo 4. Photo taken from the southeast location, facing North. Insufficient BMP installed around perimeter of location (i.e., swallow ditch) with no, to minimal unconsolidated berm. BMP appears to be in the same condition as the previous inspection.

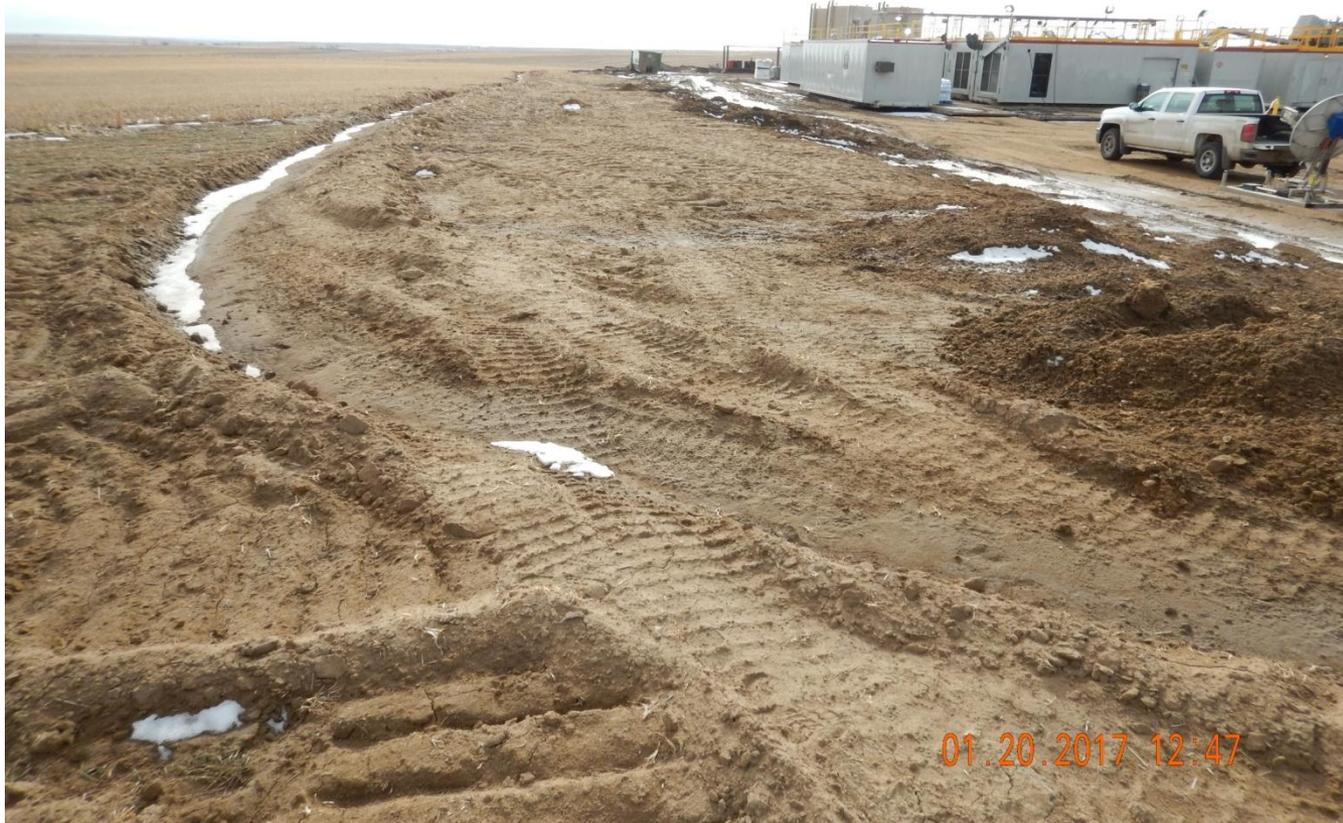
Photo 5. Photo taken from the northeast location, facing South. Insufficient BMP installed around perimeter of location (i.e., swallow ditch) with no, to minimal unconsolidated berm. BMP appears to be in the same condition as the previous inspection.
