Construction and Stormwater Inspection- Overview

Google Earth aerial photo taken 10/9/2015 of the GUEST 3N-12HZ location. Total area of 6.9 acres was mapped on 1/19/2017 using a Trimble Juno 3B handheld device. Perimeter of location mapped and highlighted in red. Intermittent Stream is the nearest downgradient surface water feature east of location by 75 feet.

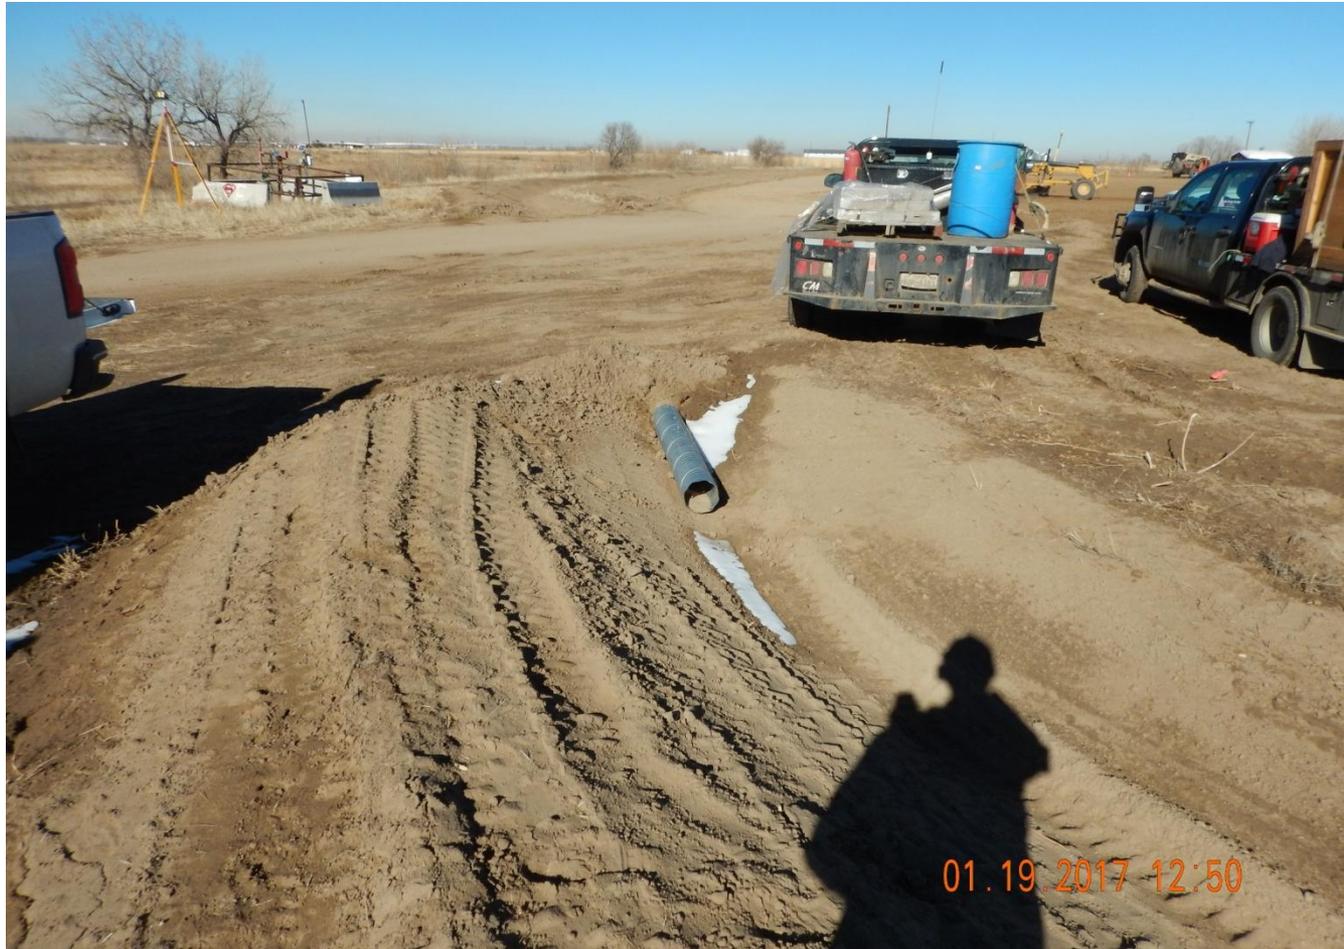
Photo 1. Photo taken from the entrance of location, facing North. Ditch and berm BMP installed around the entire perimeter of the location. Culvert installed in conjunction with ditch.

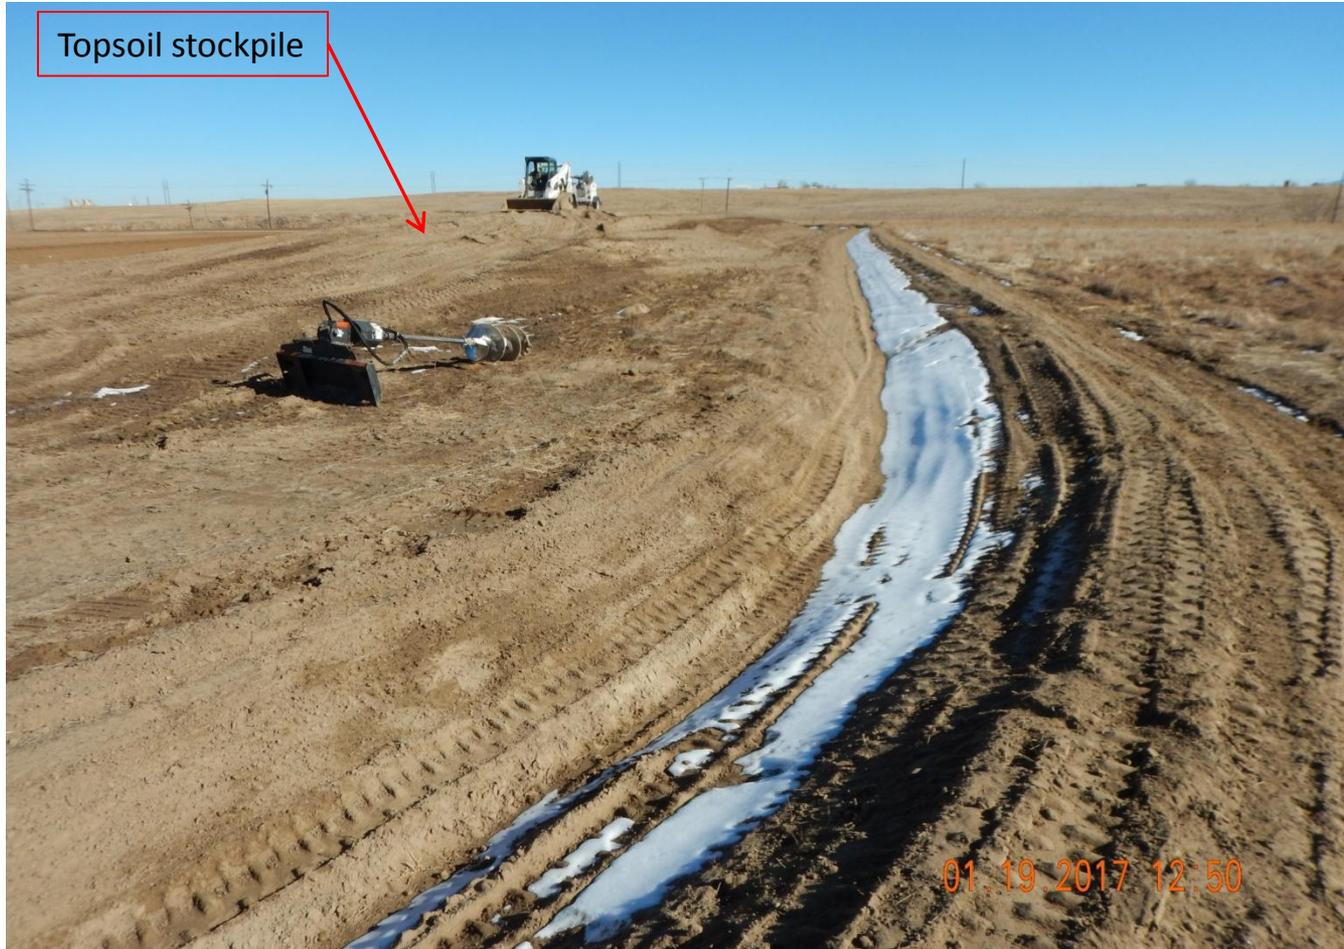
Photo 2. Photo taken from the southwest location, facing East. Ditch and berm BMP installed around the entire perimeter of the location. Topsoil has been salvaged, stored, and temporarily stabilized (i.e., tracked) along the southern perimeter location.

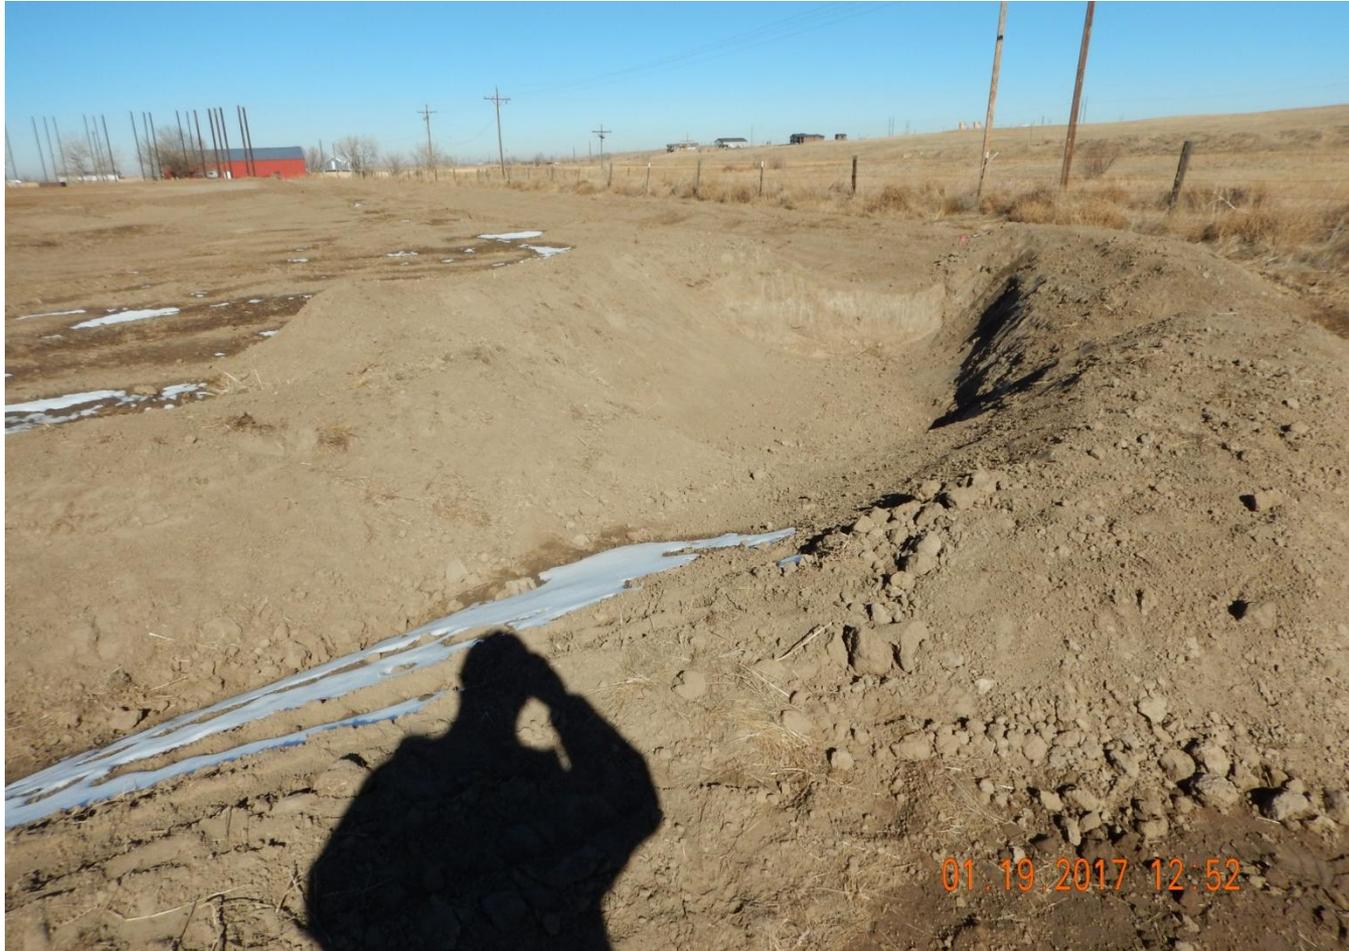
Photo 3. Photo taken from the southeast location, facing North. Sediment trap IN-PROCESS of being constructed.

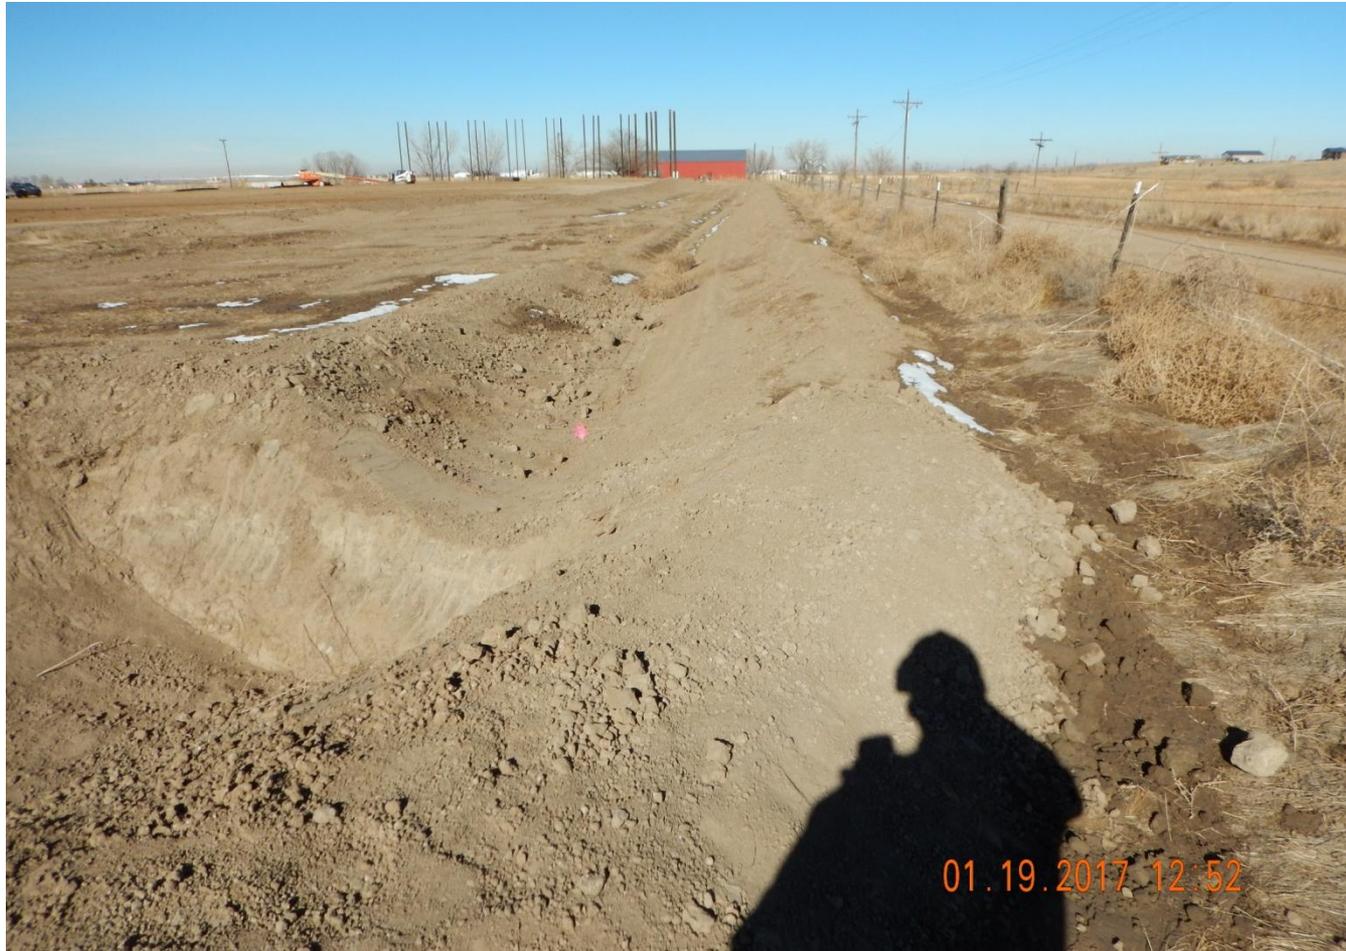
Photo 4. Photo taken from the southeast location, facing North. Ditch and berm BMP installed around the entire perimeter of the location.

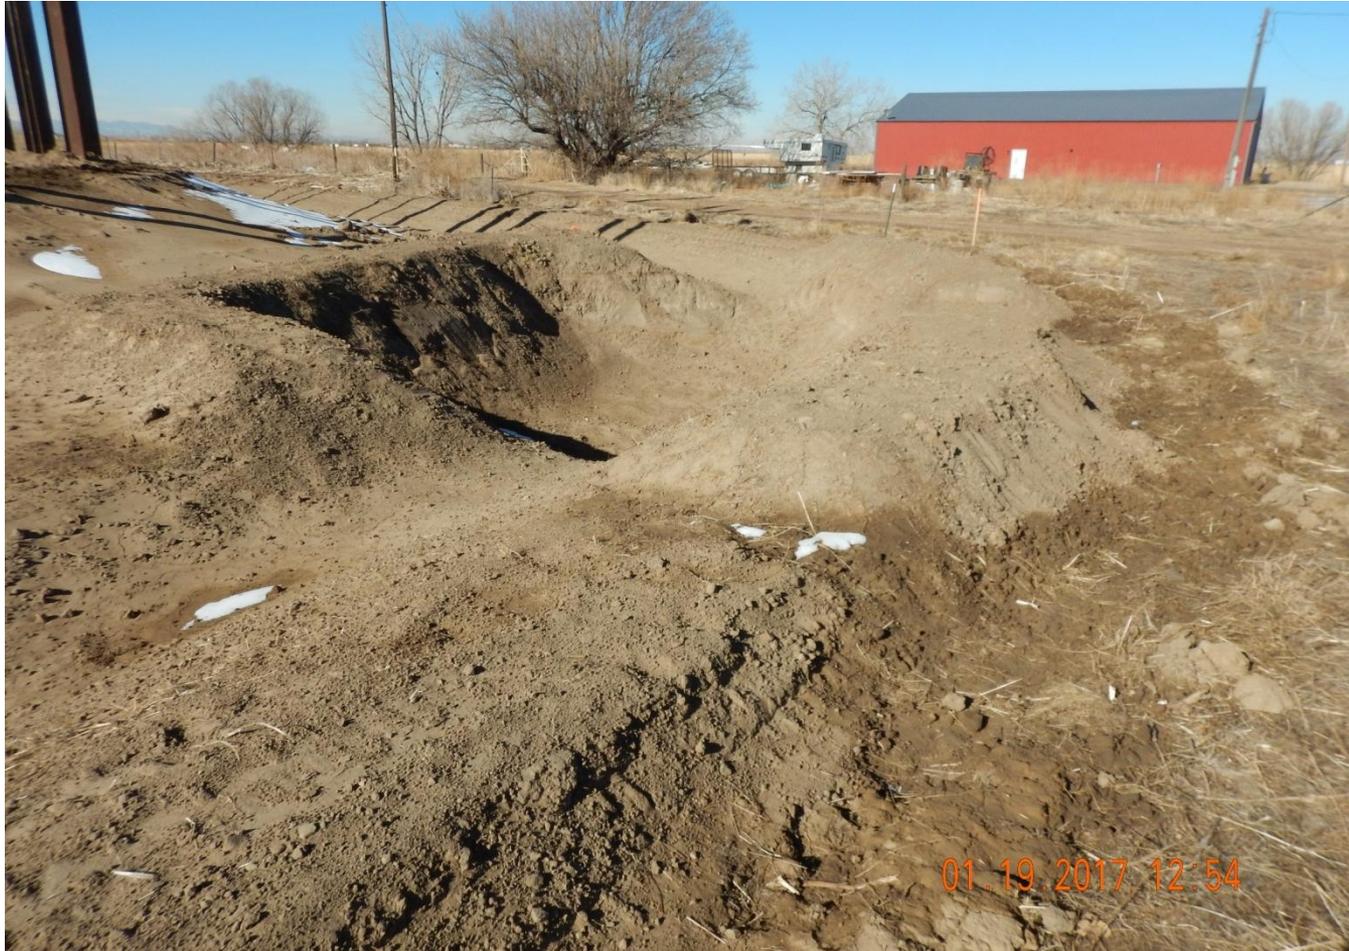
Photo 5. Photo taken from the northeast location, facing North. Sediment trap IN-PROCESS of being constructed.

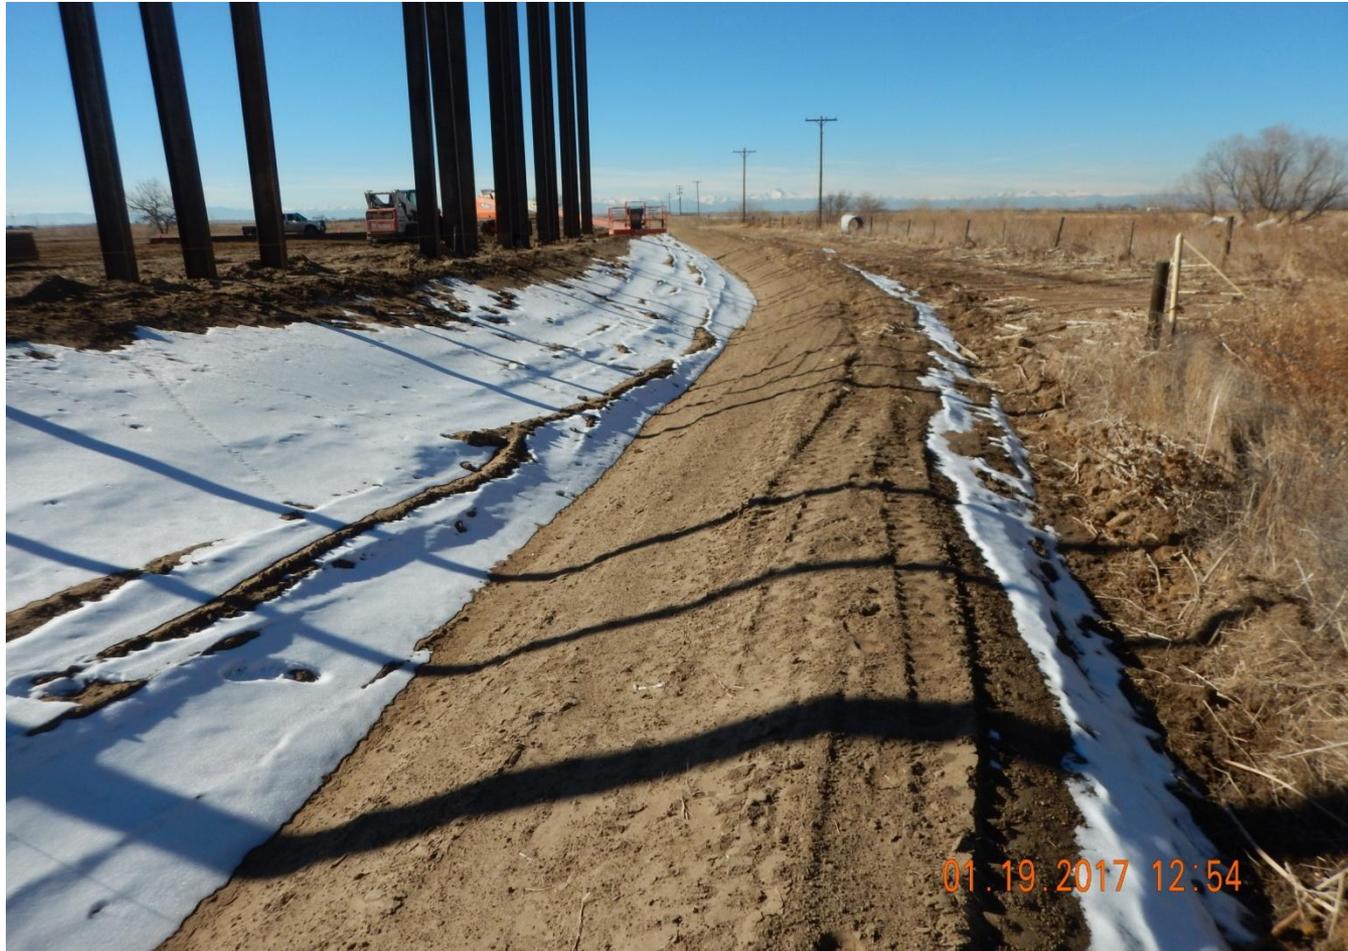
Photo 6. Photo taken from the northeast location, facing West. Ditch and berm BMP installed around the entire perimeter of the location.

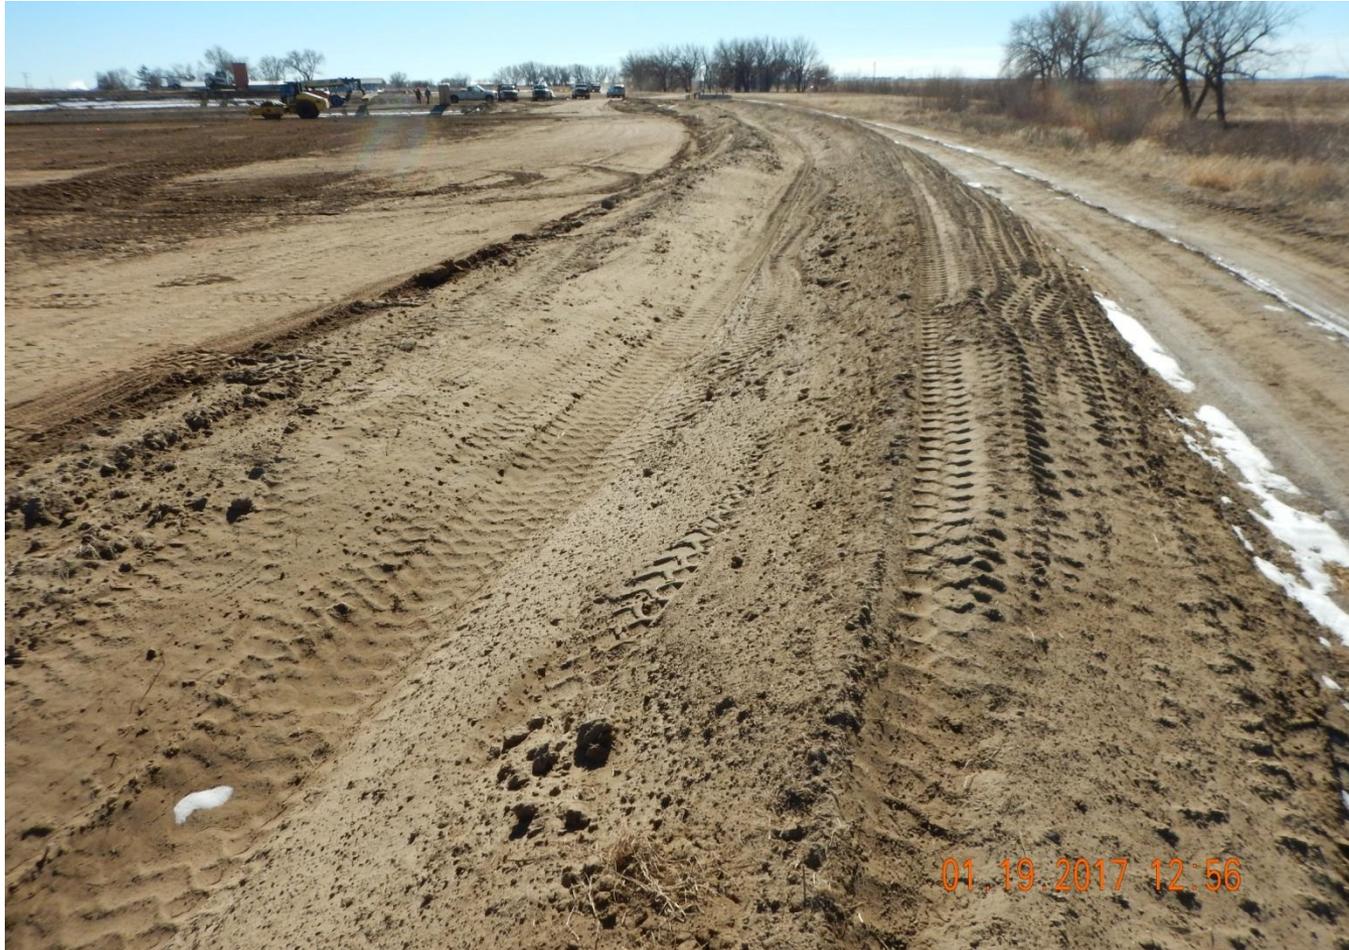
Photo 7. Photo taken from the northwest location, facing South. Ditch and berm BMP installed around the entire perimeter of the location.

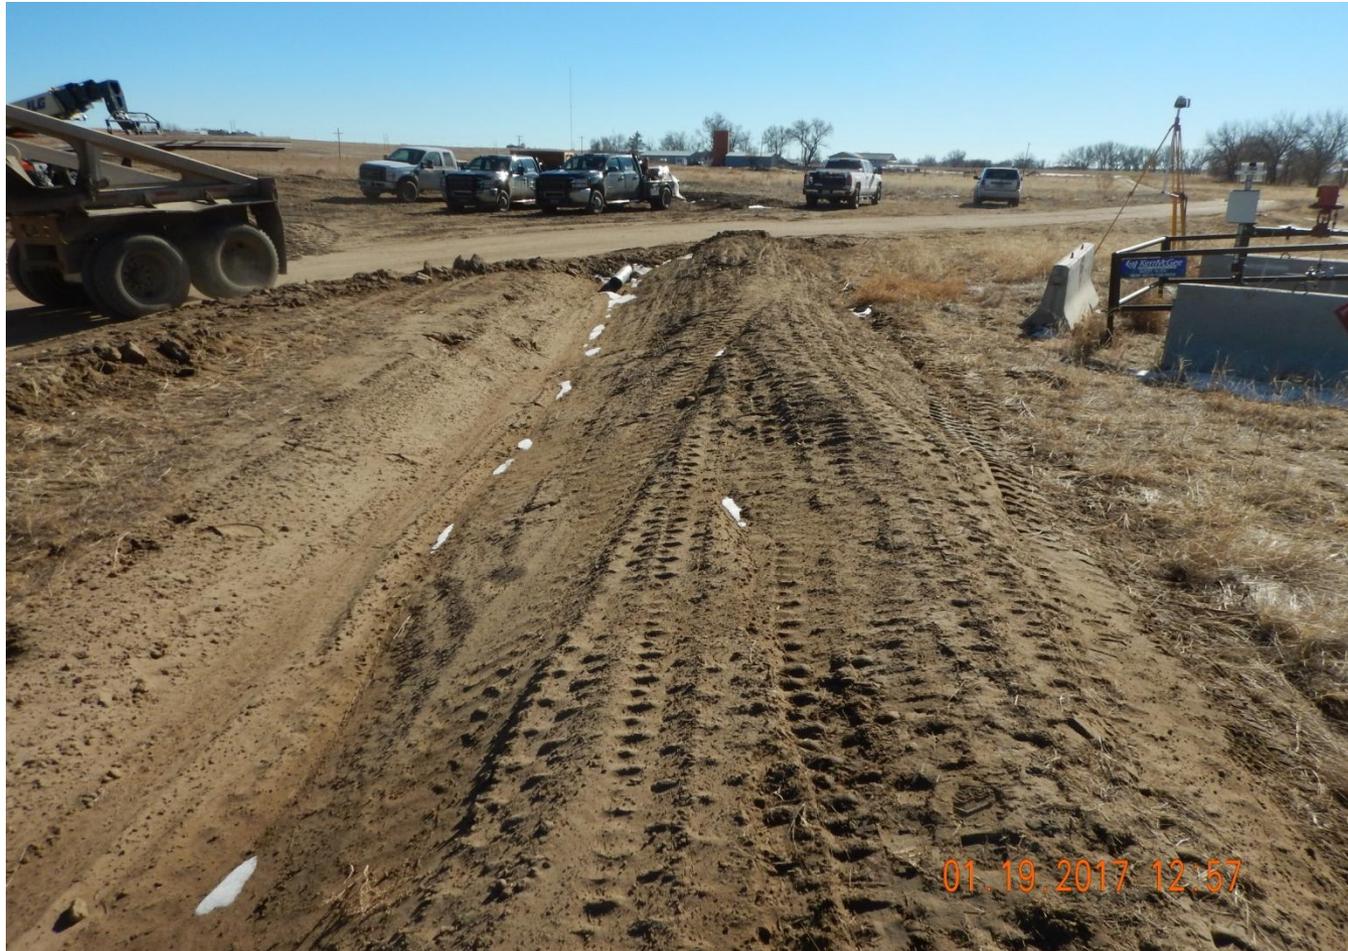
Photo 8. Photo taken from the entrance of location, facing South. Ditch and berm BMP installed around the entire perimeter of the location. Culvert installed in conjunction with ditch.
