Construction and Stormwater Inspection- Overview

Google Earth aerial photo taken 10/9/2015 of the ACCO TERRA STATE 18-36 location. Total area of 4.94 acres was mapped on 1/19/2017 using a Trimble Juno 3B handheld device. Perimeter of location mapped and highlighted in red.

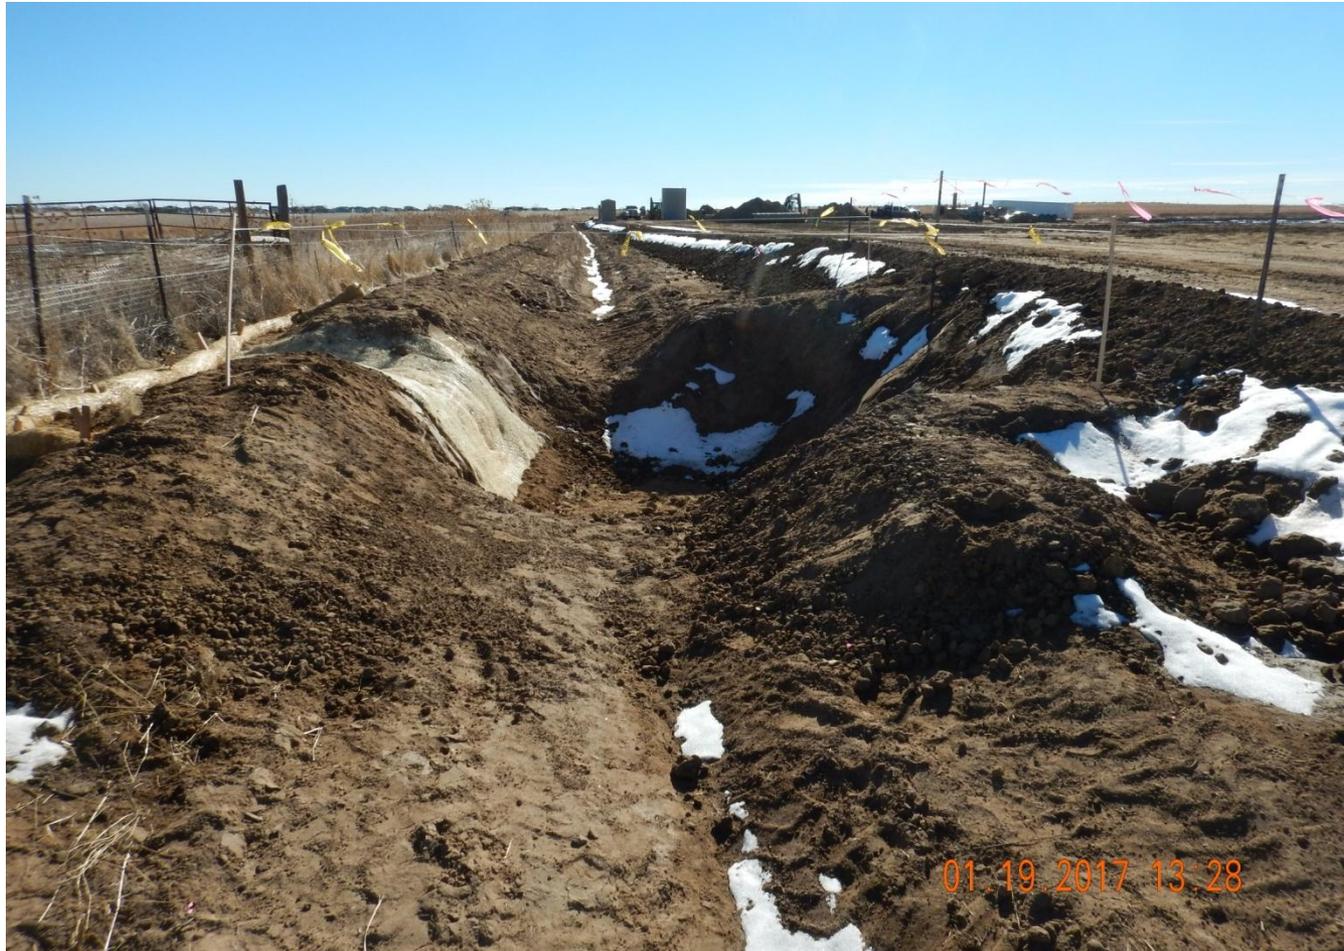
Photo 1. Photo taken from the entrance of location on the eastside of the access road, facing South. Ditch and berm BMP installed around the entire perimeter of the location. Sediment trap has been installed with a stabilized outlet.

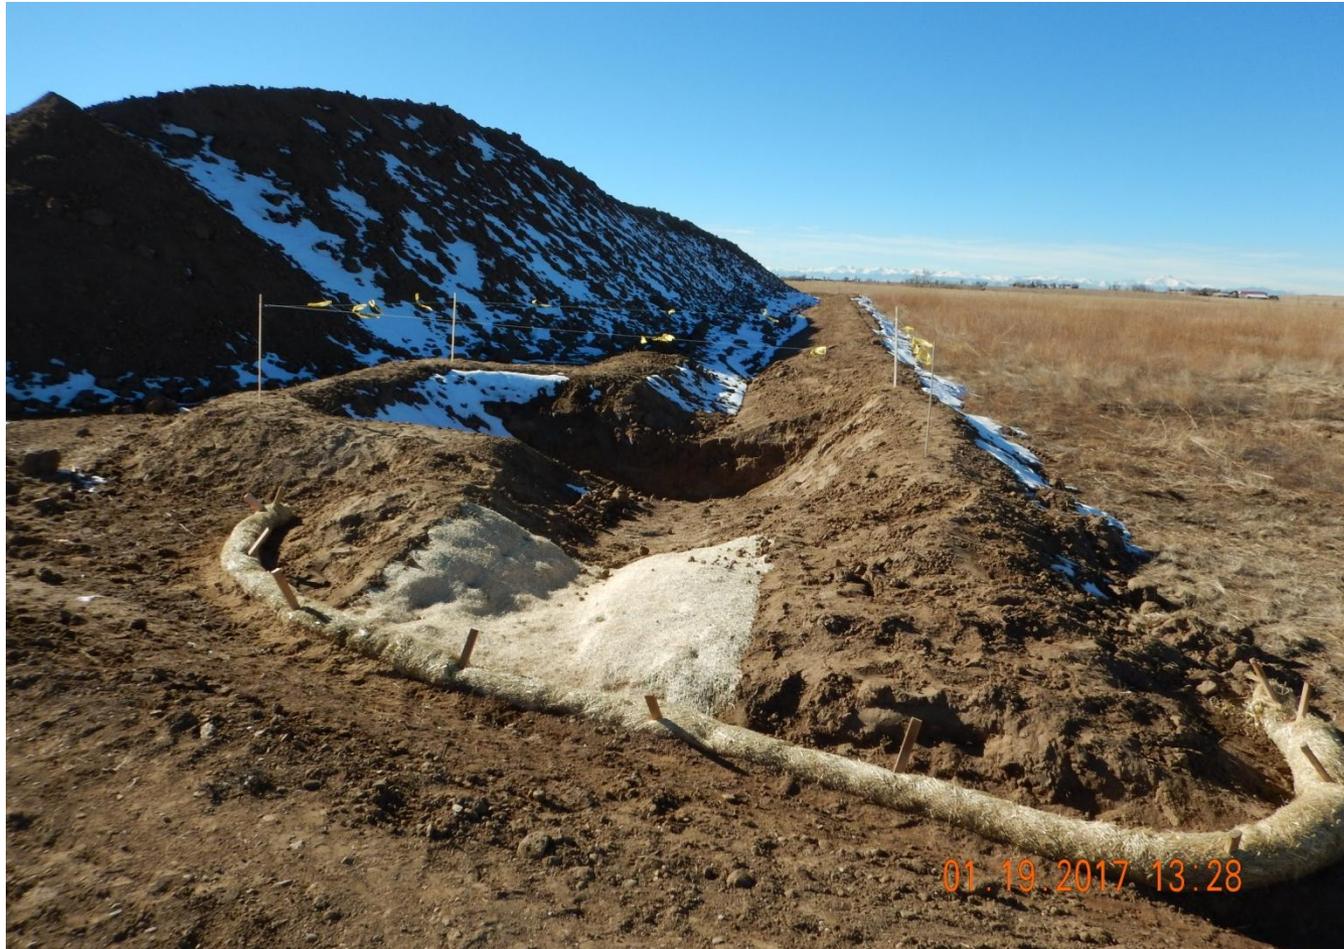
Photo 2. Photo taken from the entrance of location on the westside of the access road, facing West. Ditch and berm BMP installed around the entire perimeter of the location. Sediment trap has been installed with a stabilized outlet.

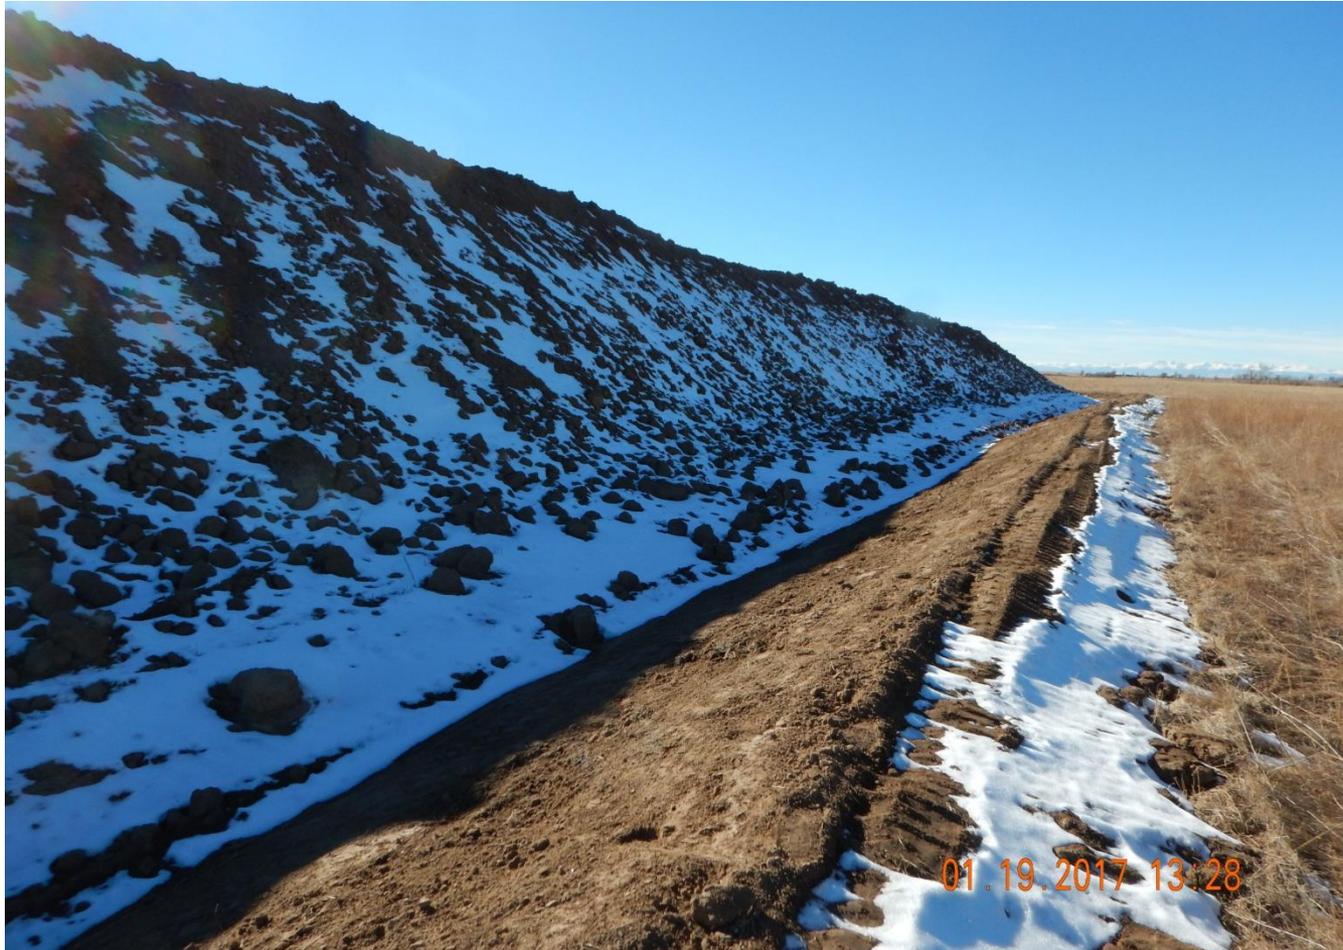
Photo 3. Photo taken from the northern location, facing West, towards the topsoil stockpile. Topsoil stockpile appears steep on the north-facing side and would be difficult for perennial vegetative growth to establish for stabilization. May consider re-contouring when conditions are suitable (i.e., after winter).

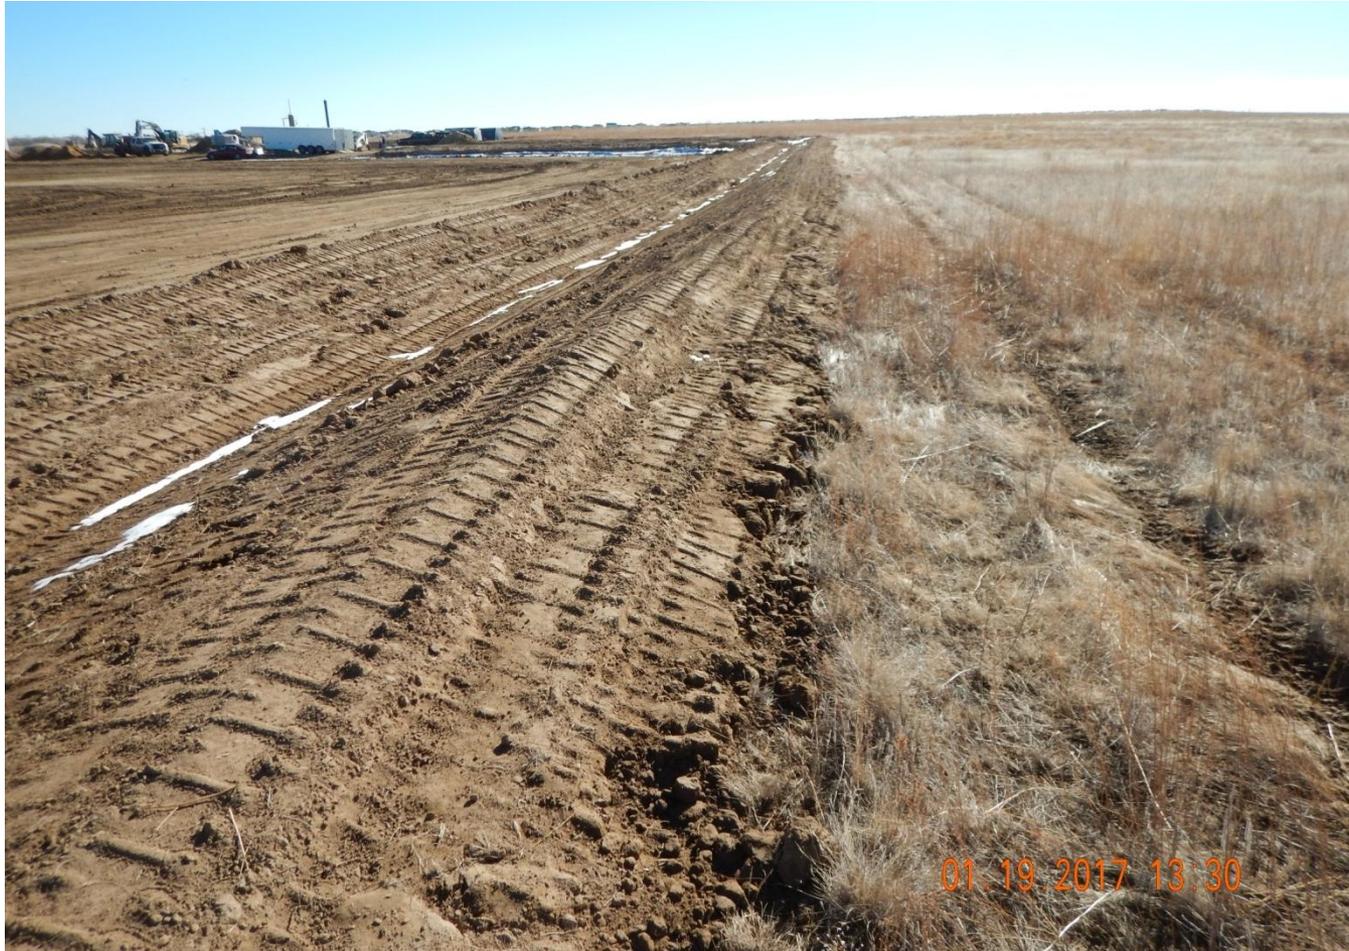
Photo 4. Photo taken from the western location, facing South. Ditch and berm BMP installed around the entire perimeter of the location.

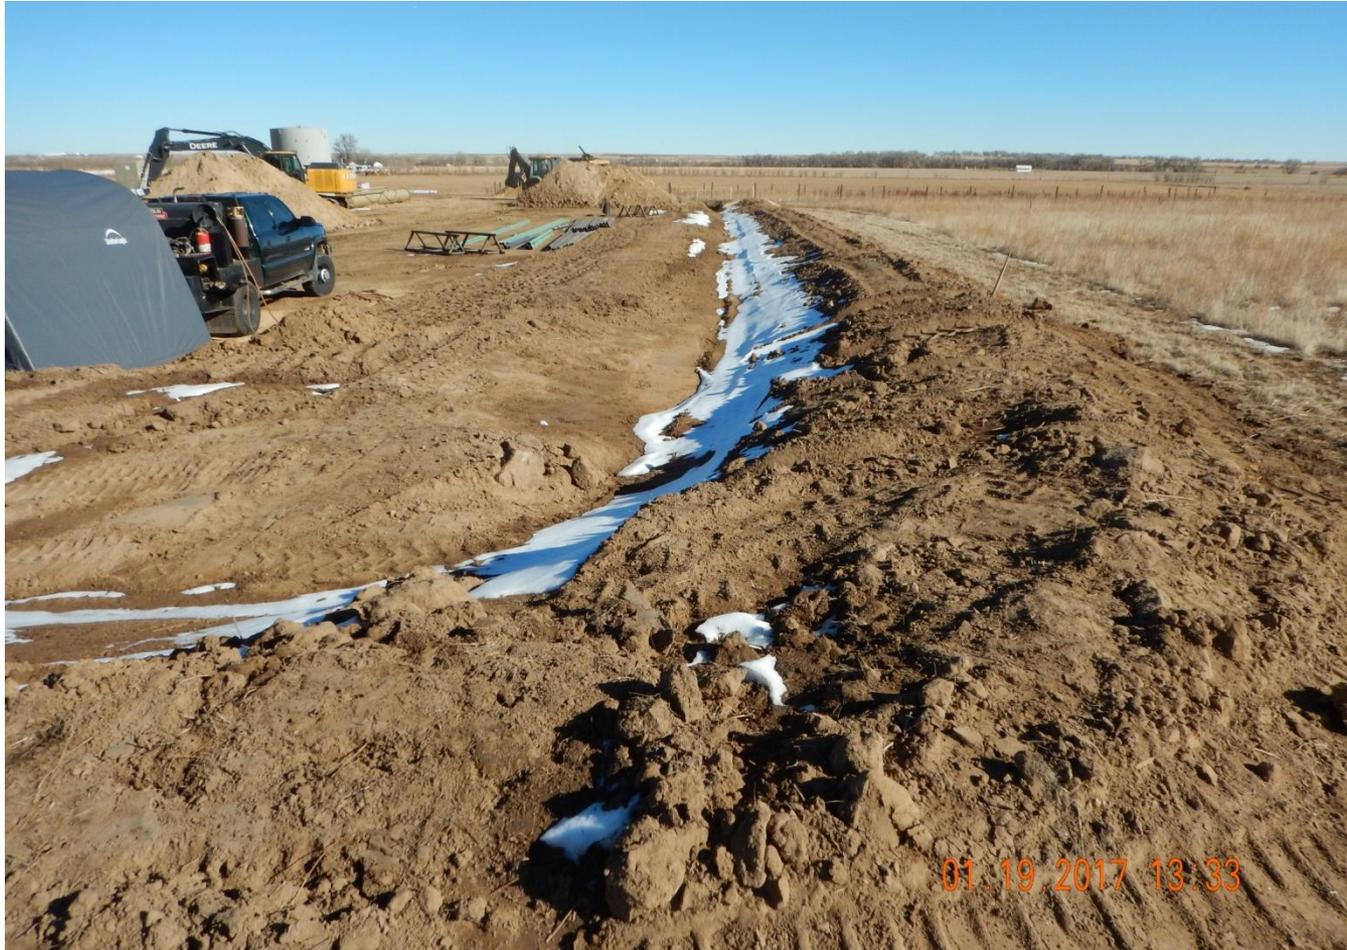
Photo 5. Photo taken from the southwest location, facing East. Ditch and berm BMP installed around the entire perimeter of the location.

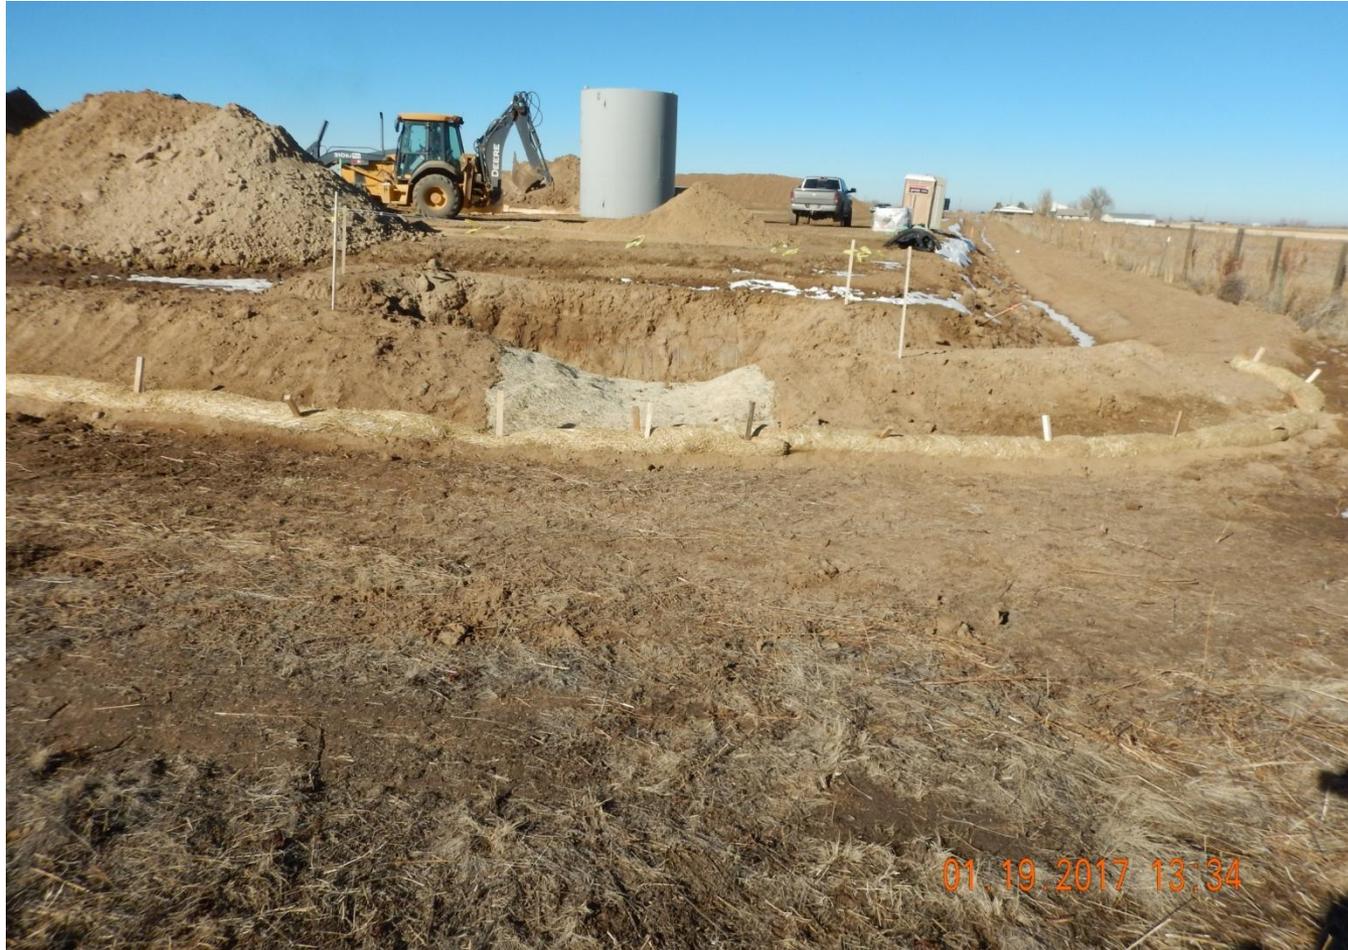
Photo 6. Photo taken from the southeast location, facing North. Ditch and berm BMP installed around the entire perimeter of the location. Sediment trap has been installed with a stabilized outlet.
