January 20, 2017

Inspection Photos: Kerr McGee PA North Rifle

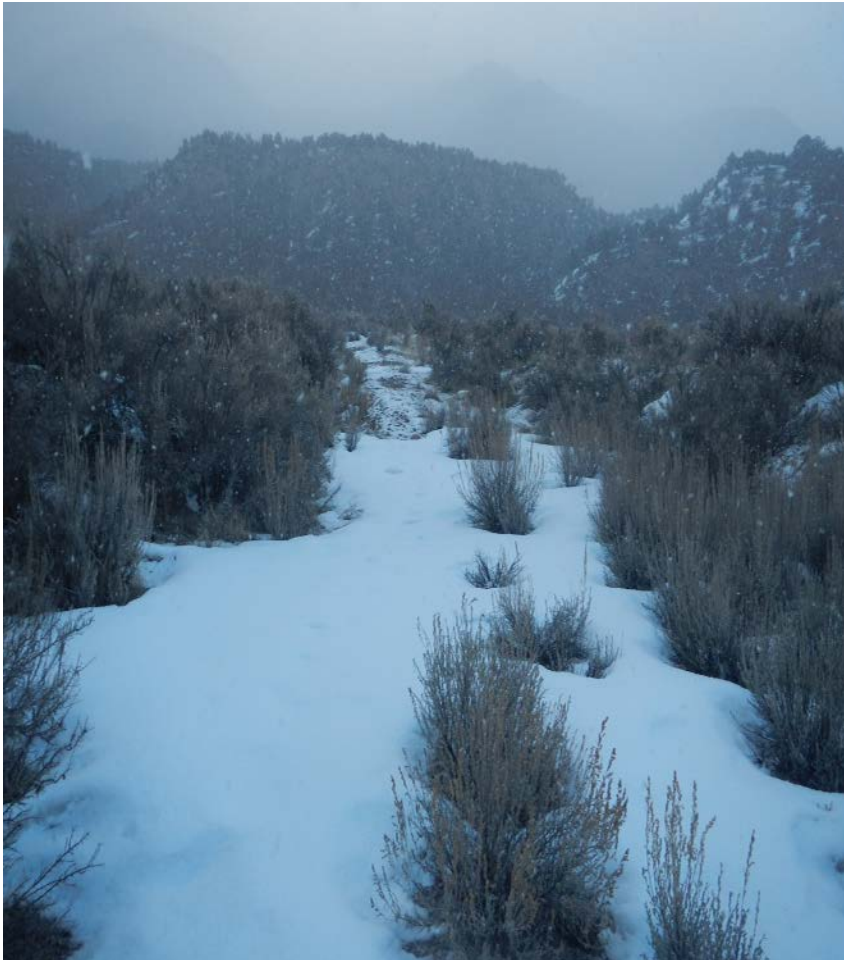
Photo#1:
Access Road into Location

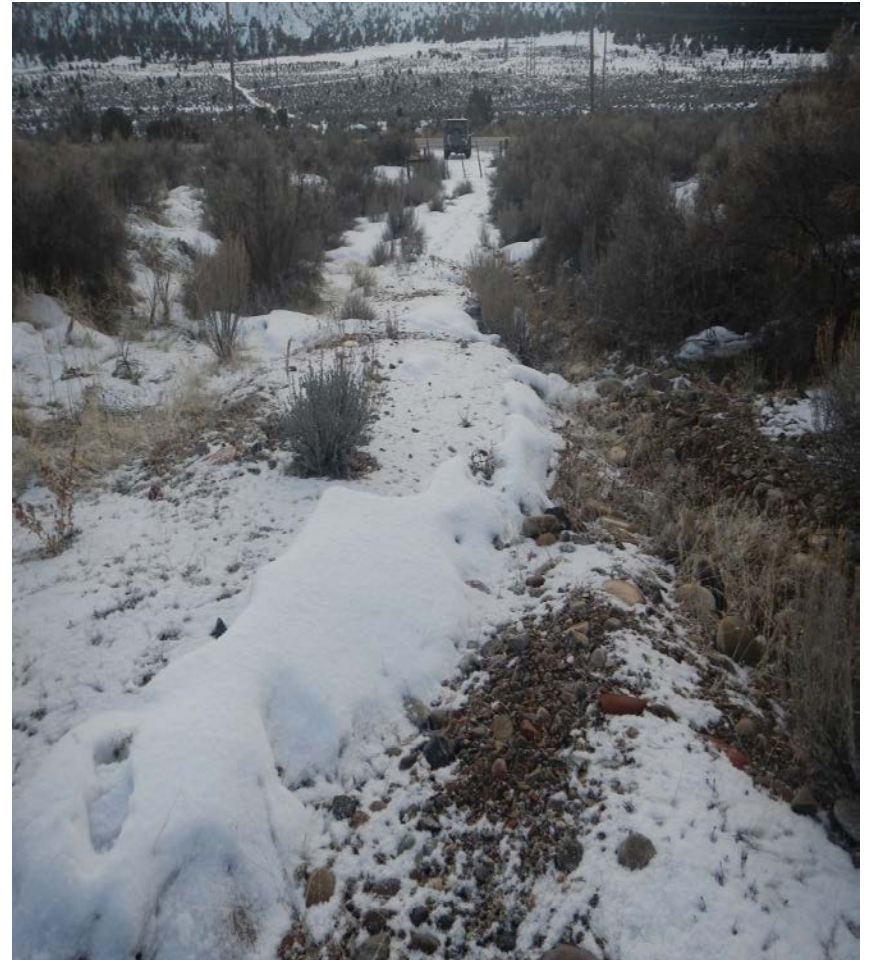
Photo#2:
Access Road exiting Location to HWY 13

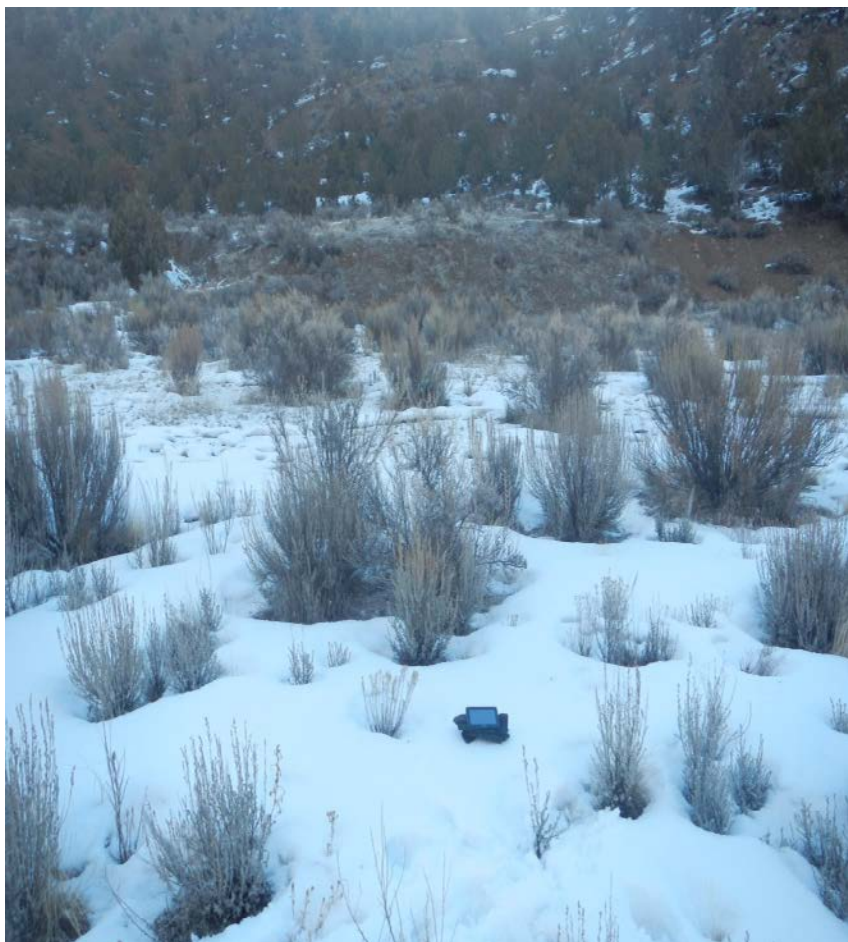
Photo#3:
View North over Location Center

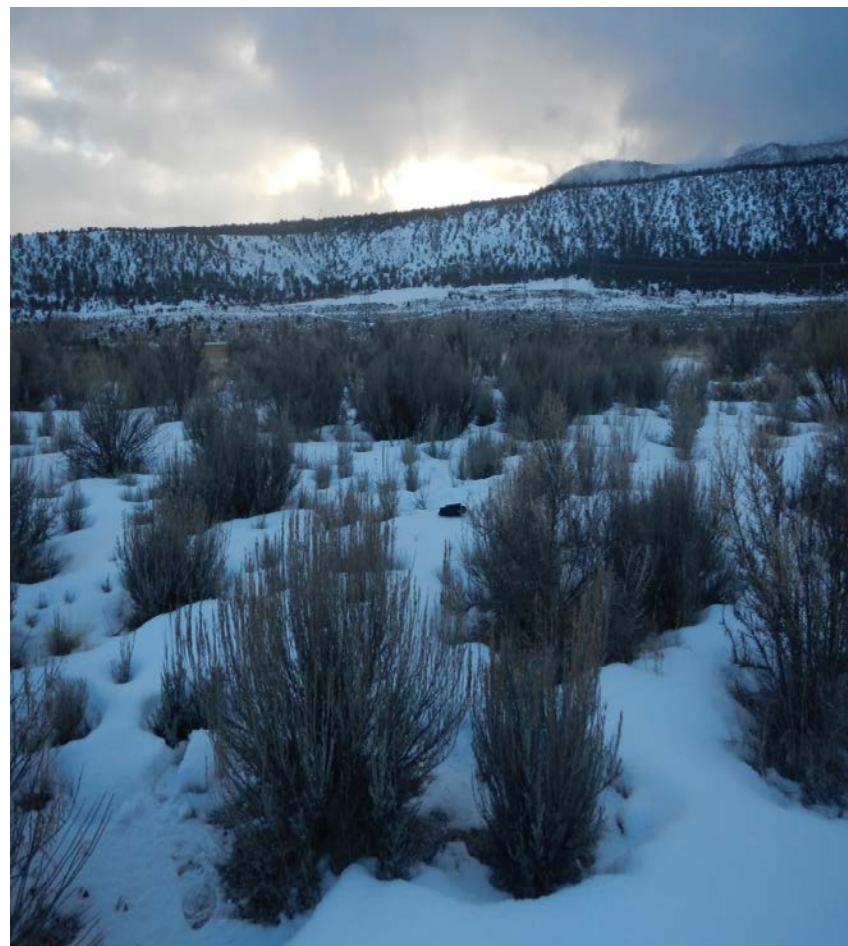
Photo#4:
View South over Location Center

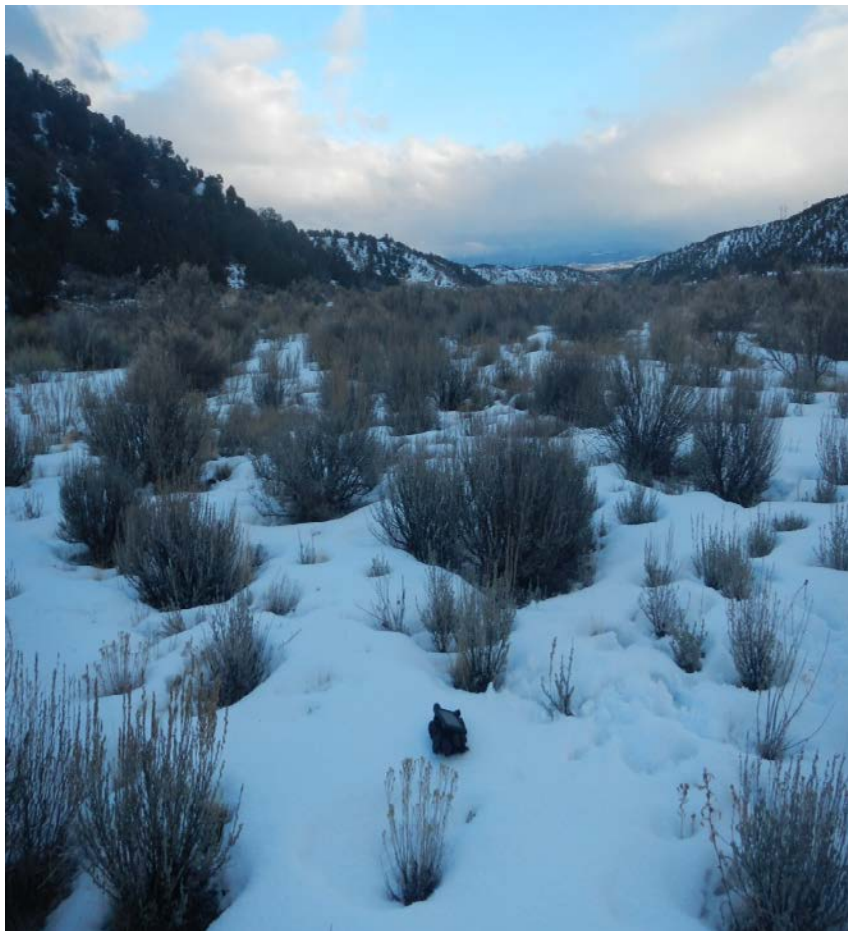
Photo#5:

View East over Location Center

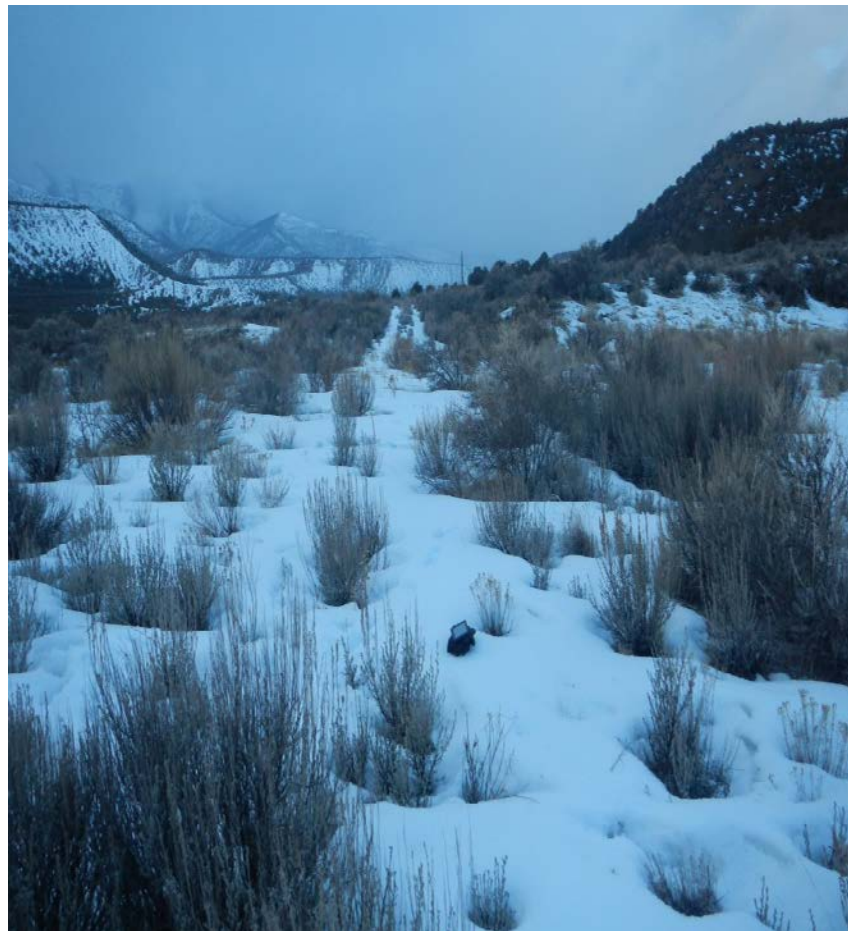
Photo#6:

View West over Location Center

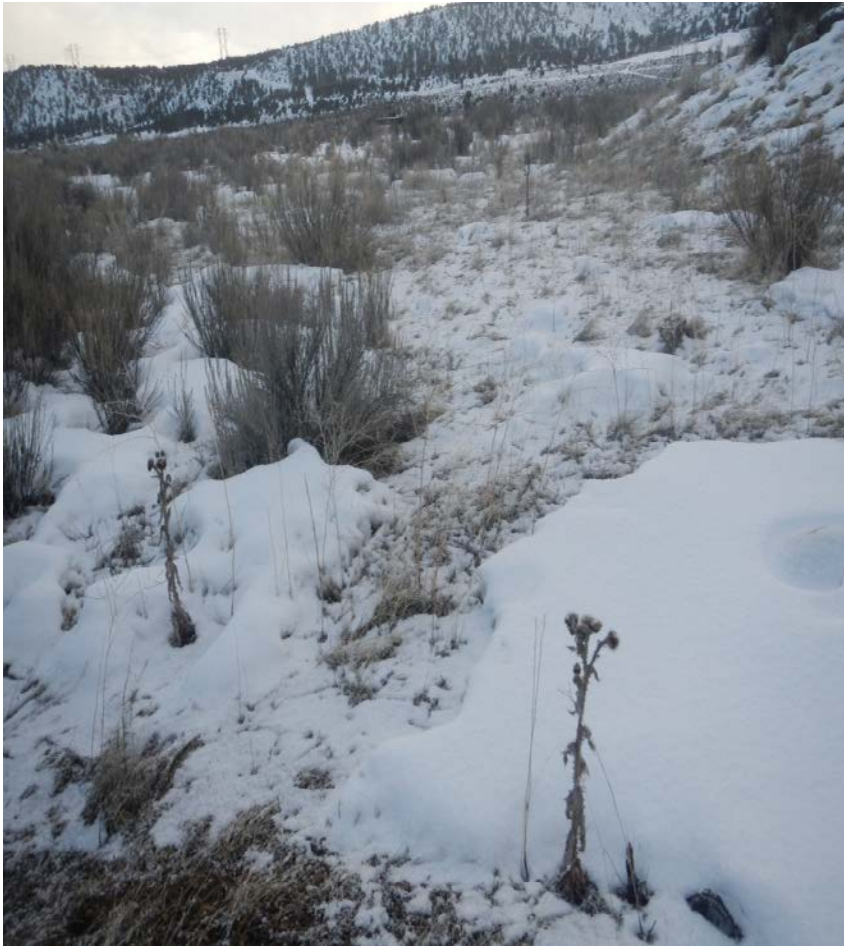
Photo#7:
Area of Thistle in NW Corner.

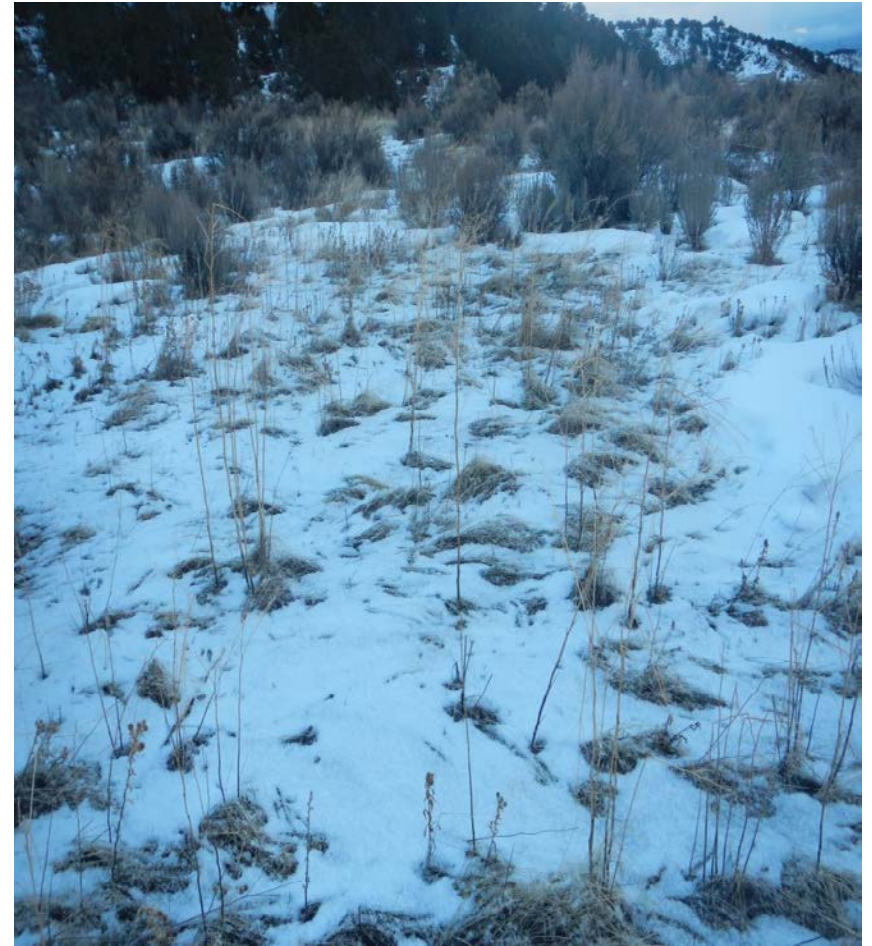
Photo#8:
Remnants of Annual Weeds in NE section.

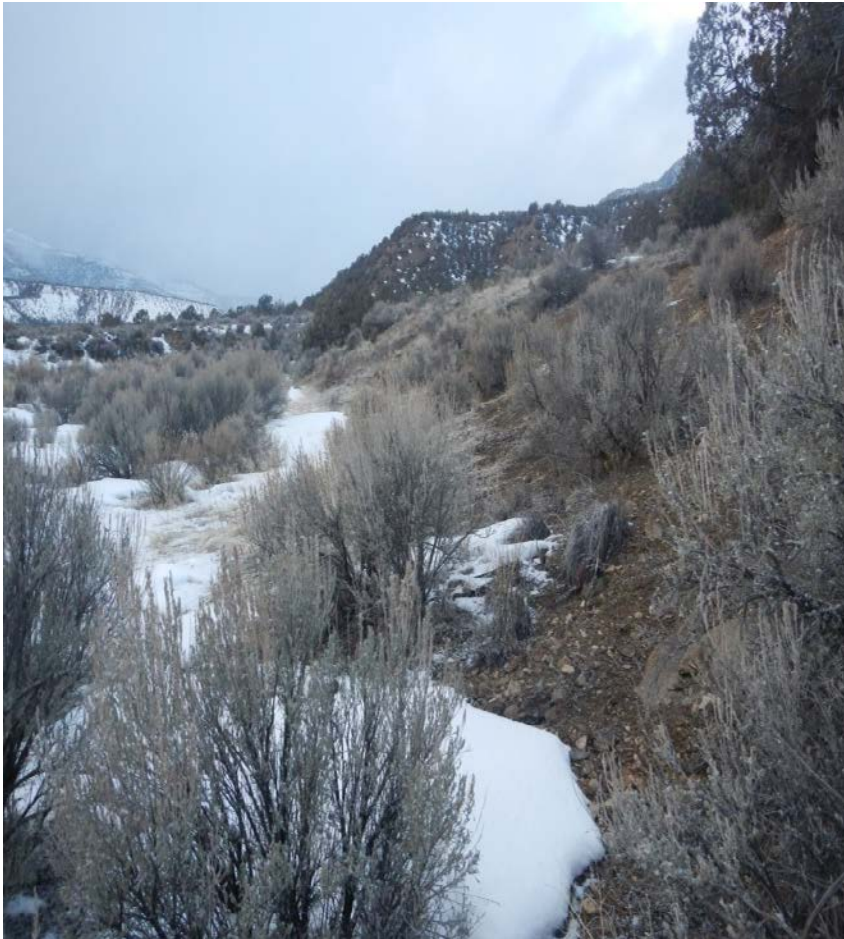
Photo#9:

Site does not appear to have been re-contoured.

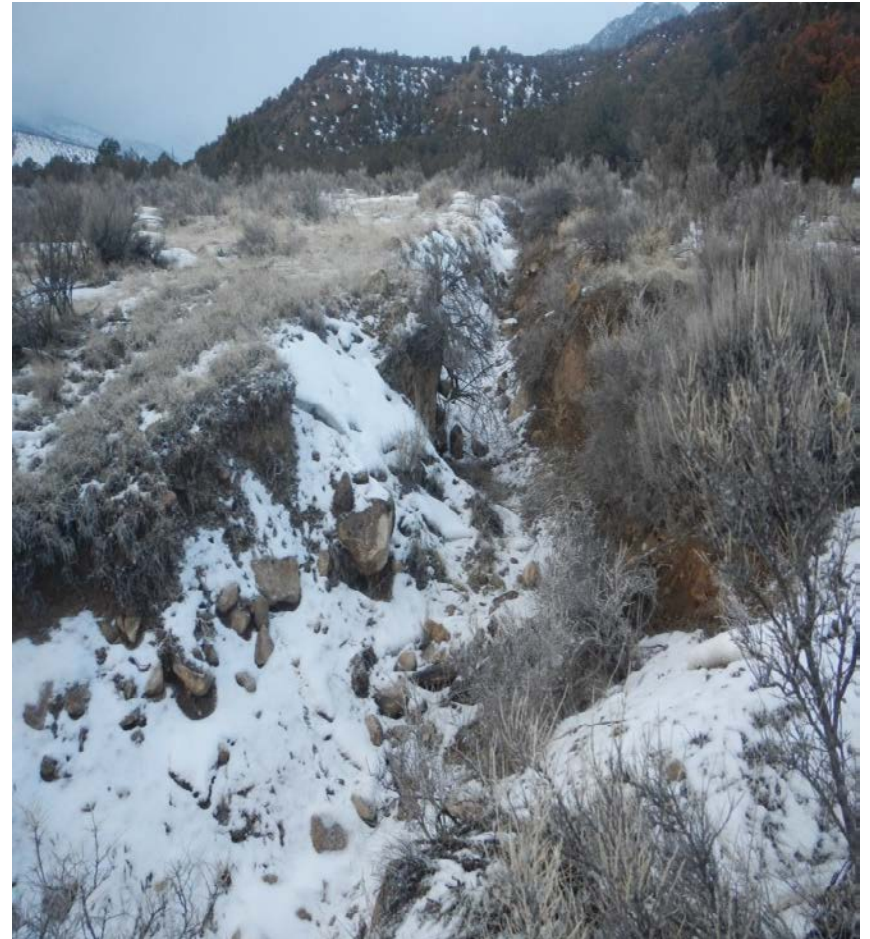
Photo#10:

Drainage that enters Location from NW
