Stormwater Inspection

COLORADO
Oil & Gas Conservation
Commission
Department of Natural Resources

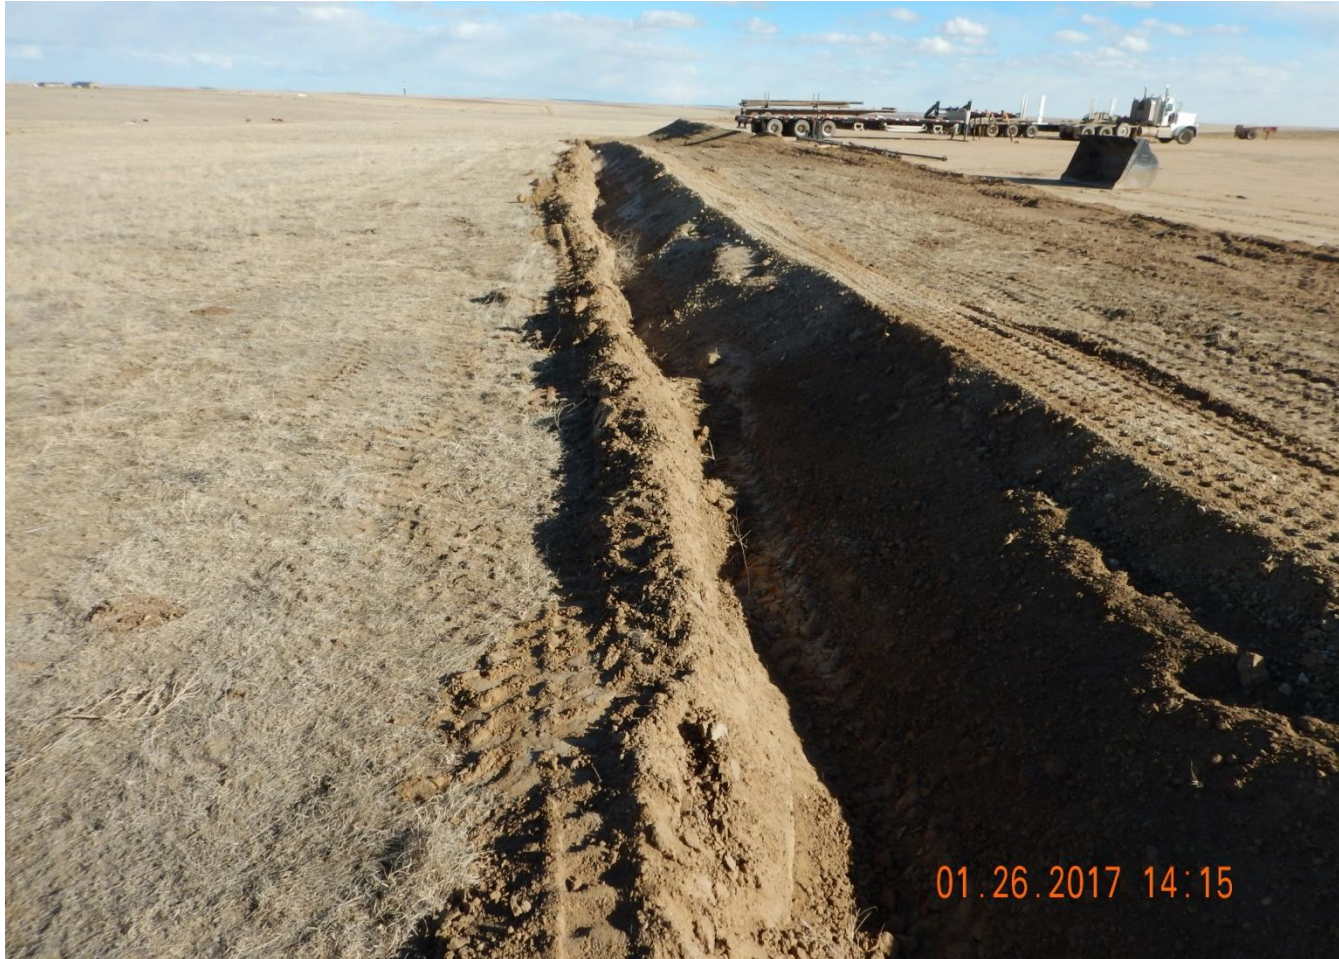
Photo 1. Photo taken from the northwest location, facing East. Berm BMP insufficient and berm not compacted.

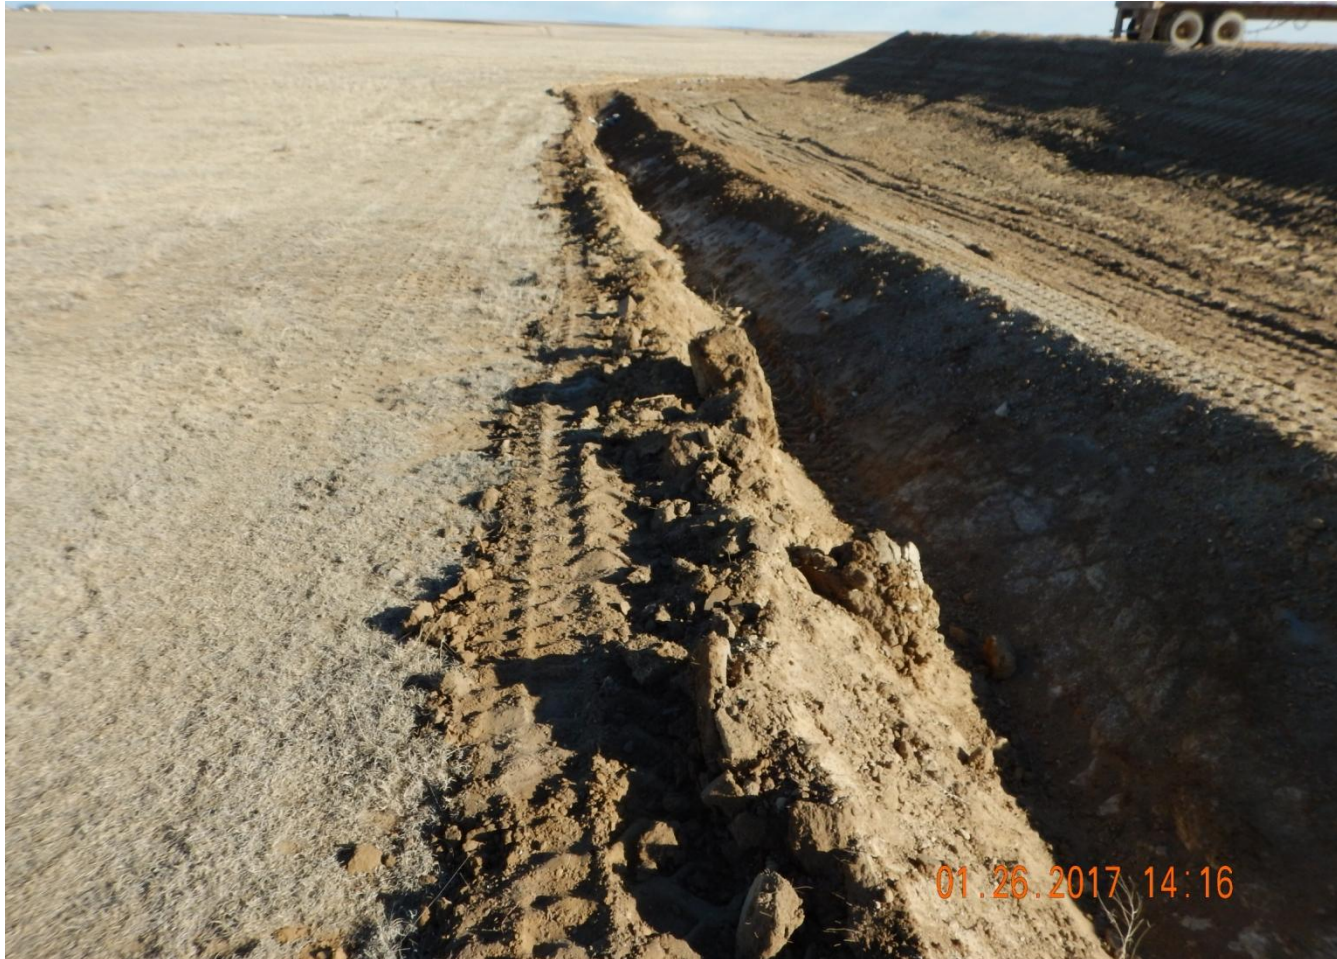
Photo 2. Photo taken from the northern location, facing East. Berm BMP insufficient along perimeter of location and berm not compacted.

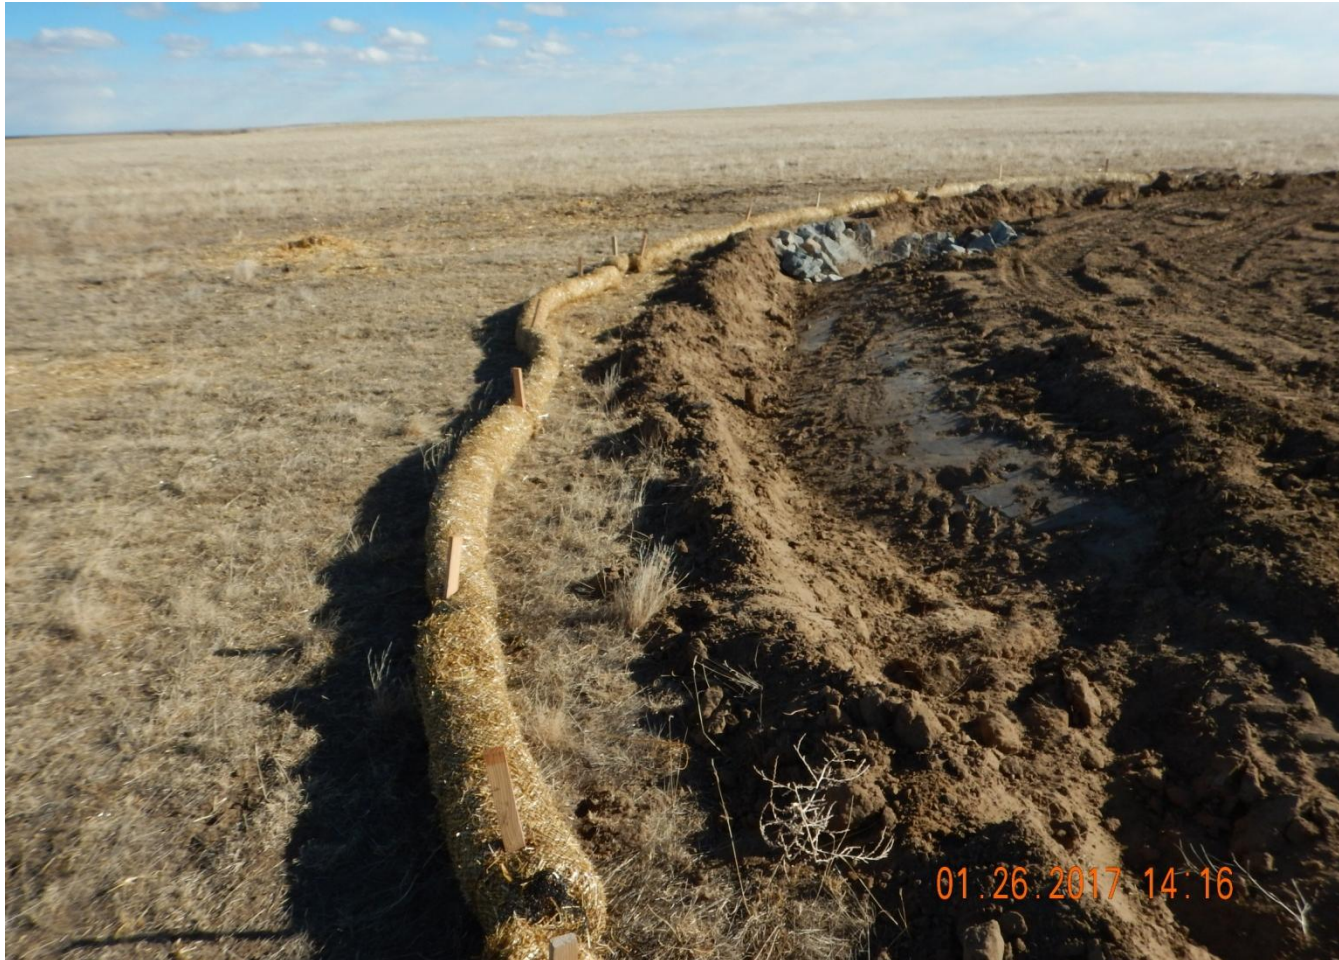
Photo 3. Photo taken from the northwest location, facing East. Berm BMP insufficient and berm not compacted. Wattle BMP has not been properly installed by trenching and backfilling the wattle, and wattles have not been overlapped at joints.

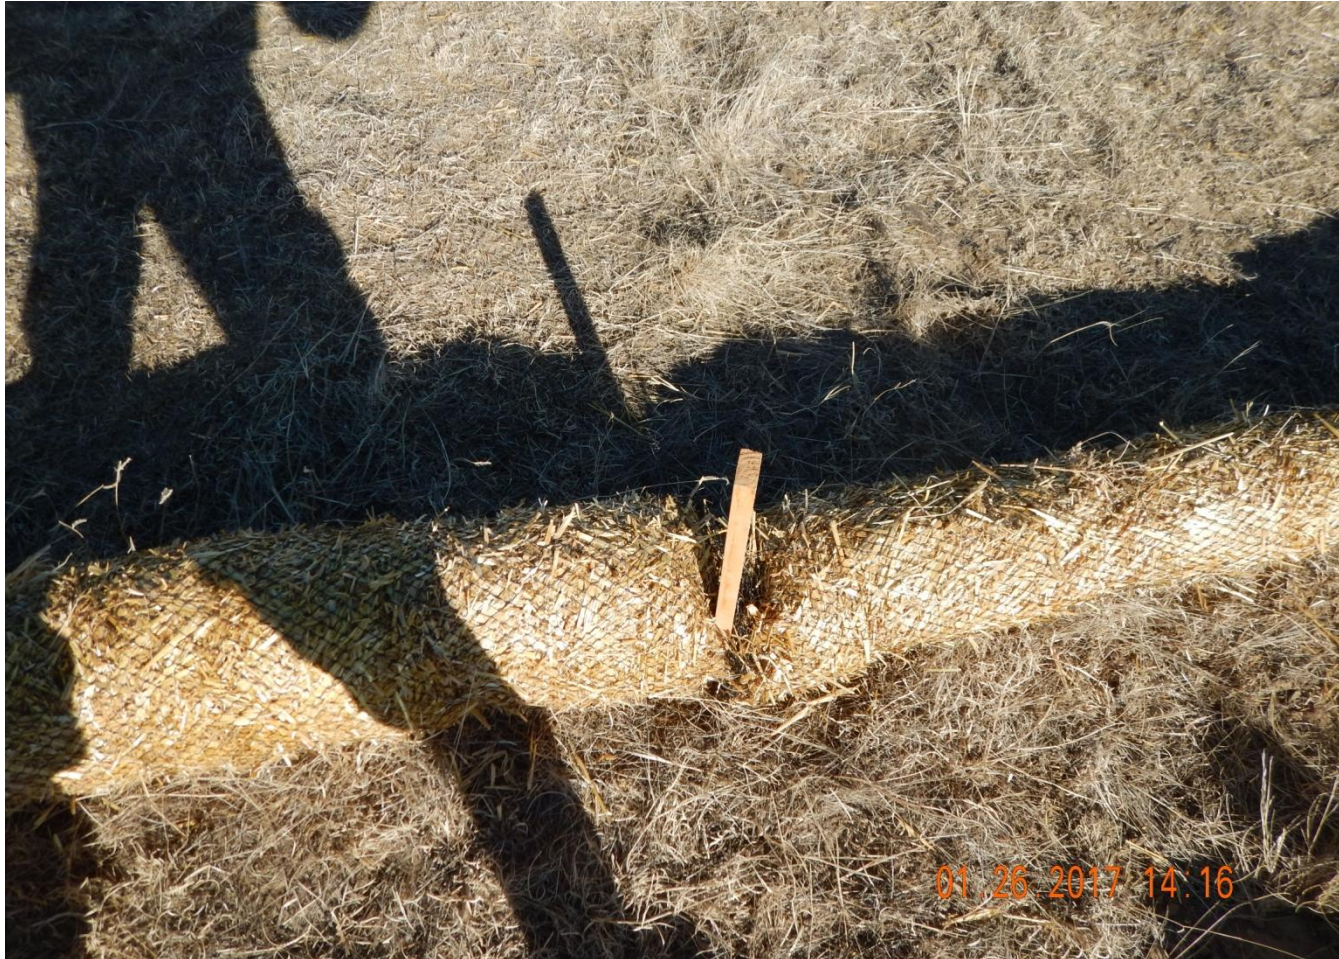
Photo 4. Photo taken from the northwest location. Wattle BMP has not been properly installed by trenching and backfilling the wattle, and wattles have not been overlapped at joints.

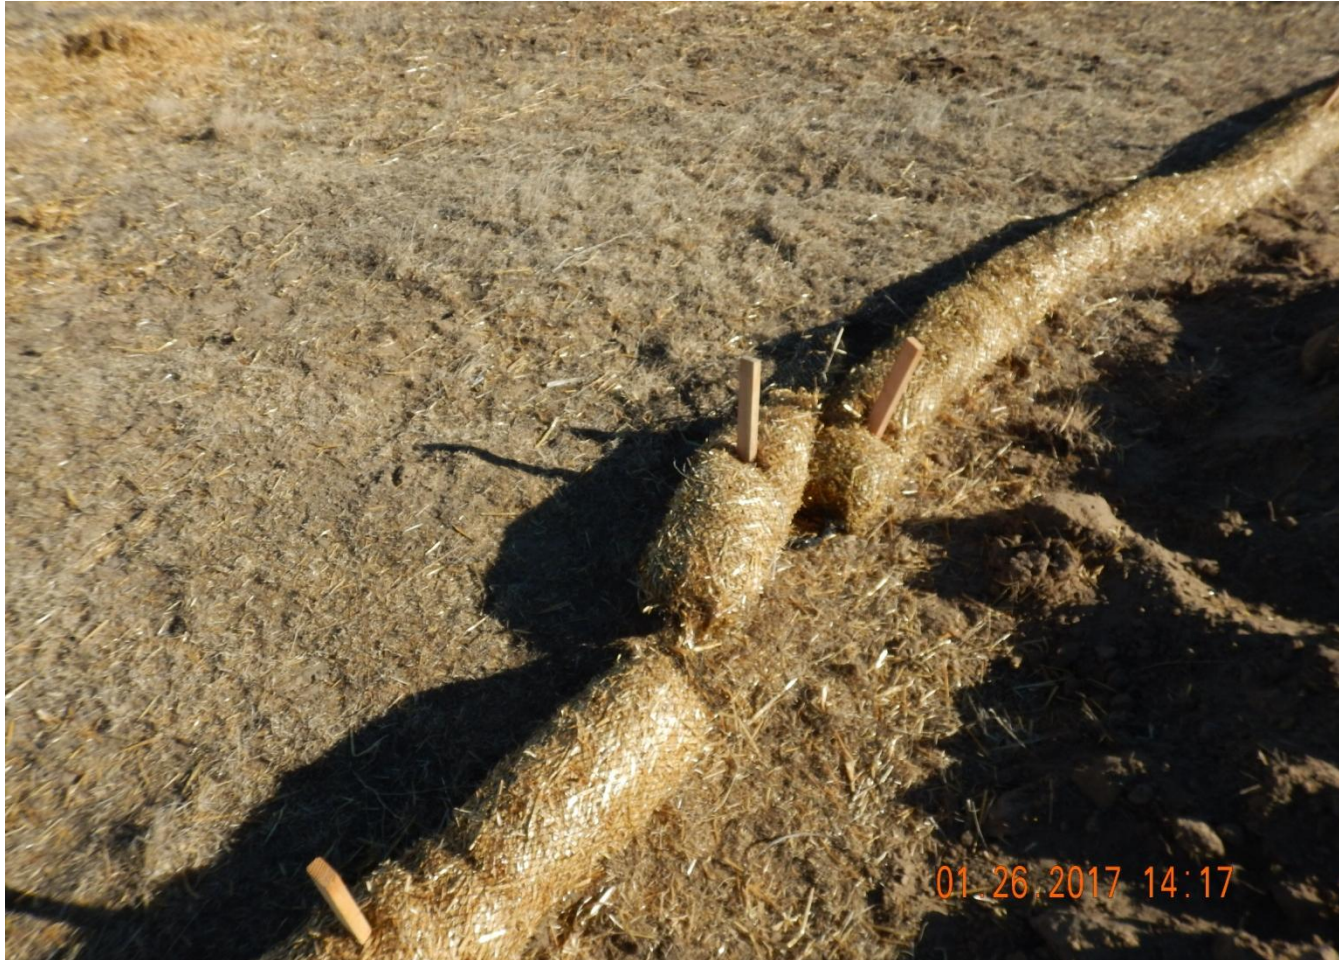
Photo 5. Photo taken from the northwest location. Wattle BMP has not been properly installed by trenching and backfilling the wattle, and wattles have not been overlapped at joints.

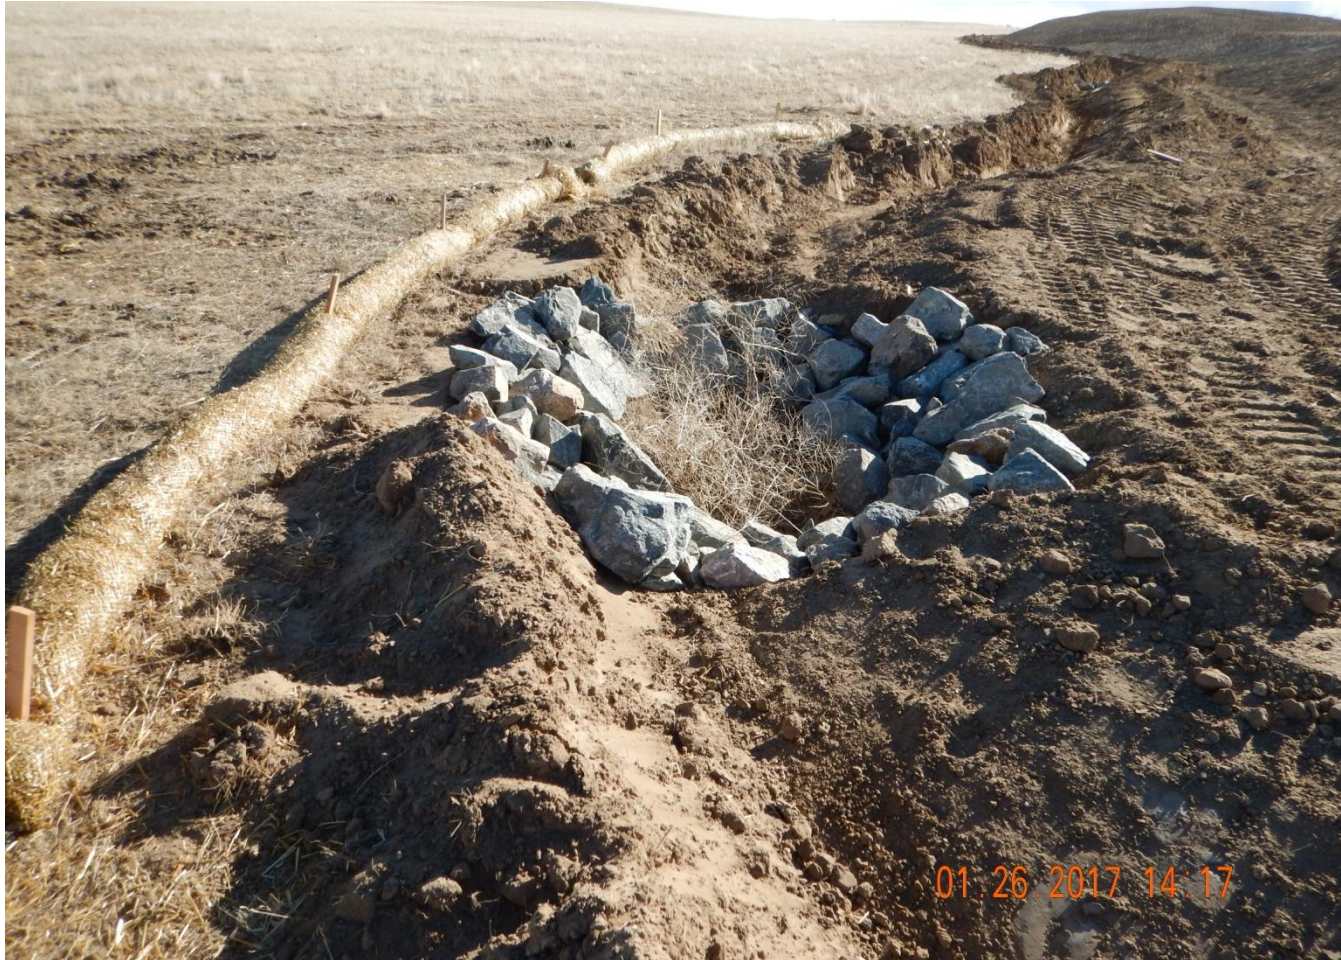
Photo 6. Photo taken from the northwest location, facing towards the sediment trap. Berm BMP insufficient and berm not compacted. Wattle BMP has not been properly installed by trenching and backfilling the wattle, and wattles have not been overlapped at joints.

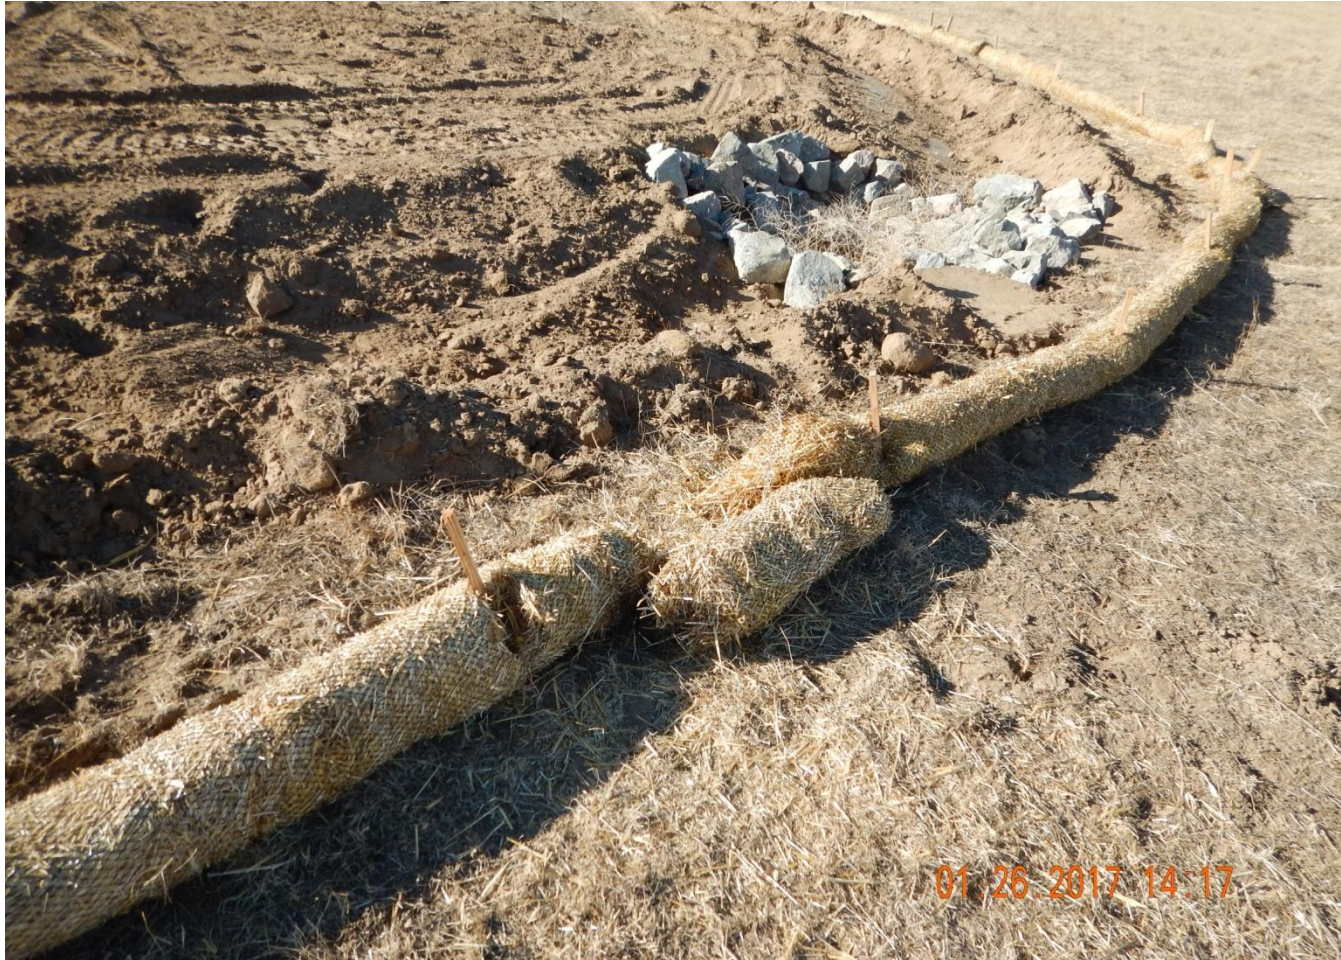
Photo 7. Photo taken from the northwest location, facing West. Wattle BMP has not been properly installed by trenching and backfilling the wattle, and wattles have not been overlapped at joints. A section of wattle is not staked.

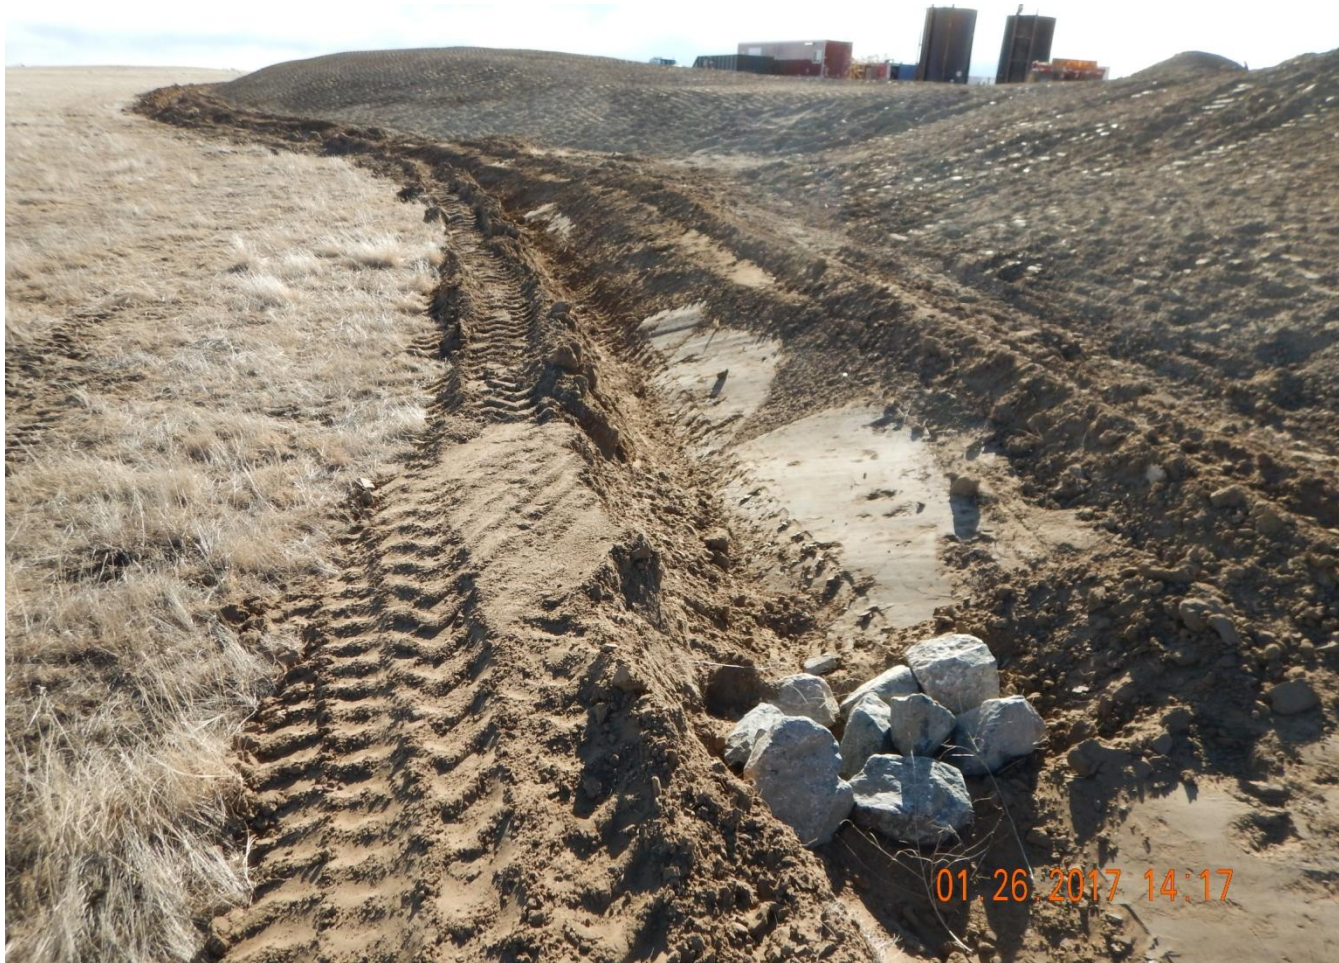
Photo 8. Photo taken from the northwest location, facing South. Berm BMP insufficient and berm not compacted. Check dam BMP installed along portions of the perimeter. Appears more rock material could be added to capture sediment.

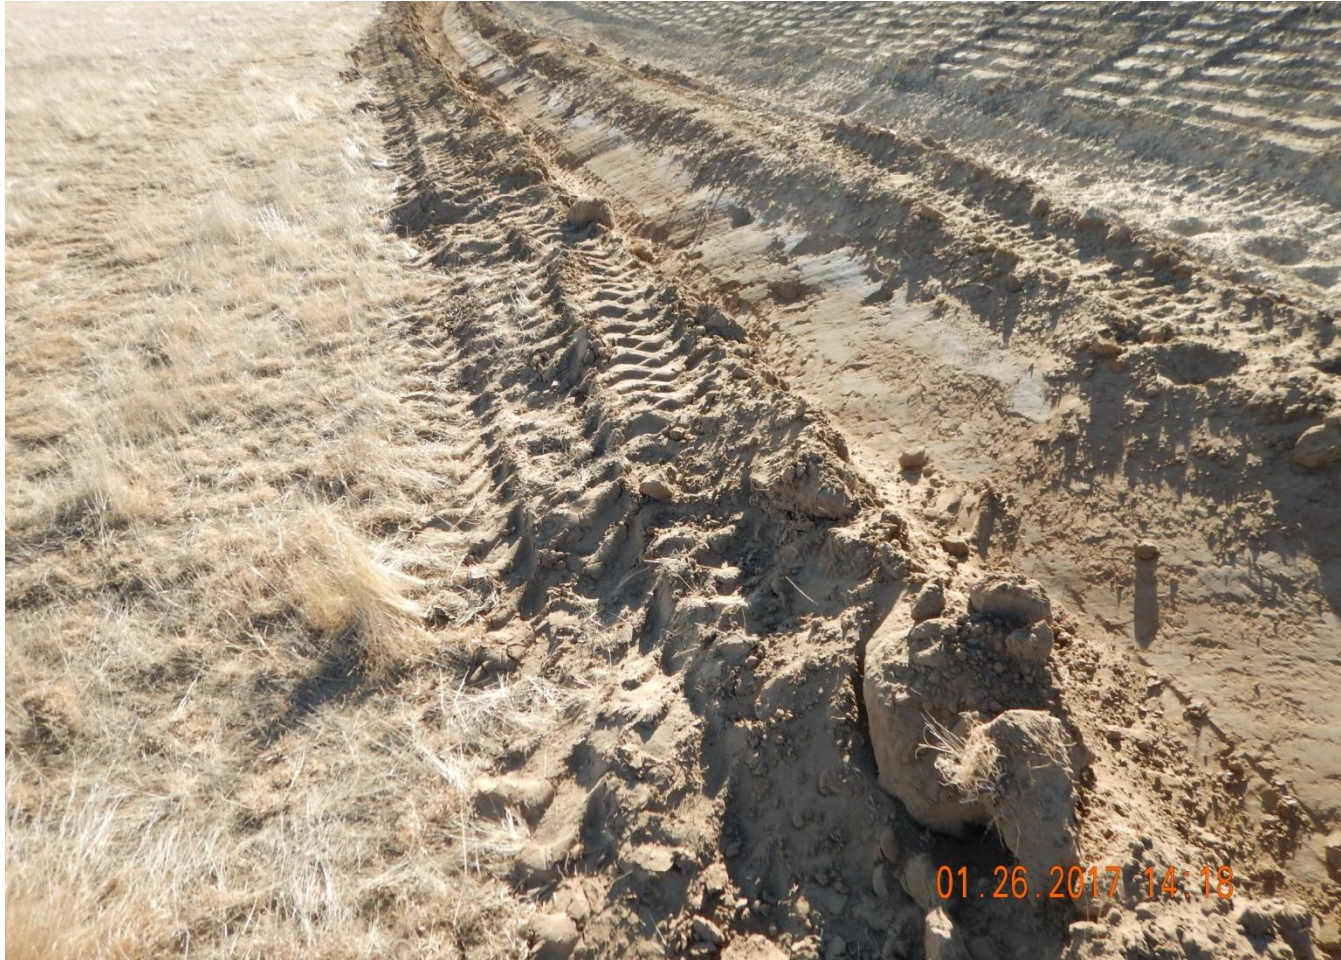
Photo 9. Photo taken from the eastern location, facing South. Berm BMP insufficient and berm not compacted.

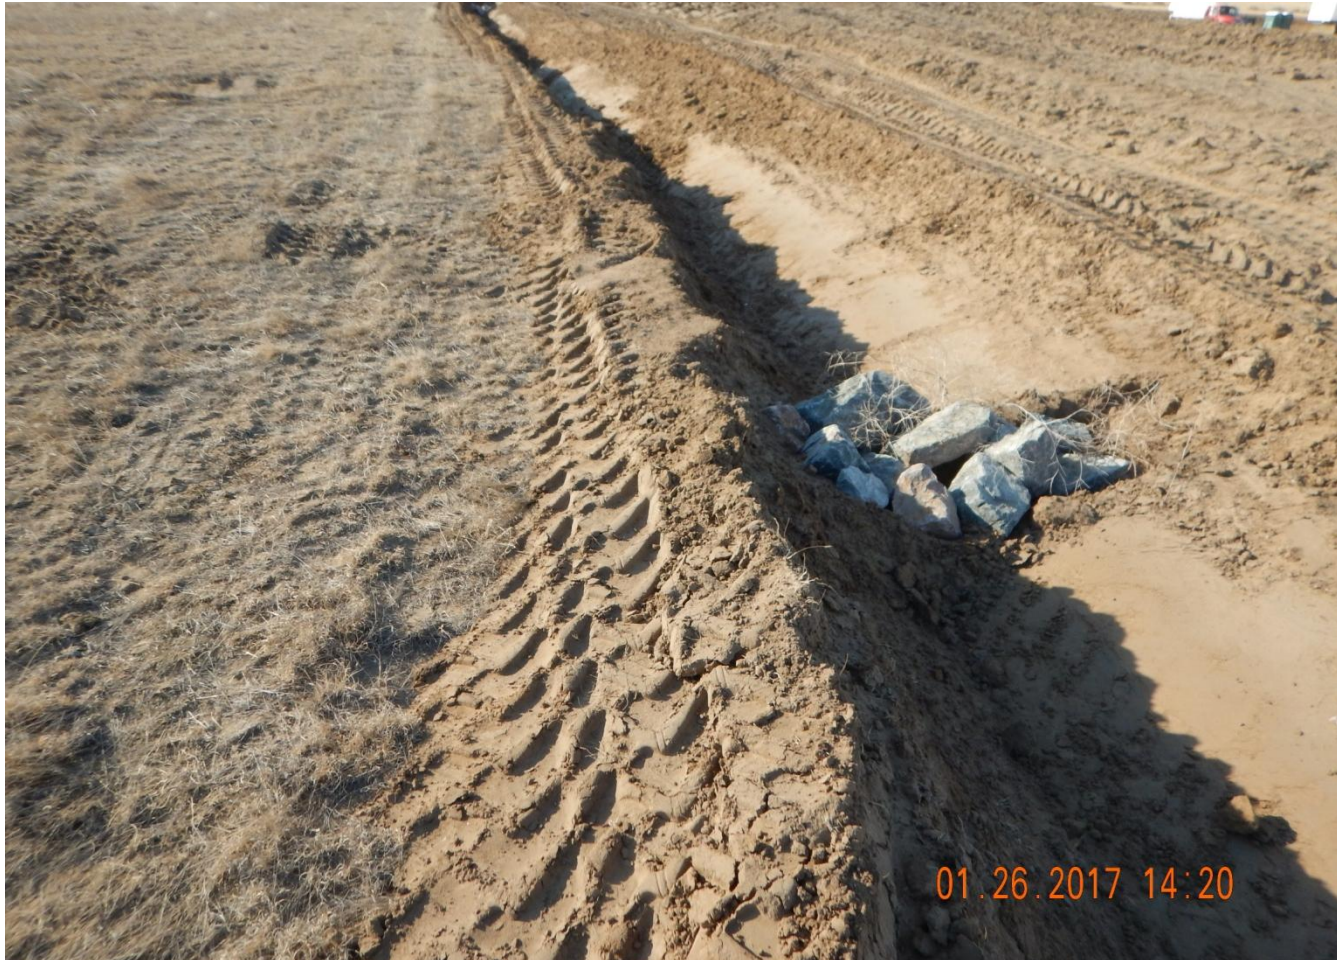
Photo 10. Photo taken from the southern location, facing West. Berm BMP insufficient and berm not compacted. Check dam BMP installed along portions of the perimeter. Appears more rock material could be added to capture sediment.

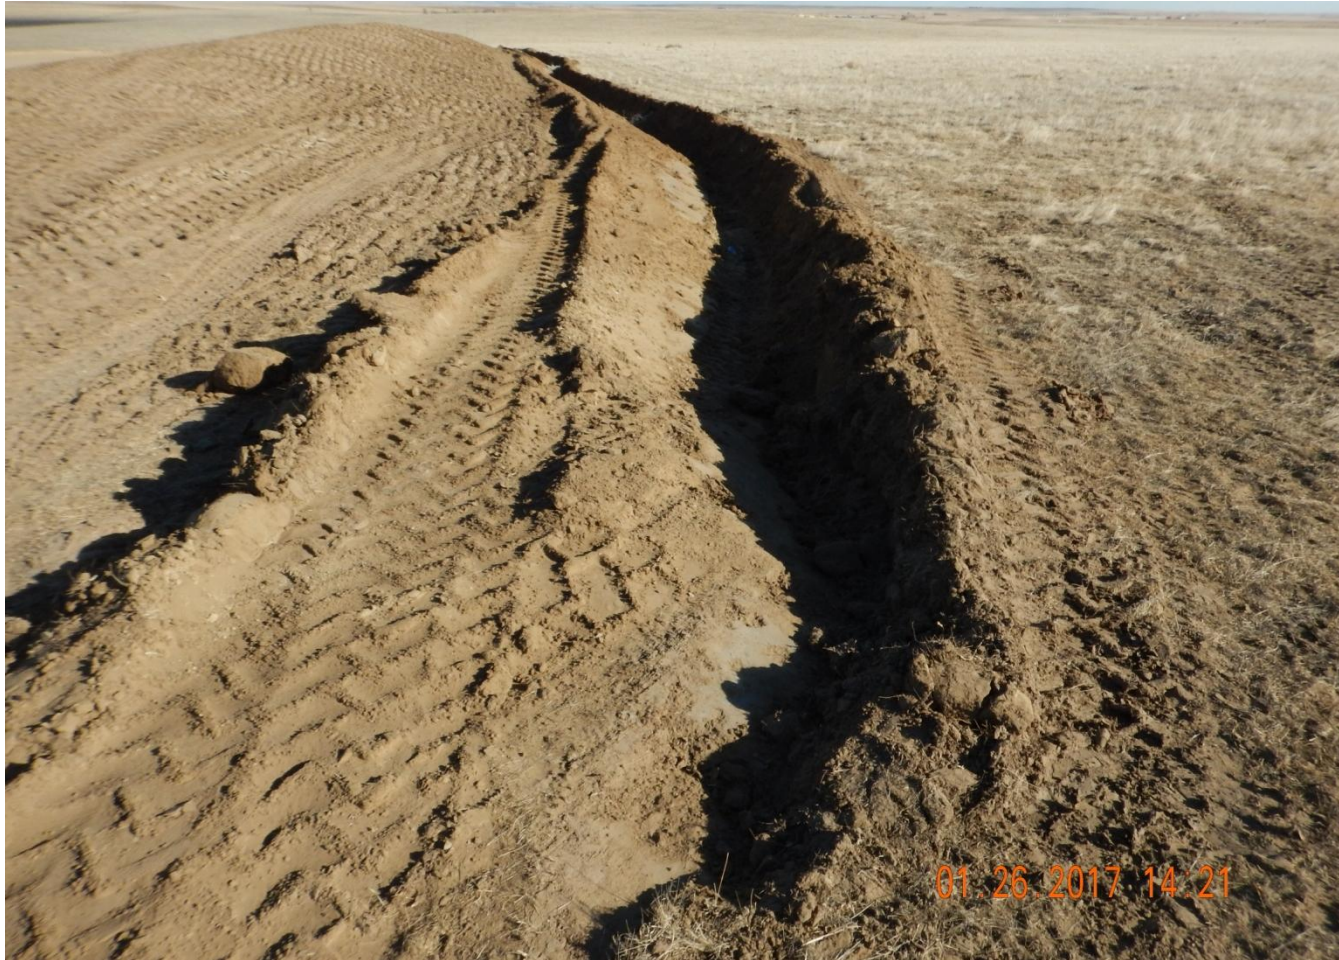
Photo 11. Photo taken from the southwest location, facing East. Berm BMP insufficient and berm not compacted.
