Construction and Stormwater Inspection- Overview

Google Earth aerial photo taken 9/7/2013 of the Will Trust 6-62-10 11 location overview. An area of 5.25 acres was mapped on January 26, 2017 using a Trimble Juno 3B handheld device. Perimeter of the area mapped and highlighted in red.

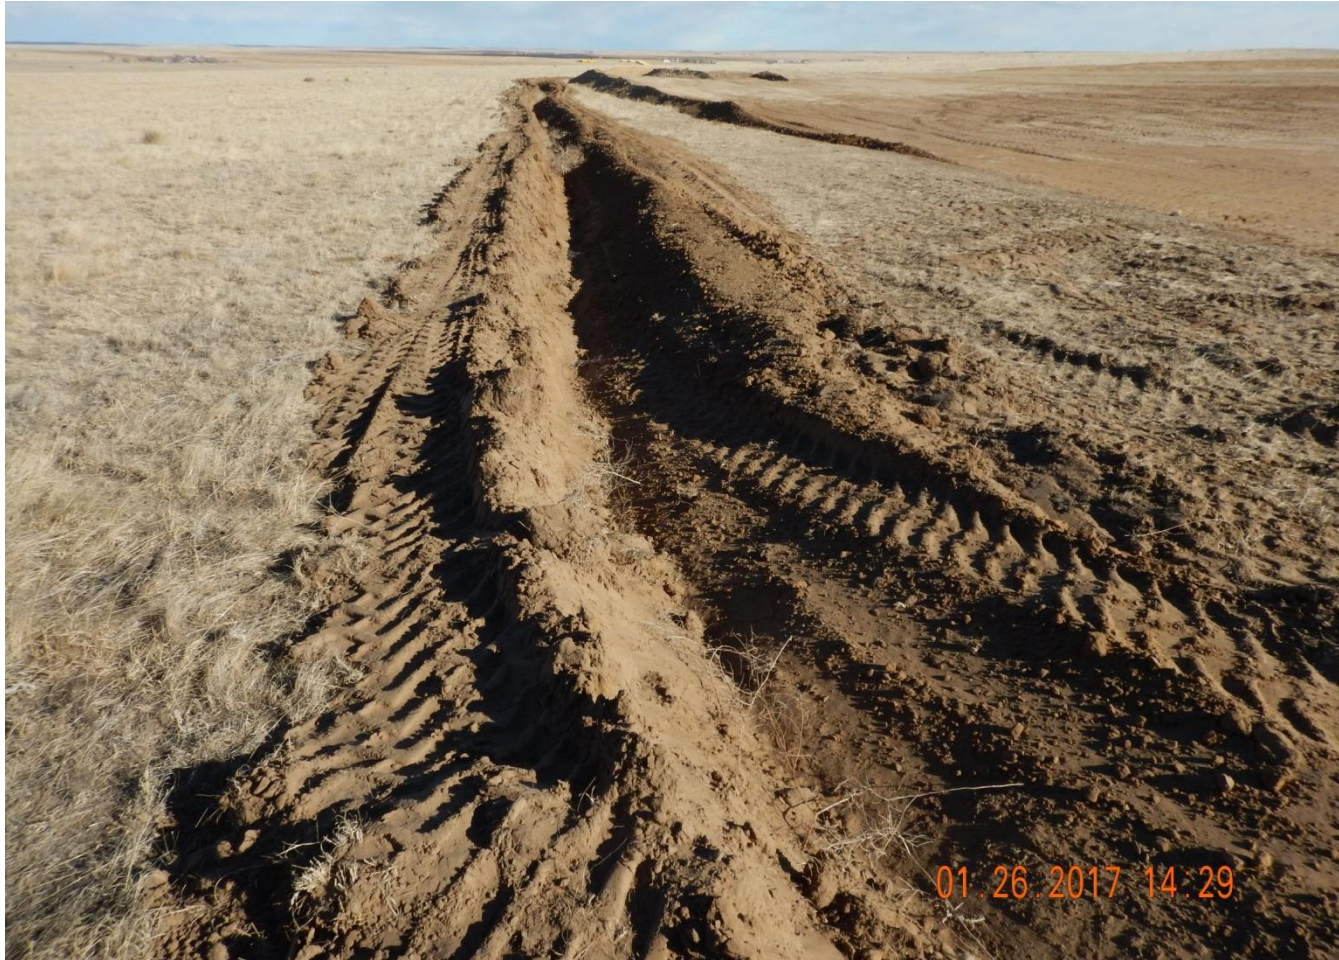
Photo 1. Photo taken from the northwest location, facing East. Berm BMP insufficient and berm not compacted.

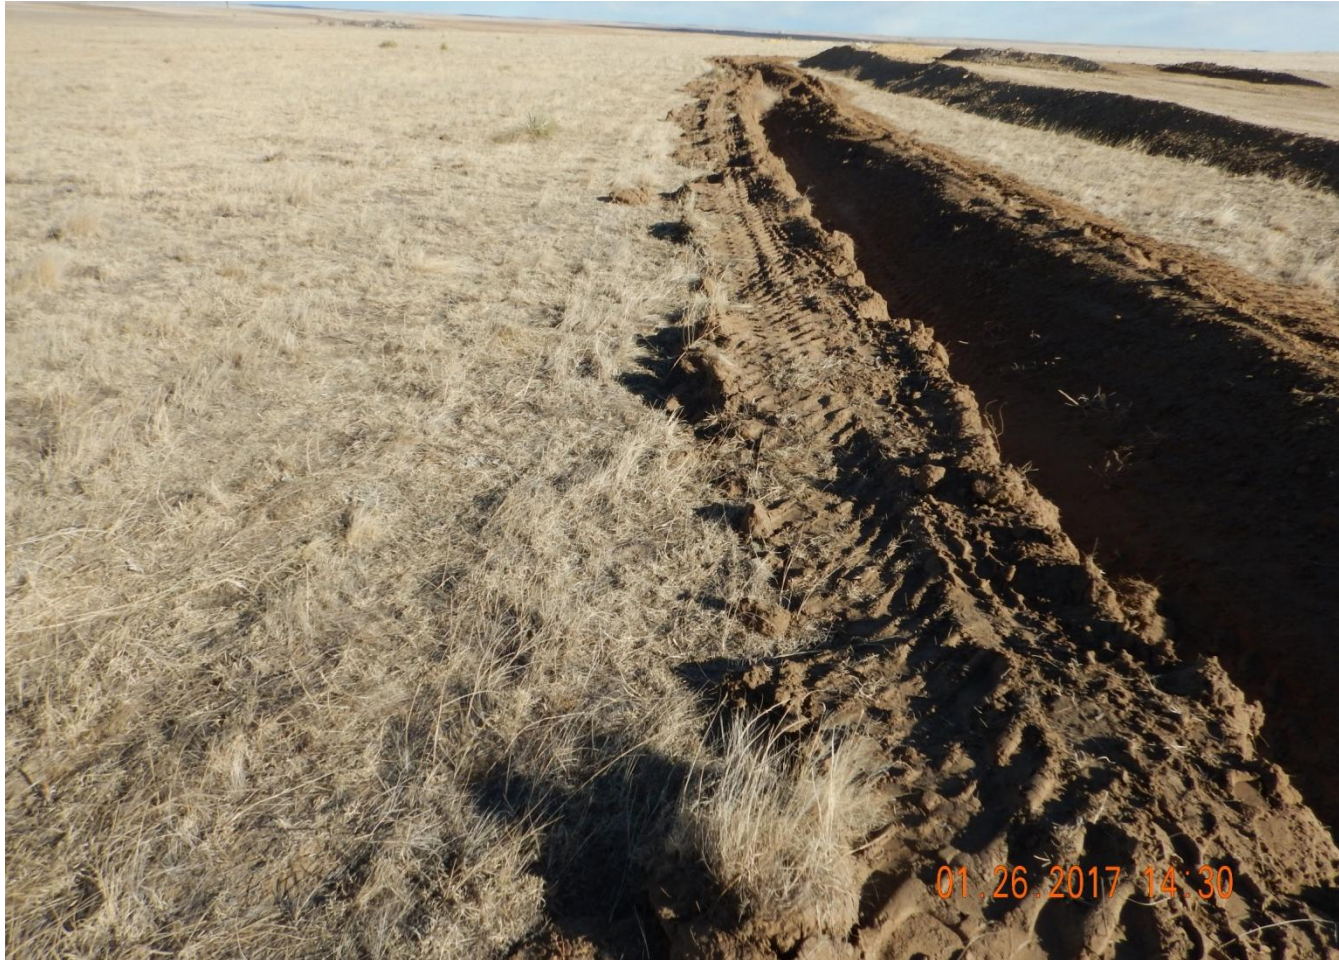
Photo 2. Photo taken from the northern location, facing East. Berm BMP insufficient along perimeter of location and berm not compacted.

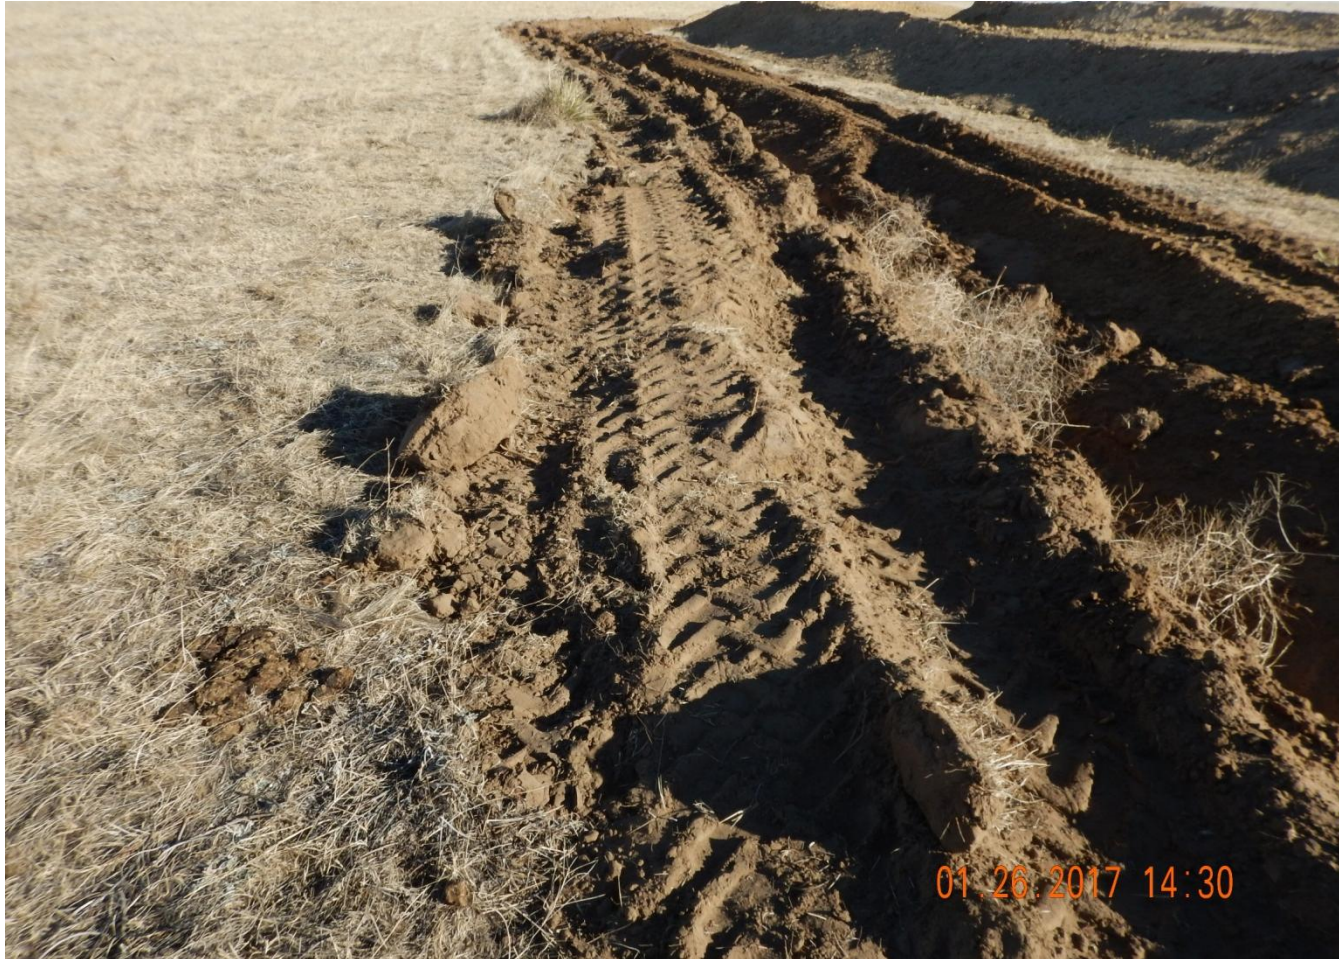
Photo 3. Photo taken from the northern location, facing East. Berm BMP insufficient along perimeter of location and berm not compacted.

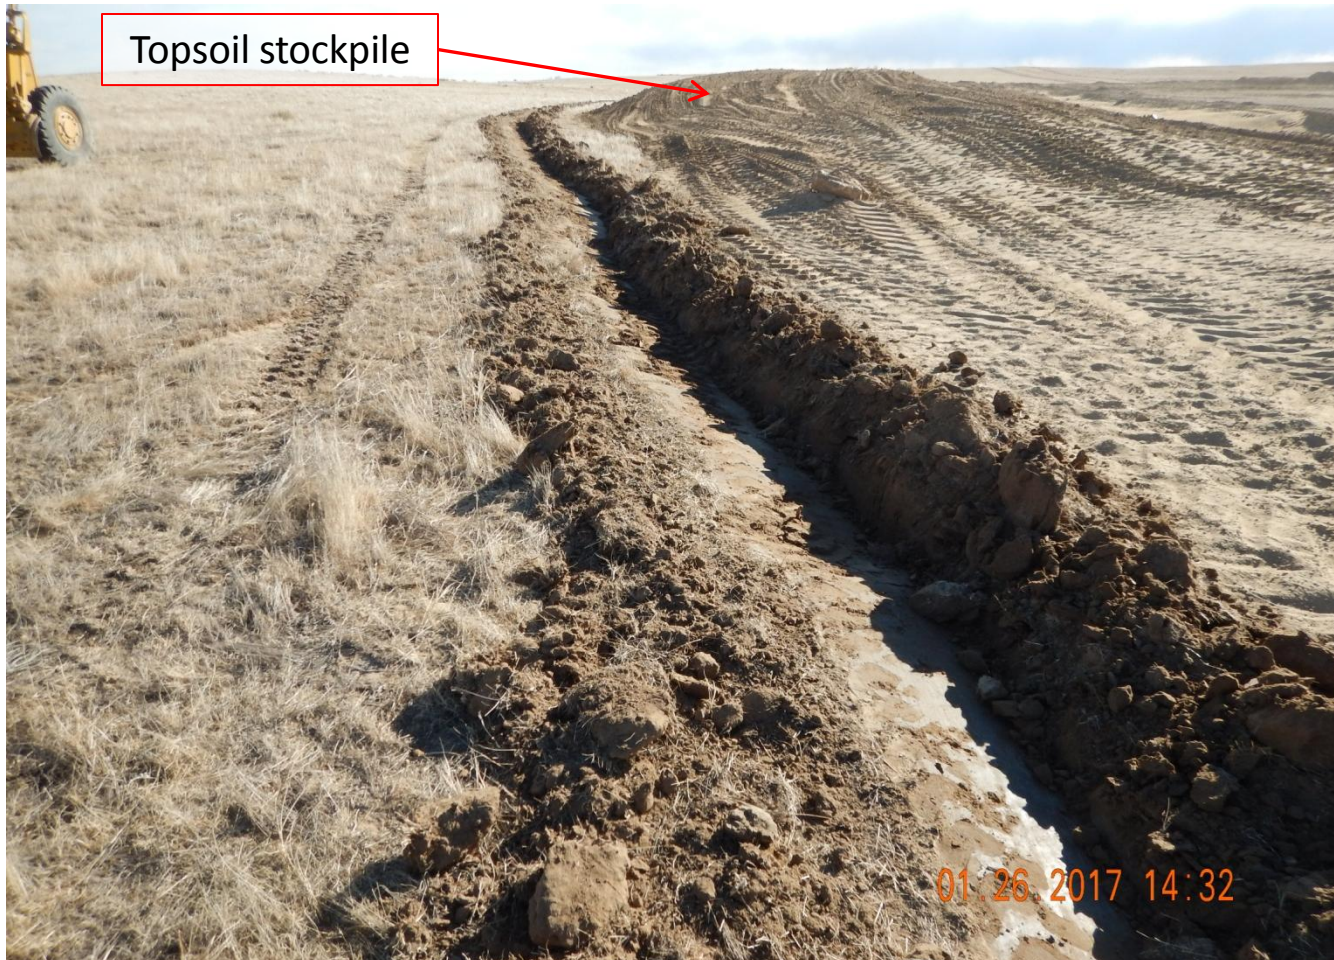
Photo 4. Photo taken from the eastern location, facing South. Berm BMP insufficient along perimeter of location and berm not compacted. BMP installed along the southeast location while COGCC staff was inspecting location.

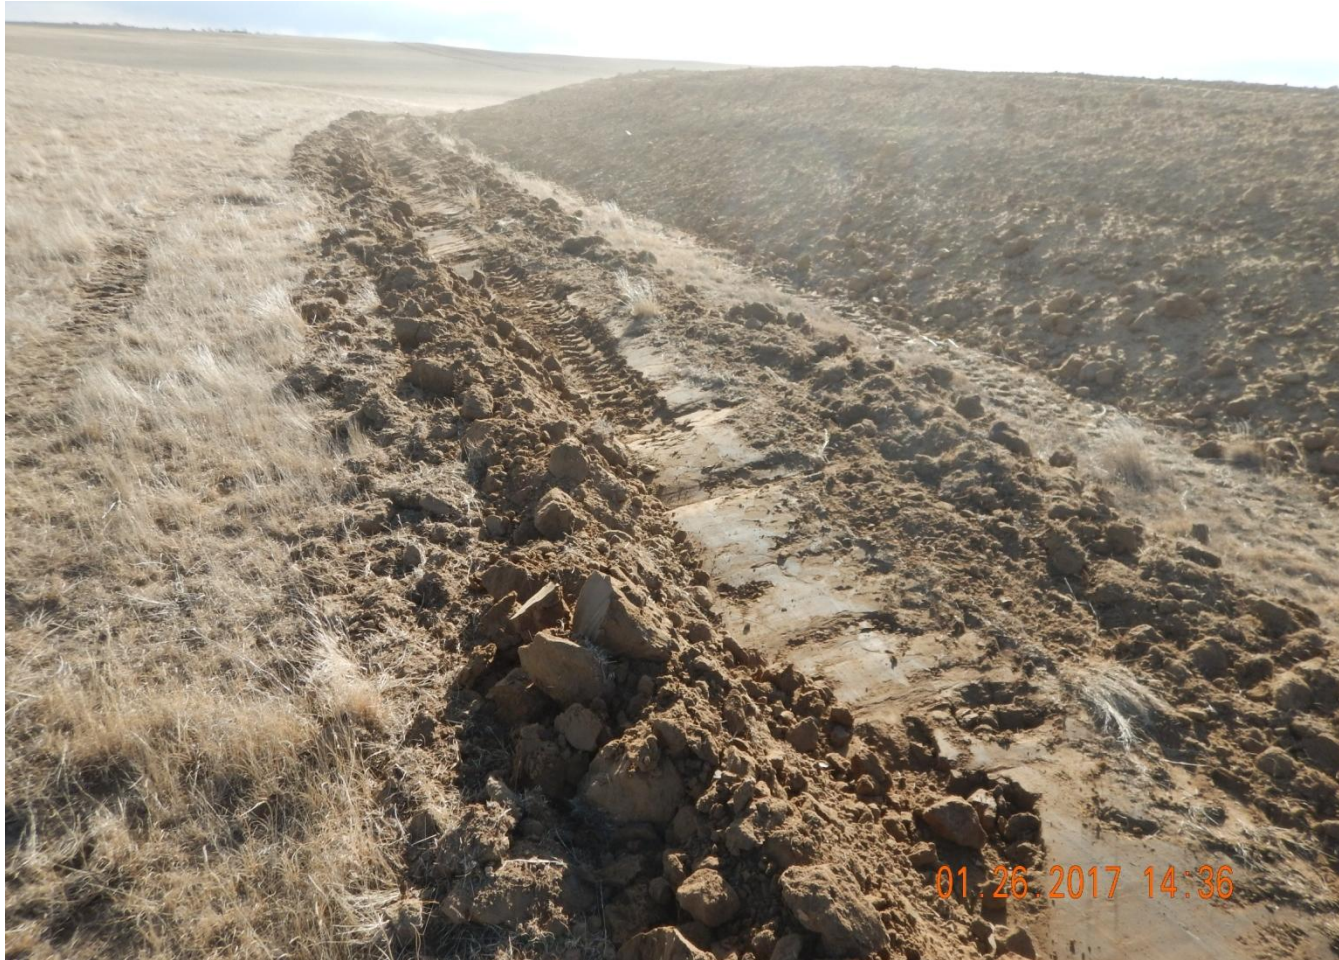
Photo 5. Photo taken from the eastern location, facing South. Berm BMP insufficient along perimeter of location and berm not compacted. BMP installed along the southeast location while COGCC staff was inspecting location.

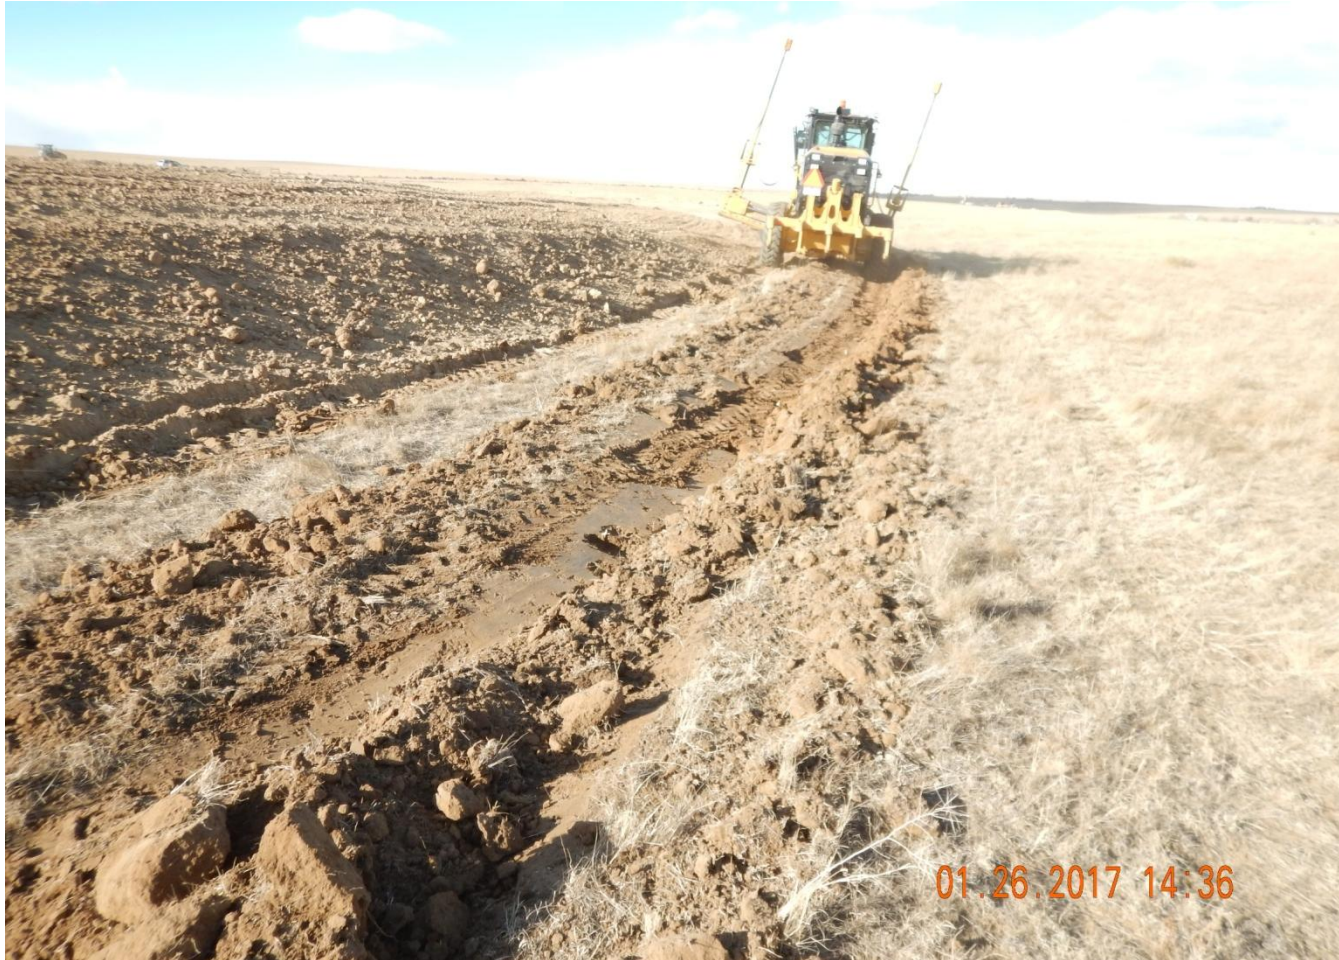
Photo 6. Photo taken from the eastern location, facing South. Berm BMP insufficient along perimeter of location and berm not compacted. BMP installed along the southeast location while COGCC staff was inspecting location.

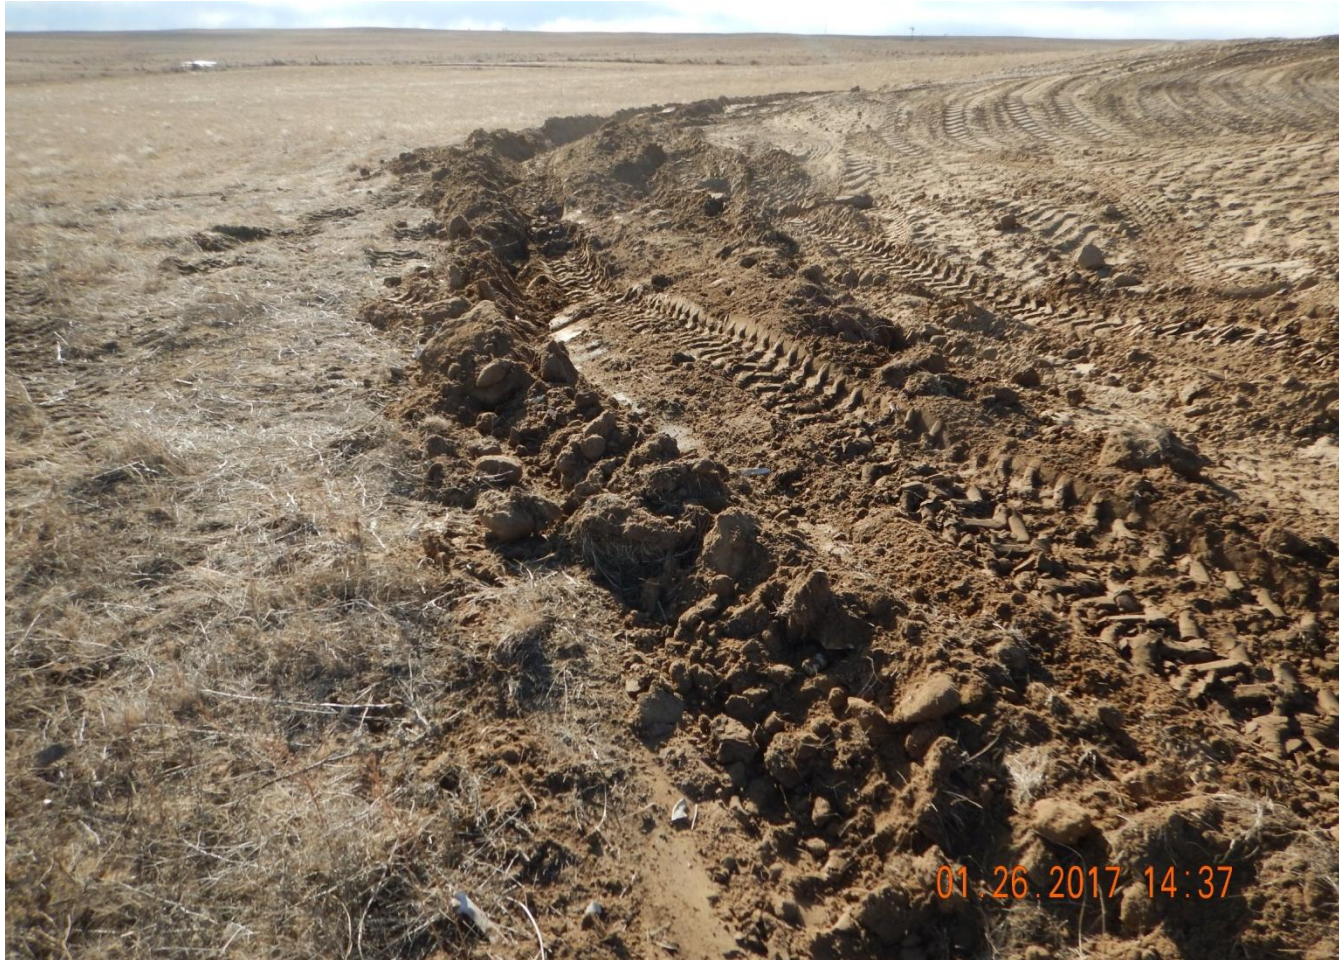
Photo 7. Photo taken from the southeast location, facing Southwest. Berm BMP insufficient along perimeter of location and berm not compacted. BMP installed along the southeast location while COGCC staff was inspecting location.

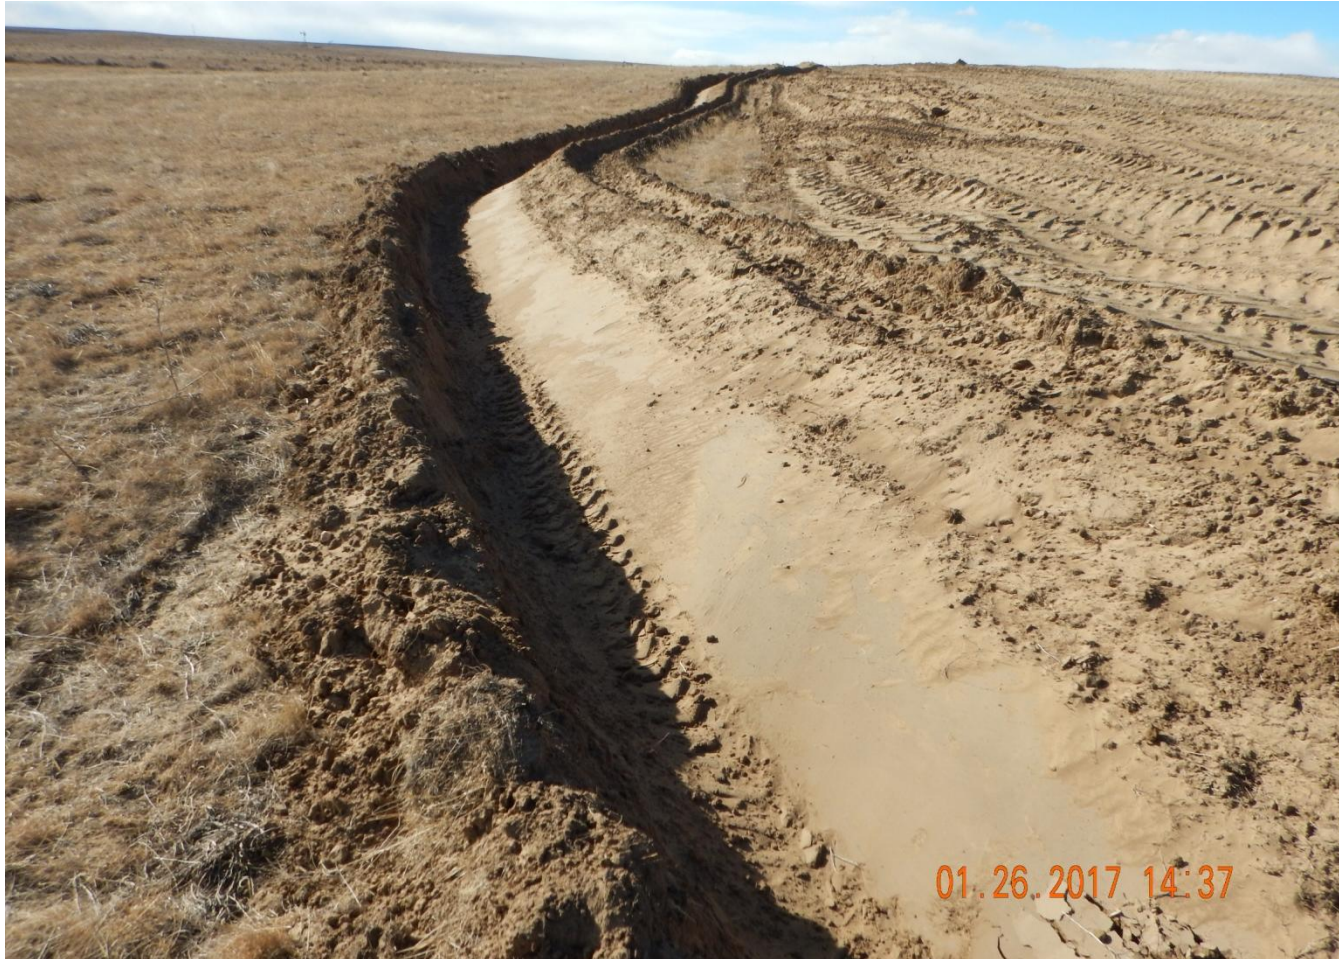
Photo 8. Photo taken from the southern location, facing West. Berm BMP insufficient along perimeter of location and berm not compacted.

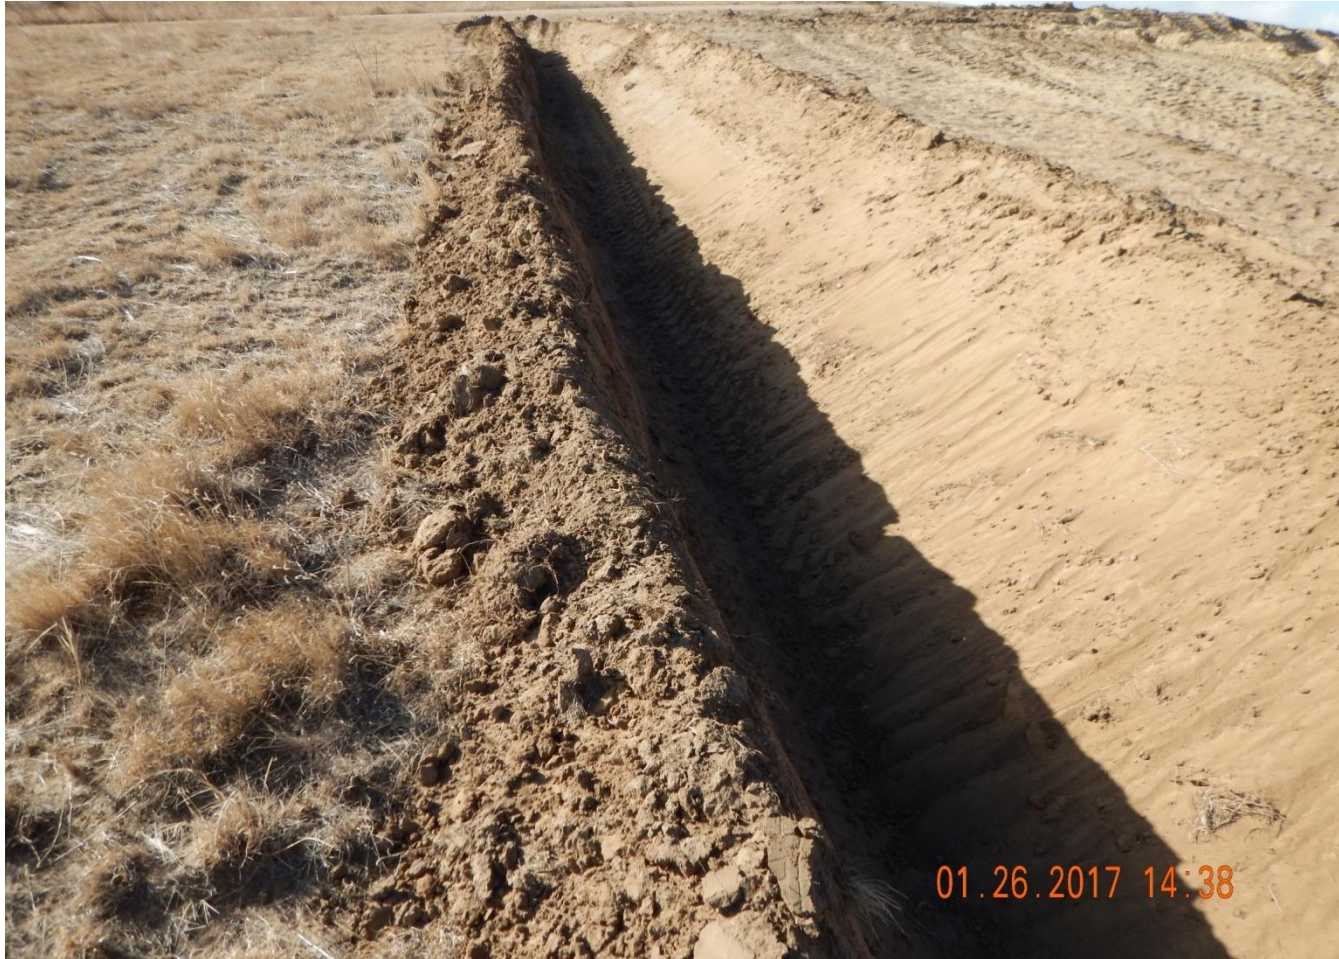
Photo 9. Photo taken from the southwest location, facing West. Berm BMP insufficient along perimeter of location and berm not compacted.
