Reclamation Inspection

01/27/2017

Operator: Conoco Phillips #19160

Location ID: 426630

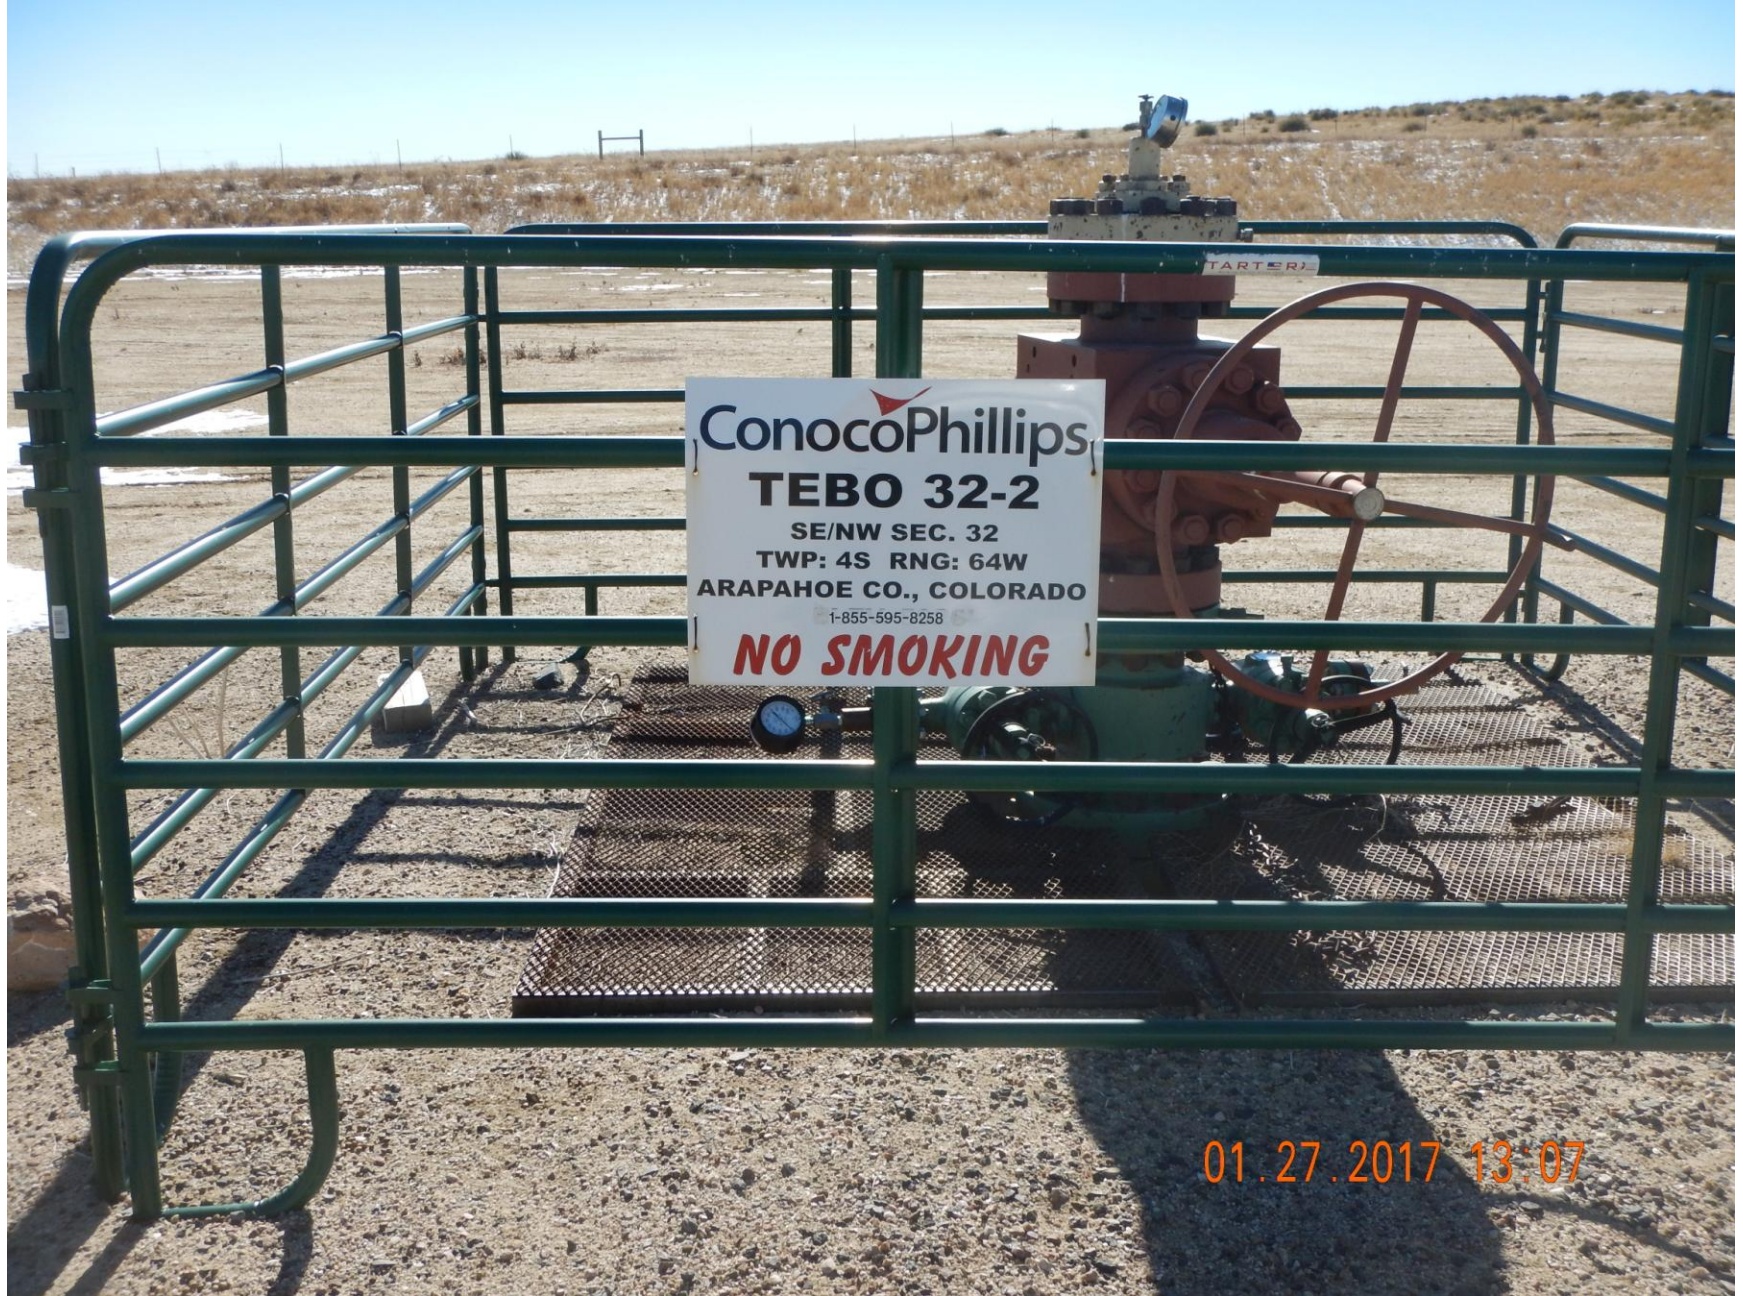
Figure 1: Photo of well on location.

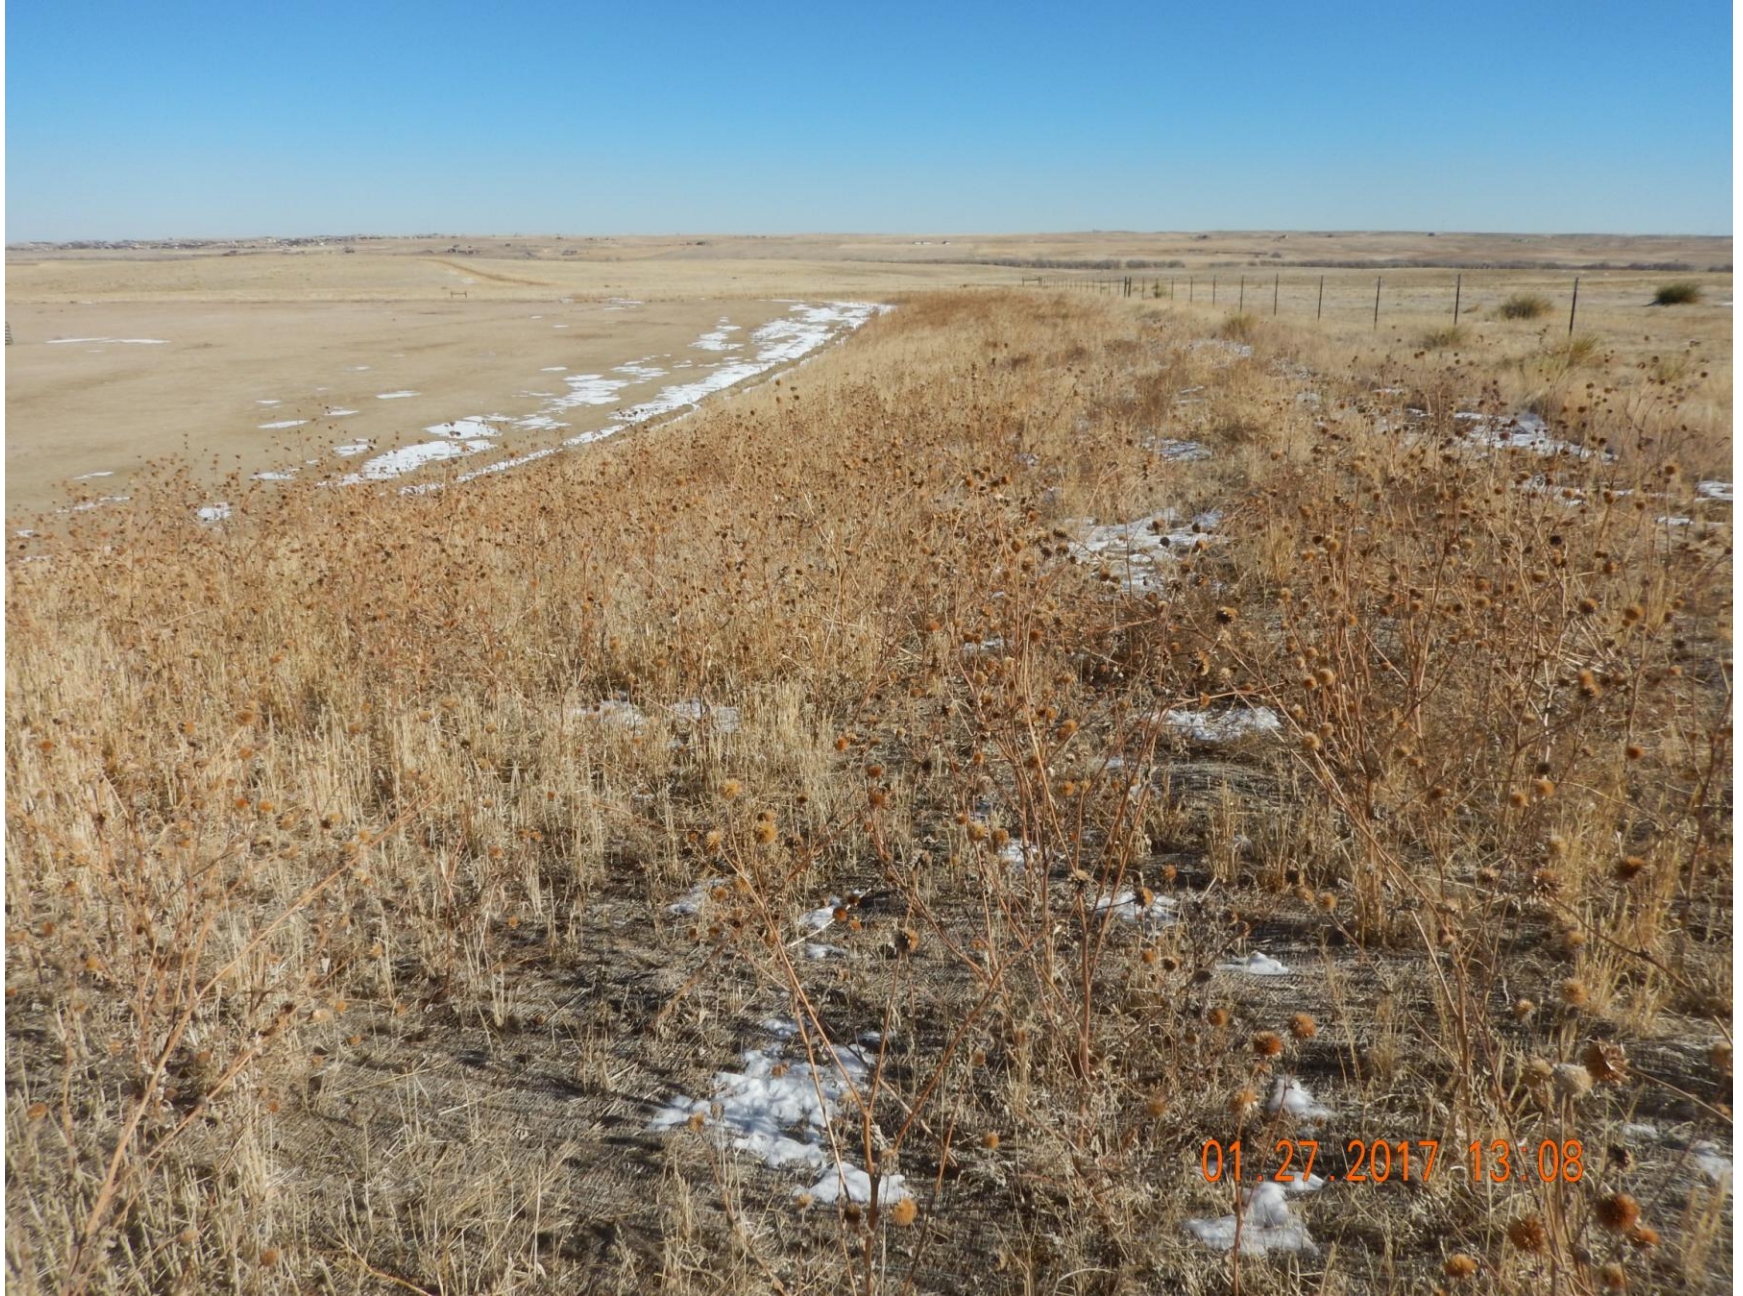
Figure 2: Photo taken from the southwest end of the location, facing east. Photo shows the project and current interim areas.

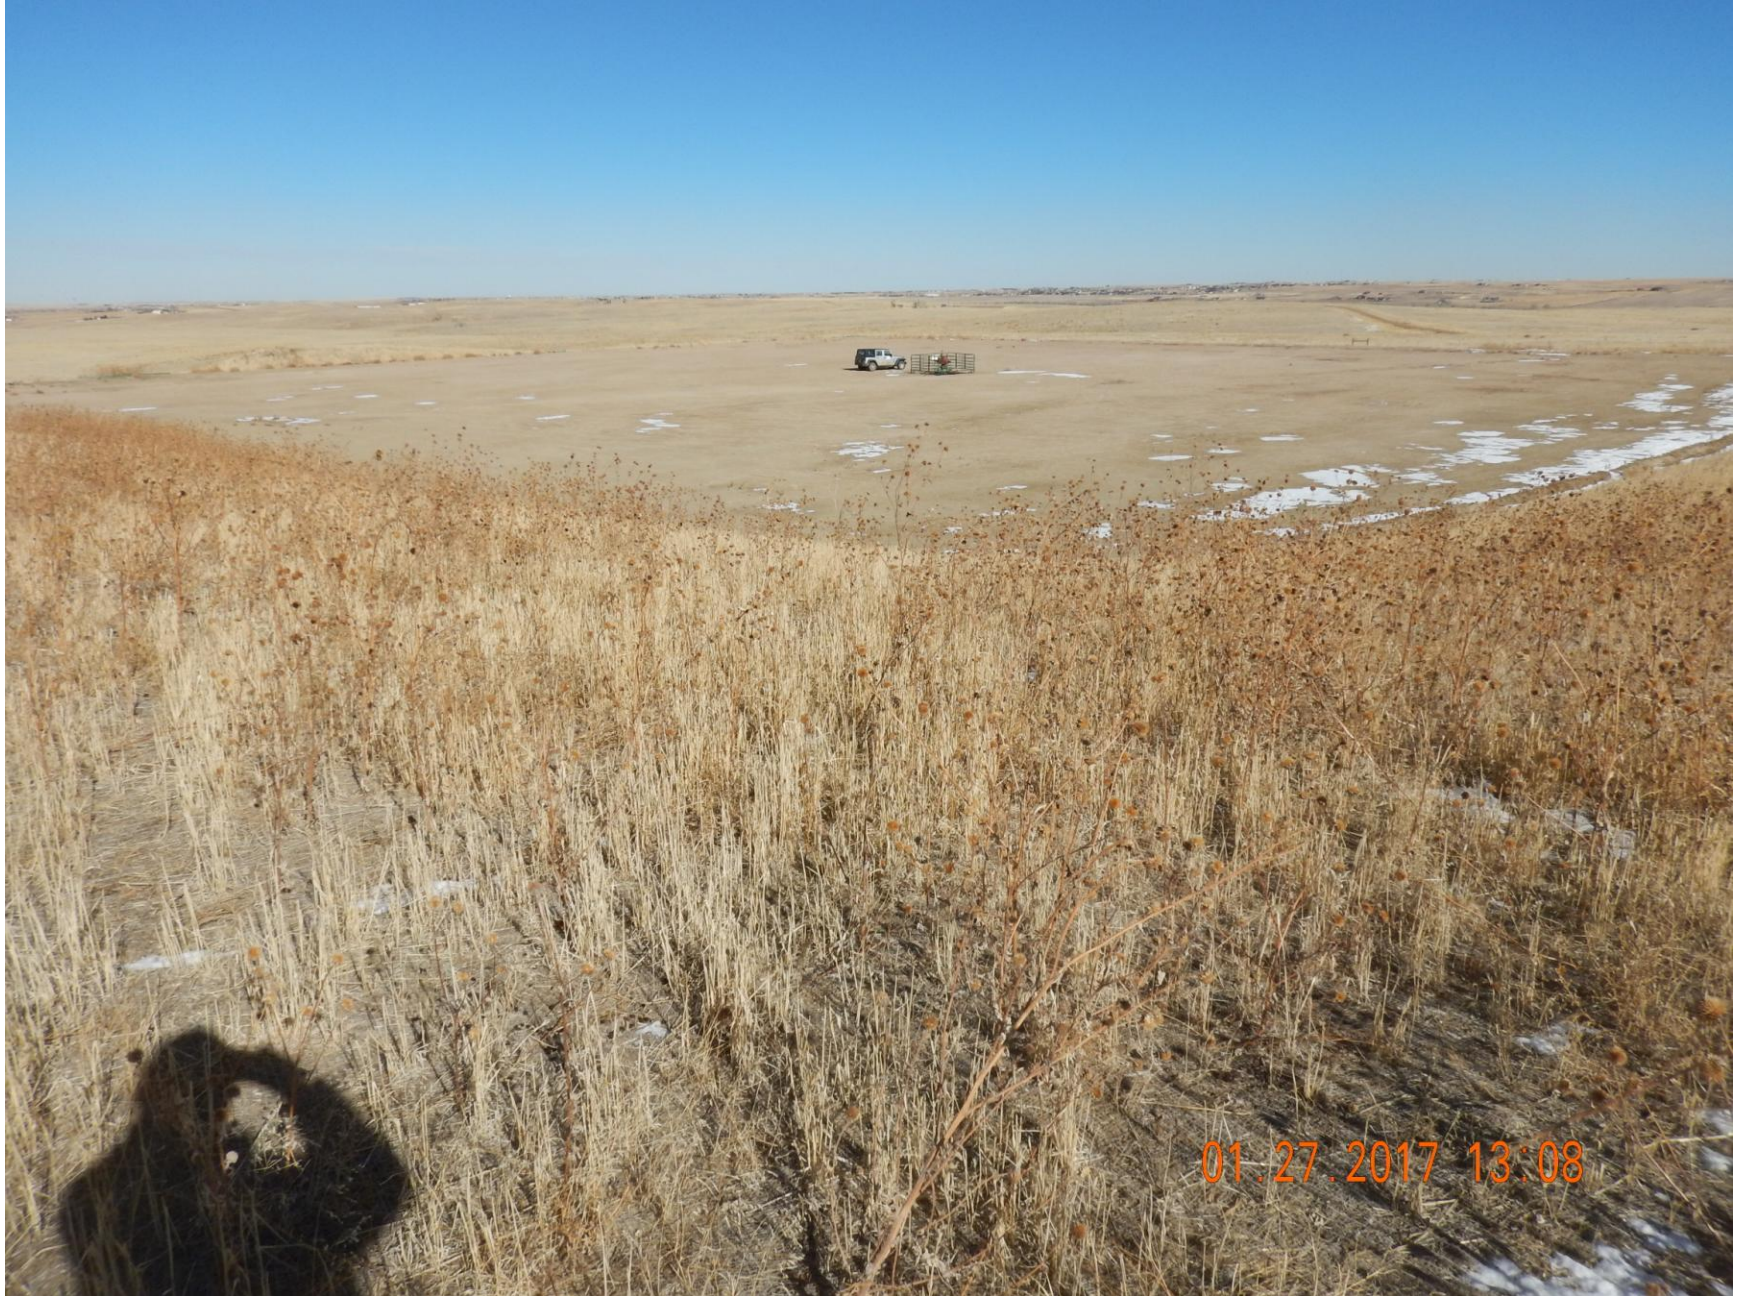
Figure 3: Photo taken from the southwest end of the location, facing northeast. Photo shows the project and current interim areas.

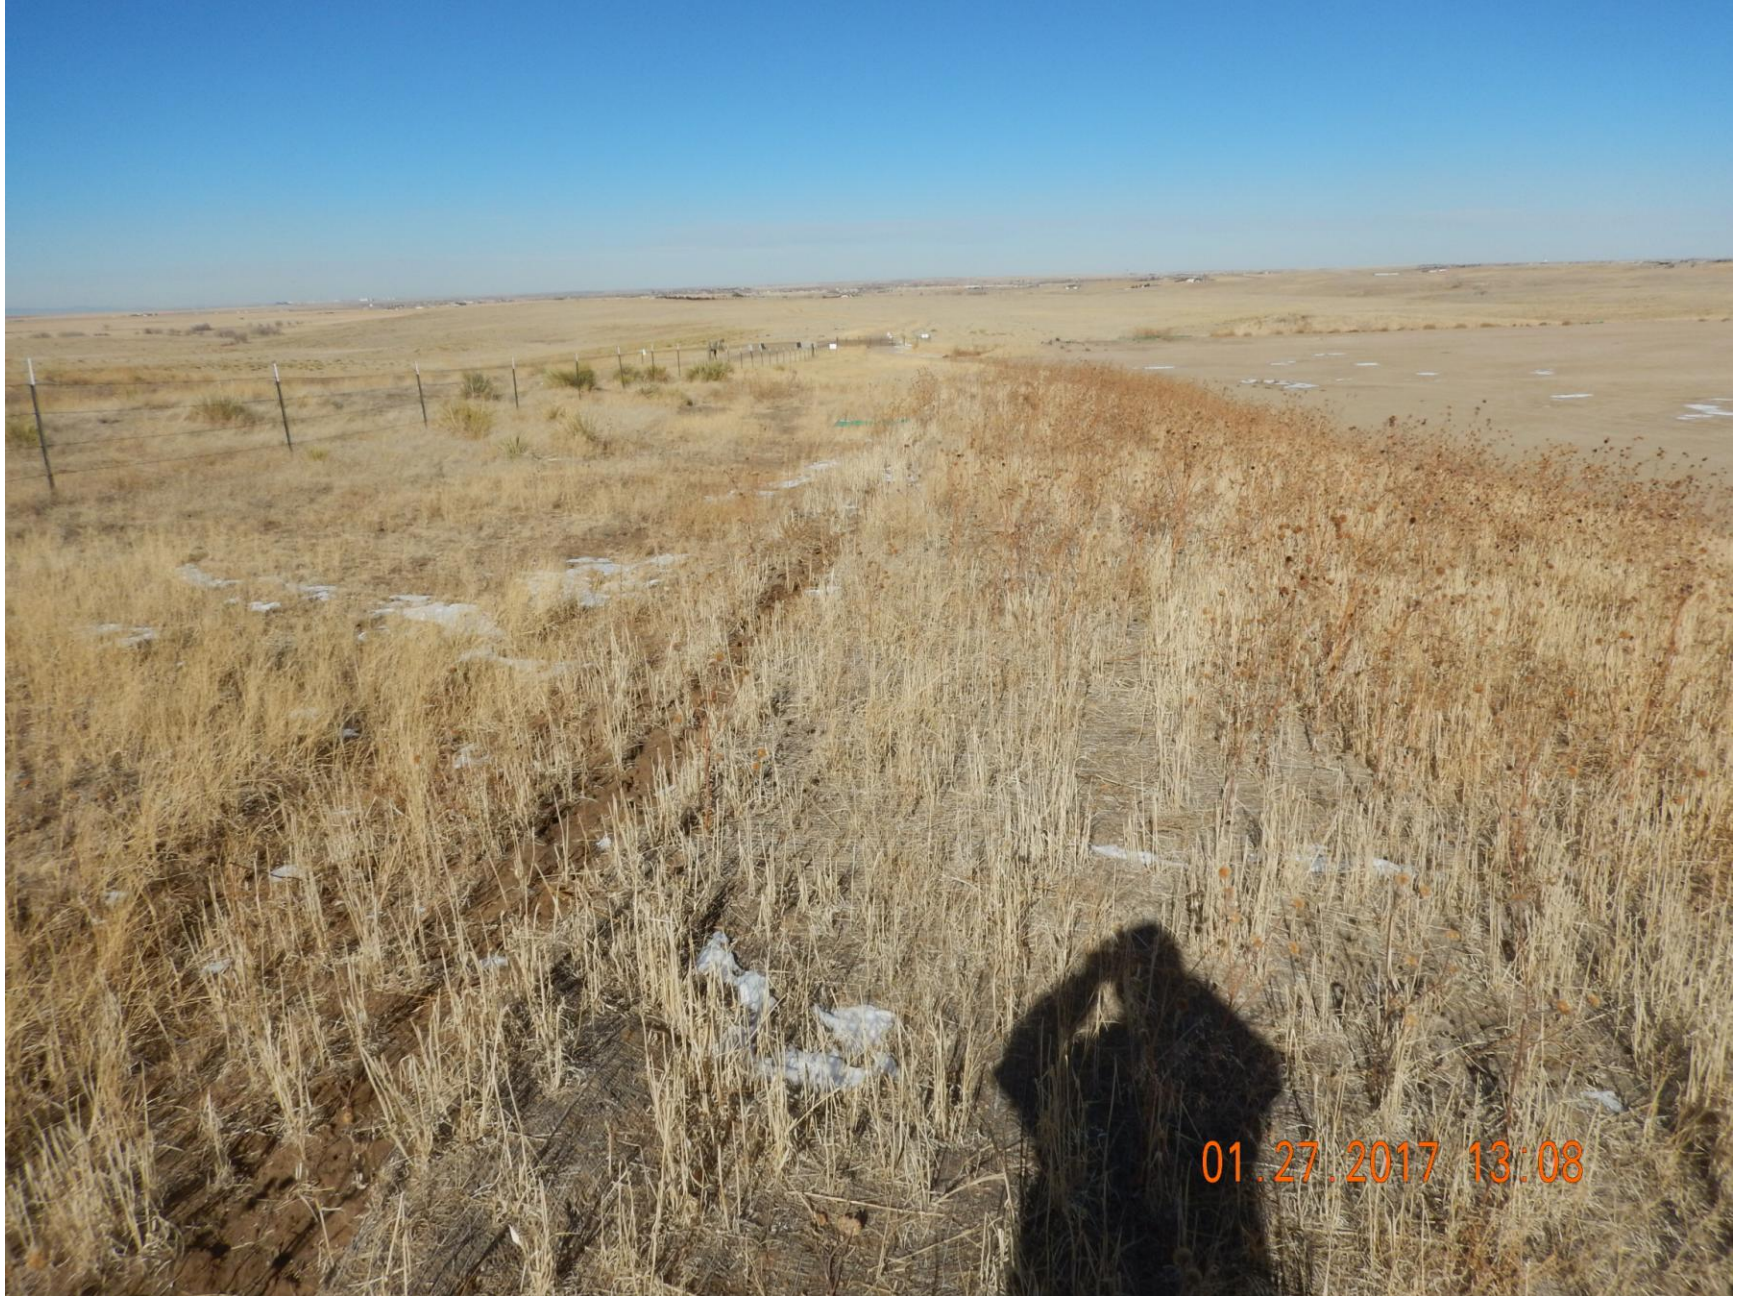
Figure 4: Photo taken from the southwest end of the location, facing north. Photo shows the project and current interim areas.

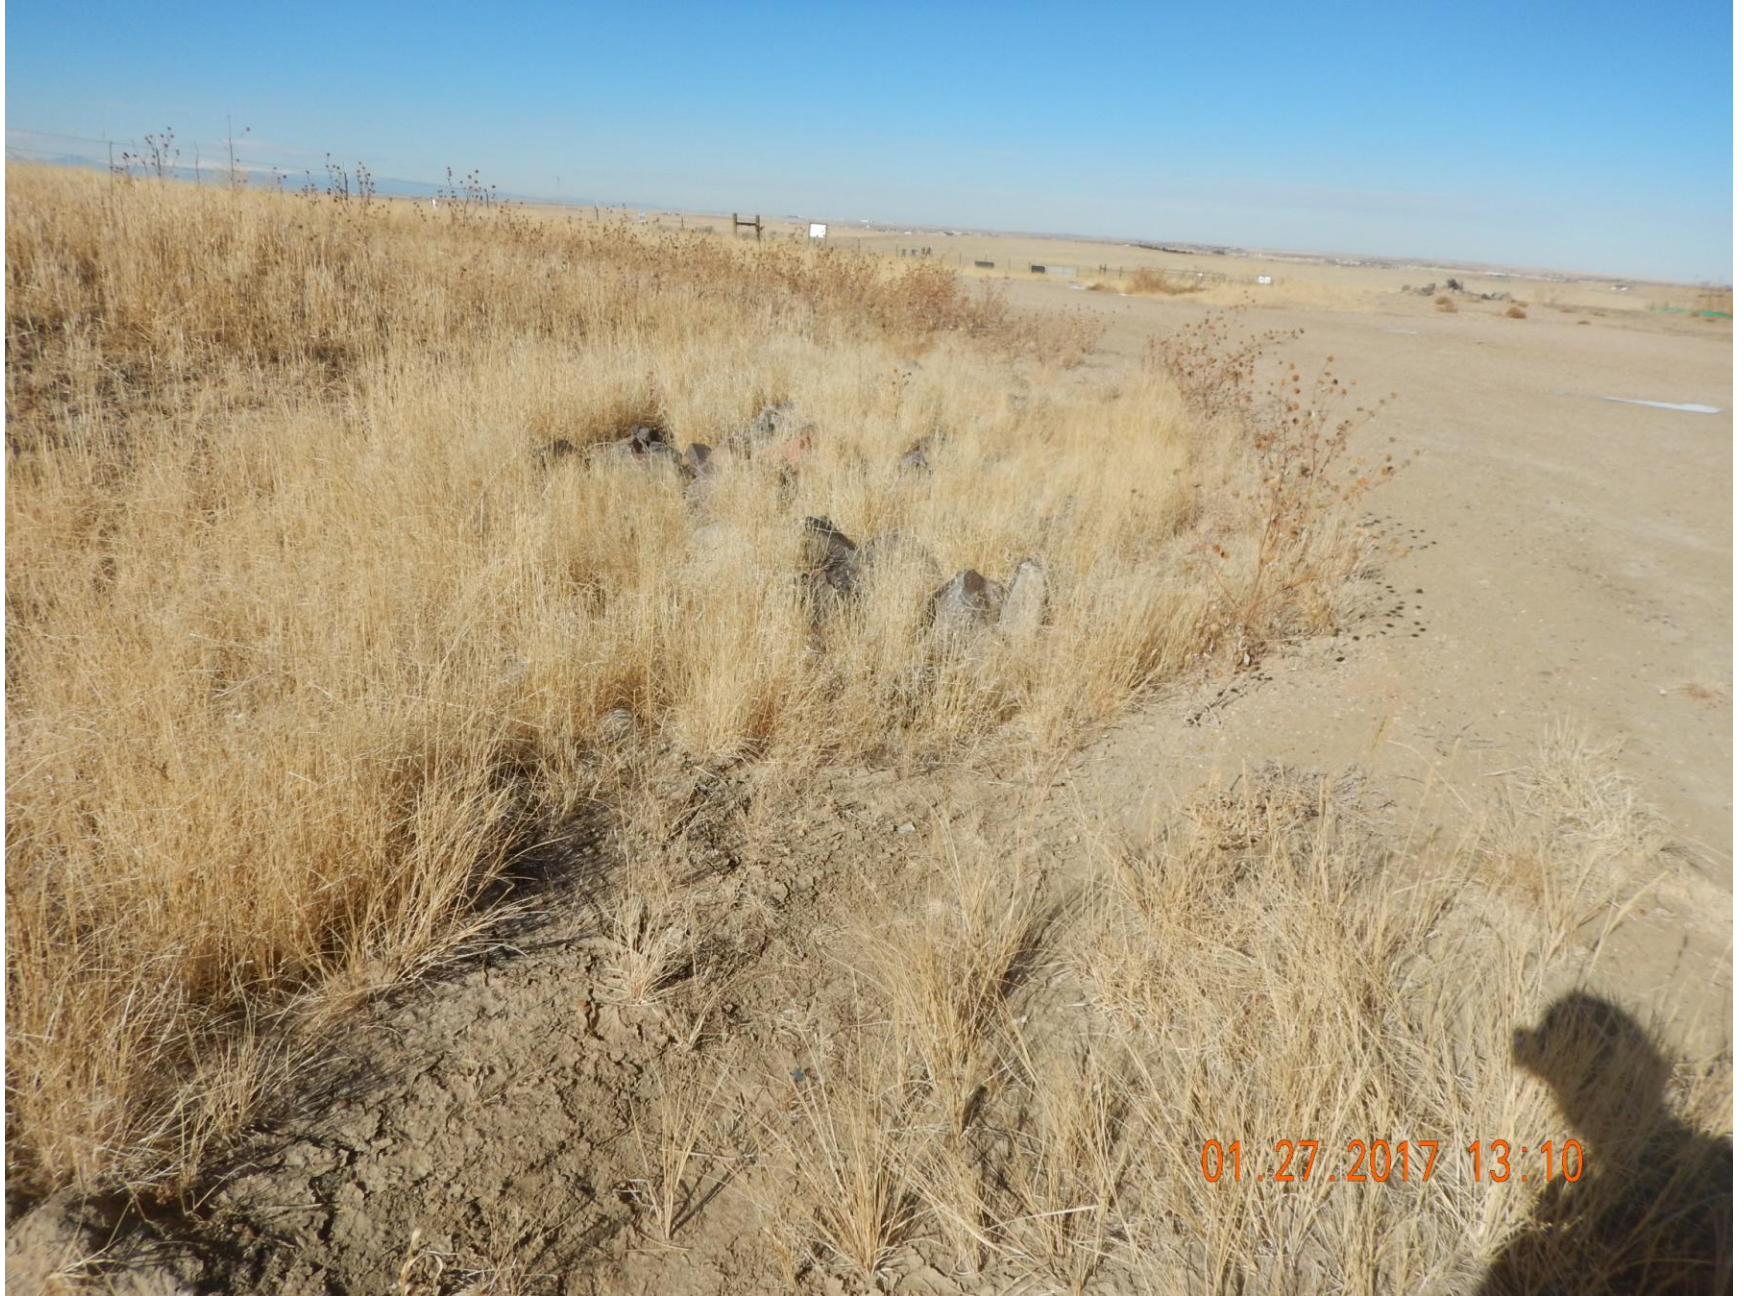
Figure 5: Photo taken from the west end of the project area, facing north. Photo shows sediment trap composed of various sized rock.

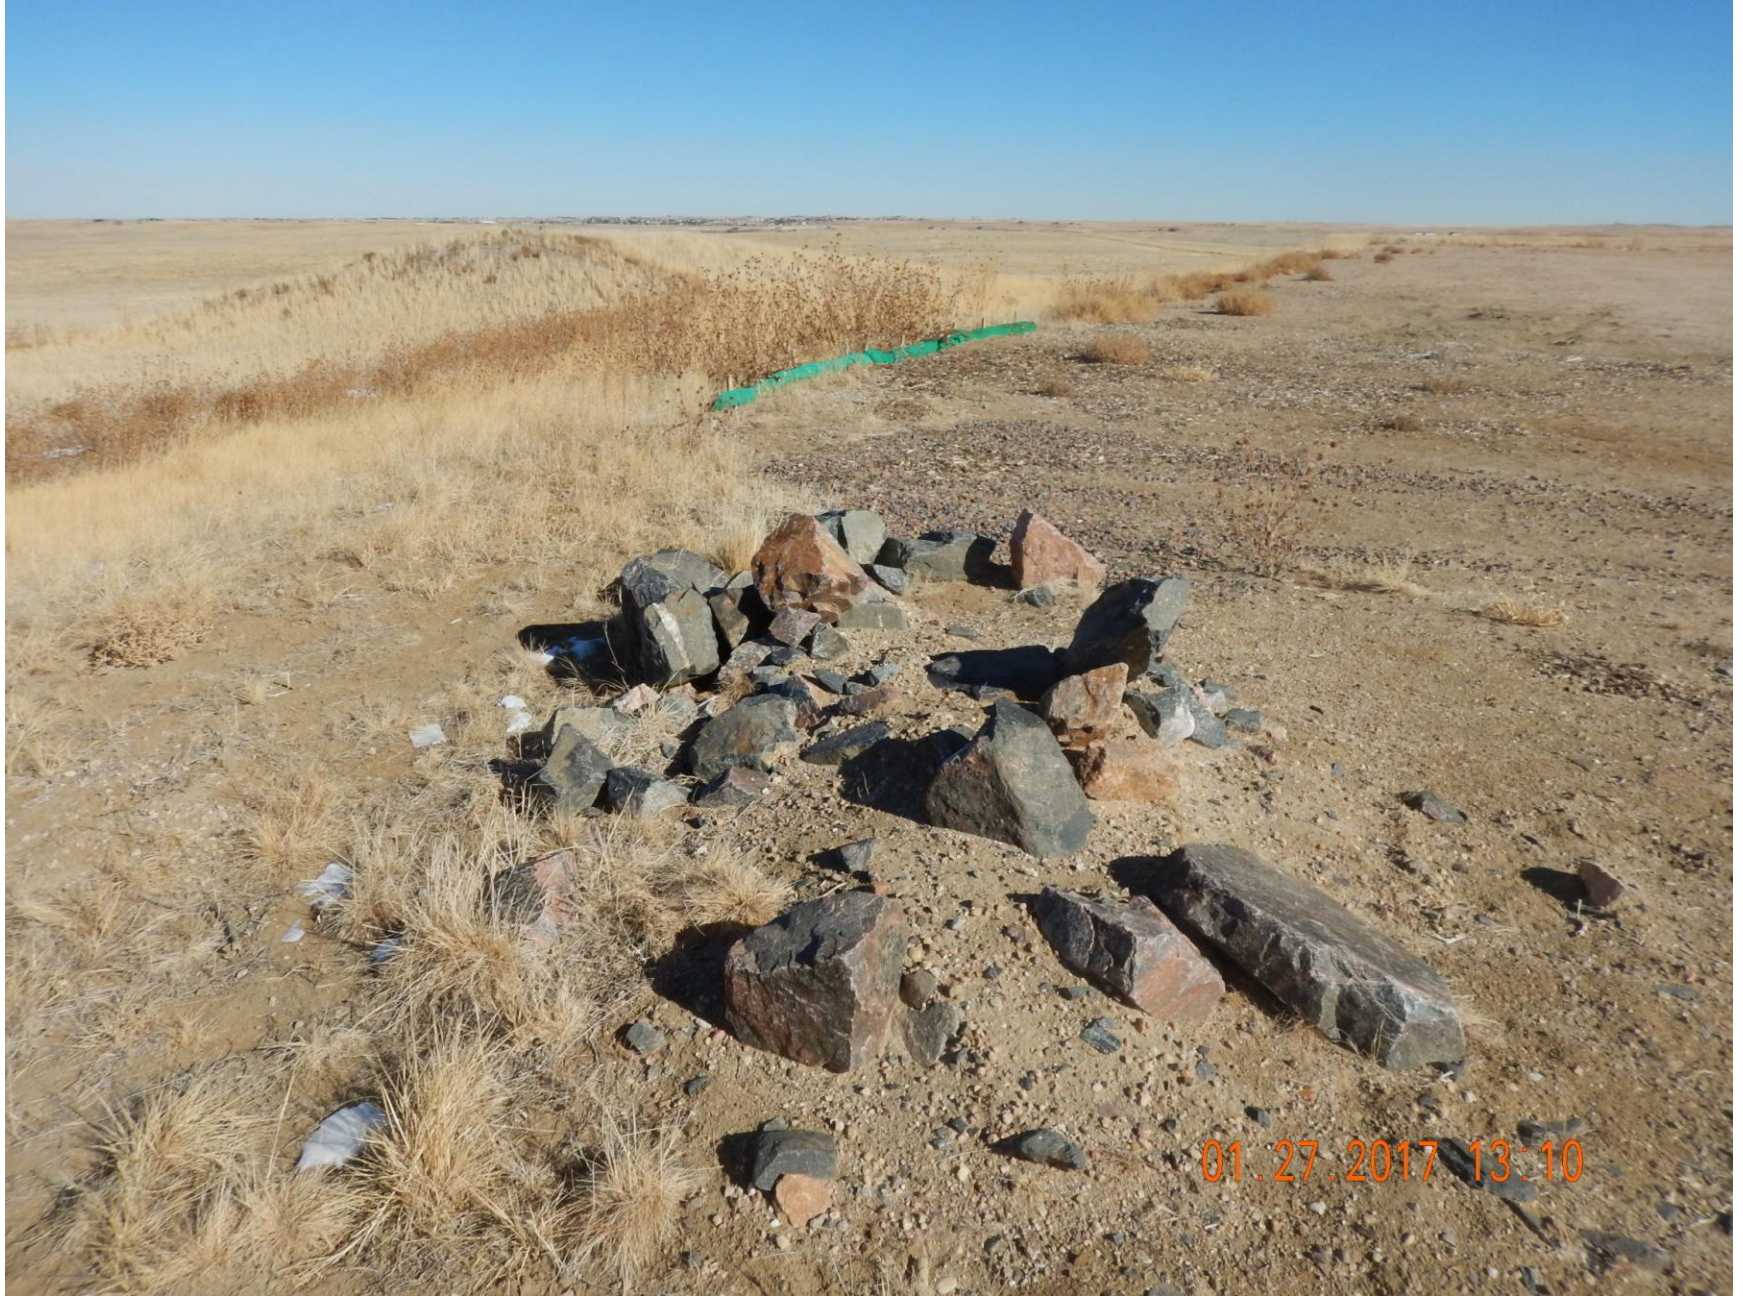
Figure 6: Photo taken from the northwest corner of the project area, facing northeast. Photo rock pile on the location, and wattle used as a stormwater and sediment control BMP.

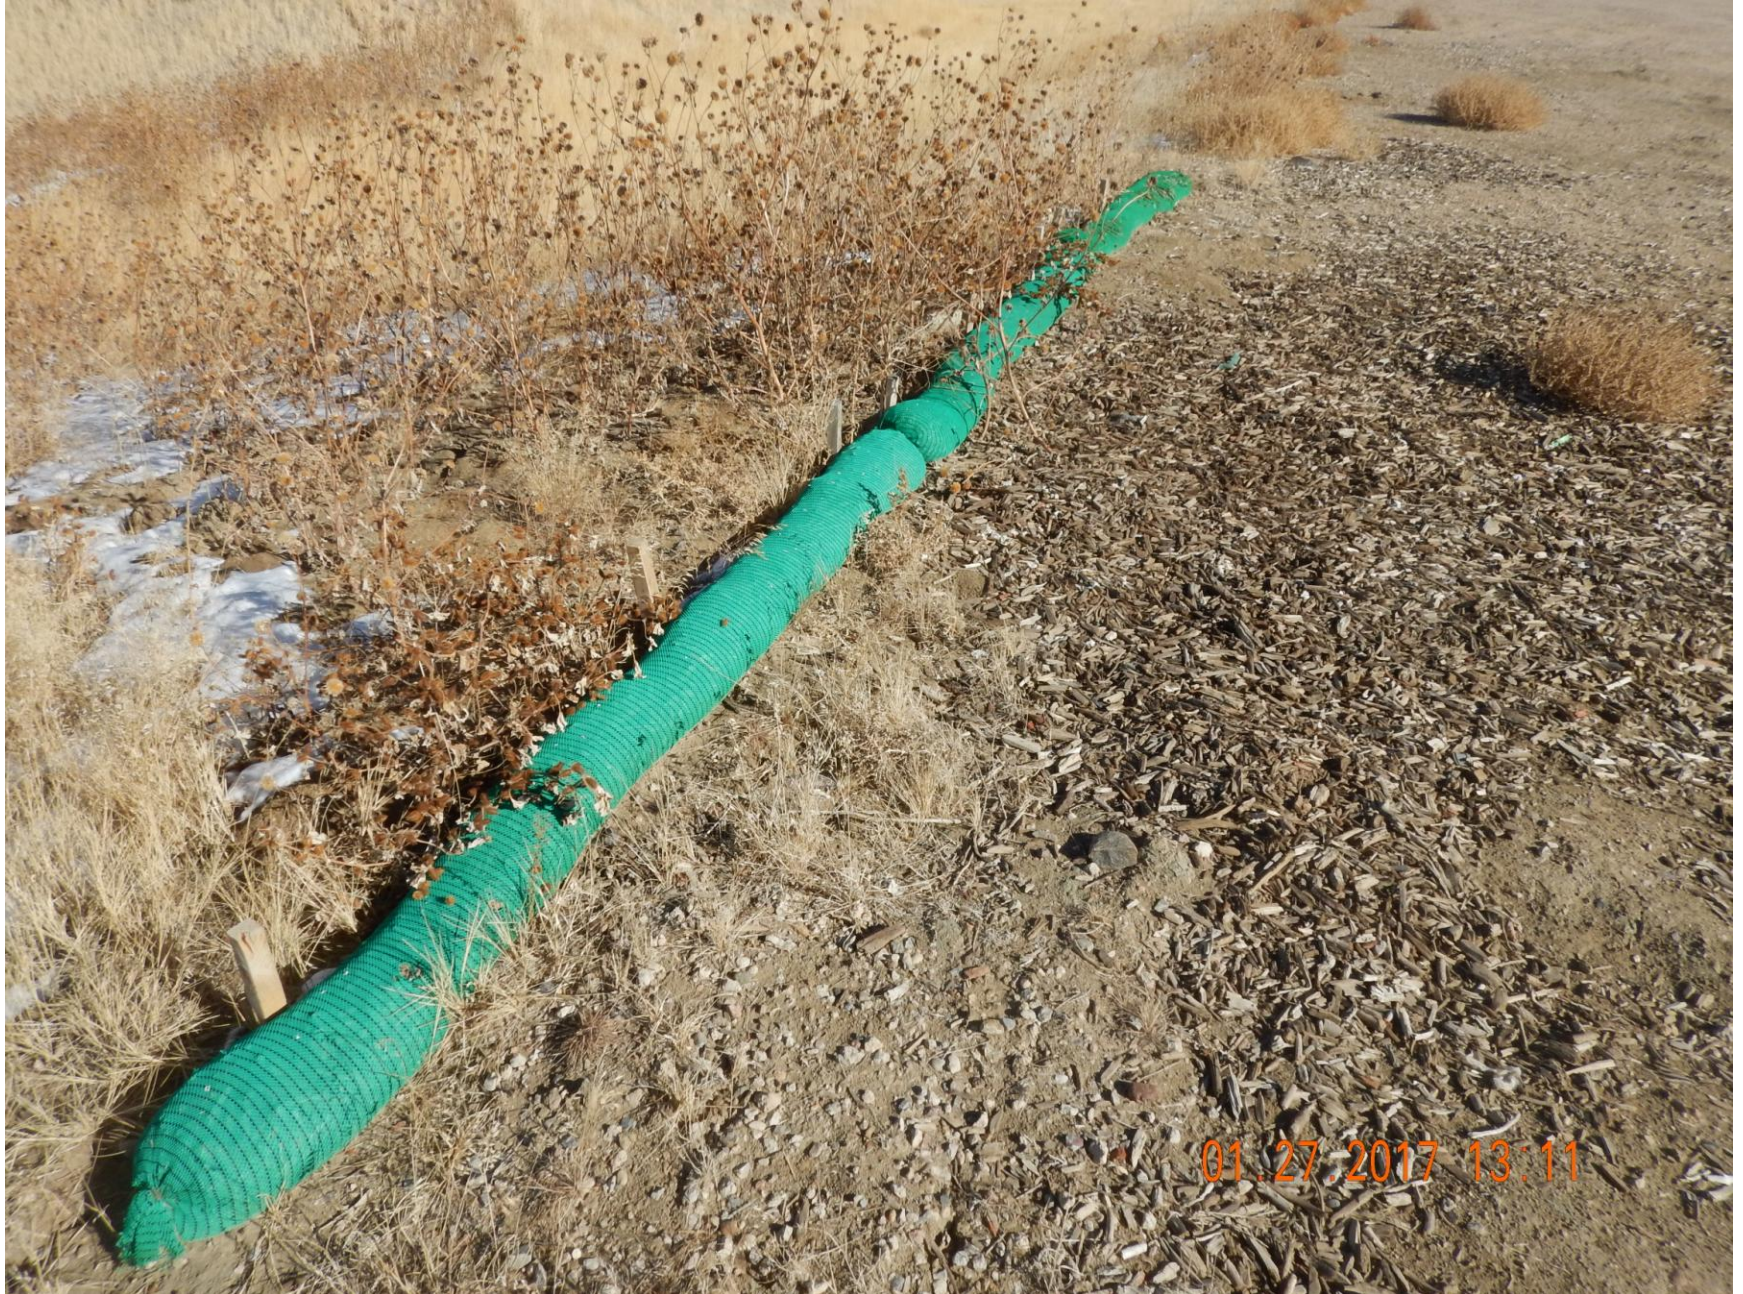
Figure 7: Photo taken from the north end of the location. Photo shows wattle used as a stormwater and sediment control BMP.

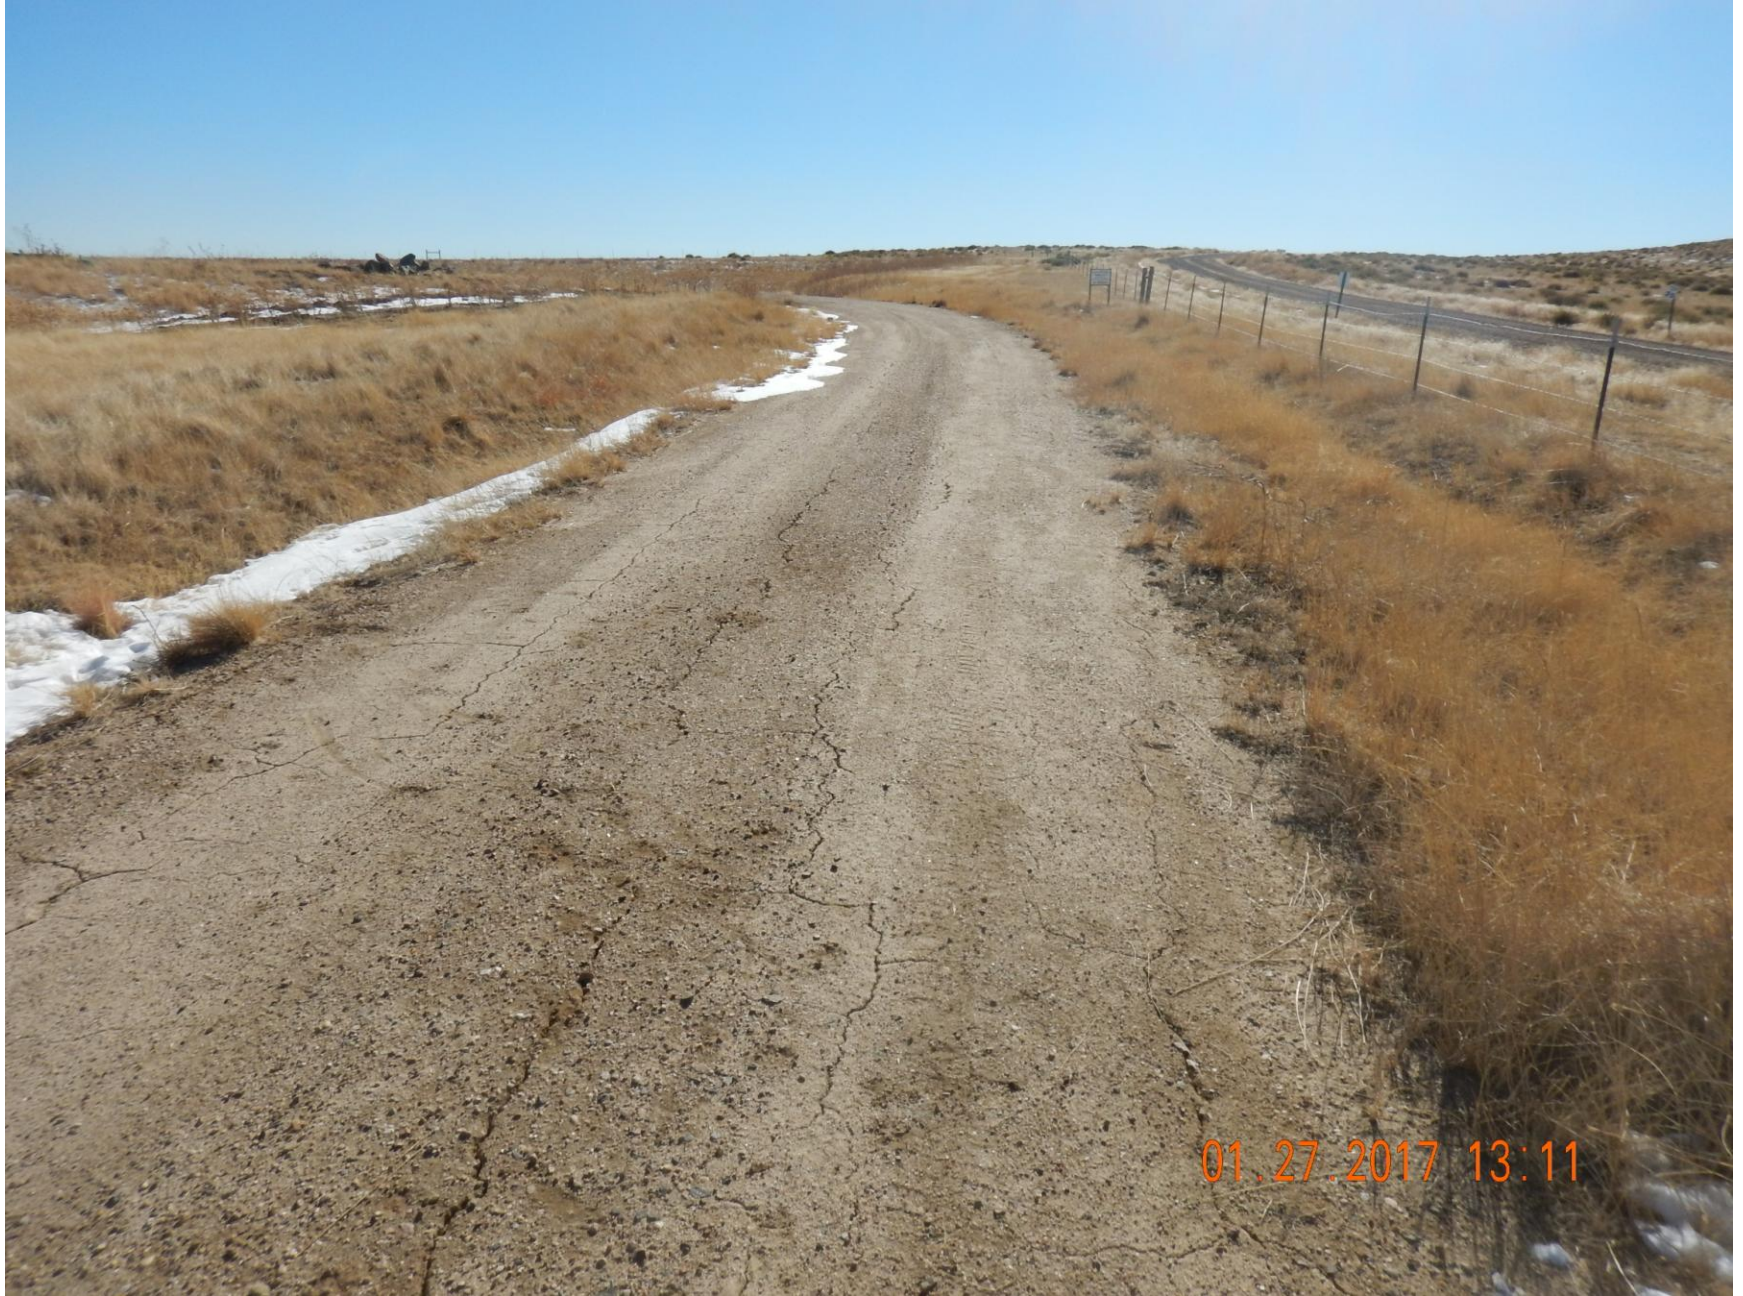
Figure 8: Photo taken from the northwest end of the location, facing south. Photo shows the project and current interim areas, as well as the access road.

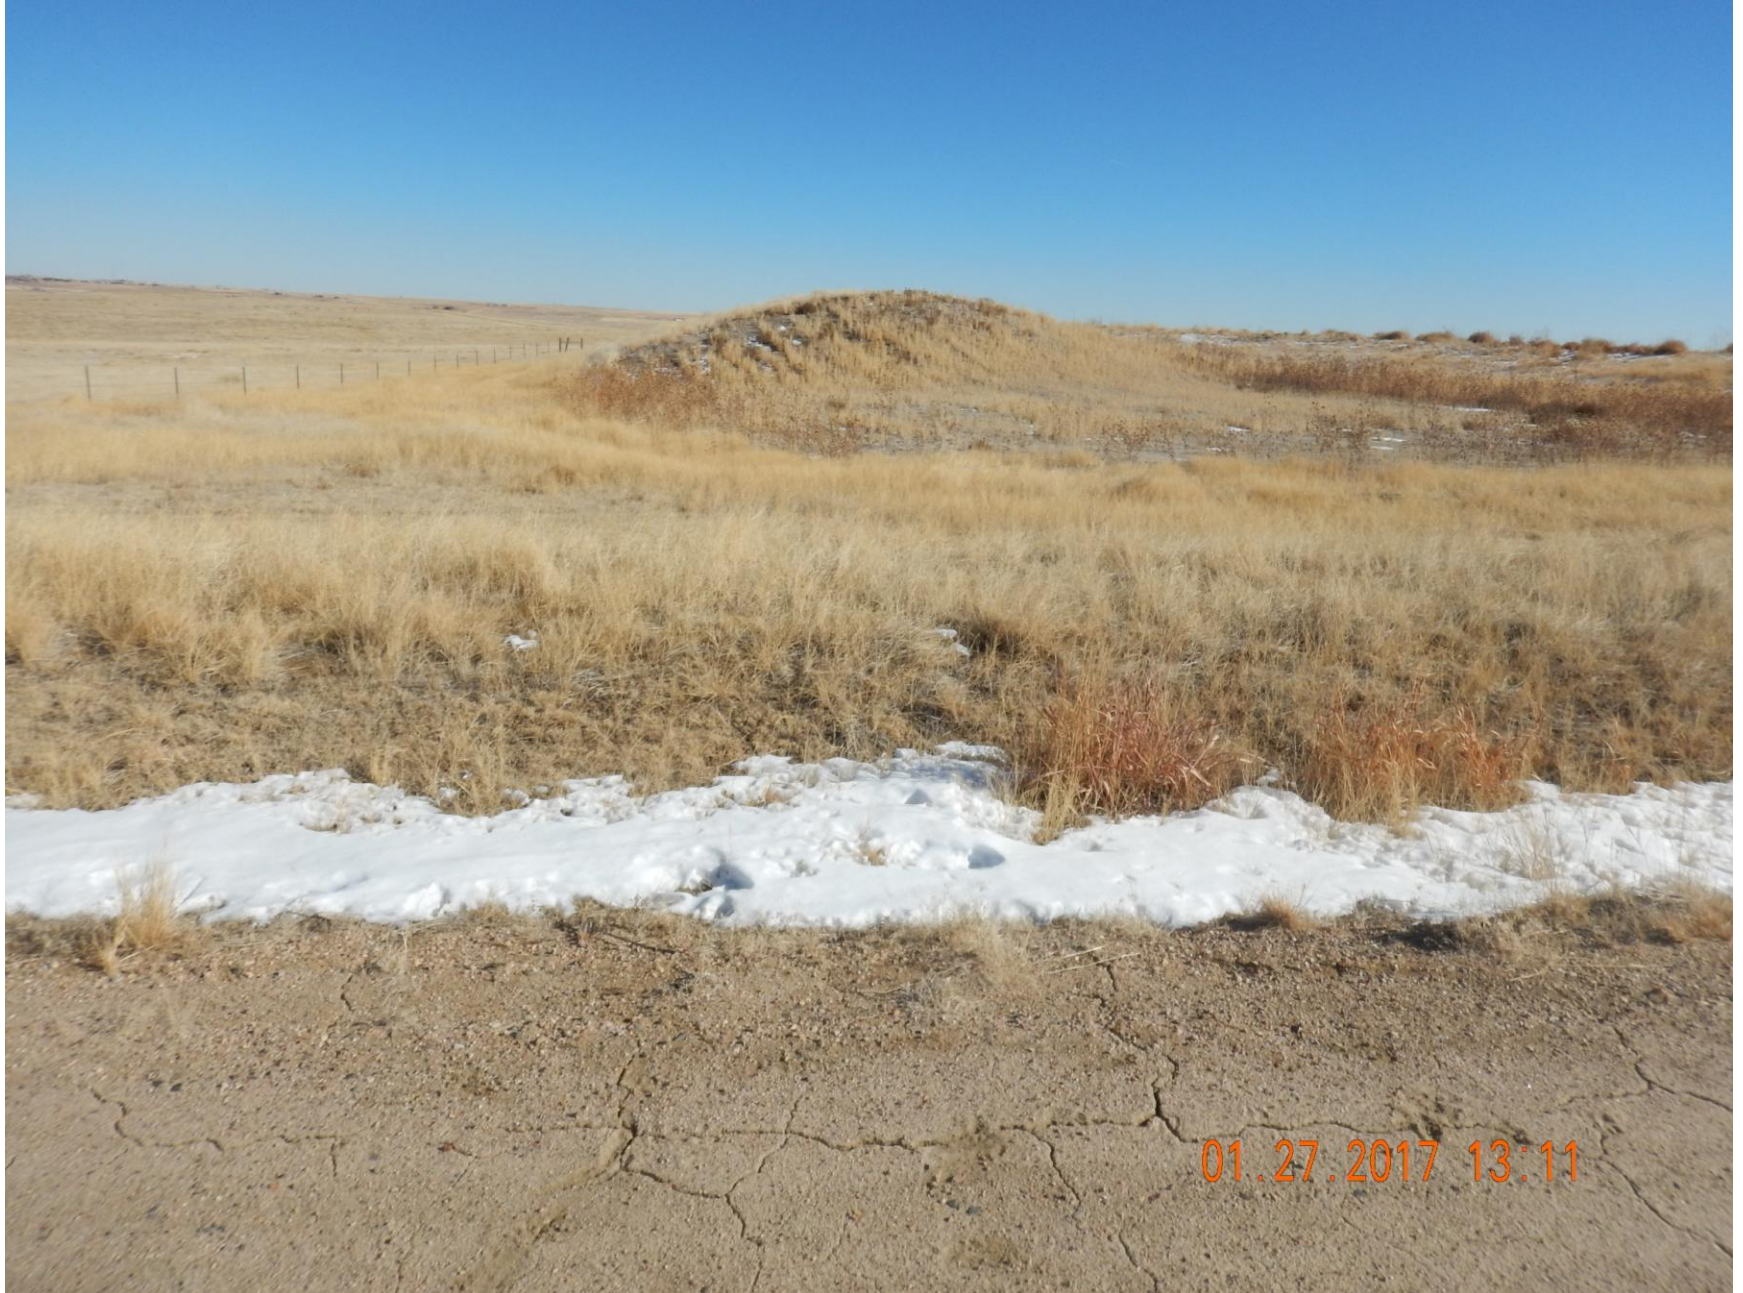
Figure 9: Photo taken from the northwest end of the location, facing east. Photo shows the topsoil berm on the north end of the location.

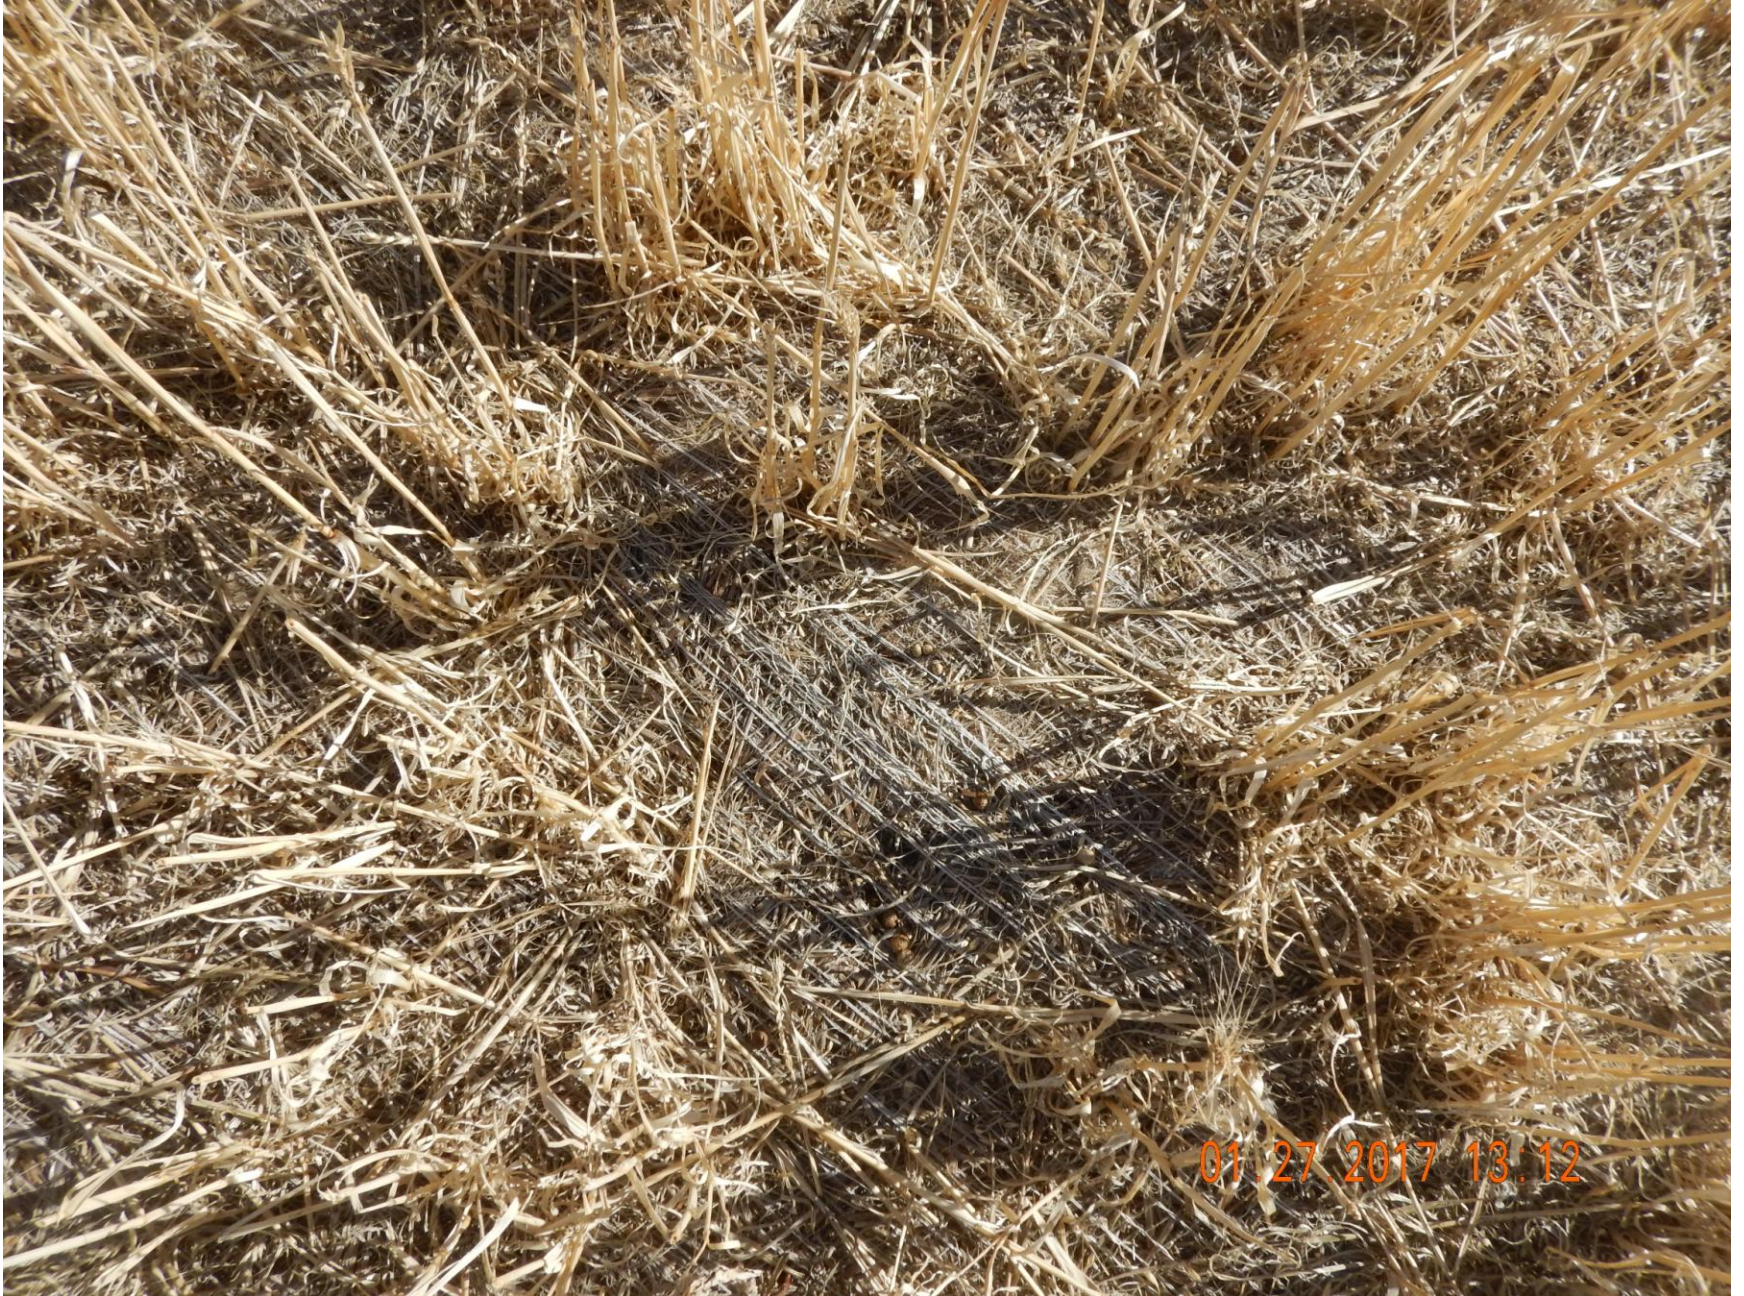
Figure 10: Photo taken from the west end of the topsoil berm. Photo shows vegetation on the berm. Vegetation seen here appears to be an annual triticum species.
