Reclamation Inspection

01/27/2017

Operator: Conoco Phillips #19160

Location ID: 426630

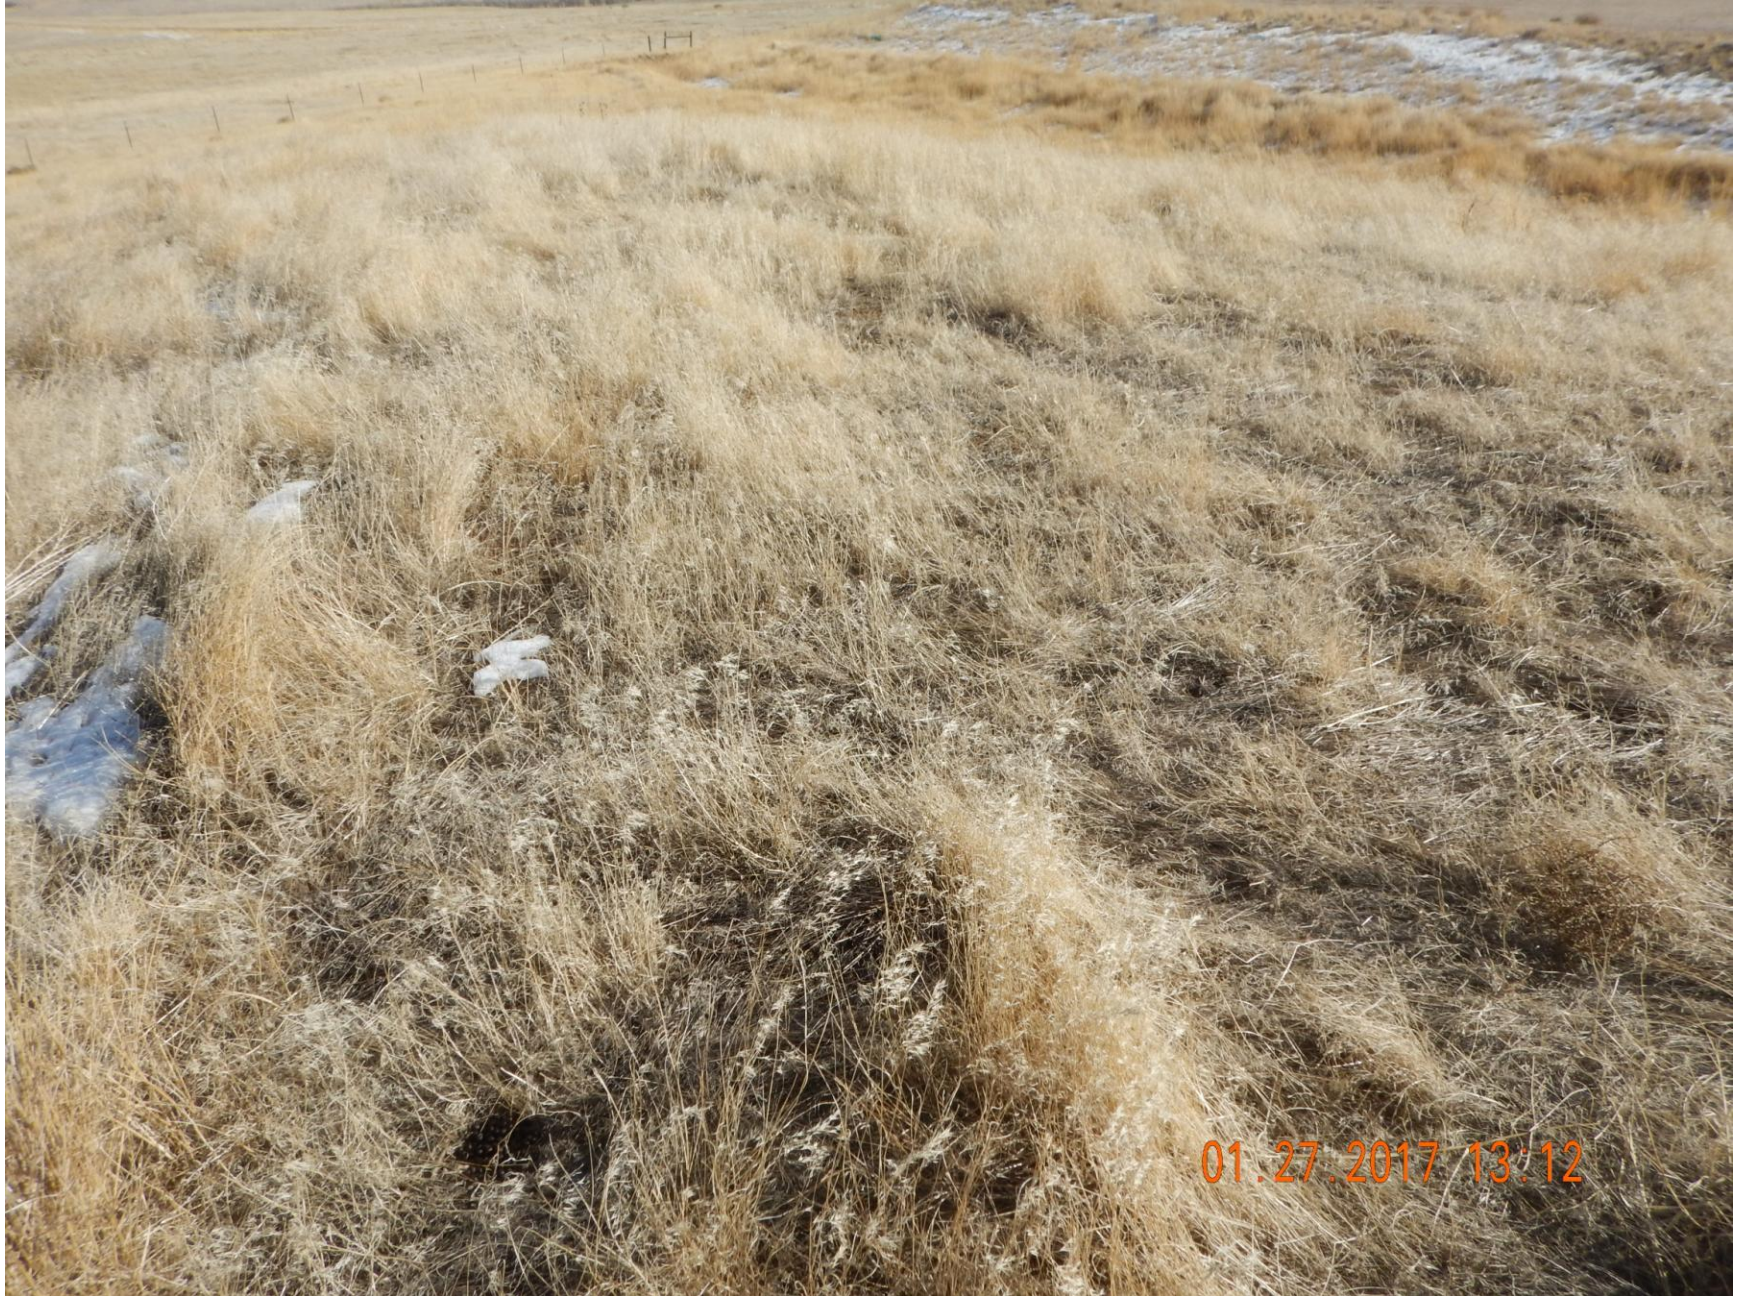
Figure 11: Photo taken from the east end of the topsoil berm, facing east. Photo shows large portions of the topsoil berm is predominantly a cheat grass monoculture. Very little perennial growth evident.

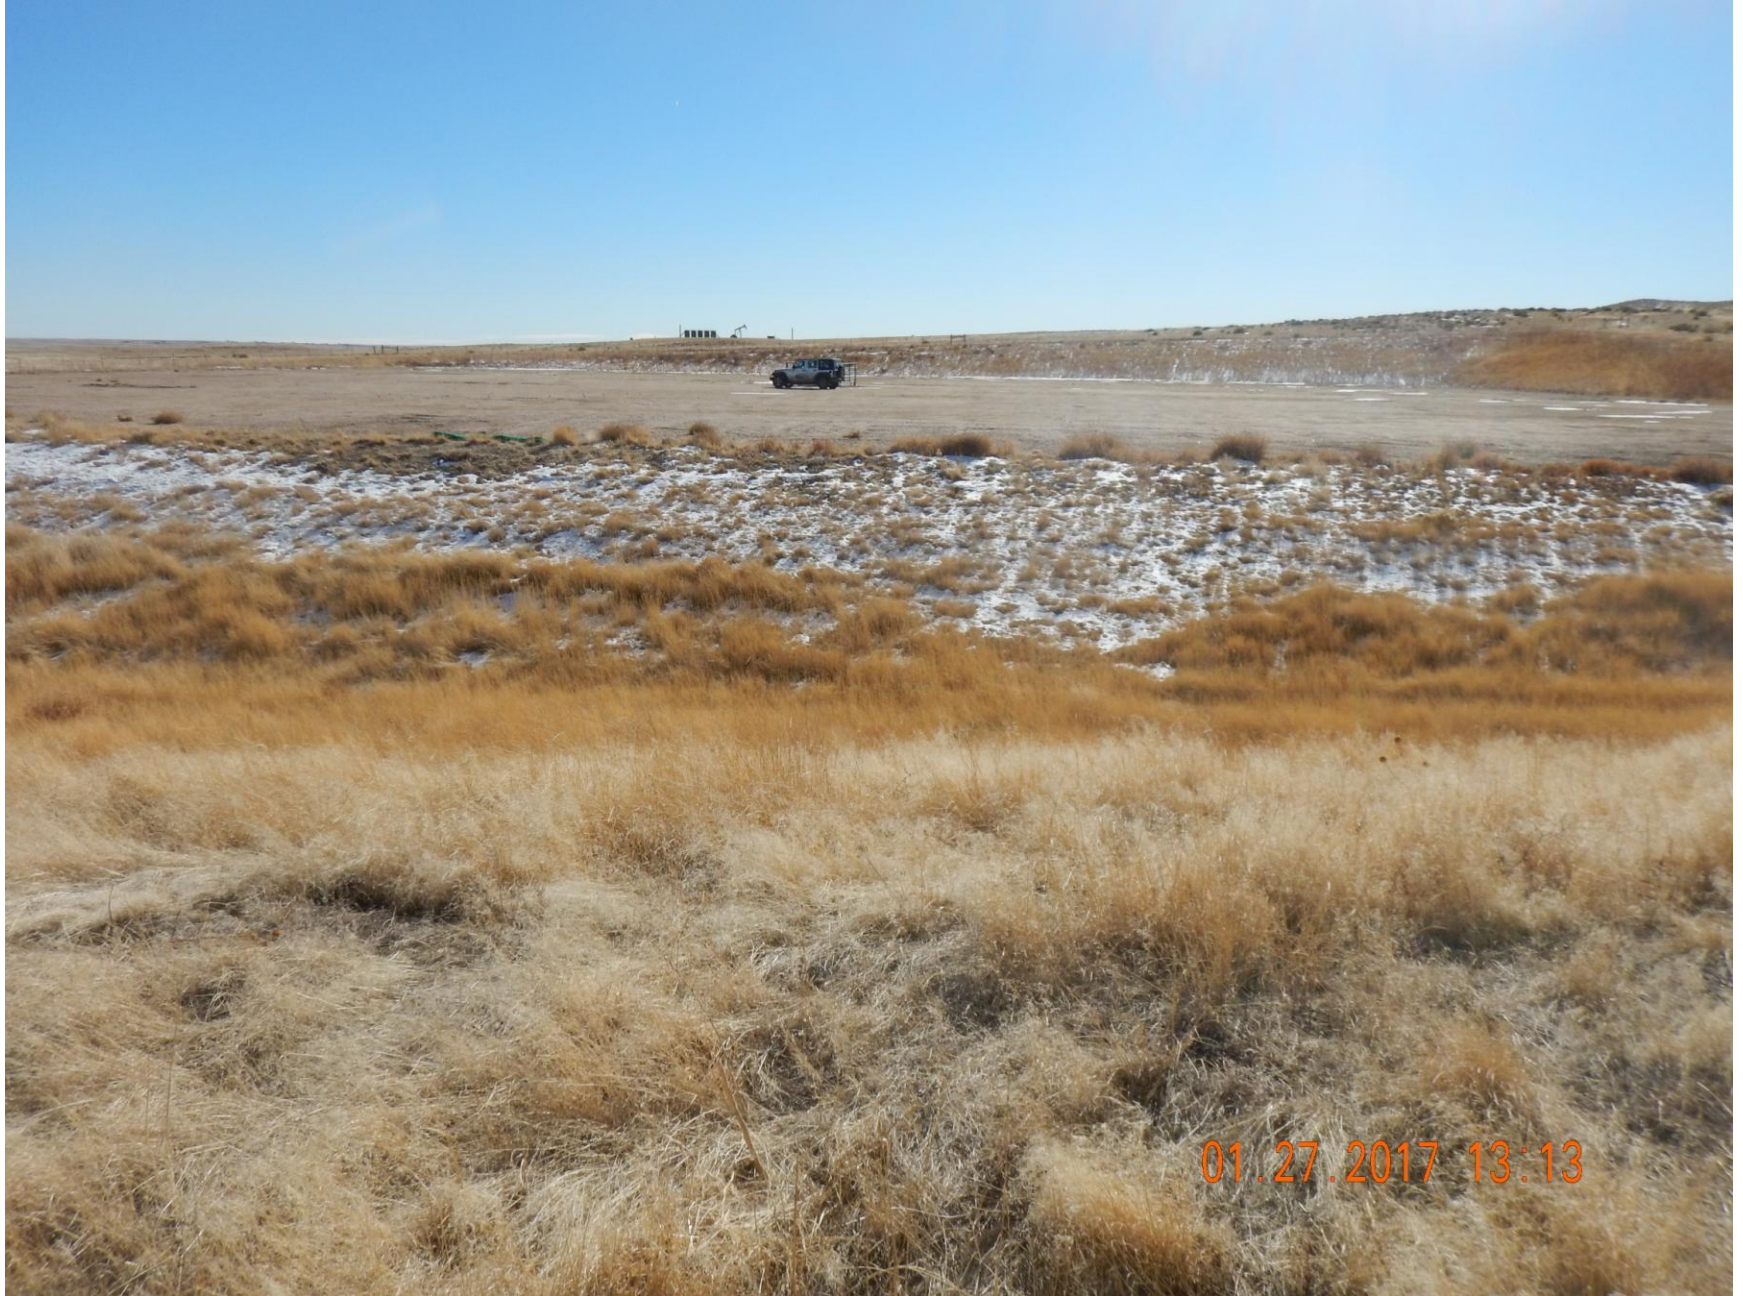
Figure 12: Photo taken from the topsoil berm, facing south. Photo shows the project and current interim areas.

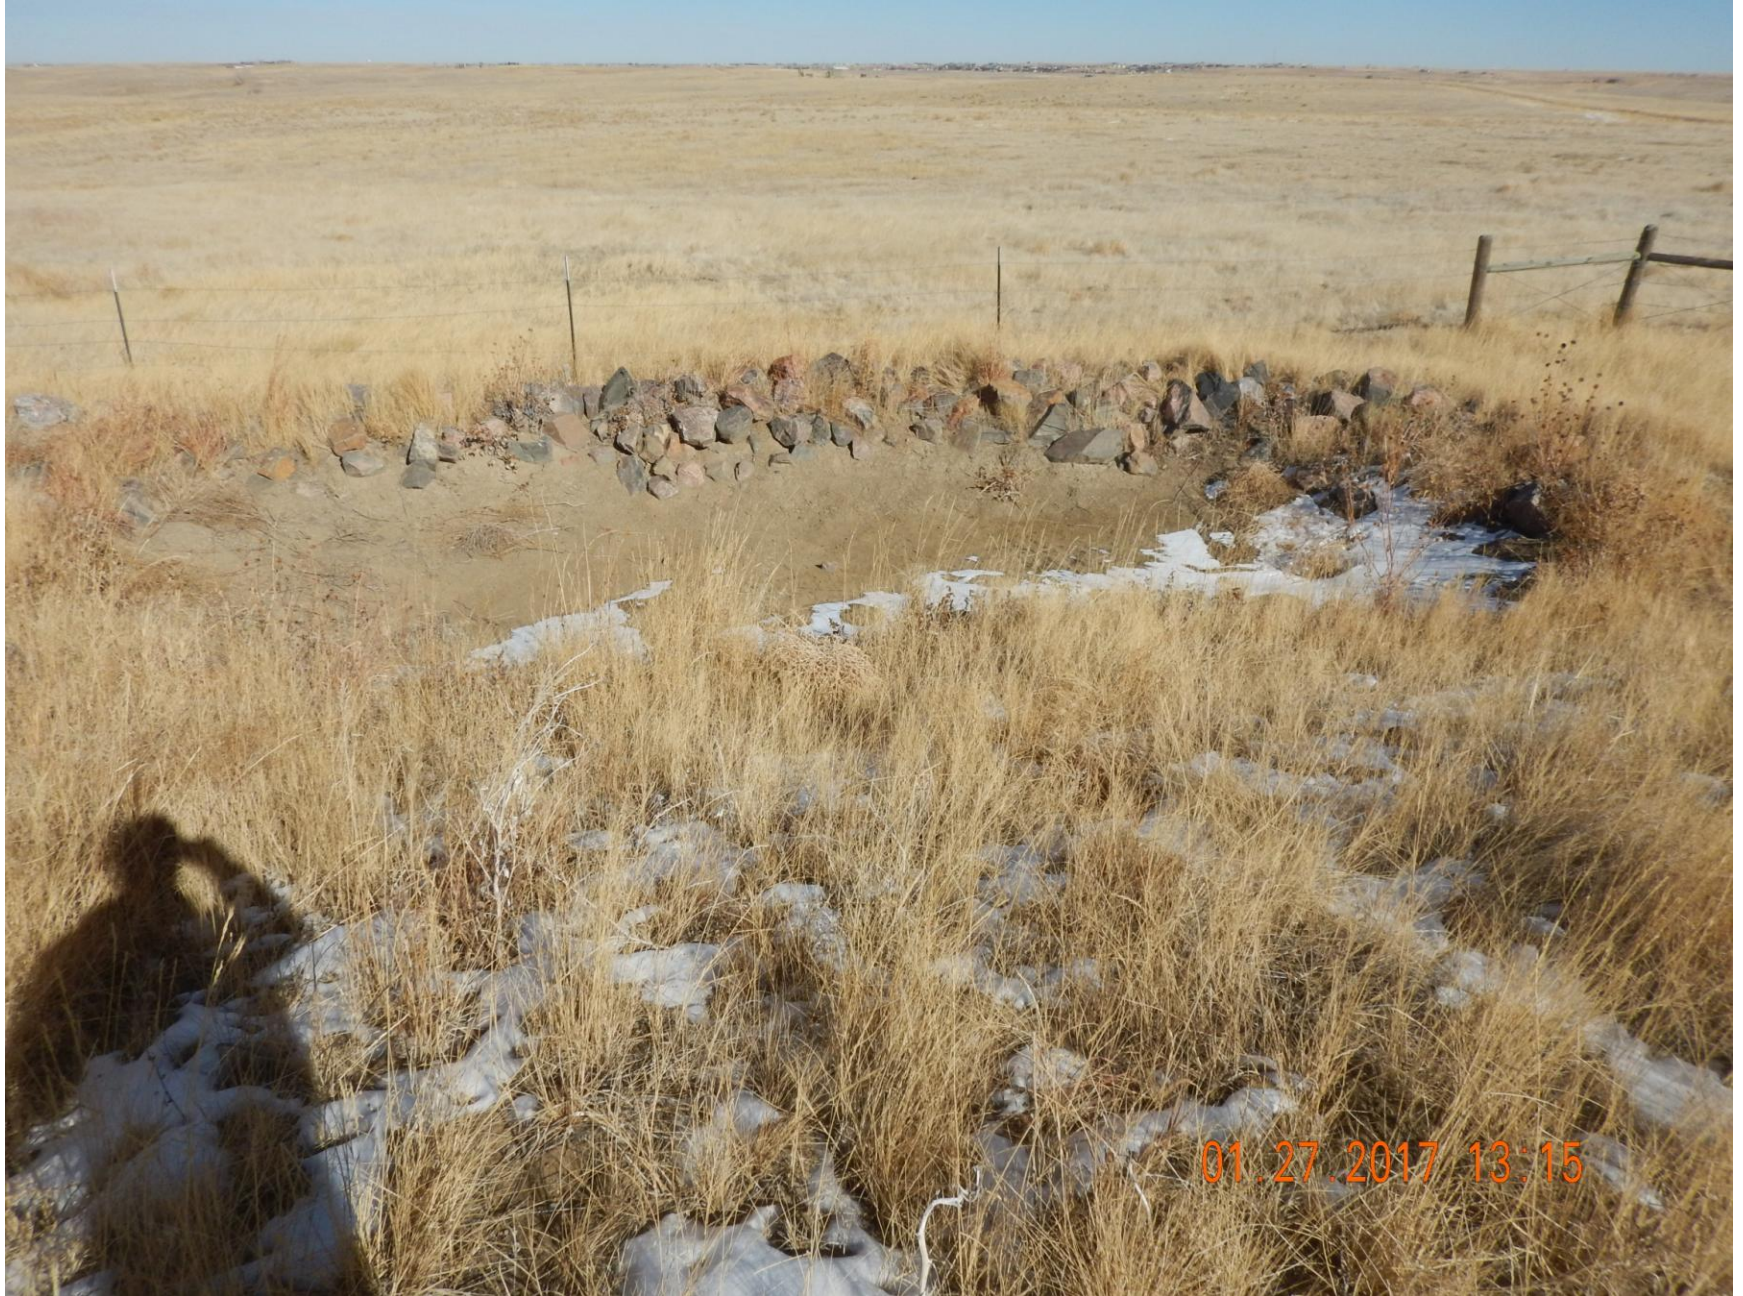
Figure 13: Photo taken from the northeast corner of the current interim area, facing north. Photo shows a sediment trap used as a stormwater and sediment control BMP.

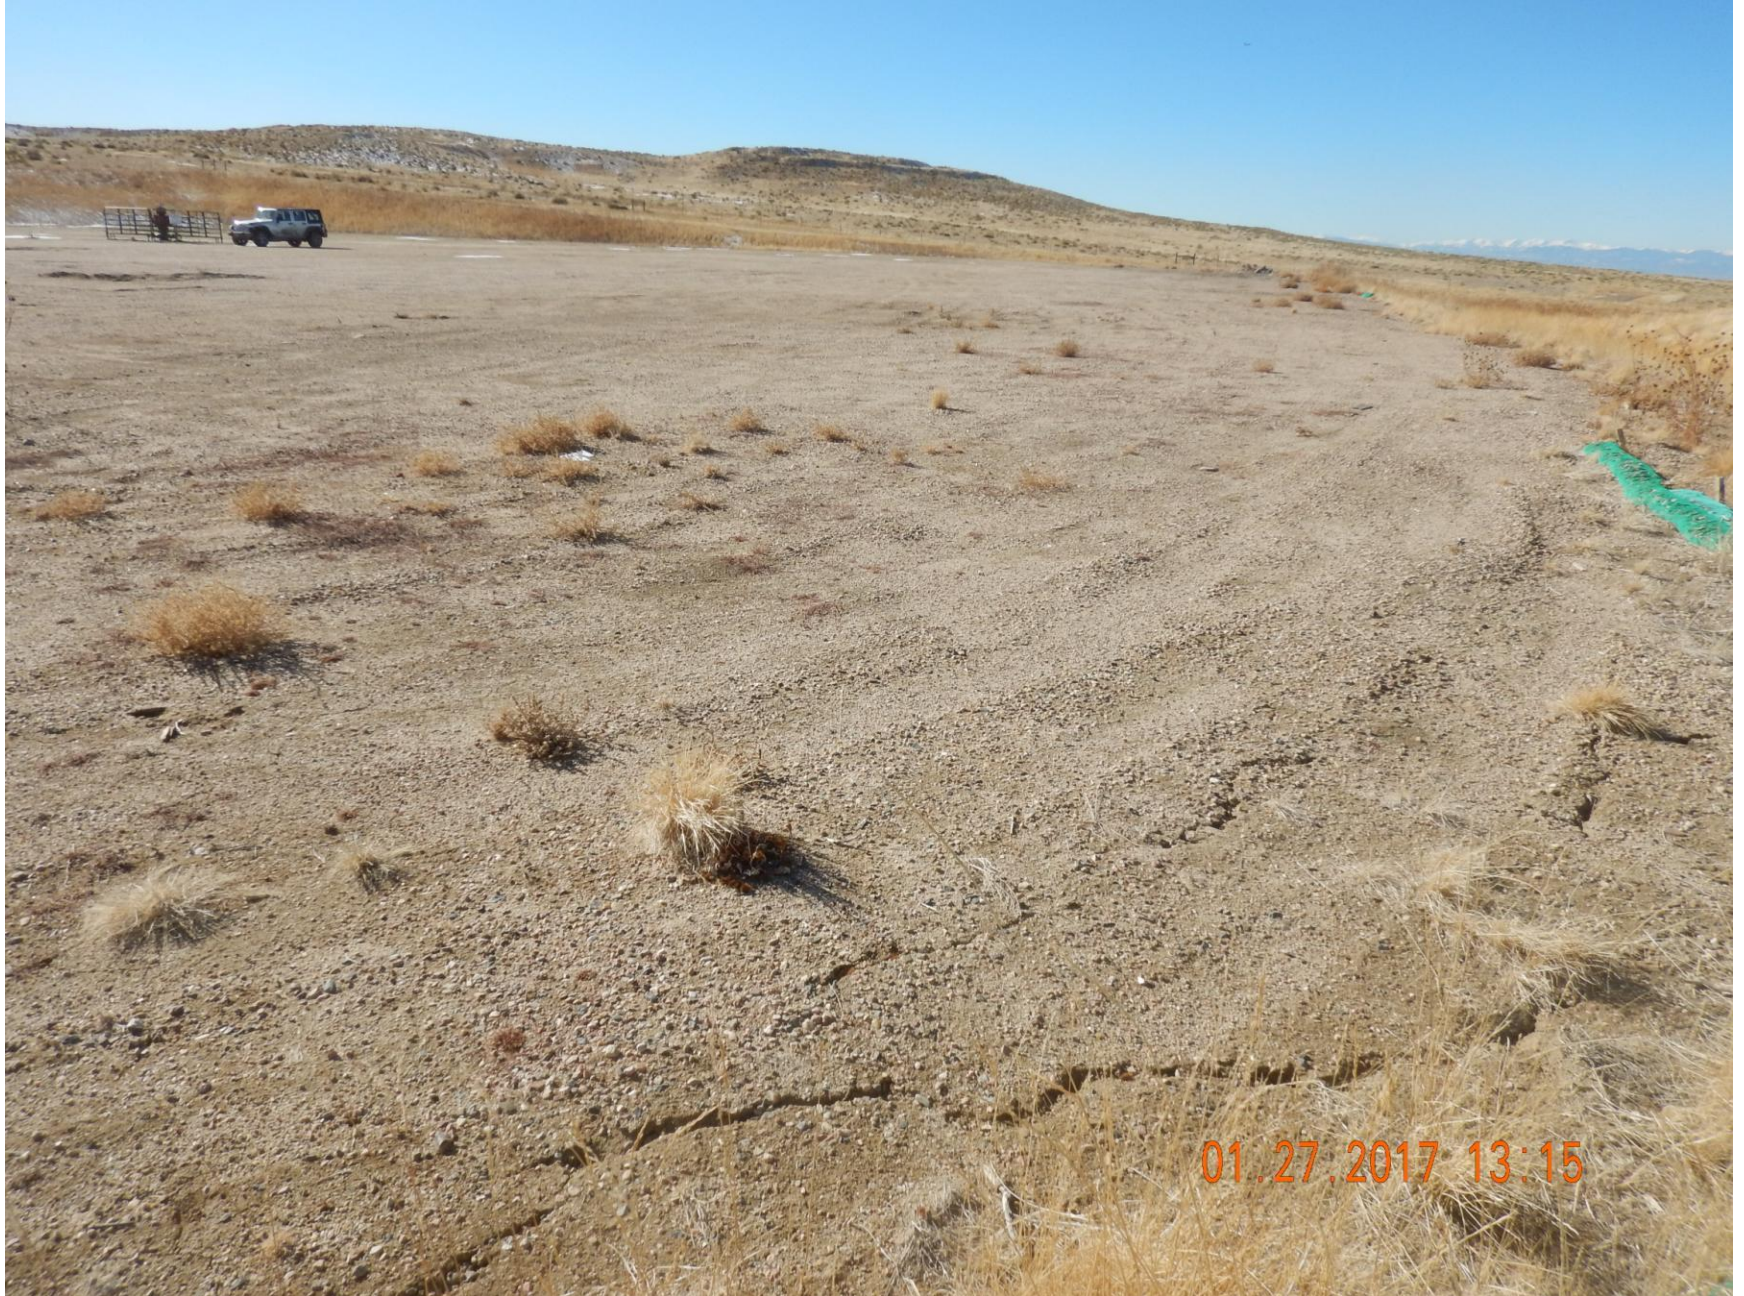
Figure 14: Photo taken from the northeast corner of the current project area, facing west. Photo shows only one well on location as stated in the 2A. Photo also shows that interim reclamation has not been conducted.

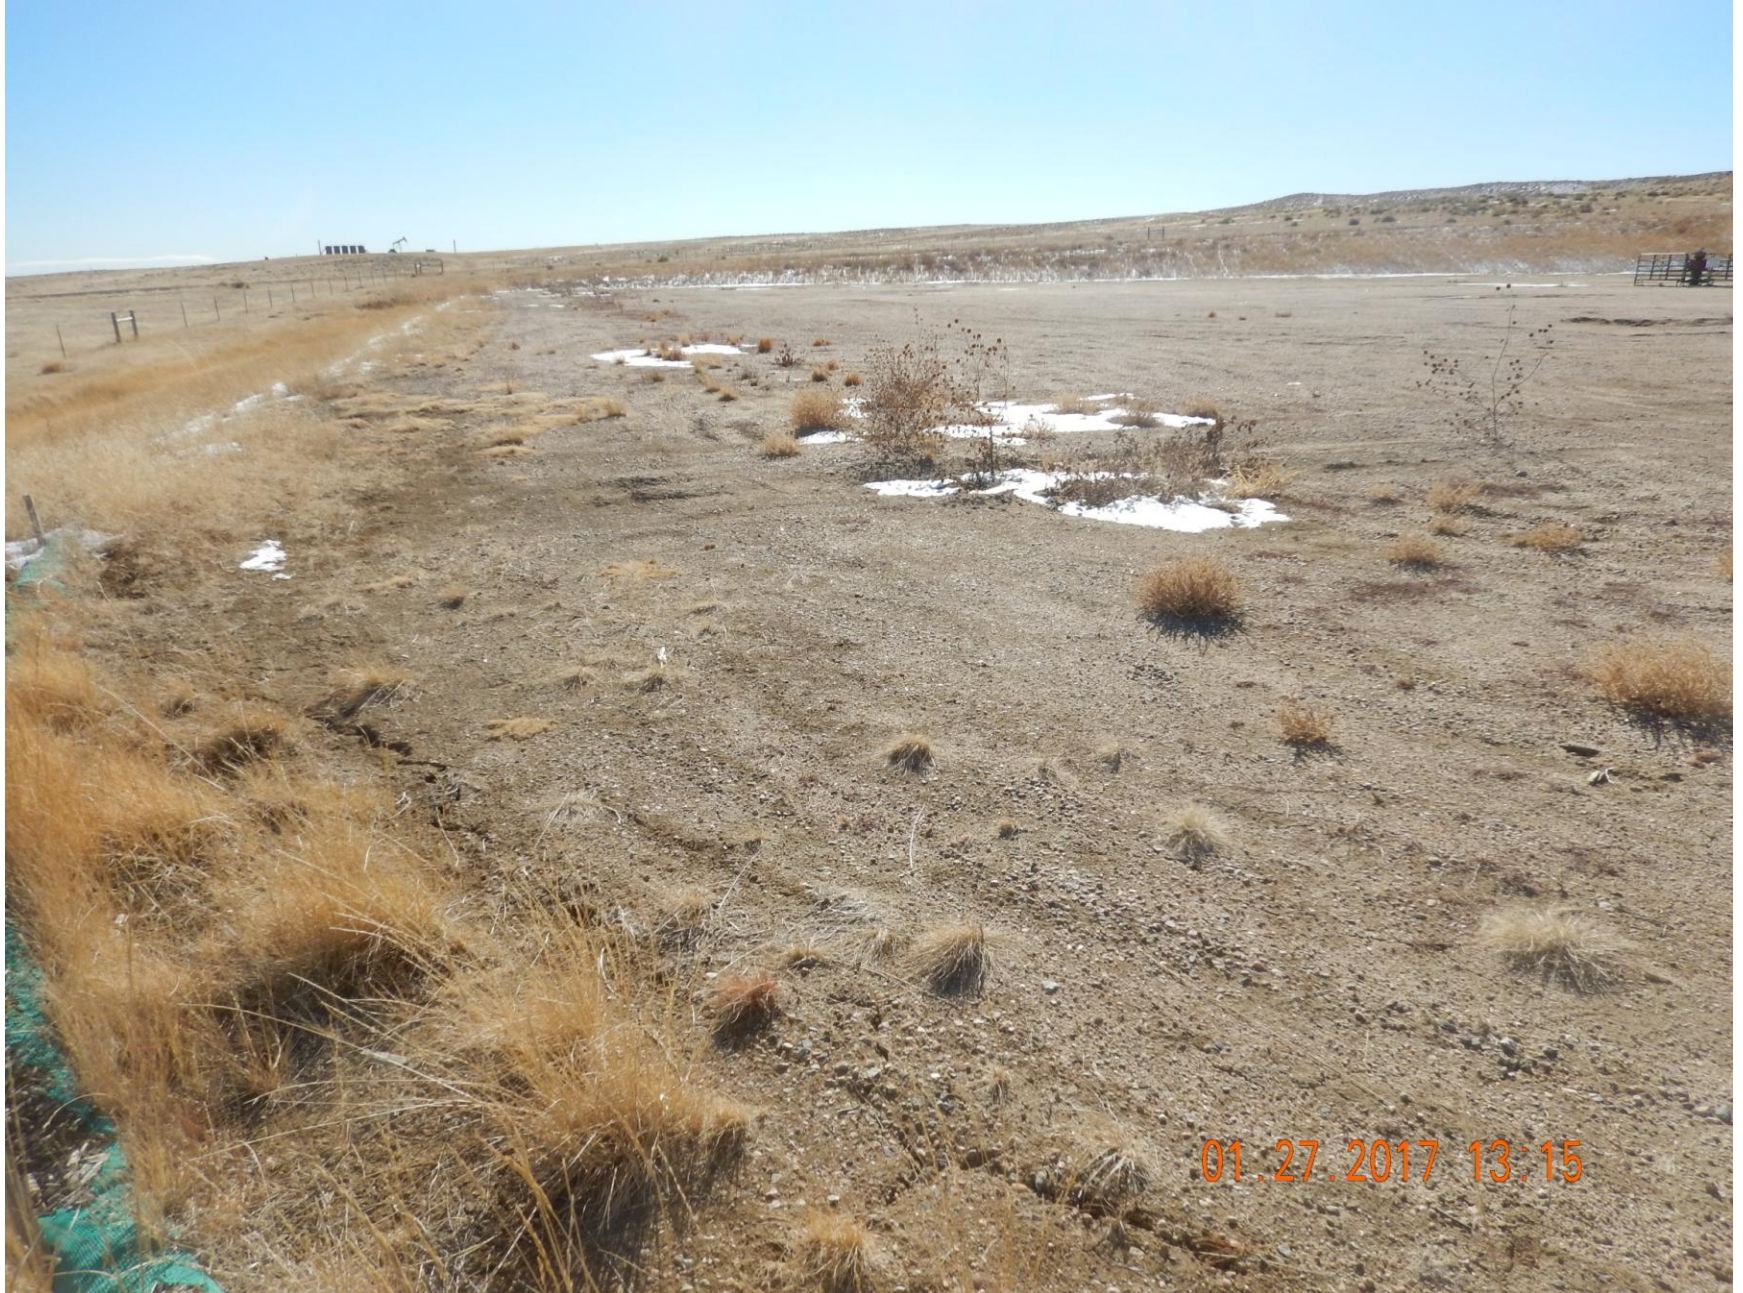
Figure 15: Photo taken from the northeast corner of the current project area, facing south. Photo shows only one well on location as stated in the 2A. Photo also shows that interim reclamation has not been conducted.

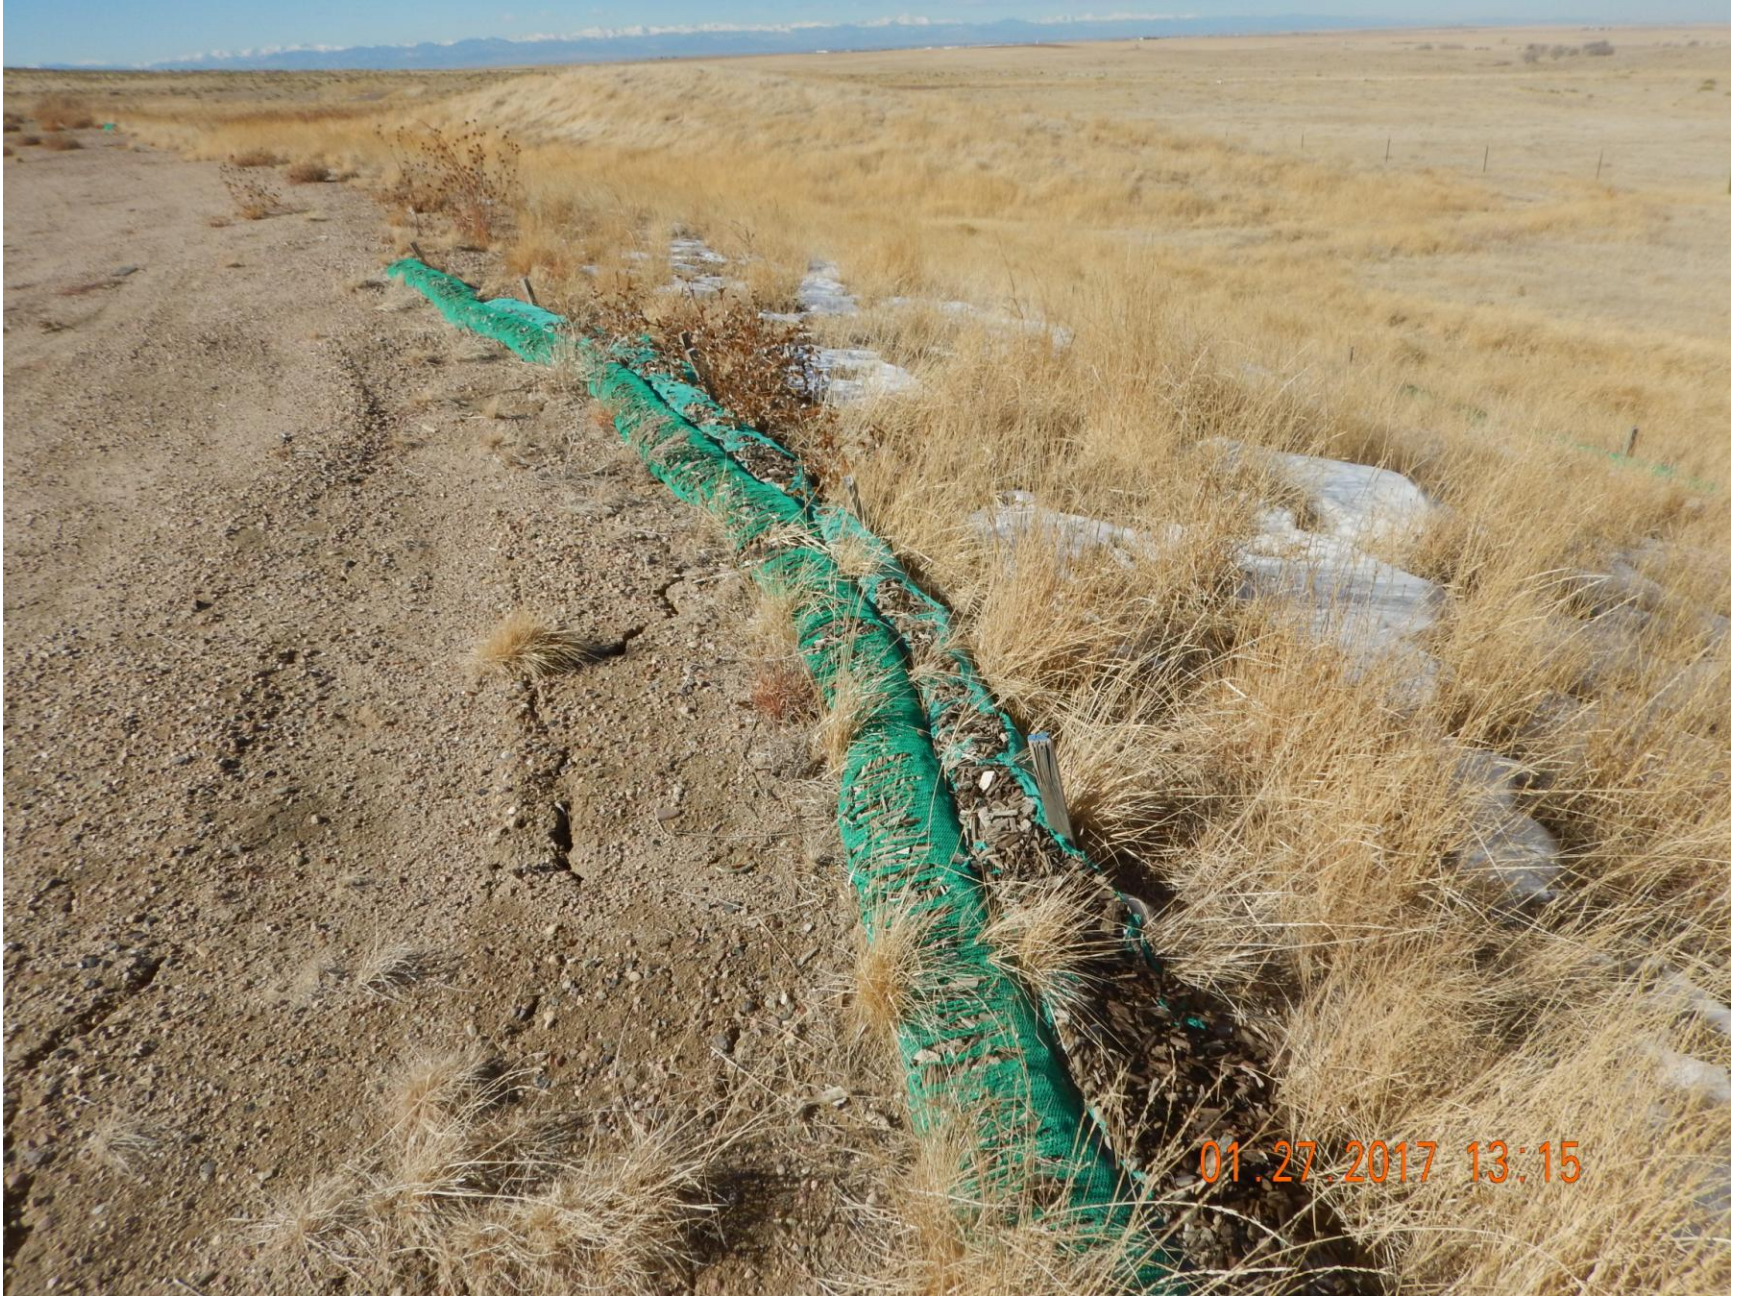
Figure 16: Photo taken from the northeast corner of the location, facing west. Photo shows wattles used as a stormwater and sediment control BMP in disrepair.

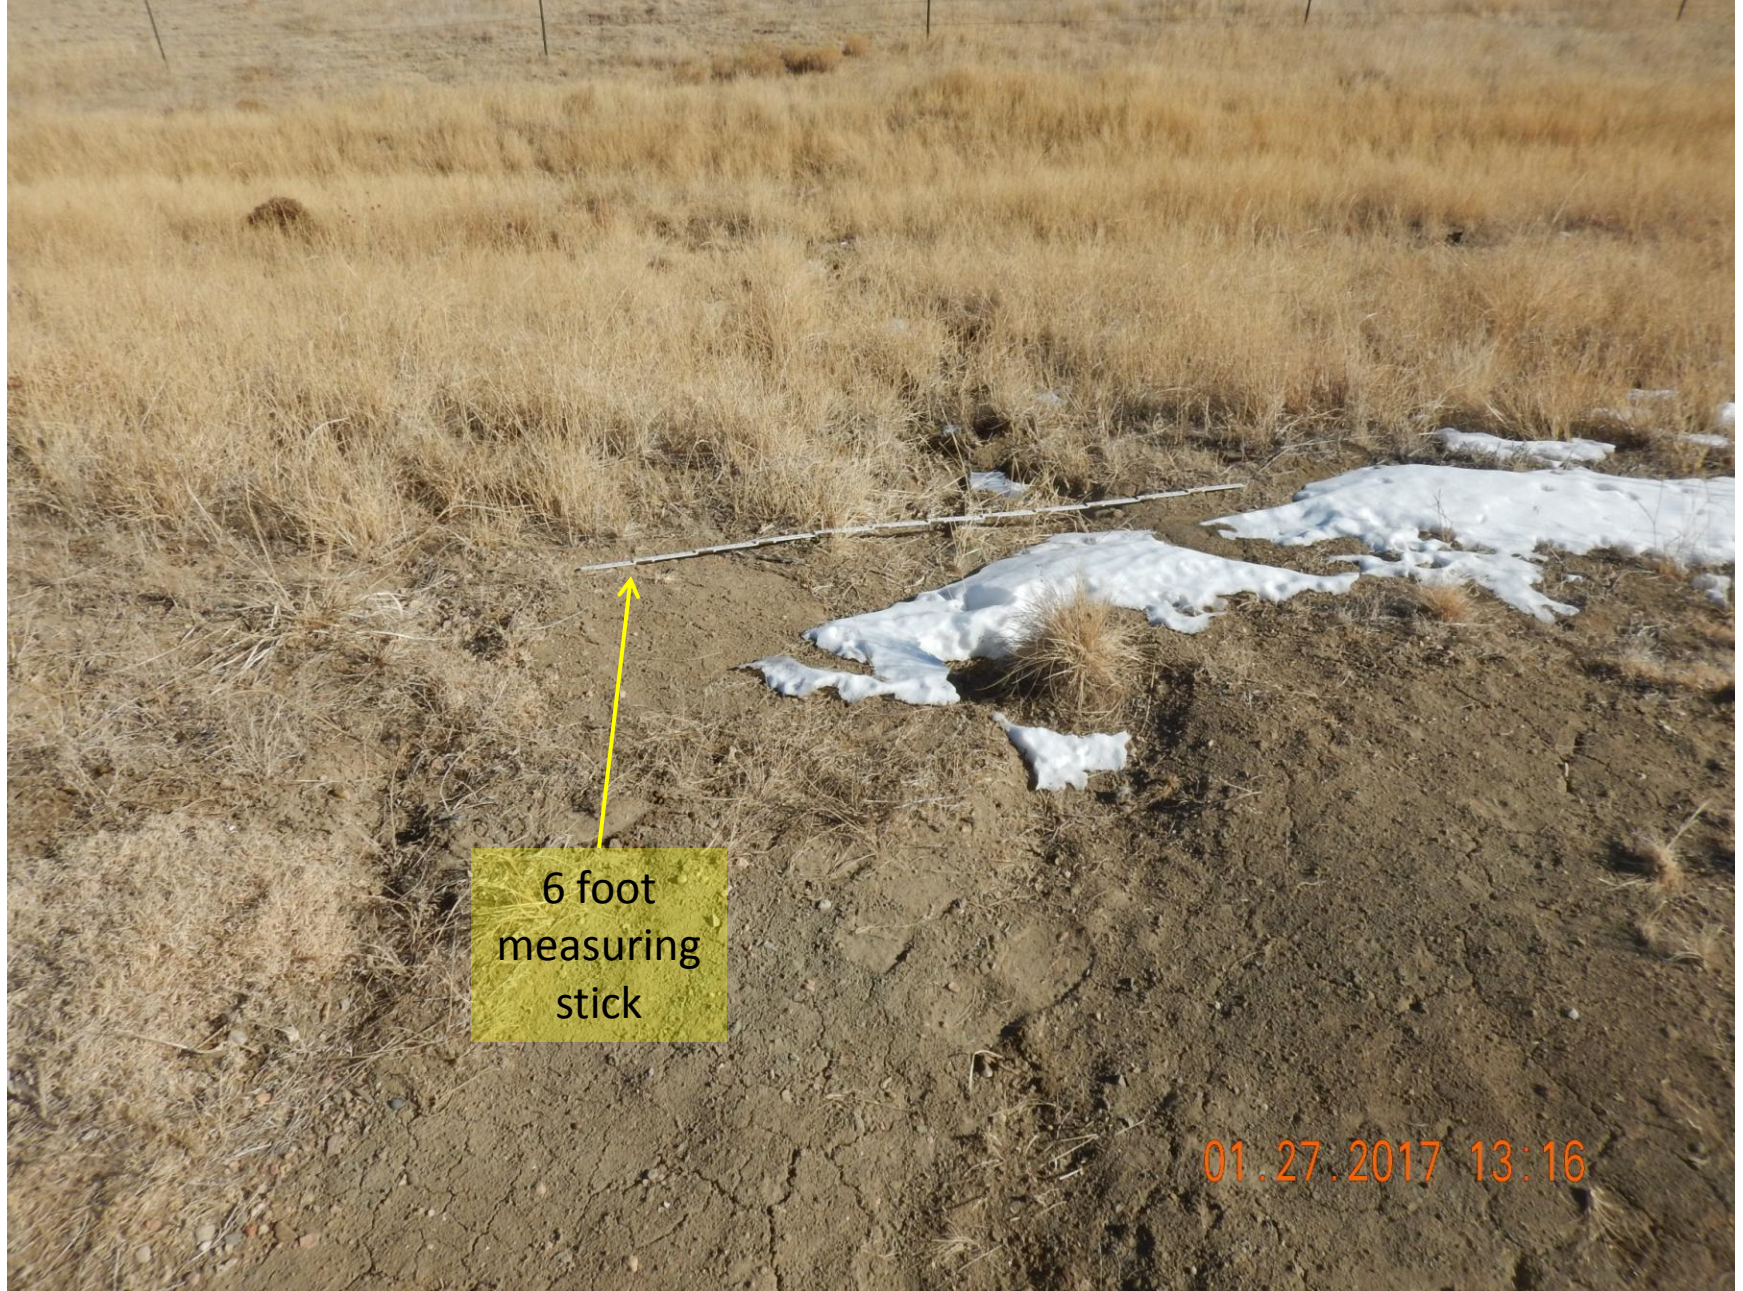
Figure 17: Photo taken from the east end of the project area, facing east. Photo shows a small gulley forming due to stormwater erosion degrading the project and interim area. Erosion will need to be repaired and stabilized. Stormwater and sediment control BMPs will need to be installed. 6 foot measuring stick used for reference.

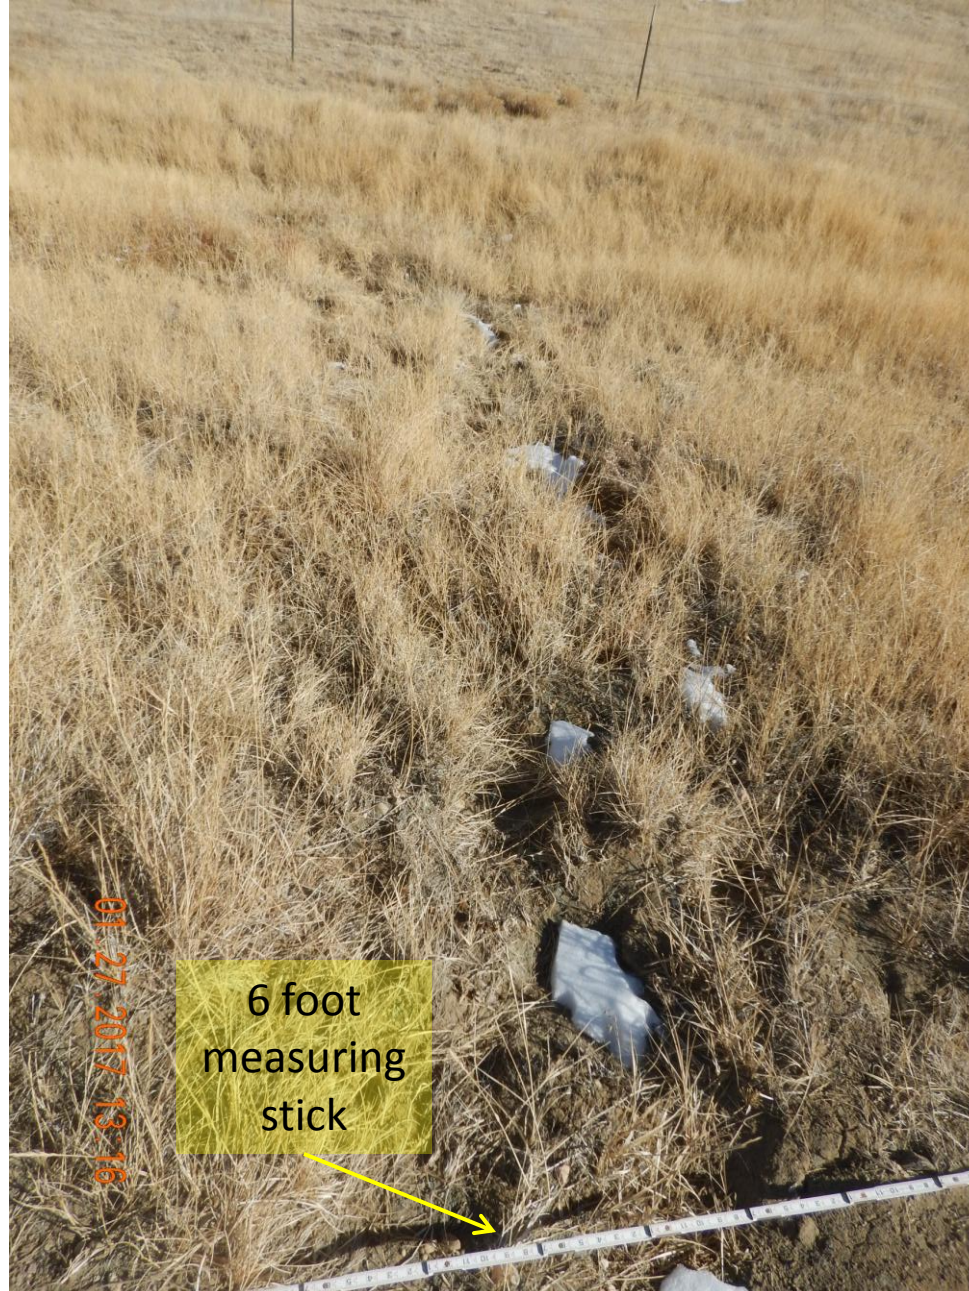
Figure 18: Photo taken from the east end of the project area, facing east. Photo shows a small gully forming due to stormwater erosion degrading the project and interim area. Erosion will need to be repaired and stabilized. Stormwater and sediment control BMPs will need to be installed. 6 foot measuring stick used for reference.

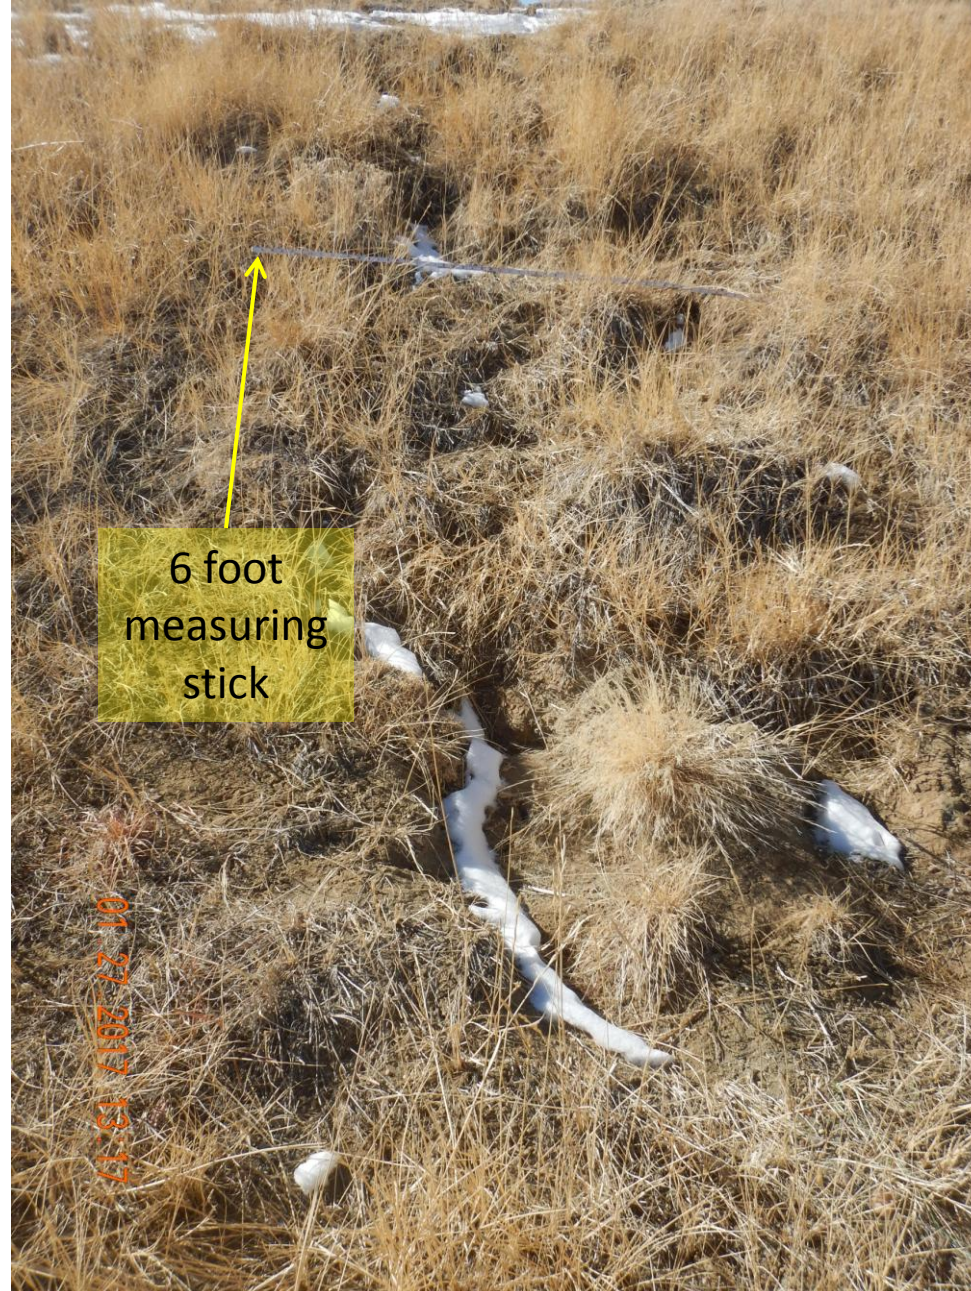
Figure 19: Photo taken from the east end of the project area, facing west towards the project area. Photo shows a small gulley forming due to stormwater erosion degrading the project and interim area. Erosion will need to be repaired and stabilized. Stormwater and sediment control BMPs will need to be installed. 6 foot measuring stick used for reference.

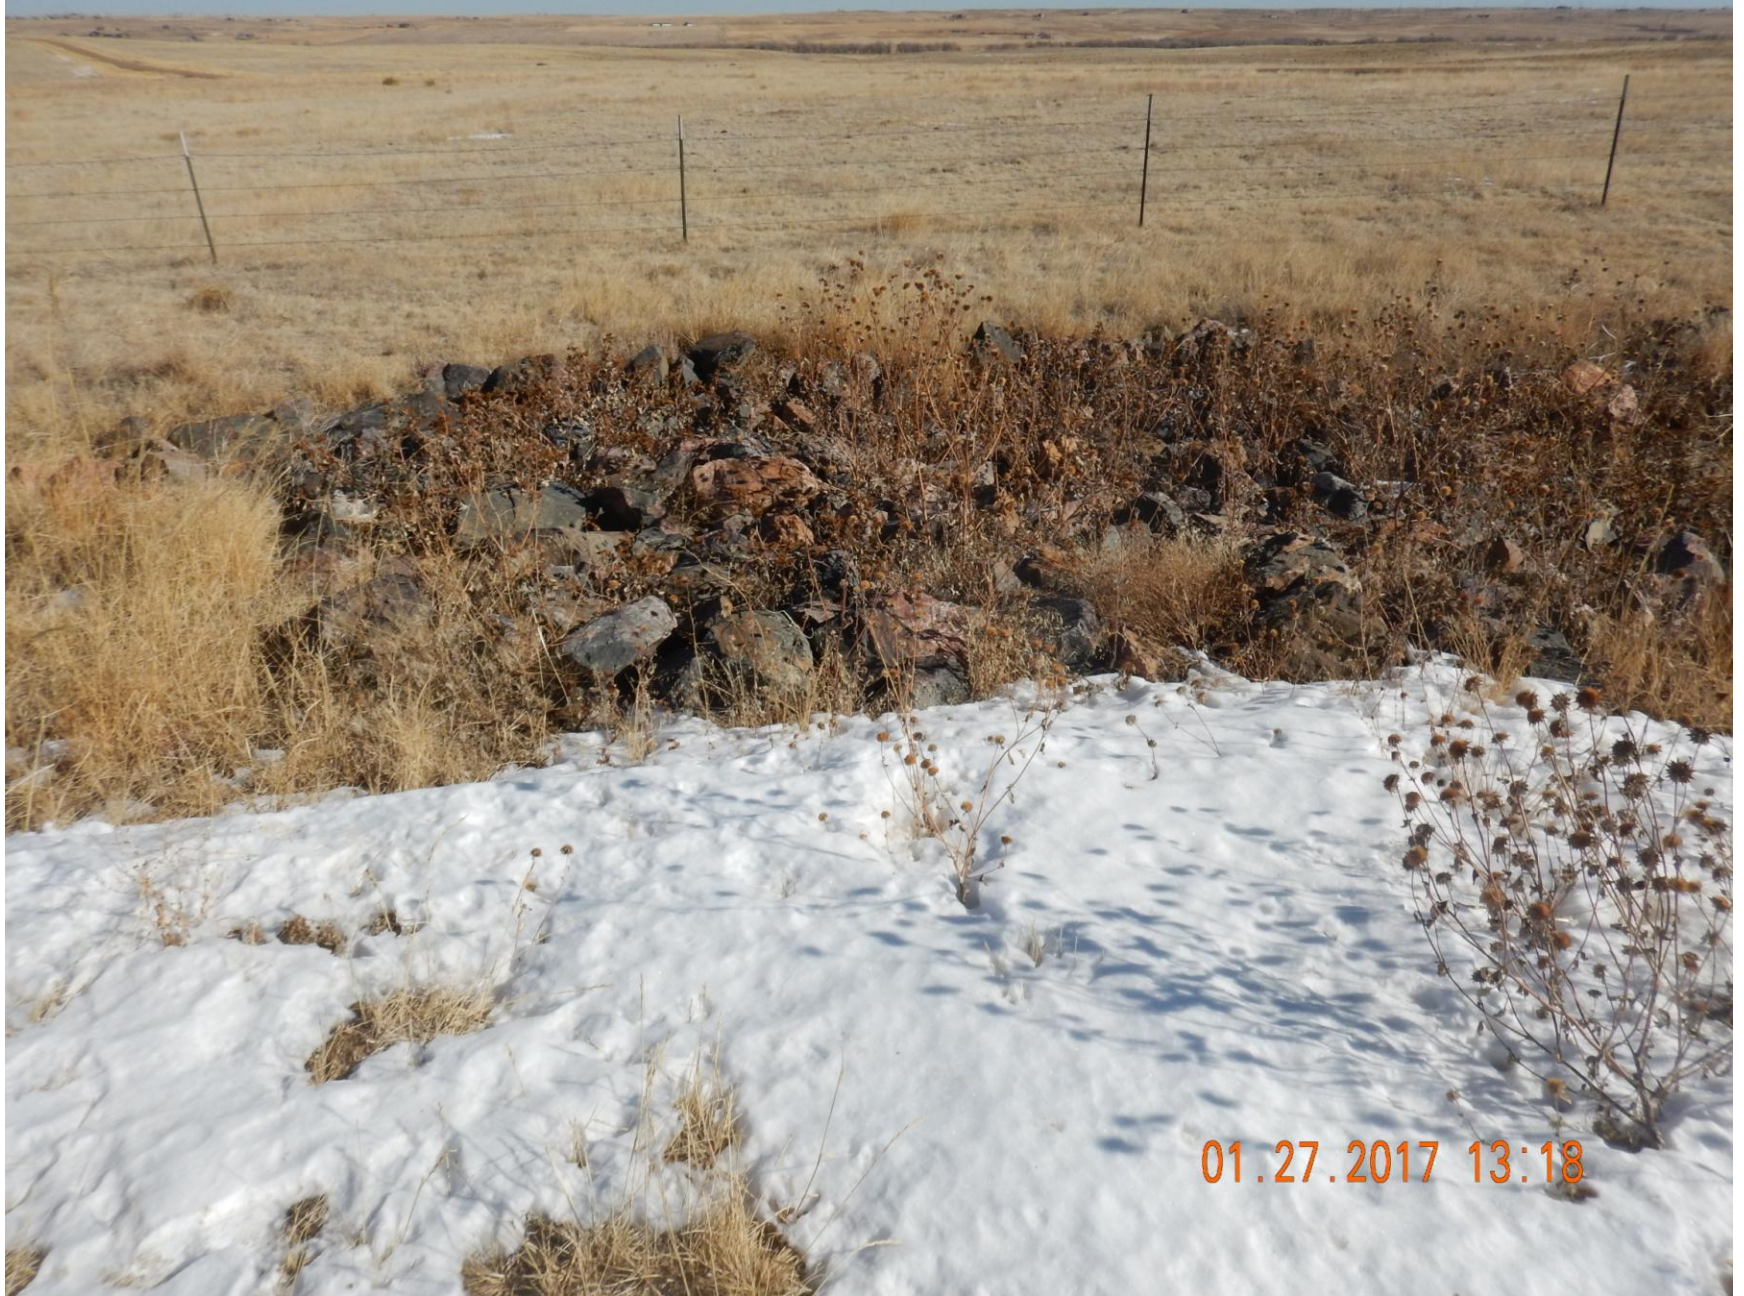
Figure 20: Photo taken from the southeast corner of the location, facing east. Photo shows sediment trapped used as a stormwater and sediment control BMP.
